## **Evaluation of Lightweight Noise Barrier on IH-30 Bridge Structure in Dallas, Texas**

CTR Technical Report:	0-6804-1
Report Date:	August 2014; Published March 2015
Project:	0-6804
Project Title:	Life Cycle Cost and Performance of Lightweight Noise Barrier Materials Along Bridge Structures
Sponsoring Agency:	Texas Department of Transportation
Performing Agency:	Center for Transportation Research at The University of Texas at Austin

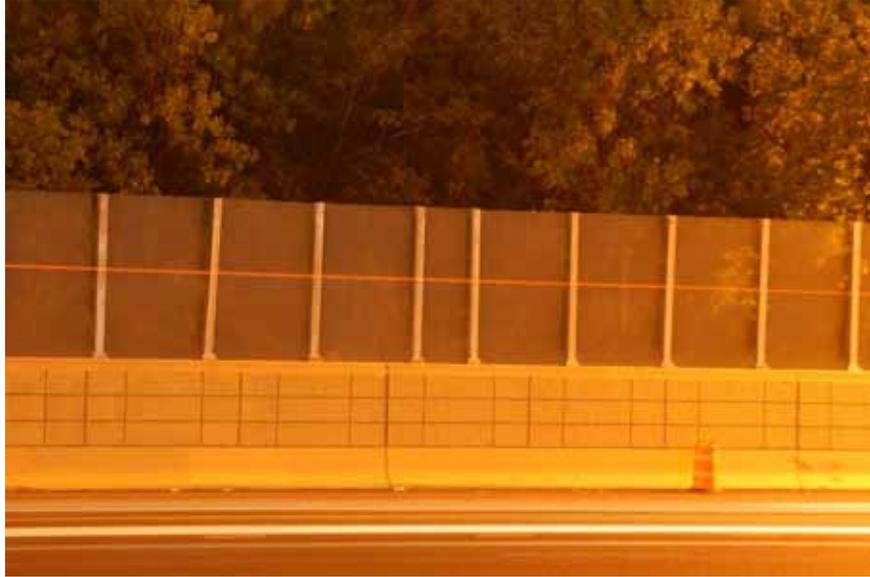
*Figure 7.9: Some vertical supports off-plumb*

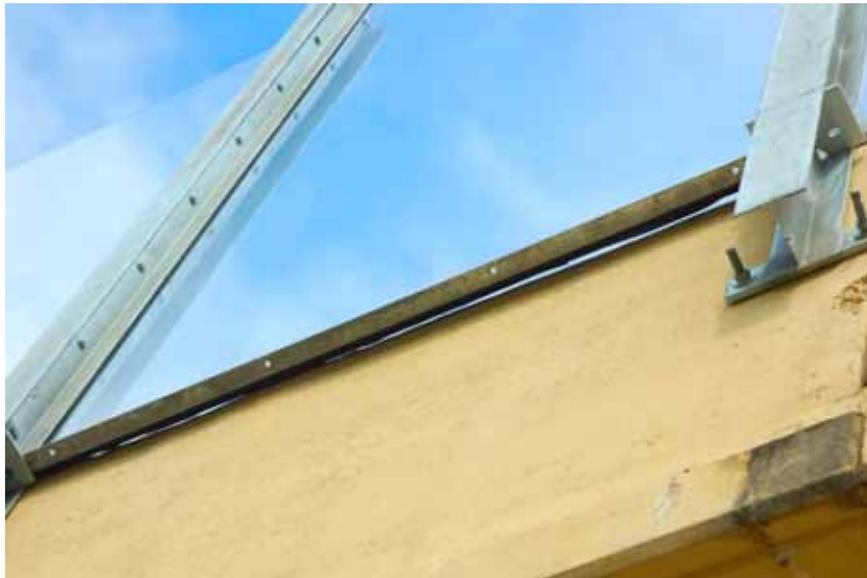
*Figure 7.13: Gap between horizontal gasket and metal support*

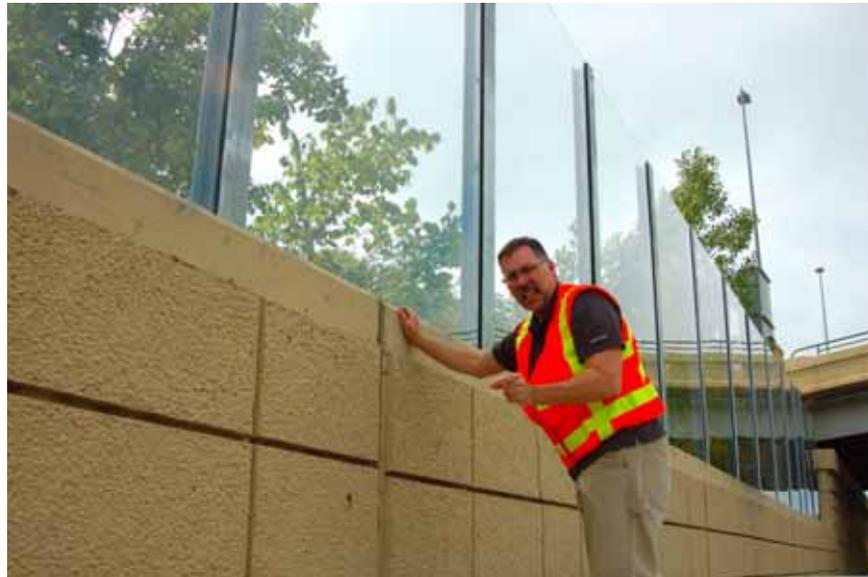
*Figure 7.14: Armtec’s Mark McIlheran inspecting the wall, showing the gap size between a panel and the gasket*

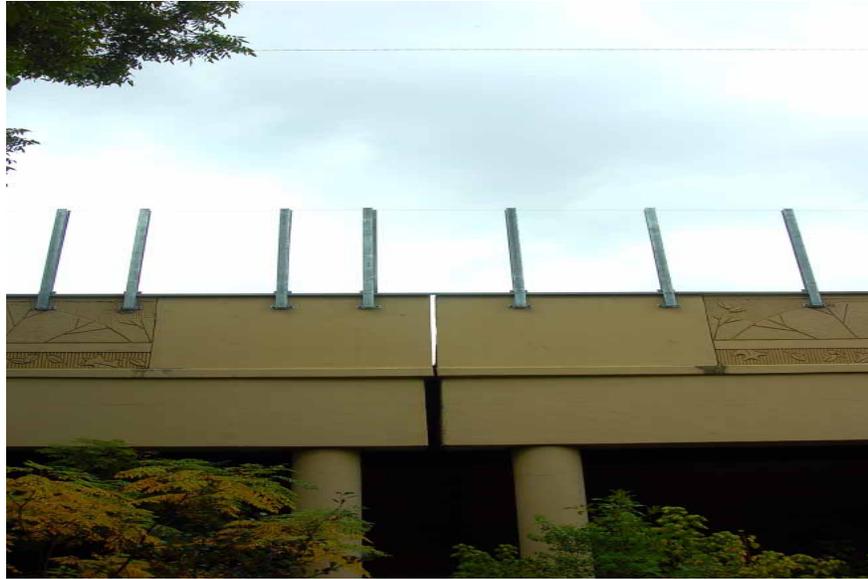
*Figure 7.15: Gap in existing concrete wall at bridge expansion joint as seen from Coombs Creek*

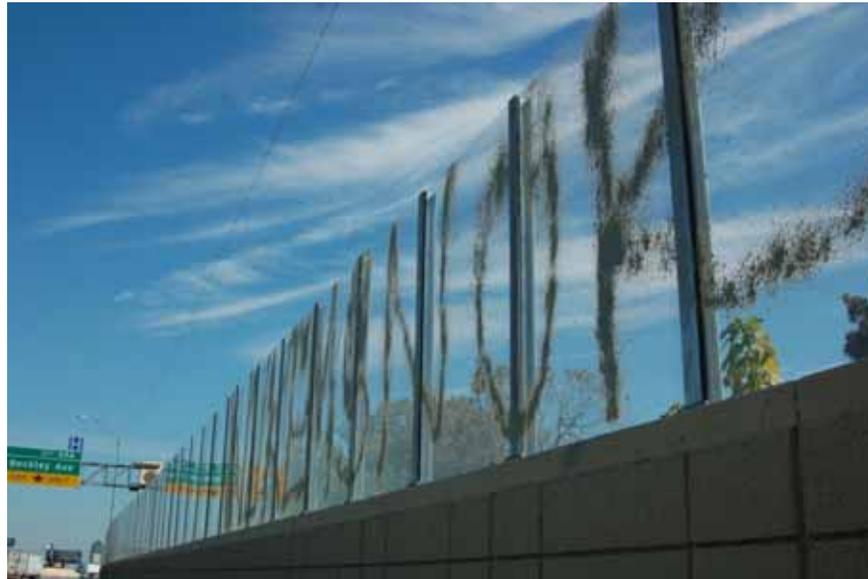
*Figure 7.17: Graffiti as seen from the highway shoulder on November 11, 2013*

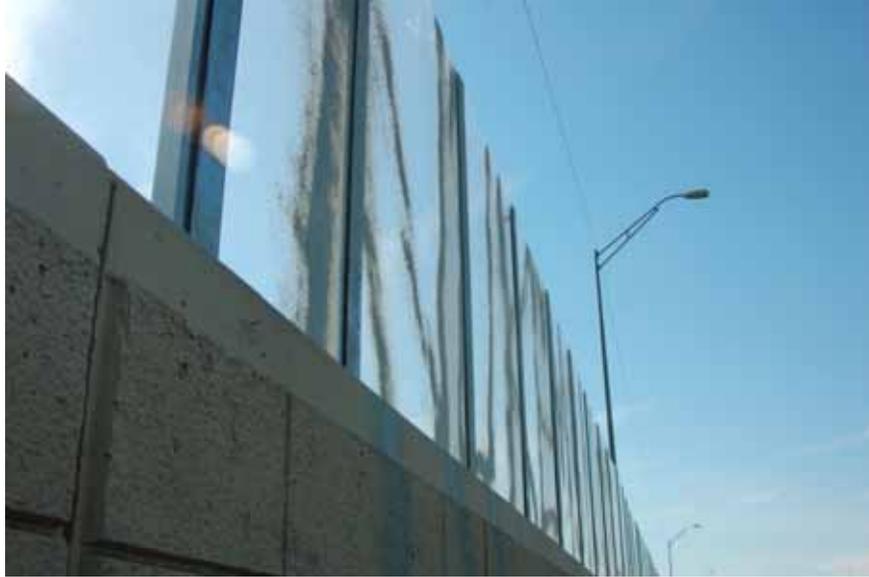
*Figure 7.19: Graffiti as seen from the highway shoulder on November 11, 2013. The damage extends to the concrete wall under span #144.*

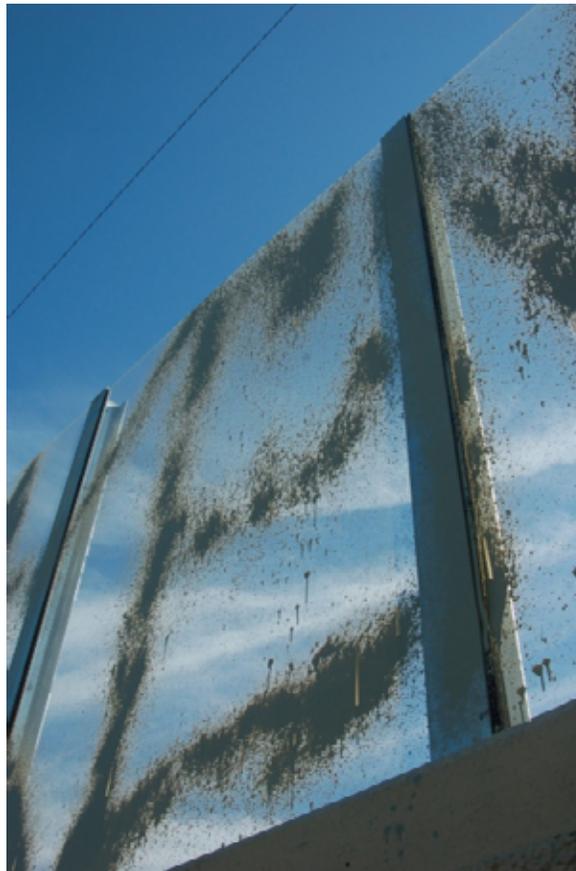
*Figure 7.20: Graffiti as seen from the highway shoulder on November 11, 2013*

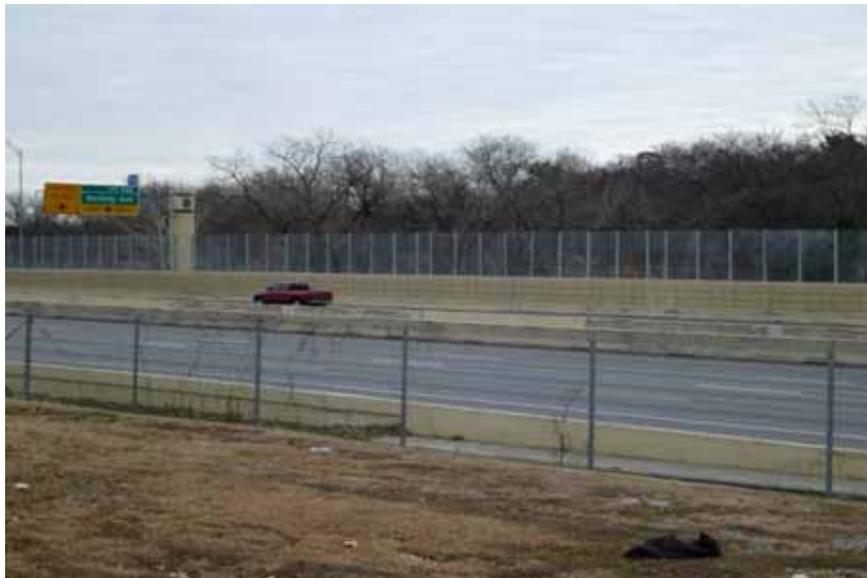
*Figure 7.27: Graffiti removed from acrylic panels*

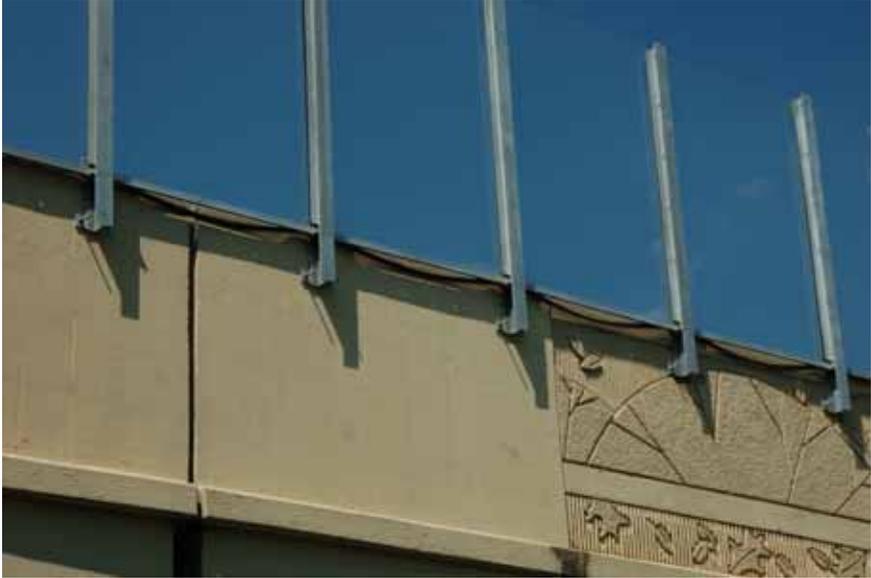
*Figure 7.28: Sagging of horizontal rubber gaskets*

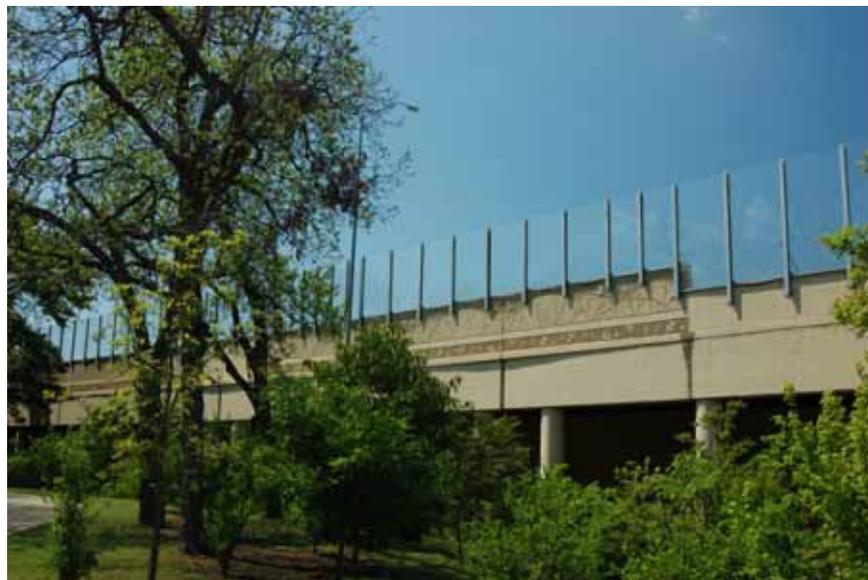
*Figure 7.31: Sagging of horizontal rubber gaskets*

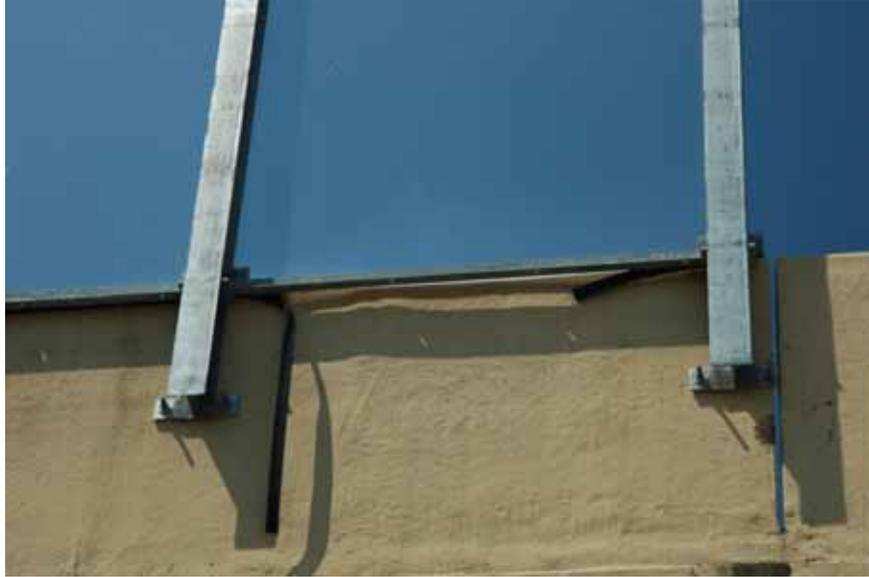
Some of the gaskets have broken, as shown in Figures 7.32, 7.33, and 7.34.

*Figure 7.32: Broken horizontal rubber gasket*

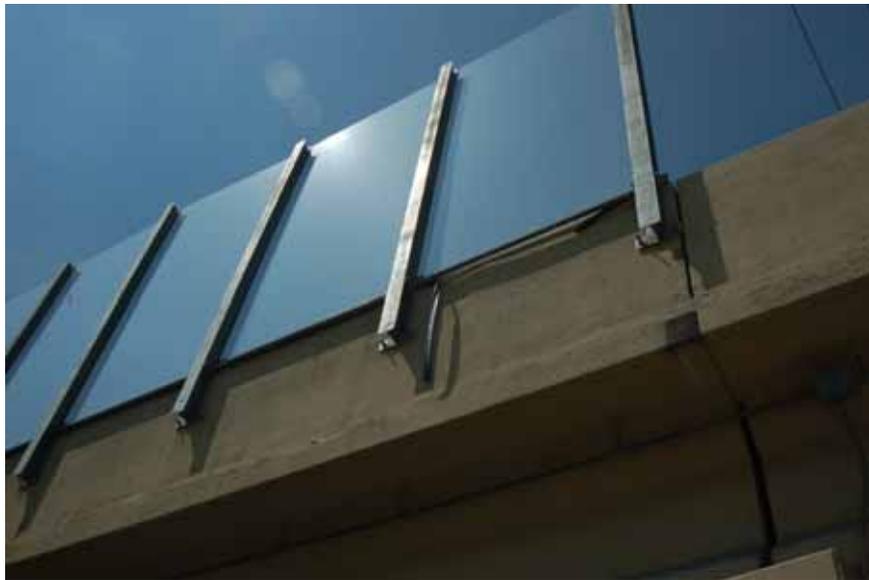
*Figure 7.33: Broken horizontal rubber gasket*

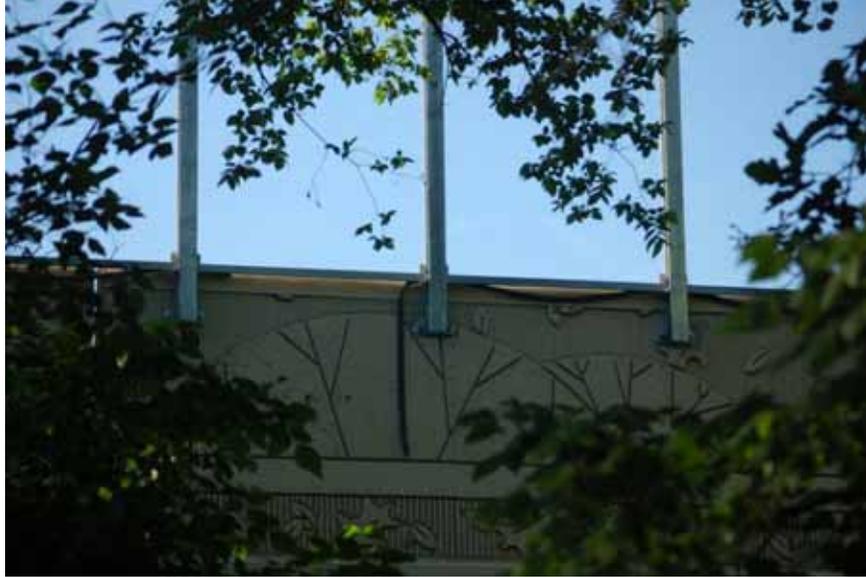
*Figure 7.34: Broken horizontal rubber gasket*

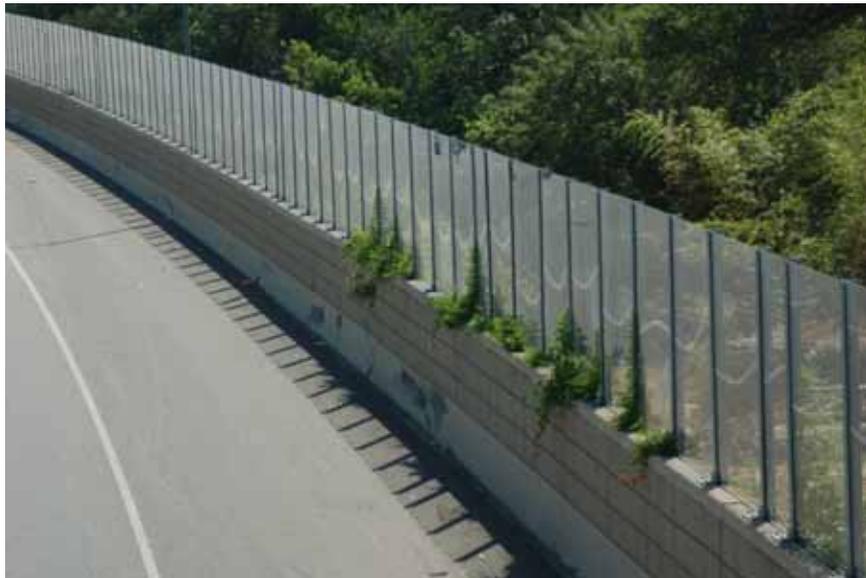
*Figure 7.35: Vegetation from the creek side growing through the openings in the gaskets under noise barrier*

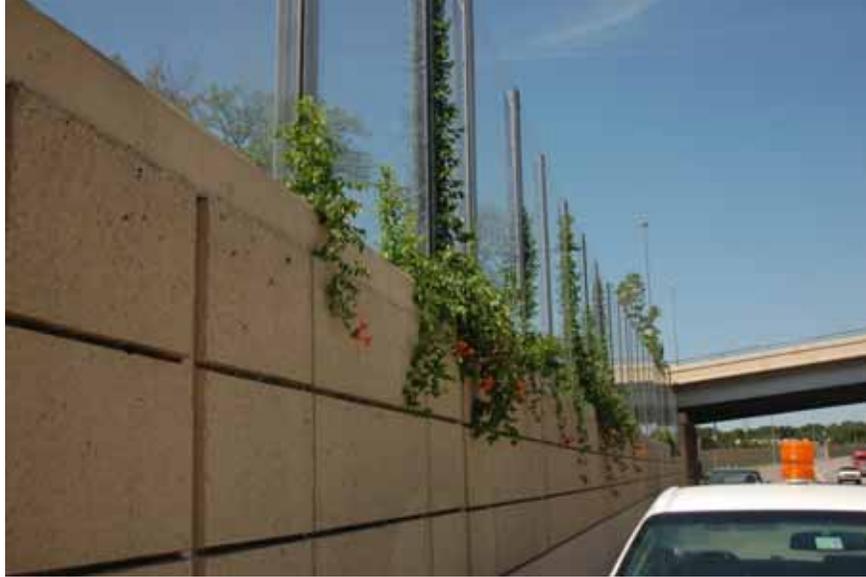
*Figure 7.36: Vegetation from the creek side growing through the openings in the gaskets under noise barrier*

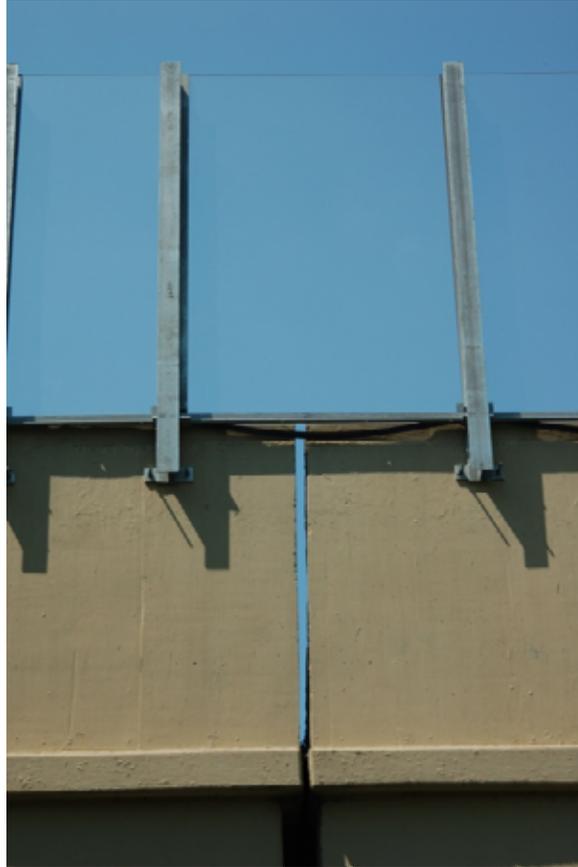
*Figure 7.37: Expansion joint opening due to lack of sealant*

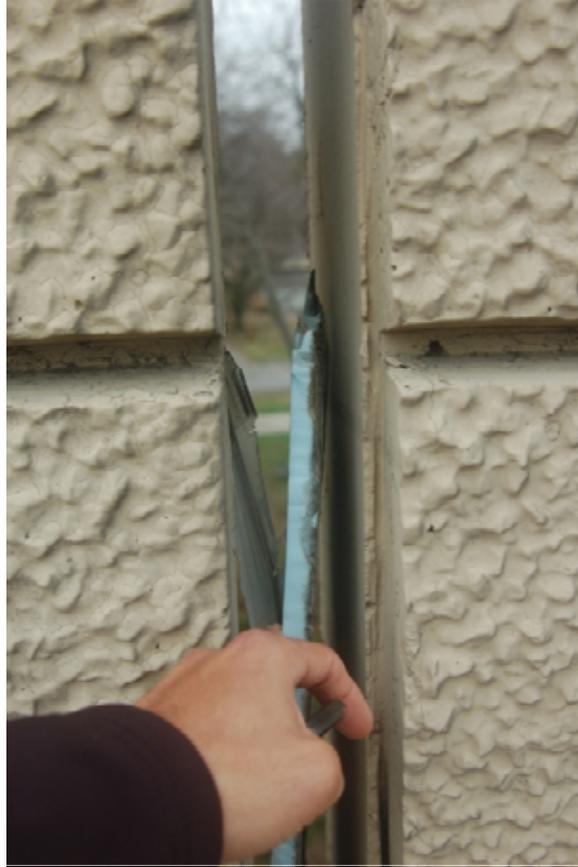
*Figure 7.38: Damaged, old sealant material in the expansion joints of bridge structure*

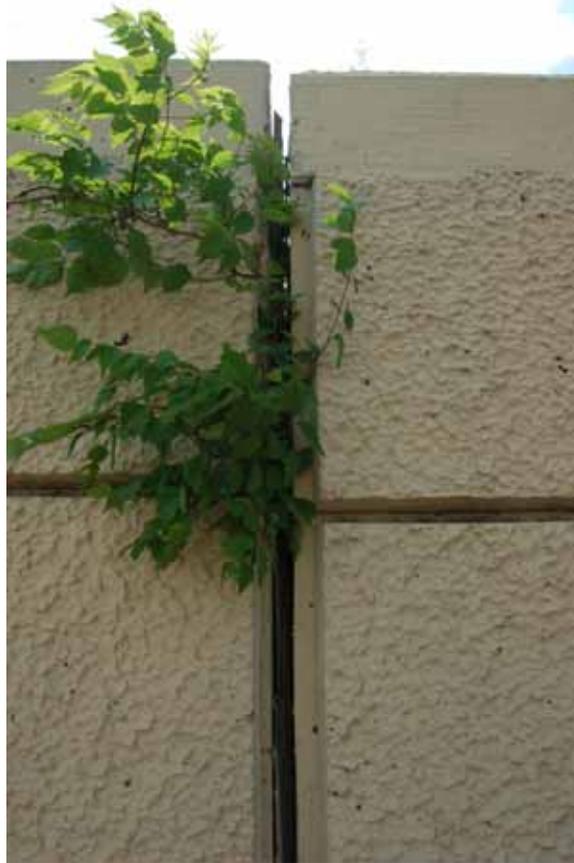
*Figure 7.39: Vegetation from the creek side growing through the openings in the concrete structure*
