TECHNICAL REPORT 5-6005-01-1

TxDOT PROJECT NUMBER 5-6005-01

**STATEWIDE IMPLEMENTATION OF THE TOTAL
PAVEMENT ACCEPTANCE DEVICE (TPAD)—
FINAL REPORT**

Kenneth H. Stokoe II
Jung-Su Lee
Tom Scullion

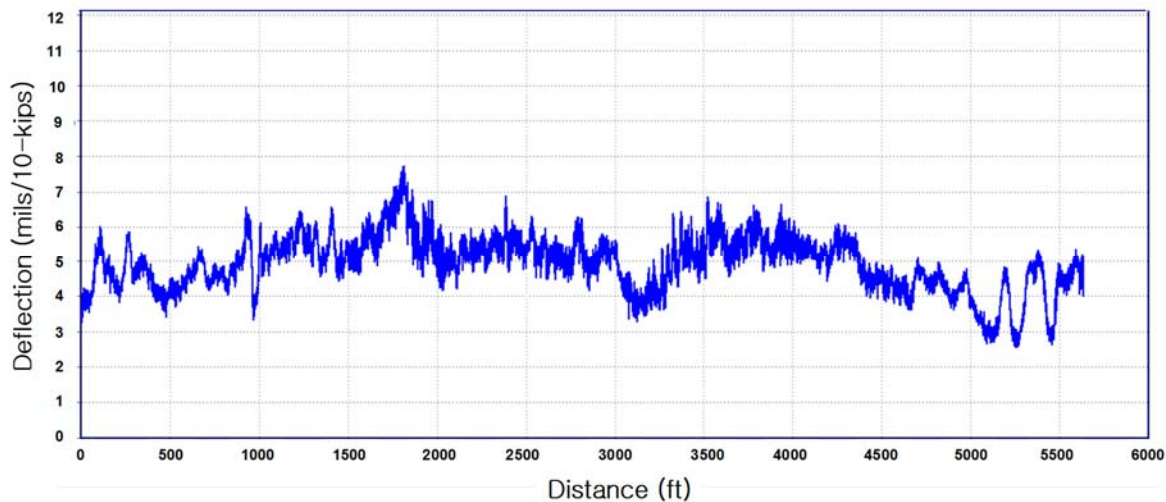
TPAD testing was performed at San Marcos Airport in coordination with Mr. Edward Oshinski at the TxDOT Aviation Division on February 19 and 20, 2013. Two runways, Runways 8/26 and 13/31, have asphalt surface layers. Four of the eight lanes of Runway 8/26 were profiled. However, the signals from the center sensor were not clear because of an inadequate connection between a connecting cable and the sensor. This problem was subsequently fixed. However, the other two rolling sensors performed well and supported adequate data. Two deflection profiles collected on Lanes 3 and 4 are shown in Figures 2.1 and 2.2, respectively. Testing was begun from the east end of the runway for Lane 3 and the west end of the runway for Lane 4. The deflection data collected along the two lanes show relatively small deflections, generally less than 7 mils per 10 kips of loading, indicating that the pavements are sound.

Figure 2.1: Deflection Profile Collected on Lane 3 of Runway 8/26 with the Center Sensor

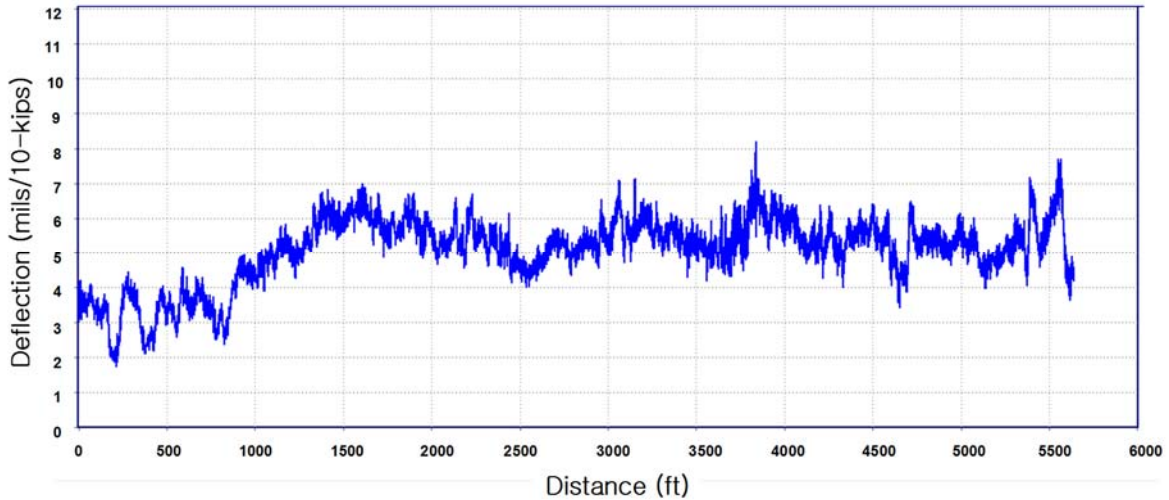
Figure 2.2: Deflection Profile Collected on Lane 4 of Runway 8/26 with the Center Sensor

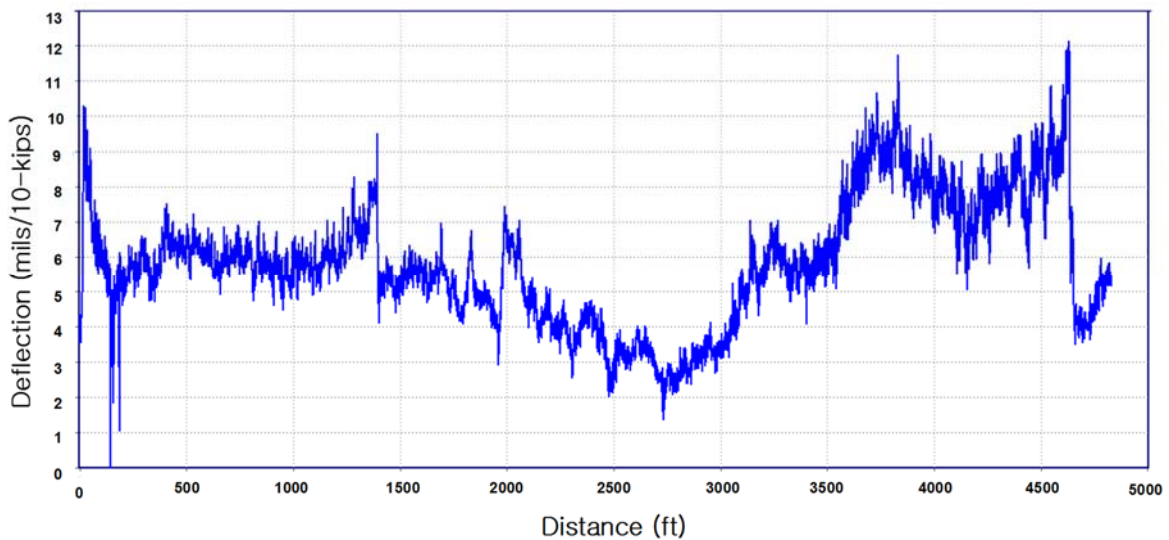
TPAD testing on Runway 13/31 was performed only on Lane 6 because of rain. The deflection data collected on Lane 6 of Runway 13/31 are shown in Figure 2.3. The deflections are generally low, with the exception of a 1000-ft long section between 3500 and 4500 ft from the northwest end of the runway. However, this 1000-ft section exhibits average deflections less than 10 mils per 10 kips of load, which indicates that this section of pavement is also structurally sound.

Figure 2.3: Deflection Profile Collected on Lane 6 of Runway 13/31 with the Center Sensor

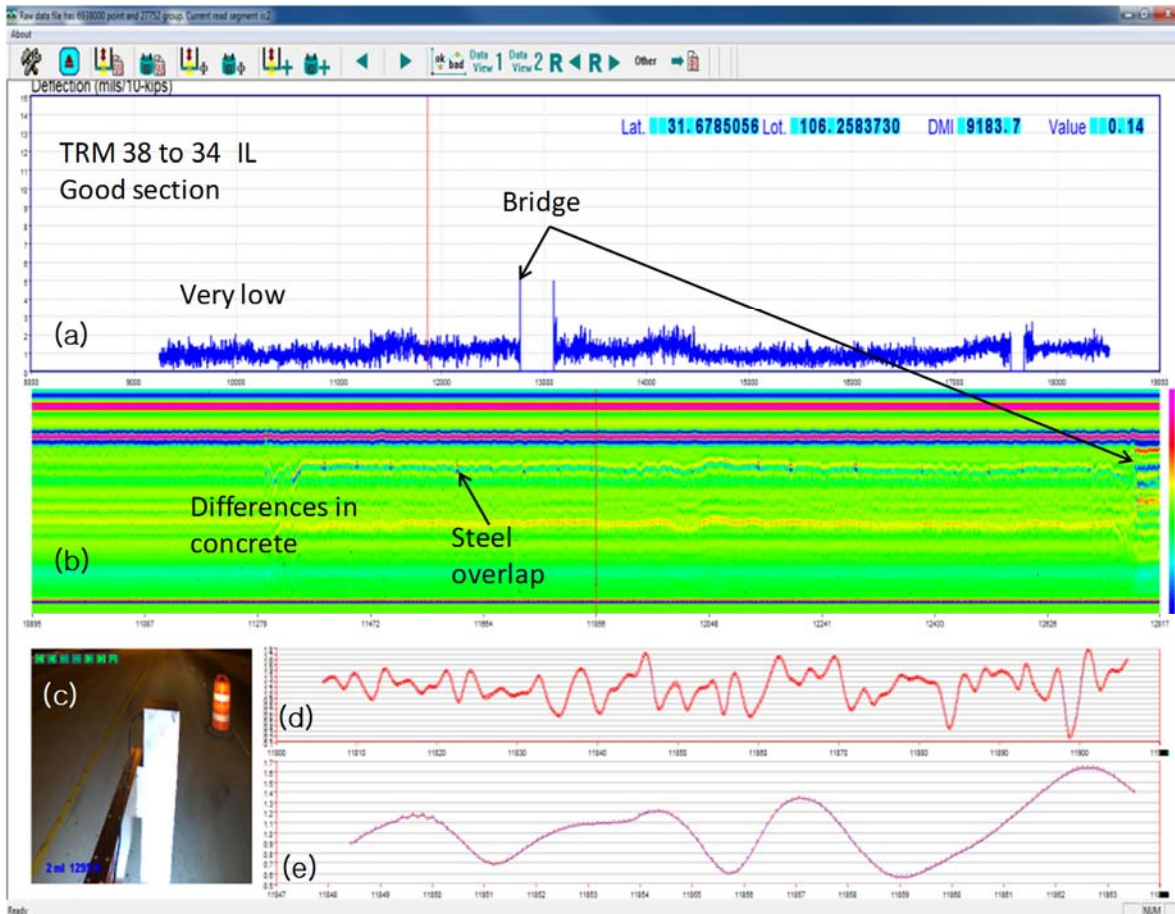
The deflection profile (Figure 2.5 [a]), GPR profile (Figure 2.5 [b]), and video image (Figure 2.5 [c]) collected on the good section (westbound from TRMs 38 to 34) are shown in Figure 2.5. Two figures (Figures 2.5 [d] and 2.5 [e]) next to the video image are expanded deflection profiles around the vertical red line in the first deflection profile (Figure 2.5 [a]). Deflections are low in this section, with deflections averaging around 1.5 mils/10 kips. The two large peaks around a distance of 13,000 ft are from the bridge approaches, on the arriving and departing slabs.

Figure 2.5: Deflection Profile, GPR Profile, and Video Image Collected on Reference Section (The “Good” Section), Westbound from TRM 38 to TRM 34: (a) TPAD, RDD Data, (b) TPAD, GPR Data, (c) TPAD Video Image, (d) Expanded RDD Data from Figure 2.5 (a) at the Red Line, and (e) Additional Expansion of RDD Data of the Red Line in Figure 2.5 (a)

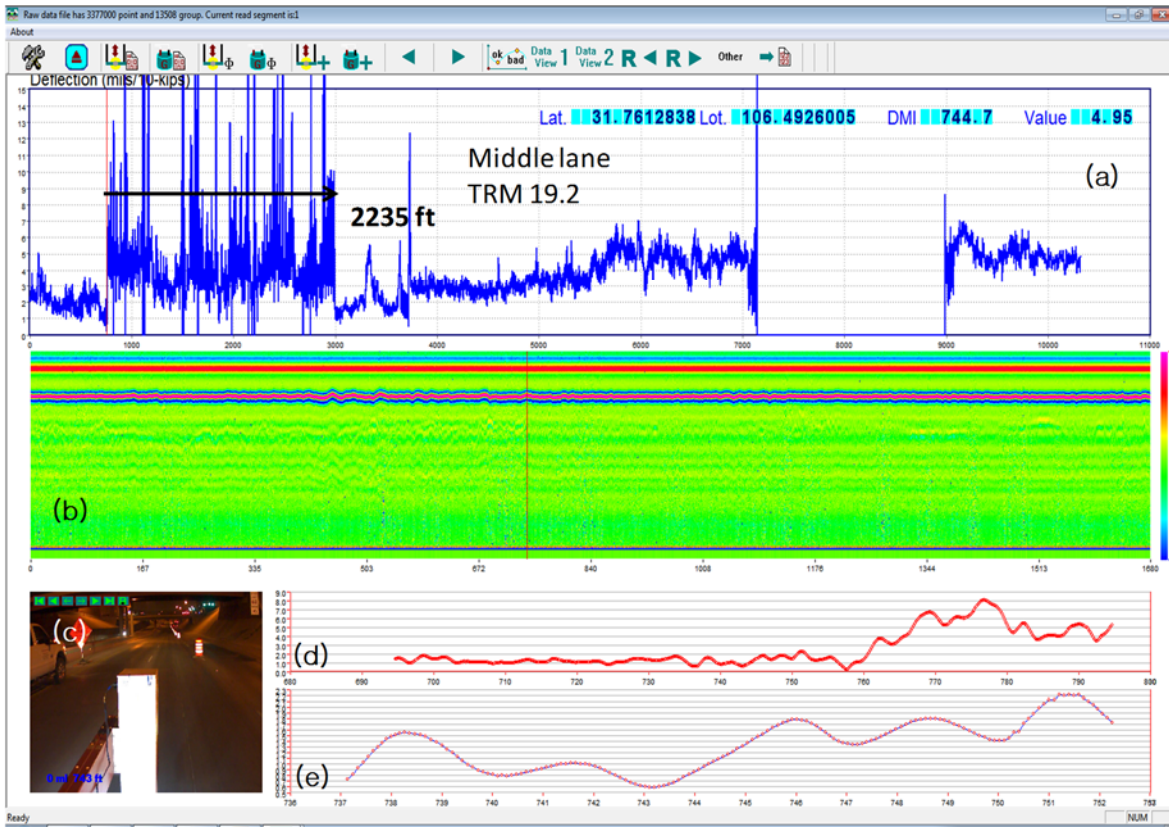
The deflection profile, GPR profile, and video image collected on the middle lane of the eastbound section from Exits 19 to 23 are shown in Figure 2.6. It is interesting to see the large deflections in a section approximately 2000 ft long. These large deflections were a surprise since this section did not exhibit structural problems. This section was found by continuous deflection profiling and clearly indicated delaminations. The data collected on the inside lane also exhibited the same pattern but a representative figure is not shown in this report.

Figure 2.6: Deflection Profile, GPR Profile, and Video Image Collected on the Middle Eastbound Lane from Exits 19 to 23: (a) TPAD, RDD Data, (b) TPAD, GPR Data, (c) TPAD Video Image, (d) Expanded RDD Data from Figure 2.6 (a) at the Red Line, and (e) Additional Expansion of RDD Data of the Red Line in Figure 2.6 (a)

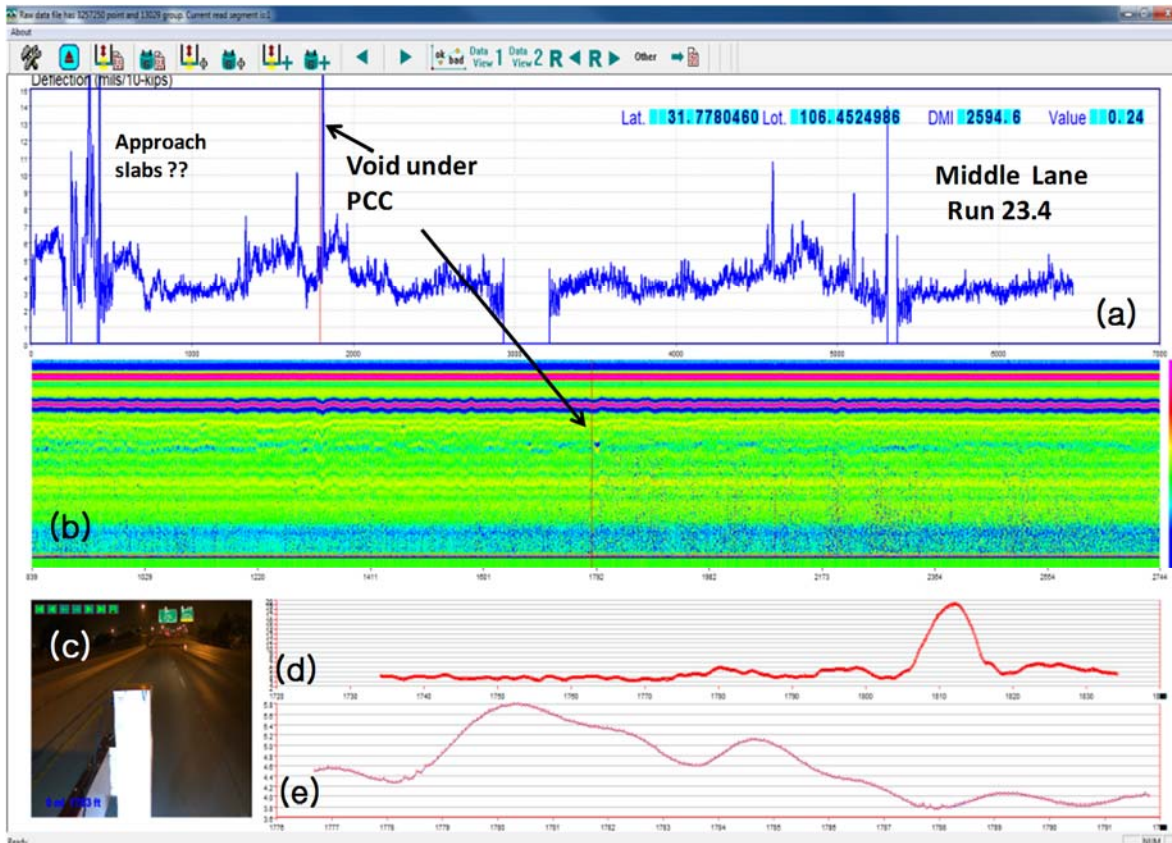
The deflection profile, GPR profile, and video image collected on the middle westbound lane from TRMs 24 to 20 are shown in Figures 2.7 (a), 2.7 (b), and 2.7 (c), respectively. The expanded RDD profiles are shown in Figures 2.7 (d) and 2.7 (e). A void under the concrete slab is shown in the GPR profile at the location marked in Figures 2.7 (a) and 2.7 (b). The void causes the large peak in the deflection profile.

Figure 2.7: Deflection Profile, GPR Profile, and Video Image Collected on the Middle Westbound Lane from TRM 24 to TRM 20: (a) TPAD, RDD Data, (b) TPAD, GPR Data, (c) TPAD Video Image, (d) Expanded RDD Data from Figure 2.7 (a) at the Red Line, and (e) Additional Expansion of RDD Data of the Red Line in Figure 2.7 (a)

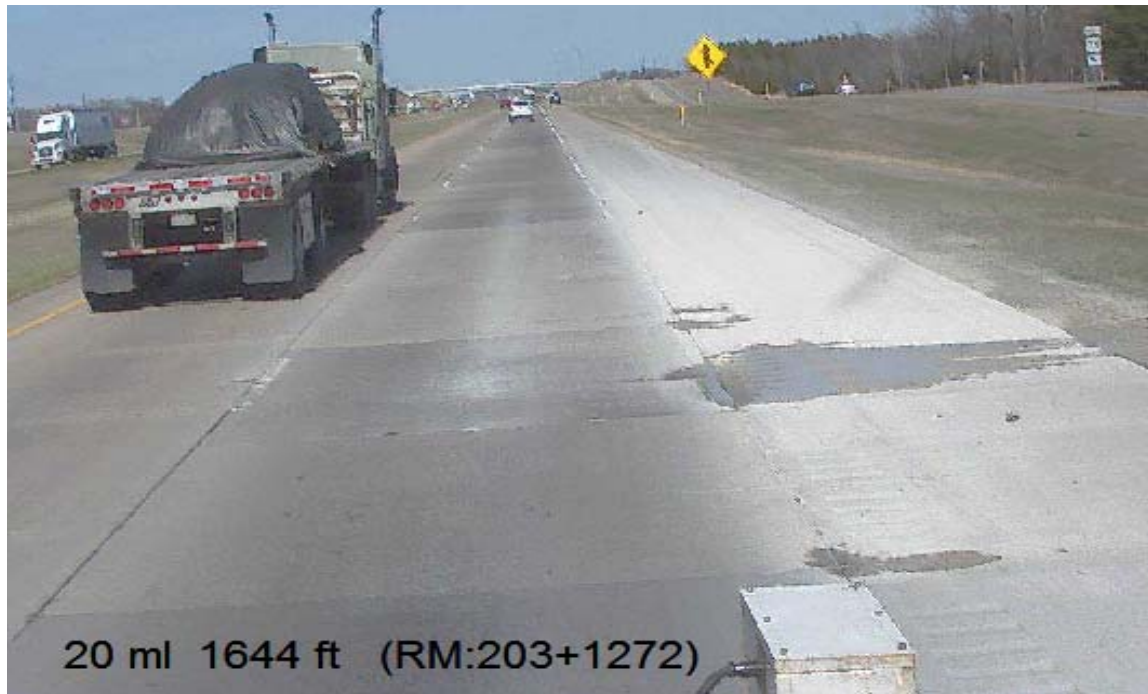
Mr. Wade Blackmon, PE, a District Pavement Engineer, was the point of contact for TxDOT's Paris District. TPAD testing was performed along a 10-mile-long section of US 75, starting in Sherman and running north for 10 miles. The pavement has four lanes in each direction. The concrete pavement is a combination of both jointed concrete pavement (JCP) and CRCP. This highway is the major connector between the City of Dallas and the State of Oklahoma. The representative pavement condition is shown in Figure 2.8. The pavement is badly distressed, with many slabs needing to be replaced and many areas with moisture trapped beneath the slabs. However, the funding for the major reconstruction is not anticipated in the near future, so innovative treatments to keep this highway operational for the next 10 years need to be investigated.

Figure 2.8: Badly Distressed Section of US 75 Just North of Sherman, TX

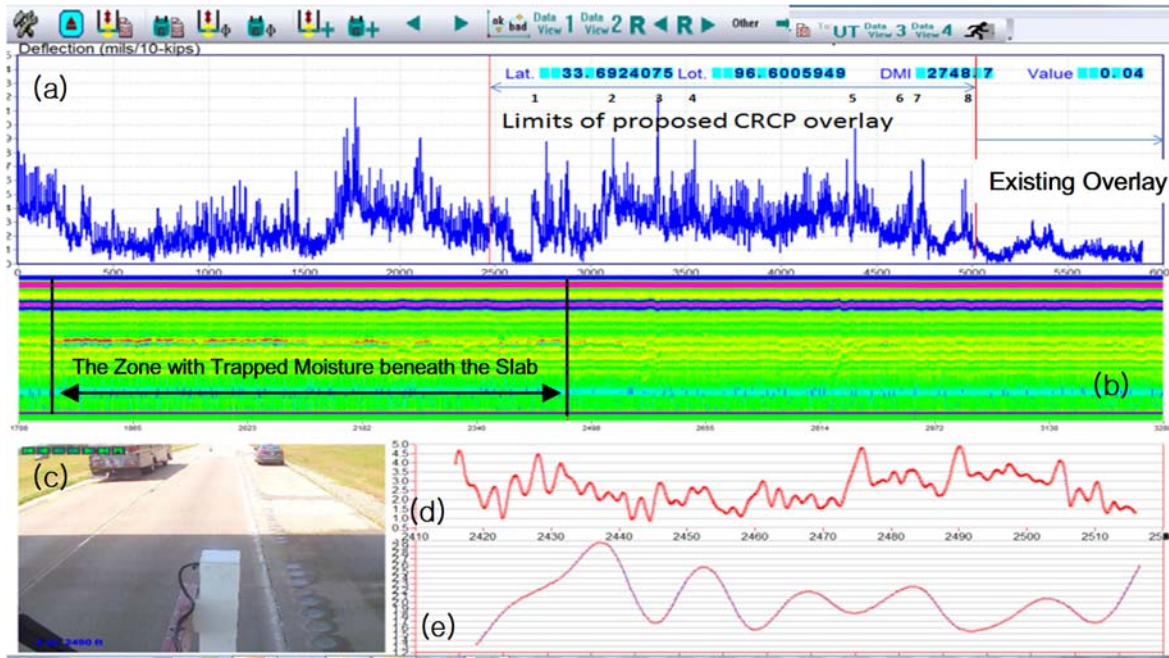
The data collected on the proposed bonded concrete pavement section are shown in Figure 2.9. The upper plot, Figure 2.9 (a), shows the deflection profile in terms of maximum TPAD deflection normalized to 10,000 lb. The deflection profile covers about 1.1 miles and includes the proposed test section, which is delineated by the two vertical red lines in Figure 2.9 (a). From these data, eight localized joints of high deflection were identified for further evaluation. These joints are potential locations where reflective cracks could occur in the new overlay. The GPS coordinates, distance from the start of the section, and a photograph of each high-deflection joint were provided to Paris District personnel for their evaluation. The other item of interest in Figure 2.9 is the zone bounded by the black lines in Figure 2.9 (b) (GPR profile). The key point in this zone is near the top of the base and beneath the portland cement concrete (PCC) slab. This zone, about 800 ft long, represents areas of trapped moisture beneath the PCC slab.

Figure 2.9: Deflection Profile, GPR Profile, and Video Image Collected over Proposed Concrete Overlay Section on US 75 in the Paris District: (a) TPAD, RDD Data, (b) TPAD, GPR Data, (c) TPAD Video Image, (d) Expanded RDD Data from Figure 2.9 (a) at the Red Line, and (e) Additional Expansion of RDD Data of the Red Line in Figure 2.9 (a)

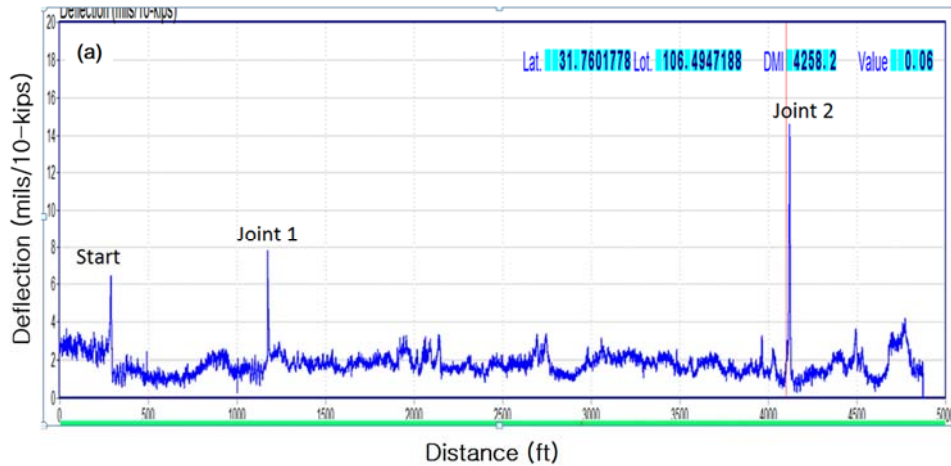
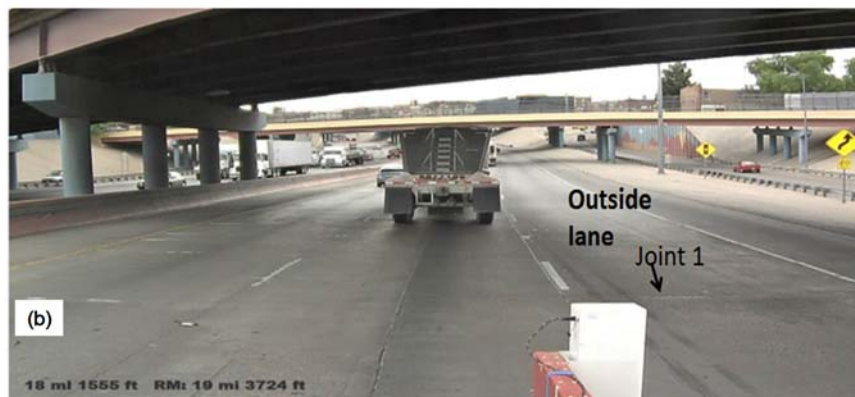
Delaminated concrete was found in the two eastbound inside lanes around TRM 19.5 in April 2013. The testing conducted in July was to investigate the other four lanes in this area to determine if they have any significant structural deficiencies. The RDD deflection profile collected on the outside westbound lane from TRMs 20 to 19 is shown in Figure 2.10 (a). As the figure depicts, the deflections were found to be low, averaging about 2 mils/10 kips; hence, no structural deficiencies were found in this location. Only two areas of high deflections were found in these tests, which occurred at longitudinal construction joints. No structural defects were found in any of the additional lanes tested from TRMs 19 to 20. This finding led to the recommendation of replacing only the debonded concrete overlay. The photograph showing the problematic joint (Joint 1 in Figure 2.10 [a]) is shown in Figure 2.10 (b).

Figure 2.10: TPAD Testing along IH 10: (a) Deflection Profile Collected on Outside Westbound Lane from TRMs 20 to 19 and (b) Photograph Showing the Problematic Joint (Joint 1 in Figure 2.10 [a])

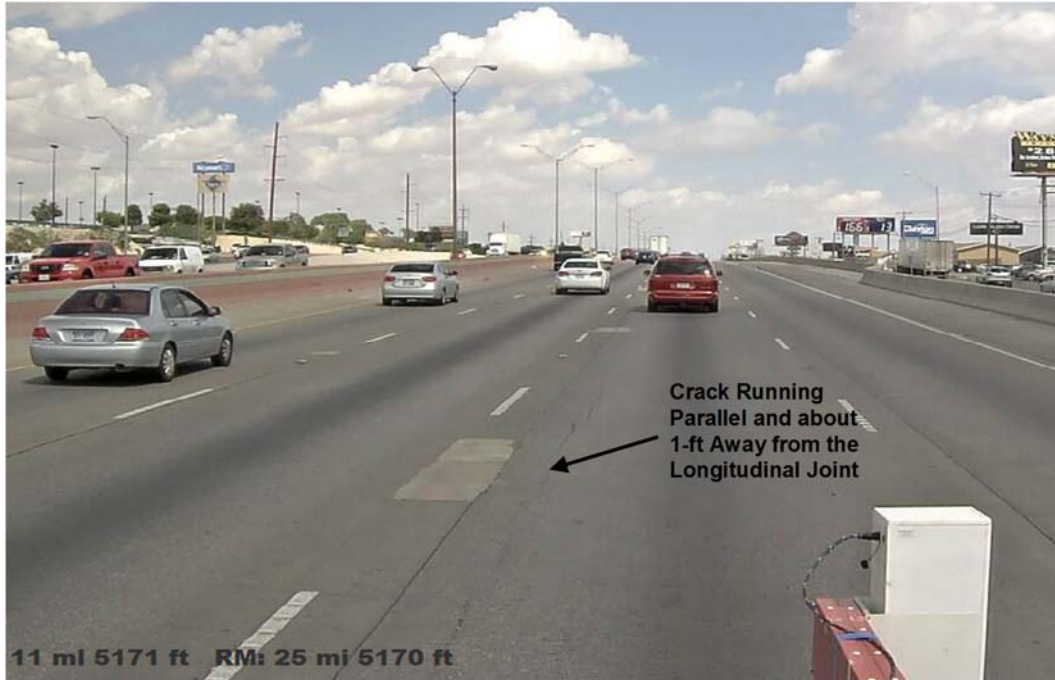
With a visual survey, the section with maintenance problems that fell in this portion of the IH 10 corridor study is near longitudinal construction joints where substantial repairs have already been made (patches seen in Figure 2.11) from TRMs 25.5 to 27. A photograph showing the longitudinal construction joints with repairs is presented in Figure 2.11. The initial distress is a crack that runs parallel and about 1 ft away from the longitudinal joint. Such cracks continue to deteriorate, becoming localized punch-outs, and then patching or other repairs are necessary. Observations made during field repairs and from discussions with maintenance personnel indicated that these are partial depth failures.

Figure 2.11: Distressed and Repaired Areas on IH 10 from TRMs 25.5 to 27

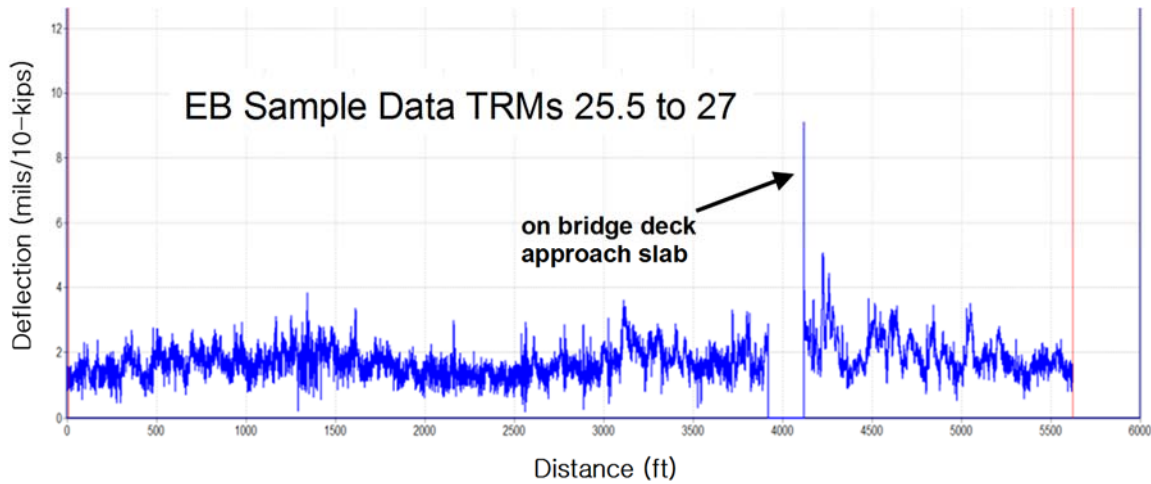
To determine the cause of these problems, TPAD RDD deflection testing was performed along the center of the slab and falling weight deflectometer (FWD) deflections were taken close to the joint. The FWD testing also included measurements of load transfer efficiency (LTE) over the failing joint. The deflection profile collected in this area is shown in Figure 2.12. As shown in the figure, no major high deflection areas were detected in the TPAD deflection data collected along the longitudinal centerline of the slab between TRMs 25.5 and 27, except for the one peak on an approach slab on a bridge deck.

The FWD testing revealed that the LTEs along the failing joint on the eastbound section were variable and, in many cases, less than 60%. From the deflection data collected with the TPAD and FWD, it was concluded that these problems are related to the longitudinal construction joints and are not associated with any overall deficiency in the pavement structure. Additional work is planned to evaluate the joint design details of the failing joints.

Figure 2.12: Low Center-Slab Deflections on Eastbound of IH 10 from TRMs 25.5 to 27

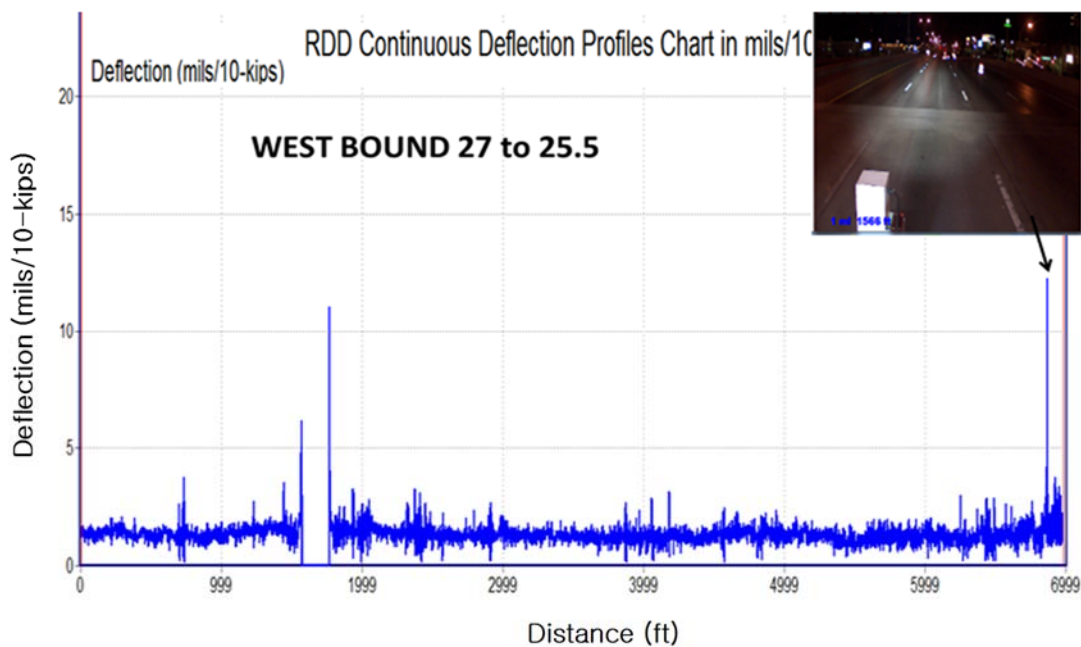
The condition of the westbound section of TRMs 25.5 to 27 is similar to the eastbound section. However, more maintenance repairs have been made in the westbound direction. The joint exhibiting the problem is a wide joint—specifically, a “keyed joint” with no tie bars, which is a design no longer used in Texas. Requests have been made to get schematics of the joint configuration used but this information appears to be no longer available. Figure 2.13 shows the TPAD data collected in the center lane, and again absolutely no strength or support problems appeared in the middle of the lane. The peaks in the deflections are either at approach slabs or at construction joints, as shown in the photo in the upper right of Figure 2.13. However, the LTEs by FWD testing are troublesome; long sections of the westbound direction have LTE values less than 40%.

Figure 2.13: Low Center-Slab Deflections on Westbound of IH 10 from TRMs 25.5 to 27

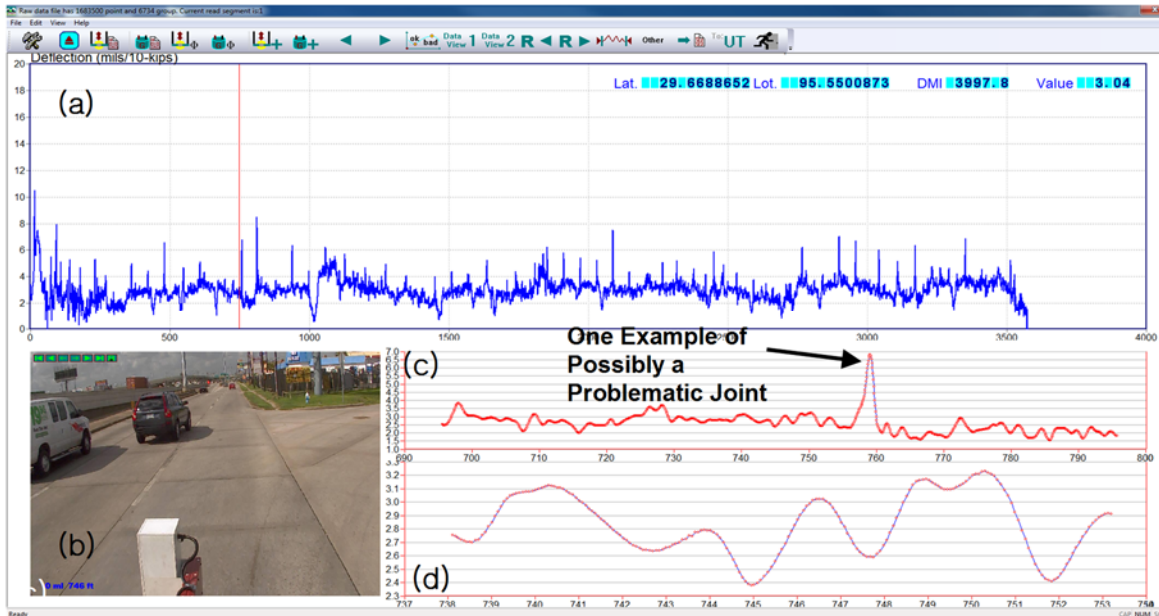
Representative TPAD data are shown in Figure 2.14. The deflection profile is shown in Figure 2.14 (a). In general, the deflections are relatively low compared to deflections collected on other JCP sections. It was, therefore, concluded that this section is overall a good candidate for a thin overlay. However, it was also concluded that approximately seven joints in each direction need further evaluation. One of the joints requiring more evaluation is shown in Figure 2.14 (b). The location of this joint is identified by the vertical red line in Figure 2.14 (a).

Figure 2.14: Deflection Profile and Video Image Collected on US 59 Frontage Road in Houston: (a) TPAD, RDD Data, (b) TPAD Video Image, (c) Expanded RDD Data from Figure 2.14 (a) at the Red Line, and (d) Additional Expansion of RDD Data of the Red Line in Figure 2.14 (a)

Further testing of this area will include FWD testing of the problematic joints, about seven in each direction. Those joints found to be substandard, with LTEs less than 60%, will be recommended for saw and seal repair. The TPAD testing was able to assist the Houston District in determining the suitability of this JCP for a thin asphalt overlay.

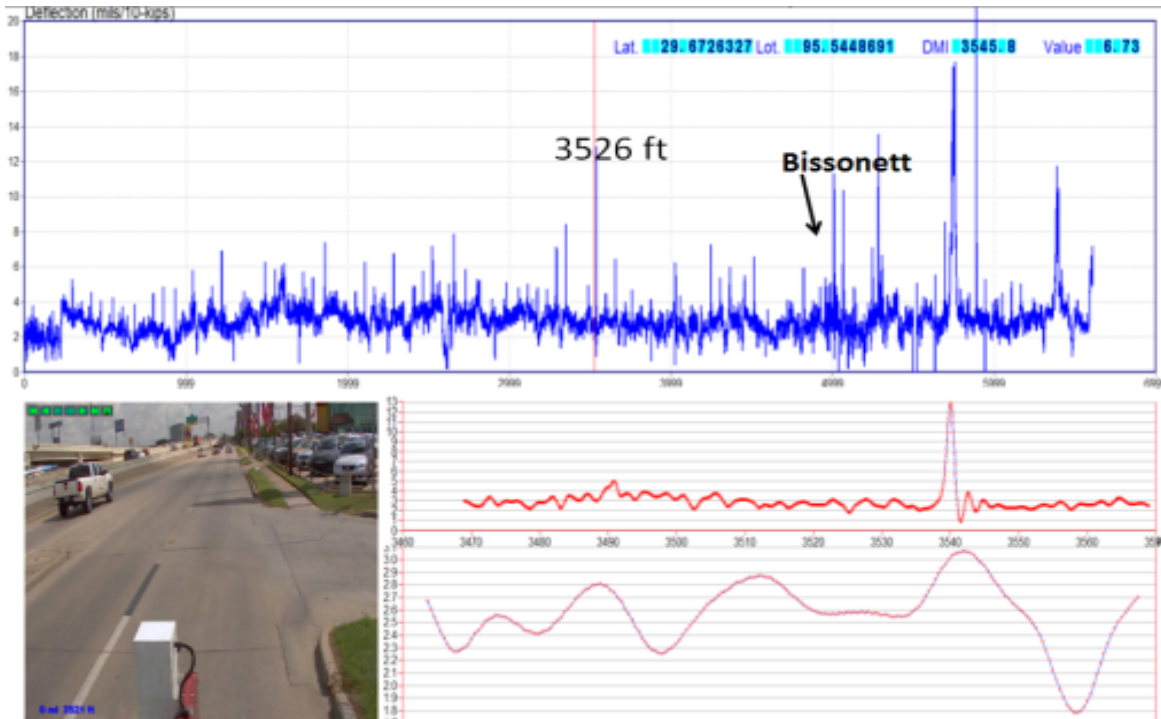
The typical maximum deflection pattern for the TPAD is shown in Figure 2.16. The start location was just north of Beltway 8. The location of the intersection with Bissonett is marked in the figure. The deflections before Bissonett Road were judged to be relatively low, with few deflections increasing to more than 6 mils. Earlier studies within TxDOT and with other projects have found that this level of deflection is judged to be reasonable for good performance from a thin HMA overlay.

Figure 2.16: Typical Maximum Deflection Pattern on the Section from BW 8 to Bissonett

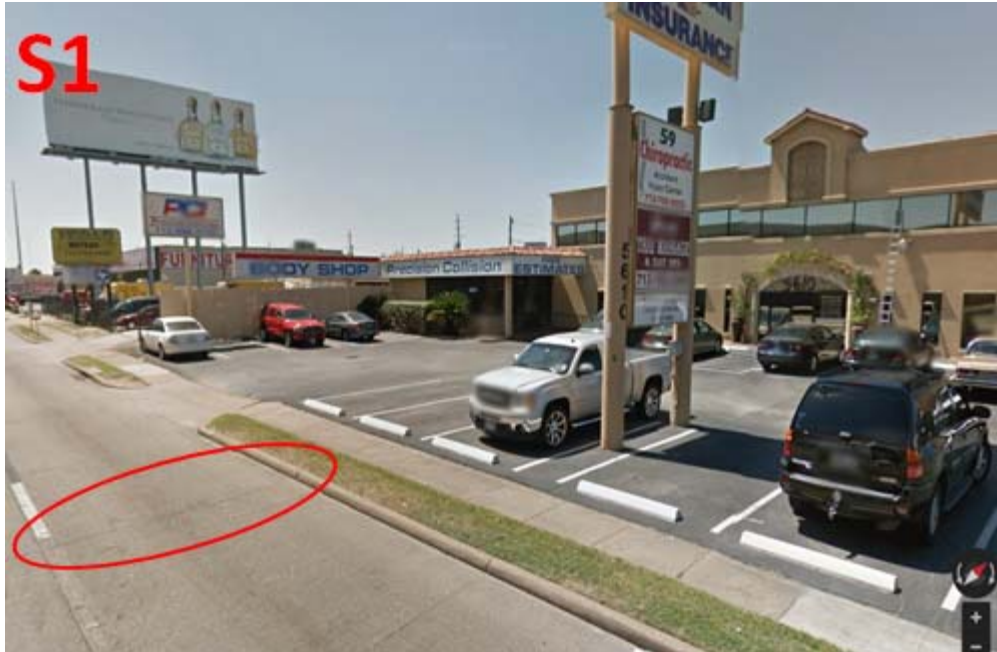
In the section before Bissonett is just one joint with a high deflection; this is marked in the data at 3526 feet from the start of the project. The deflection at this location is also plotted in the lower figure; over this joint the deflection increases to over 13 mils. With a major increase such as this, a reflection crack would likely occur quickly at this location. However, this is just one problematic joint in almost 5000 feet of pavement. Except for the section described below, the rest of the data indicated similar deflection patterns. The entire run was almost 15 miles long with over 3000 joints. From a review of the TPAD data, it was concluded that there were just over 100 problem joints like the one shown in Figure 2.16. These data were presented to the Area Office personnel and it was decided to proceed with the thin overlay project while making adjustments for the joints identified as suspect. In this case, the Area Office asked if TTI could identify all of the suspect joints so that a “saw and seal” operation could be undertaken at those joints. To accomplish this, the GPS coordinates of each problem joint were reported and a photo of each location provided. One of these locations is shown in Figure 2.17. As stated, just over 100 of these locations were identified. This thin overlay project has been let and construction will be underway in the fall of 2014. The entire project consists of localized joint repair, hot rubber under-seal, 1 inch of thin overlay mix, and then a saw and seal operation over the identified problematic joints.

Figure 2.17: One Joint with High Deflection Scheduled for a Saw and Seal Operation

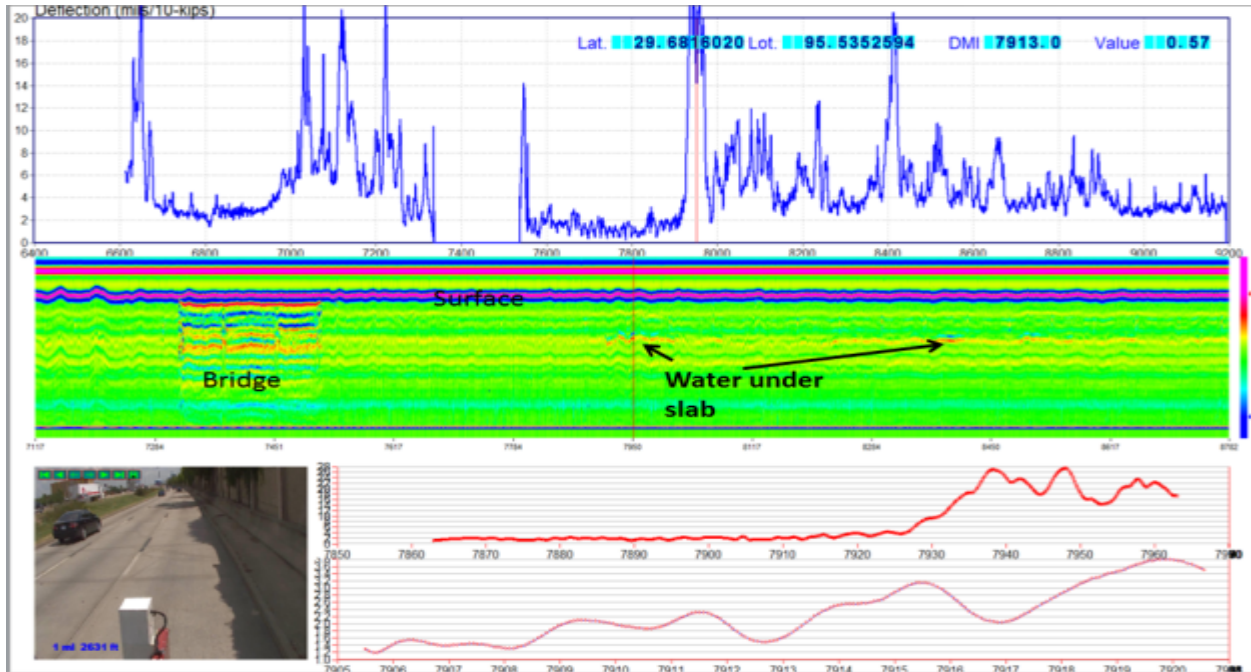
However, one real problem area was identified in the short section from Bissonett Road to South Gessner in the northbound direction. The very high deflections in this location are shown in Figure 2.18, where the deflections are over 20 mils at points along the section. These very high deflections are on either side of a bayou, and it was reported that TxDOT had already completed some void filling projects at this location. The bayou is represented in Figure 2.18 as the gap in the deflection plot, as no deflection data was collected over the bridge deck. Just after the bridge is a section of very low deflection; after that is what appears to be additional voided areas.

Figure 2.18: TPAD Data from Bissonett to South Gessner, Problematic Section

In total, six locations were identified to the Area Office as areas that need to be investigated prior to placing a thin overlay on this section. This work is currently underway.

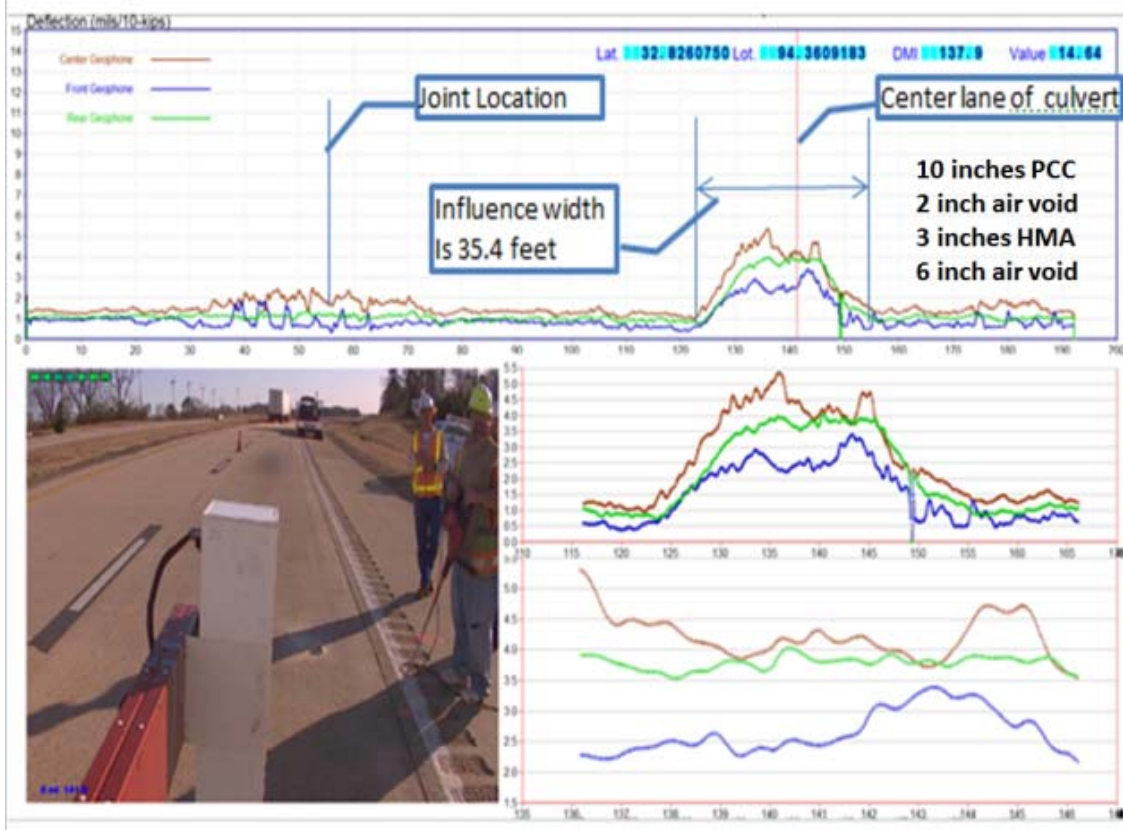
The data collected with the TPAD over this suspect location is shown in Figure 2.20. As with other new CRCP pavements, the measured deflections are very low—in the 1 to 2 mils range. However, over the suspect location, measurements from all three TPAD sensors increased substantially. In the middle of the voided area, an access hole was drilled; the researchers found that the material had indeed settled. Directly under the slab was a 2-inch void, then 3 inches of hot mix asphalt (HMA); below that was another 6-inch air void. The total width of the suspect area was estimated to be 35 feet.

Figure 2.20: TPAD Deflection Data Collected over a Section with Suspected Voids beneath the Concrete

This section was repaired by the contractor, the concrete was removed, the fill material was re-compacted, and the slab was replaced.

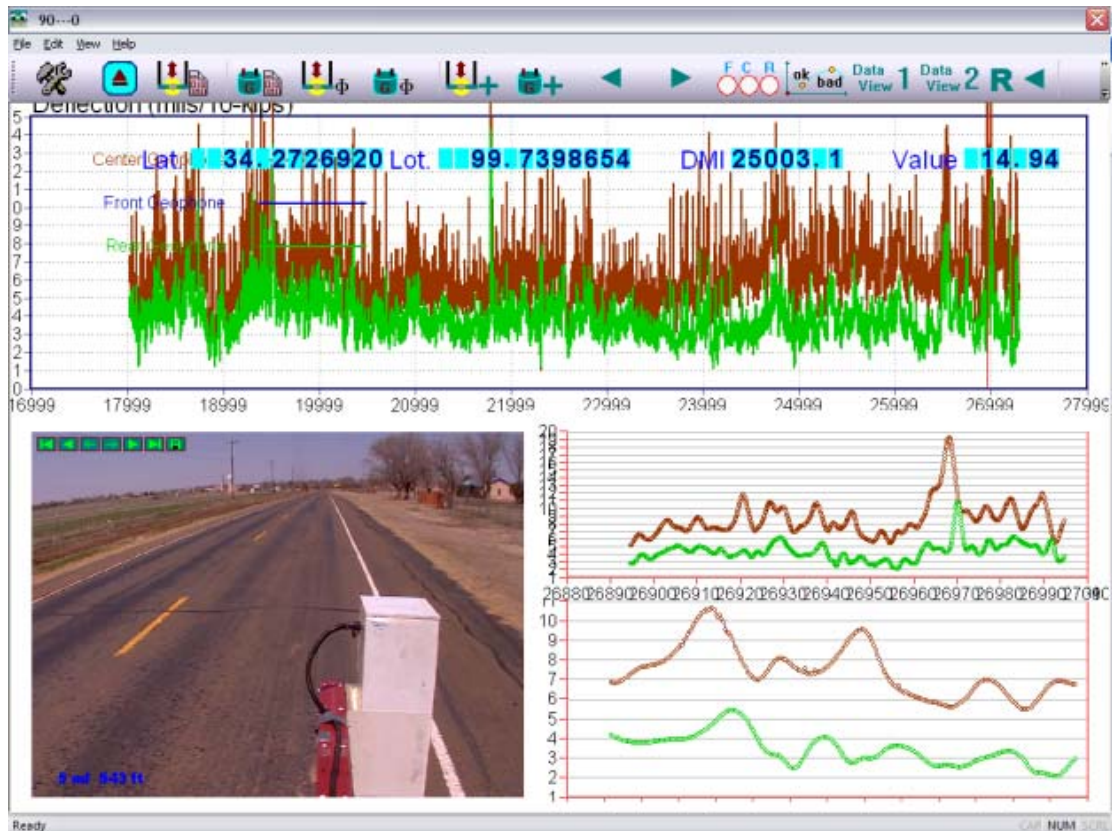
Rubblization has been problematic in the Childress District in the past. Localized wet spots beneath the slab can cause inadequate slab breakage; in one case, major failures occurred under the asphalt laydown machine caused by slab rotation. To be a good candidate for rubblization, the amount and severity of weak areas need to be defined. The TPAD was used to test the entire project and locate areas of high deflection. Figure 2.21 shows representative TPAD data. The pavement has 3 to 4 inches of HMA with a 9-6-9 jointed concrete slab. The brown plot in Figure 2.21 is the maximum deflection profile under the normalized 10,000 lb. load.

Figure 2.21: Representative TPAD Data for SH 6

Based on the TPAD data, six locations were selected for field investigation. Locations 1 and 2 were measured to have moderate deflections. The other four areas had either high deflections or suspect load transfer efficiencies. Table 2.1 and Figure 2.22 present the summary information from the focused field tests with the DCP, which is used to assess the risk level associated with rubblization. Analysis of the data shows that rubblization may not be the best option for this pavement due to marginal support conditions under the slab and substantial weak support, particularly at the transverse joints. The data suggest that the District may have decent success (~70%) rubblizing most of the slab area; however, each instance of testing near the joint showed extremely poor support in the vicinity. The data suggest that many localized full-depth repairs surrounding the joints would be necessary.

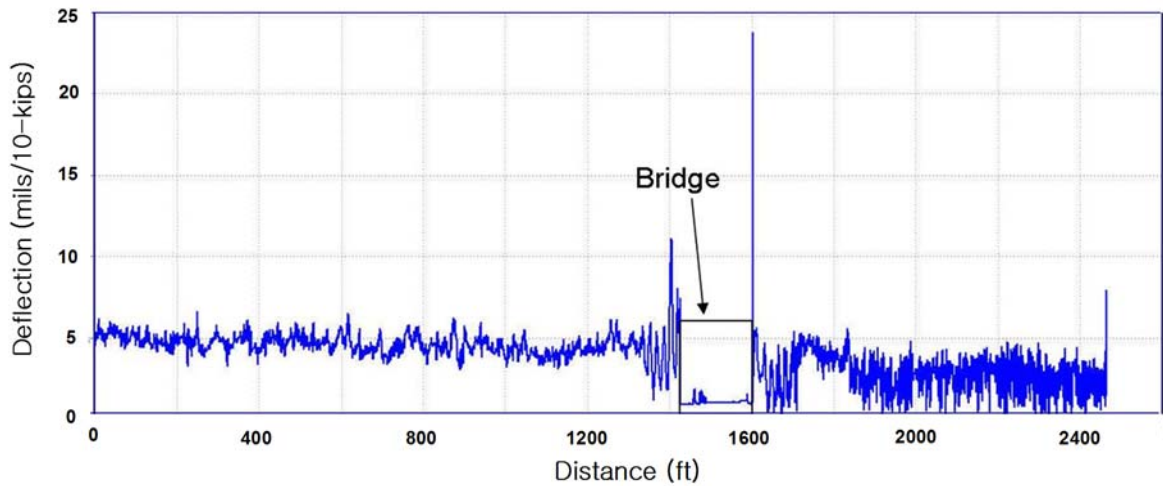
Figure 2.24: Deflection Profile Collected on a Section with Somewhat Larger Slab Movements along IH 27 in Lubbock, TX

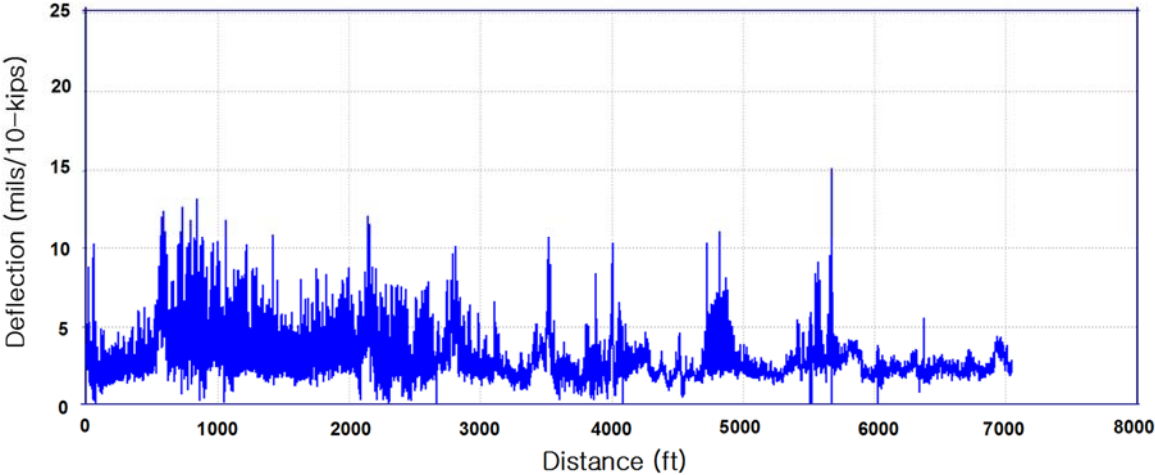
Figure 2.25: Deflection Profile Collected on Westbound Lane of US 287 in Quanah, TX

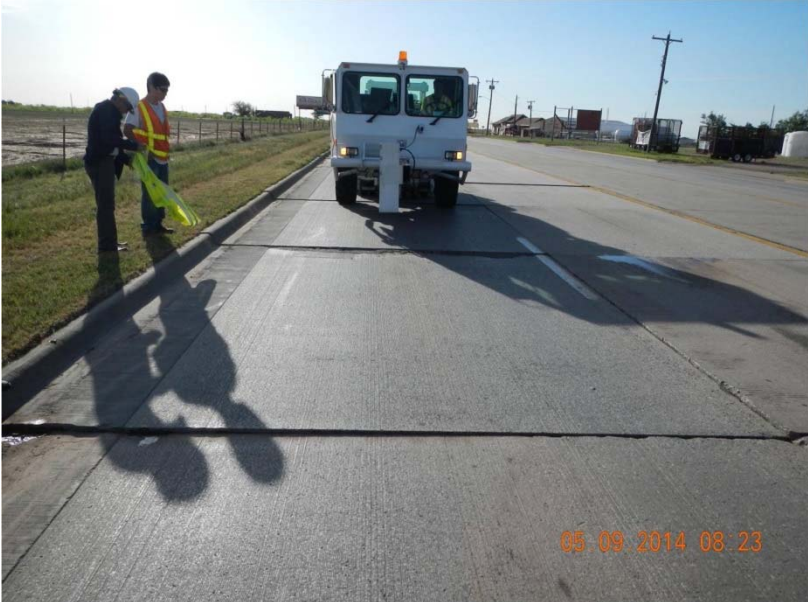
Figure 2.26: Transverse Joints Showing Faulting on Westbound Lane of US 287 in Quanah, TX

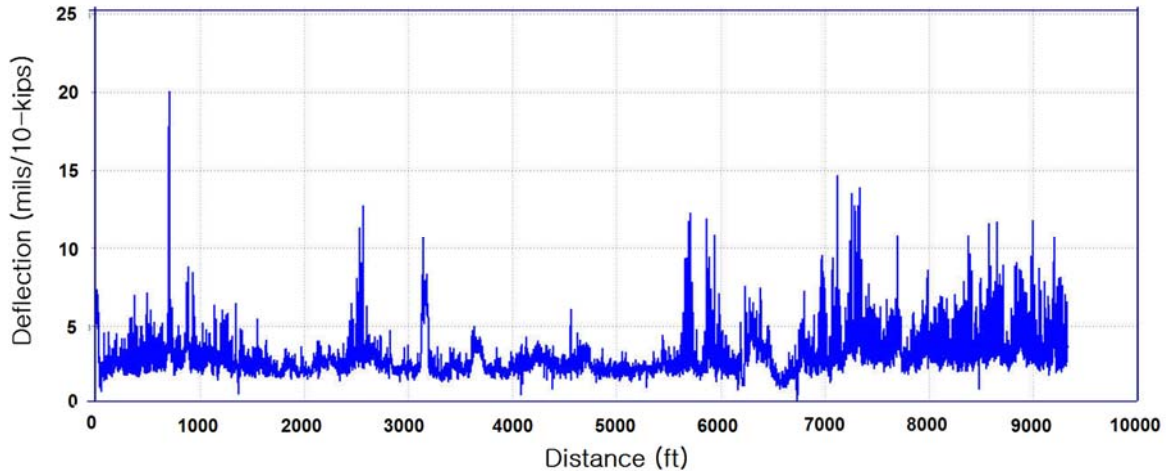
In Figure 2.27, the portion of the deflection profile collected on the eastbound lane of US 287 is shown. Significant peak deflections occur in this profile after 7000 ft, which corresponds to the location on the westbound lane (the westbound from 600 to 2800 ft) where severe faulting exists. Several high peaks before the distance of 7000 ft also occurred due to deteriorated transverse joints. The mid-slab deflections on the westbound and eastbound lanes seem to be low for a JCP (about 3 mils/10 kips in average). It was concluded that this area has severe problems associated with transverse joints. Further evaluation will be necessary to determine the source of these problems and a viable rehabilitation option.

Figure 2.27: Deflection Profile Collected on Eastbound Lane of US 287 in Quanah, TX

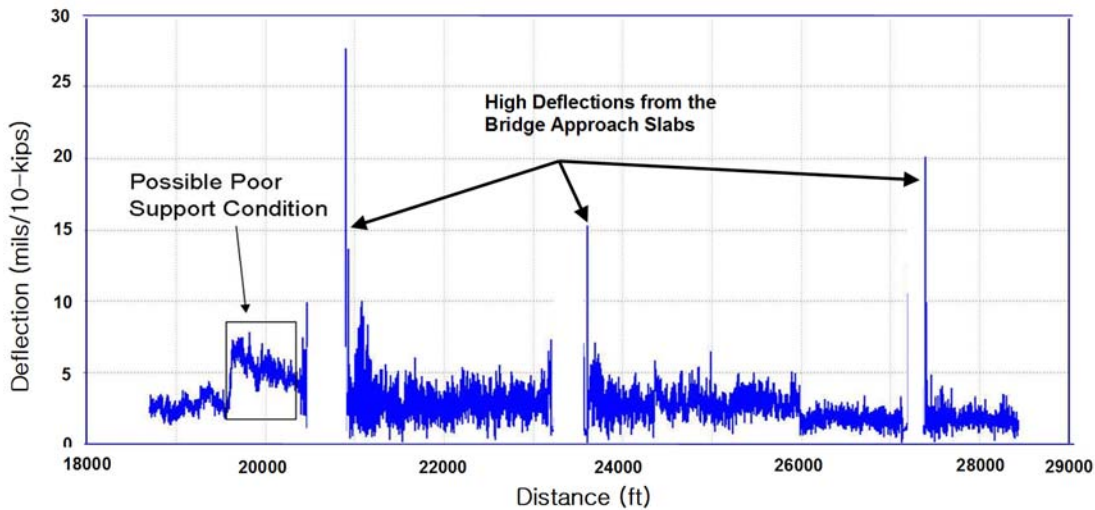
Some examples of deflection profiles collected on the section are presented in Figures 2.29 through 2.33. Possible poor support conditions are shown in Figure 2.29; this area has sudden increased deflections. Other peaks are from the bridge approach slabs. The section shown in Figure

Figure 2.29: Deflection Profile Showing Possible Poor Support Condition on Middle Lane of Southbound SH 288

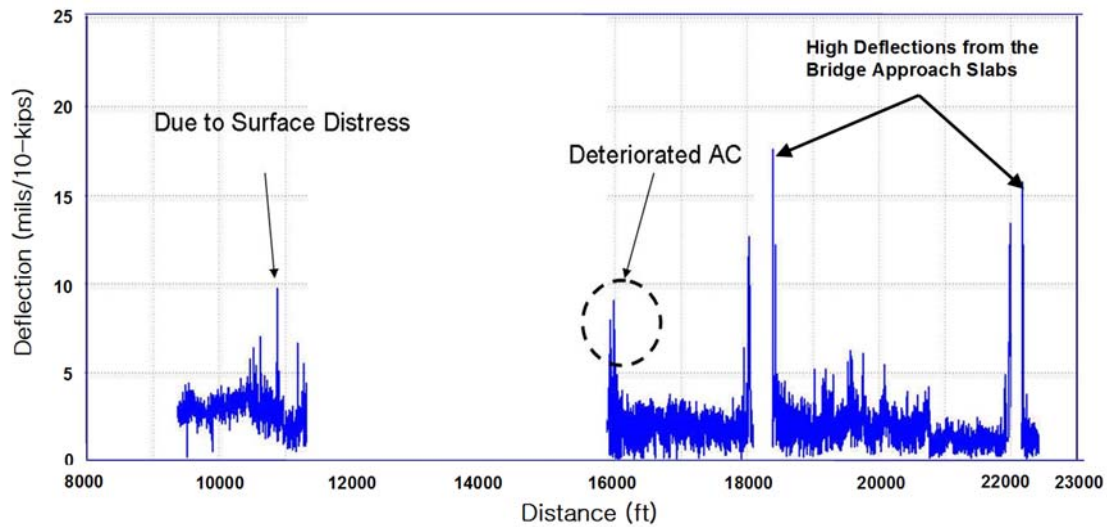
2.30 exhibits overall good and uniform support conditions, except for one peak caused by surface distresses and one area with deteriorated AC overlay. Figure 2.31 depicts two large peak deflections. One is from the transition area between AC overlay and CRCP and another one is from the full-depth repair joint. A large deflection from the area with a deteriorated AC and a large deflection due to the change in AC material quality are shown in Figures 2.32 and 2.33, respectively.

Figure 2.30: Deflection Profile Showing High Deflections due to Surface Distress and Deteriorated AC on Outside Lane of Southbound SH 288
