TECHNICAL REPORT 5-6005-01-1

TxDOT PROJECT NUMBER 5-6005-01

**STATEWIDE IMPLEMENTATION OF THE TOTAL
PAVEMENT ACCEPTANCE DEVICE (TPAD)—
FINAL REPORT**

Kenneth H. Stokoe II
Jung-Su Lee
Tom Scullion

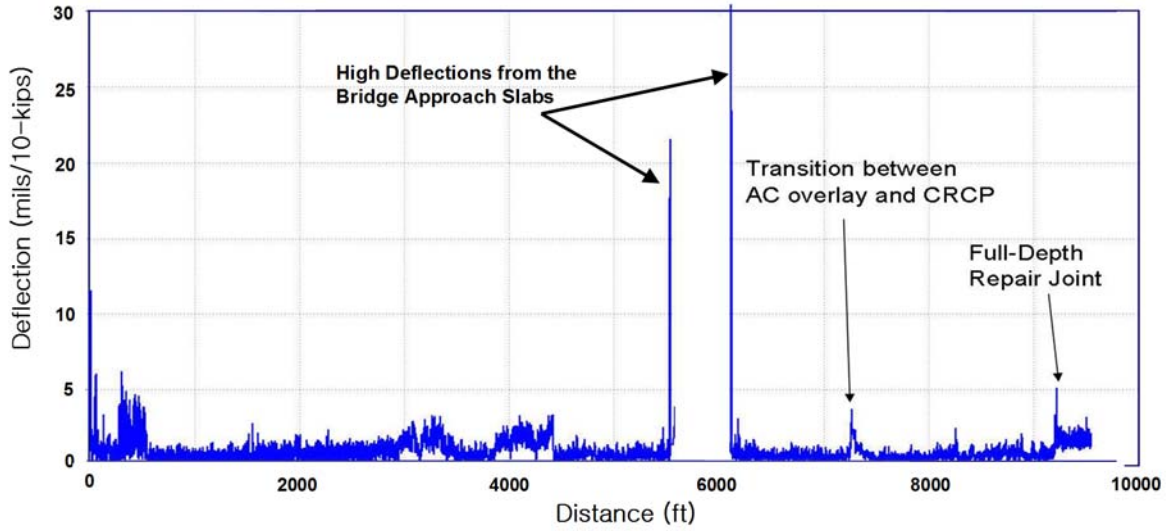
Figure 2.31: Deflection Profile Showing High Deflections due to Transition between AC Overlay and CRCP and Full-Depth Joint Repair on Outside Lane of Southbound SH 288

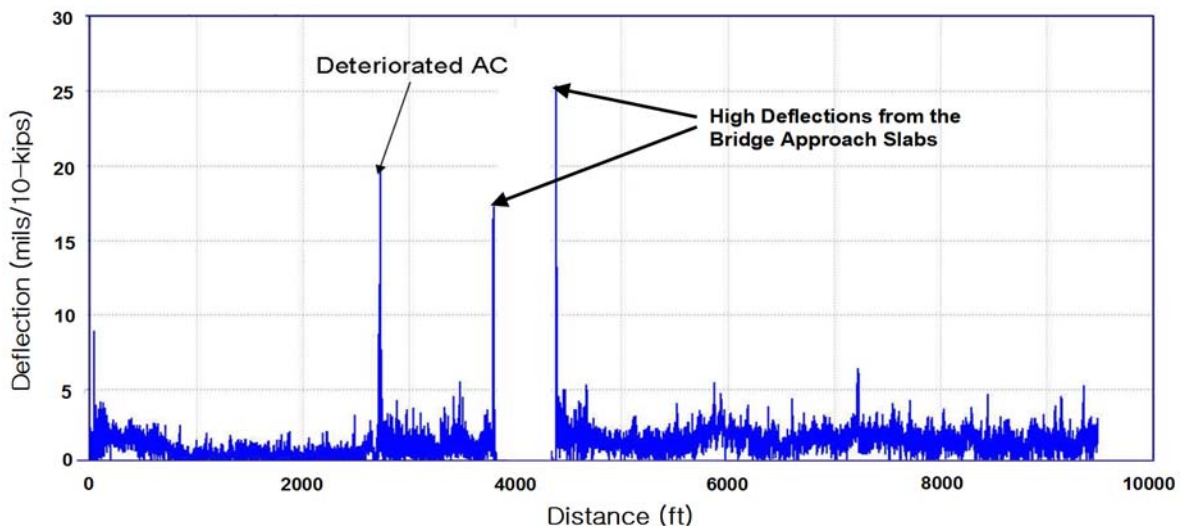
Figure 2.32: Deflection Profile Showing High Deflections due to Deteriorated AC Overlay on Middle Lane of Northbound SH 288

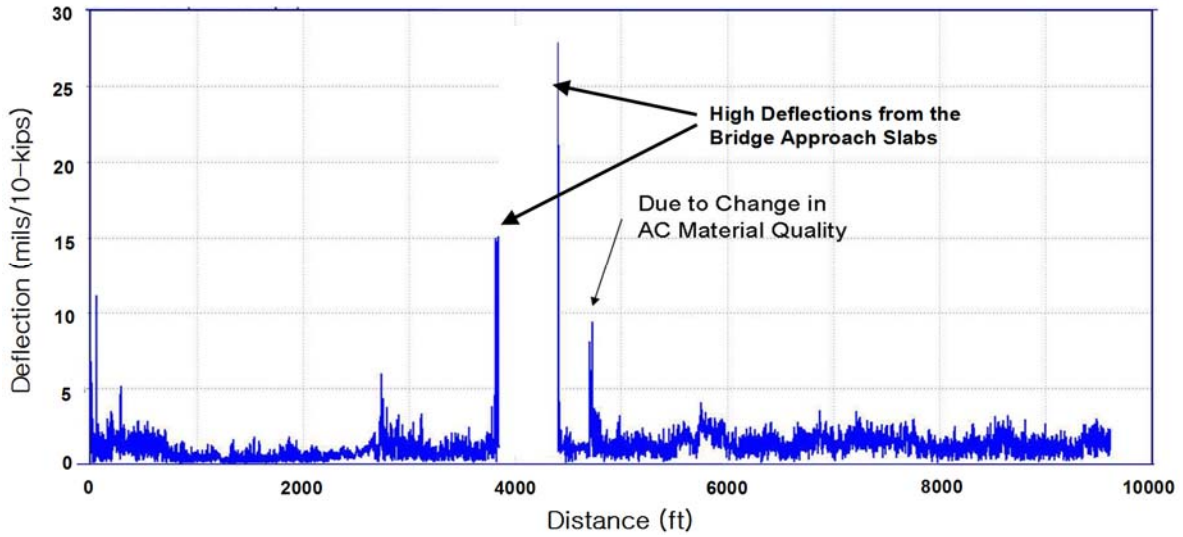
Figure 2.33: Deflection Profile Showing High Deflections due to AC Quality Change on Outside Lane of Northbound SH 288
