# PAVEMENT DAMAGE DUE TO HEAVY LOADS IN TEXAS: AN AREA STUDY

STATE DEPARTMENT OF HIGHWAYS  
AND PUBLIC TRANSPORTATION

**July 1978**

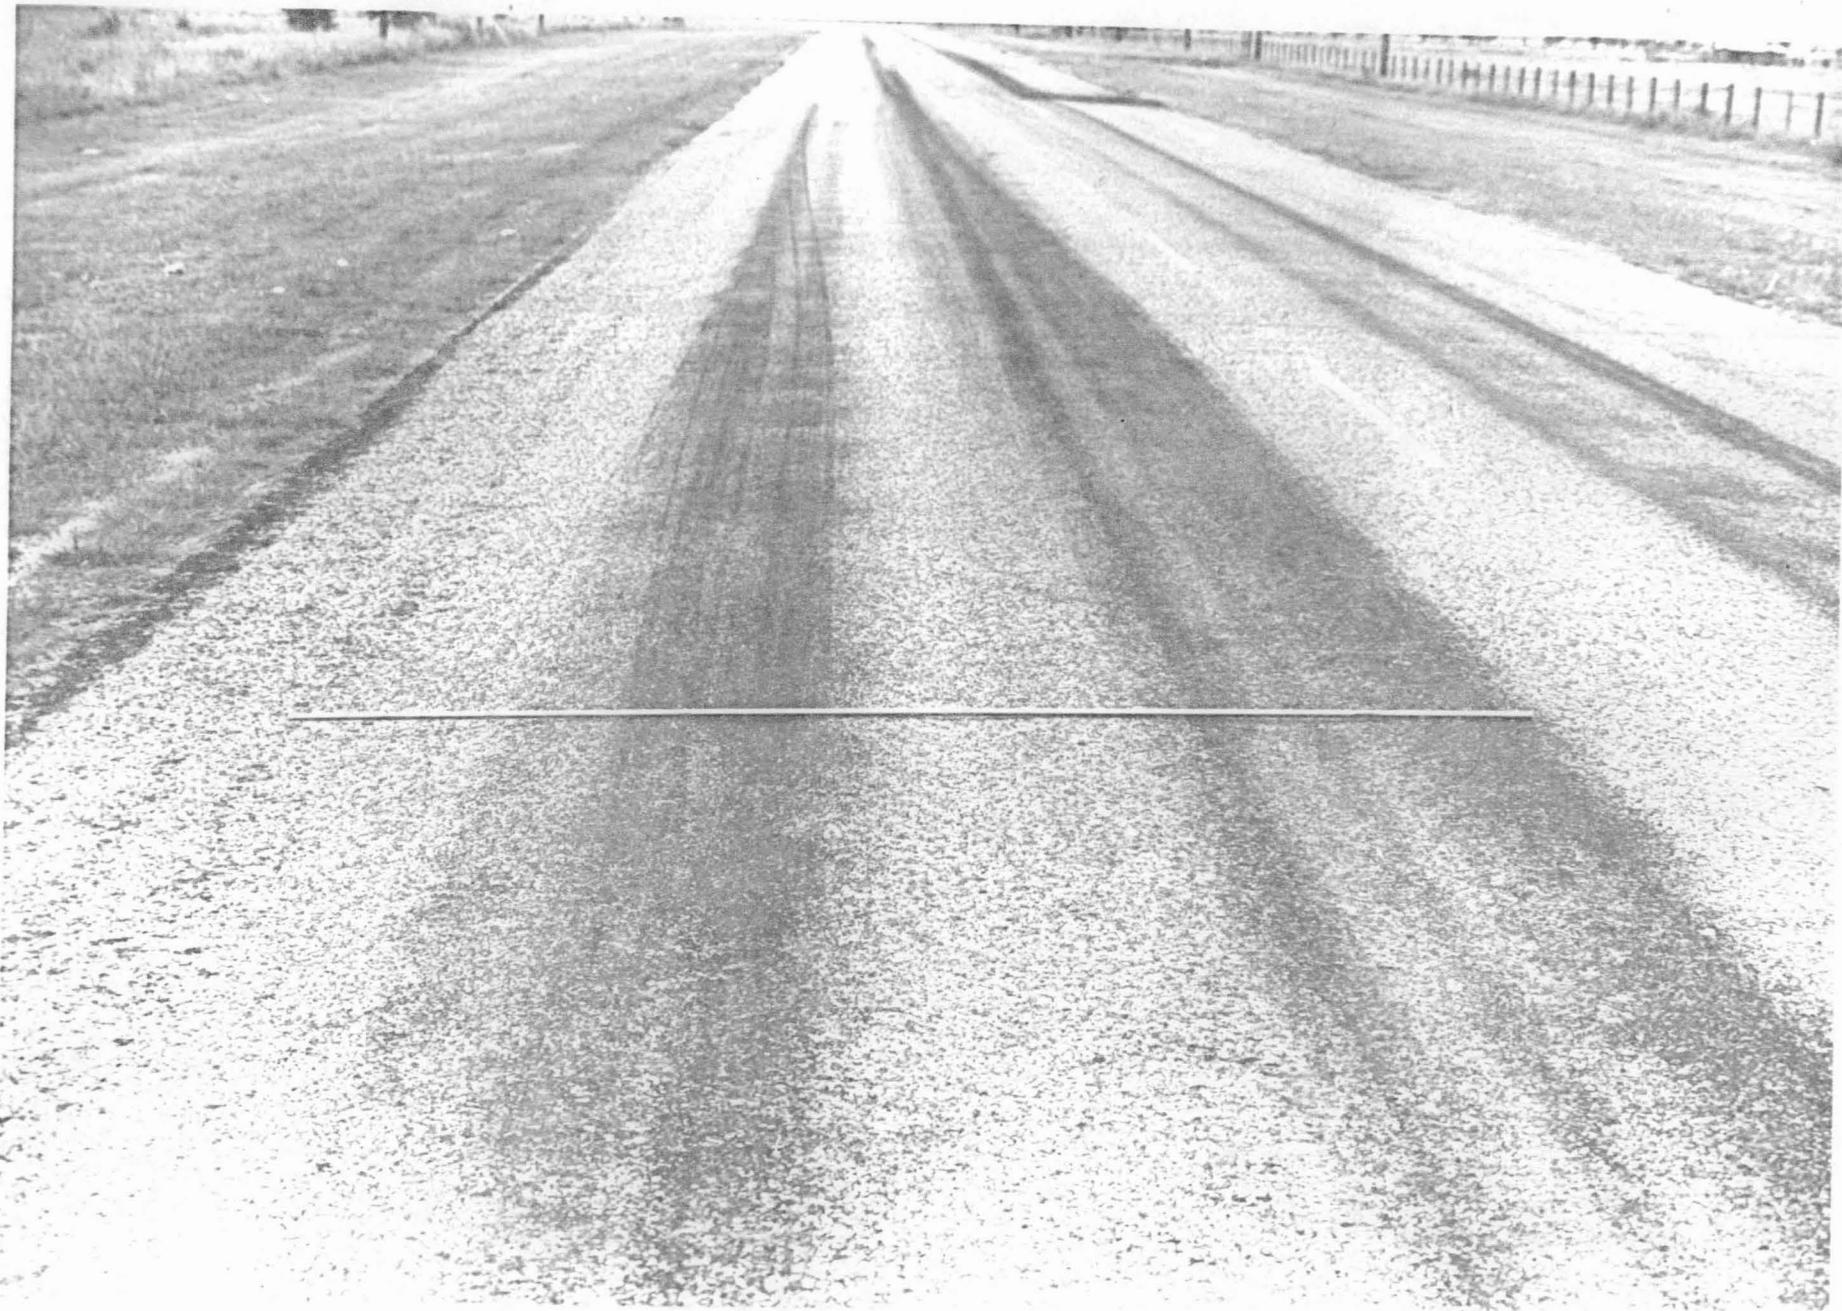
Picture 4

The picture shows a surface which is flushed in the loaded lanes. The return lanes have minor flushing. The surface was sealed in 1976. This seal hides much of the prior distress.

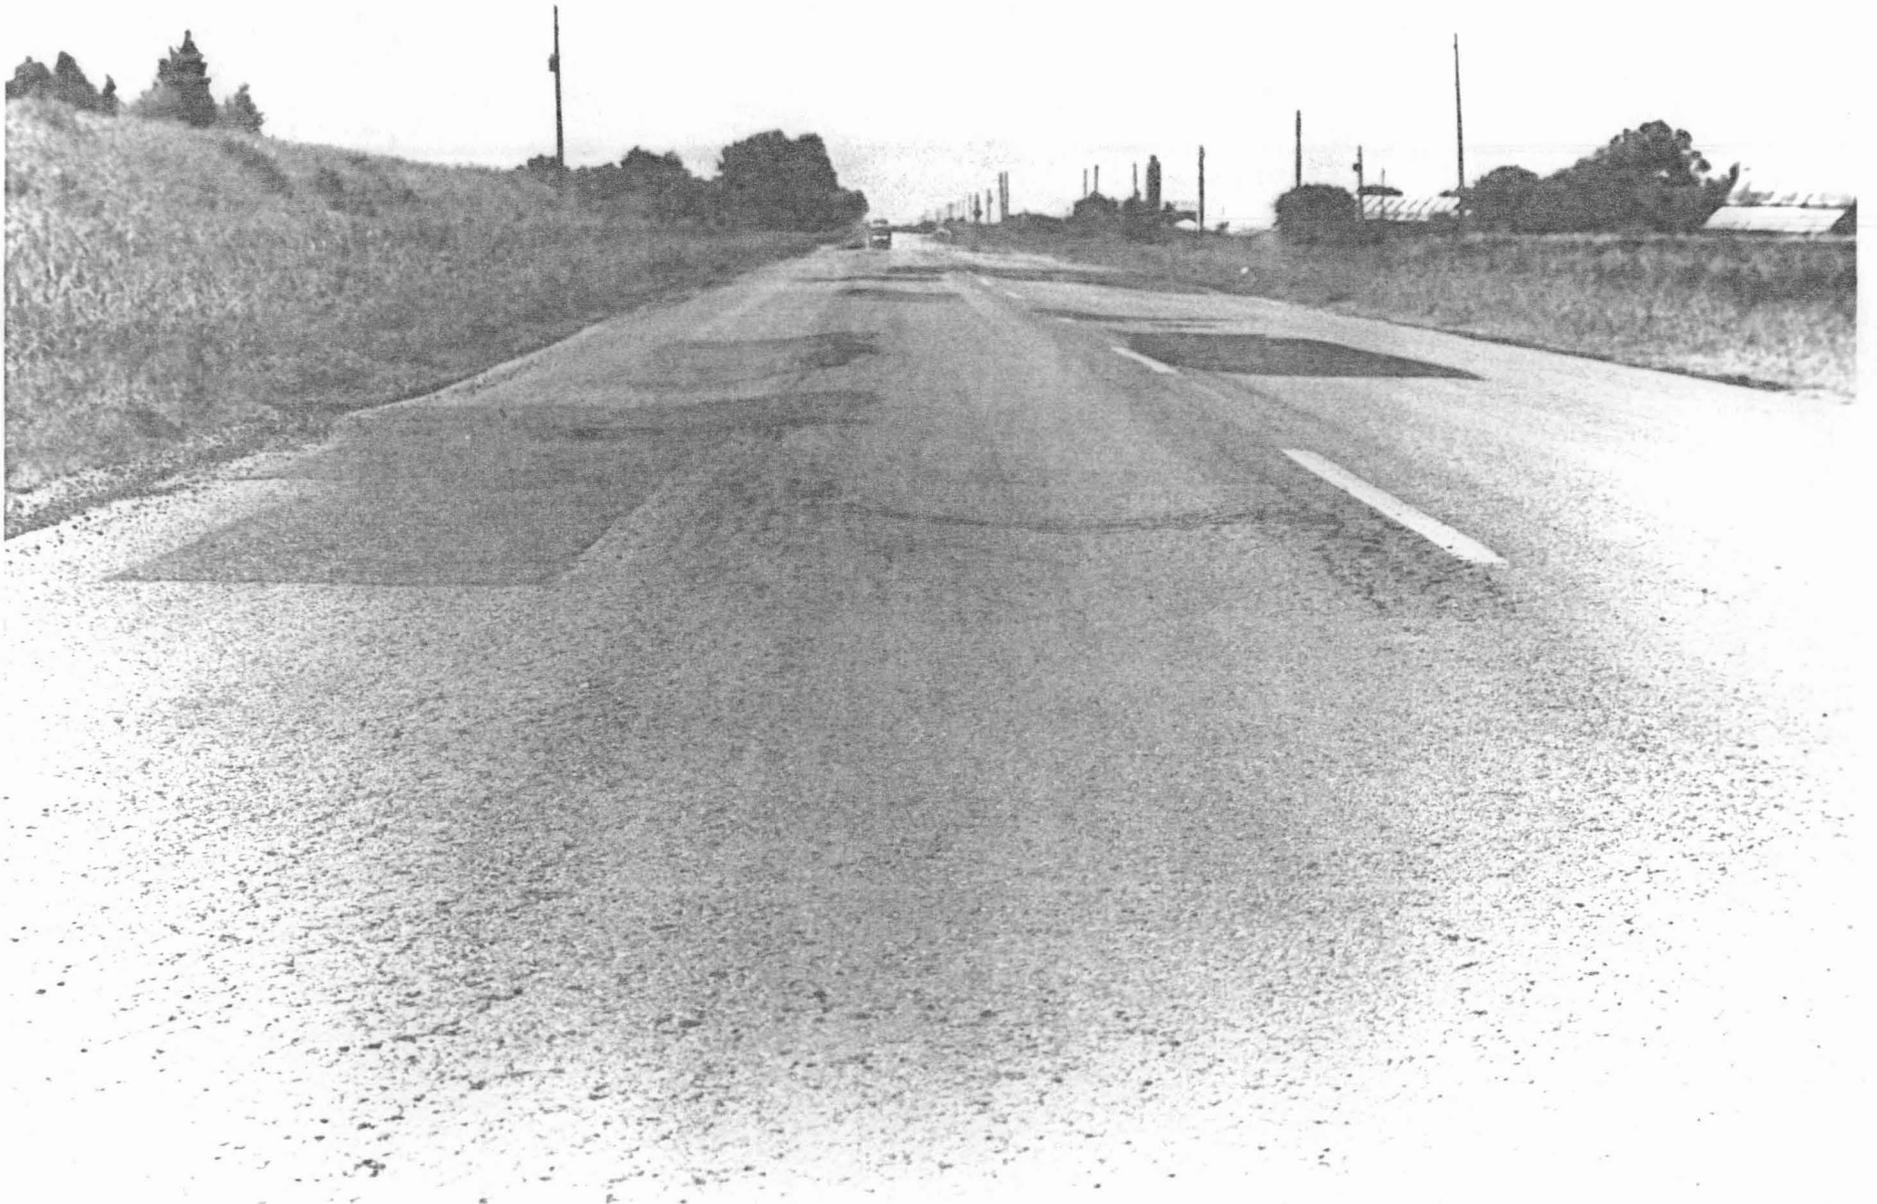
Picture 5

Picture shows loss of original cross-section particularly on loaded lanes. On this roadway almost every conceivable type of distress may be noted - patches, rutting, shear failures, extensive alligator cracking and excessive roughness. These types of failure are associated with heavy loads. Note the resurfacing in 1975 has helped to reduce repair costs in 1975-76 but the repair costs are increasing in 1976-77.

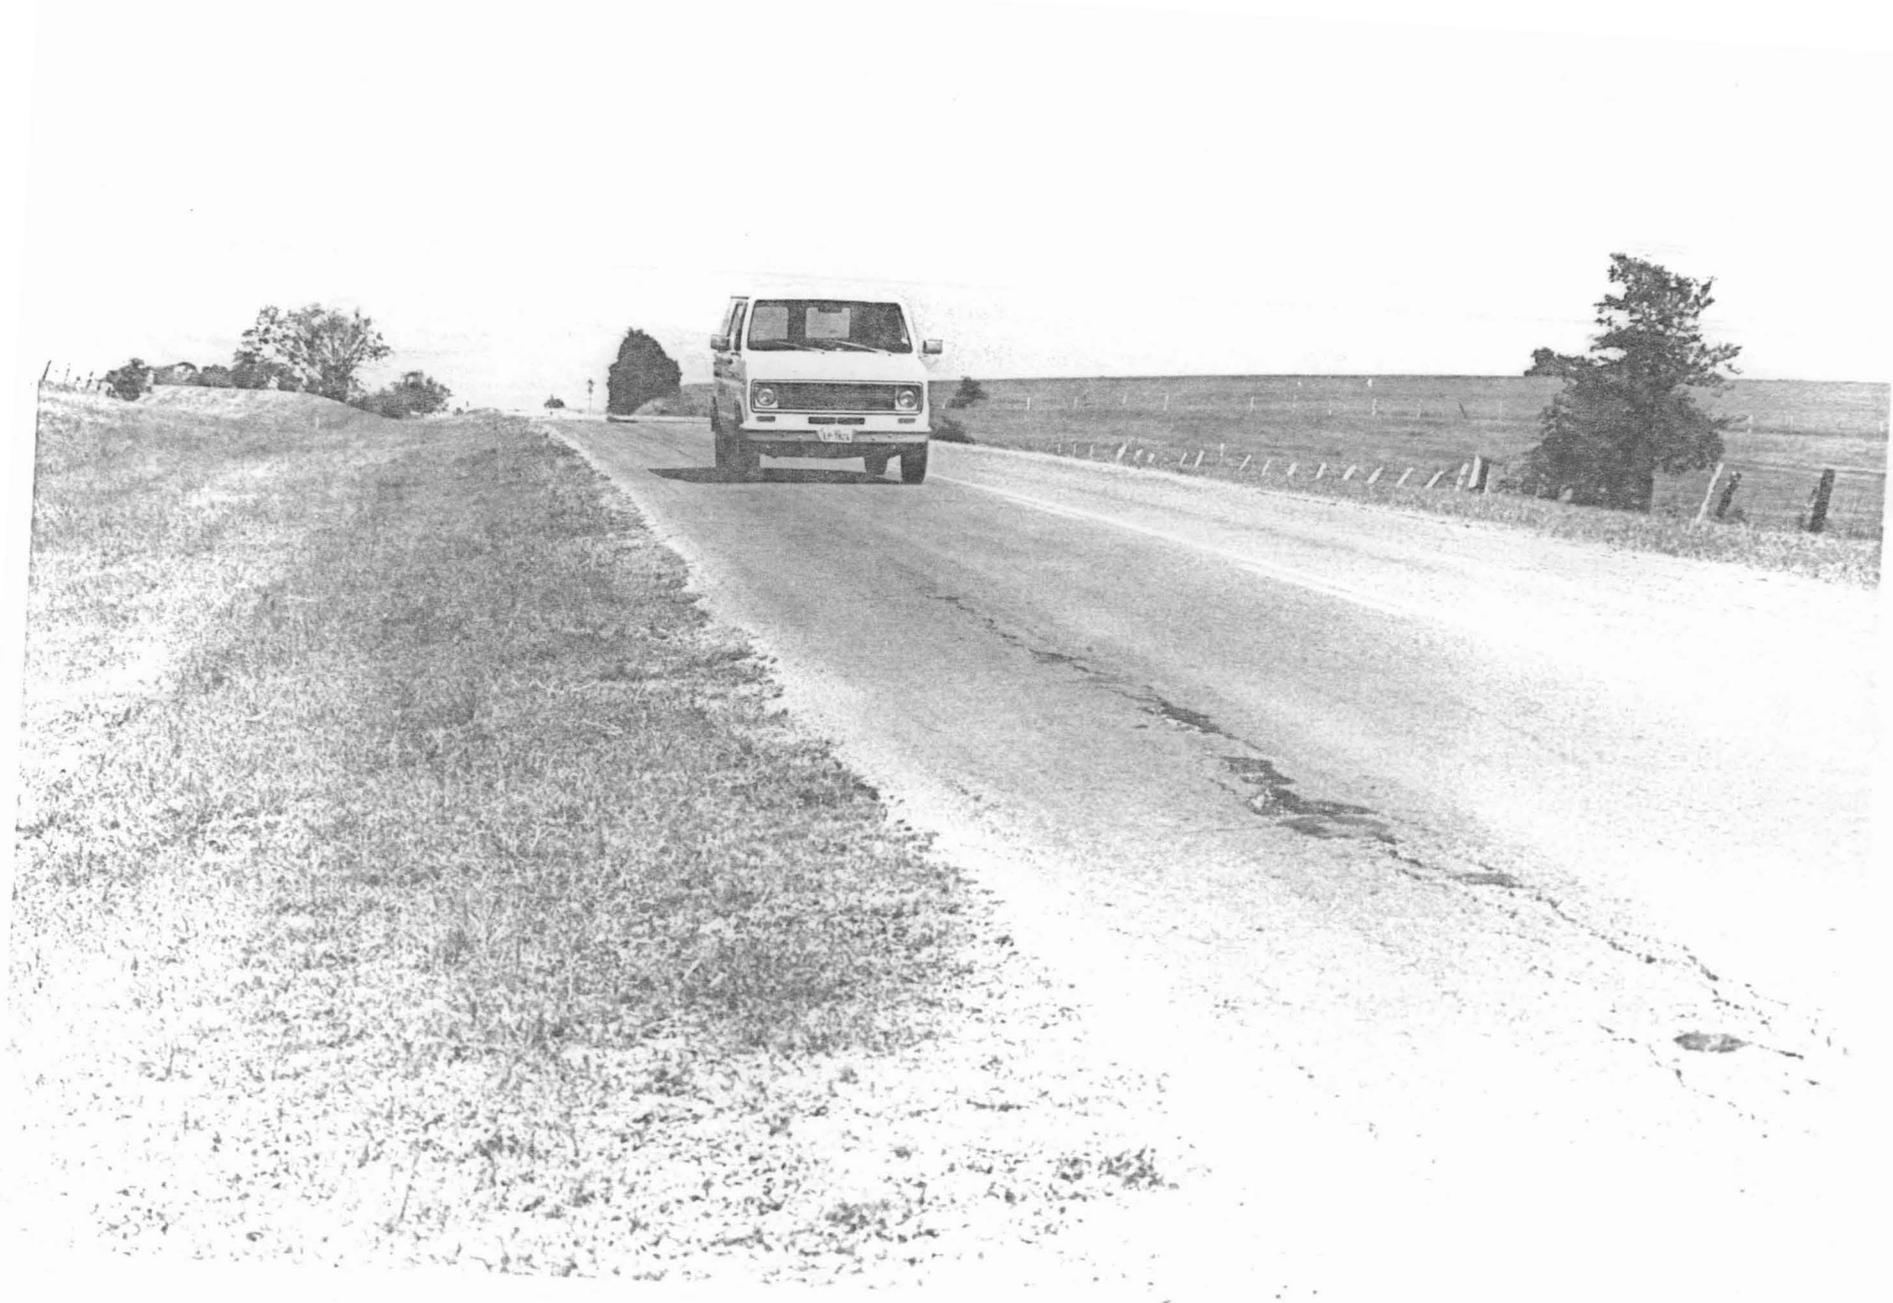
Picture 6

Picture shows a load oriented longitudinal crack in right wheel path of loaded lanes along with spalling and minor pot holes. Typically a longitudinal crack will occur in the left wheel path; ladder or block cracking will occur; and the blocks will loosen and be whipped out by traffic.

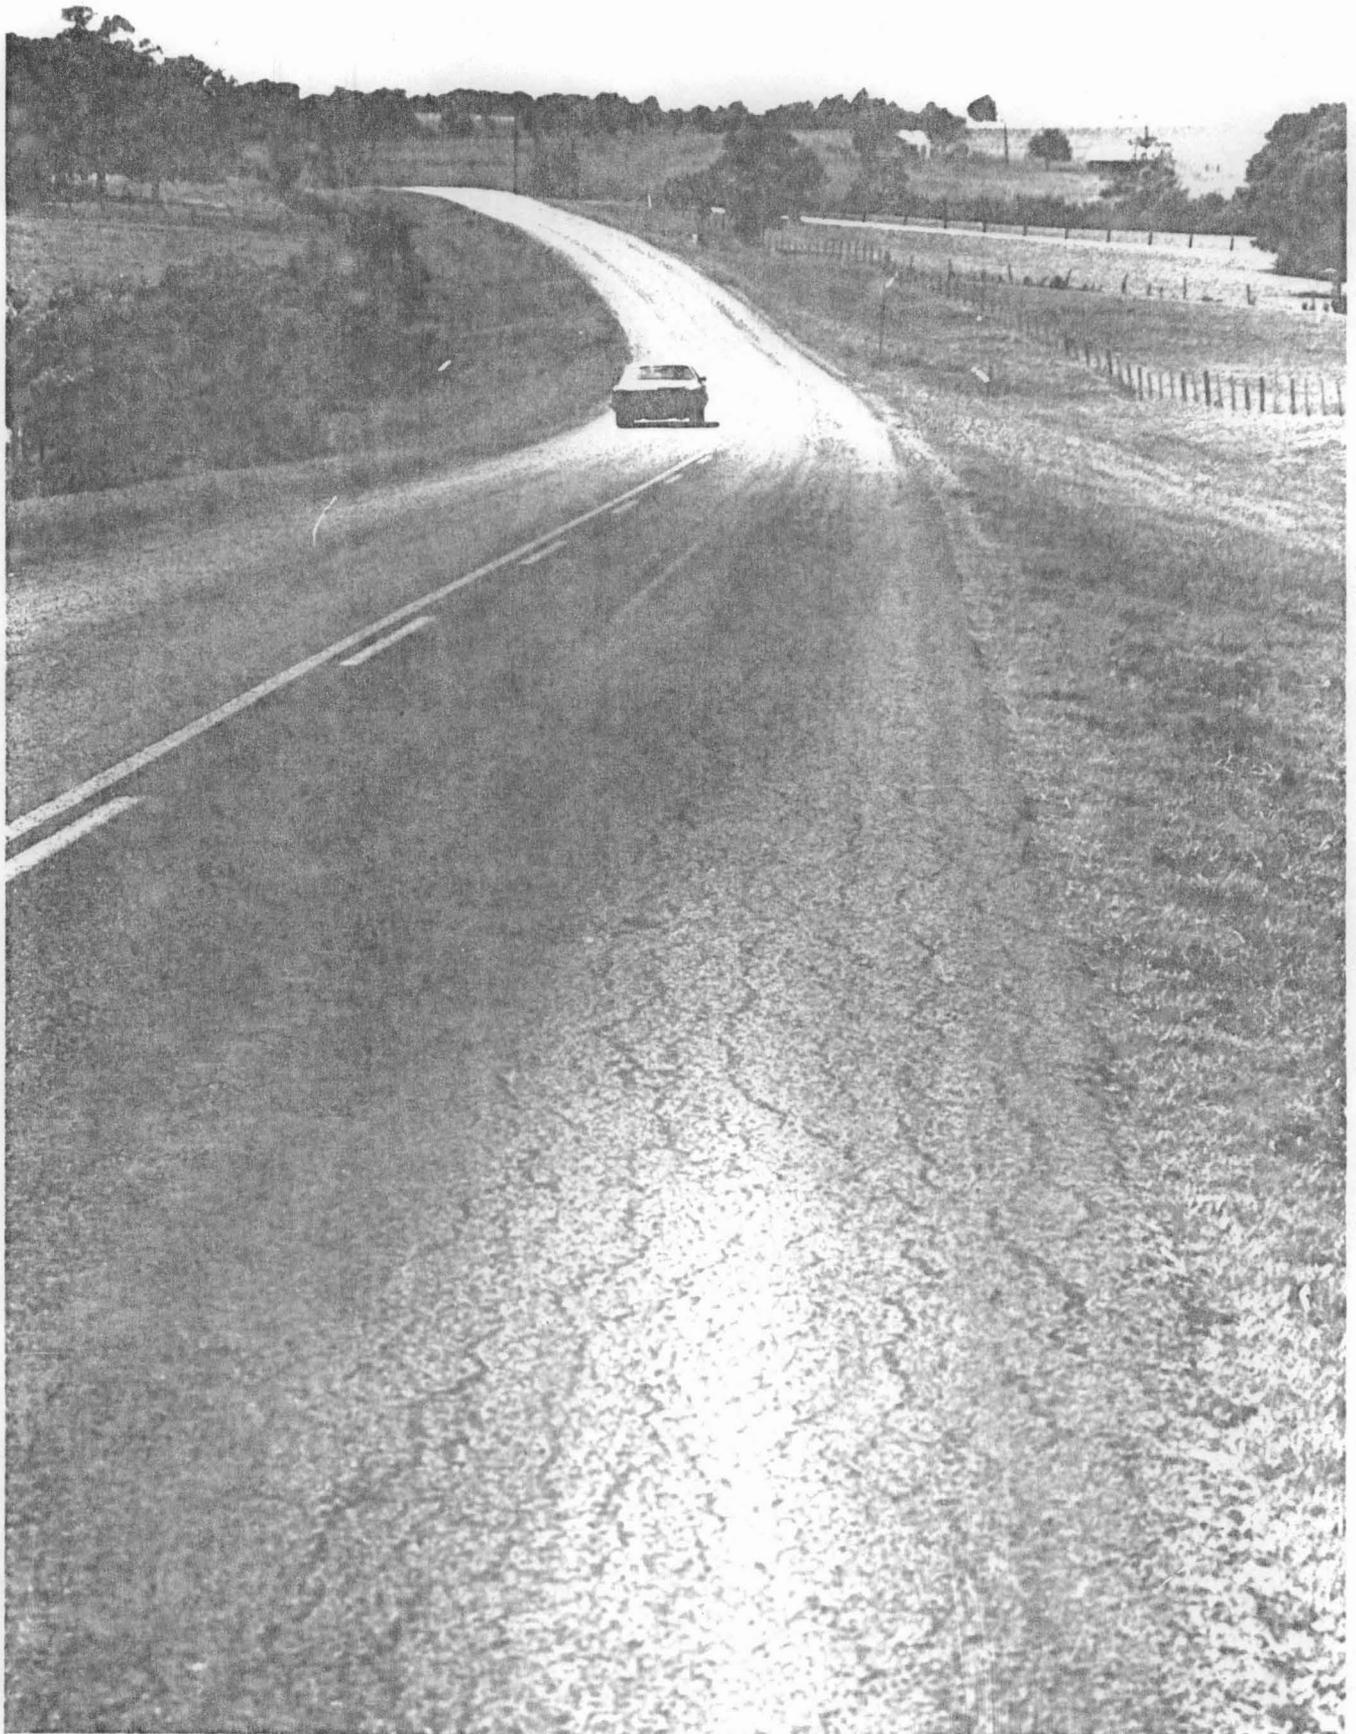
Picture 7

Picture shows excessive rutting and alligator cracking typical of the loaded lanes. This type of distress is associated with heavy loads.

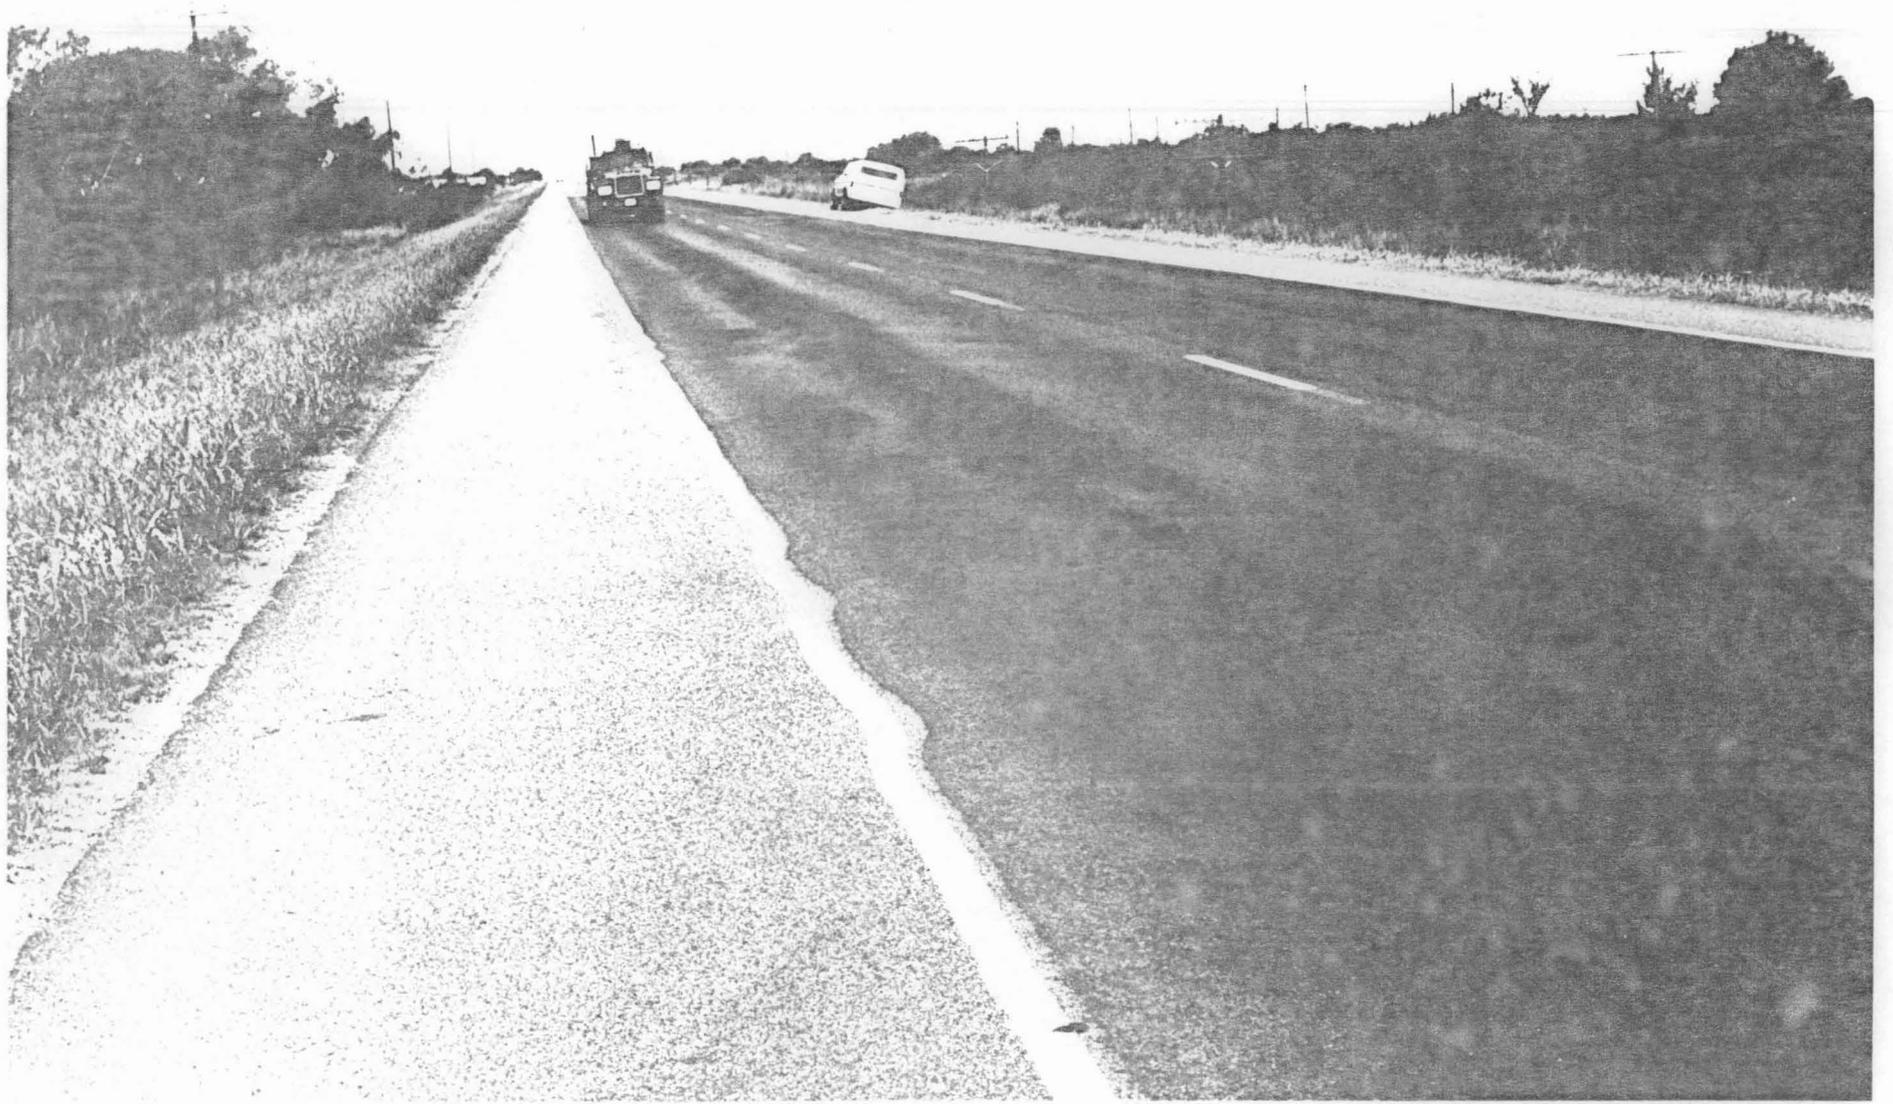
Picture 8

Picture shows misalignment of edgeline on the loaded Eastbound lane toward Houston. Misalignment has been caused by pavement material shoved out by the shearing action of heavy loads. Rutting in the wheel paths may also be noted. Note major rehabilitation in 1974-75 has helped reduce repair costs in 1976-78.

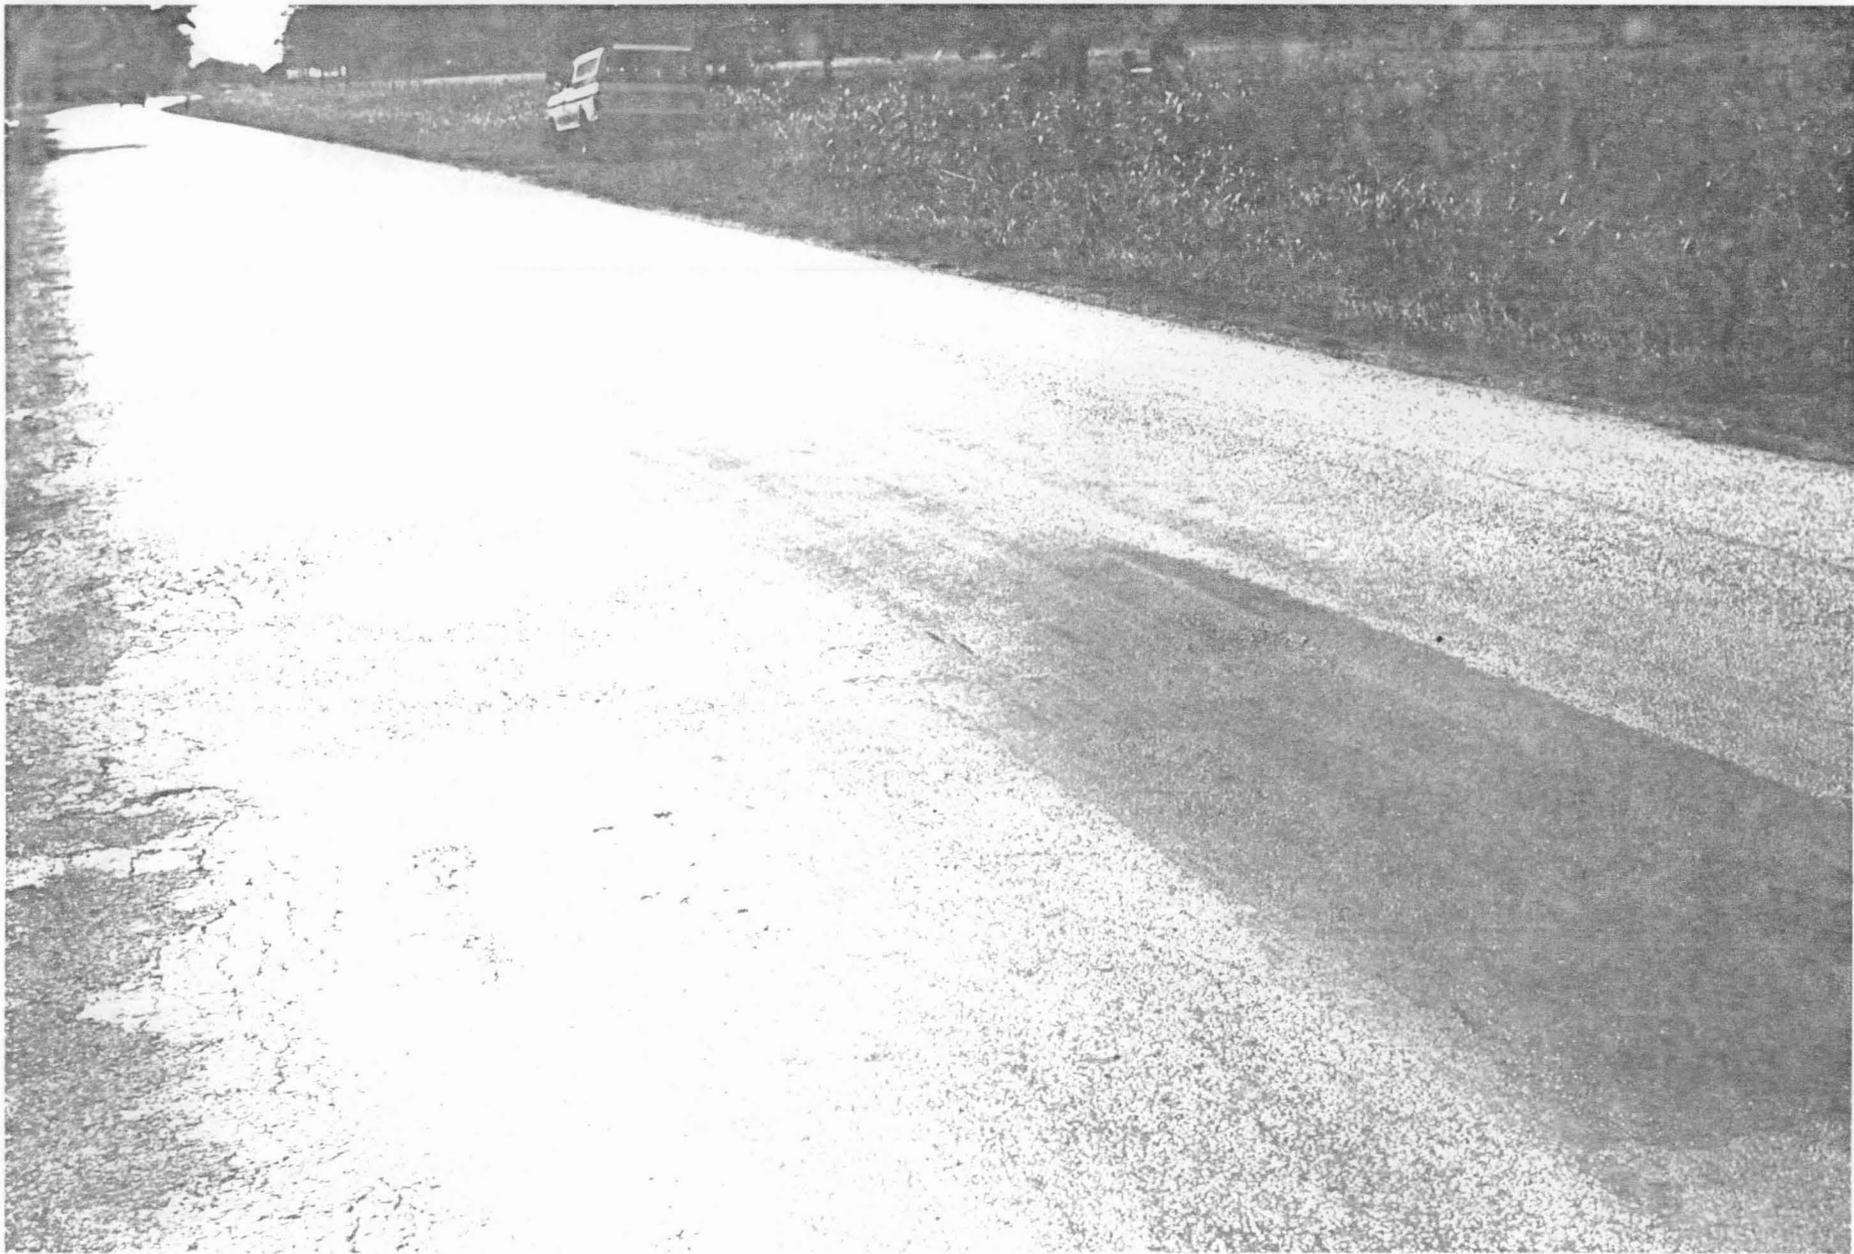
Picture 9

Picture shows shear failures, cracking and repair areas typical of the loaded lanes. The condition of this pavement is a good example of damage caused by loading. An aggregate source is located near the county line of Colorado and Wharton Counties. The loaded lanes eastbound in Wharton County show more distress than the return lanes. However, the westbound lanes carry the loaded trucks in Colorado County and the westbound lanes have more distressed areas than the eastbound lanes. Note major maintenance occurred during 1975-76 which reduced repair costs in following years.

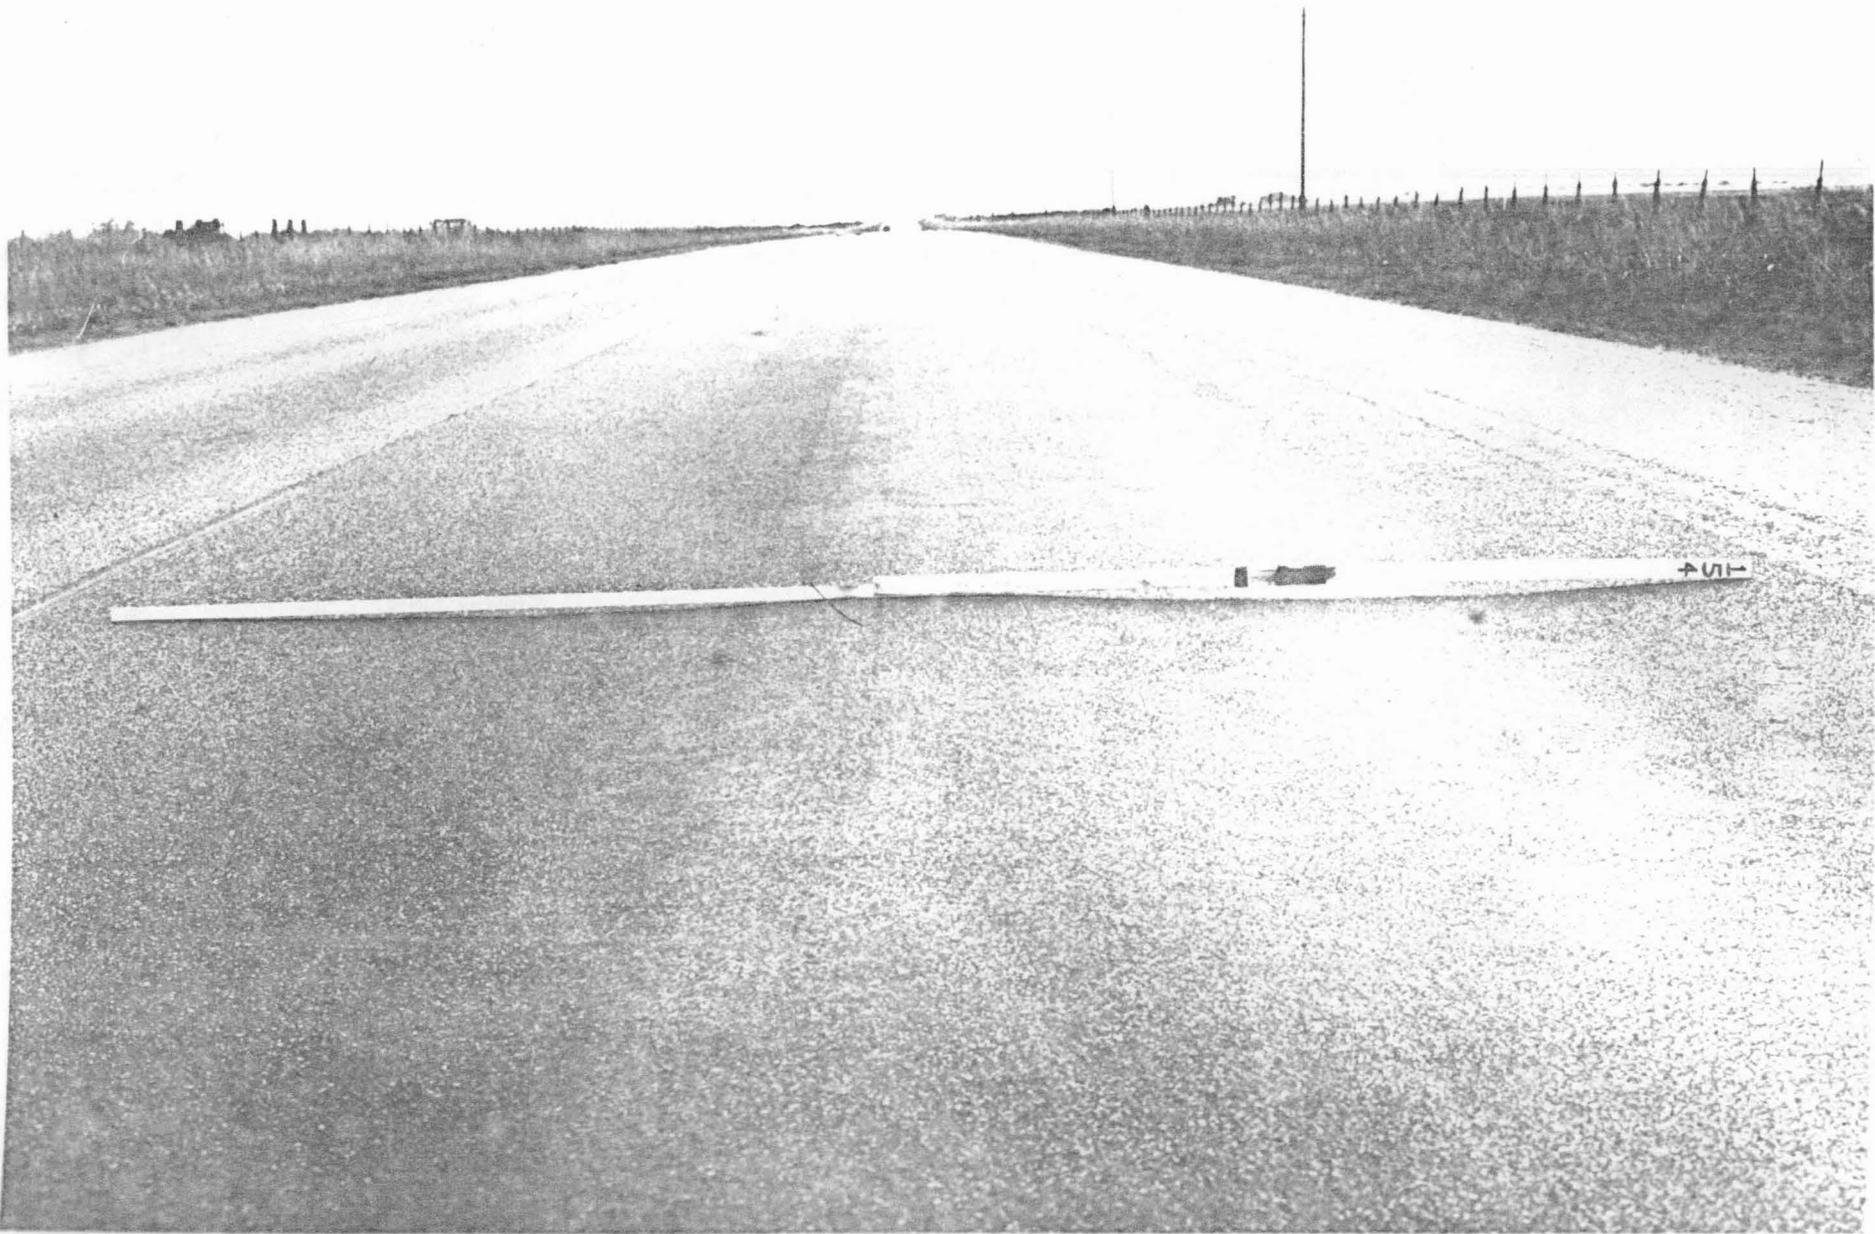
Picture 11

Picture shows extreme rut depths in loaded lanes. Since the highway is relatively new, the repair areas are few and the surface is smooth. The highway is nice with an excellent geometric layout - dark surface and contrasting white shoulders. The highway will carry high speed traffic and hydroplaning will be a problem during periods of rainfall because of the excessive water depths in the rutted wheel paths. Where water can accumulate to depths of 0.1-inch, hydroplaning can readily occur at speeds of approximately 50 mph. Even at lower speeds partial loss of control is a serious problem which must be considered.
