RESEARCH REPORT 1857-1

BRIDGES WITH PREMATURE CONCRETE
DETERIORATION: FIELD OBSERVATIONS
AND LARGE-SCALE TESTING

A. Boenig, L. Fúnez, R. E. Klingner, and T. J. Fowler

OCTOBER 2000

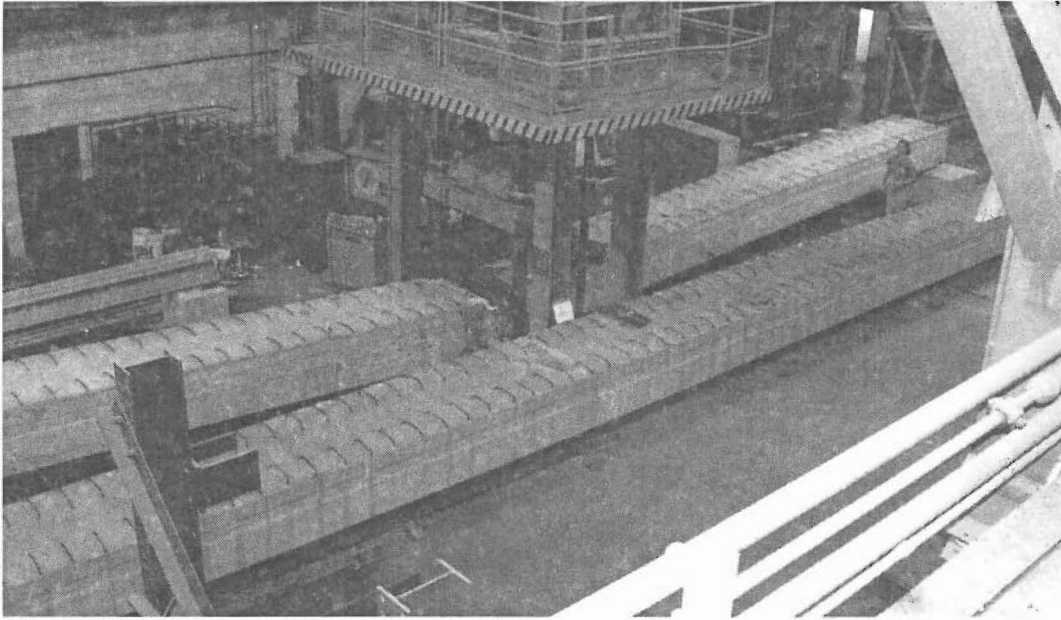
Figure 4.1 Failure of BG1F at 118.6 kips (527 kN)

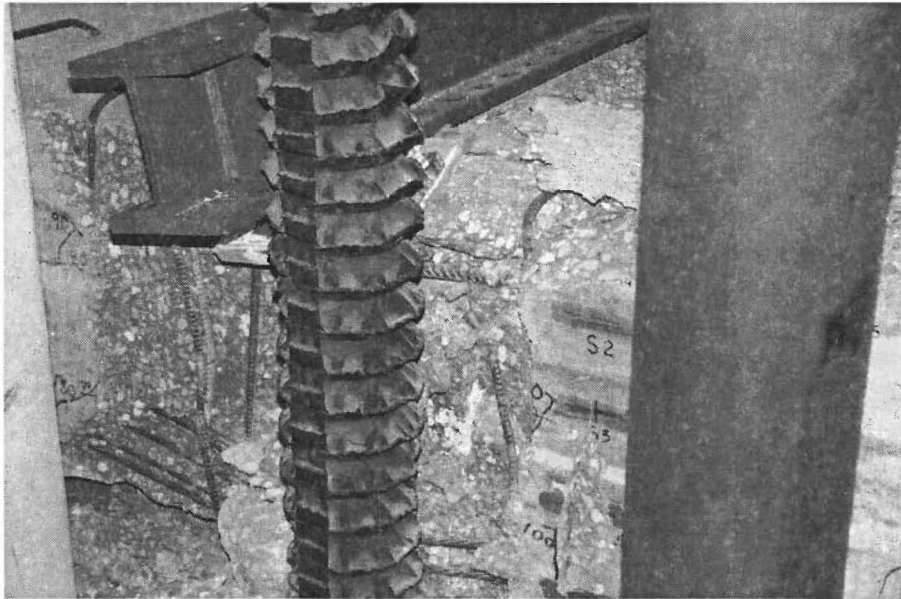
Figure 4.5 Flexural crack through Gages S3 and S4

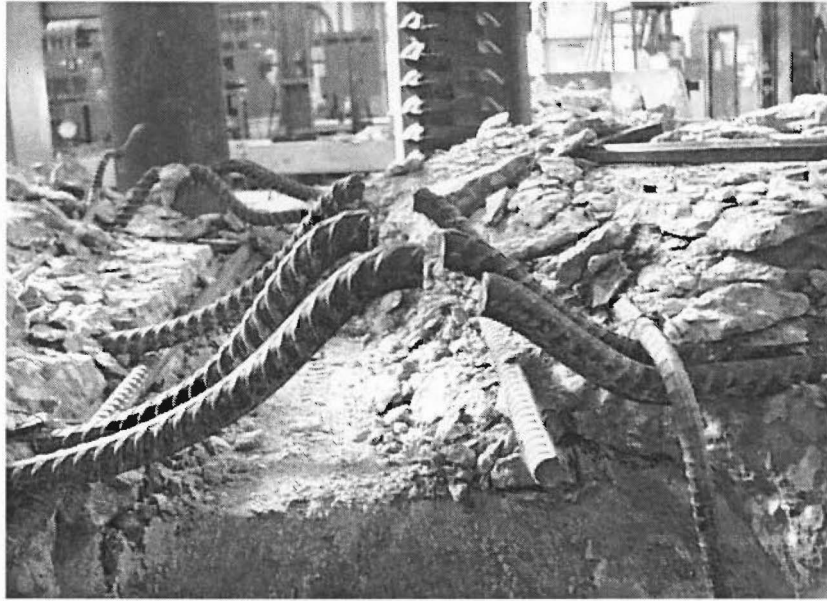
Figure 4.14 Fractured top reinforcement in BG4F

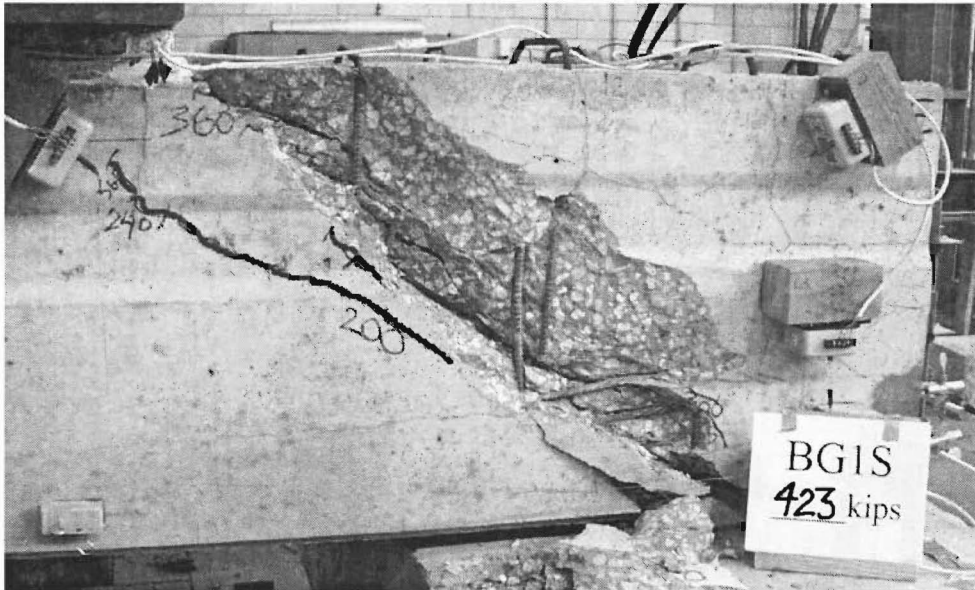
Figure 4.22 Failure of the east face of BG1S at 423 kips (1880 kN)

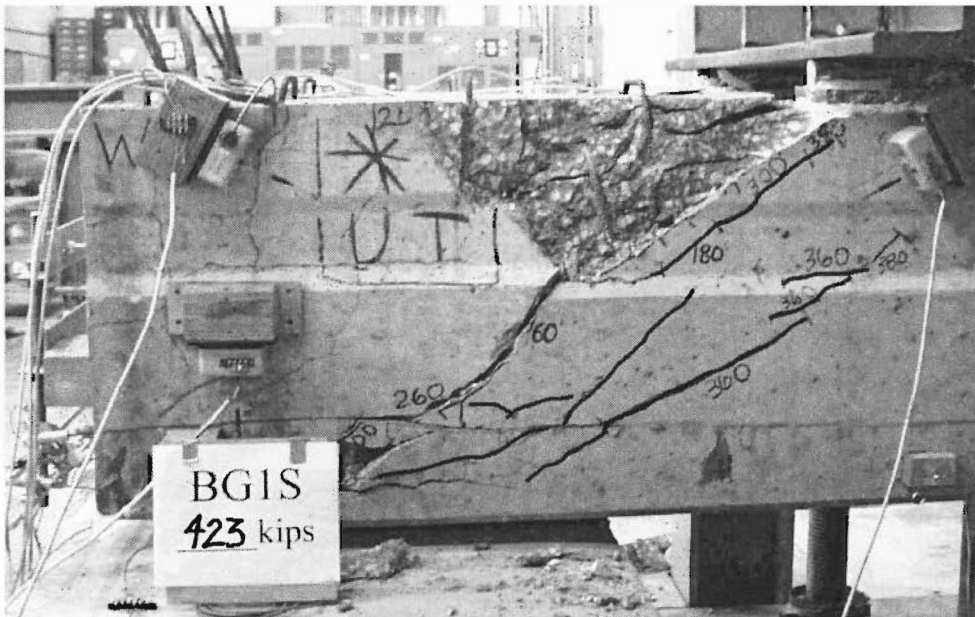
Figure 4.23 Failure of the west face of BG1S at 423 kips (1880 kN)

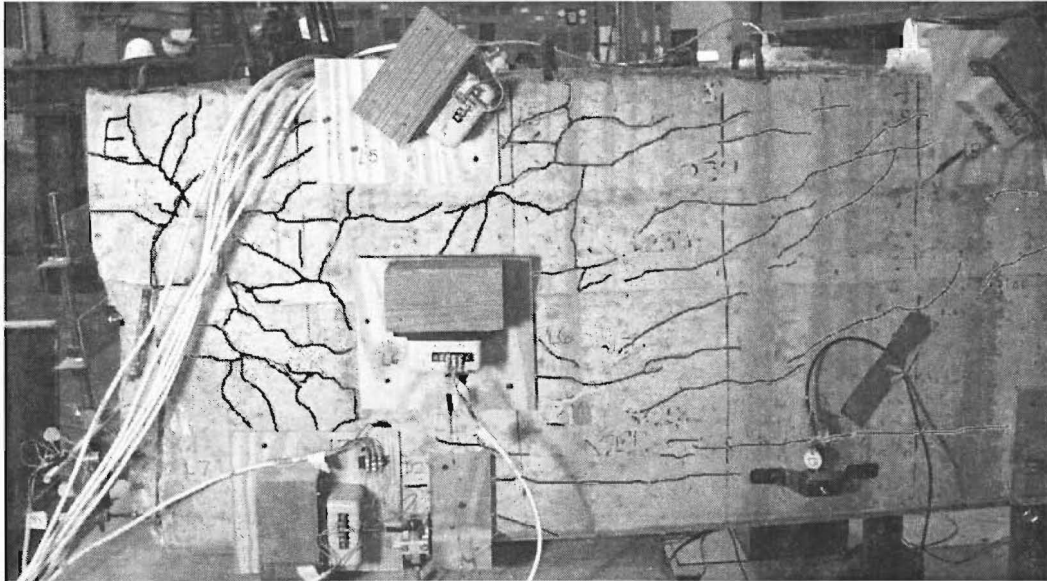
Figure 4.28 Pre-existing cracks on the east face of BG2S

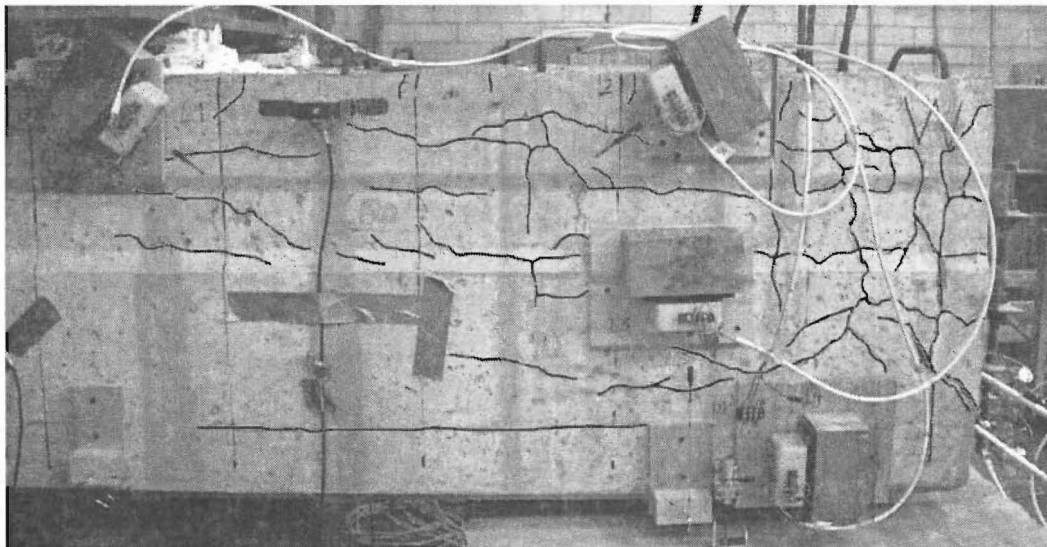
Figure 4.29 Pre-existing cracks on west face of BG2S

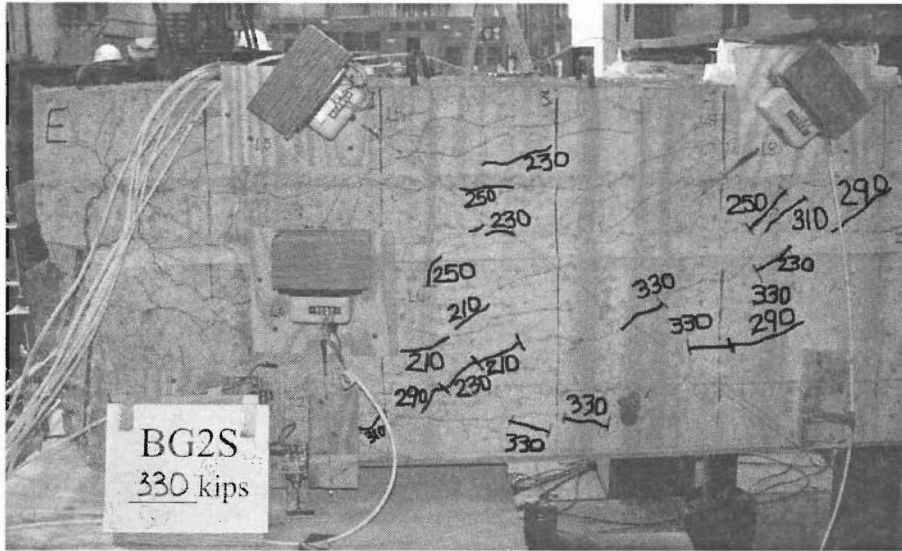
BG2S was tested on November 30, 1999. Shear cracks first appeared at 170 kips (756 kN) on the west side, and at 210 kips (934 kN) on the east side. Figures 4.30 and 4.31 show the development of cracks at 330 kips (1470 kN) on the east and west sides.

Figure 4.30 Shear-induced cracks on the east face of BG2S under a load of 330 kips (1470 kN)

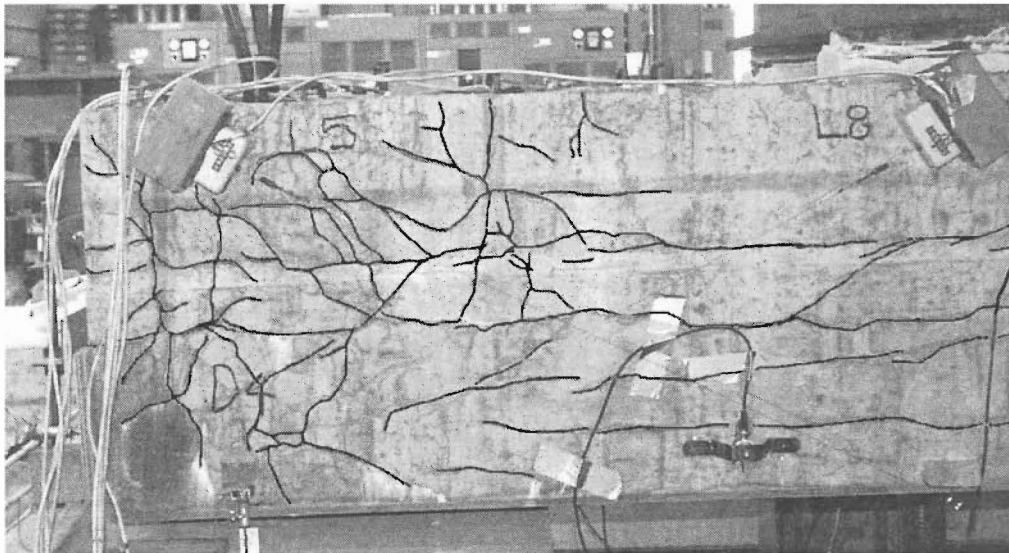
Figure 4.39 Pre-existing cracks on the east face of BG4S

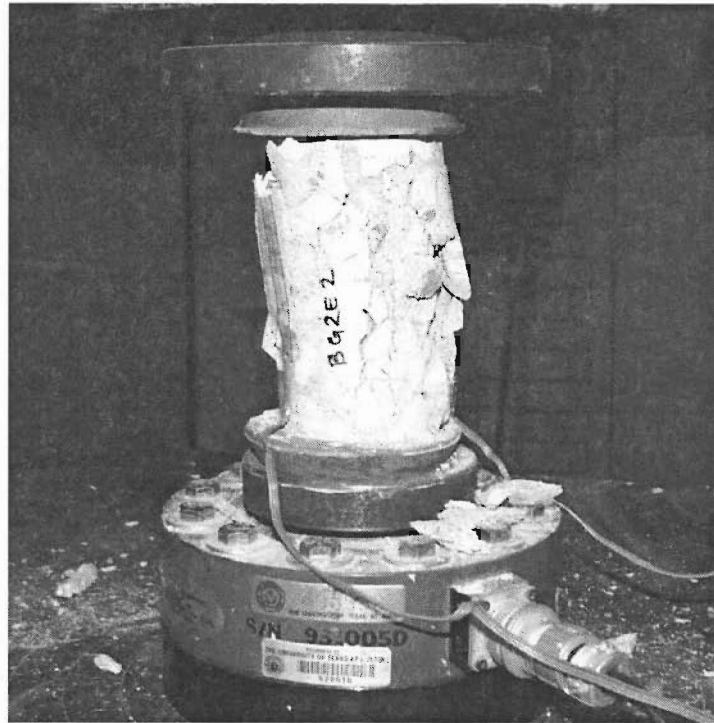
Figure 4.51 Failure of BG2E-2, typical of more-damaged cores

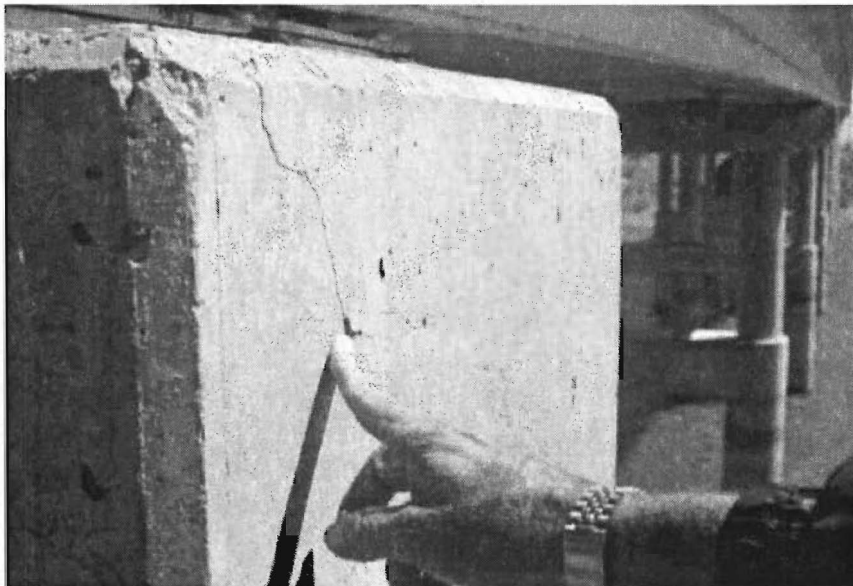
Figure 7.28 Map cracking at ends of bent cap (Bent 5)
