RESEARCH REPORT
TR-5-74

**RIGID PAVEMENTS ON INTERSTATE
HIGHWAY USING GLASS FIBER
REINFORCEMENT**

July 26, 1974

PATCHING OF RIGID PAVEMENTS ON INTERSTATE HIGHWAY
USING GLASS FIBER REINFORCEMENT

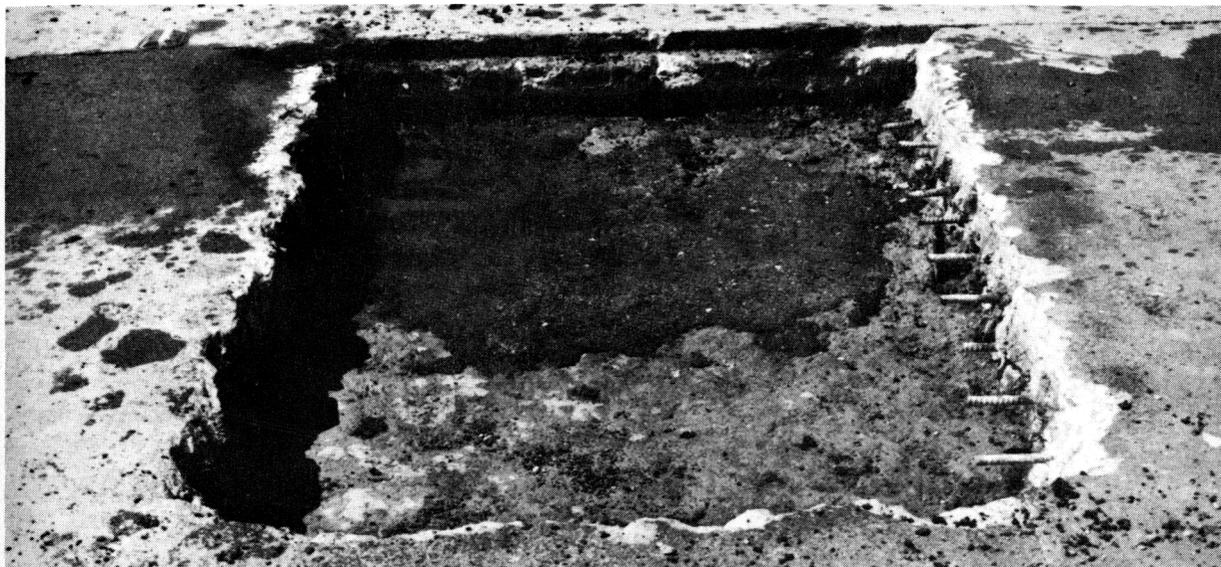
Repair patch #1 was of a volume of 0.9 cubic yards. All steel in the patch section was removed as shown by Figure 2. The patch was made without steel reinforcement as shown by Figure 3. The concrete mix was designed for the proportions shown in Table 2.

Figure 2: PATCH #1 BEFORE BEING FILLED WITH FIBERGLAS REINFORCED CONCRETE

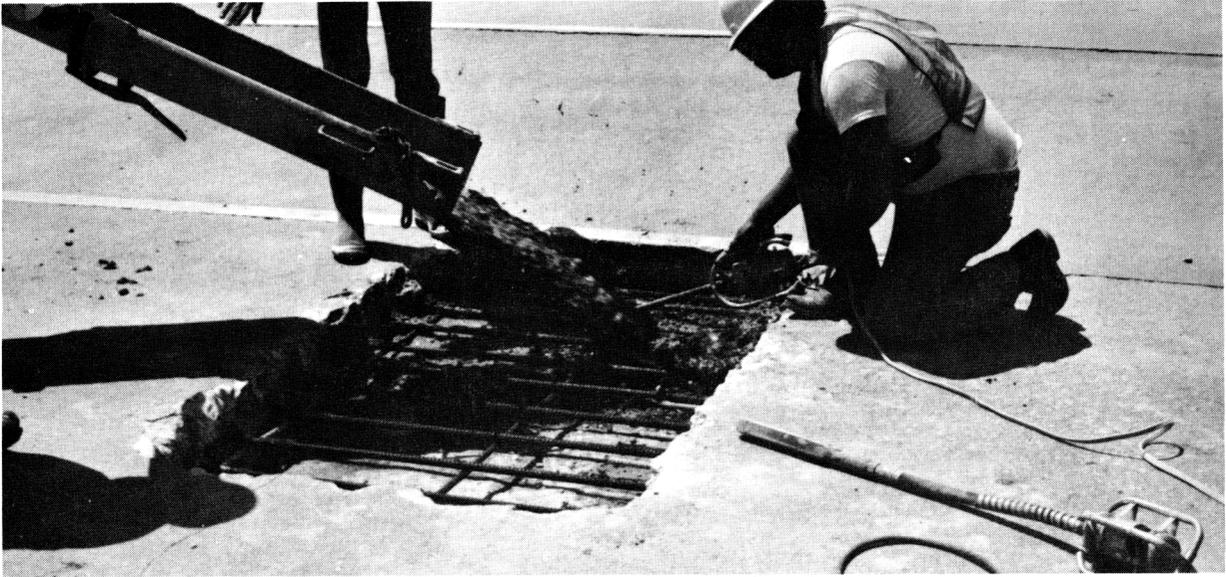
The concrete was placed around steel reinforcement (#5 \emptyset bars at 6-inch centers longitudinally and #4 \emptyset bars at 24-inch centers laterally, as shown by Figure 7 in Patch #2) would normally have resulted in substantial shrinkage cracking about the perimeter of the patch.

Figure 7: POURING OF PATCH #2

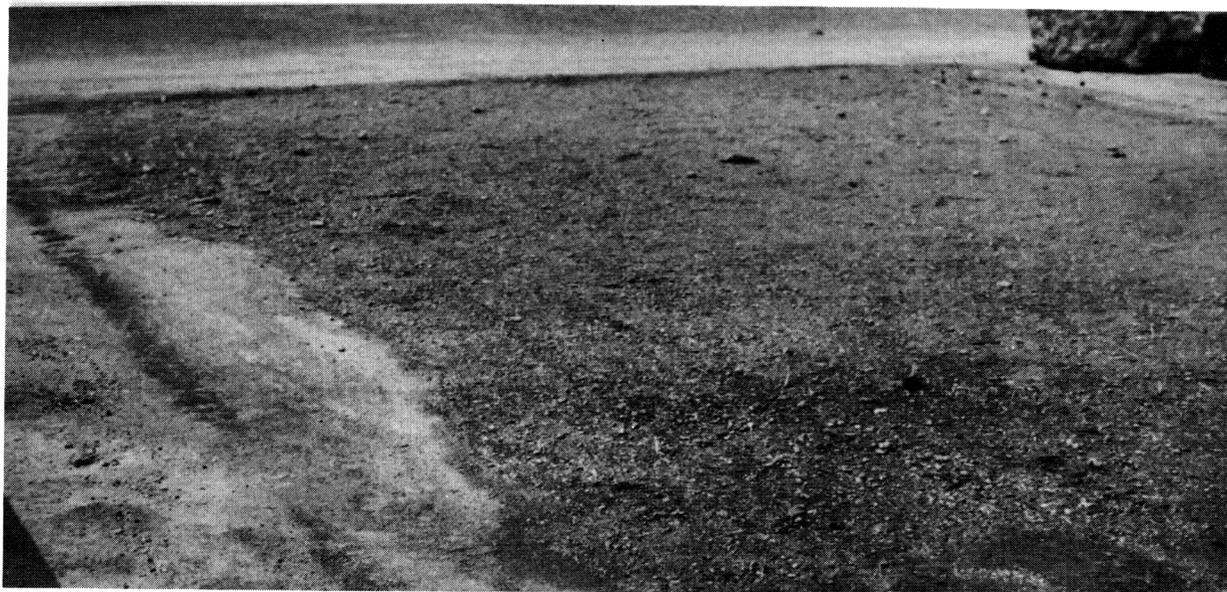
Figure 13: CLOSE UP SHOWING ABRASION OF PATCH #2

After two weeks of traffic, the surface of Patch #2 showed some effects of abrasion. See Figure 13. This is believed to be the result of the floating of highly diluted cement paste to the surface of the high slump, sandy concrete employed in this patch.

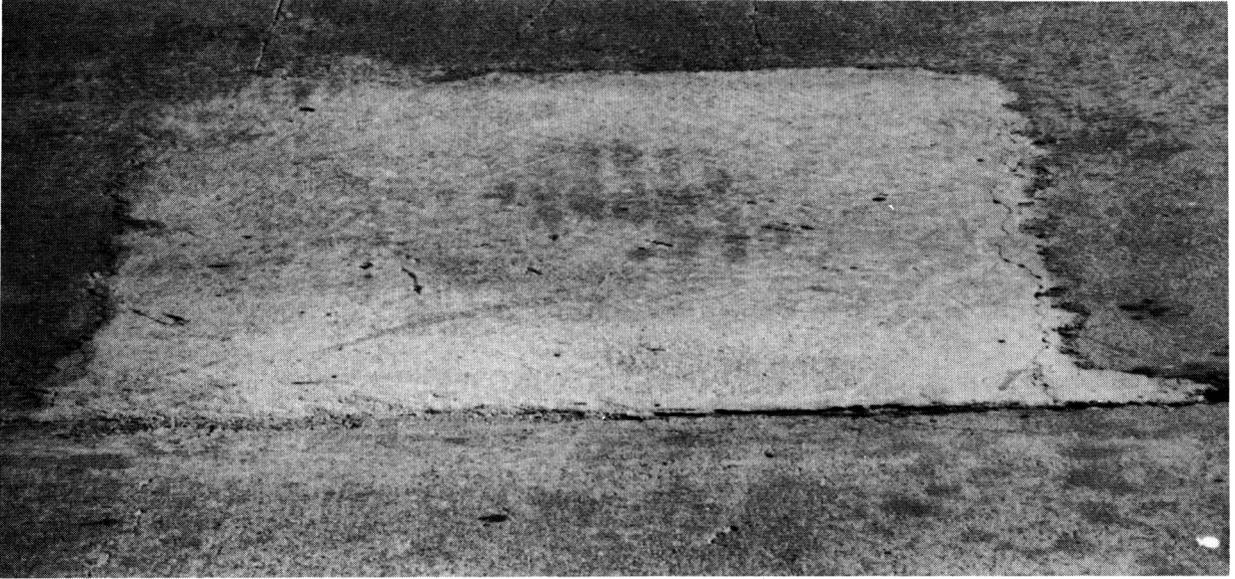
Patch #1 was observed to have developed a Class 3 crack, discernible in the photograph, Figure 14, after 56 days of exposure to traffic. The crack runs laterally (from North to South) on the entire railing edge with respect to the direction of traffic flow (e. g. : East edge) of the patch where it joins that portion of the pavement that was undisturbed.

Figure 14: PATCH #1 AFTER 56 DAYS OF TRAFFIC

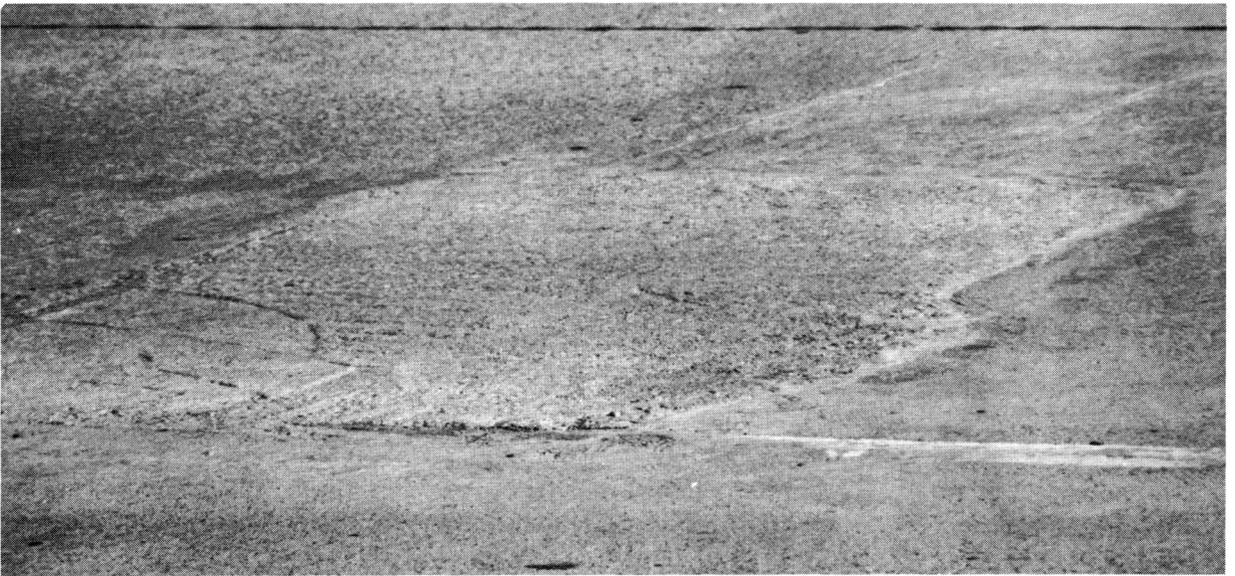
Patches #2 through #4 (Figures 15 through 17) showed no further appreciable changes.

Figure 15: PATCH #2 AFTER 56 DAYS OF TRAFFIC

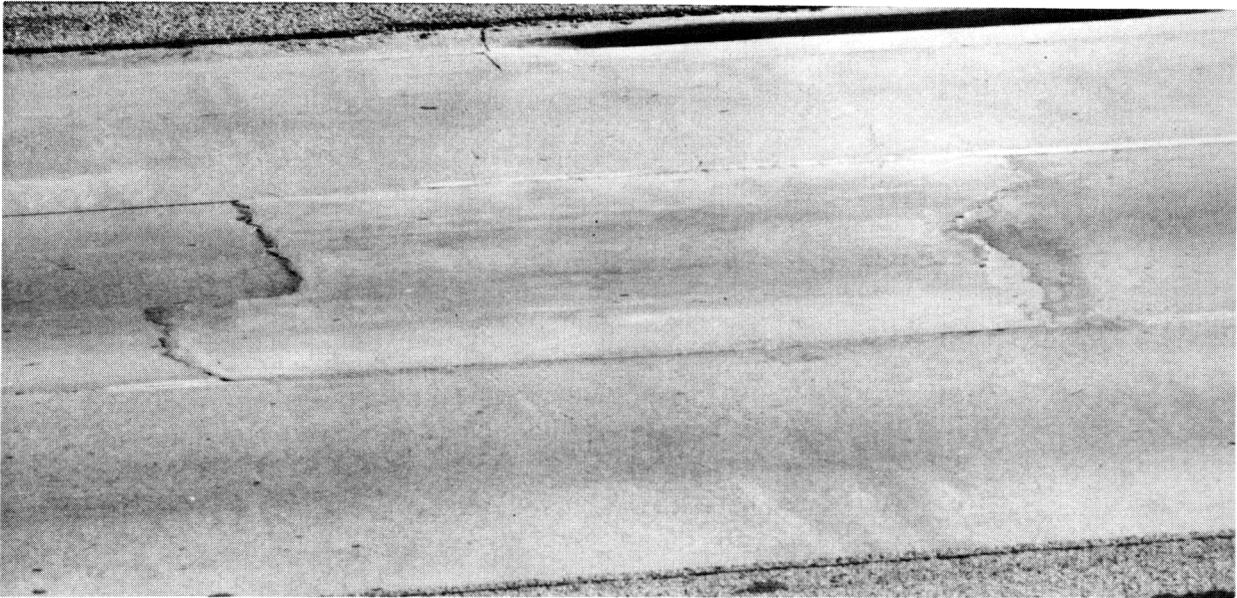
Figure 16: PATCH #3 AFTER 56 DAYS OF TRAFFIC

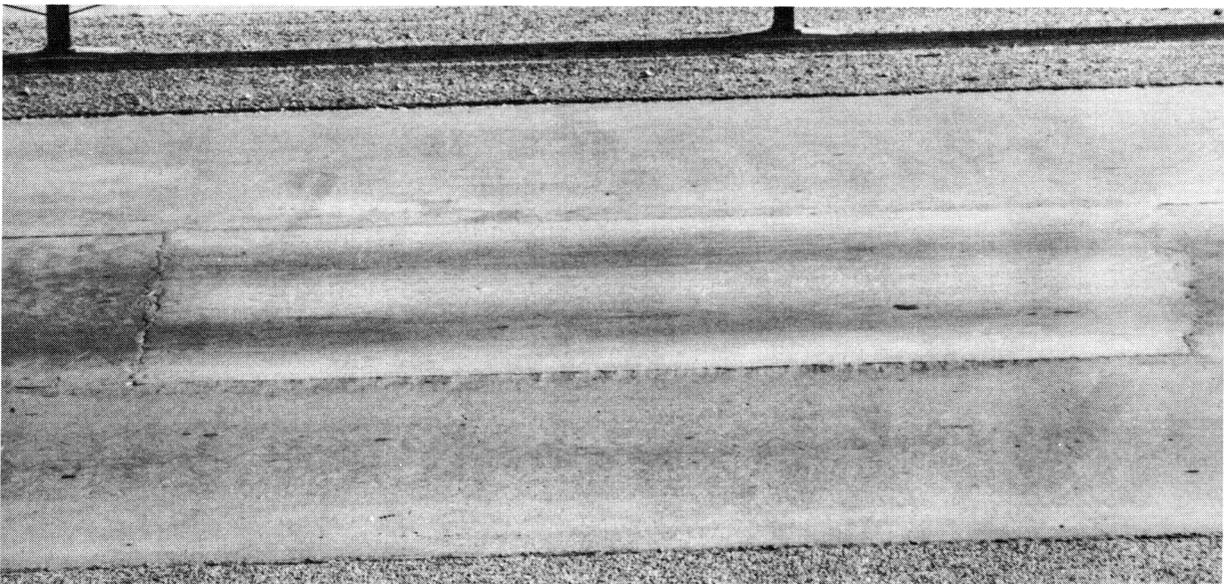
Figure 17: PATCH #4 AFTER 56 DAYS OF TRAFFIC
