"REPORT ON THE STATIC AND DYNAMIC TESTING  
OF FRANKLIN'S U-POST AND EZE-ERECT CONNECTION"

Research Report 3491-1F

Final Report  
on  
Project RF 3491

Texas A & M Research Foundation  
Texas Transportation Institute  
Texas A&M University  
College Station, Texas 77843

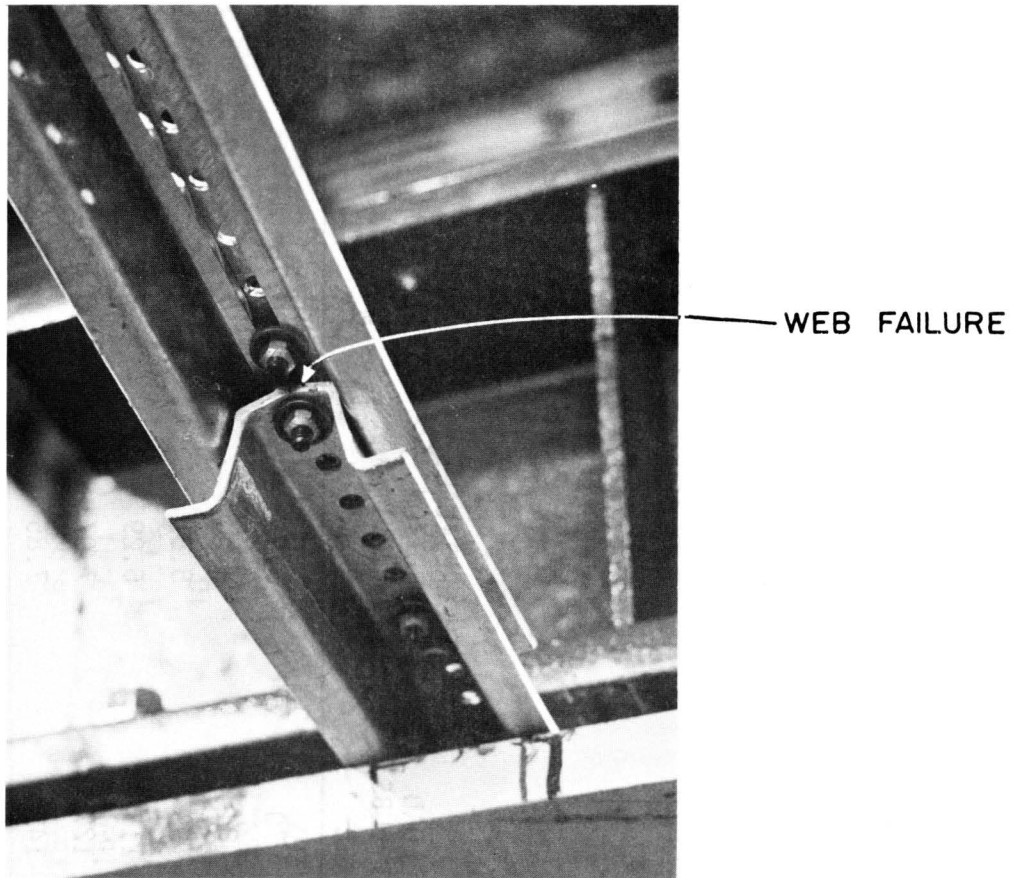
FIGURE 7. FAILURE OF WEB SECTION.

Results of the static load tests are given in Tables 1 and 2 and Figures 5 and 6. It can be seen that the amount of permanent set and/or slippage was relatively small up to the design load for both loading configurations, for both front and rear loading directions. Although the limited instrumentation precluded an exact determination, it is likely that most if not all of the "permanent" deflections, up to design load, were caused by slippage of the bolted base connection. A structural failure occurred in Configuration II at 136 percent of the design load when the web section of the base post split down the center line of the punched holes. The failure is shown in Figure 7.

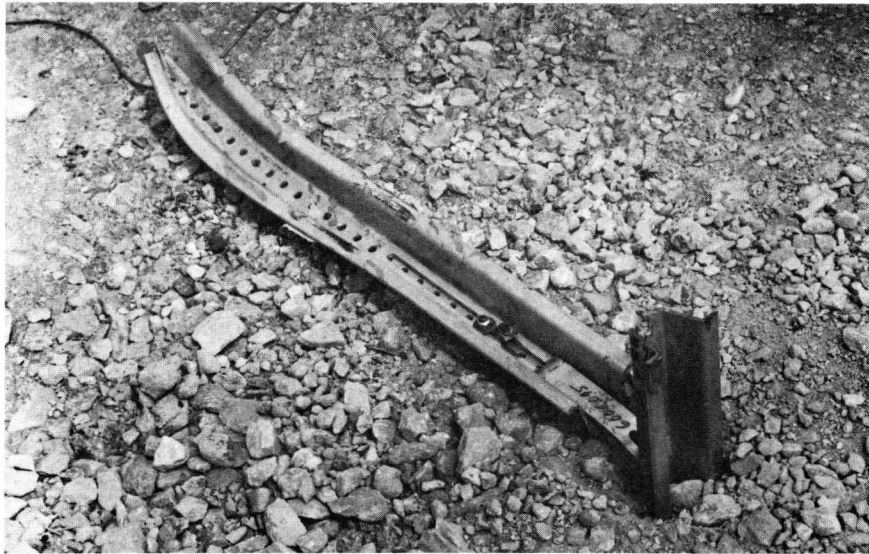
FIGURE 24. EZE-ERECT CONNECTION AFTER TEST 1.

The web section of the base post was torn out where the top bolt connects the base post to the signpost. The signpost was twisted and broken at the bumper height of the car. Both the signpost and the base post would have to be replaced for the reinstallation of the sign. The sign itself was undamaged and was reusable. Damage to the installation is shown in Figures 24 and 25.

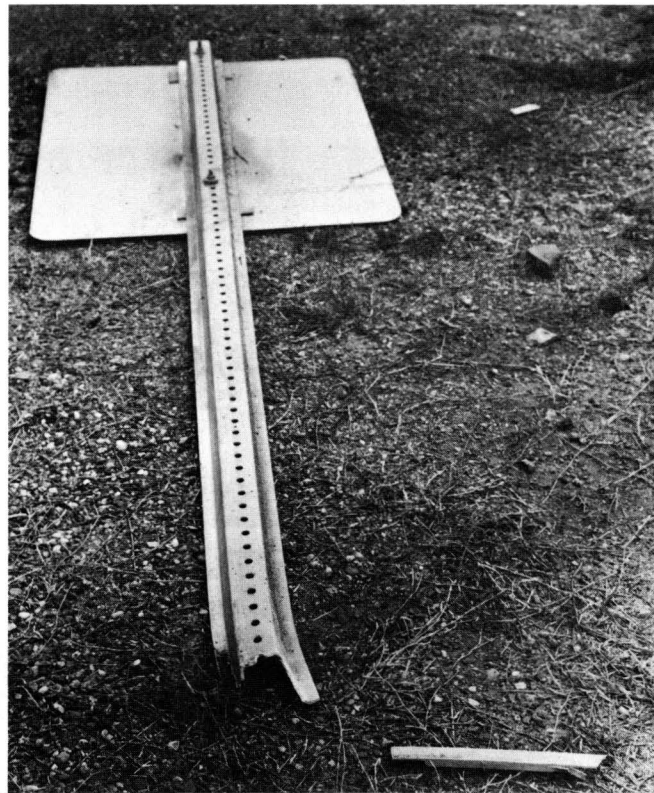
FIGURE 25. SIGNPOST AFTER TEST 1.

of the web section in the base post. The signpost broke also at the bumper height (20 in.) of the car upon impact. The upper part of the signpost with the sign attached flew forward after it broke loose and was rehit by the car.

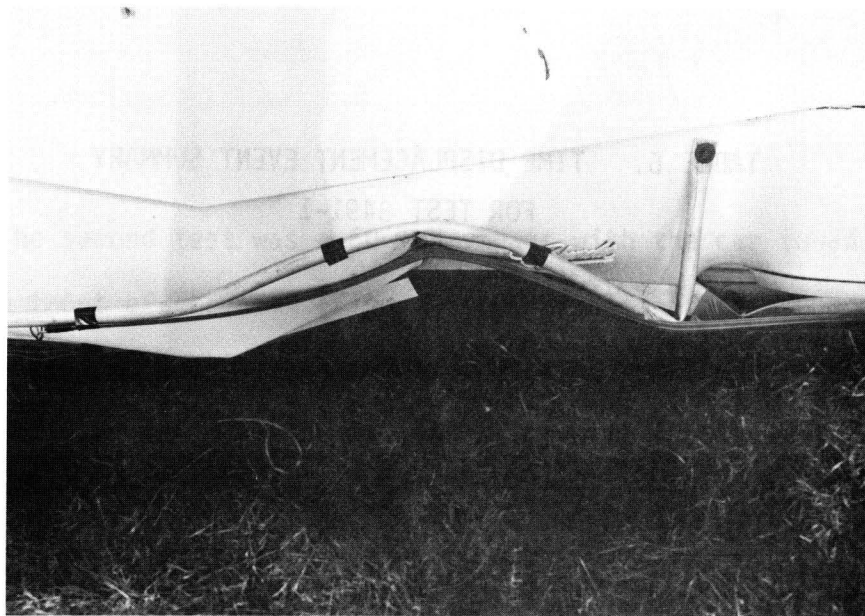
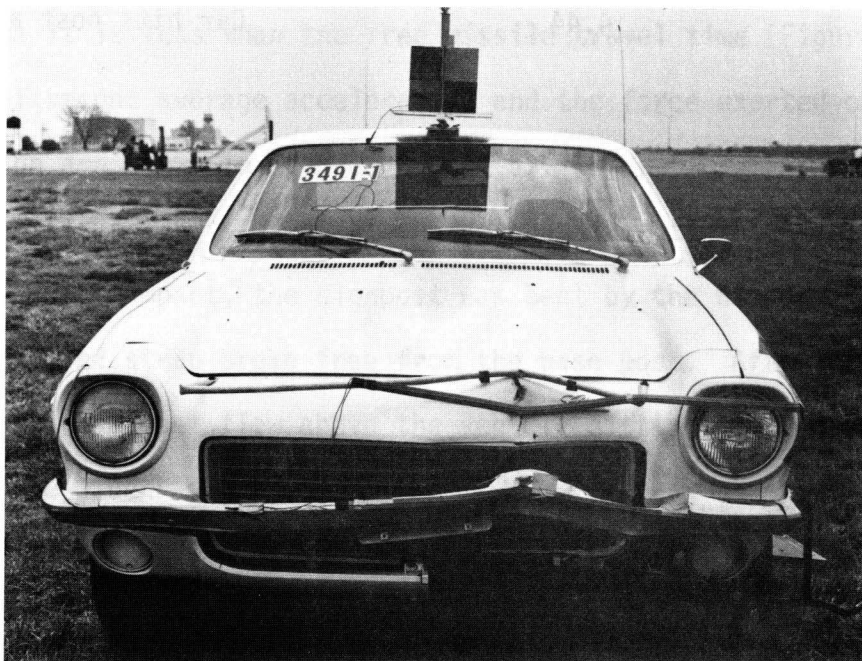
Before and after photographs of the car are shown in Figures 26 through 29. Permanent deformation of the car was minor with the bumper being displaced into the grill and the metal above the front grill being slightly damaged. Damage to the vehicle was assessed using the TAD<sup>7</sup> and SAE<sup>8</sup> damage rating scales and the results are given in Table 5.

FIGURE 28. TOP VIEW OF CAR AFTER TEST 1.

FIGURE 29. FRONT VIEW OF CAR AFTER TEST 1.

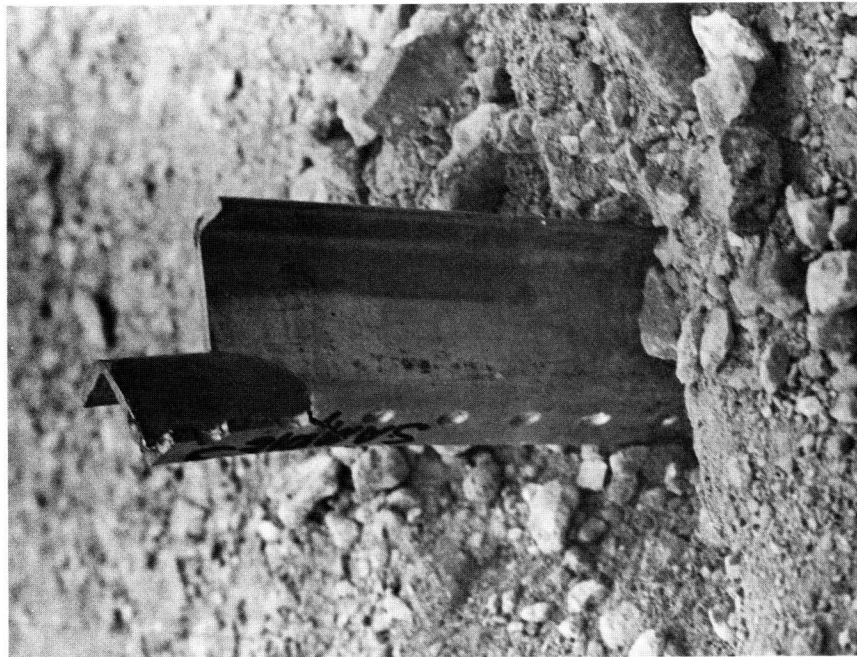
FIGURE 37. BASE POST.

panel was damaged when it came in contact with the top of the car. For reinstallation, the base post, signpost, and sign panel would have to be replaced.

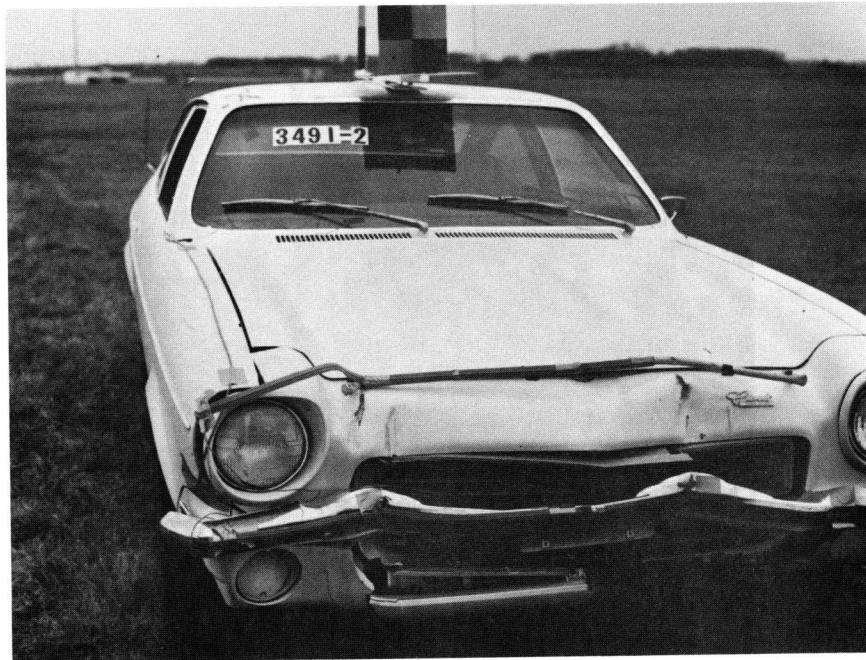
FIGURE 40. CAR AFTER TEST 2.

The before and after damage to the car is shown in Figures 39 and 40, with the damage for this test being on the left portion of the vehicle. The permanent deformation was minor with the bumper being displaced, damaging the metal section above the grill. The top of the car above the windshield was dented. Damage to the vehicle was assessed using the TAD and SAE systems and is presented in Table 7.

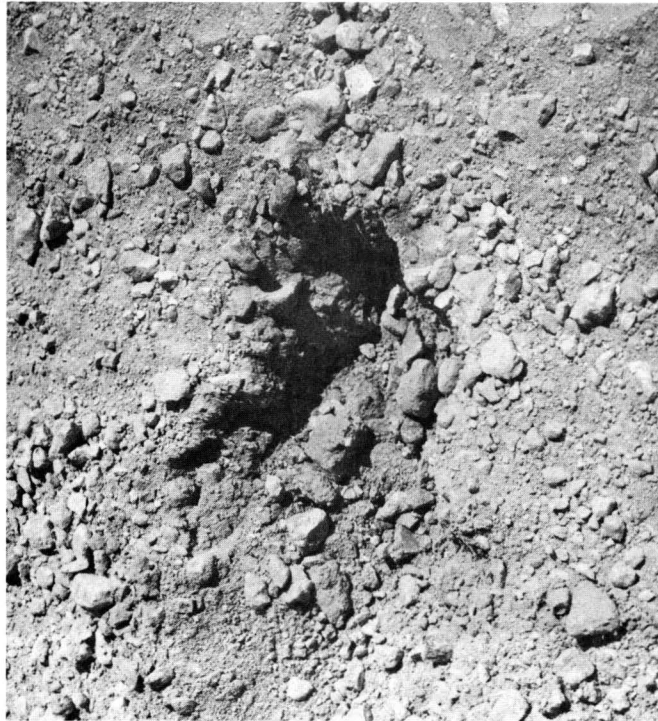
FIGURE 48. BASE POST BROKEN IN GROUND IN TEST 3.

Sequential photographs from the high-speed film are given in Figure 47. Upon impact, the base post fractured approximately 5 inches below the ground (Figure 48). After the base post broke, the signpost with sign panel attached first flew, then slid along the ground in front of the car.

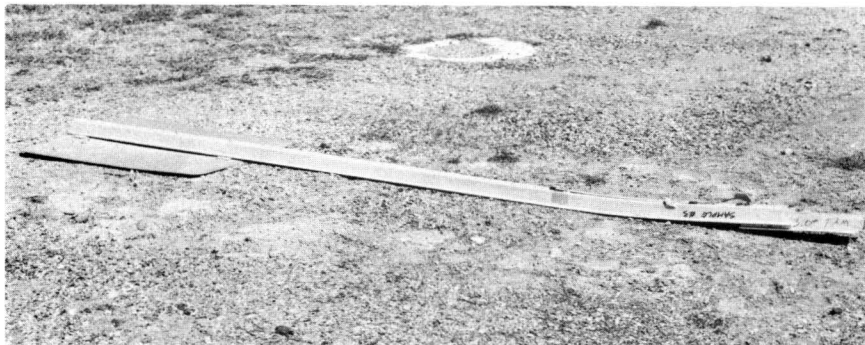
FIGURE 49. SIGNPOST AFTER TEST 3.

The base post would have to be replaced but the signpost could probably be reused if the slight bend was straightened out (Figure 49). The sign was scratched up but could probably be reused after rescreening.

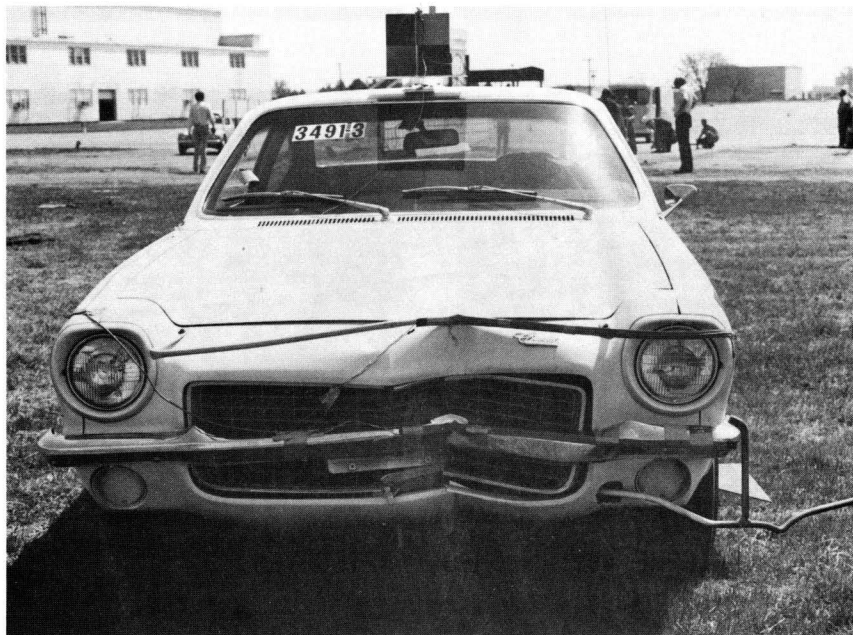
FIGURE 51. CAR AFTER TEST 3.

grill deformed. The damage to the car was assessed as in previous tests by the TAD and SAE systems. The results are given in Table 9.

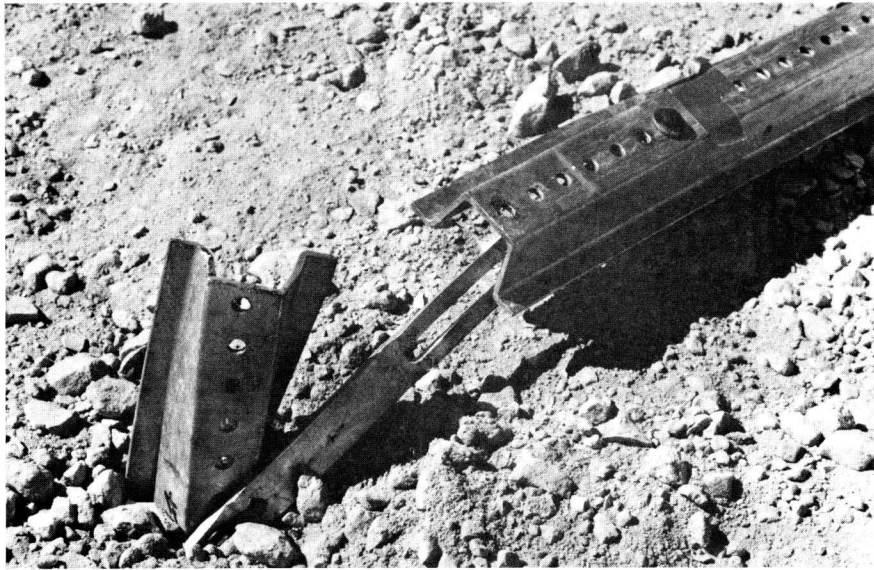
FIGURE 59. EZE-ERECT CONNECTION AFTER TEST 4.

Sequential photographs from the high-speed cameras are given in Figure 58. After impact, the bending and twisting action of the signpost caused the bolts in the Eze-Erect connection to fail. However, the retainer strap kept the signpost from further travel and the signpost fell to the ground in front of the car. The right front tire contacted the base post causing the car to veer off to the right.

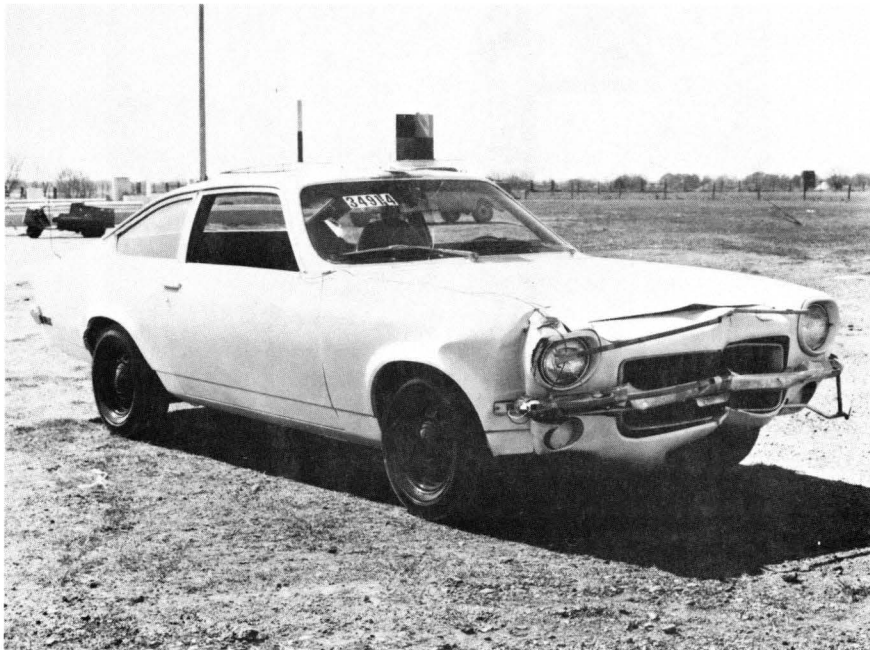
FIGURE 62. CAR AFTER TEST 4.

Figures 61 and 62 show the before and after photographs of the car. The front right end of the car was pushed up against the tire damaging the area between the headlight and the right front tire. The TAD and SAE systems were used to assess the damage to the car and are presented in Table 11.
