TECHNICAL MEMORANDUM 505-1S

THE MODULAR CRASH CUSHION

A Tentative Progress Memorandum on Contract No. CPR-11-5851

August 1970

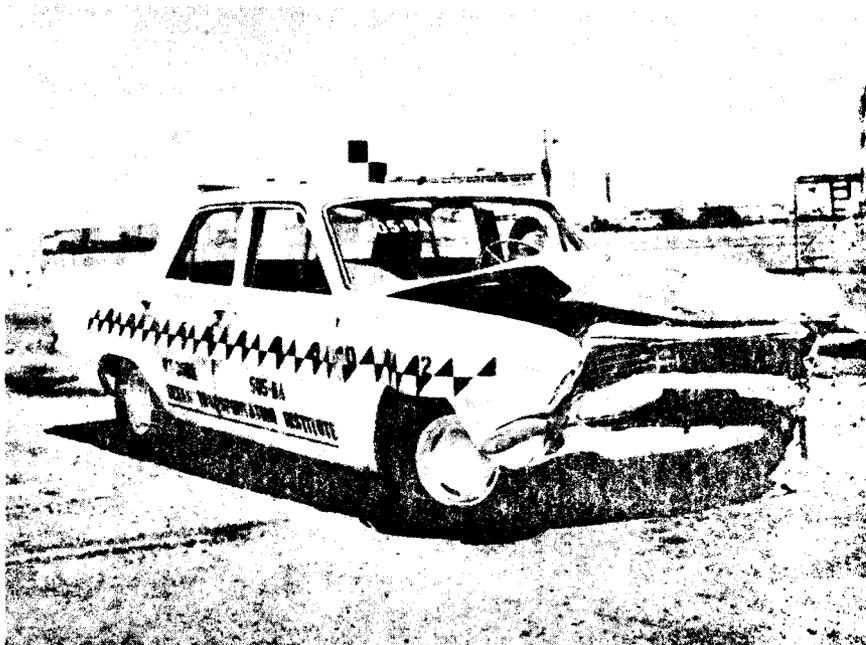
Figure 6, Vehicle After Test 505 B-A.

Analysis of the accelerometer traces showed the average deceleration to be 10.8 g's longitudinally and 1.1 g's laterally. Damage to the vehicle was rather severe due to the impact with the rigid wall (see Figure 6).

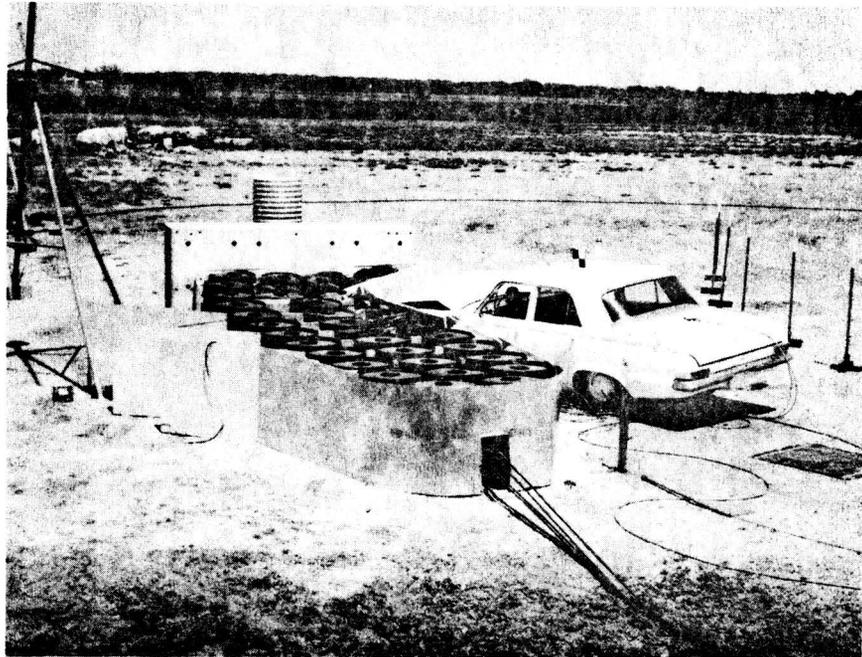
Figure 9, Crash Area After Test 505 B-A.

After initial contact, the lateral stability of the redirection panels was not sufficient to prevent the vehicle from "pocketing" and crushing several barrels before impacting the edge of the rigid wall. This was the reason for the high maximum longitudinal deceleration of 53 g's. Duration of this high deceleration was about 80 msec, as can be seen from Figures A1 and A2. Contact with the rigid wall occurred about 240 msec after impact, at which time the g level on the accelerometer traces begins to rise sharply (see Figures A1 and A2 in the Appendix).

This redirection system did not perform as intended. The undesired behavior was attributed to lack of lateral attenuation space at the rear of the barrier adjacent to the edge of the rigid wall. In addition, the barrier had insufficient lateral stability due to the anchor cable positions and to insufficient overlapping of the redirection panels. Subsequent test cushions incorporated design changes which resulted in better redirection capabilities.

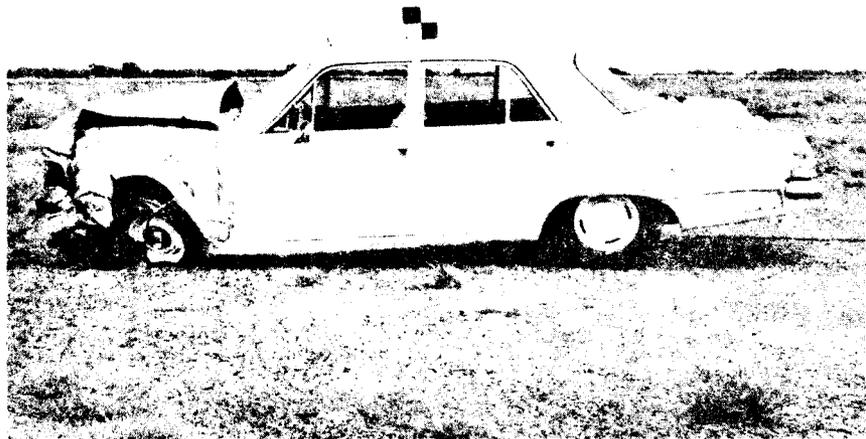
Figure 11, Vehicle After Test 505 B-B.

The left front end of the vehicle was permanently deformed about 1.5 ft. Damage to the barrier was slight. Since only a few barrels were crushed, as seen in Figure 15, the barrier was easily repaired before the next test. This test was considered successful in that the vehicle was redirected as intended, with deceleration levels well within acceptable human tolerances.<sup>5</sup>

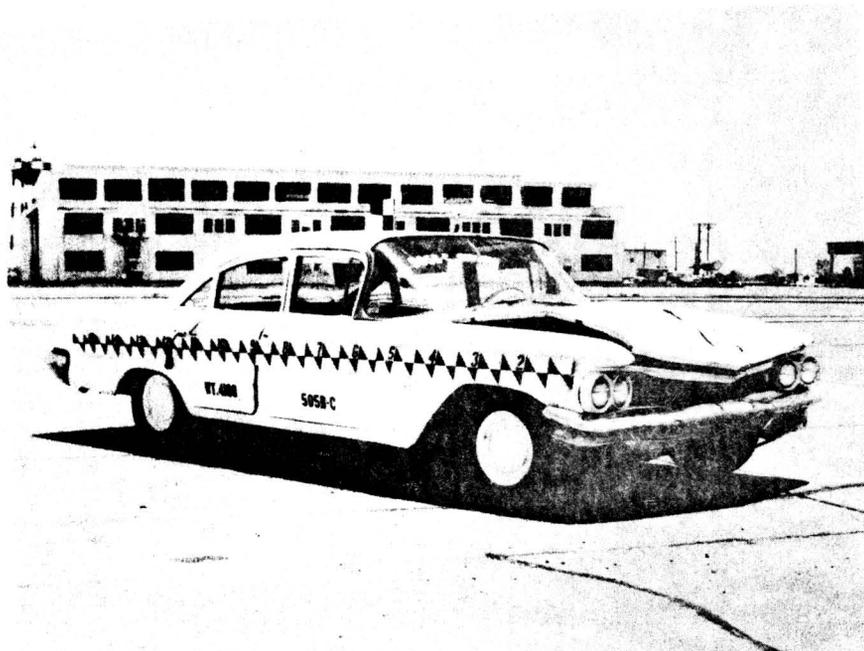
Figure 17, Vehicle After Test 505 B-C.

The system performed as designed. The vehicle damage was very minor as shown in Figure 17. Permanent vehicle front end deformation was only 2 inches. The headlights of the vehicle were not broken.

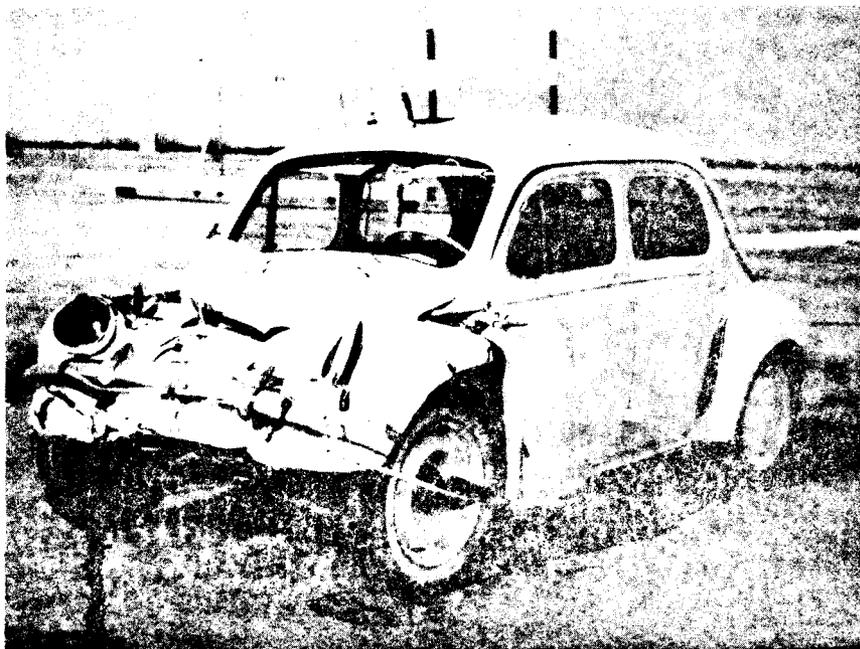
Figure 29, Vehicle After Test 505 B-E.

The head-on test of the third crash cushion prototype utilized a lightweight, rear-engine vehicle. Although the damage to the vehicle's front end was severe, it was expected in this case since the engine was in the rear and only a light, sheetmetal luggage compartment protected the front end. Actually, this crushing too is part of the attenuation process. The passenger compartment was not penetrated. The g levels were not excessive considering the weight and speed of the test vehicle. The vehicle maintained a stable posture throughout the impact, with no overturning tendency.
