DETERMINING VIBRATIONAL FORCES  
EXPERIENCED BY HIGH PRESSURE  
SODIUM VAPOR LAMPS IN  
ROADWAY LUMINAIRES

SUPPLEMENT  
TO  
FINAL REPORT  
Research Report Number 273-1F  
Research Project Number 1-8-81-273

August 1988

REPORT A  
ROADWAY LUMINAIRE VIBRATION  
ENVIRONMENTS

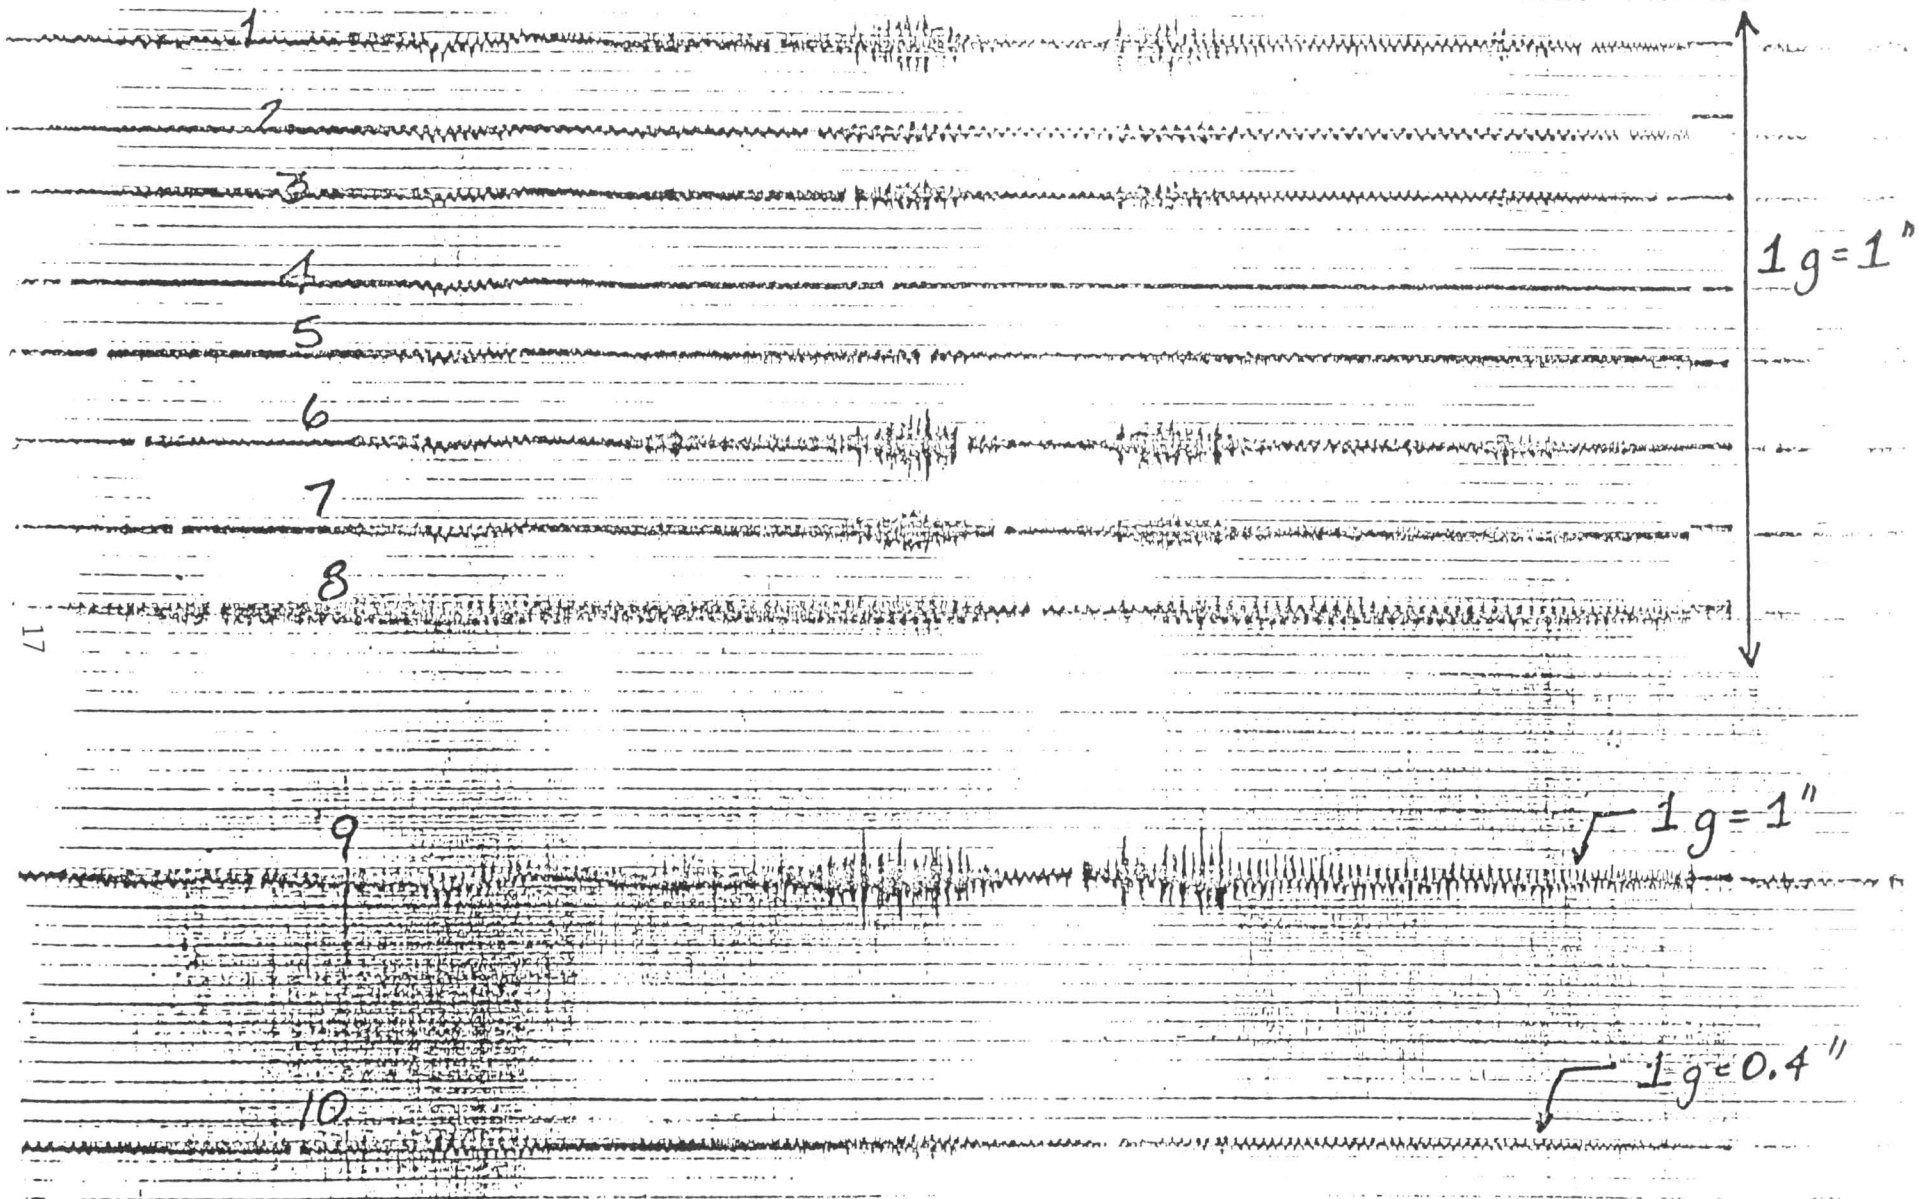
At Site 4 the instrumented luminaire was mounted near midspan on an elevated on-ramp. As at Site 2, vortex induced pulses at the arm end were insignificant. More characteristic of this site was highly random, low-level vibration of the luminaire structure precipitated by passing vehicles exciting the ramp foundation supporting the luminaire, see Figure 16. Spectral analyses show the frequency content of the vibration to be distributed, Figure 17.

Figure 4.2 - Luminaire Vibration on the Bridge Ramp

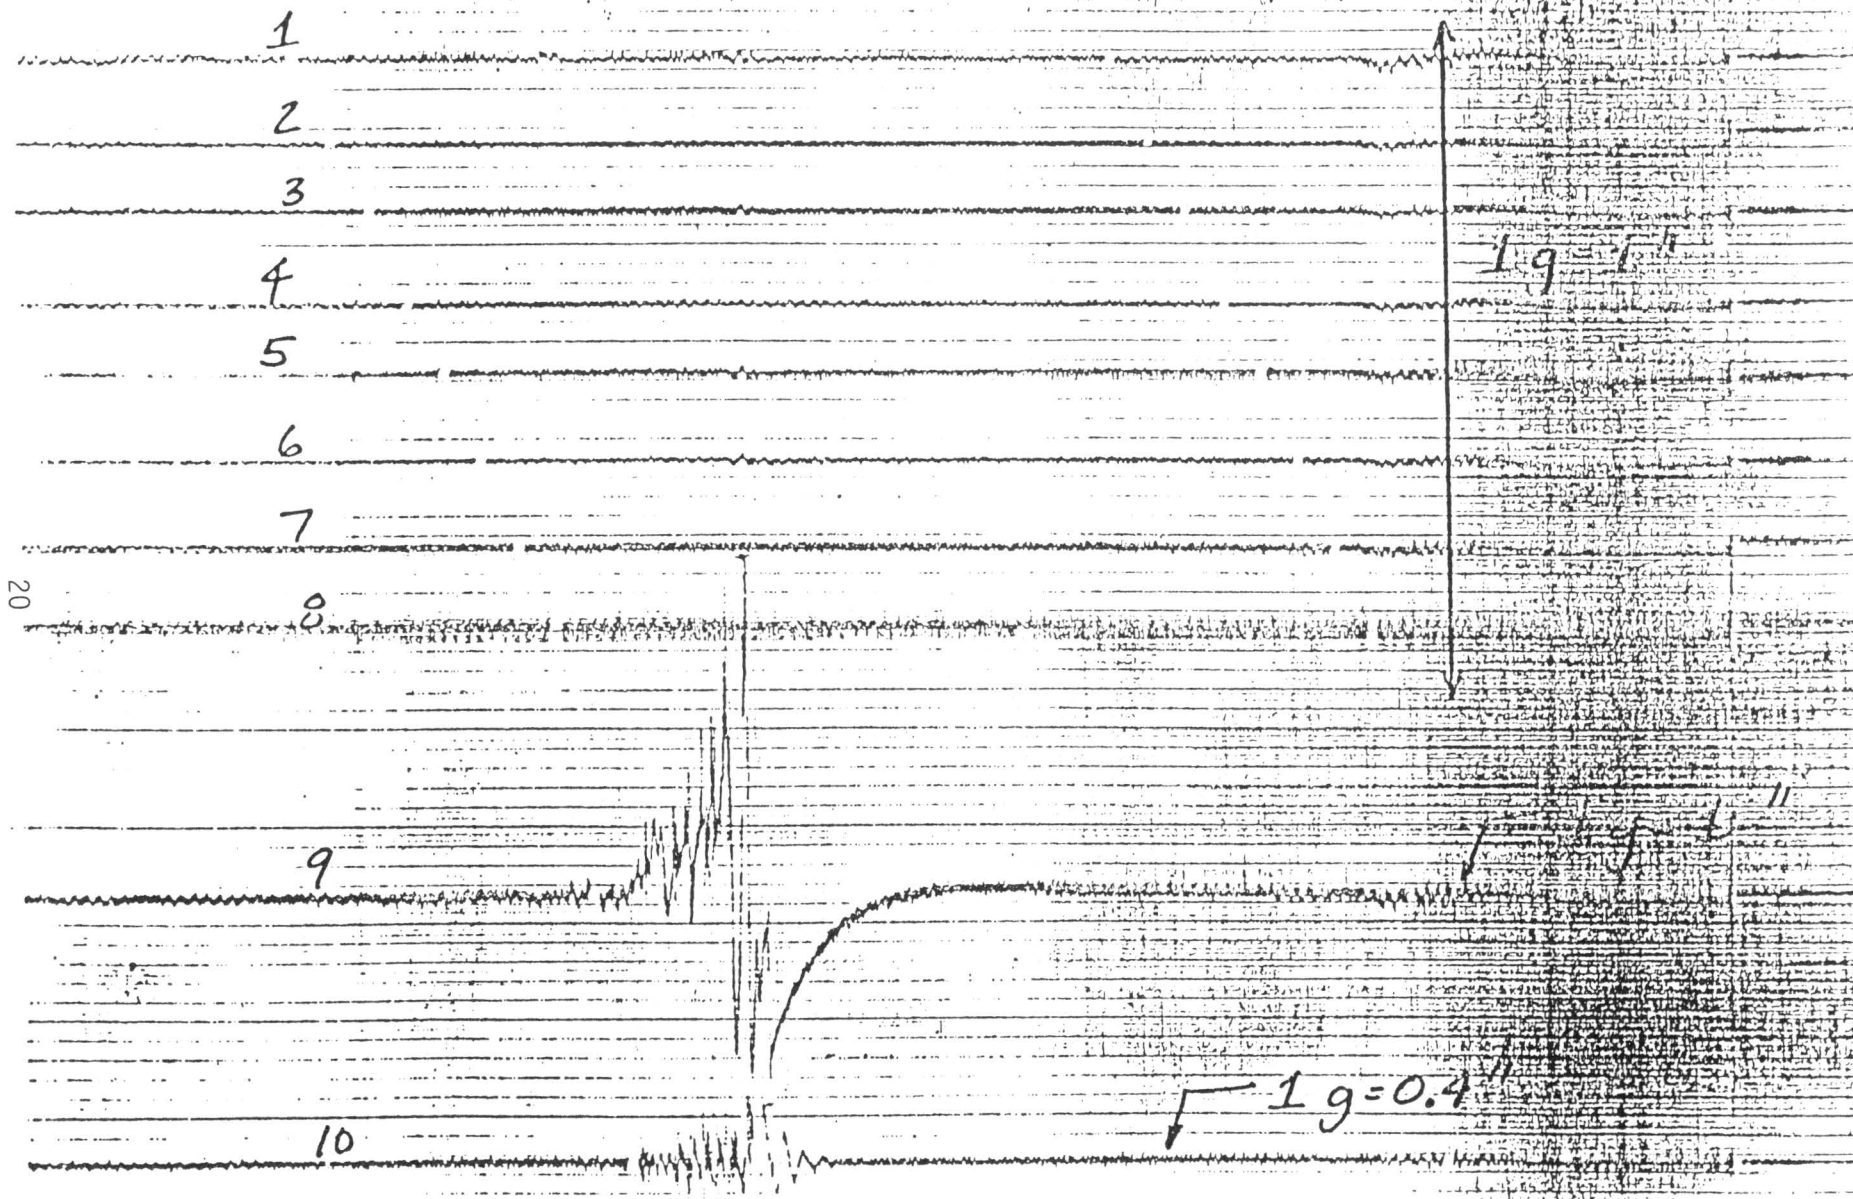
Site 5 proved to be a more active site for wind gust induced vibration of the luminaire arm. Vibrational responses appeared quite similar to those found at Site 1 but at reduced levels. Gust loads up to 3 g's peak-to-peak were not unusual, see Figure 5.1 for one example. More specific results can be found in PART II of this report.

Figure 5.1 - Gust Induced Vibration (approx. 3 g's p-p)

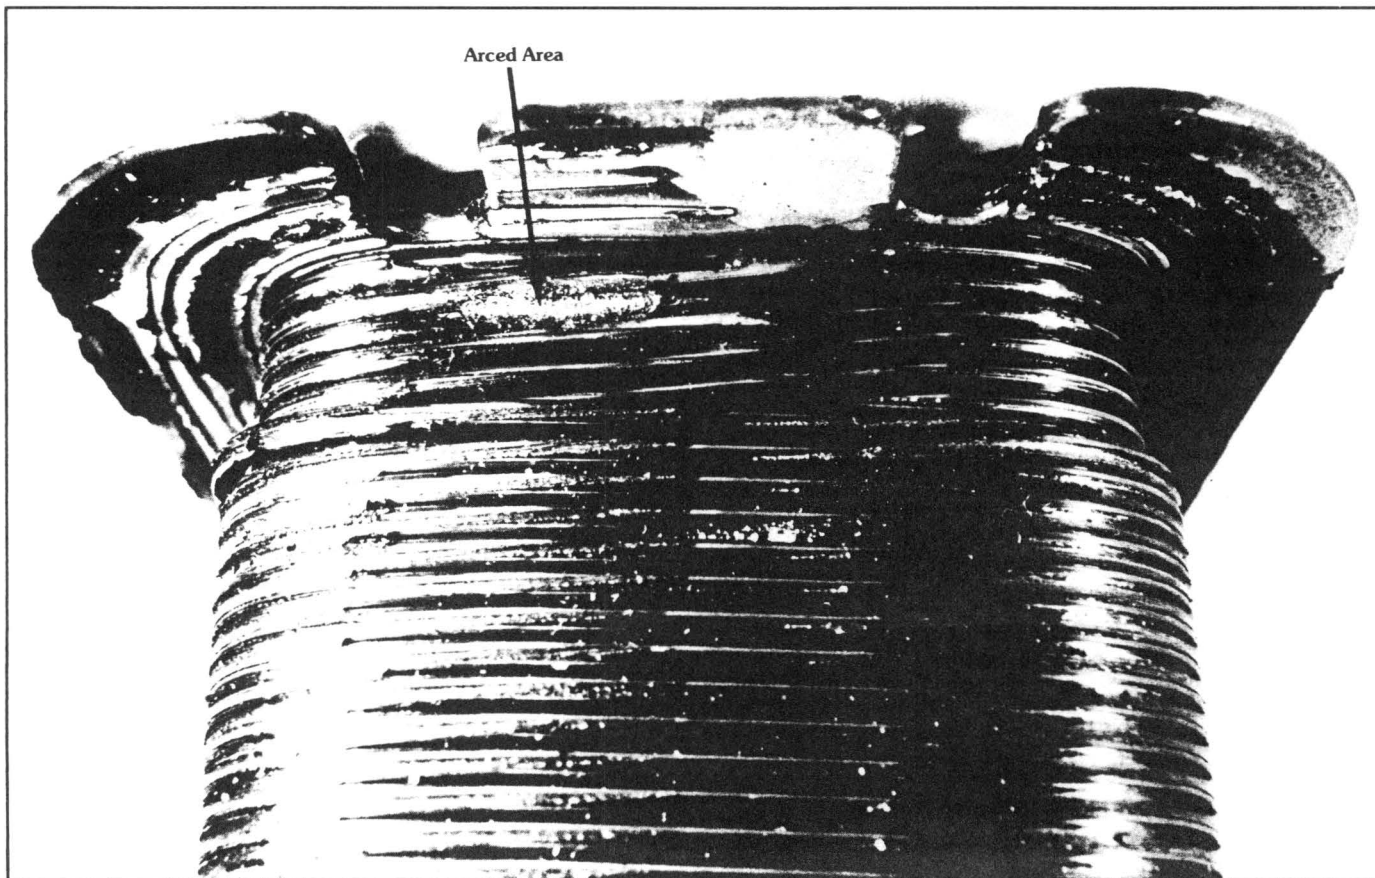
Figure 1  
Arced Area

A single arc-over due to an impulse will not cause a ballast to fail, but it does cause some carbon tracking at the point of breakdown. Successive impulses can lower the breakdown voltage to the point where the normal voltage on the ballast will arc-over. Repeated impulses of this nature can ruin essentially any HPS ballast in use today. An example of a short caused by a broken weld is shown in Figure 1. Note the evidence of prolonged low energy arcing which ultimately led to a layer to layer short circuit.

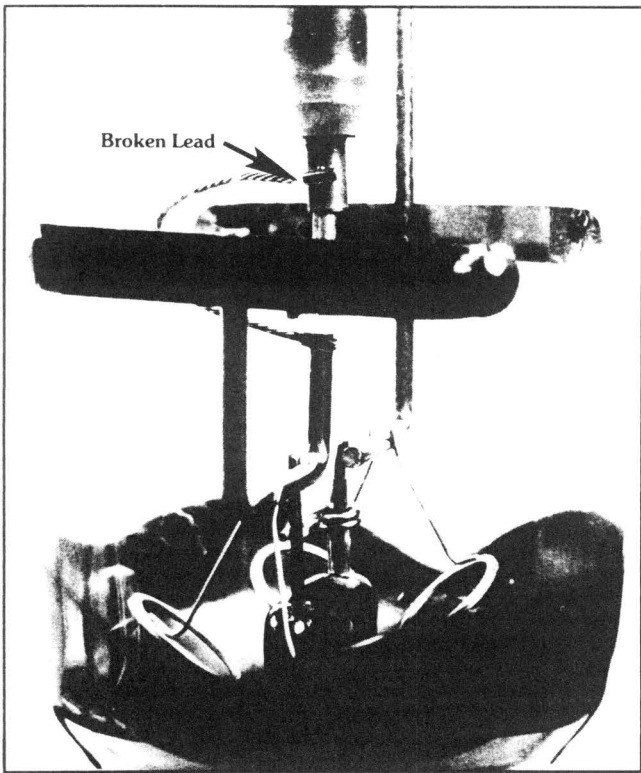
Figure 2  
Broken Lead

Lamps with broken welds are shown in Figures 2 through 5. With the first three designs, it is not obvious when a weld is broken. With all four designs, intermittent contact can be made even with broken welds.

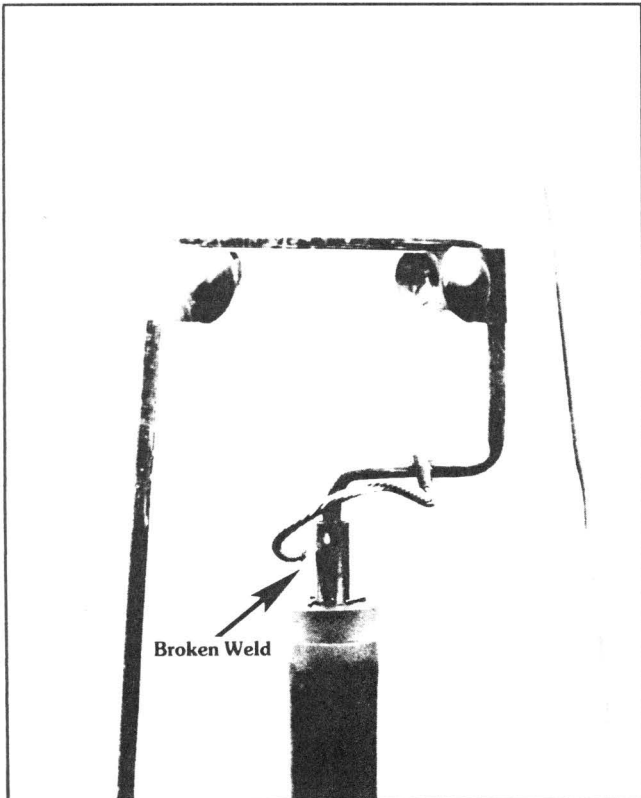
Figure 3  
Broken Weld

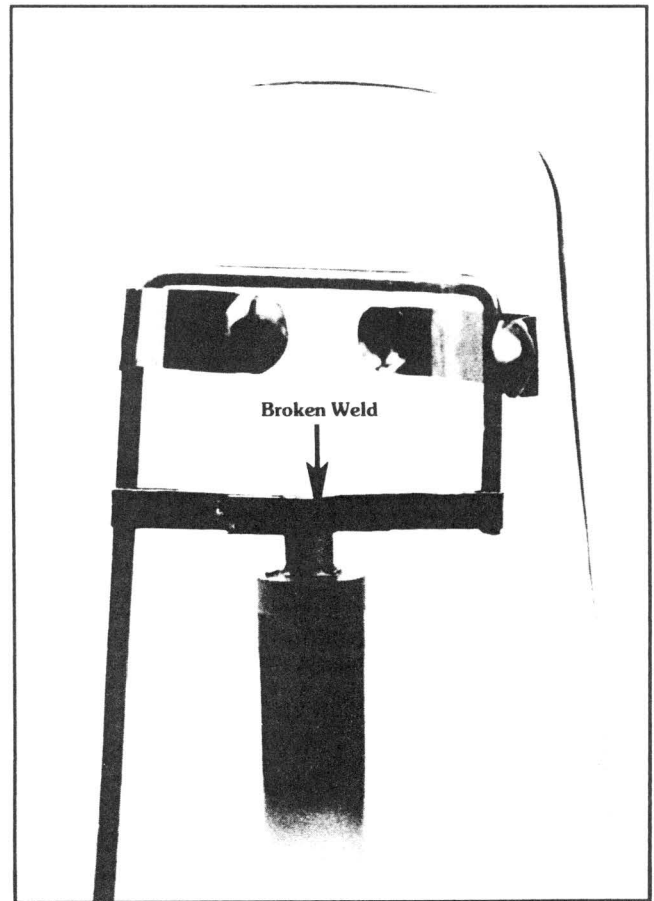
Figure 4  
Broken Weld

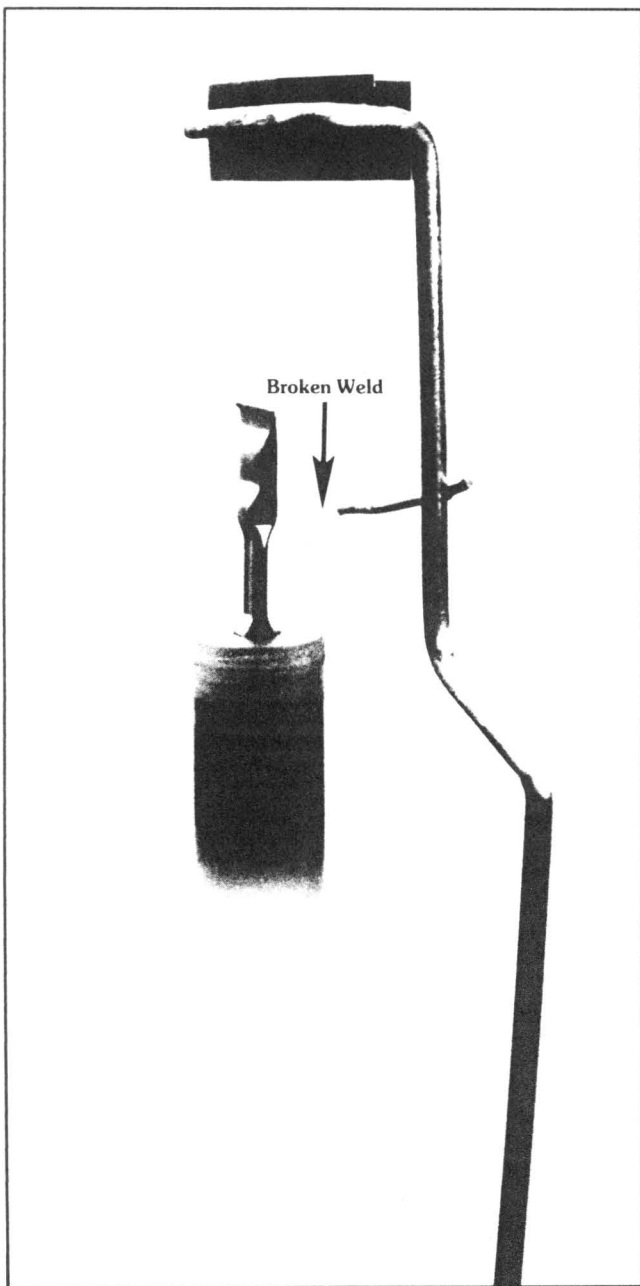
Figure 5  
Broken Weld
