A FIELD SURVEY AND EXPLORATORY EXCAVATION OF TERMINAL ANCHORAGE FAILURES ON JOINTED CONCRETE PAVEMENT

TEXAS HIGHWAY DEPARTMENT

By
B. F. McCullough
Supervising Design Research Engineer

Technical Report No. 39-1
for
Terminal Anchorage Installations
Research Project 1-8-63-39

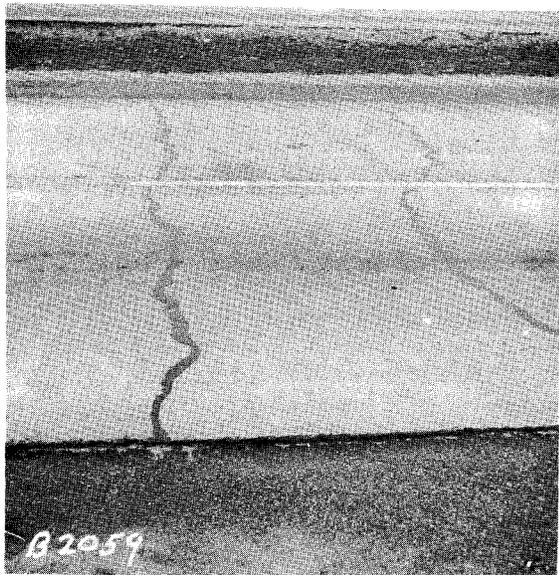
Figure 1.2 portrays transverse cracks in a typical anchorage slab. The magnified width is due to an unsuccessful attempt to seal the crack by state maintenance forces. The crack widths were so small that the sealing material failed to penetrate into the crack, hence it was spread over the pavement surface by traffic.

FIGURE 1.2 - Transverse cracks in the anchor slab. An attempt was made to seal cracks.

During the data survey, the cracks in the anchor slabs were recorded on the data sheets, and this data is presented in Table 3.5 in terms of performance. The data shows that 94 per cent of the satisfactorily performing anchor systems had cracks in the anchor slab. Whereas, only 56 per cent of the anchor systems that were in a failure condition had cracks in the slab. The four anchor units (6 per cent) without transverse cracks that were presently performing satisfactorily were less than two years old, hence were not old enough for the pavement growth forces to be transmitted to the structure. The anchor units with cracks, but experiencing failure, probably performed satisfactorily for a short period of time. Therefore, it may be concluded that the presence of transverse cracks in the anchor slab is one positive sign that the anchor system is performing satisfactorily.

The cracks are simply volume change cracks that occur due to contractive stresses, since the anchor slab is a short section of continuous pavement, if the lugs are providing proper retainment.³ In all probability, the anchor systems that are in a failure condition and do not have volume change cracks never performed in accordance with the design intent. The lugs did not prevent expansive and contractive movement of the anchor slab due to volume changes since experience shows the stresses were of sufficient magnitude for tensile cracking to occur.

(4) The presence of transverse cracks in the anchor slab is not a sign of alarm, but indicative that the anchor system is performing satisfactorily. Crack width measurements revealed that the cracks were only volume change cracks and the magnitude was minor which indicates that the cracks should not be sealed.

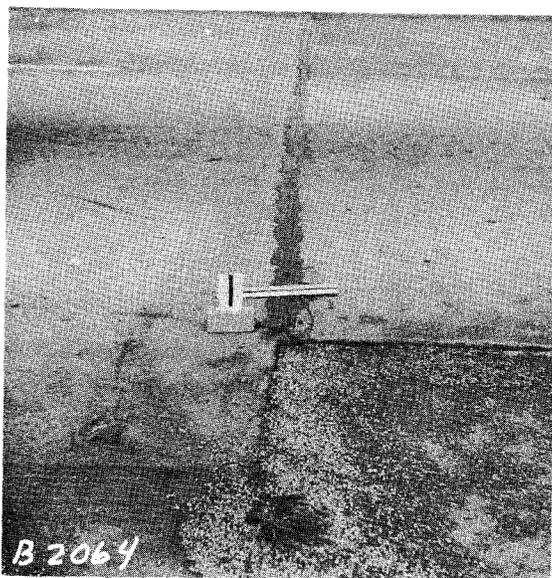
Figure 1.3 portrays a typical expansion joint at the end of the anchor slab. Considering the $3/4$ inch core fill material placed in the joint, this joint is closed for all practical purposes.

FIGURE 1.3 - Closed expansion joint between pavement and bridge approach slab. Joint was $1\frac{1}{2}$ inches wide at time of construction.

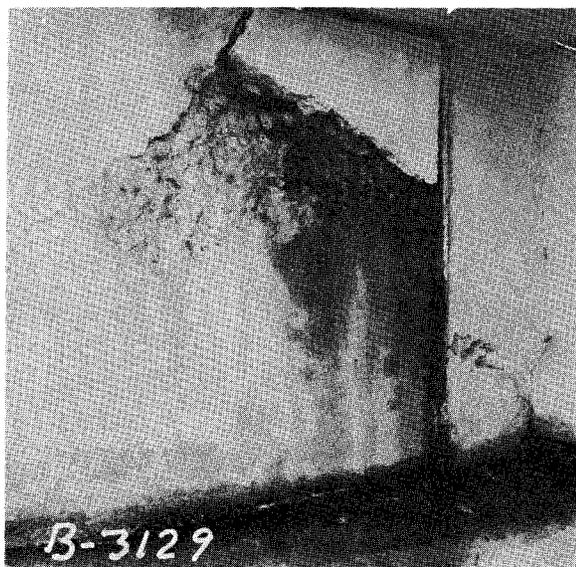
Figures 1.4 and 1.5 depict the general nature of the cracking and faulting experienced in the abutment wall at several of the structures. The differential faulting ranged from $1/8$ inch to approximately two inches at various locations. The cracking of the abutment walls was a graphic demonstration of the expansion forces involved. This faulting is different from abutment wall cracking normally associated with soil expansion in that there is a definite cleavage plane that can be associated with the pavement growth.

FIGURE 1.4 - Fracture and faulting of bridge abutment wall due to pavement growth.

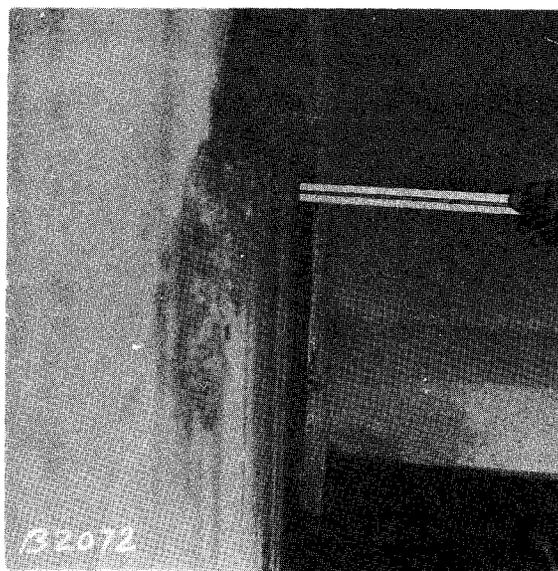
FIGURE 1.5 - Edge view of abutment wall faulting due to pavement growth.

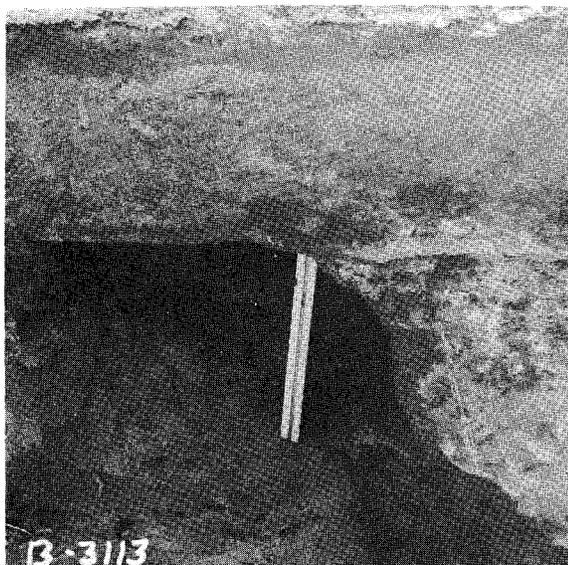
FIGURE 4.6 - Void behind anchor lug due to movement of the anchor system. The anchor slab is at the top of the picture and the lug is to the right. Camp Strake Road Overpass.

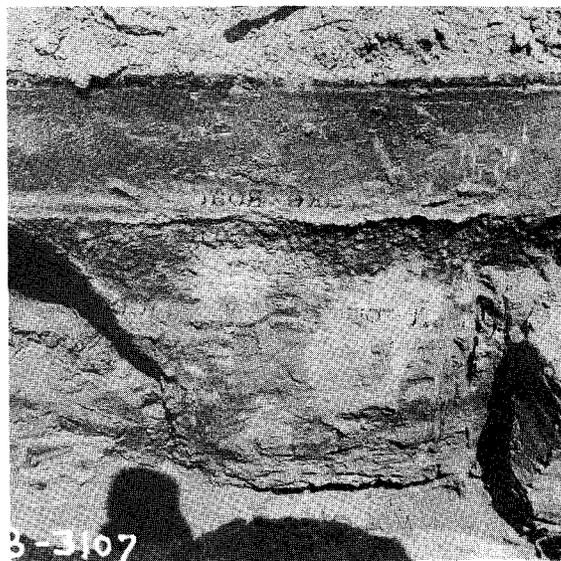
The excavation revealed that both the anchor slab and the lug were structurally intact as may be seen in Figure 4.7. This observation precluded the possibility of an inadequate concrete structure design as a possible cause of failure. A side view of the anchor slab (Figure 4.8) eliminated apprehension that the transverse cracks in the anchor slab were detrimental to the structure. The cracks were the result of volume change stresses and were typical of those found in continuously reinforced concrete pavement. The cracks became progressively narrower from top to bottom and the maximum range was from 0.024 to 0.008 of an inch.

FIGURE 4.7 - Edge view of lug and anchor slab looking into the trench. Camp Strake Road Overpass.

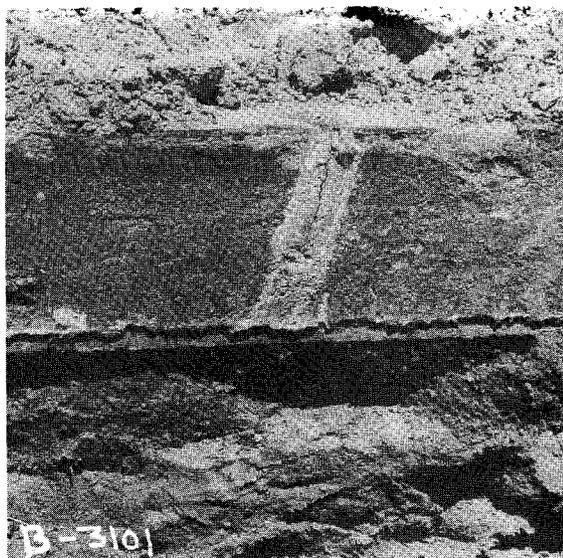
FIGURE 4.8 - Edge view of a transverse crack in the anchor slab. Camp Strake Road Overpass.

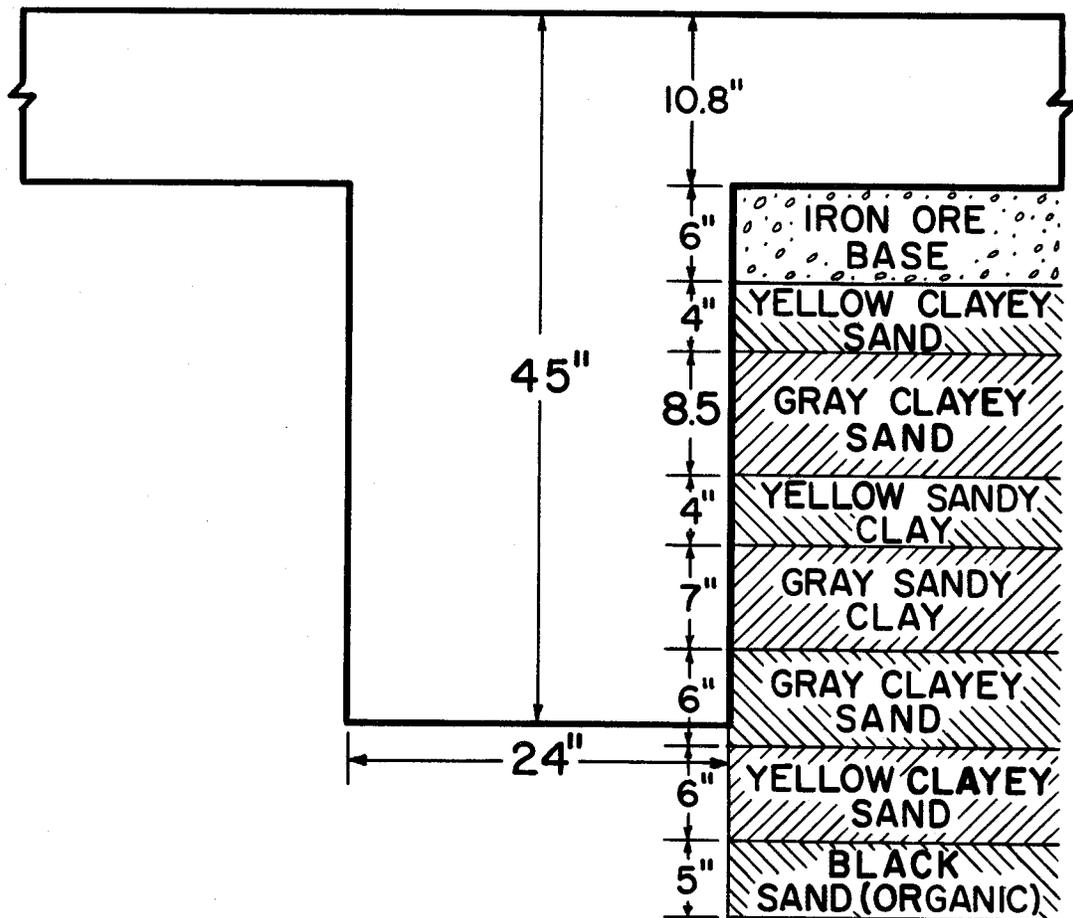
Fig. 4.9

EDGE VIEW OF LUG SHOWING THICKNESS
AND DESCRIPTION OF THE SOIL LAYERS
ENCOUNTERED IN SAND FILL AT
CAMP STRAKE ROAD O/P

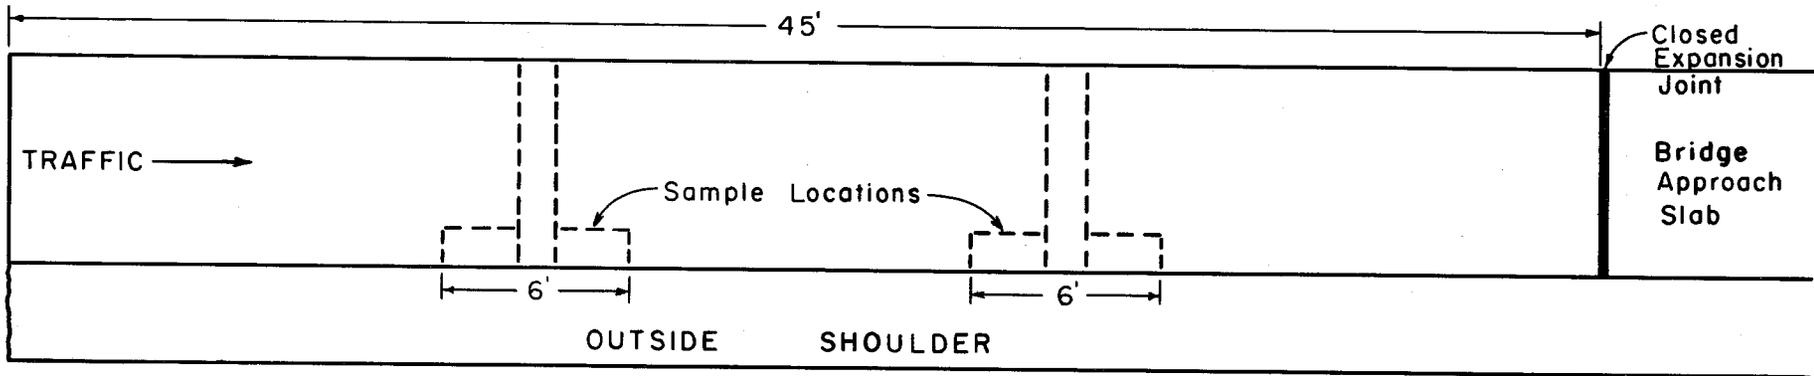
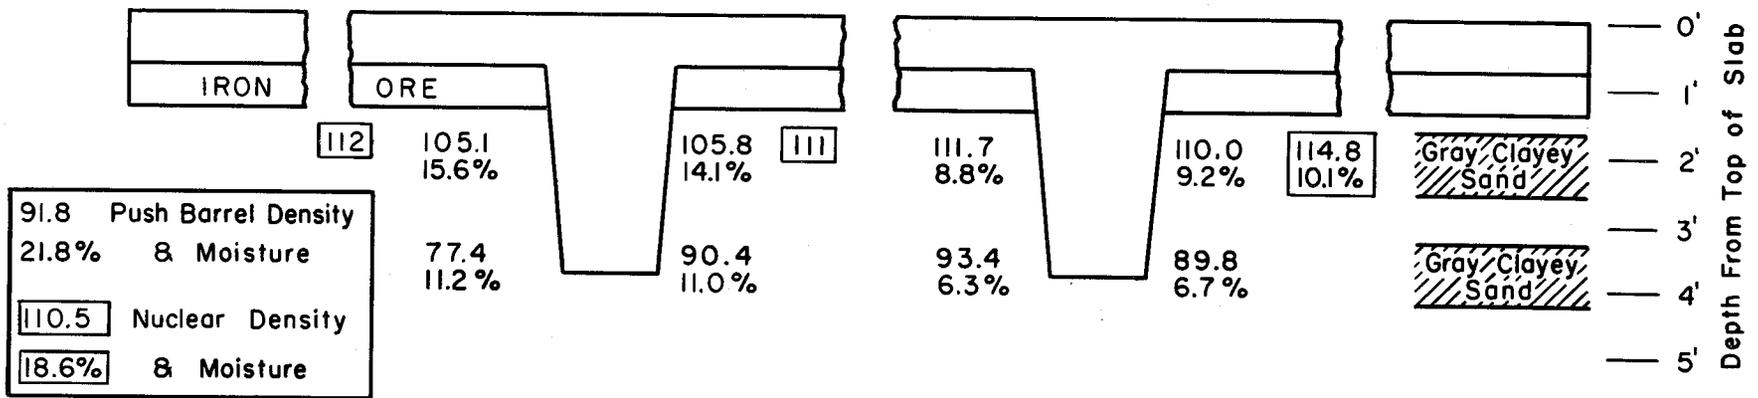
Fig. 4.10

well as the physical dimensions of the anchor system. Figure 4.10 portrays the dry density and moisture contents of the soil at various locations along the face of the excavation that were obtained by both the nuclear method and push-barrel sampling. In the case of both lugs, the density on the up-side and down-side of the lug were approximately equal, although the densities nearer the structure were greater relative to those farthest away from the structure. The converse is true of moisture content, in that the upper side is less than the lower side. For any given layer, the wet densities are approximately equal which conjectures the possibility of the soil moving as a block.

Considering the densities from a vertical standpoint, there is a sharp reduction in density progressing downward from the top of the slab. A slight reduction in density would be expected as a result of normal construction operations, but not to the degree experienced here. As a result of the low densities at the bottom of the lug, which is an area of high stress concentration, a shear failure occurred along this plane in all probability. The relative looseness of this layer would obscure any definite slippage plane.

COMPARATIVE MOISTURE AND DRY DENSITY VALUES NEAR ANCHOR LUGS
CAMP STRAKE ROAD O/P

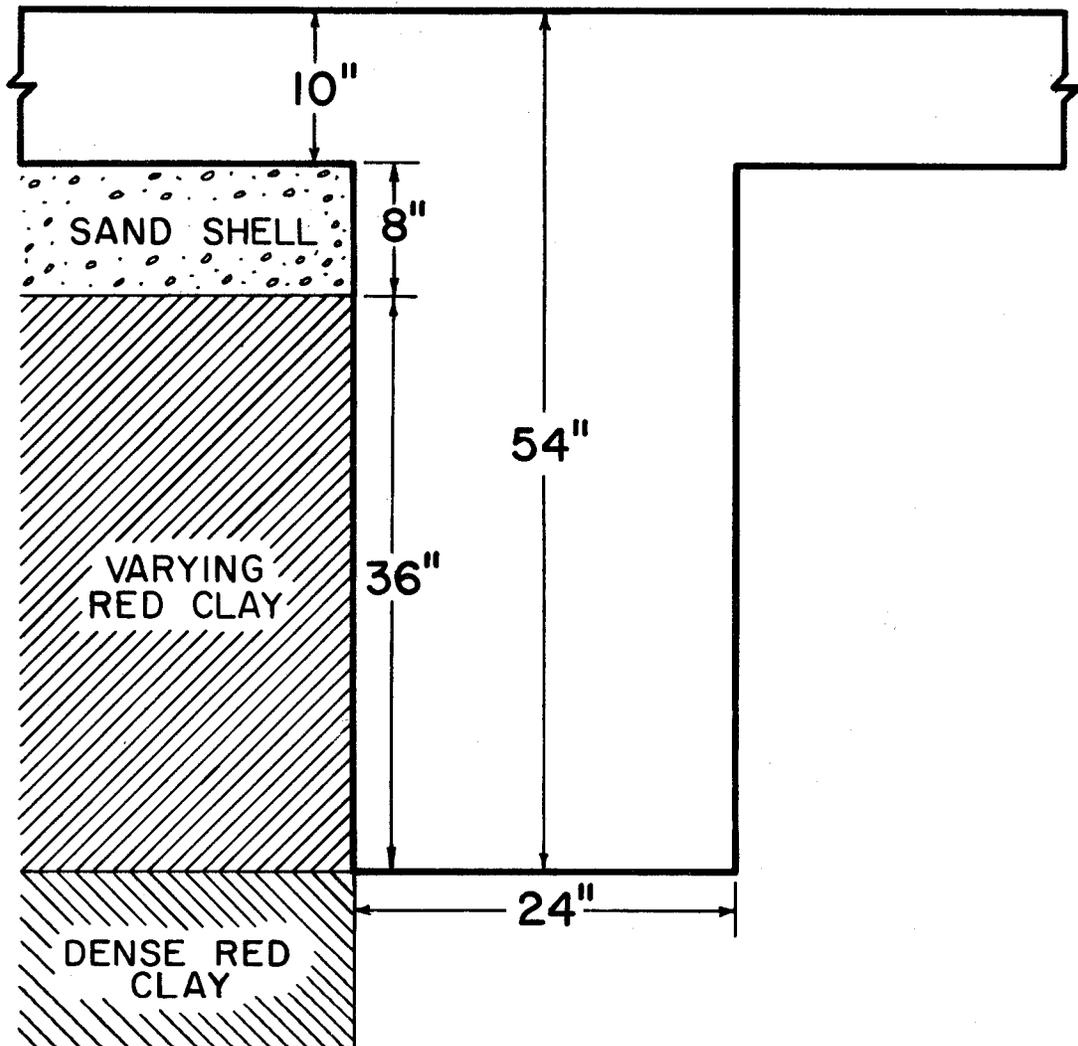
Fig. 4.11

Clay Fill (Site #2). This excavation was conducted in a manner similar to the preceding, and the general observations may be found in Column 3 of Table 4.1. As was the case with the earlier excavation, the removal operation disclosed that there was an excessive amount of moisture present in each of the layers and various amounts of free water. The median on this project was a raised, free draining, sand-shell material without an impermeable membrane on top. Hence, the median and the sand shell subbase served as an aqueduct for bringing water into the area of the lug and distributing it across the width of the slab.

EDGE VIEW OF LUG SHOWING THICKNESS
AND DESCRIPTION OF THE SOIL LAYERS
ENCOUNTERED IN CLAY FILL AT
MONROE ROAD O/P

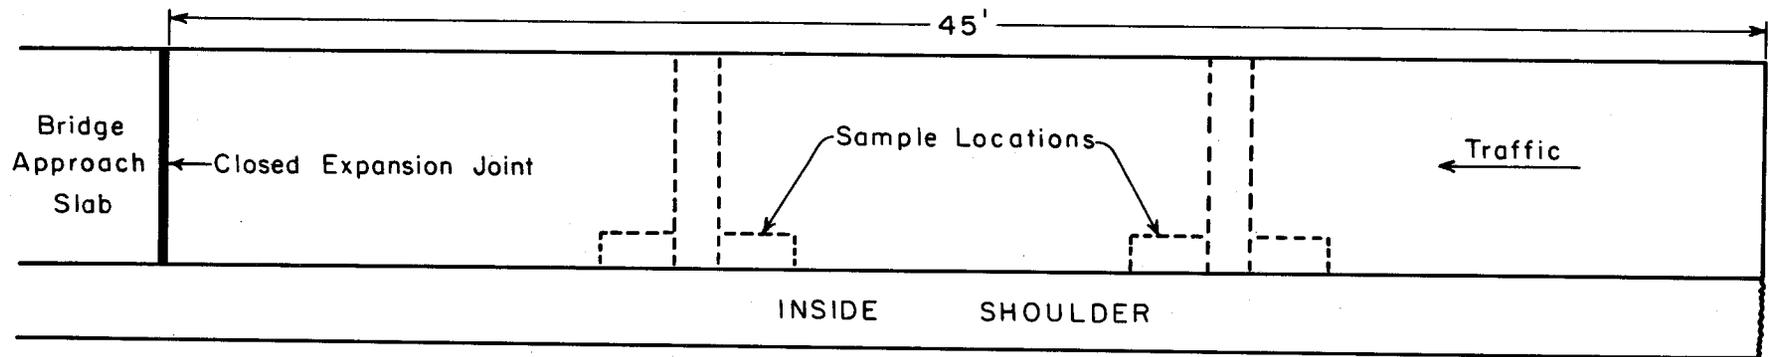
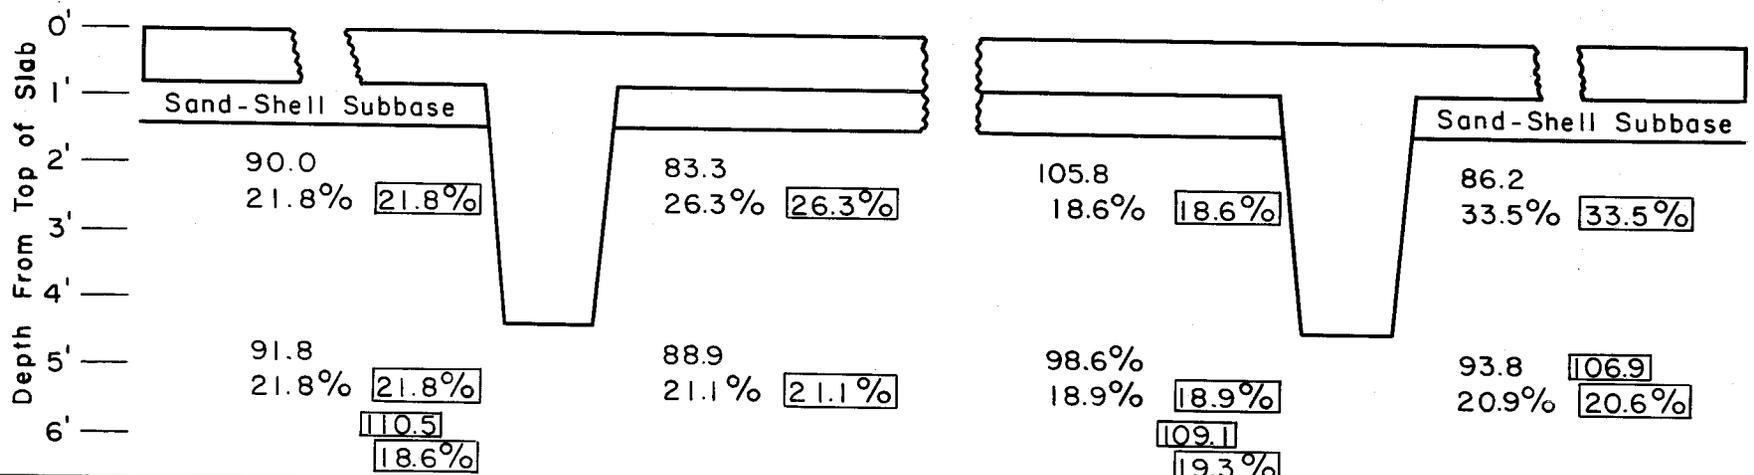
Fig. 4.12

The results of the density and moisture test are shown on Figure 12. Although the measurements obtained with the nuclear device have not proven to be completely reliable for clay materials, they may be used as a relative measure. In contrast to the previous excavation, there appears to be some consolidation of material on the side towards the structure since the densities are higher on the up-side of the lug. The results of the unconfined compressive tests shows that the maximum strength is less than 14 psi and in most cases less than eight psi for the range of moisture contents present (see Figure B.1 in Appendix B). This gives shear values of four to seven psi which are relatively low.

COMPARATIVE MOISTURE AND DRY DENSITY VALUES NEAR ANCHOR LUGS MONROE ROAD O/P

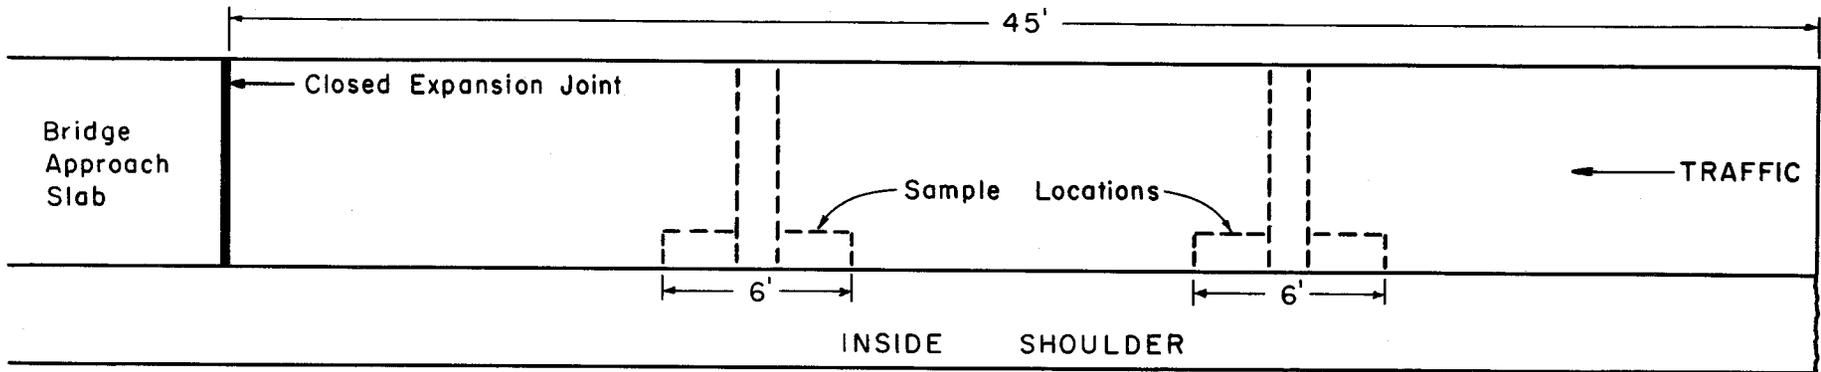
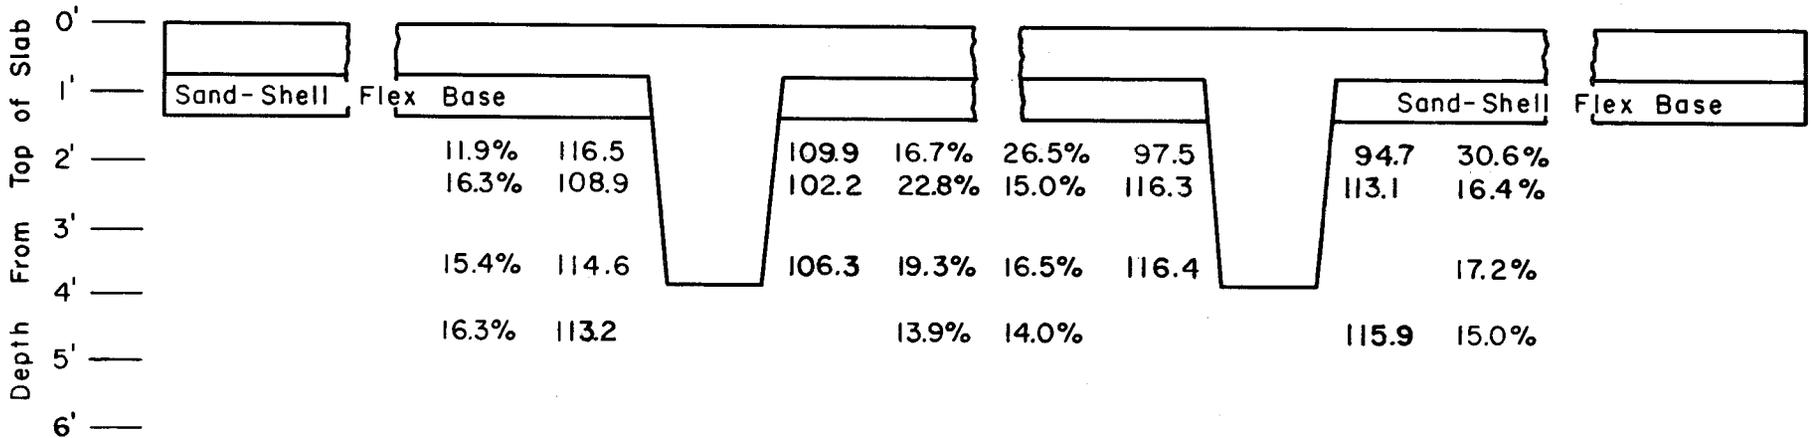
COMPARATIVE MOISTURE AND DRY DENSITY VALUES NEAR ANCHOR LUGS LEE ROAD O/P

the material in this embankment was considerably dryer than that removed from the other two locations. This was borne out by the moisture test as shown in Figure 4.14; with the exception of two high readings, the moisture contents were less than 17%. The higher densities and lower moisture-contents resulted in higher shear values. Laboratory tests showed the soil shear strength to be in excess of six psi.
