1. Report No. DHT-46	2. Government Accession No.	3. Recipient's Catalog No.	
4. Title and Subtitle AN EVALUATION OF FACTORS AFFECTING MOISTURE SUSCEPTIBILITY OF PAVEMENTS IN NORTHEAST TEXAS		5. Report Date October 1998	6. Performing Organization Code

AN EVALUATION OF FACTORS AFFECTING MOISTURE SUSCEPTIBILITY OF PAVEMENTS IN NORTHEAST TEXAS

Prepared by a TxDOT Task Force:

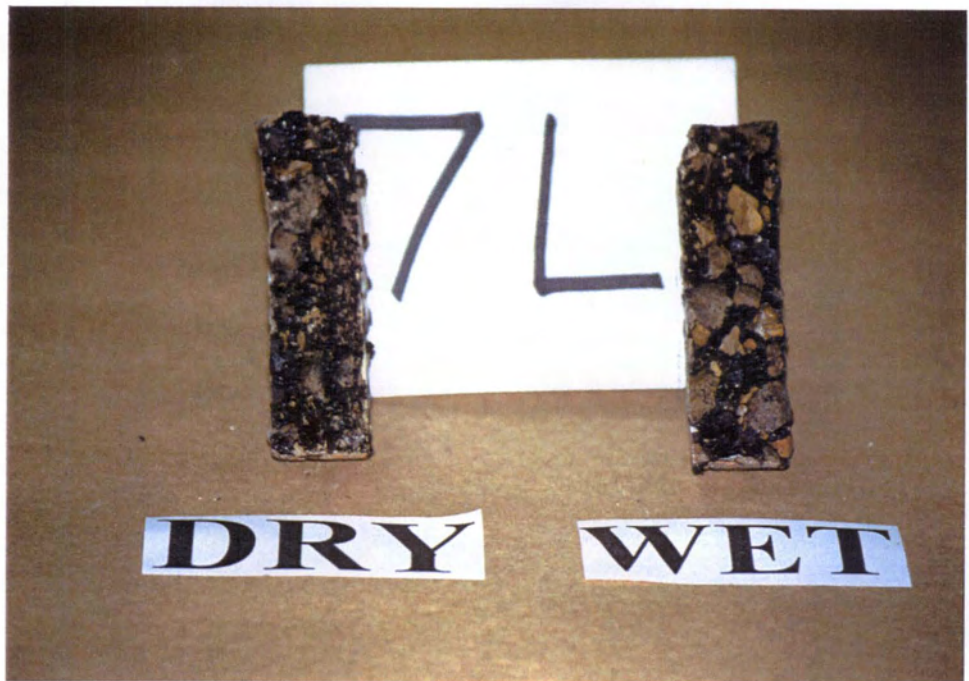
After conditioning and indirect tensile strength testing, as described in the next section, the freshly fractured surfaces of the cores were evaluated for evidence of stripping using the same scoring system as used to evaluate the cut sides of the cores. The dry-conditioned and moisture-conditioned cores were evaluated separately. These scores are also shown in Table 3. Photographs of the fractured faces of the tested cores are also found in Appendix F. Figure 1 shows pictures of cores with rating of 1.8 and 4.9 for moisture conditioned specimens.

Figure 1A. Cores from Lufkin-7 Section. Visual stripping ratings are 2.5 and 1.8 for Dry and Moisture Conditioned Specimens, respectively.

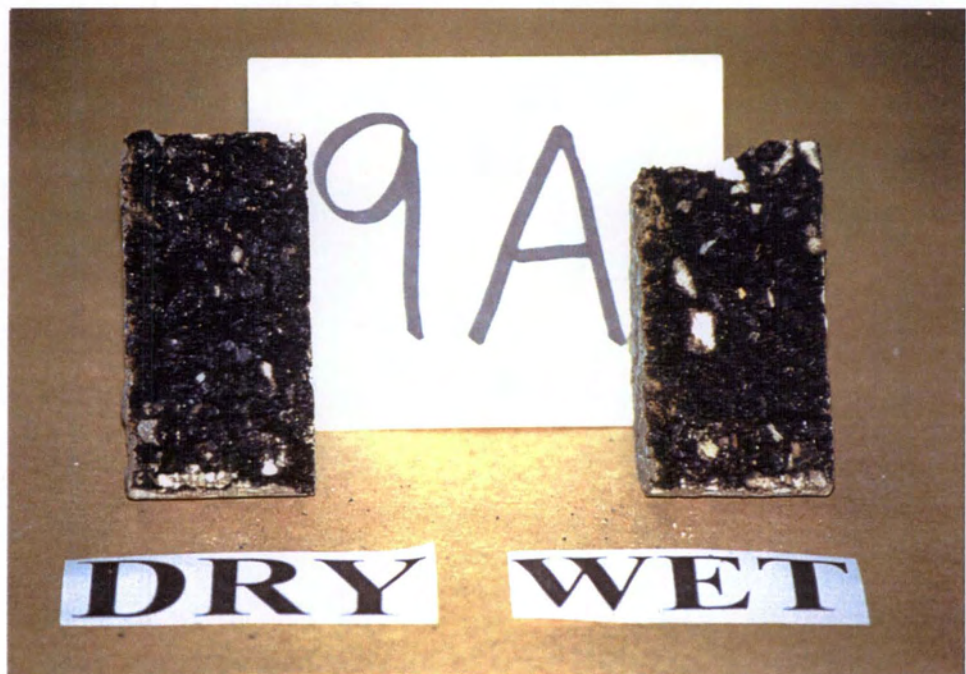
Figure 1B. Core from Atlanta-16 Section. Visual stripping ratings is 4.9 for both Dry and Moisture Conditioned Specimens.

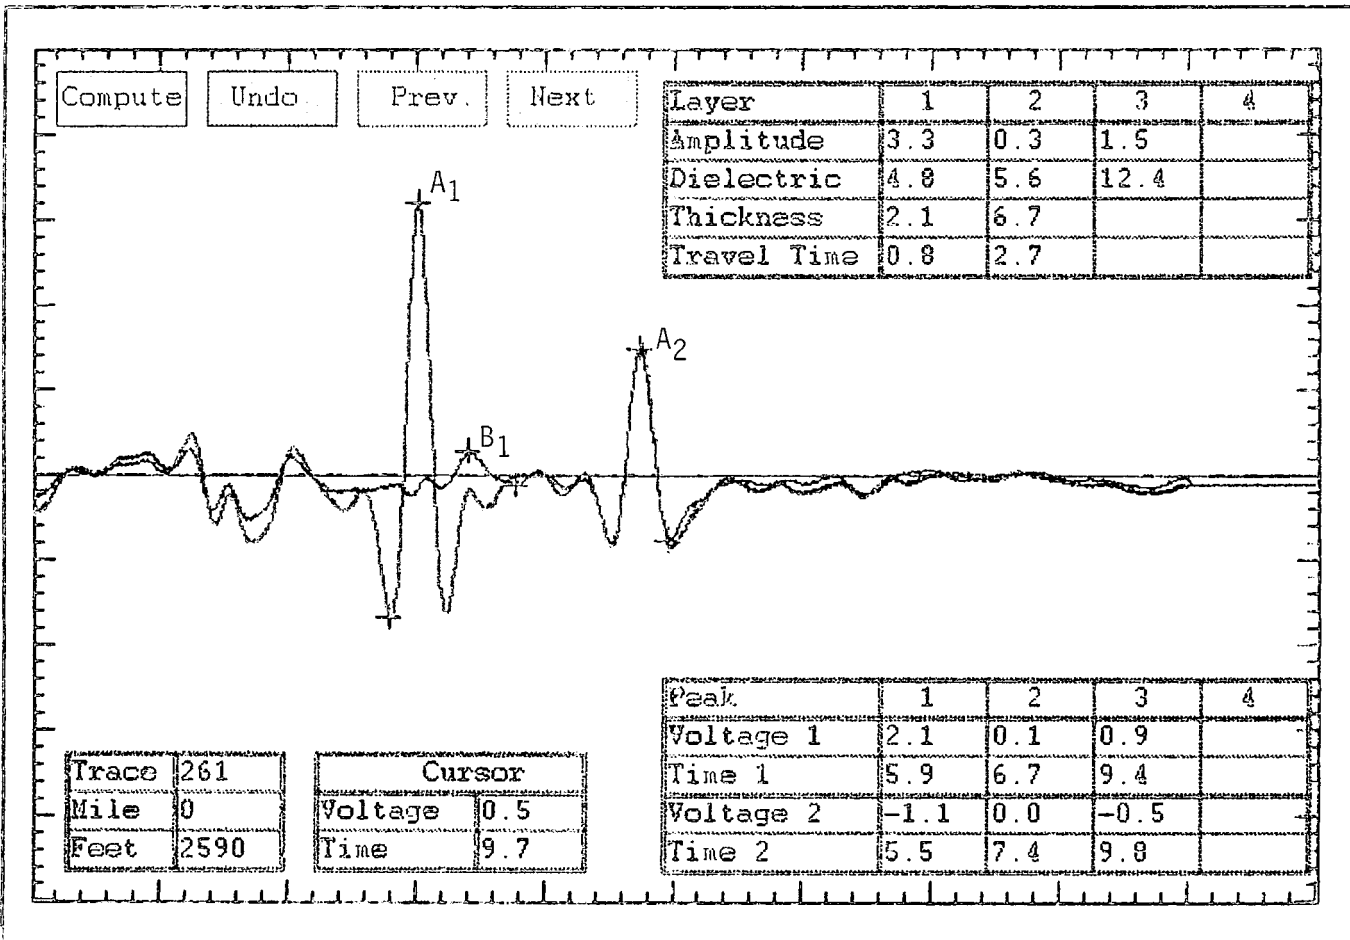
The trace shown in Figure 2 is classified as an ideal trace for a recent thin HMA overlay over an existing flexible pavement. The small reflection at the interface (B_1), which is found after surface removal, indicates that there is only a small contrast between the old and new layers. As shown on Figure 2 the dielectrics for the upper and lower layers were computed to be 4.8 and 5.6 respectively which are considered to be normal. The thickness of the overlay was computed to be 2.1 ins and the old HMA layer at 6.7 ins. As there are no strong reflections in the lower HMA layer between B_1 and A_2 therefore this layer is judged to be homogeneous and defect free, it should be possible to extract a solid core from this pavement. The dielectric from the top of the flexible base was calculated to be 12.4 which is classified as marginal for granular material. Top quality flexible base material have been found to have a calculated dielectric of below 10, saturated layers have a value greater than 16.

Figure 2. Typical GPR return signal from a flexible pavement with a thin overlay. Reflections A₁, B₁, A₂ from surface, bottom of overlay, top of flexible base, respectively. This is viewed as the "Ideal" Case 1, well bonded overlay no deflects in lower HMA. The blue line is raw GPR return signal, the red line is obtained after surface removal.

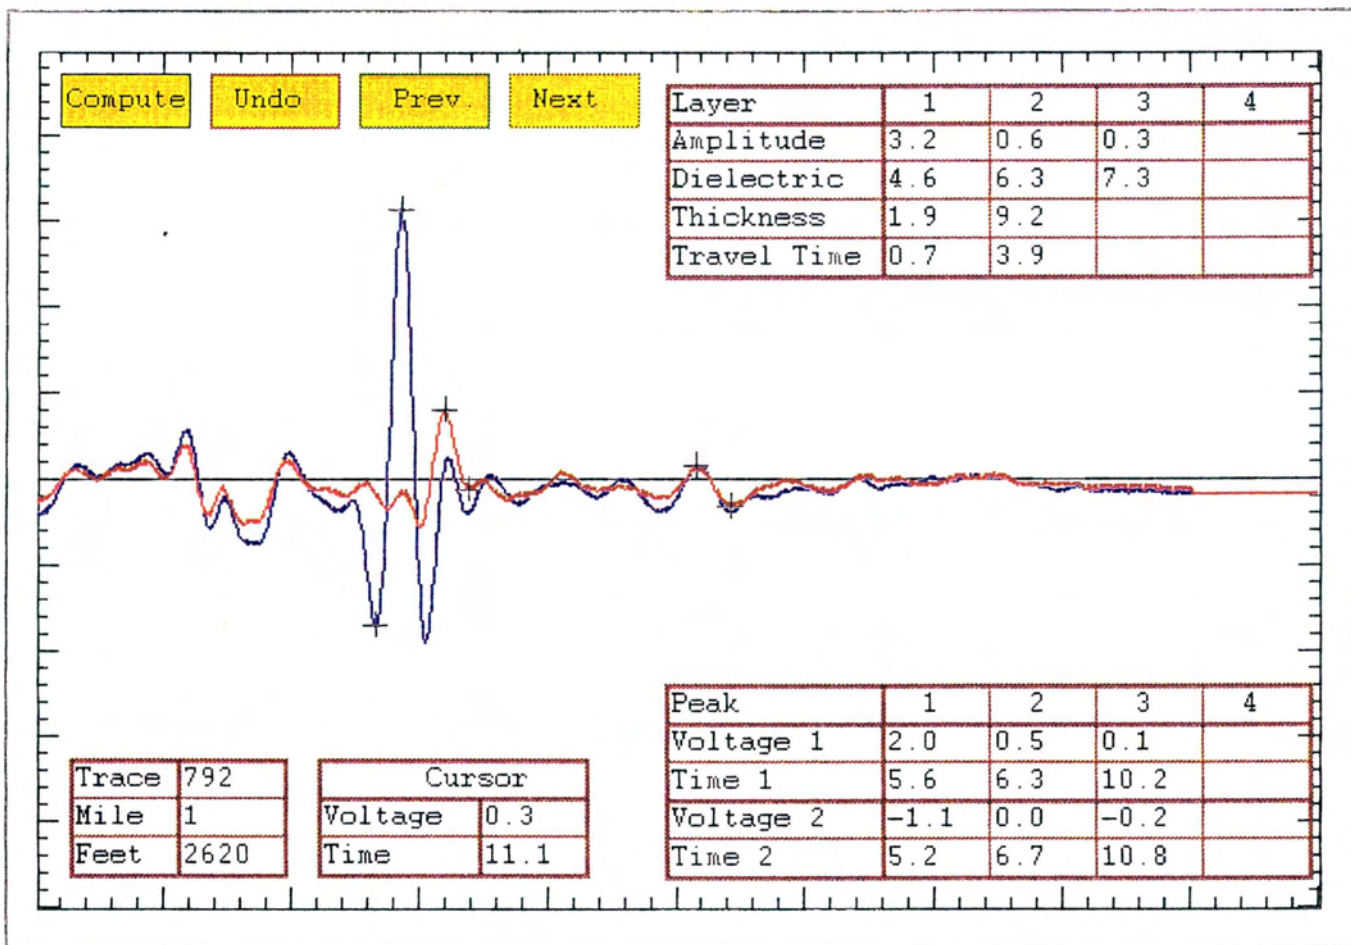
(1) CORE #	(2) STA OR DIST FROM REFERENCE	(3) DIRECTION AND LANE	(4) LOCATION IN LANE	(5) CORE DIA (IN.)	(6) DEPTH BELOW SURF		(7) LAYER THICKNESS (IN.)	(8) DIST. BETWEEN CORES CUMUL.	(9) H.I. ABOVE SURFACE (FT.)	(10) DISCRIPTION OF LAYER INCLUDING KIND, TYPE, CONDITION
					FROM (IN.)	TO (IN.)				
		NBL	OWP 4	4	0	15 1/8				TYPICAL GRAVEL *
					15 1/8	17 1/8				LT WT GR 4 SAND
									*	SOME PITTING ON CORE, BUT INSIDE WALLS OF CORE HAVE NONE

Figure 5. GPR Trace and Coring Data from FM 1397 (Section 13). Ideal Trace for New Pavement.

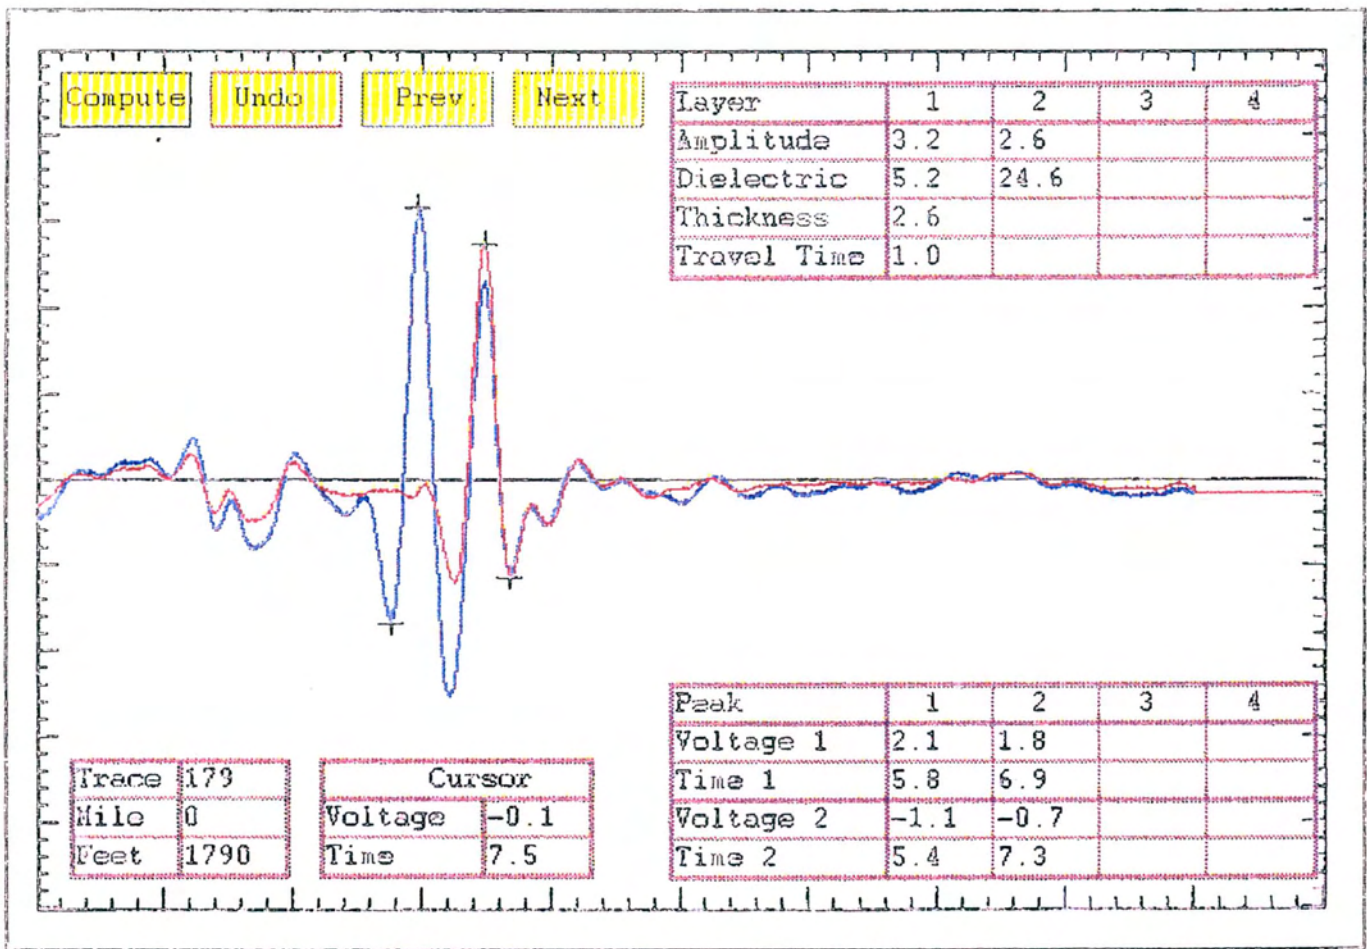
Figure 6. GPR Trace and Coring Data from SH 11 (Section 16). Thin HMAC Over Wet Base.

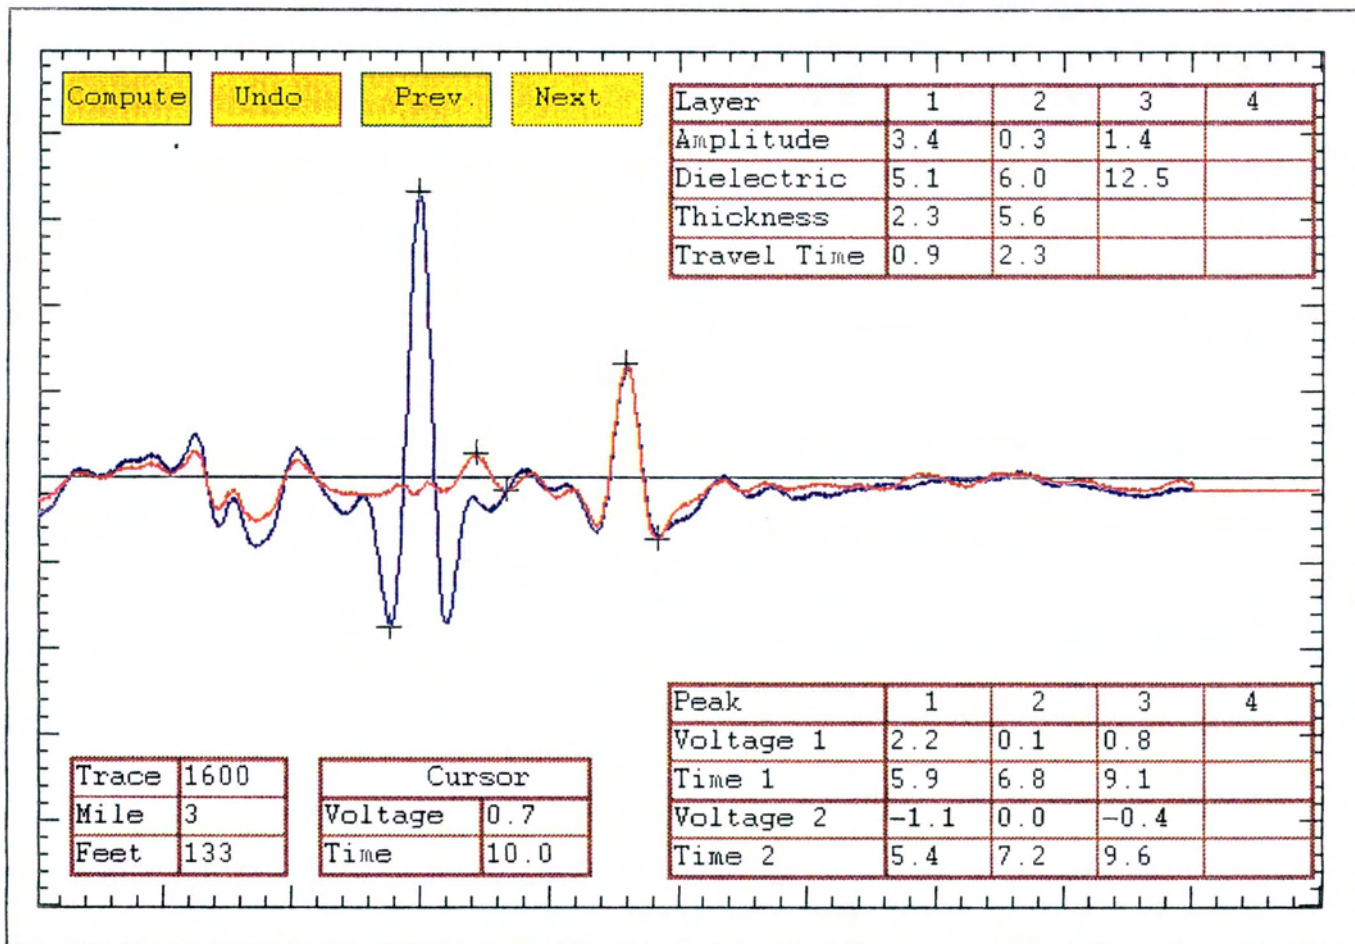
(1) CORE #	(2) STA. OR DIST FROM REFERENCE	(3) DIRECTION AND LANE	(4) LOCATION IN LANE	(5) CORE DIA (IN.)	(6) DEPTH BELOW SURF (IN.)		(7) LAYER THICKNESS (IN.)	(8) DIST. BETWEEN CORES CUMUL.	(9) H.I. ABOVE SURFACE (FT.)	(10) DESCRIPTION OF LAYER INCLUDING KIND, TYPE, CONDITION
					FROM	TO				
10A		NBOL	OWP	4	0	2 ³ / ₈				GHLR T9 C SOME LOSS OF FINES @ CA.
					2 ³ / ₈	8'				GHLR T4 B LOWER LEFT SPECIMEN #4 CRACKED.

Figure 7. GPR Trace and Coring Data from US 59 (Section 6). Ideal Trace, No Moisture Damage in Either HMA Layers Good Bond Between Layers.

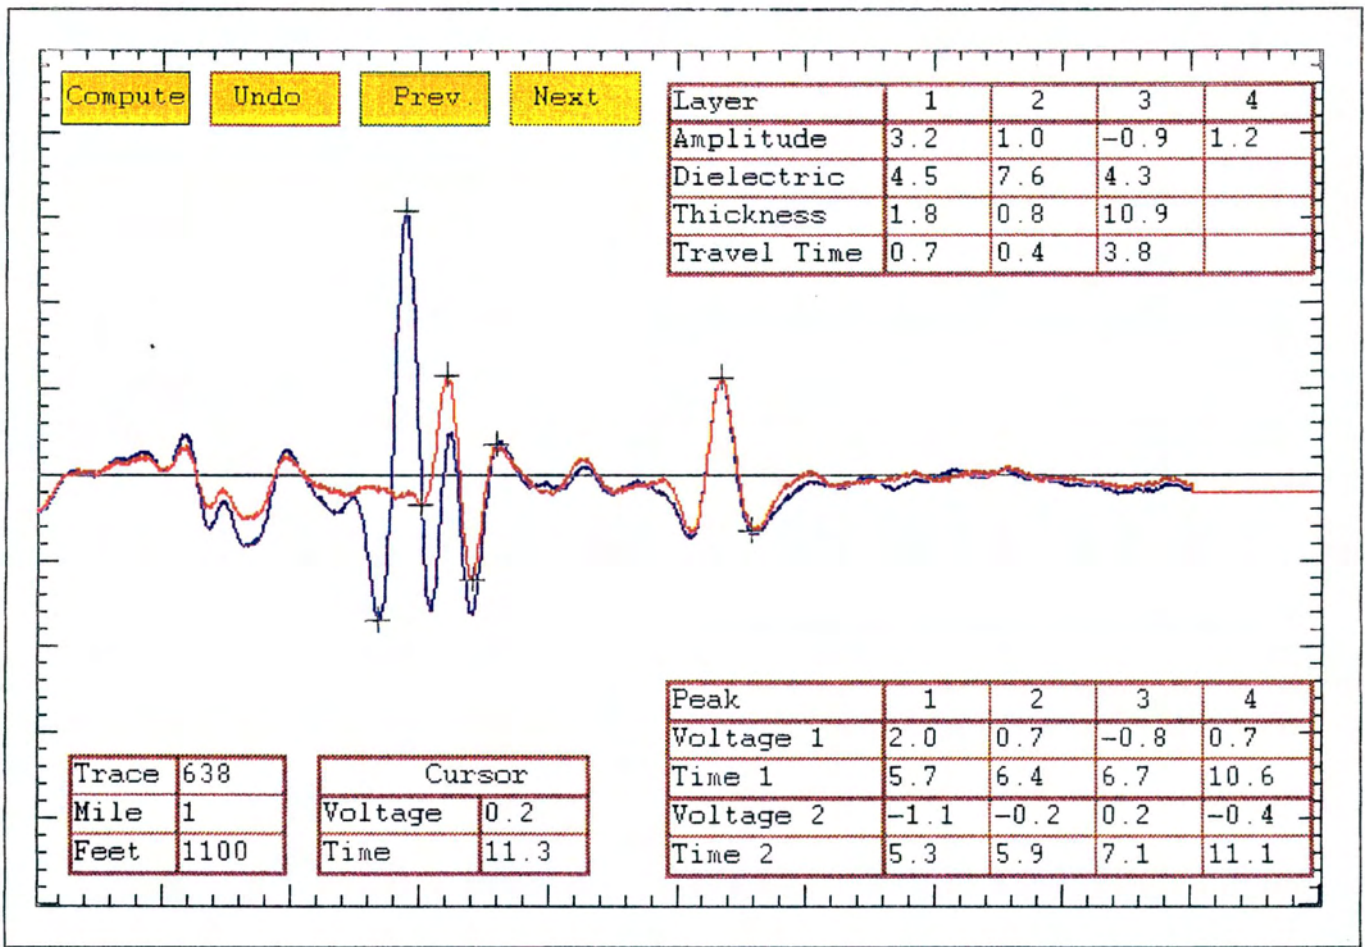
(1) CORE #	(2) STA. OR DIST FROM REFERENCE	(3) DIRECTION AND LANE	(4) LOCATION IN LANE	(5) CORE DIA (IN.)	(6) DEPTH BELOW SURF (IN.)		(7) LAYER THICKNESS (IN.)	(8) DIST. BETWEEN CORES CUMUL.	(9) H.I. ABOVE SURFACE (FT.)	(10) DISCUSSION OF LAYER INCLUDING KIND, TYPE, CONDITION
					FROM	TO				
41A		SBOL	OWP	4	0	2 1/2				T4 C. GHR GRAVEL
"		"	"	"	2 1/8	2 1/8				LT WT G24 SEAL
"		"	"	"	2 1/8	12 1/4				T4 A. ACP GHR 4 LIETS - 3RD LIET FROM BOTTOM LAST FINES AROUND C.A. 3/8" RUT OWP & IWP

Figure 8. GPR and Coring Data from US 59 (Section 18). Example of a Case 3 Reflection, Moisture Build Up at Layer Interface.

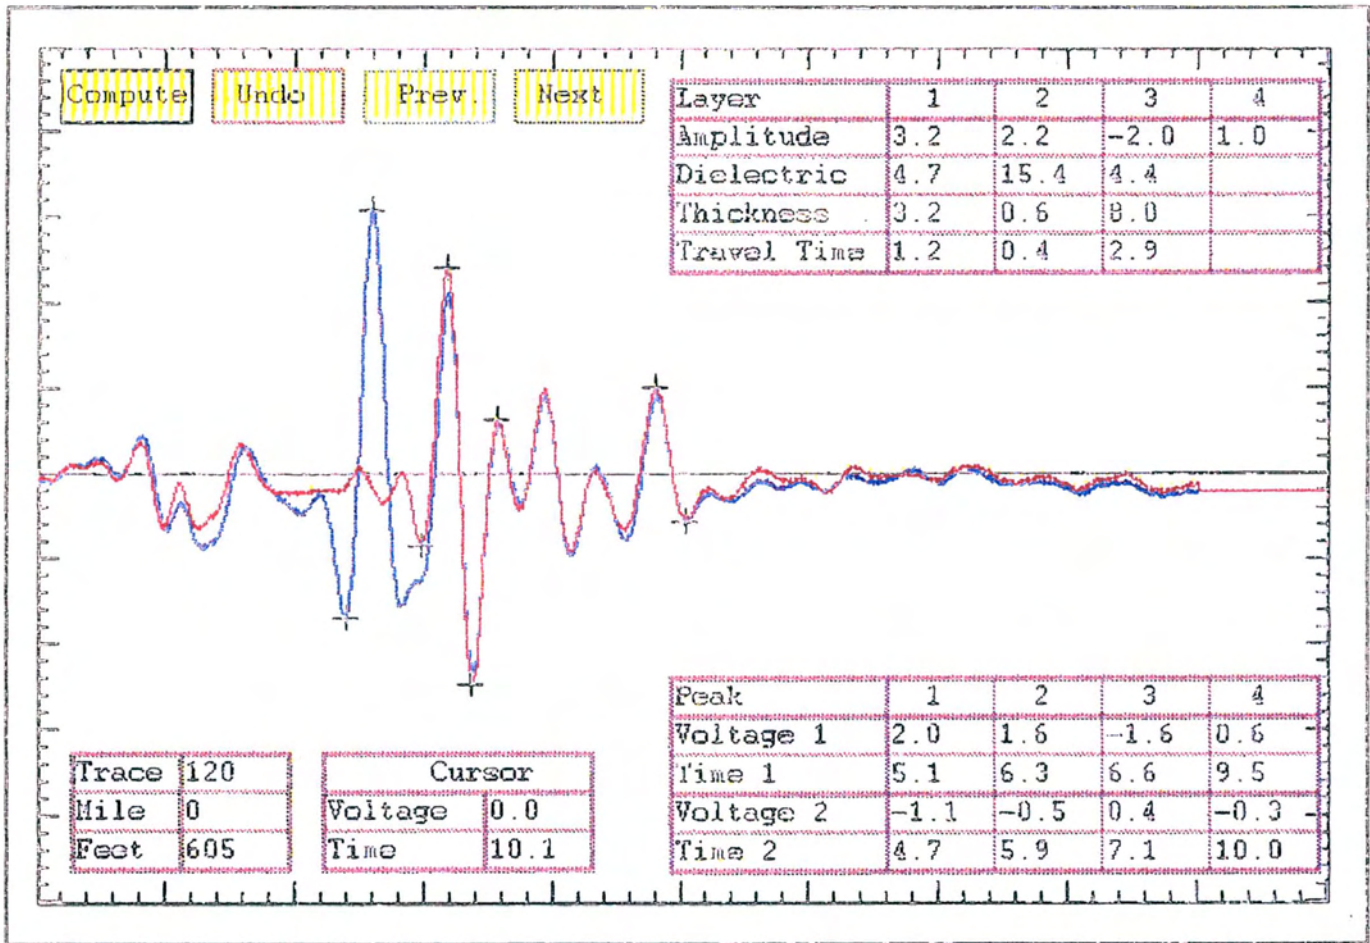
- Figure 9 US 271, thin overlay over existing HMA layer (Section 15), data collected one day after rainfall. Major moisture trapped within upper pavement layers (Case 3). If these lower layers are susceptible then anticipate rapid stripping of these layers. As the saturated layer was calculated to be 3 inches below the surface it is possible that the GPR trace and core were not from same location. Note with large reflections like this within layers it is impossible to make accurate layer thickness estimates.

Figure 9. GPR Trace and Coring Data from US 271 (Section 15). Large Amount of Moisture Trapped About 3 Inches Below Surface.

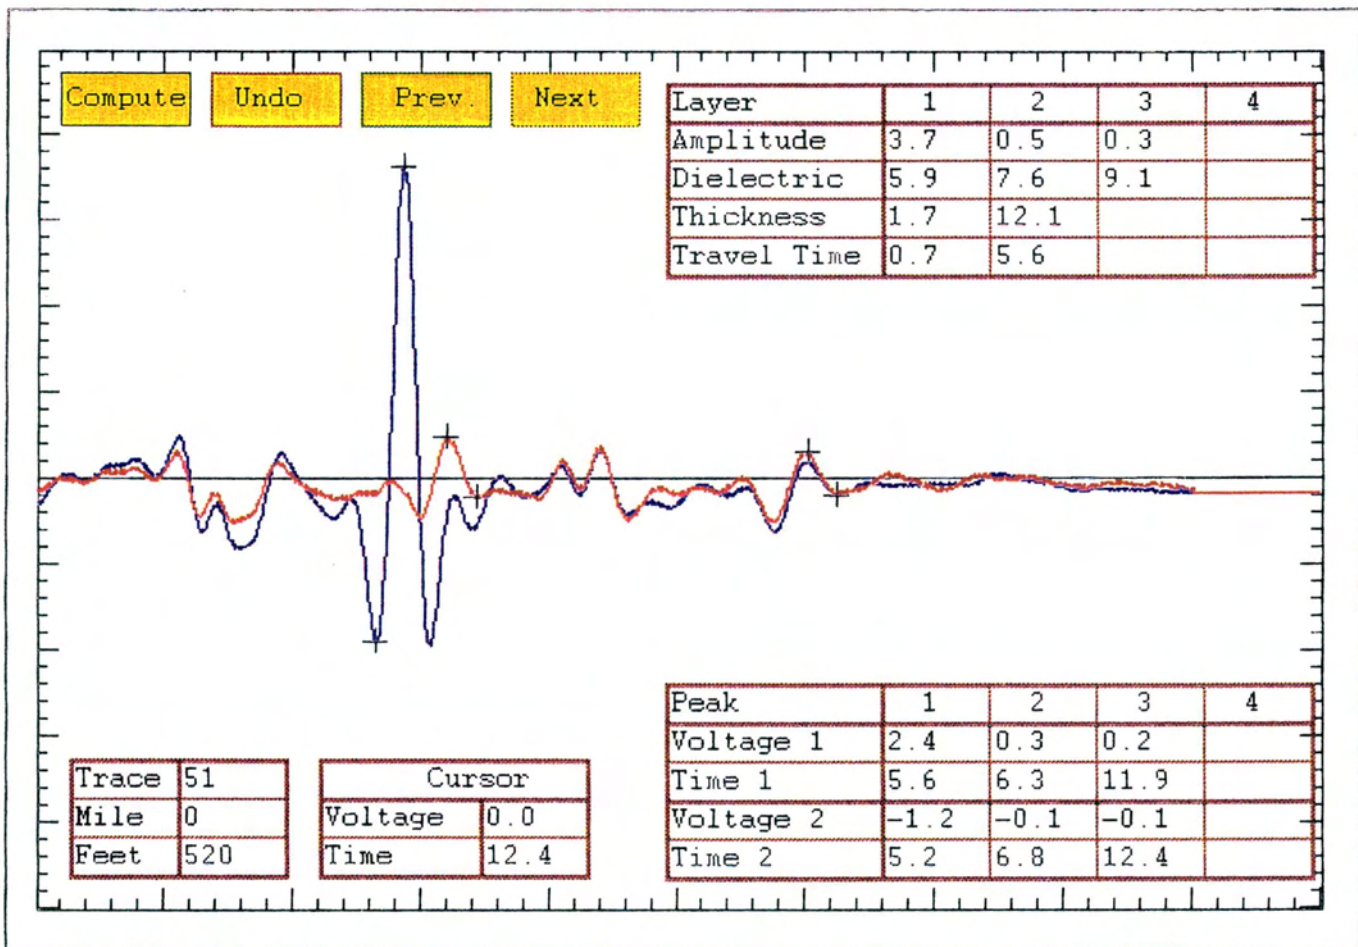
- Figure 10 US 271, thin overlay over existing HMA layer (Section 3), data collected over three days since significant rainfall. Case 1 reflection at bottom of thin overlay. Intermediate reflections at mid depth in lower HMA layer and non standard reflection at base interface indicating possible subsurface deterioration.

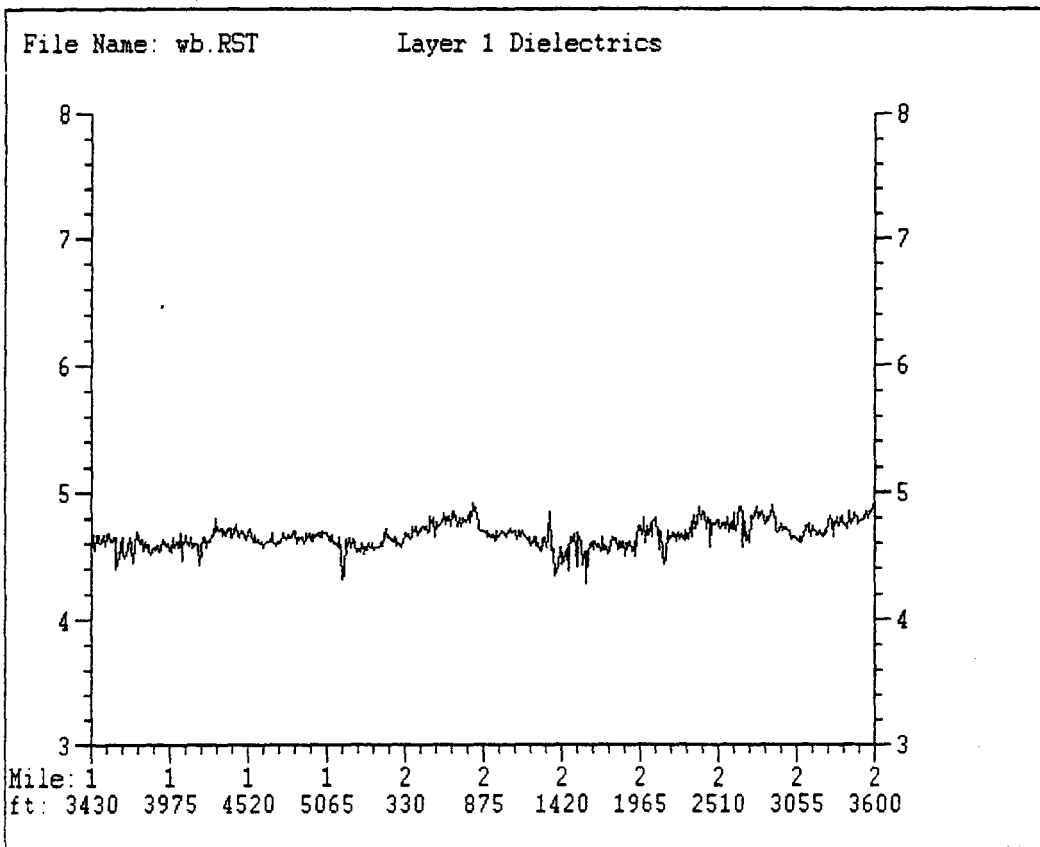
a. "Good" Pavement - Little Change in Density Along Section.

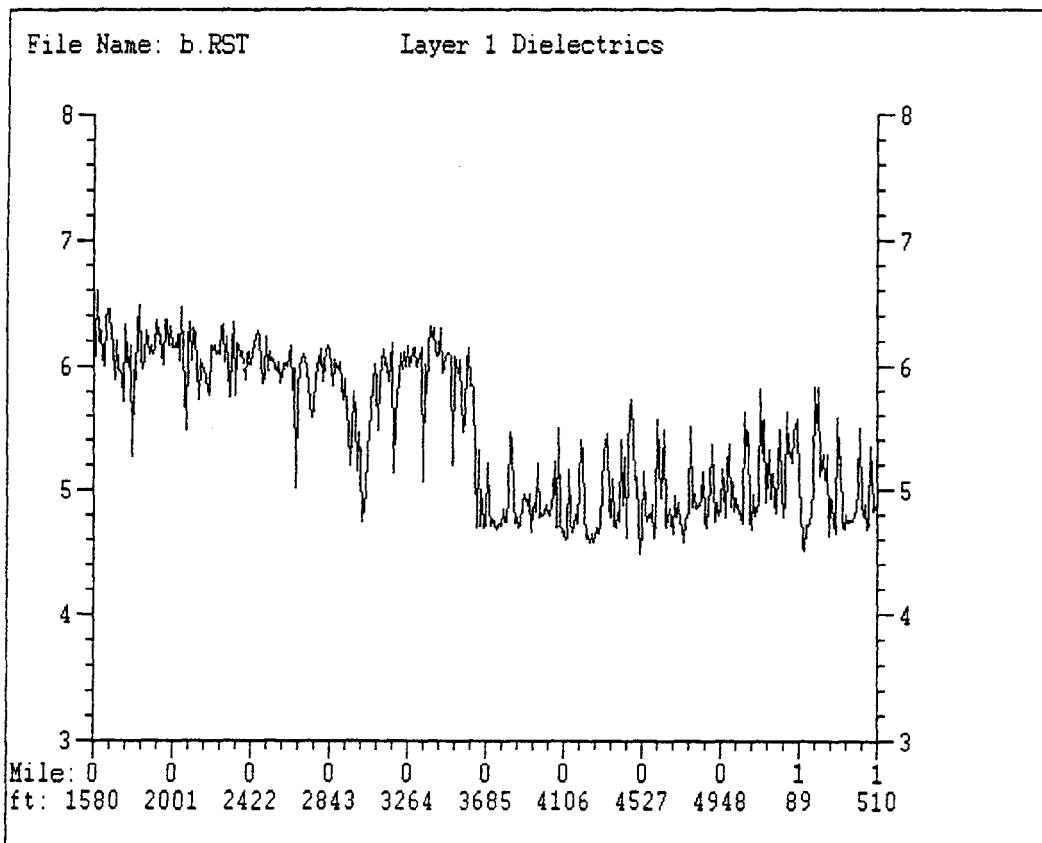
b. "Poor" Pavement - Change in Surface Type and Density.

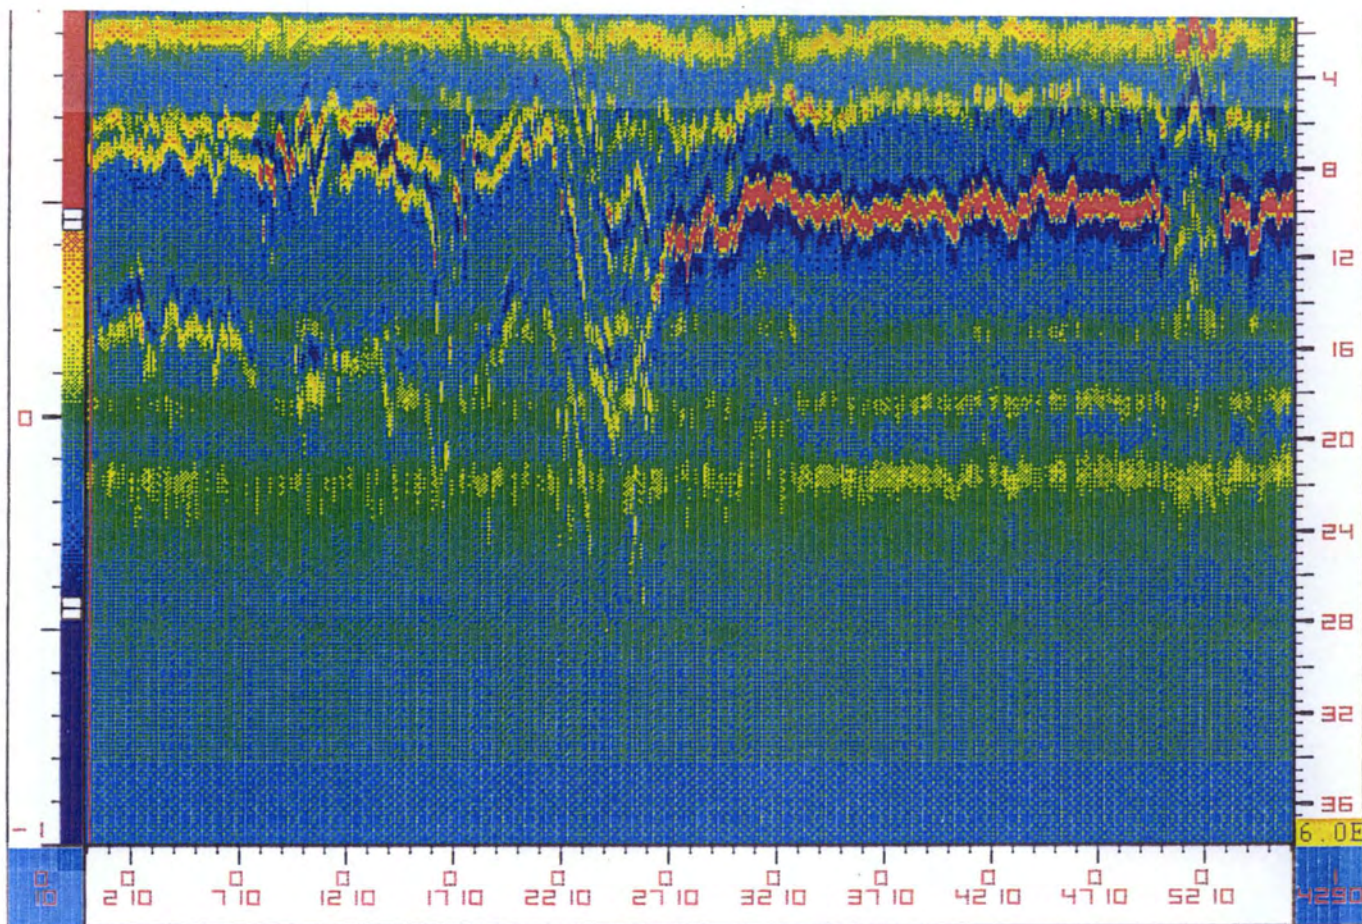
a. US 271 - Section Break - Stripping: Wet Base.

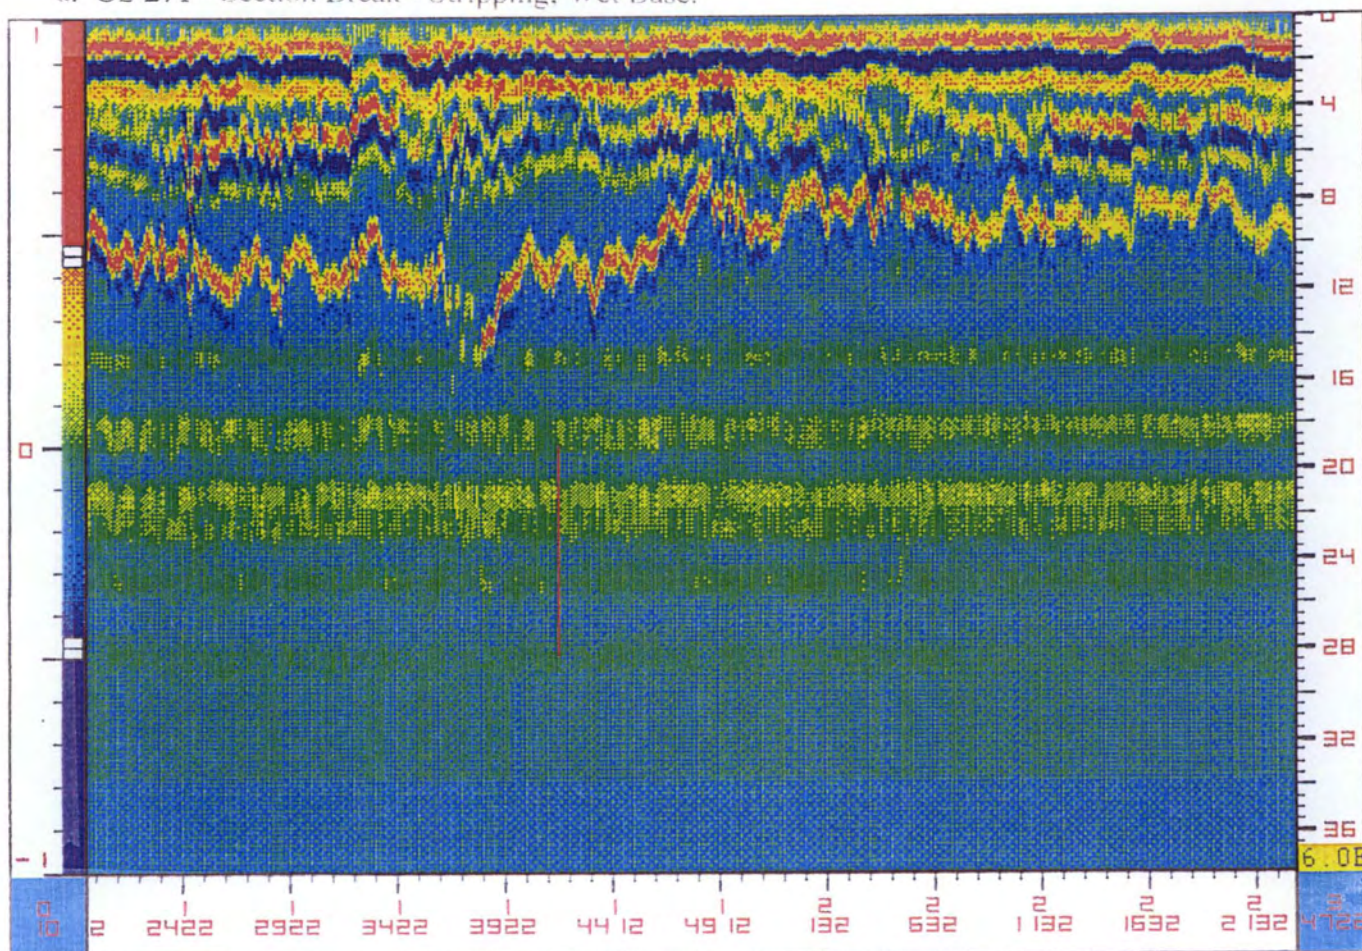
b. Section 10, US 79 - Variable Lower HMA, Possible Stripping.

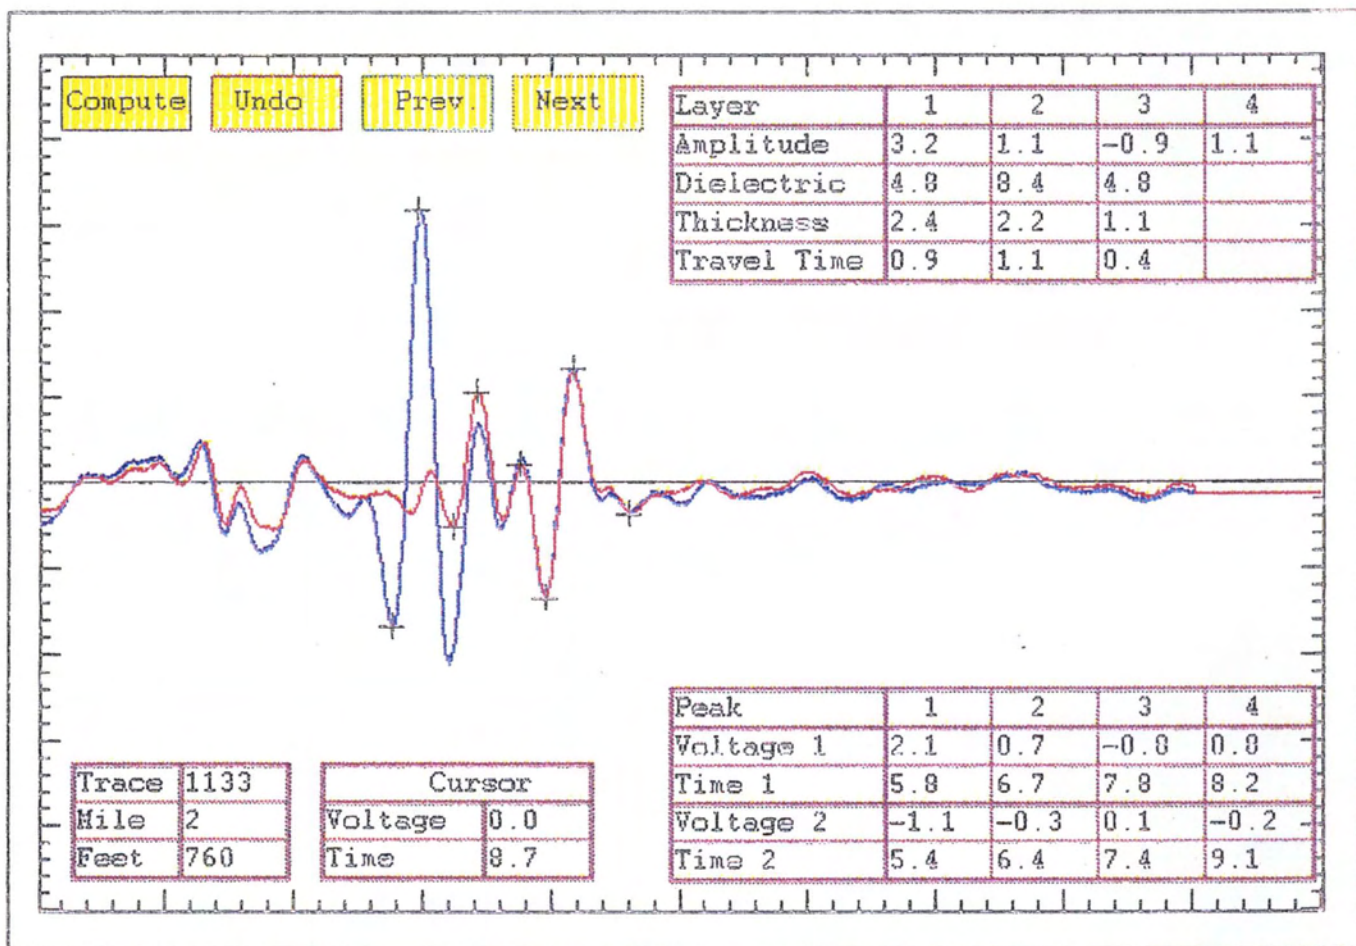
Figure 13. Large Positive Reflection from Interface Between New Overlay and Old HMA (Section 12 on SH155).

HMA produced a lower HMA dielectric of 8.4. This pavement has approximately 2 inches of new material over 3 inches of old. There appears to be some problems with the lower HMA layer.
