EVALUATION OF SURFACE-SEALING SYSTEMS UTILIZING SEAL COATS AND POLY-FAB UNDERSEAL

SECOND ANNUAL
CONDITION SURVEY REPORT
FOR
EVALUATION OF EXPERIMENTAL
CONSTRUCTION PROJECT

INTERSTATE HIGHWAY 40
OLDHAM AND POTTER COUNTIES
TEXAS

SECOND ANNUAL REPORT NOVEMBER, 1979

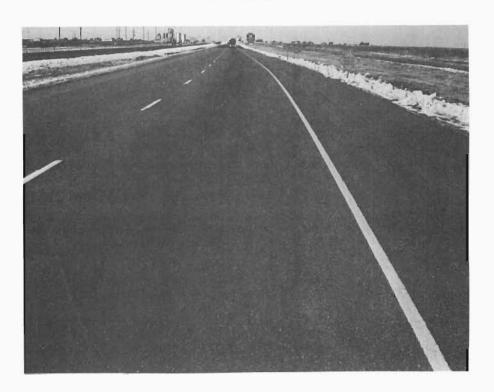
SYSTEM I - 1979 2 YEARS AFTER OVERLAY

Some cracks have appeared in all test sections. It has not been established if these cracks are reflective. They have not required maintenance. There are transverse cracks in all sections across both the inside and outside lanes at intervals of about 40 feet. There are a greater number of cracks and they are more pronounced in System I than the other systems.

The longitudinal cracks are more nearly continuous in System I than the other systems. There are approximately three times as many linear feet of longitudinal cracks in System I than in the other systems.
