FIBERGLASS PLACEMENT

IH 20, Ector County
Project M-5-13-16
Control 5-13

A NARRATIVE REPORT

September, 1975

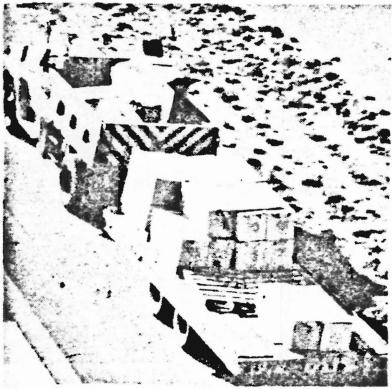
FIGURE 1

The material was delivered to the project in 500' rolls, 52" wide in boxes.

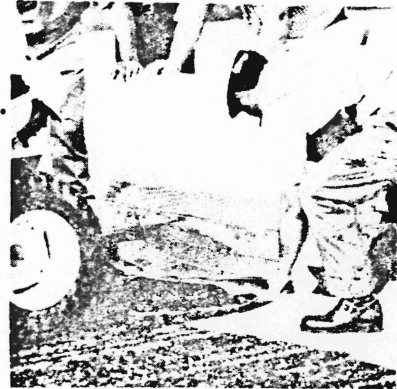
FIGURE 2

The roll was mounted on a roller to lay the material. The personnel are threading the material under the roller to roll it onto the pavement. A tack coat has been placed on top of the pavement. A tack coat of .15 gal/sy is ordinarily sufficient, according to company representative. It was necessary to go to .17 to .18 gal/sy on this particular project because the surface was a fresh seal coat which was placed as an underseal for the hot-mix overlay.

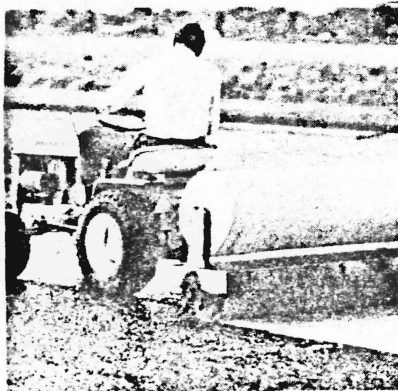
FIGURE 3

The roller was pulled by a garden type tractor. A pointer was used to assist in driving straight. The material does tend to buckle if the line is not kept straight while driving.

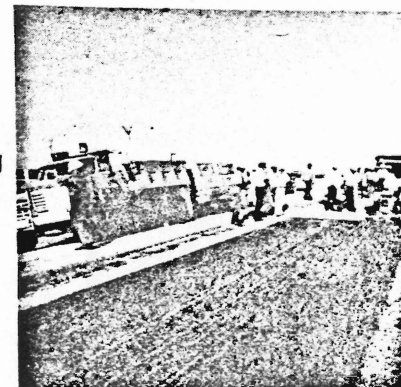
FIGURE 4

The tack coat has been placed and the first width of glass fiber is being placed. An attempt is being made to lay this on the tack coat. The contractor's hot mix equipment is immediately behind the operation.

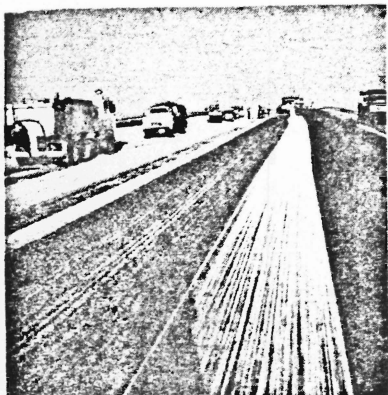
FIGURE 5

The first width of fabric has been laid on a 12' lane. The tack coat was about .12 gal/sy and some skips can be observed in the tack coat where good coverage was not obtained.

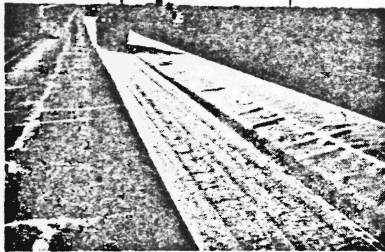
FIGURE 9

The ends of the material were at the same place when it was laid. As the roller came up a grade separation grade, it tended to make the material pull downhill and buckle. The roller was removed and brought to the top of the hill and rolled downhill only.

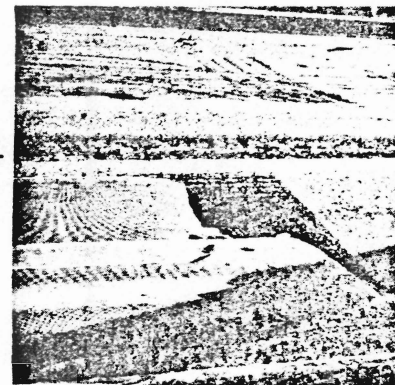
FIGURE 10

It will be noted that the squares in the material have been pulled at the meeting between the section that has been rolled and the one that has not. The fabric on the left has been pulled by the roller while rolling up the grade separation at a location downhill from where the photo was made.

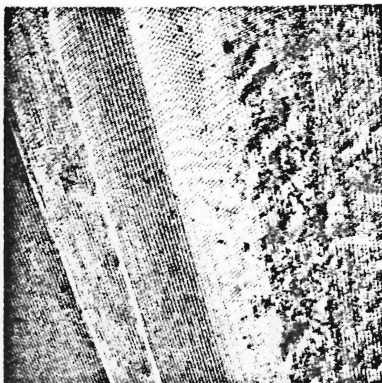
FIGURE 11

It will be noted behind the truck, that there is some wrinkling and pulling up immediately behind the tires.

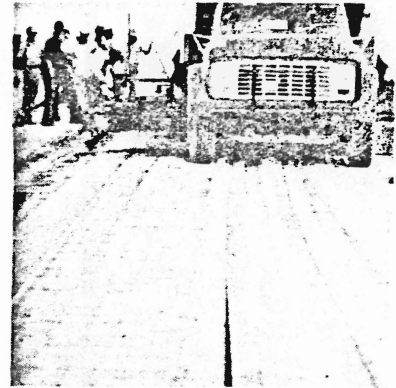
FIGURE 13

This gives an indication as to what was experienced as far as buckling on a portion of the material. The tack coat seemed to stick to the tires and pick up the material. This particular section was tacked a little light and this possibly contributed to the problem.

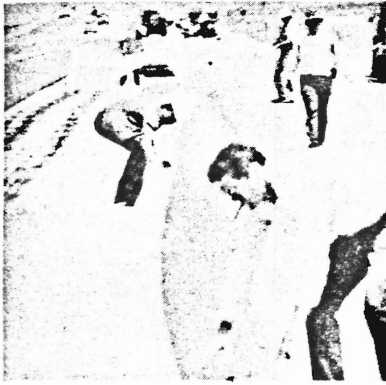
FIGURE 16

Some problems were encountered with the wind blowing the material up before it was rolled into the tack coat.

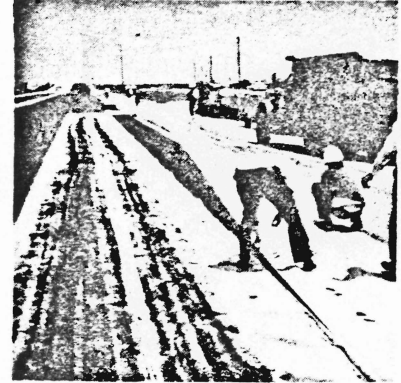
FIGURE 17

Another view of the wind problem. The tack coat in this view was about .17 gal/sy and was ample. The temperature had risen a little over the earlier temperature and the asphalt being used did not hold the material down during the fifteen to twenty mile per hour cross wind.

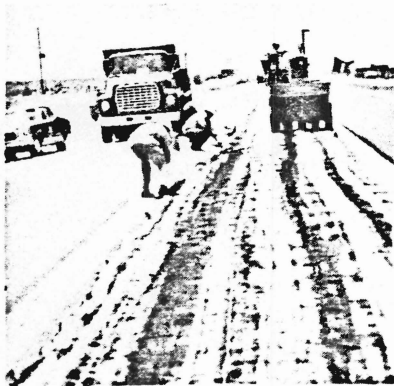
FIGURE 18

The roller operation is shown here. The edge of the material is blowing up due to the high cross wind.

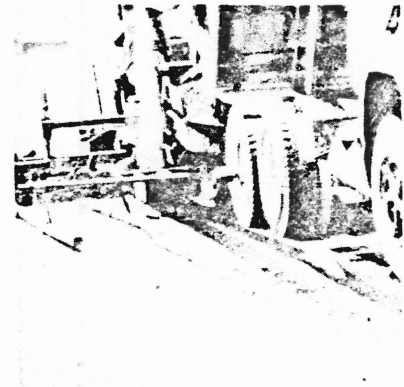
FIGURE 19

Some of the edges blew up, rolled over, and caused a problem. All of the wrinkles could not be straightened out and were laid over with hot-mix.

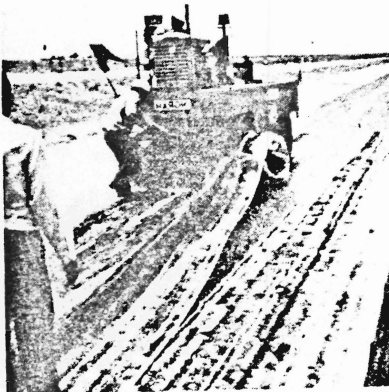
FIGURE 20

Here is an indication of the problems encountered when the end of a roll is rolled over and precautions are not taken to keep it from sticking to the tires.

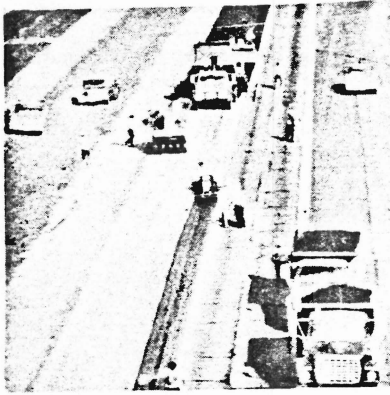
FIGURE 21

This indicates the cracking problems on the uncovered lane and is the type of cracking which an attempt was made to keep out of the new overlay. A problem arose when the hot-mix machine started a new roll of glass fiber. The fabric would stick to and roll up around the wheels of the hot-mix machine if it had not been tucked under the previous roll, and a little hot-mix material coated on top of the fabric prior to running over it with the hot-mix machine.
