## EVALUATION OF PRESSURE GROUTING EXISTING CONCRETE PAVEMENT

Report Number 625-1

EVALUATION OF  
PRESSURE GROUTING  
EXISTING CONCRETE PAVEMENT

IH-10  
FROM 3.0 MILES WEST OF GLIDDEN  
TO ALLEYTON ROAD

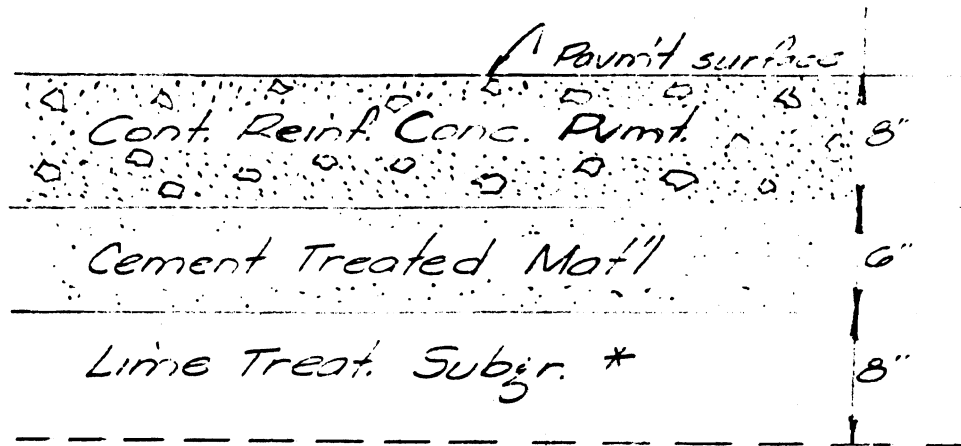
# TYPICAL RDWY SECTION

With the excessive amount of cracking and punchouts in the Continuous Reinforced Concrete Pavement and previous tests and studies made, it was determined that there should be voids under the concrete pavement located between the concrete pavement and the cement treated material. (See Sheet No. 7). Upon excavation along the edge of the pavement, between it and the shoulder, the material excavated the full 8" pavement depth was found to contain little to no binder or fines. Only segregated, loose gravel was found. This evidenced pumping of water out from under the pavement. The shoulders showed signs of "streaking", this being water and light fines being flushed from under the pavement and out through the cracks between the pavement and

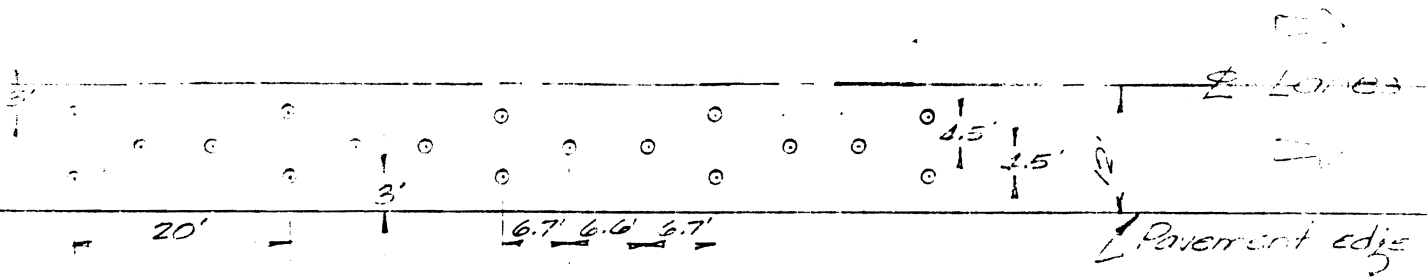
At the beginning of construction, the mix used was a sand and cement ratio of 1:2 using an approved fluidifier called Orzan A. The hole pattern used was as set up in the plans and shown as Hole Pattern No. 1 on enclosed Sheet No. 8. The depth of the initial drilling was 8" which is just the depth of the concrete pavement as shown on the section on Sheet No. 7.

Several areas (different locations) were drilled and the pumping of grout was attempted with little to no grout being placed under the slab (reference attached Sheet No. 9). Several variations with respect to mixtures were tried to thin the mix including a pure cement mix with no sand, a flyash and cement mixture and

finally just water, all under a 400 psi pressure. Nothing was pumped under the pavement. The tests were done in the most deteriorated section of pavement with no results. We also experimented with several sand-cement ratios by changing the water ratio but could only get an approximate 12 second flow using the Flow Cone Test Method.

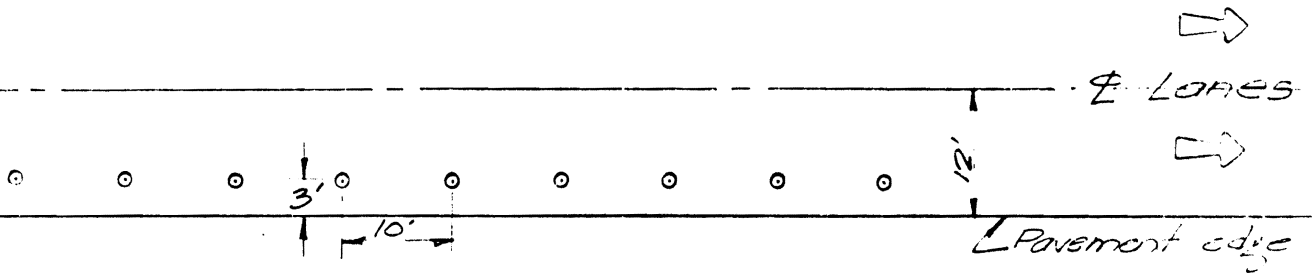
Upon evaluating the procedures we were using with no success, it was decided to experiment for other results. We authorized the drilling of the holes to a depth of 18" using Hole Pattern No. 2 to check if a grout flow could be established (See Sheet No. 8).

The Contractor was able to pump grout at a rate of approximately one cubic foot per hole pumped. There seemed to be no resistance to flow into these holes, however, the Flow Cone Test yielded only a 13 second flow. With no resistance to flow, it was decided to change the sand-cement ratio to 3:4. The results were satisfactory but with no change in flow, however, more volume for the amount of cement was produced. To assure uniform coverage of the areas requiring grouting, we changed the hole pattern to Pattern No. 3 as shown on Sheet No. 7. With this pattern the flow of grout could be seen from hole to hole. At this point we also changed to a 14" hole. This depth was determined to be the needed depth by experimenting with a hole depth pattern. This was accomplished by drilling consecutive holes in one inch increments from 8" to 18" depths. In almost all cases the grout began pumping at the 14" depth hole. All holes of less than 14" depth did not take grout.
