## TEST AND EVALUATION OF RURAL MAILBOX SUPPORTS

TEST AND EVALUATION OF RURAL MAILBOX SUPPORTS

Research Report 0969-1

October 1980

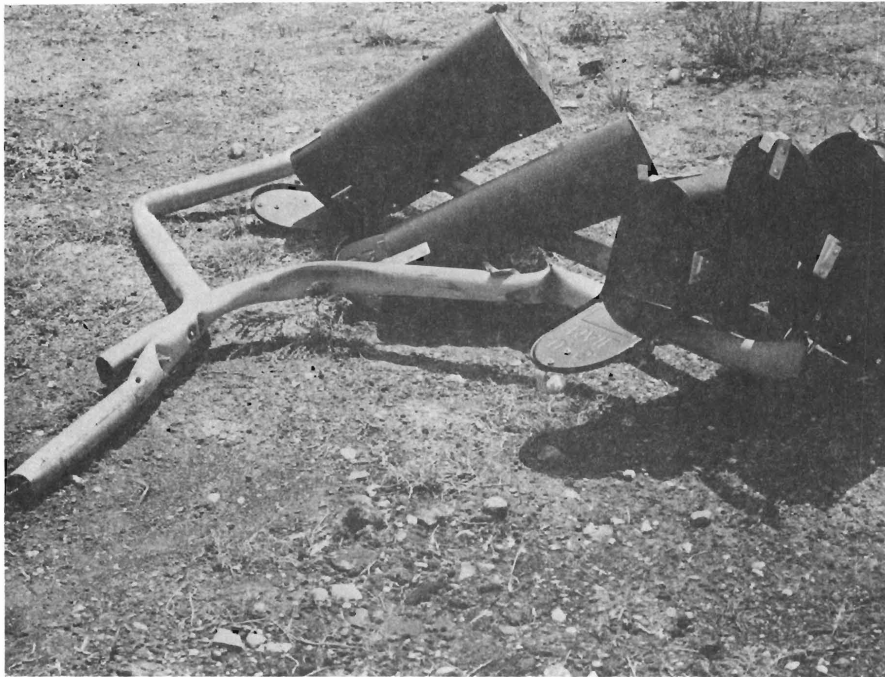
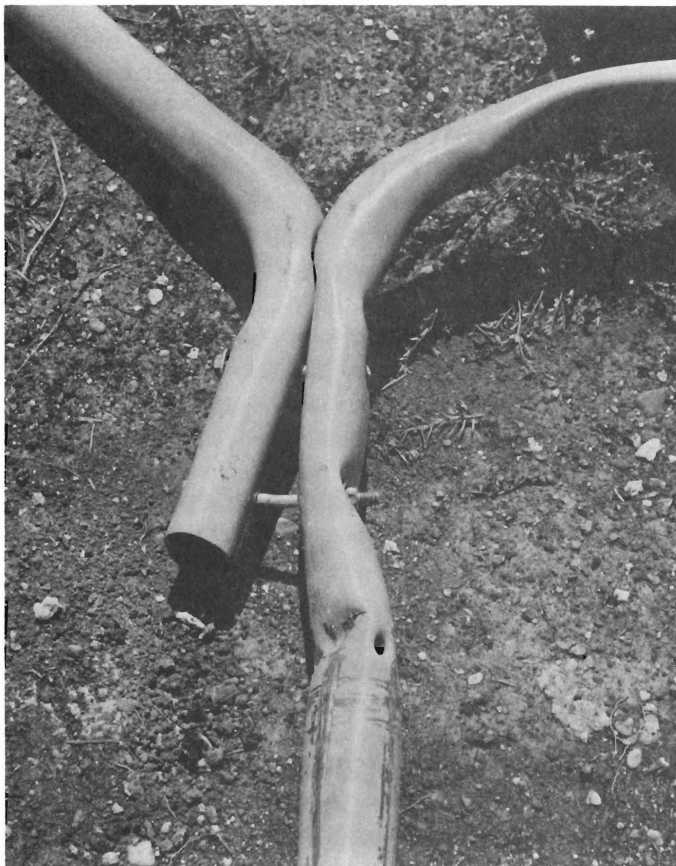
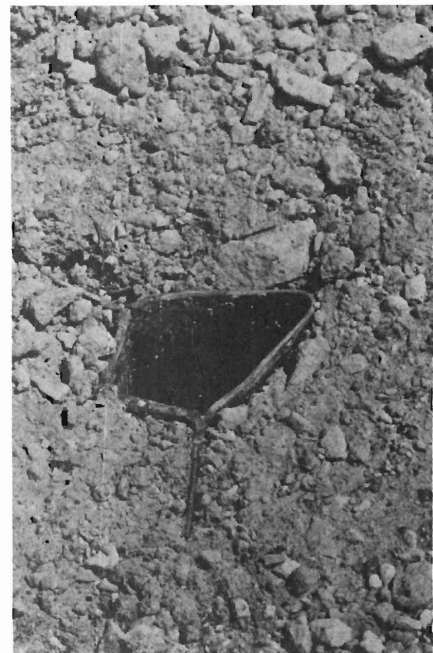
Figure 8. Mailbox Support After Test 1.

TIME (sec)	NOMINAL VEHICLE DISPLACEMENT (ft)	EVENT
0.000	0.00	Impact
0.014	1.25	Rectangular support begins to collapse
0.037	3.28	Vehicle strikes base of post
0.053	4.69	Mailboxes impact hood of vehicle
0.074	6.54	Base of support is pulled from ground
0.129	11.39	Mailbox support loses contact with vehicle
0.212	18.71	Mailboxes lose contact with vehicle
0.292	25.77	Mailbox assembly flies clear of vehicle

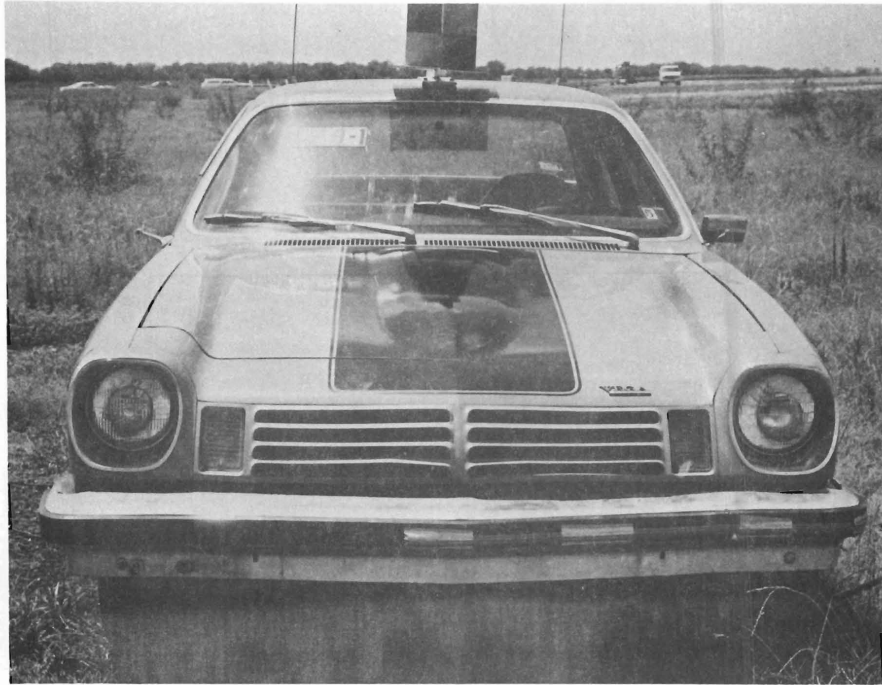
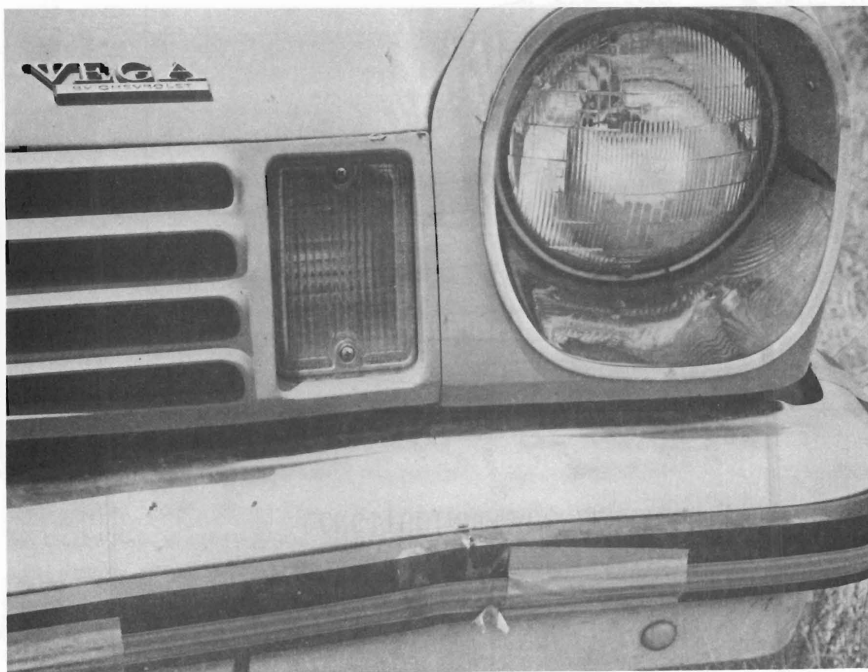
Figure 9. Vehicle After Test 1.

It can be seen that the change in momentum of the vehicle during impact with each design was well below the preferable limit of 750 lb-sec recommended in TRC No. 191. There was no penetration of the passenger compartment by the test article in any test. In fact, the windshield remained unbroken throughout all six tests (same car used in each test). As can be seen in Figure 35, the vehicle sustained only minor damage and was operable at the conclusion of the test program.

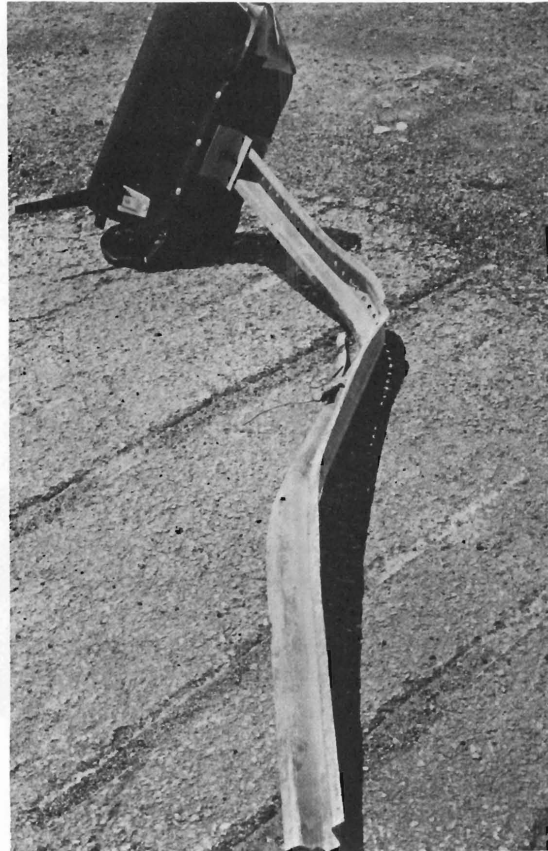
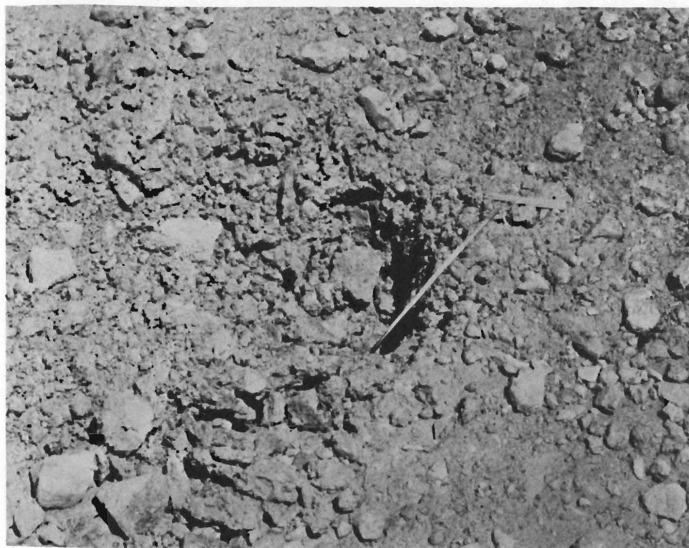
Figure 15. Mailbox Support After Test 2.

TIME (sec)	NOMINAL VEHICLE DISPLACEMENT (ft)	EVENT
0.000	0.00	Impact
0.020	1.81	Mailbox strikes hood
0.034	3.06	Support is pulled from ground
0.065	5.83	Mailbox loses contact with vehicle
0.118	10.57	Support falls to ground
0.150	13.43	Assembly is dragged by vehicle
0.197	17.63	Mailbox falls to ground
0.237	21.20	Vehicle rolls over assembly

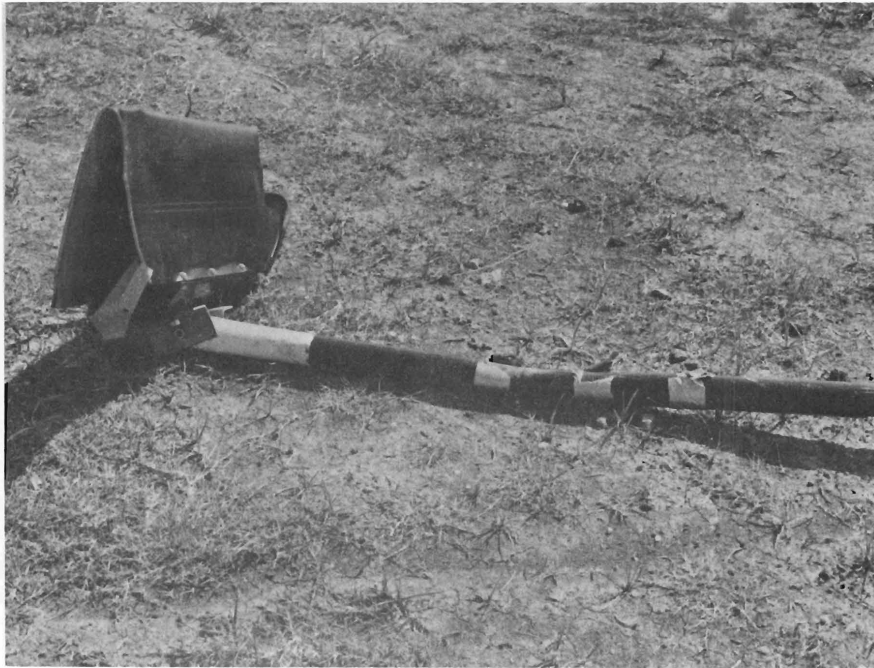
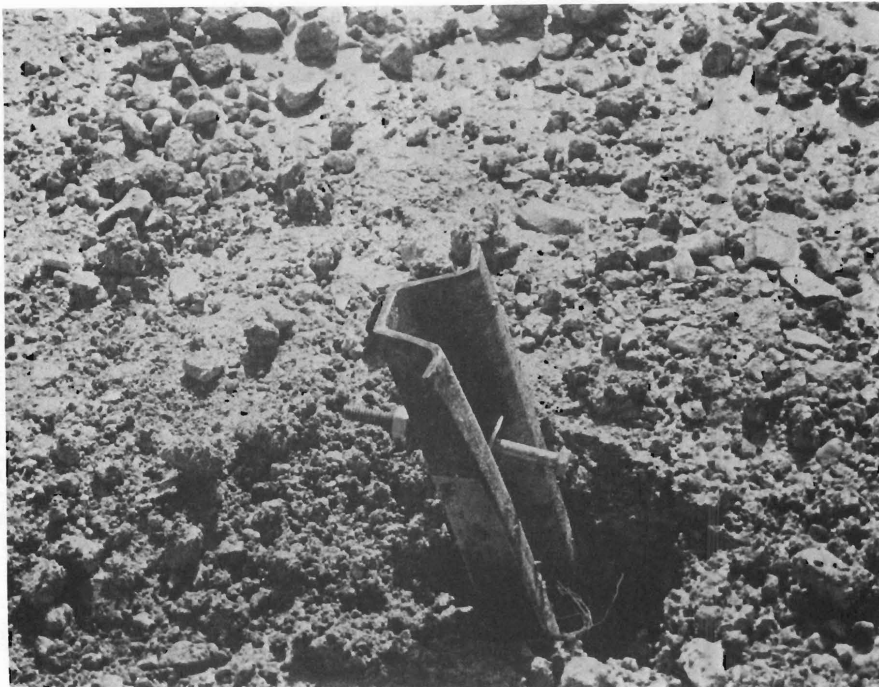
Figure 24. Mailbox Support After Test 3-1.

TIME (sec)	NOMINAL VEHICLE DISPLACEMENT (ft)	EVENT
0.000	0.00	Impact with first installation
0.006	0.54	Mailbox strikes hood
0.022	1.98	Plastic pipe breaks
0.049	4.41	Plastic pipe springs back
0.108	9.71	First installation loses contact with car; impact with second installation
0.121	10.87	Mailbox strikes hood again
0.196	17.61	Support breaks
0.274	24.57	Assembly is carried away by vehicle

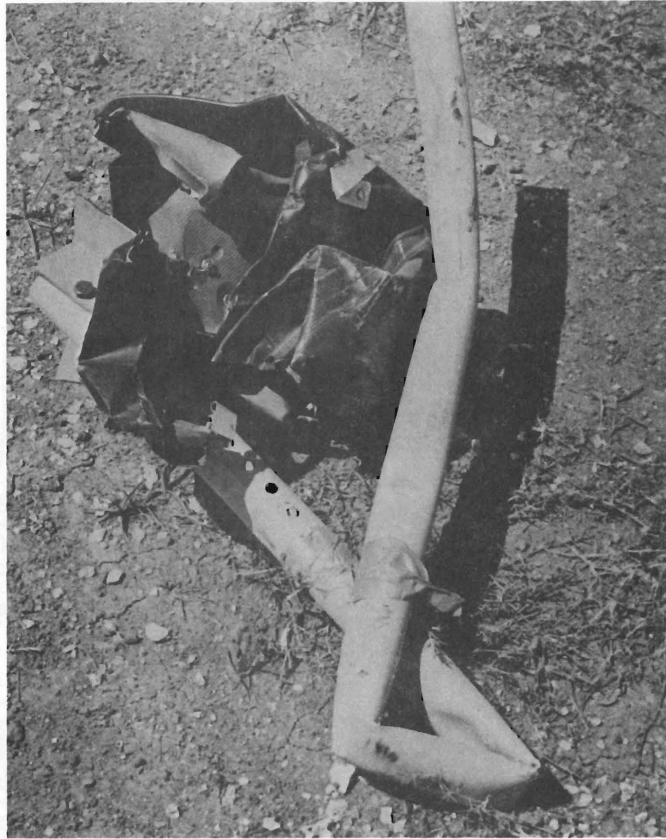
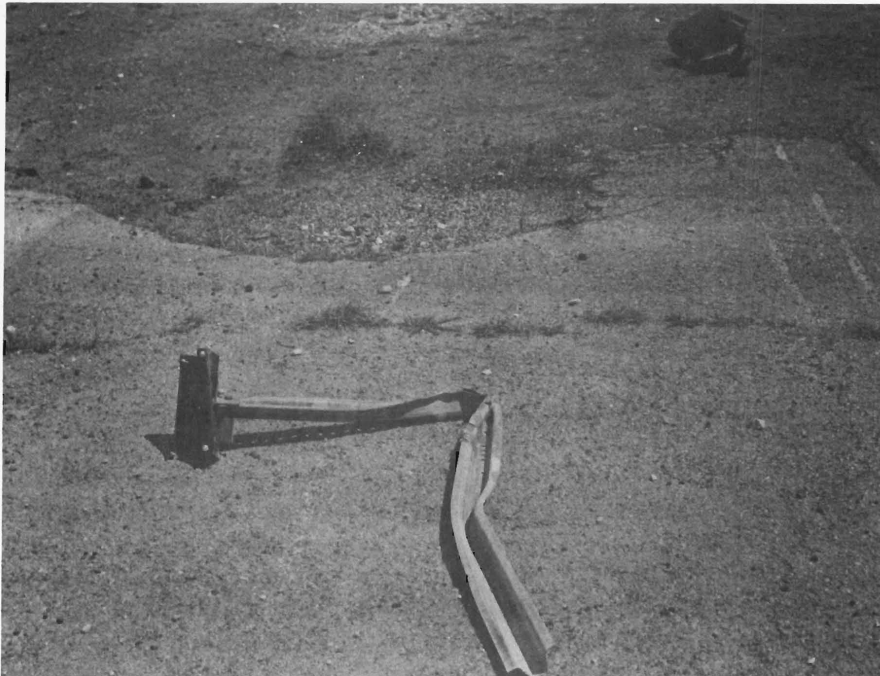
Figure 34. Mailbox Supports After Tests 4-1 and 4-2.

<u>TIME (sec)</u>	<u>NOMINAL VEHICLE DISPLACEMENT (ft)</u>	<u>EVENT</u>
0.000	0.00	Impact with first installation
0.022	1.95	Mailbox strikes hood
0.071	6.25	Support is pulled from ground
0.141	12.58	Impact with second installation
0.175	15.56	Mailbox strikes hood
0.224	19.82	Support breaks
0.295	26.00	Both installations fall to ground
0.344	30.26	Vehicle rolls over mailbox supports
