Report Number SS 7.0

REPAIR OF CONTINUOUSLY REINFORCED
CONCRETE PAVEMENT

TEXAS HIGHWAY DEPARTMENT

August 1969

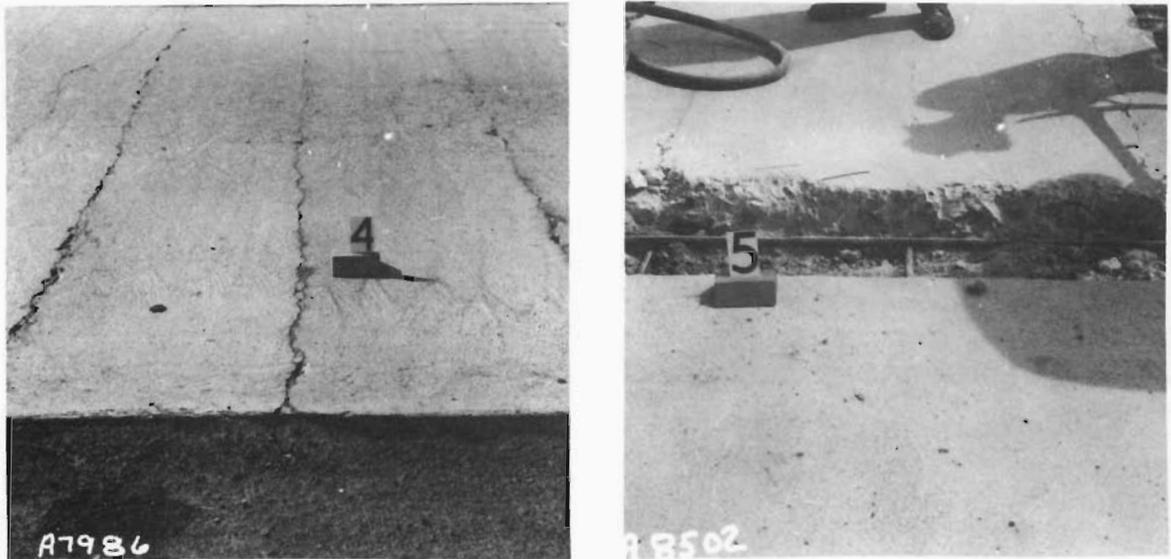
Transverse crack patterns, such as shown in Figure 1, which are identical to the detail of the transverse reinforcing steel usually are a sign of unconsolidated concrete beneath the steel mat. Usually pavements such as shown in Figure 1 tend to distress or fail rather rapidly when subjected to heavy traffic loading during very wet seasons. Longitudinal cracks begin to appear subsequently, as support is lost. Usually the loss of support comes from a degrading of the honeycombed or porous concrete in the bottom half of the slab and not the removal of subbase material from beneath the slab. In general it might be stated that whenever a longitudinal crack appears in continuously reinforced concrete pavement, a problem exists.

FIGURE 1a & 1b Transverse crack pattern
identical to steel layout.

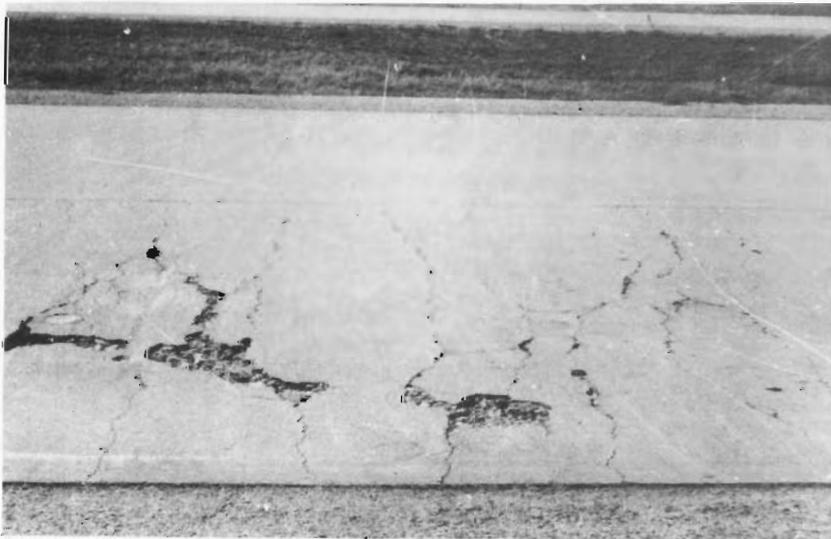
Cracking patterns such as that shown in Figure 2 are an indica-

FIGURE 2. Closely spaced, web shaped crack
pattern.

tion of something other than improper consolidation. In this pavement the problem was the concrete composition. Improper batching was the problem. Insufficient cement causes the spider web type crack pattern which continues to grow more severe with the number of load applications. These areas can be quite extensive. They might also be as small as one batch of concrete from the conventional dual drum paver.

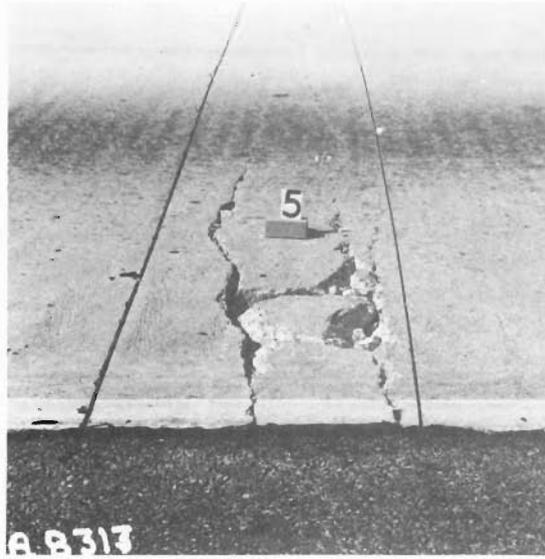
Figure 3 shows typical saw cuts made to bound a repair area. In small areas such as shown in Figure 3 the concrete is always removed from the steel, i.e., the steel is always left in place. Jackhammers are used to break away concrete in the repair area. Many failure areas are of the nature such that the concrete above the steel is sound and the concrete beneath the steel is loosely consolidated with little structural strength. Figures 4,5 and 6 show typical jackhammer operations in removal of the concrete from the reinforcing steel mat. Extreme caution should be exercised so that the longitudinal reinforcing steel is neither damaged nor cut while removing the concrete. Detail of reinforcing steel can be obtained from construction plans

FIGURE 3 Typical saw cuts

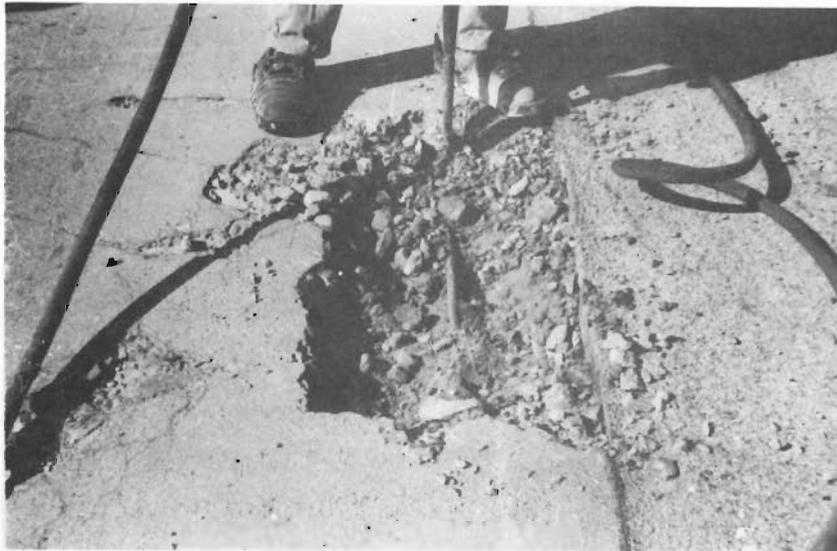
FIGURE 4 Jackhammer cracking concrete

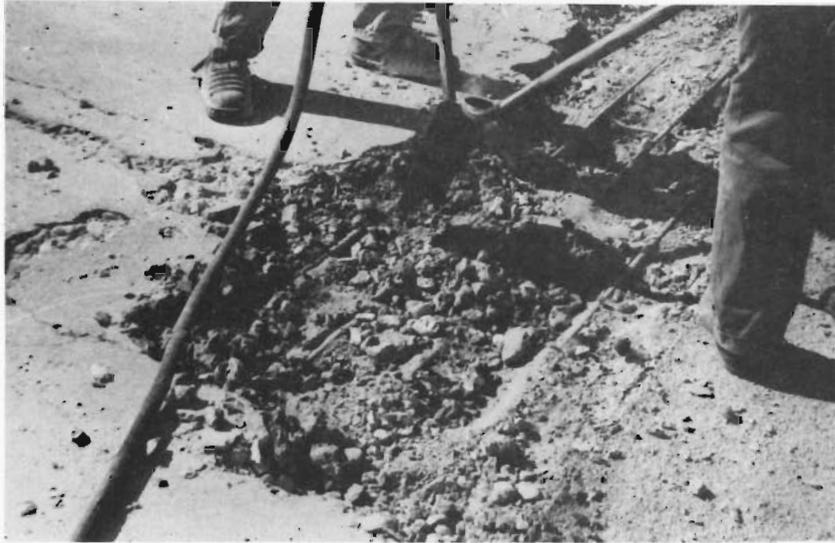
FIGURE 5 Jackhammer breaking concrete which is being removed by hand method.

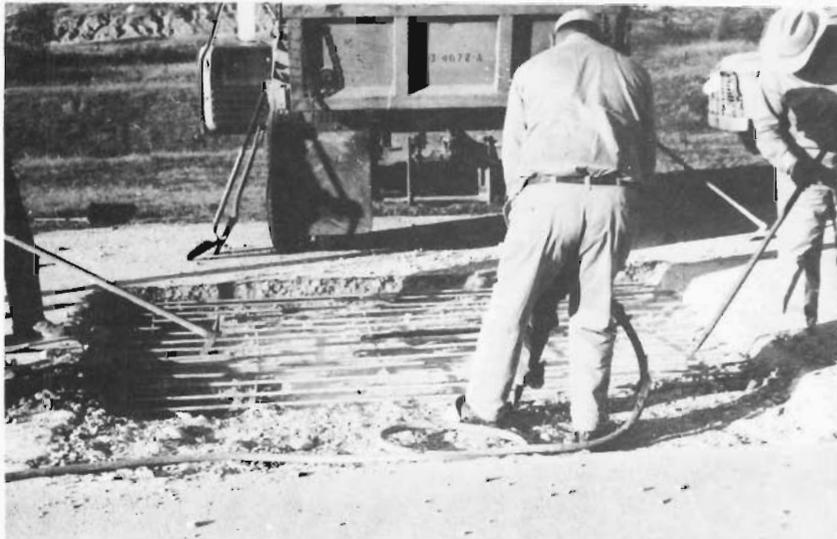
FIGURE 6 Rather extensive removal of concrete leaving steel in place.

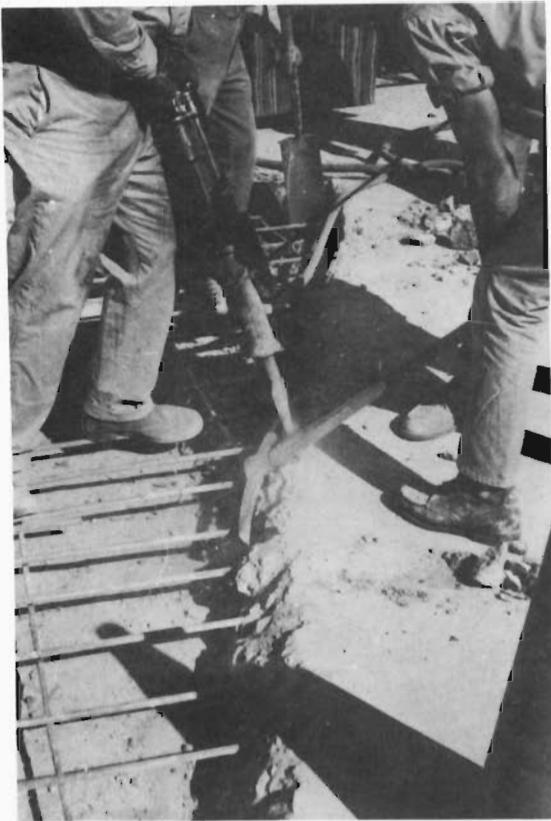
FIGURE 7

Figure 7 shows operations where concrete is being removed in an area where saw cuts were not used to bound the repair area. Note the special technique used to give a vertical face to the edge of the concrete slab.

Preparing vertical
face on slab where
no saw cut was used.

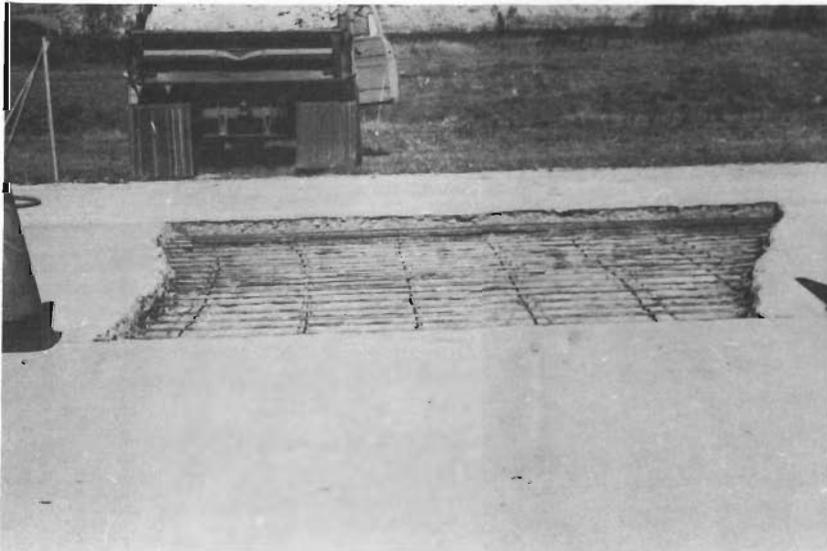
Figure 8 shows this same area after all broken concrete had been removed and the area completely cleaned. Note the repair area is one lane wide, that is, 12 feet and is trapezoidal in shape, i.e., the longitudinal ends are not at right angles to the longitudinal edge of the pavement. They are skewed, however, not to the 1 to 4 as has been suggested. If a concrete saw is not available, a edge can be obtained simply by using the jackhammer as shown in Figure 9. This technique requires skill and good workmanship.

FIGURE 8 Failure area with all undesirable
material removed.

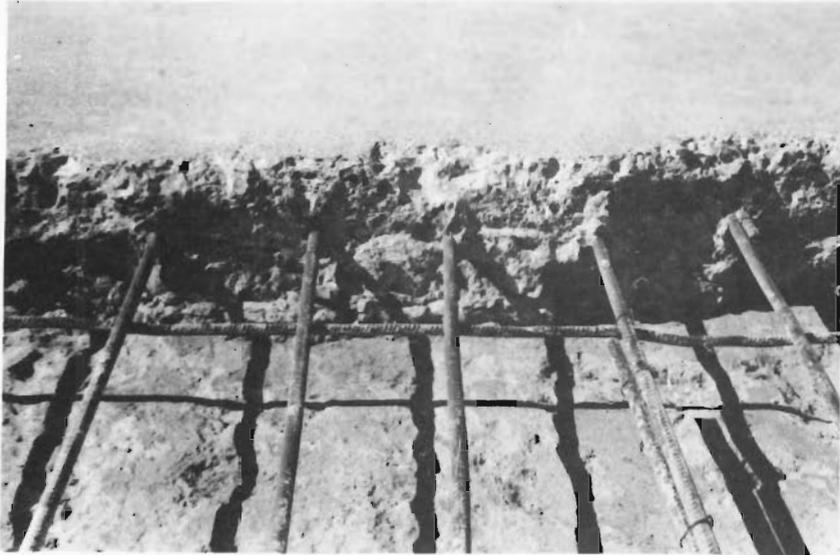
FIGURE 9 Vertical face made with jackhammer.

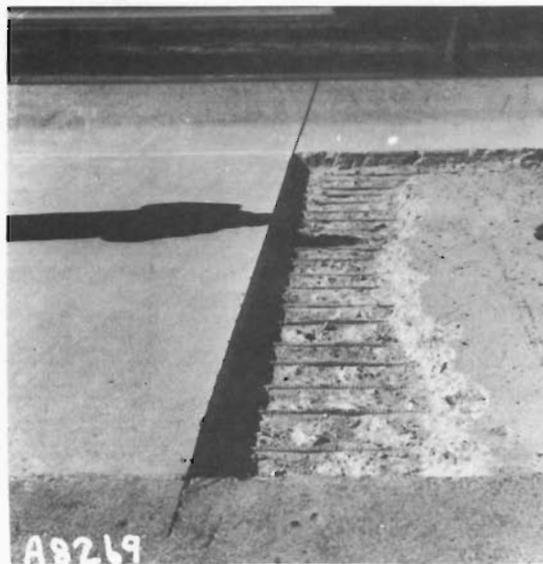
If a failure area is quite large, then it might be more economical to remove the entire pavement, i.e., concrete and steel rather than just the concrete.* Typical operations are shown in Figures 10, 11 and 12 where the concrete and the steel were both removed. Figure 10 shows that sufficient concrete has been removed from the area near the saw cut so that when the steel is to be cut there will be sufficient protrusion of the existing steel for sufficient lap.

FIGURE 10 Concrete removed from steel to be left for lapping to new steel.

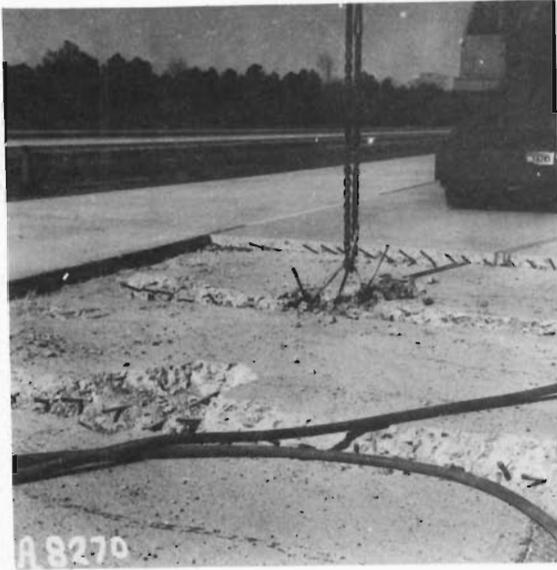
FIGURE 11

Figure 11 shows the area to be removed. Note all the steel bars

have been cut and a crane is being used for removal of the slab segments.

Concrete and steel to
be removed from
pavement.

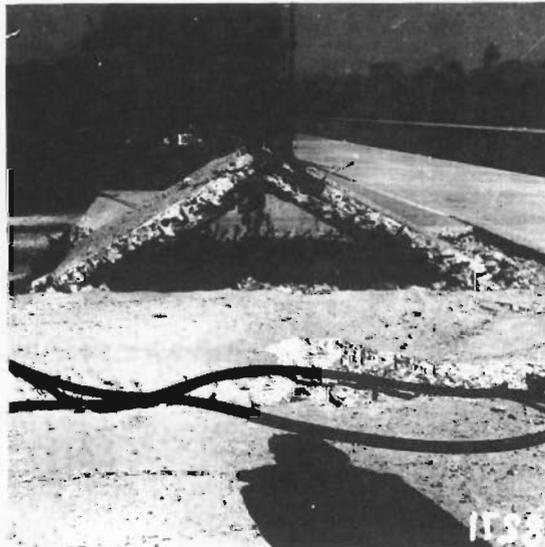
FIGURE 12

Figure 12 shows some of the slab being lifted off the subbase. Any damage done to the subbase should, of course, be repaired, i.e. restored to the initial grade. After all problem concrete has been removed, new reinforcing steel should be tied or welded in place in the area. This is shown in Figure 13. Experience has shown that when all of the steel is lapped in one transverse plane lap failures occur. In the repair shown in Figure 13, long laps were used to insure that no lap failure would occur at the ends of the repair area. Also to insure that the steel would remain continuous, the steel bars which were inserted were welded to the protruding bars in the existing slab.

Removal of slab
by mechanical device.

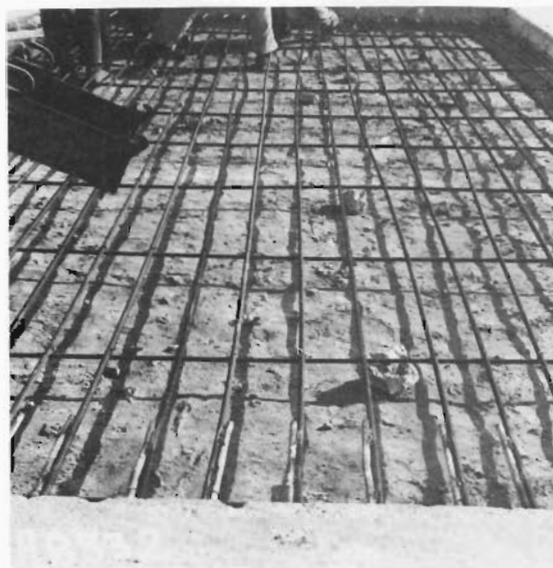
FIGURE 13 Steel being placed in repair area.

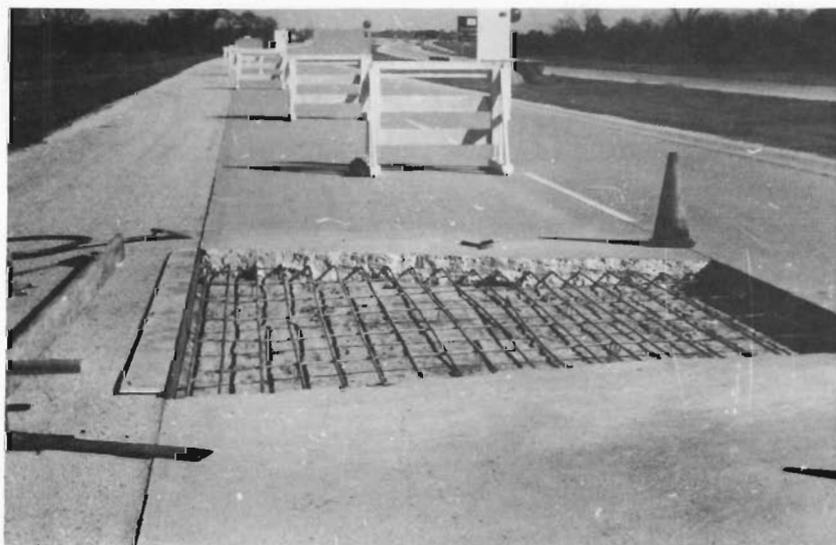
After the entire area is clean and all steel in its proper place the area is ready to be paved or patched. However, just prior to placement of concrete in the repair area, it is good practice to paint the exposed faces of the slab with an epoxy bonding agent as has been done in Figure 14. The performance of the particular repair area shown in Figure 14 is quite good.

FIGURE 14 Exposed faces of pavement slab painted with epoxy bonding agent.

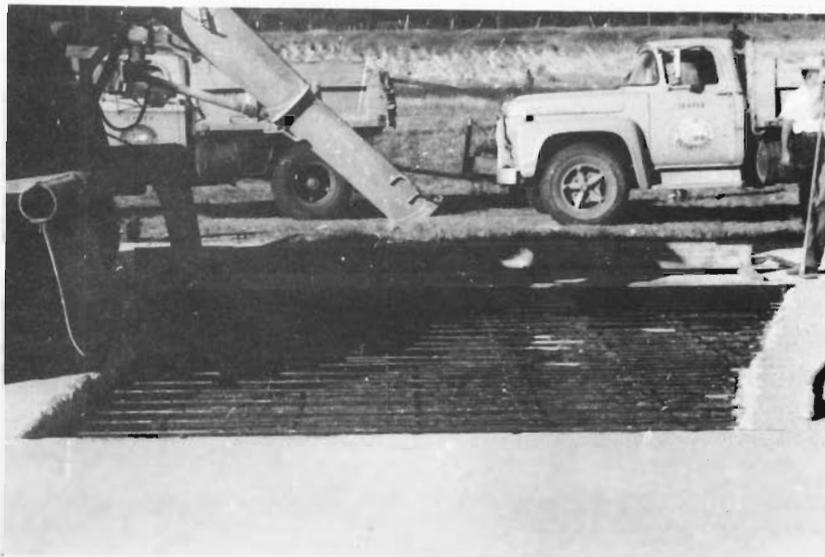
Figure 15 shows an area which is ready to have the concrete placed in it, the subbase has been dampened and the exposed faces of the slab have been painted with an epoxy bonding agent. In this particular case ready-mix concrete was used.

FIGURE 15 Ready for concrete placement.

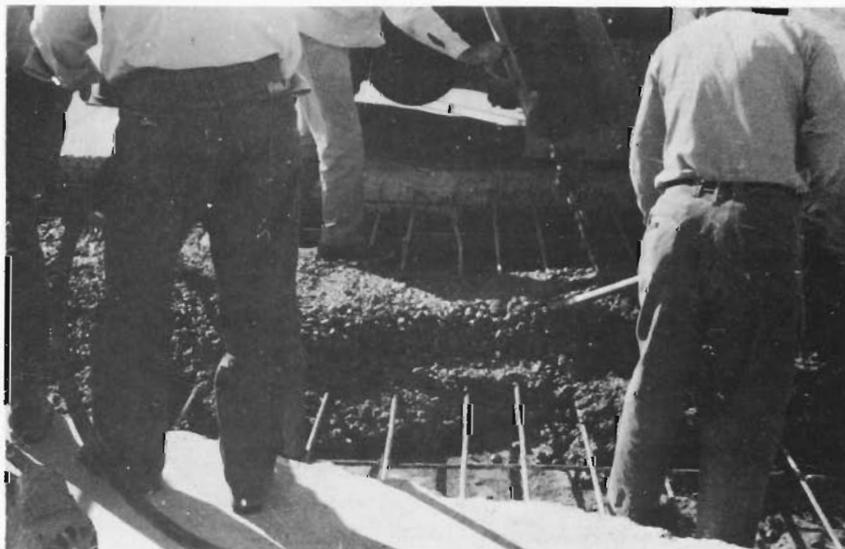
Figure 16 shows the concrete being placed into the repair area. Workmen are spreading the concrete by hand as well as with the dump from the agitating ready-mix truck.

FIGURE 16 Concrete being replaced in repair area.

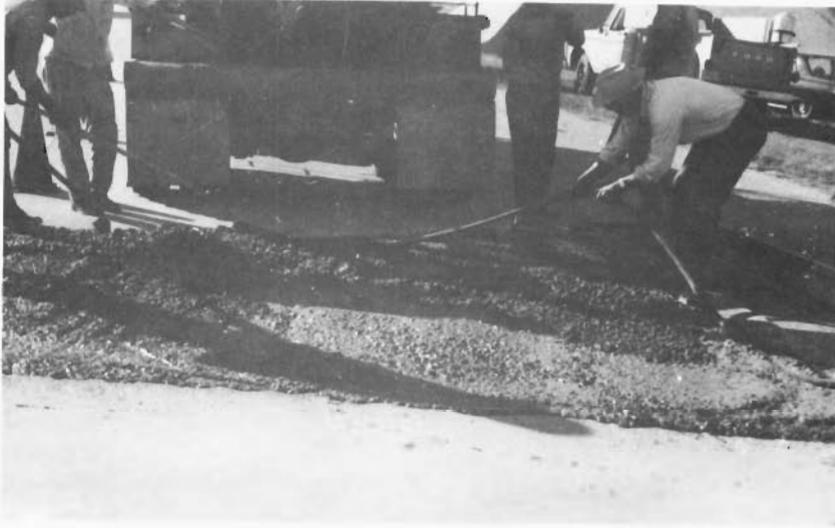
Figure 17 shows all the concrete placed in the repair area. It is being compacted and vibrated by use of a hand-manipulated vibrator. Sufficient vibration in repair areas is very important to avoid any honeycombing or unconsolidation.

FIGURE 17 Vibrating concrete with hand manipulated vibrator.

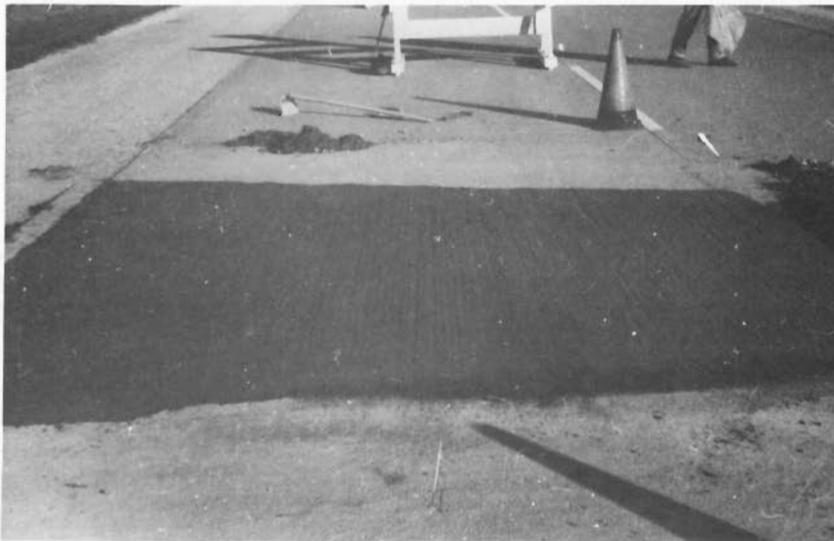
Figure 18 shows the completed patch. All finishing was done

FIGURE 18 Completed repair

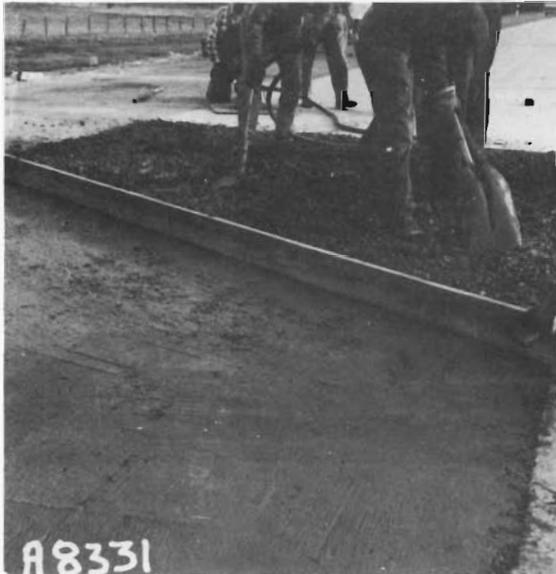
by hand. Figure 19 shows another case where hand finishing was used. Note the 2" x 8" lumber used as a screed. Note also the hand manipulated vibrator which the workman is using to consolidate the plastic concrete. In most cases the wood float used to finish the concrete gives sufficient texture for adequate skid resistance; however, if this would not be sufficient, a burlap drag or a broom could be used to give the desired texture.

FIGURE 19 Hand finishing and vibration.
