Report Number SS 9.1

## FIBROUS CONCRETE OVERLAY

FIBROUS CONCRETE OVERLAY

Interstate Highway 10

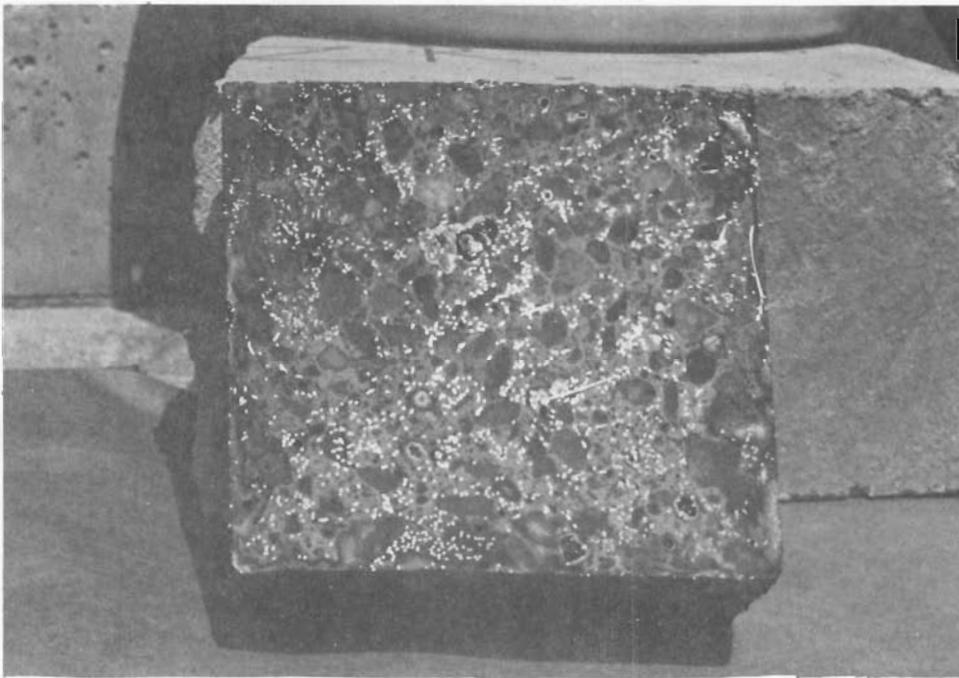
PHOTO NUMBER 1

1. Failure in all cases occurred by the fibers "pulling out" of the concrete rather than fracture of the steel.
2. Distribution of the fibers throughout the break was extremely good indicating that fiber distribution throughout the mix was successful. (See Photo #1)

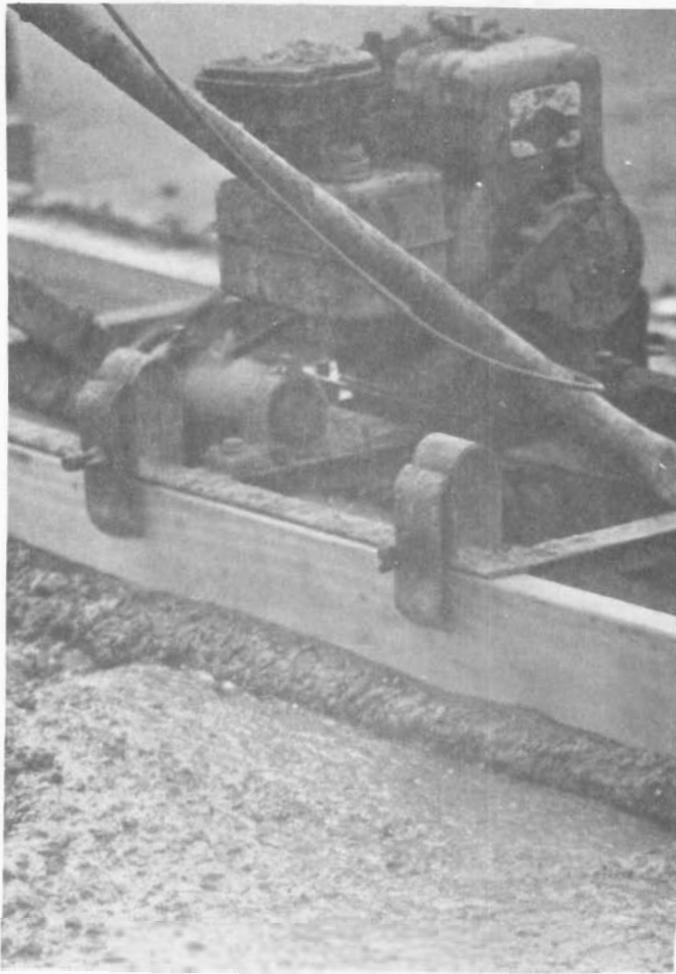
PHOTO NUMBER 3

Some difficulty was encountered initially with screeding and finishing. A vibrating screed was used and at first was only pulled longitudinally causing it to tear gaps or holes in the surface. (See Photo #3) This problem was rectified by simply moving the screed in a sawing motion as it was moved forward. An attempt to use a straight edge to finish the surface was unsuccessful because it would pull the fibers from the surface. A long handle metal float was then used which provided a satisfactory surface. The surface was then given a broom finish. (See Photo #4, for resulting texture) No attempt was made to tie the two slabs together and there is a longitudinal construction joint between the two slabs.

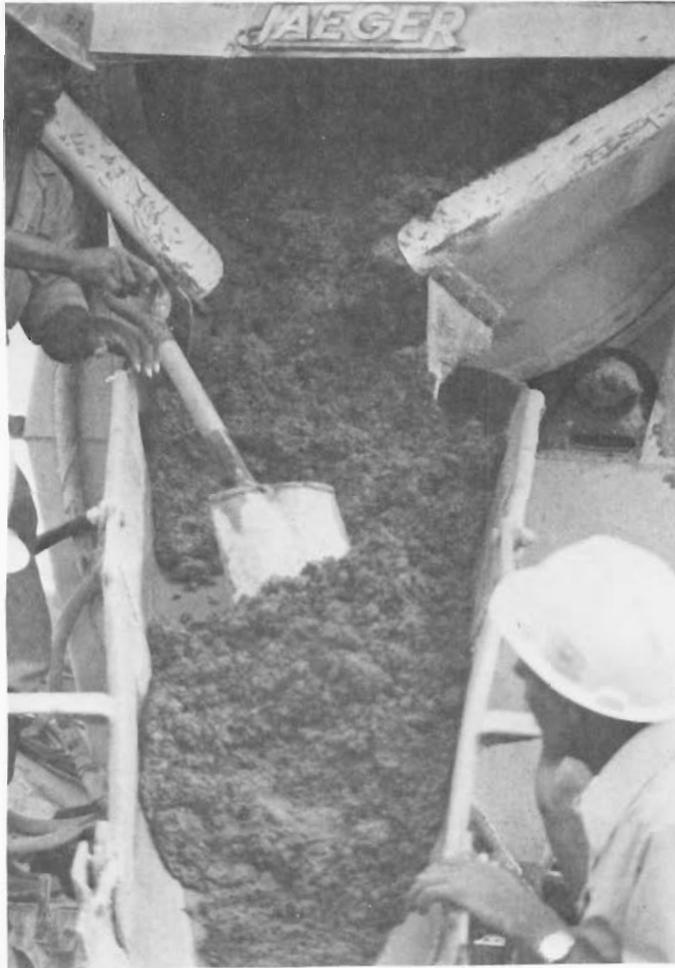
PHOTO NUMBER 5

The workers commented that the material is very difficult to work because of its stiffness and adhesive characteristics. (See Photo #5) We believe that these characteristics would not present any particular problem with the use of proper machinery for placing the fibrous concrete.

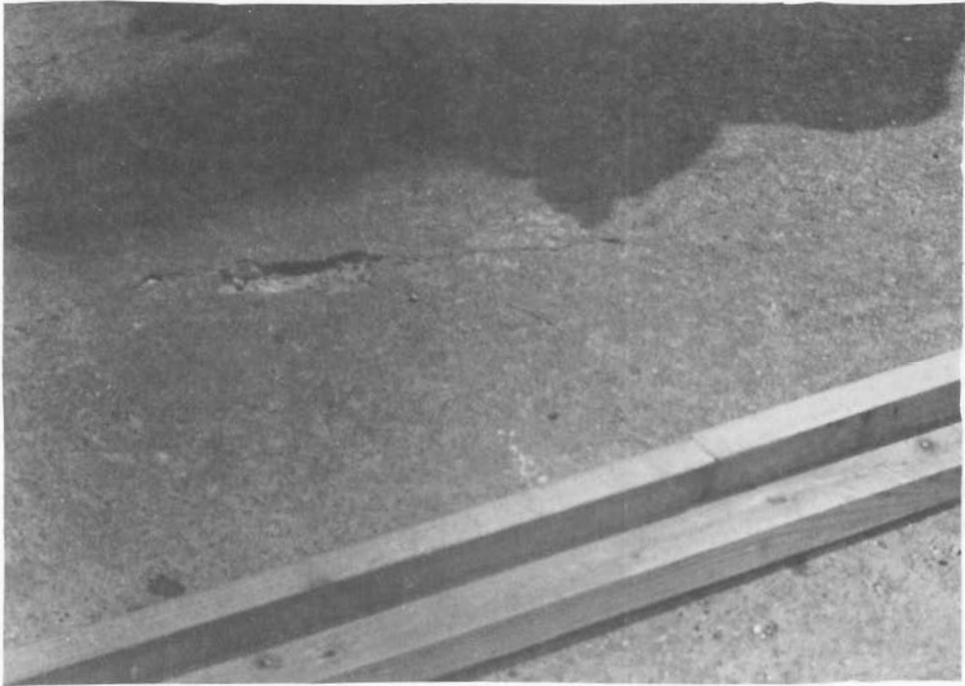
PHOTO NUMBER 6

1. The first crack which was discovered occurred directly over a joint between the original pavement and a patch placed by State Maintenance Forces earlier. This crack was discovered three days after the pour and prior to any traffic traveling over the patch.
2. The second crack was first observed ten days after pouring. This crack occurred over an area of existing pavement which was extremely distressed and which would

have been removed and patched using conventional methods had the fibrous concrete overlay not been used. (See Photo #6)
