CRUSHED SANDSTONE FROM EAST TEXAS STONE COMPANY'S
BLUE MOUNTAIN PIT, FREESTONE COUNTY, TEXAS

Materials and Tests Division
Texas Highway Department

TP 11-70 MR
July 1970

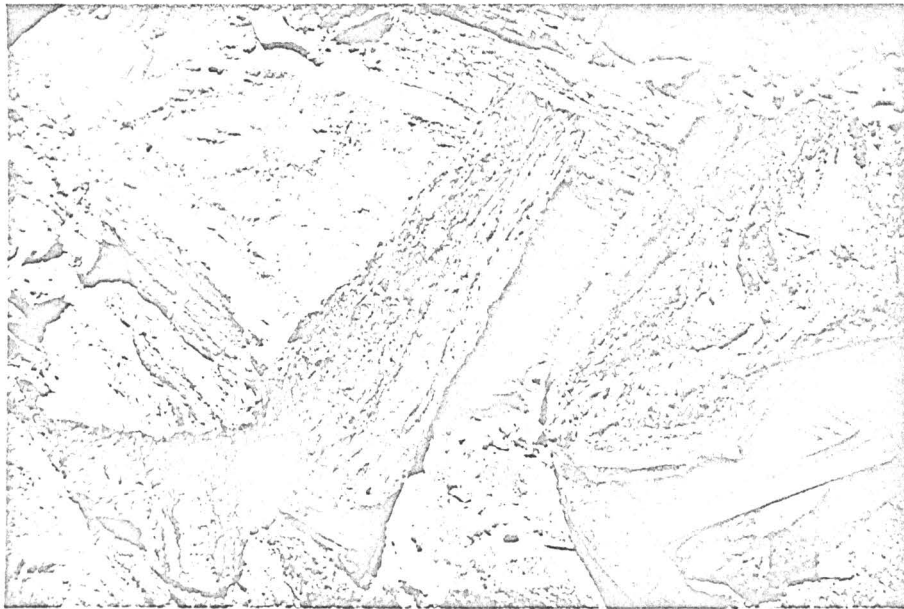
Figure 14. Lignite on bedding planes.

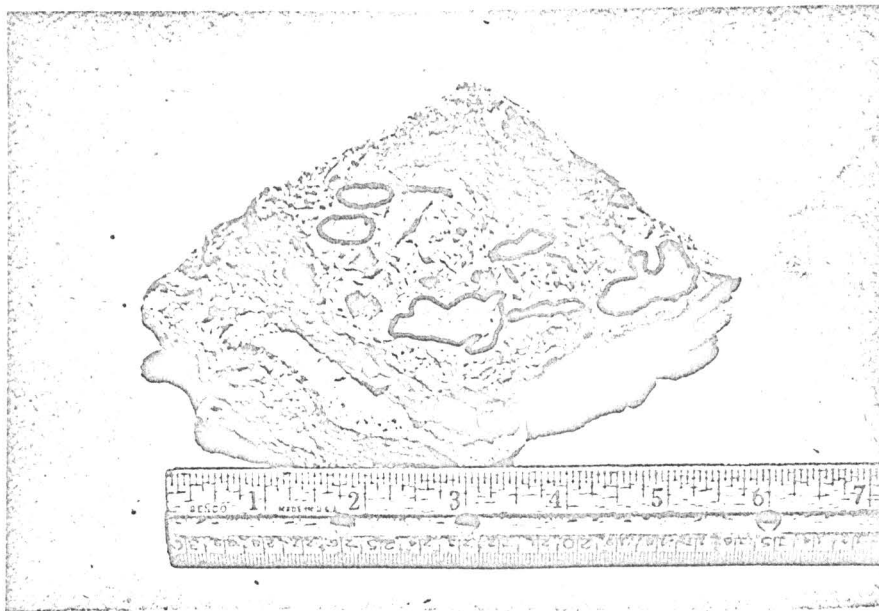
Figure 16. Hand specimen having irregular shaped pyrite nodules in association with lignite. Pyrite outlined.

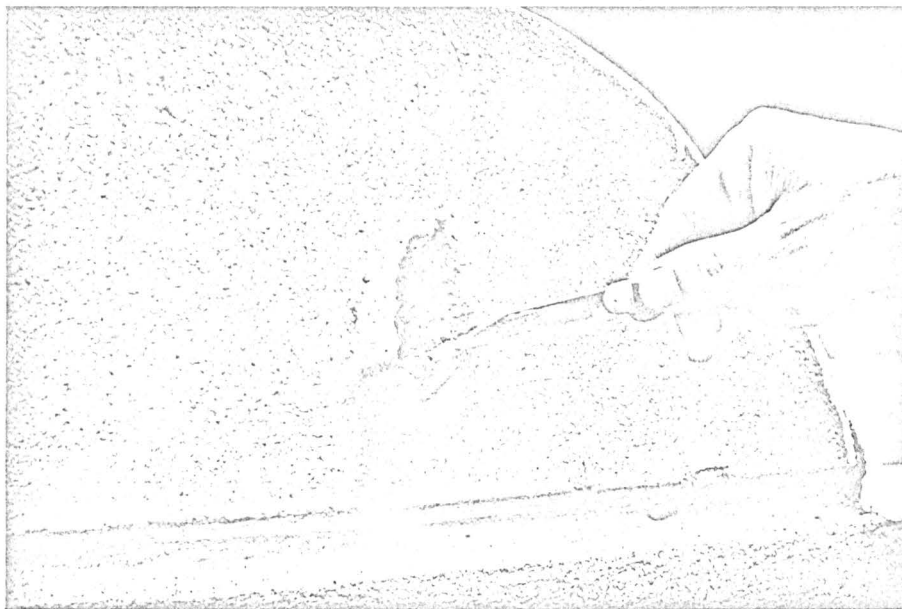
Figure 22. Pyrite popout.

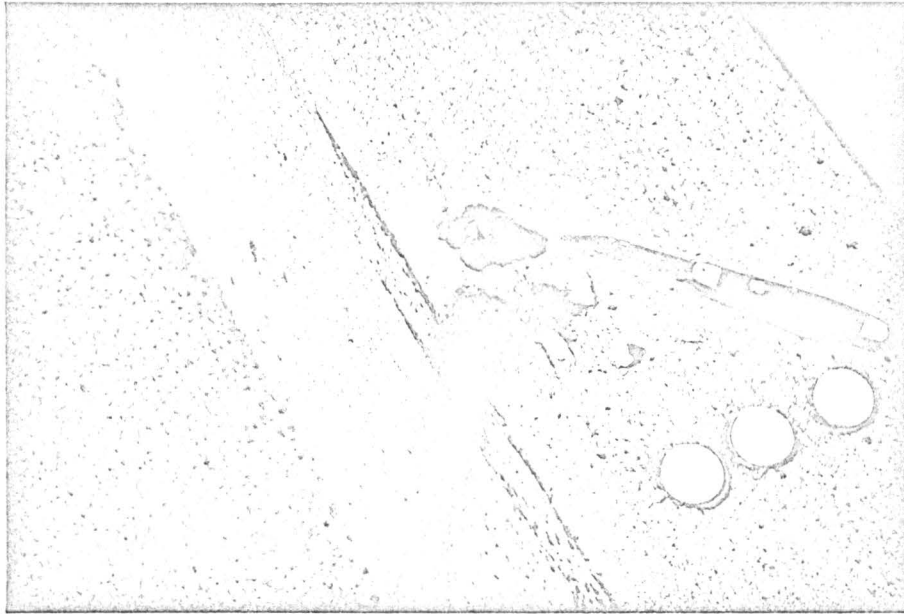
Figure 23. Lignite and pyrite popout.

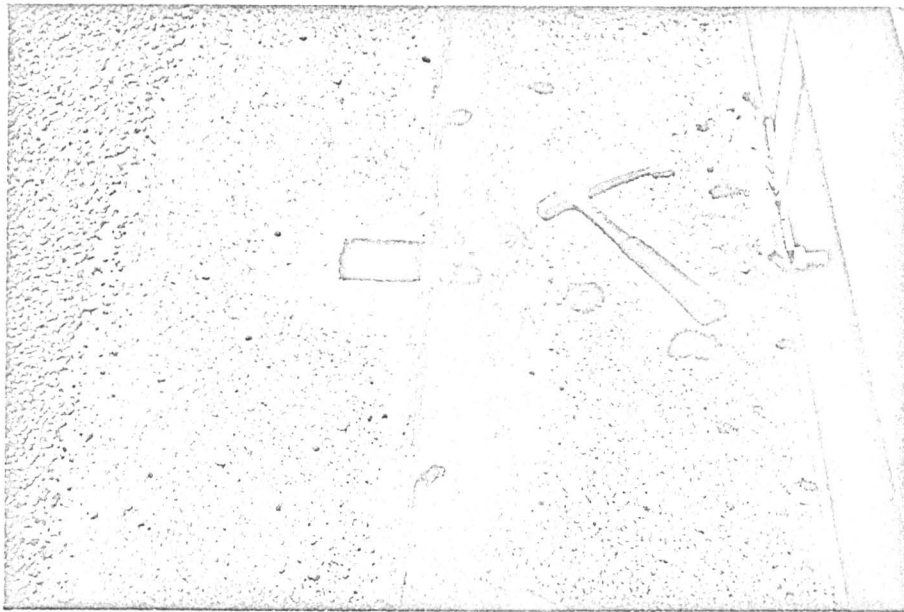
Figure 24. Pyrite popouts along bridge curbing.

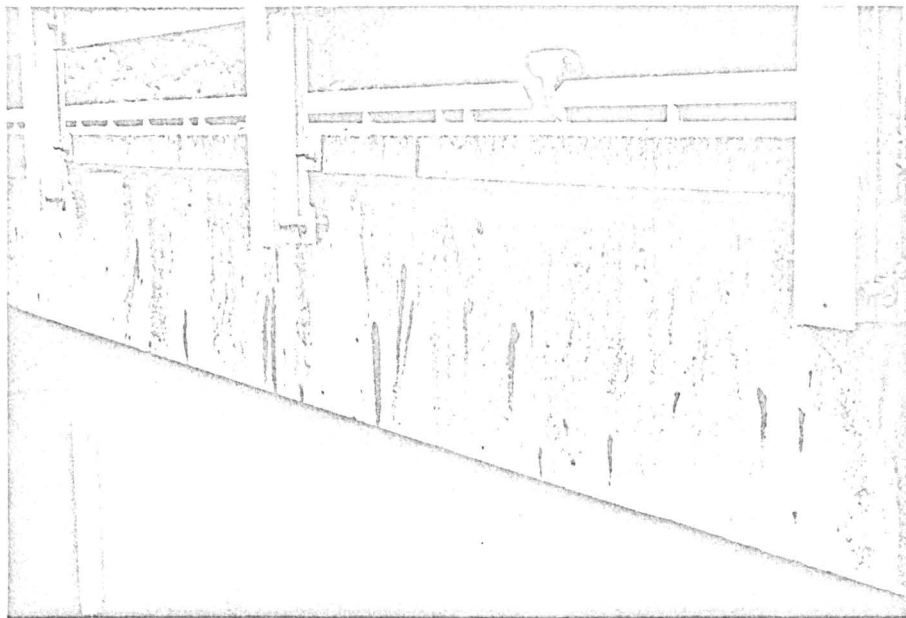
Figure 25. Popouts and staining on bridge side.

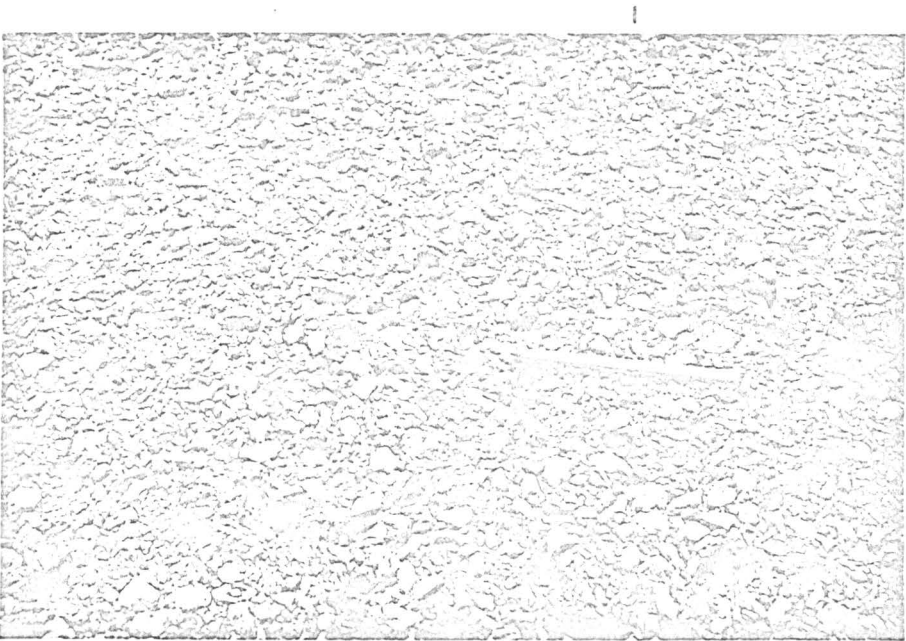
Figure 31. Close-up of surface showing popouts.

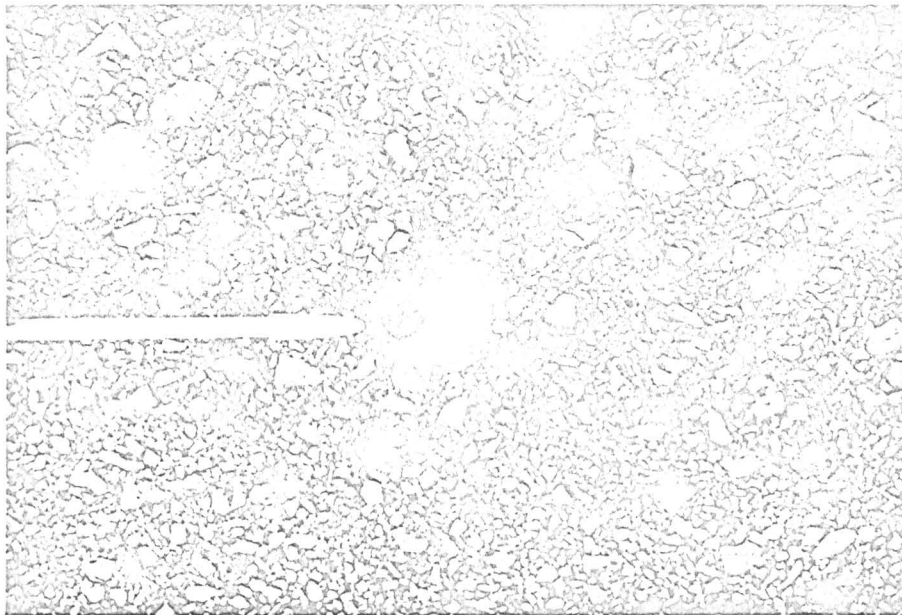
Figure 33. Close-up of pyrite staining and popout.

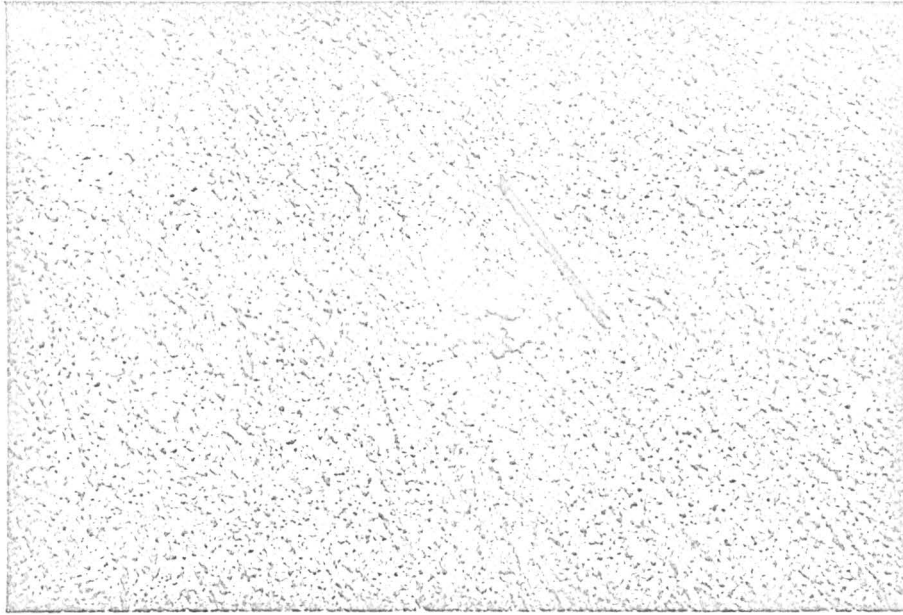
Figure 36. Bridge deck with initial stages of pyrite-popout developing.

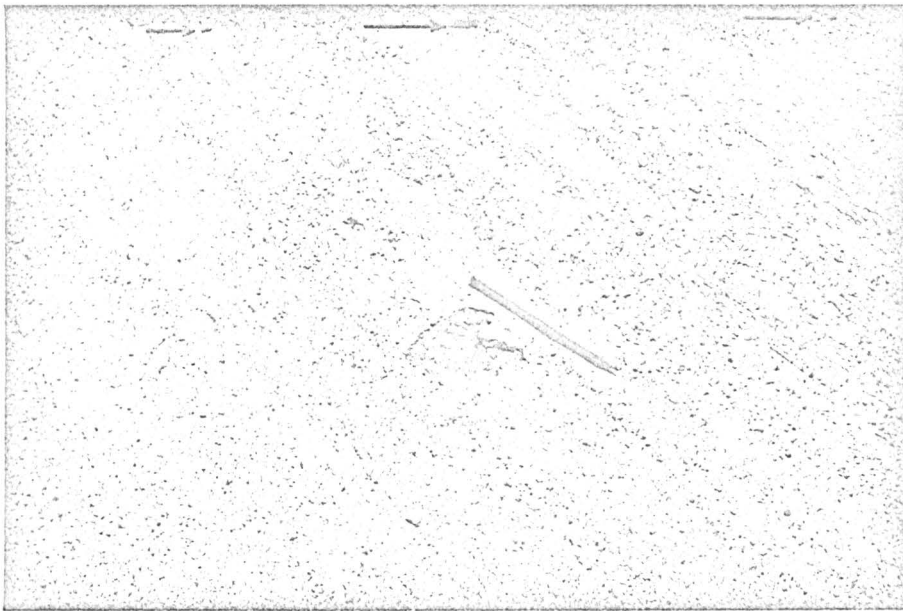
Figure 37. Bridge deck with more advanced stage of pyrite-popout.
Other reactive areas are indicated.

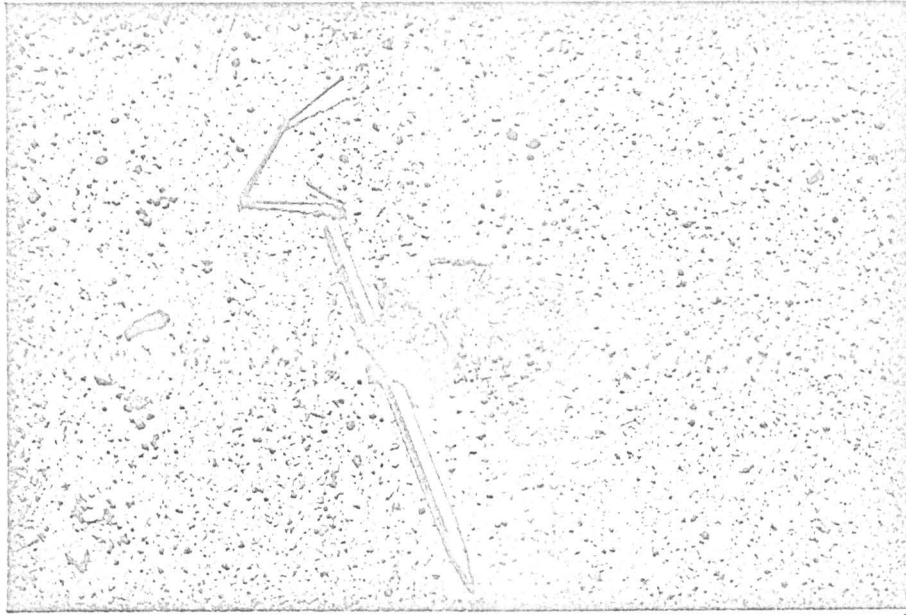
Figure 38. Pyrite popout in bridge deck showing reaction rings around pyrite nodule and characteristic stain.

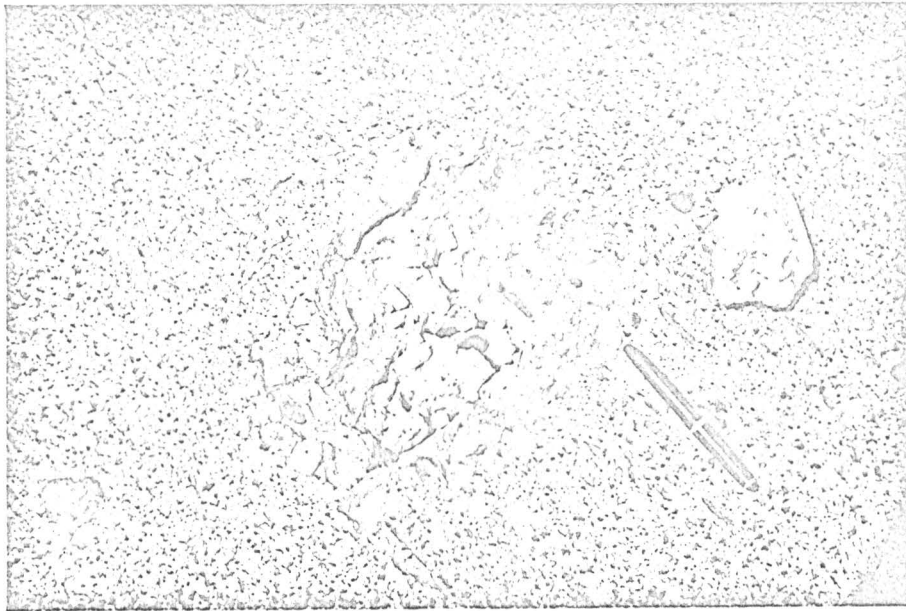
Figure 39. Large bridge-deck failure exposing rebar; the coarse aggregate shows the characteristic pale blue-gray color of the sandstone.

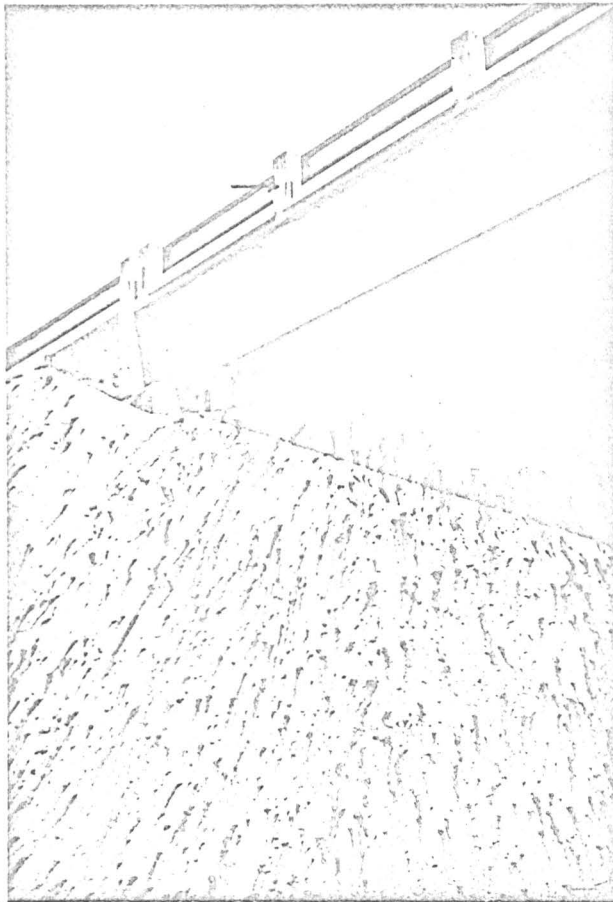
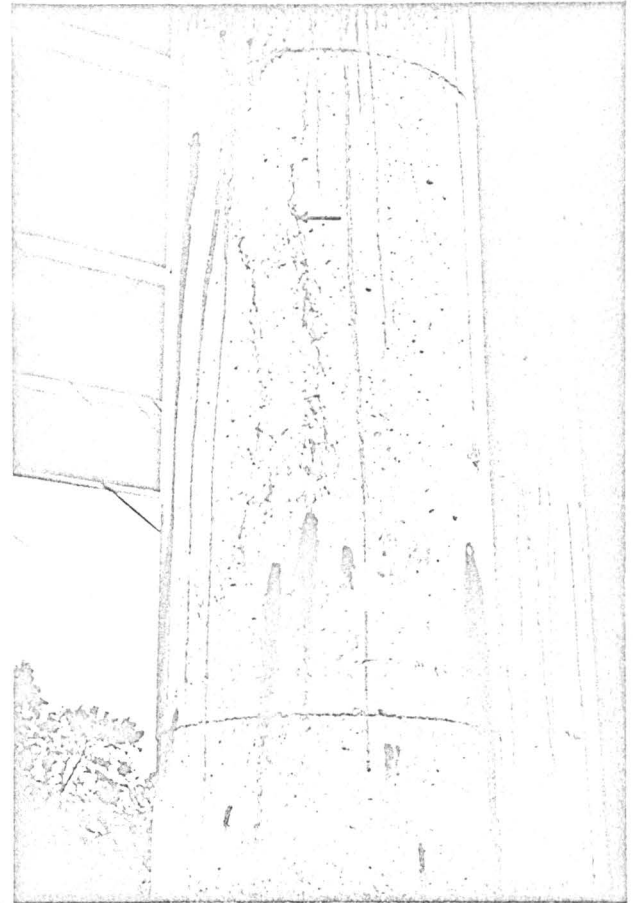
Extensive popout and staining on riprap area, guard-rail post, bents, and underdecking. Note cracking in columns.

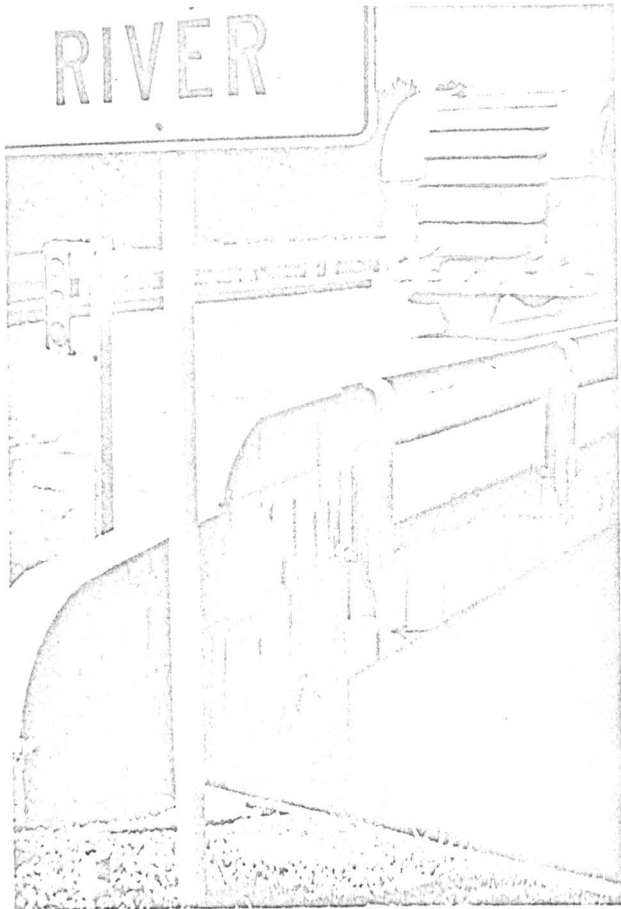
Figure 42. Reactive areas on side of bridge and on deck. Below is close-up of indicated popout.

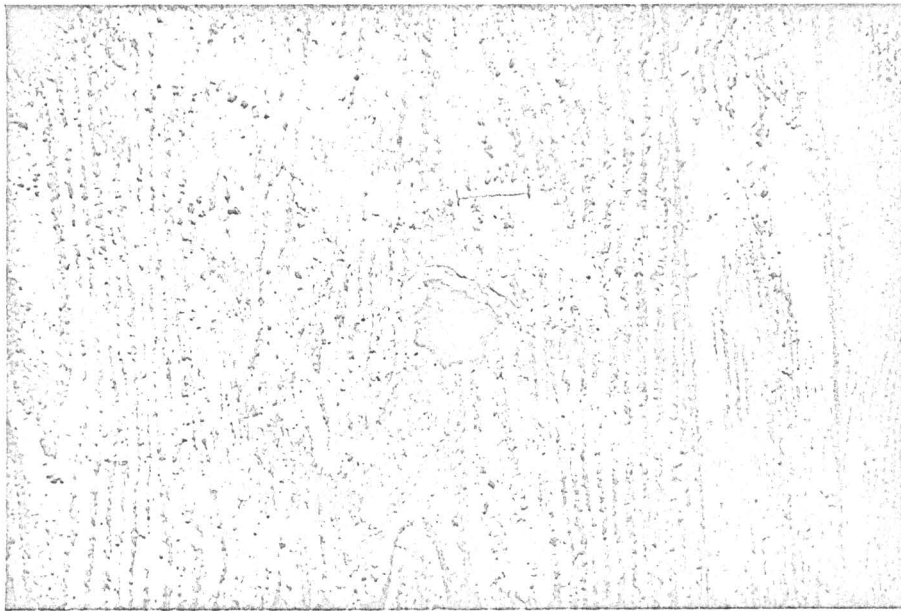
Figure 47. Close-up of lignite popout on underside of IH 45 structure not yet open to traffic.

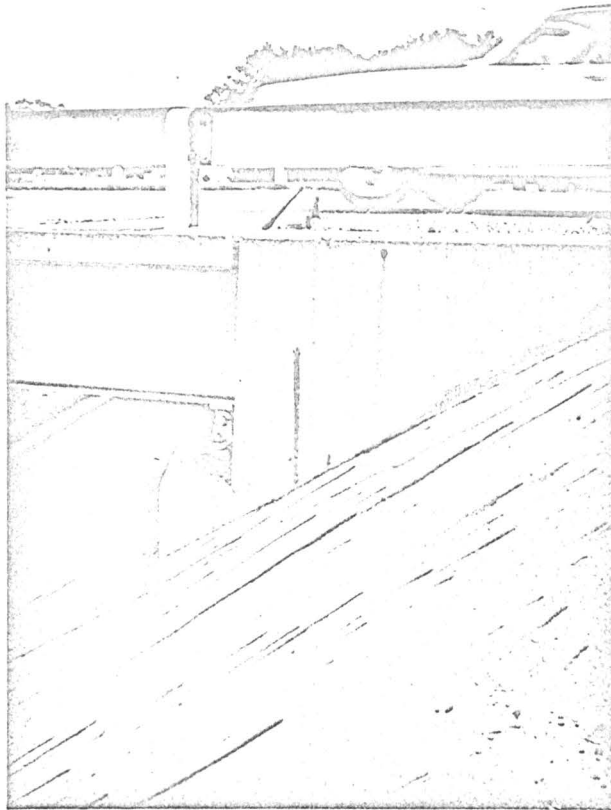
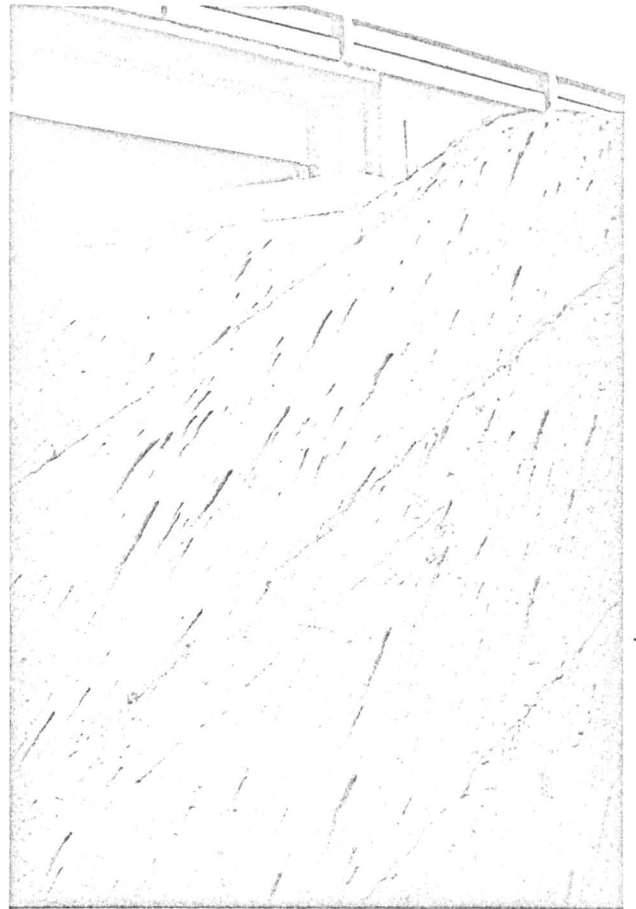
Reactive areas on IH 20 overpass that's been open to traffic about four years.

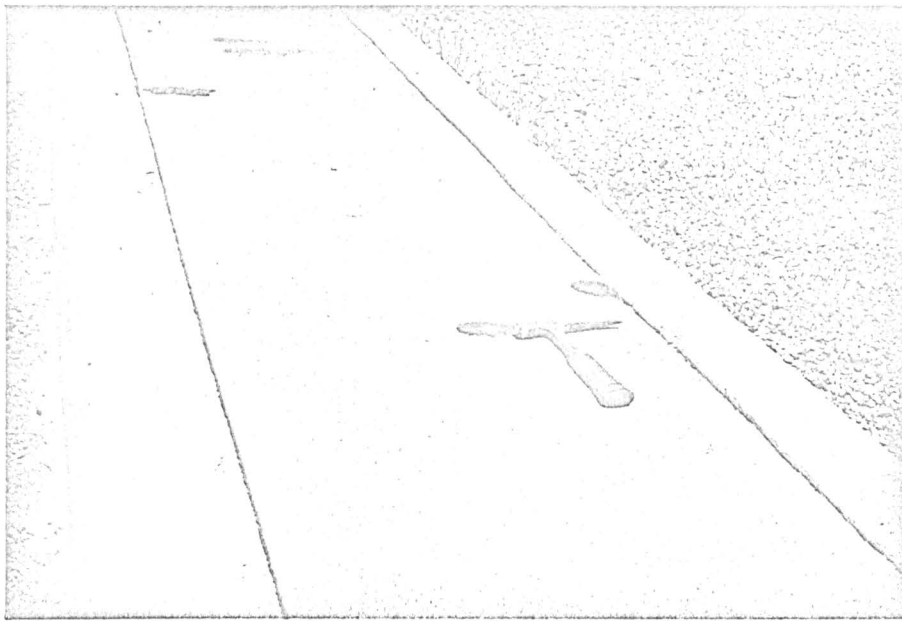
Figure 52. Pyrite popouts and staining of intersection median.

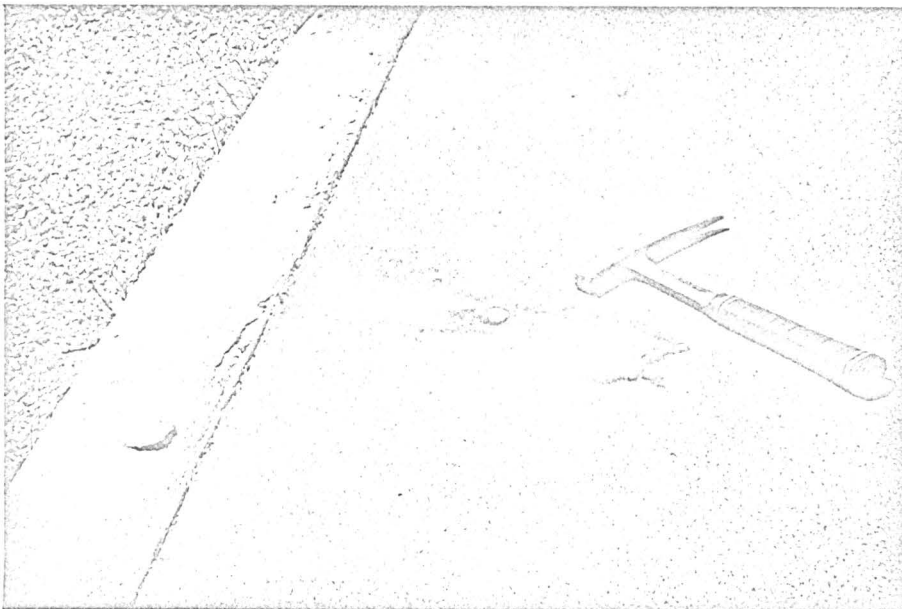
Figure 53. Close-up of pyrite popouts.
Note popout occurring under painted surface.
