Water Intrusion in Base/Subgrade Materials at Bridge Ends: Final Report

Department of Civil Engineering
Texas Tech University

Texas Department of Transportation

Report No. 0-5096-1

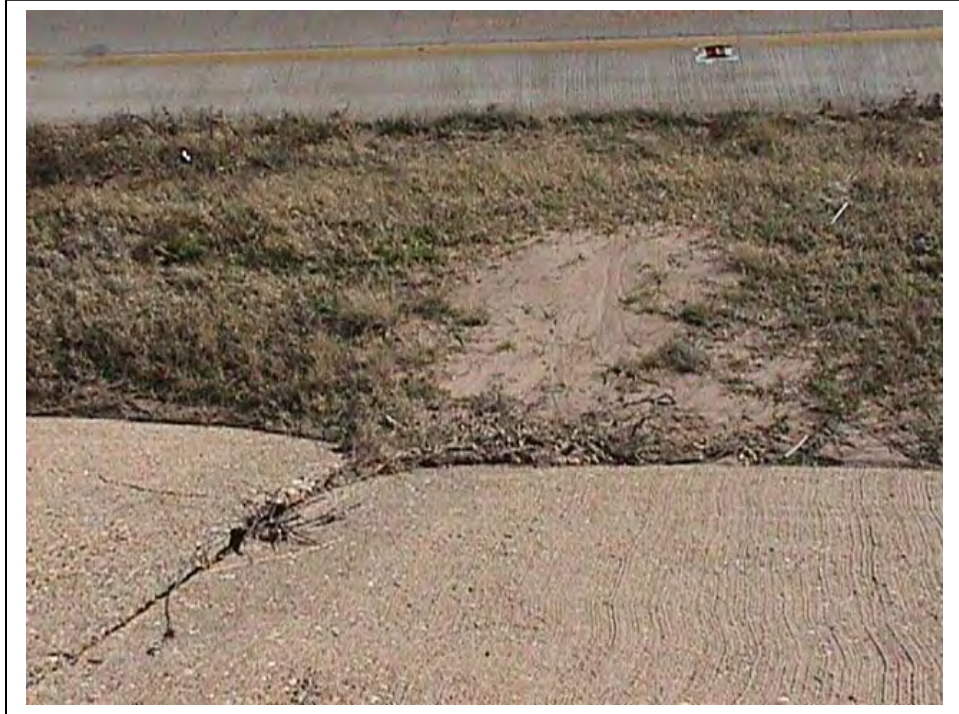
Figure 4.2 Top View of Riprap with Washed-Out Fines at Toe

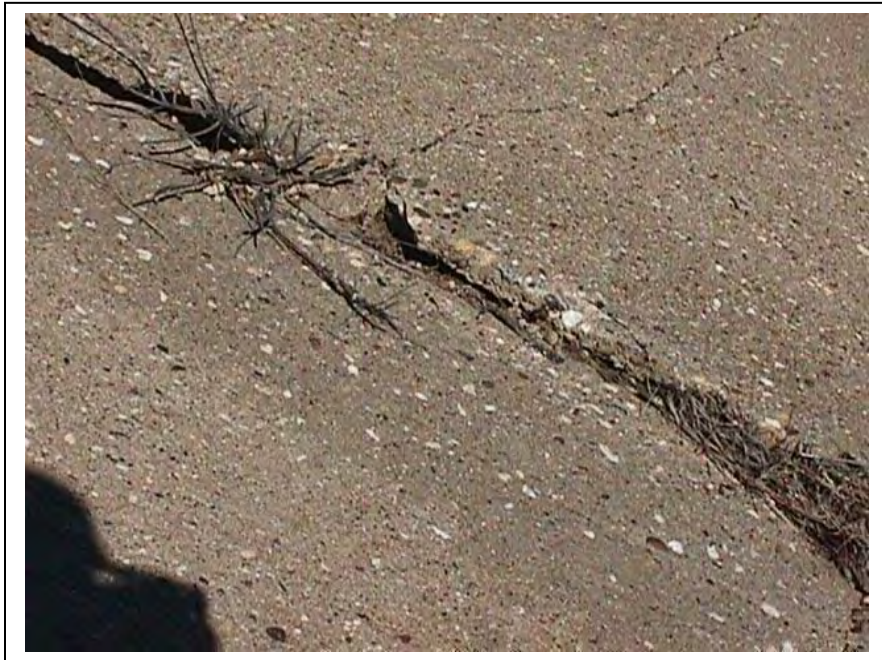
Figure 4.3 Damaged Joint in Riprap Slab

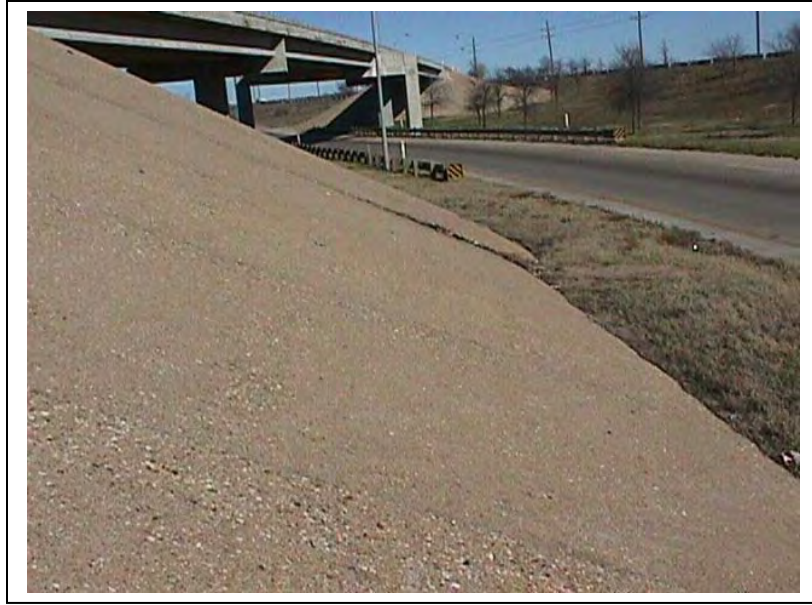
Figure 4.4 Differential Settlement of Riprap Slab (Side View)

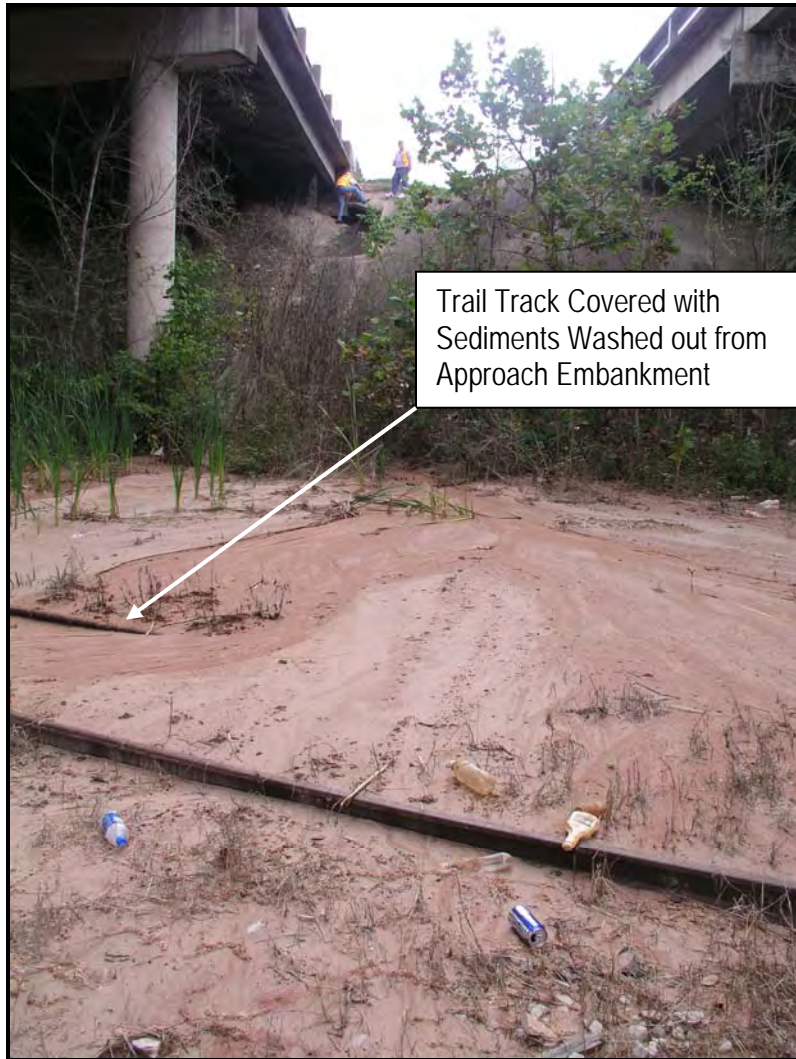
Figure 5.1 Extensive Erosion at Business 69 Overpass over Southern Pacific Railroad in Lufkin District

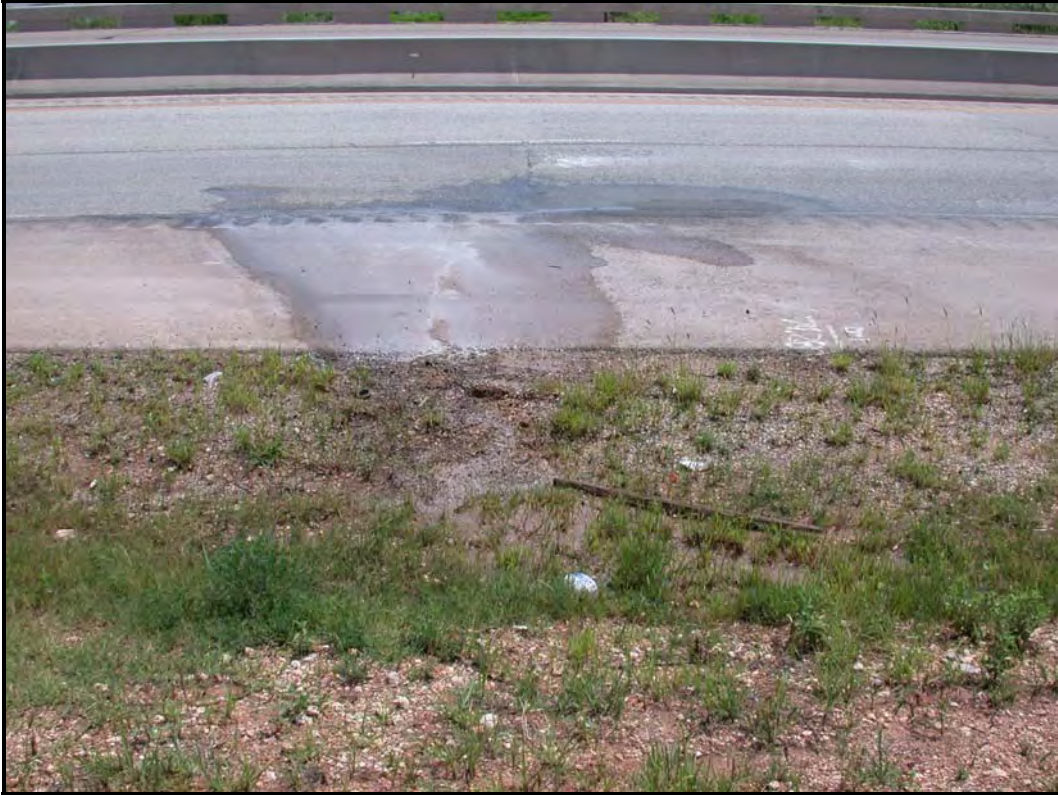
- c) *Evidence of Water Seepage:* Sometimes, water seepage can be seen although there are no signs of material loss accompanying it. Once again, this is a clear indication that there is a water intrusion problem that must be addressed during repair of the bridge approach. These conditions were found in the US-83 Overpass

Figure 5.3 Water Seepage at the US-83 Overpass Bridge Departure over Antilley Road in Abilene District

- A detailed design of a repair and installation of a under drain should be accomplished for the US 83 overpass of Antilley Road in Abilene. The under drain design should be similar to the detail provided by the Tyler district.

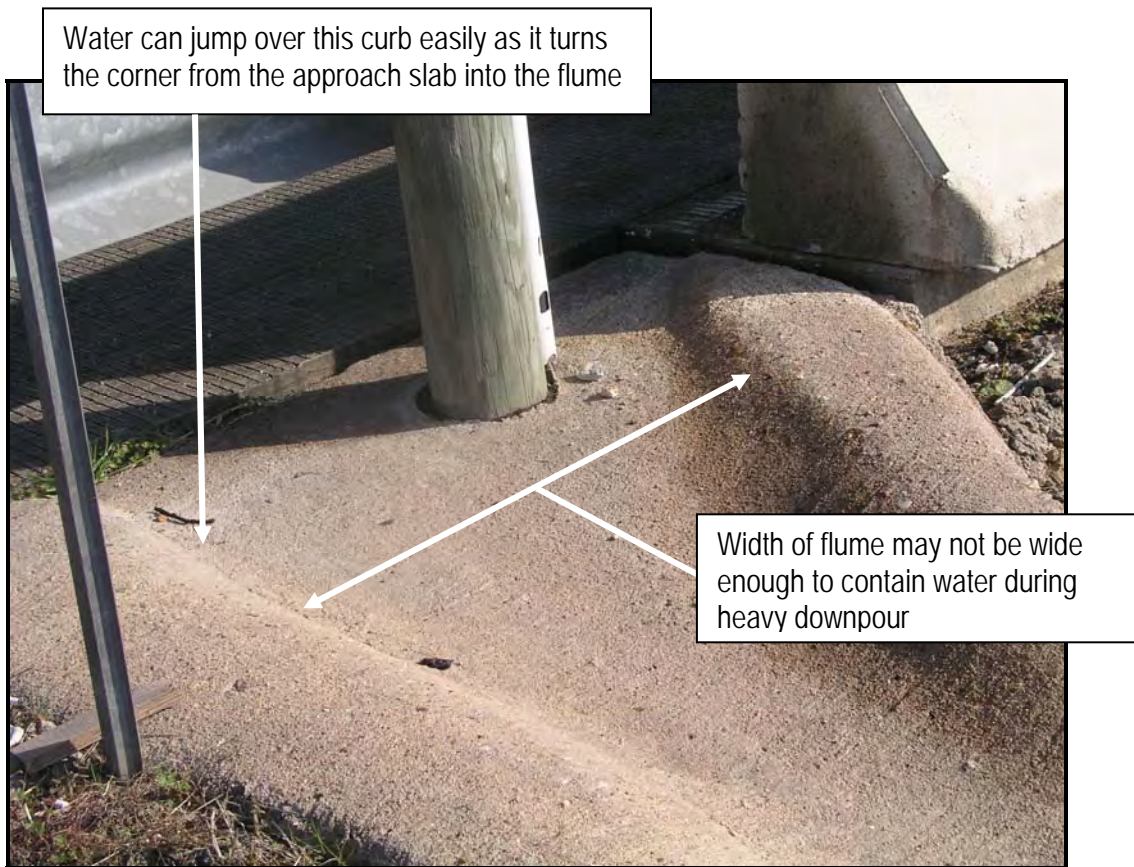
Figure 5.4 Drainage Flume at the Bridge End (Houston District)

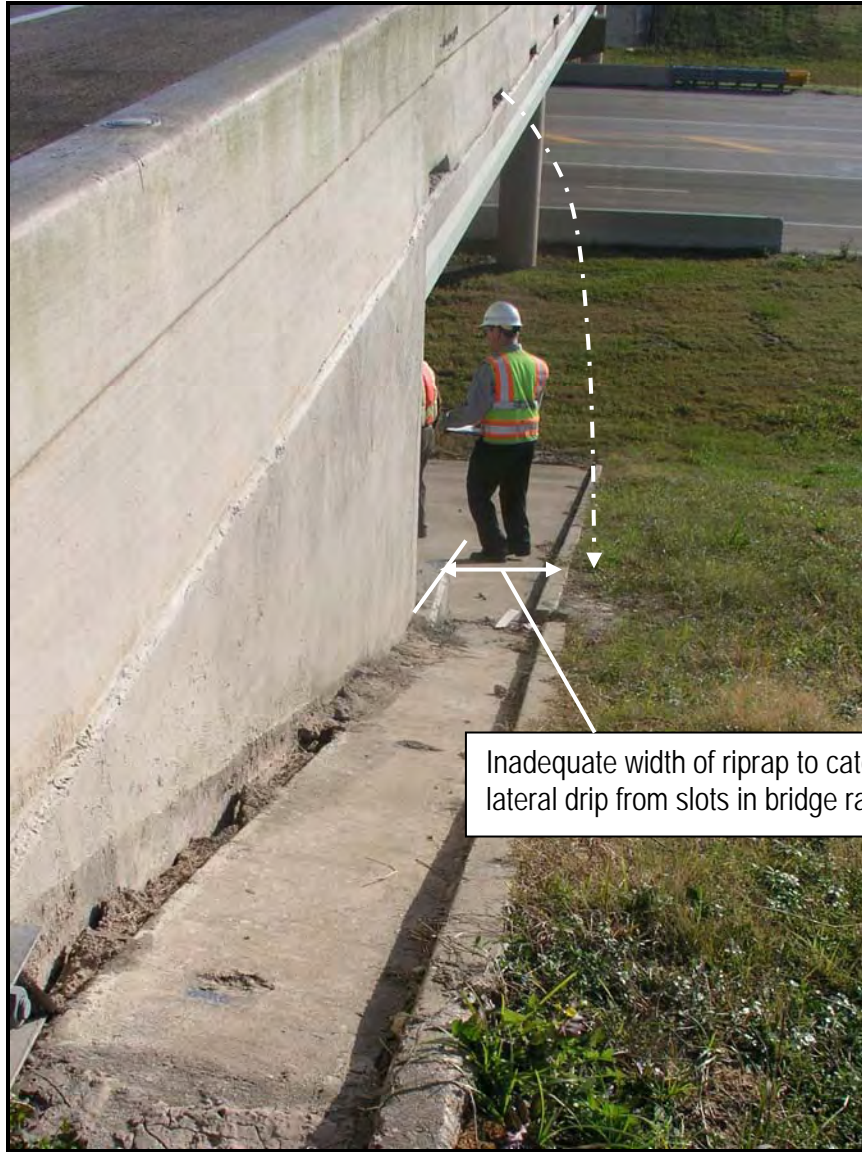
Figure 5.5 Inadequate Riprap Width (Houston District)

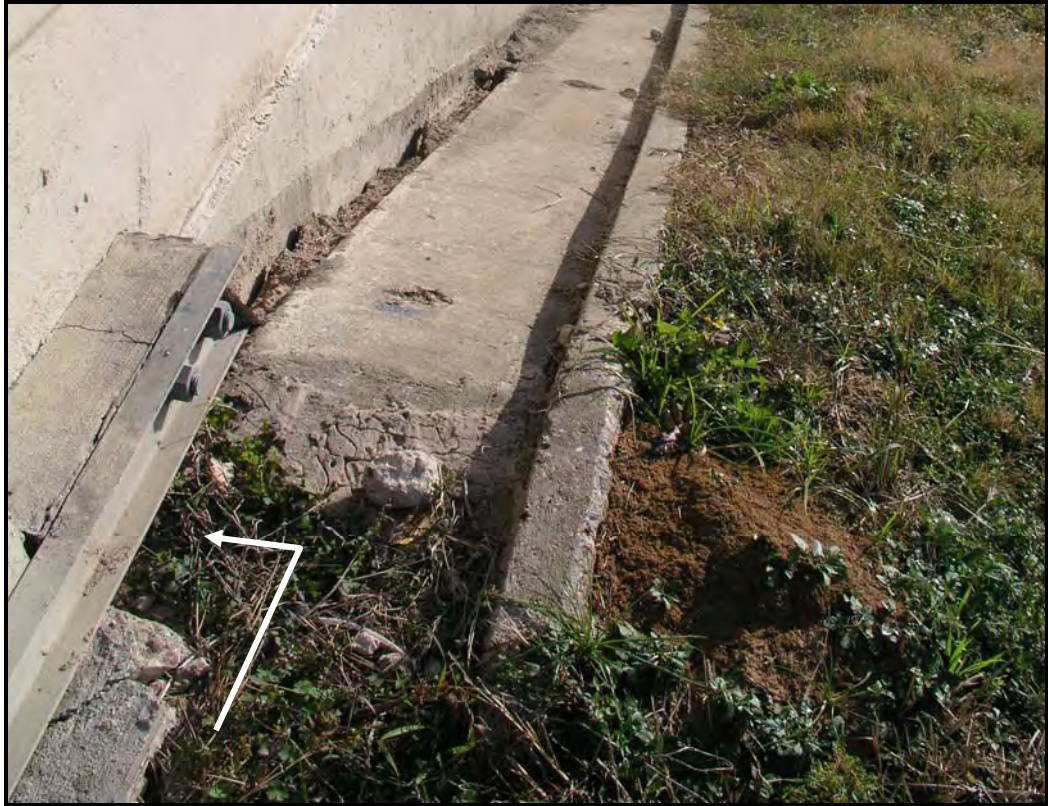
Figure 5.6 Badly Damaged Drainage Flume Allowing Water to Flow Underneath Approach Slab

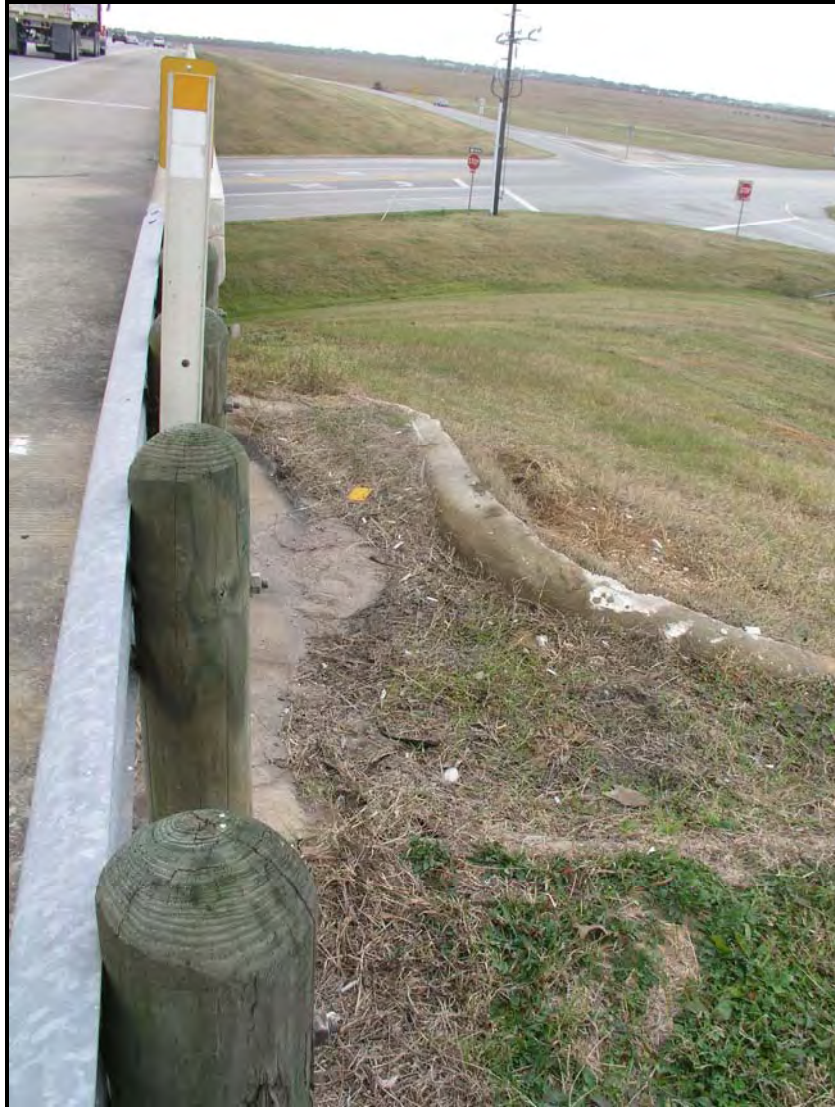
Figure 5.7 Effectiveness of Drainage Flume Impaired by Weeds and Debris Collection

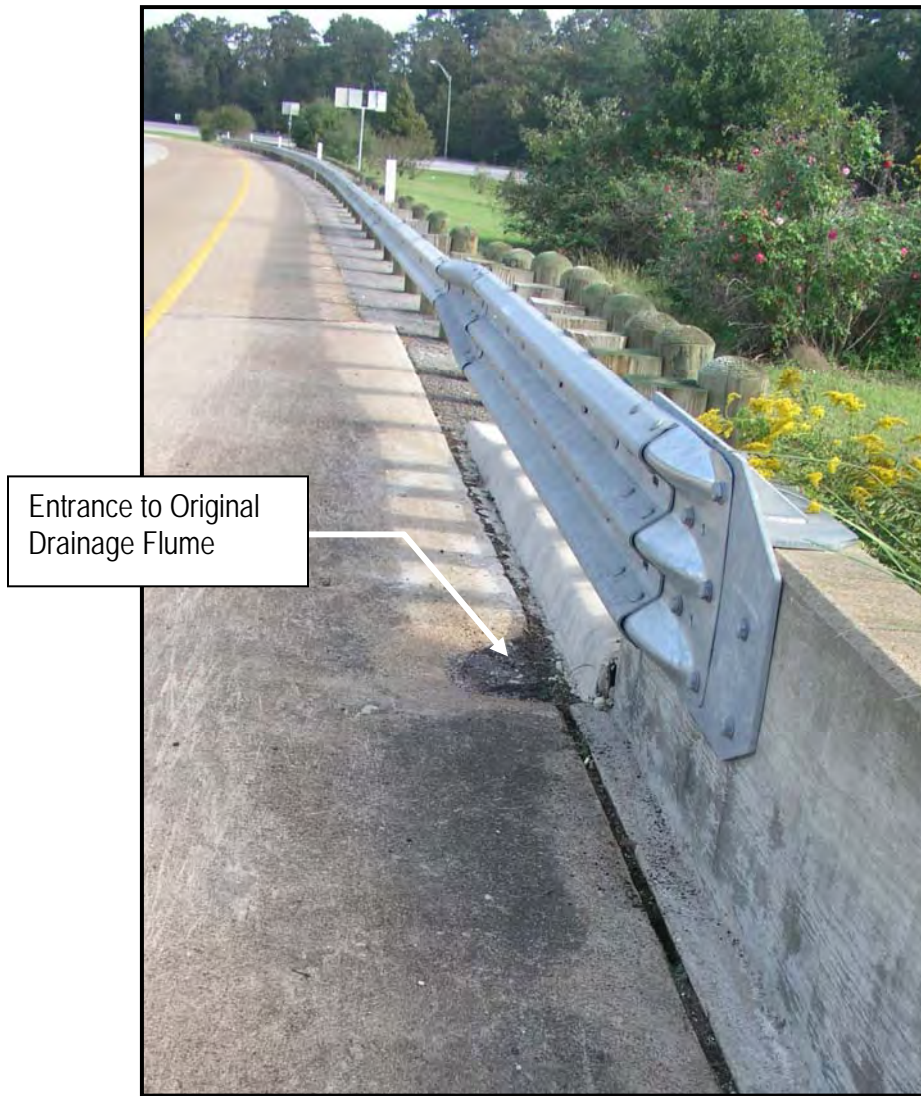
Figure 5.8 Entrance to Original Drainage Flume Blocked by the Installation of the Monocurb in the New Thrie Beam Guardrail System

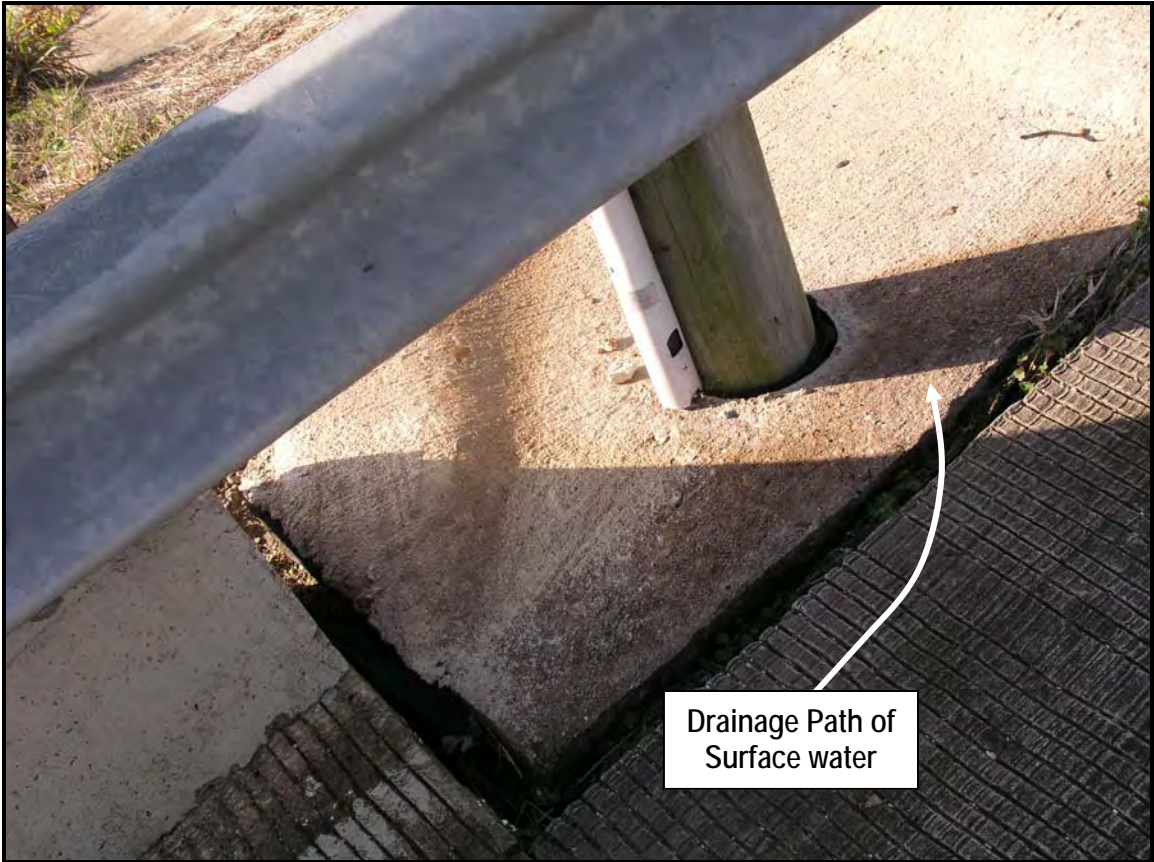
Figure 5.11 Open Joint between Approach Slab and Mow Strip

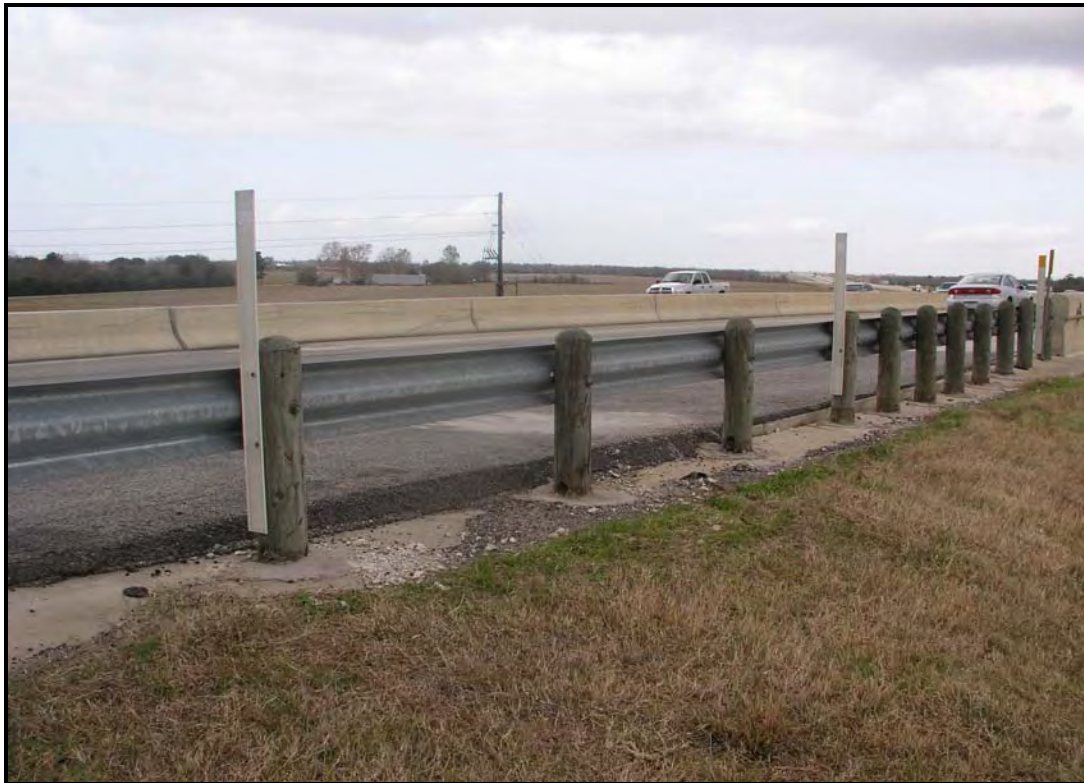
Figure 5.16 Multiple Overlays Used to Remedy Bridge End Settlement
