TEXAS TECH UNIVERSITY

Implementing the Ultra-High Pressure Water Cutter for Roadway Maintenance Applications: Interim Report

Report #: 5-5230-01-1
www.techmrt.ttu.edu/reports.php

June 2012

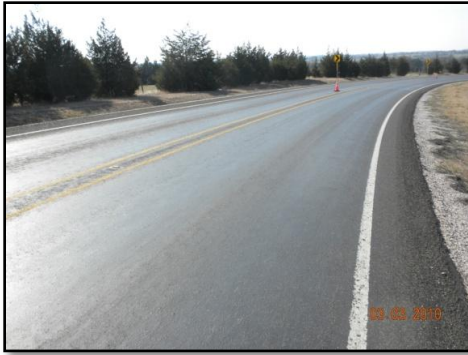
(a) FM 2562, Grimes County

As can be seen in Figure 1.3, the section of FM 2562 selected for treatment was very heavily flushed. The contractor made five passes with the UHP water cutter, varying the rate of advance to accomplish different degrees of asphalt removal. One finding of the demonstration was that Rampart's technology is actually superior, or more advanced, than the New Zealand/Australia technology. Rampart's UHP water cutter truck uses a *fixed* deck blaster rather than an umbilical-mounted deck blaster, eliminating the need to have a person walk behind the truck and operate the unit. Further, Rampart's truck relies on a hydrodynamic transmission to better control the rate of advance of the water cutter unit. The result is improved control of the asphalt surface treatment, and a safer maintenance process.

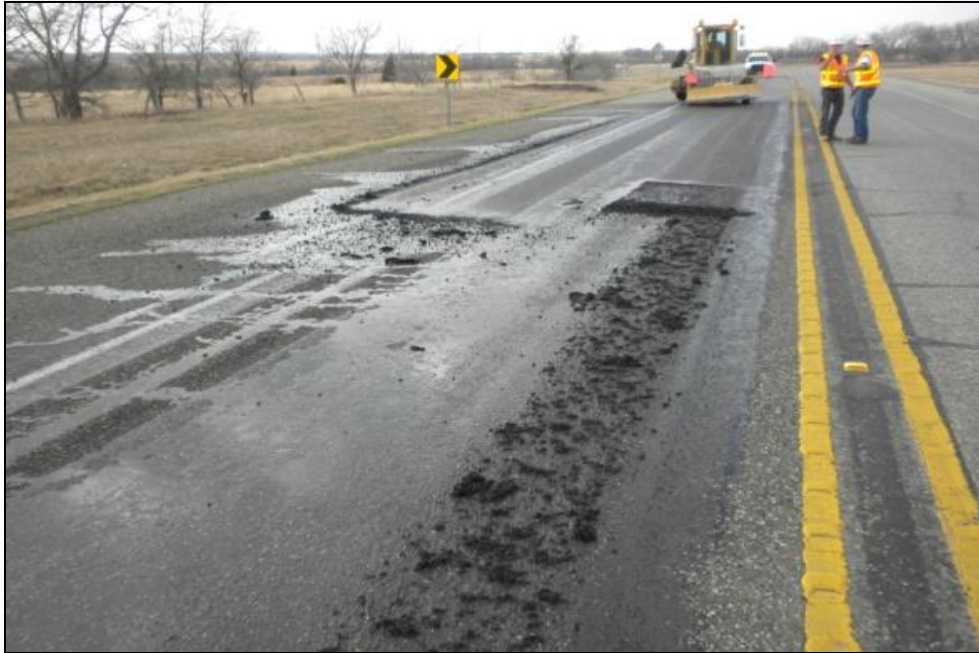
Figure 4.5 illustrates some situations we observed during the treatment process. The UHP water cutter removes a significant amount of excess asphalt material from the pavement surface. The actual quantity removed will depend on the travel speed, rotational speed of the spray bar, the nozzle configuration in the bar, extent of flushing on the road and the asphalt and aggregate material characteristics. Figure 4.5 (a) shows the removed asphalt left on the road when the vacuum system is not operating. Under conditions that can be labeled as "typical," the vacuum system in the machine is capable of sucking up all the material. Typical conditions would mean desirably cool temperatures and modified binders. However, there can be situations where the vacuum system is unable to remove all the cut asphalt as shown in Figure 4.5 (b). Figure 4.5(c) shows a power broom following the water cutter to ensure that all material is removed from the roadway before traffic is allowed back.

Figure 4.5(d) also illustrates a phenomenon where the treatment process may leave a sharp shallow drop along the edge of the treated strip. This drop is not deep enough to cause traffic to lose control if caught on the edge. This issue can be alleviated by changing the nozzle configuration to gradually taper-off the treatment depth towards the outside of the treated strip. Another outcome that is influenced by the nozzle configuration is not having sufficient nozzle coverage in a certain part of the treatment trip. Figure 4.5(e) shows a narrow strip along the center of the treated strip where all excess asphalt was not removed. This results in a lightly-scored pattern on the surface.

FIGURE 4.5. Flushed asphalt removed from the treatment operation left on the road when vacuum suction pump was turned off

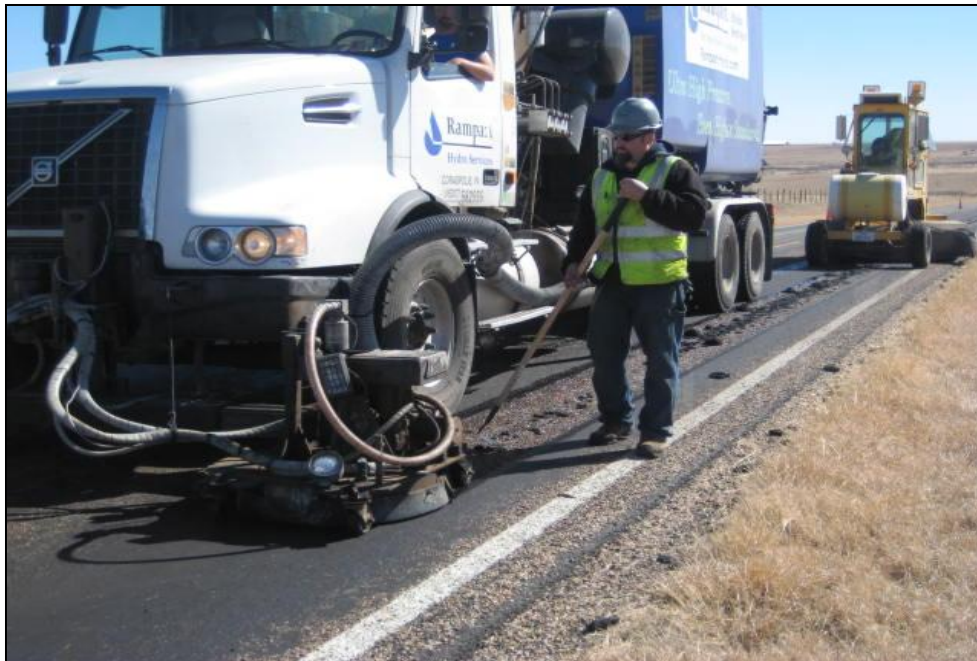
FIGURE 4.10. Maintenance worker using a shovel to remove excess lumps of asphalt

Figure 4.10 shows treatment of a pavement surface that was heavily flushed. When this section was being treated, the removed asphalt was found to be very sticky and was forming into balls of asphalt that were clogging the vacuum system. This picture shows a maintenance worker pulling out the asphalt lumps not picked up by the vacuum system to make sure they do not get pressed back on to the treated area of the roadway. This section of road had excessive flushing, and the asphalt used was unmodified AC-10. In this case, the stickiness of the asphalt arose in part because the binder was too soft at the working temperature. The binder type and grade is also an important consideration when planning water cutter treatment activities.

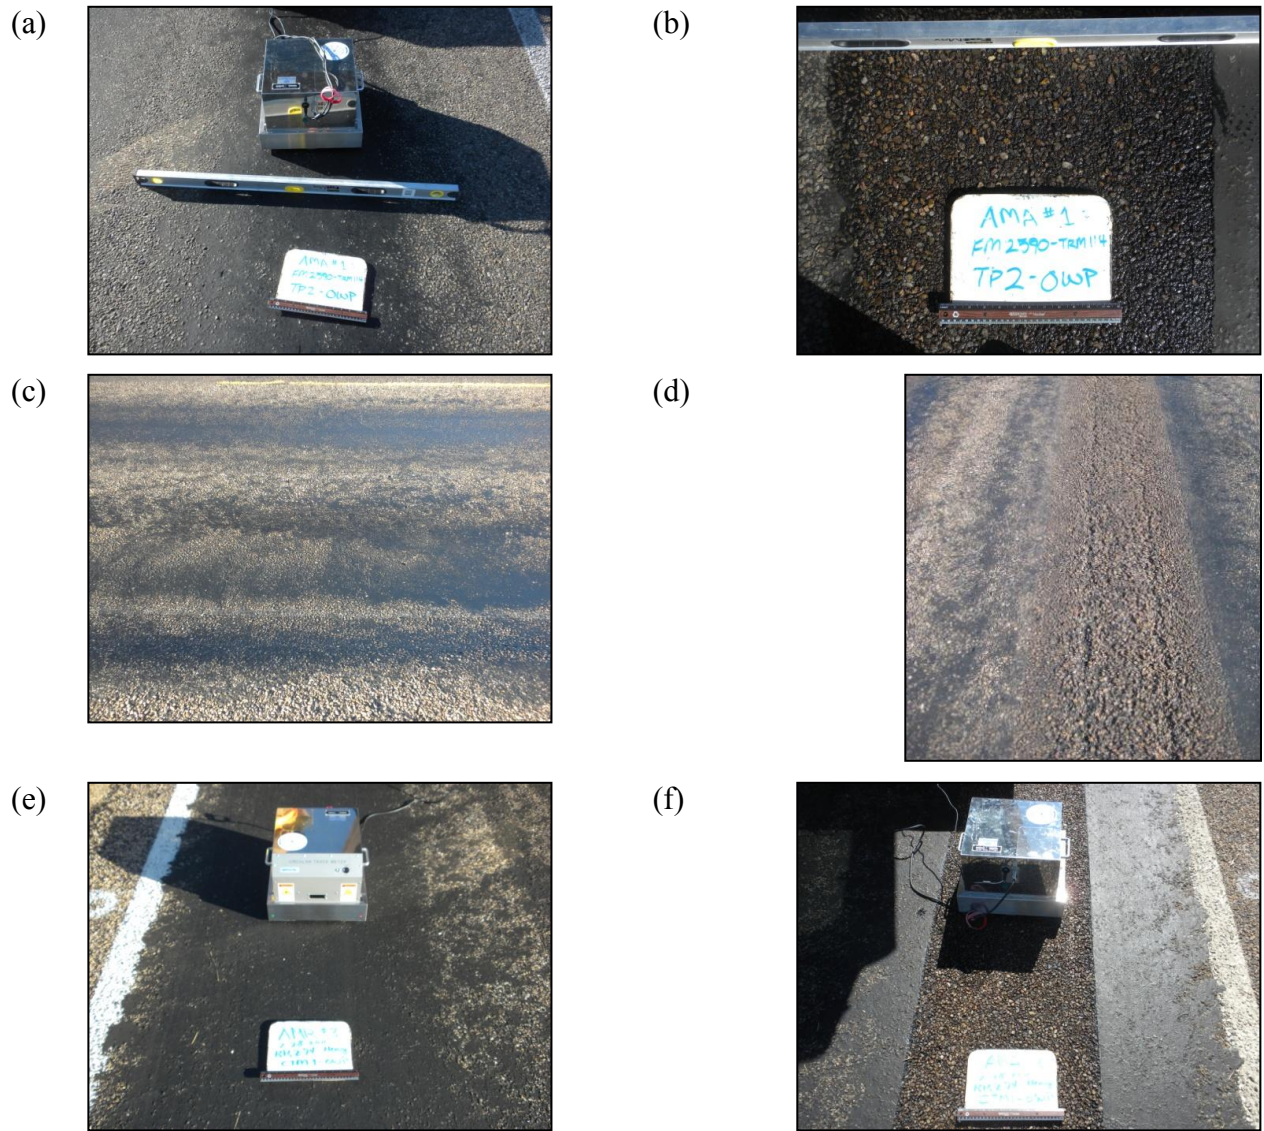
Snapshots of Amarillo test sections before and after treatment are shown in Figure 4.11. The first section (AMA1) was located near the city of Canyon and had a high ADT. AC20-5TR and siliceous aggregate was used in this section, and was part of a highway that has experienced significant flushing since its surfacing in 2008. Many maintenance treatments have been tried to correct its flushing with little long-term success. The second and third Amarillo District test sections were in rural settings and used unmodified AC 10 binder. AMA2 has significant truck traffic from aggregate pits in the area and AMA3 has very little traffic of any kind. The degree of flushing in AMA3 was extensive. Treatment of AMA1 was very successful. An alternate nozzle configuration was tried in AMA2, with the two larger (0.013”) nozzles placed in the interior of the spray bar and the smaller 0.009” nozzles moved to the outside. This caused raveling in the middle of the treatment strip as shown in Figure 4.11(d). AMA3 treatment was difficult due to soft binder clogging the vacuum system. An additional maintenance worker had to pull the balled asphalt away from underneath the machine to prevent the removed asphalt from being pressed back into the roadway by the tires.

FIGURE 4.11. Test pavement pictures from Amarillo District (a) AMA1 before treatment; (b) AMA1 soon after treatment; (c) AMA2 before treatment; (d) AMA2 soon after treatment; (e) AMA3 before treatment; (f) AMA3 soon after treatment

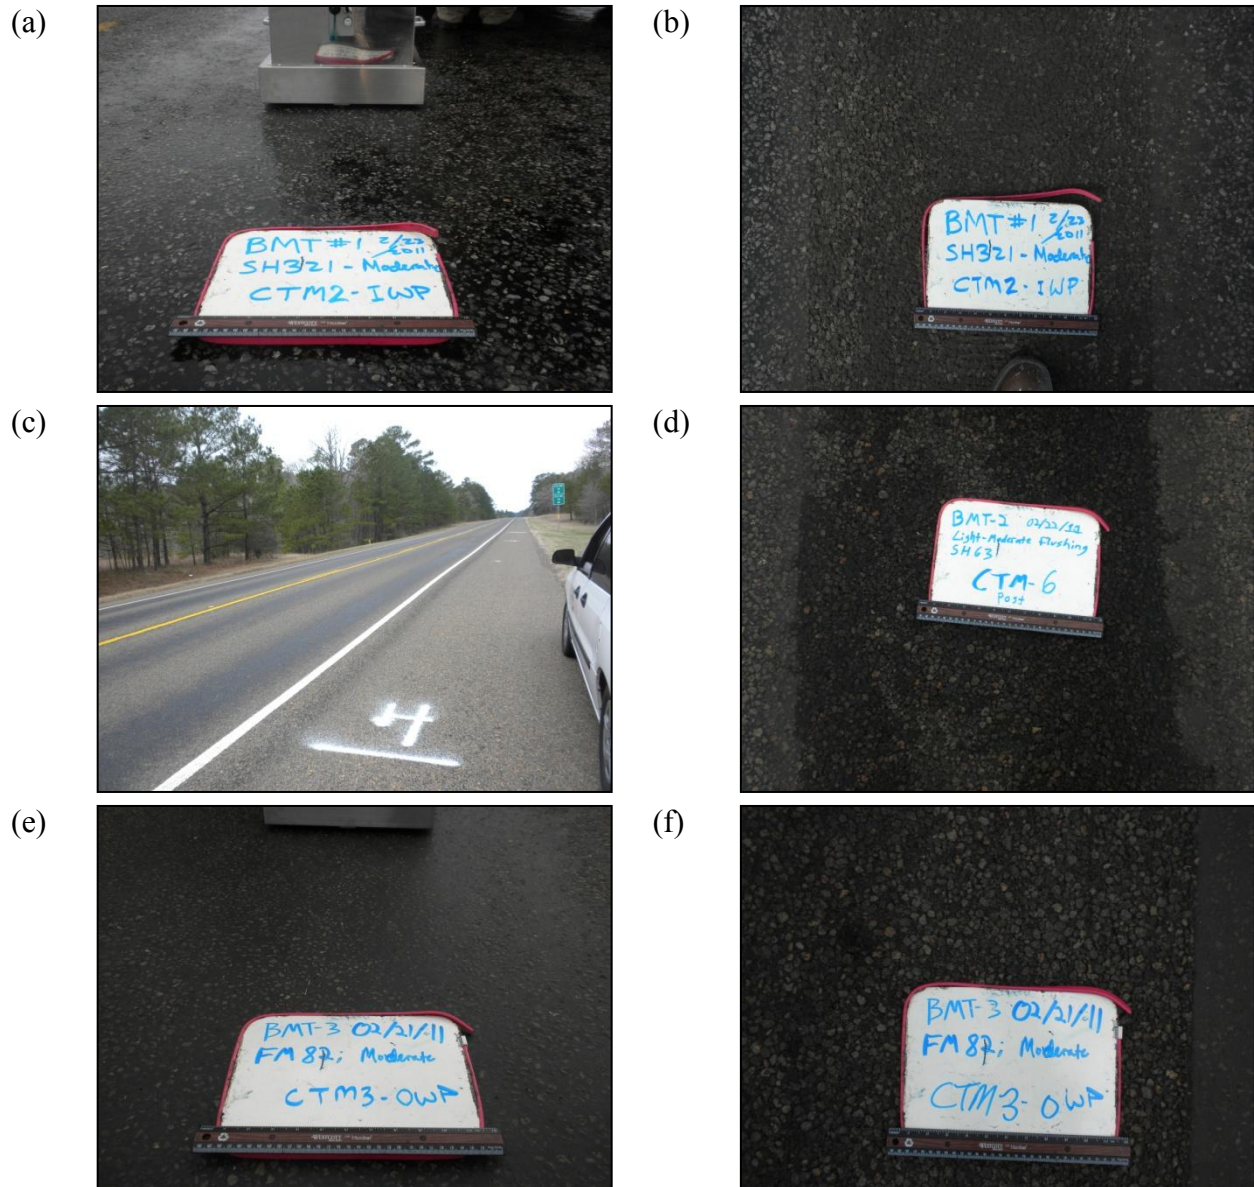
Snapshots of Beaumont test sections before and after treatment are shown in Figure 4.12. The first of the three Beaumont sections (BMT1) was located near the city of Cleveland and had high traffic including a significant level of trucks. The last surfacing on this section in 2008 used AC20-5TR and limestone aggregate. BMT2 was a rural section in a wooded area and carried some logging truck traffic. BMT3 was near the city of Kirbyville and had a low ADT. BMT2 and BMT3 used CRS-2P emulsion binder with lightweight aggregate. Treatment of these three sections was successful. There was some difficulty in getting the BMT2 section dry after the treatment to conduct the post-treatment CTM test.

FIGURE 4.12. Test pavement pictures from Beaumont District (a) BMT1 before treatment; (b) BMT1 soon after treatment; (c) BMT2 before treatment; (d) BMT2 soon after treatment; (e) BMT3 before treatment; (f) BMT3 soon after treatment

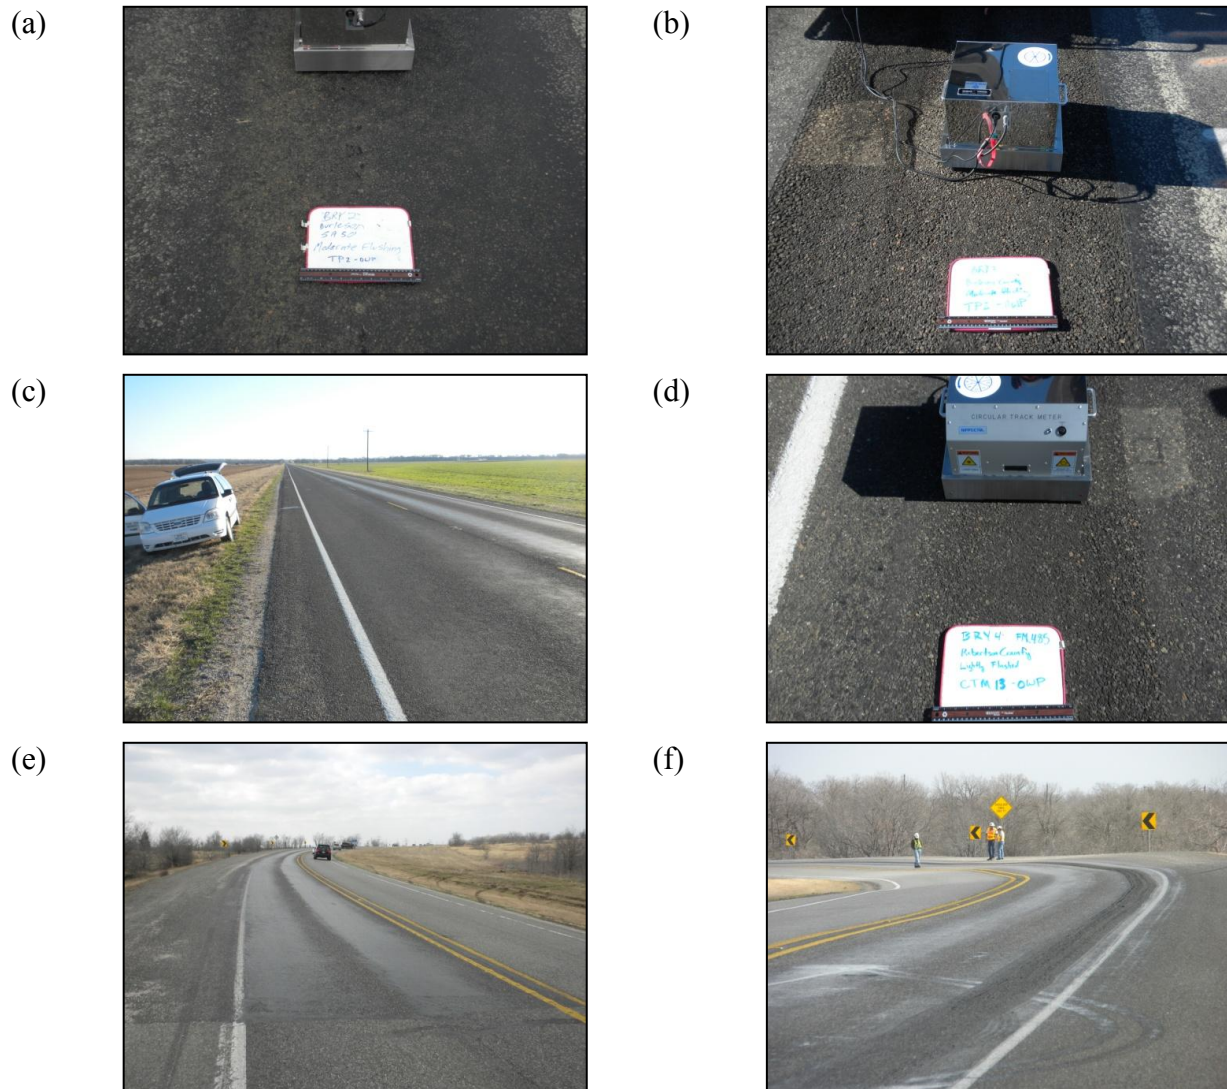
Snapshots of three of the five Bryan District asphalt test sections before and after treatment are shown in Figure 4.13. The first section (BRY2) was located next to cotton fields and had some truck traffic. This section used AC 20-5TR binder and limestone asphalt rock (LRA) aggregate. The treatment process included a 20-nozzle spray bar and the treatment appeared to work reasonably well. It was observed that a dark gray powder was left on the treated area. It was the opinion of the TxDOT personnel that the powder might have come from the LRA aggregate.

Prior to the second installment of treatment in BRY5, a decision was made to change the spray bar configuration to include 28 nozzles to produce a more uniform treatment.

FIGURE 4.13. Test pavement pictures from Bryan District (a) BRY2 before treatment; (b) BRY2 soon after treatment; (c) BRY4 before treatment; (d) BRY4 soon after treatment; (e) BRY5 before treatment; (f) BRY5 soon after treatment

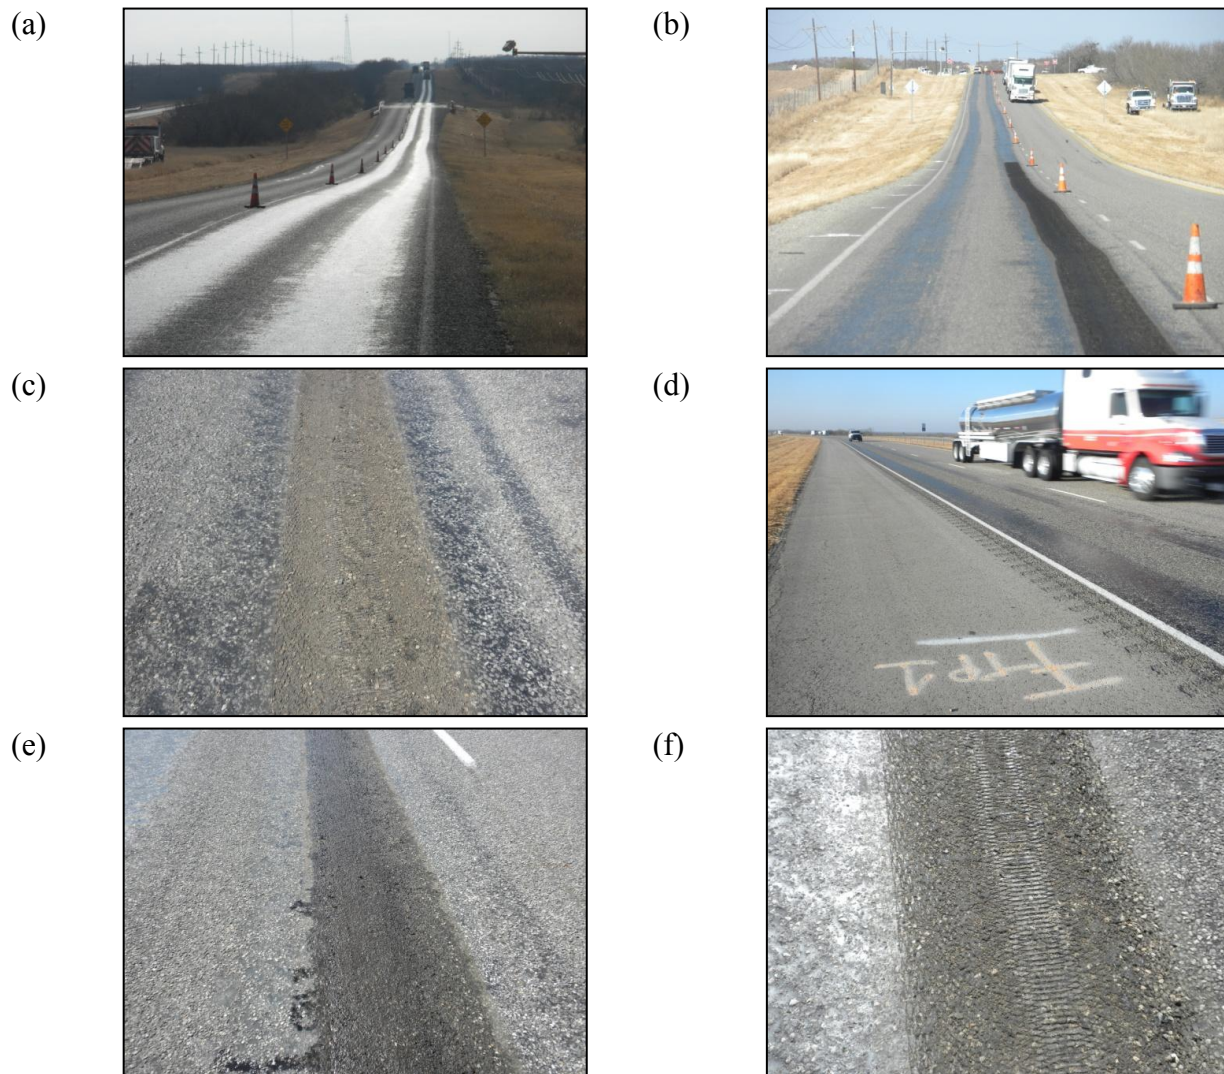
The two test projects in the Laredo District both had two lanes in each travel direction. Figure 4.14 illustrates the test project and its “before and after” treatment images. The section LRD2 was near a warehouse area and the outside lane of this roadway, as shown in Figure 4.14(a), was heavily flushed. The treatment in this section was not very successful, perhaps because the aggregate used in this section was a weak and dusty limestone, and it left residue on the roadway that stained the treated area [see Figure 4.14(c)]. On the other hand, the water cutter spray bar was operating at a lower rotational speed in the two Laredo sections, and that contributed to the zig-zag effect along the middle of the treated area. The second test section in Laredo (LRD3) was on IH-30 and had a very high level of truck traffic as well. The materials used on this surface were similar to LRD 2, and the observations were similar in nature.

FIGURE 4.14. Test pavement pictures from Laredo District (a) LRD2 before treatment; (b) LRD2 soon after treatment; (c) LRD2 close-up view soon after treatment; (d) LRD3 before treatment; (e) LRD3 soon after treatment; (f) LRD3 close-up view soon after treatment

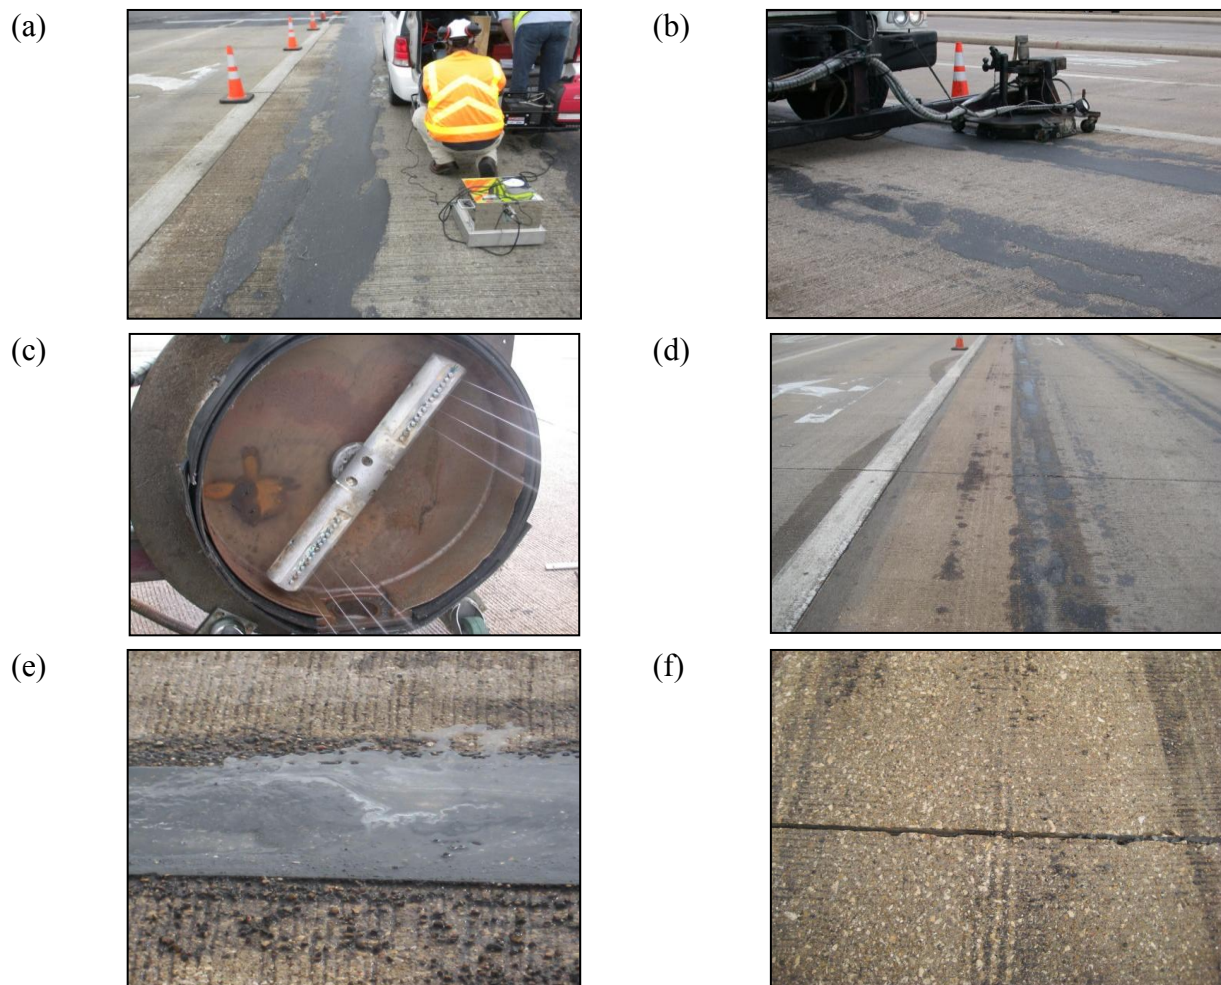
A jointed rigid pavement section was included in the Bryan District treatment program. The objective was to assess the feasibility of the UHP water cutter to remove up to 7mm of tracked asphalt from the tined concrete surface, and Figure 4.15 illustrates the work done at this section. Figure 4.15(a) and (b) show the extent of tracking on the wheelpaths. An 8-nozzle spray bar configuration, shown in Figure 4.15(c), was used for this purpose. Figures 4.15(d) and (e) illustrate that more than one pass of the treatment head was needed to remove the tracked asphalt, and in the thickest areas, it took up to four or five passes to remove all the asphalt. The removal process was particularly difficult because of the transverse tines in the concrete pavement. In the end, the section was successfully cleaned. Once the water cutter operators had more understanding of the extent of tracking and of the concrete surface, adjustments were made to the travel speed of the truck and the rotational speed of the spray bar to remove the asphalt in two passes. The treatment using multiple passes did create some minor spalling at the joints of the concrete pavement and also removed some of the joint sealant material in the treatment area.

FIGURE 4.15. Test pavement pictures from Bryan District concrete pavement section where tracked asphalt was removed using UHP water cutter (a) tracked asphalt on inside wheel path; (b) removal of tracked asphalt using UHP water cutter; (c) 8-nozzle configuration used in spray

bar; (d) inside wheel path after several passes of UHP water cutter; (e) close-up view of treated area; (f) some joint damage (slight spalling) due to water cutter treatment
