1. Report No. FHWA/TX-03/0-4138-3		2. Government Accession No.		3. Recipient's Catalog No.	
4. Title and Subtitle PERFORMANCE OF THE TXDOT T202 (MOD) BRIDGE RAIL REINFORCED WITH FIBER REINFORCED POLYMER BARS				5. Report Date October 2002 Resubmitted: November 2003

11. Contract or Grant No. Project No. 0-4138	
12. Sponsoring Agency Name and Address Texas Department of Transportation Research and Technology Implementation Office P.O. Box 5080 Austin, Texas 78763-5080				13. Type of Report and Period Covered Research: September 2000 - August 2002

**PERFORMANCE OF THE
TxDOT T202 (MOD) BRIDGE RAIL
REINFORCED WITH FIBER REINFORCED POLYMER BARS**

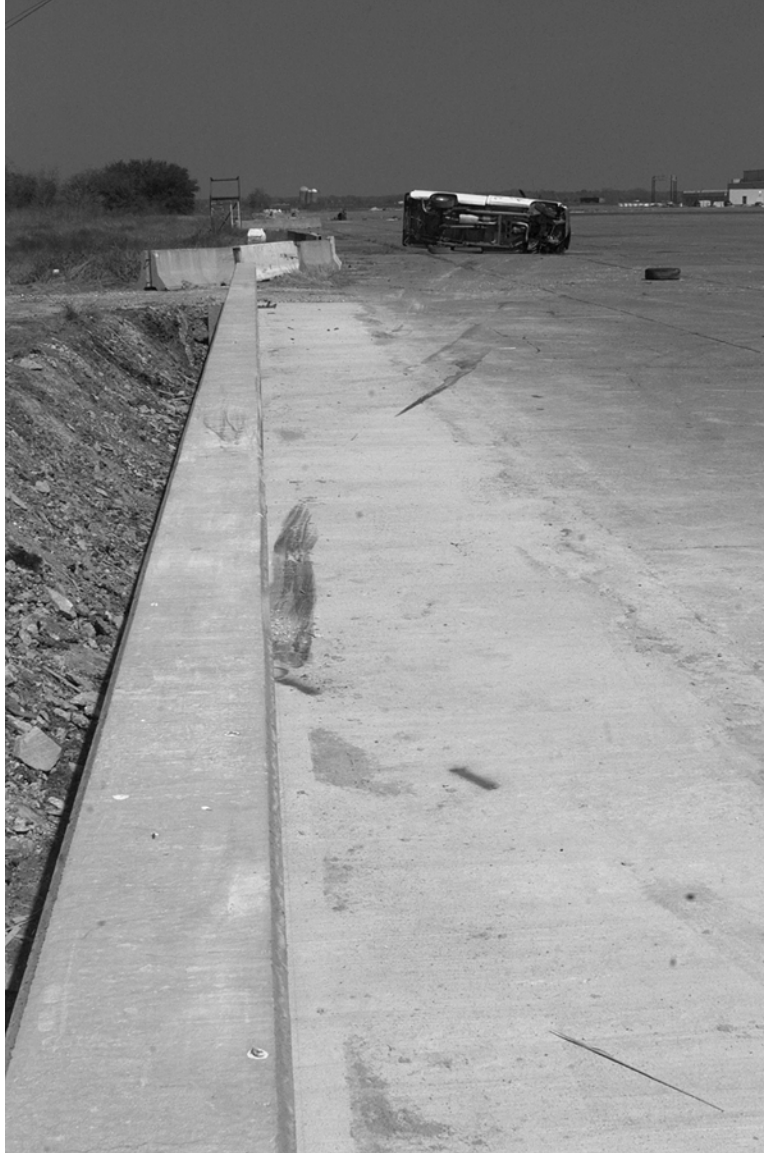
Figure A-8. After Impact Trajectory for Test 441382-1.

F.	<i>The vehicle should remain upright during and after collision although moderate roll, pitching, and yawing are acceptable.</i>	The 4498-lb (2042 kg) pickup truck rolled onto its left side after exiting the installation.	Fail
Vehicle Trajectory

K.	<i>After collision it is preferable that the vehicle's trajectory not intrude into adjacent traffic lanes.</i>	The vehicle subsequently came to rest on the left side, 52.6 m downstream of impact and 9.5 m forward of the traffic face of the rail.	Fail*

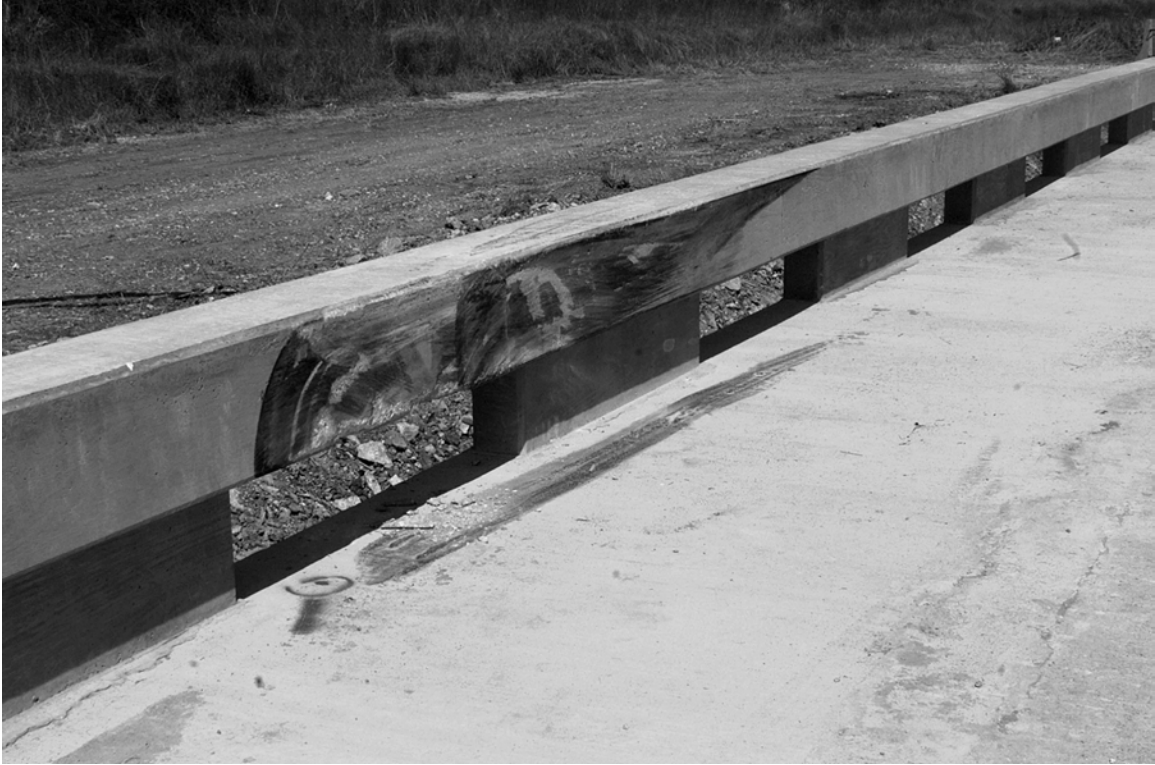
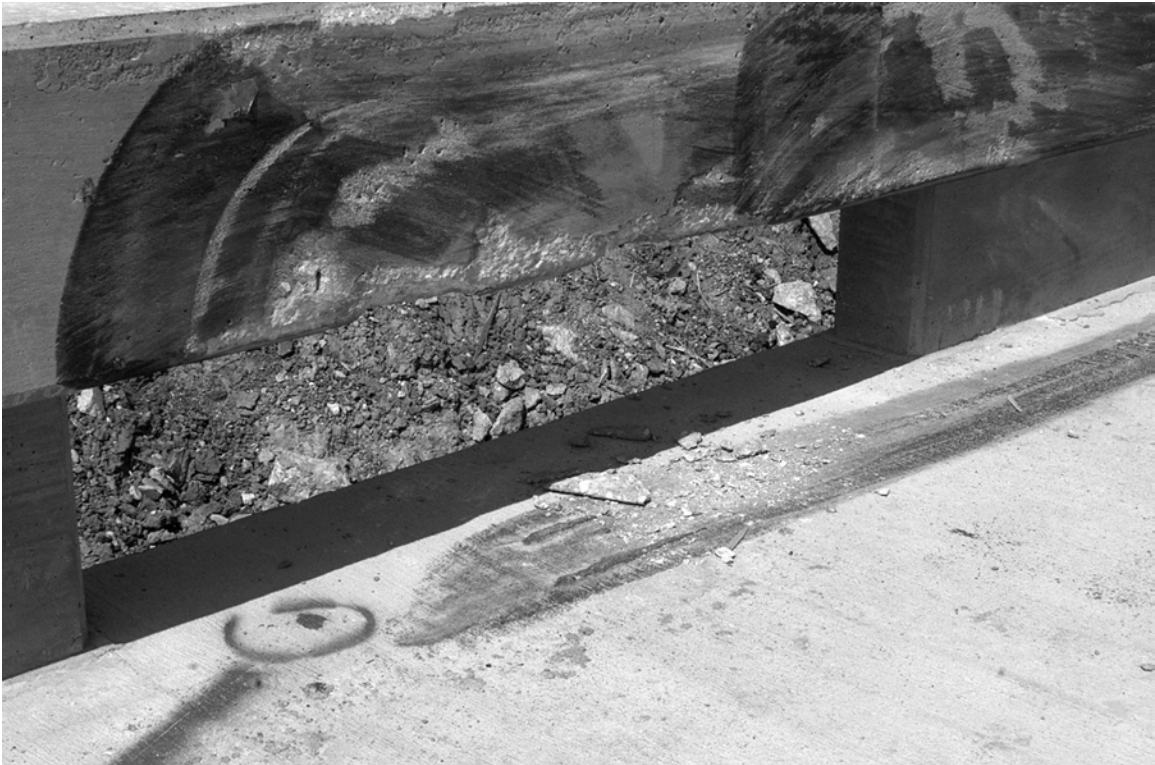
Figure A-9. Installation after Test 441382-1.

Pieces of concrete were chipped out of the lower edge of the beam rail where the vehicle's tire/wheel contacted it. Hairline cracks in the deck radiated from both sides of post 3. The vehicle was in contact with the bridge rail for a distance of 13.85 ft (4.22 m). Figures A-8 and A-9 show photographs of the damage to the bridge rail. There was no indication of significant structural damage to the rail or the deck. There was no indication that the GFRP exhibited any undesirable traits.

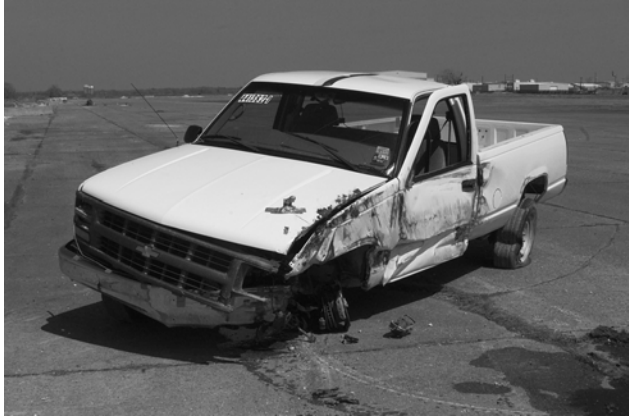
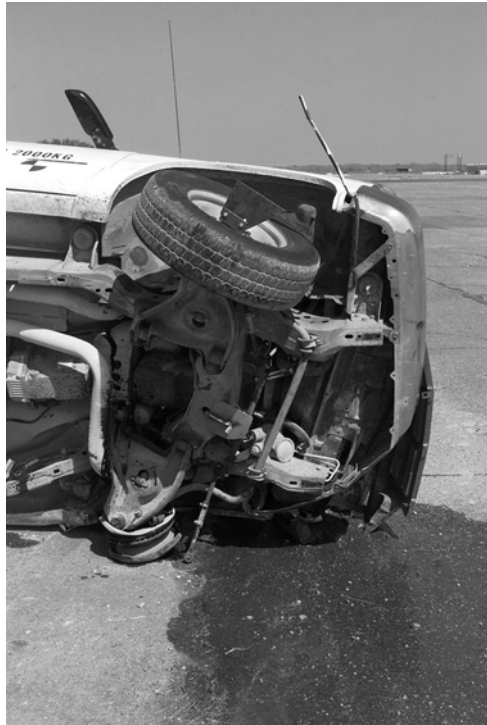
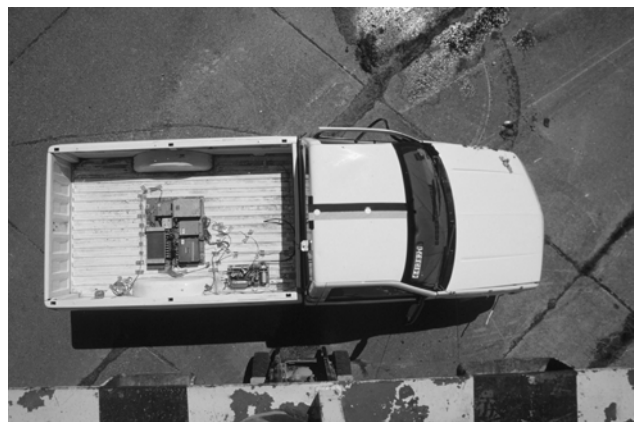
Figure A-10. Vehicle after Test 441382-1.

Figure A-10 shows damage to the vehicle. Structural damage was imparted to the stabilizer bar, left upper and lower A-arms, left rod ends, left front frame member, firewall, and floor pan. Also damaged were the front bumper, hood, radiator, fan, left front tire and wheel rim, left front quarter panel, left door and window glass, and left rear exterior bed. The windshield broke during vehicle rollover. Maximum exterior crush to the exterior of the vehicle was 22.8 inches (580 mm) in the front plane at the left front corner near bumper height. Maximum occupant compartment deformation was 5.0 inches (128 mm) in the floor pan to instrument panel on the left side near the driver's feet. Figure A-11 shows photographs of the interior of the vehicle. Tables A-1 and A-2 show exterior vehicle crush and occupant compartment measurements.

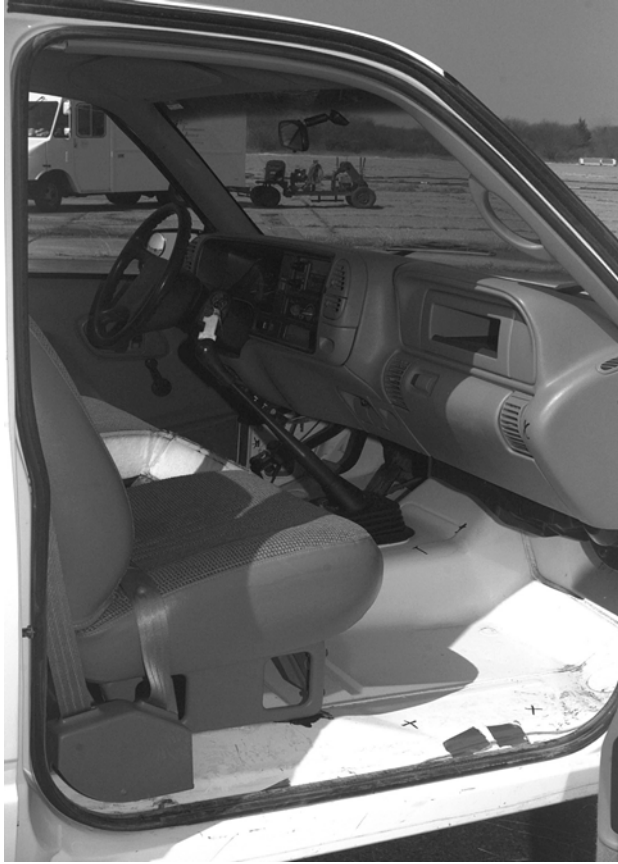
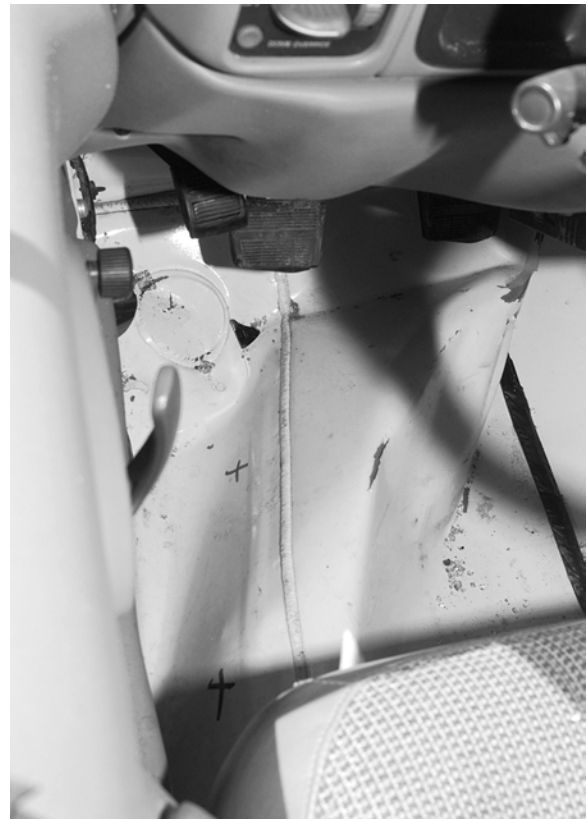
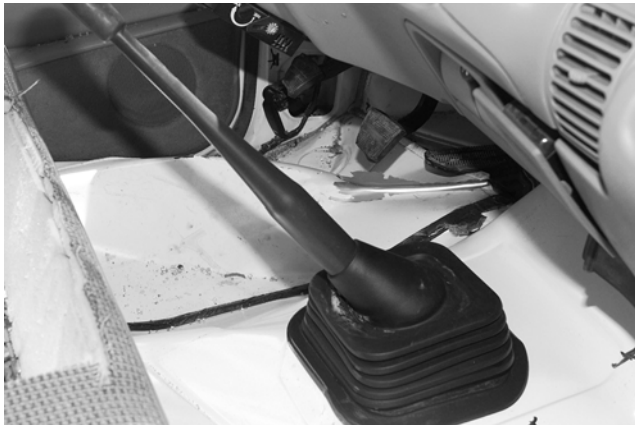
Figure A-11. Interior of Vehicle for Test 441382-1.

Results: No detached elements, fragments, or other debris were present to penetrate or to show potential for penetrating the occupant compartment, or to present undue hazard to others in the area. Maximum occupant compartment deformation was 5.0 inches (128 mm) in the floor pan to instrument panel on the left side near the driver's feet.
