1. Report No. FHWA/TX-06/0-4240-4		2. Government Accession No.		3. Recipient's Catalog No.	
4. Title and Subtitle DATABASE OF SULFATE STABILIZATION PROJECTS IN TEXAS				5. Report Date November 2005 Resubmitted: February 2006

DATABASE OF SULFATE STABILIZATION PROJECTS IN TEXAS

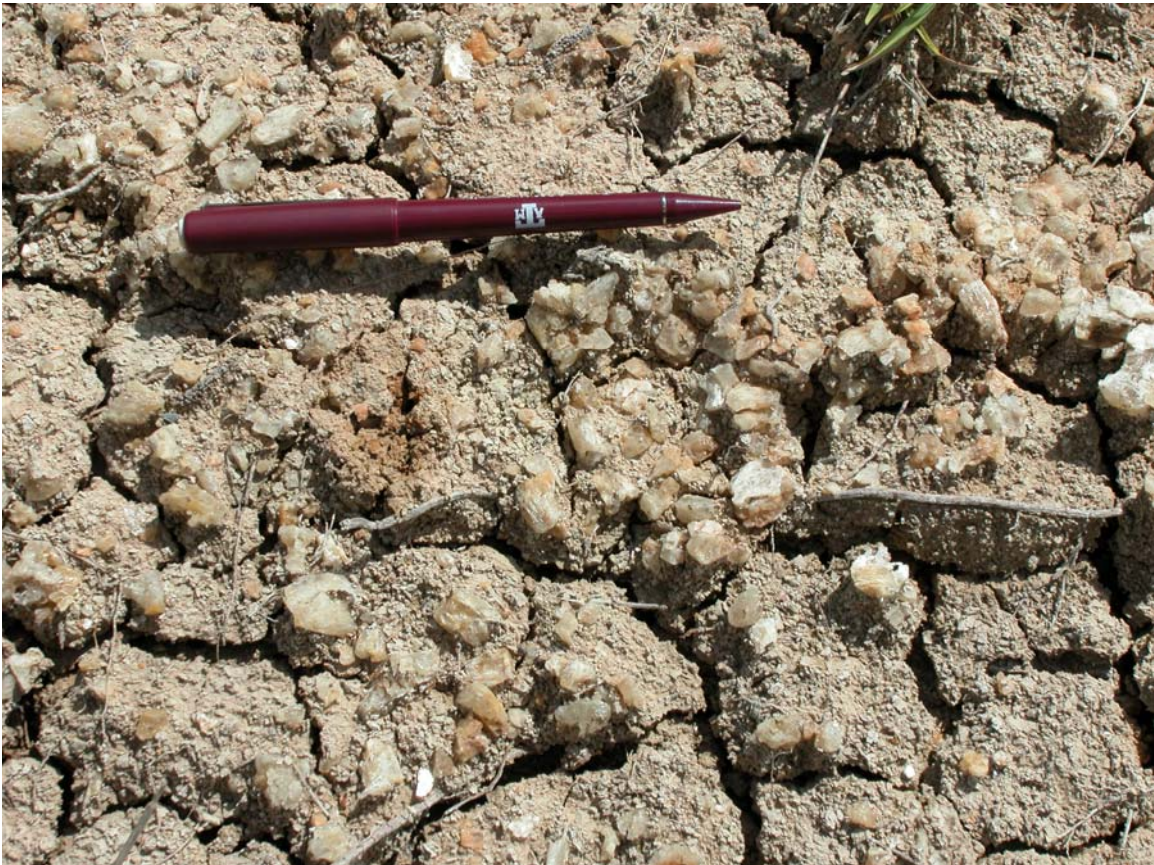
Figure 3. White Crystals below the Mechanical Pencil are Gypsum Crystals in Drainage Ditches on FM 201.

The ettringite in the stabilized layer and gypsum crystals found on the job site (Figure 3) suggested that sulfate-induced heave caused the rough road on FM 201. For the new construction, TxDOT decided to remove the existing subgrade and replace it with 2 feet of select fill (Plasticity Index [PI] = 20 to 25). Portland cement was mixed with the select fill and allowed to mellow for 2 to 5 days before compacting at 3% to 5%

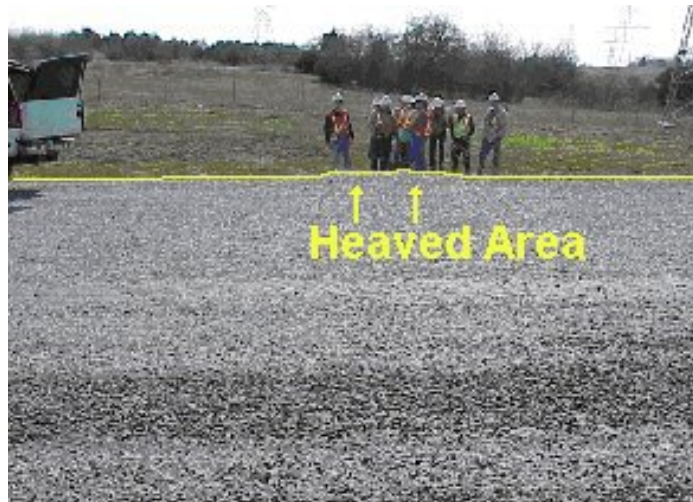
TxDOT (Dar-Hao Chen) contacted TTI about a failure on a new construction site in the Paris District. There was unexplained heaving of a lime-treated subgrade soil on the east side of the project (Figure 4). The west side had not been treated yet.

Figure 4. Heaved Area on the Eastbound Side of US 82 Near Sherman, Texas.

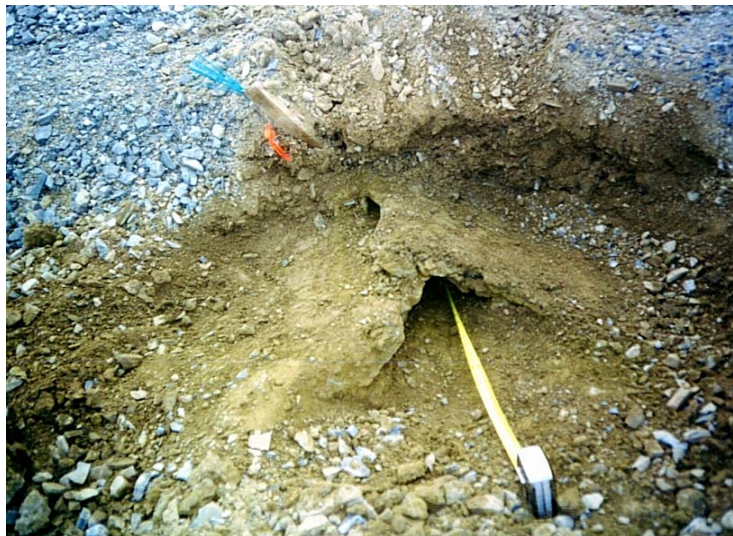
Figure 15. Trench Cut along Heaved Section of US 82.

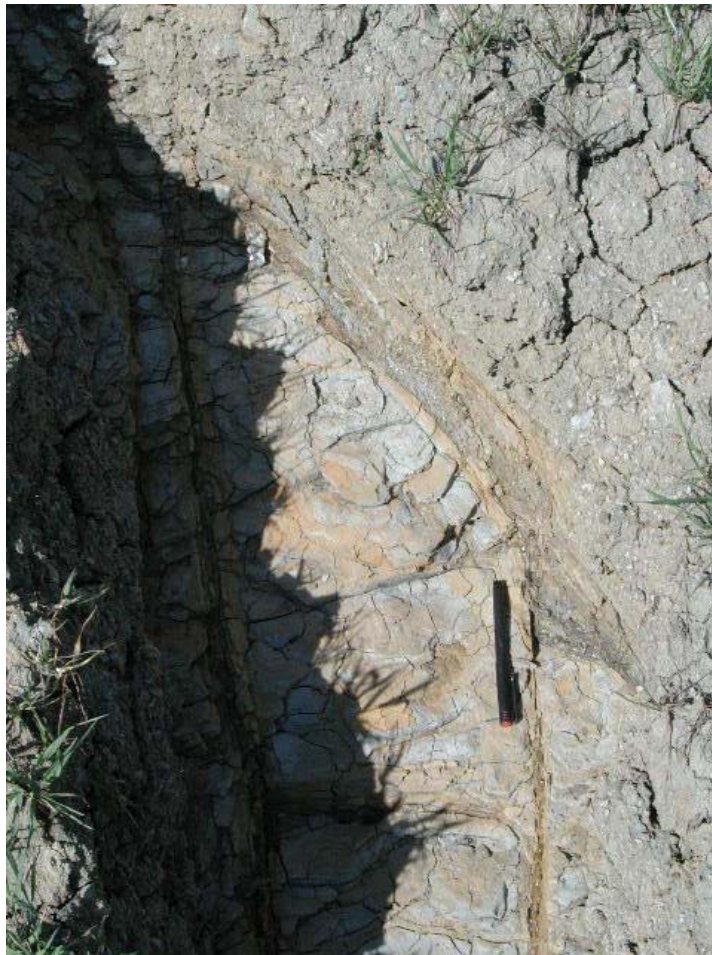
Figure 16. Veins of Gypsum (pen) Filling Fractures in Eagle Ford Formation along US 82.

- As illustrated in [Figure 16](#), and from the field testing, these sulfate seams can be quite localized.
- The researchers recommend stabilization with lime on the western section that has been tested because the sulfate concentrations are low enough to stabilize with lime. However, they need to continue sulfate testing as areas are filled to grade and prior to stabilization on the remainder of the project.

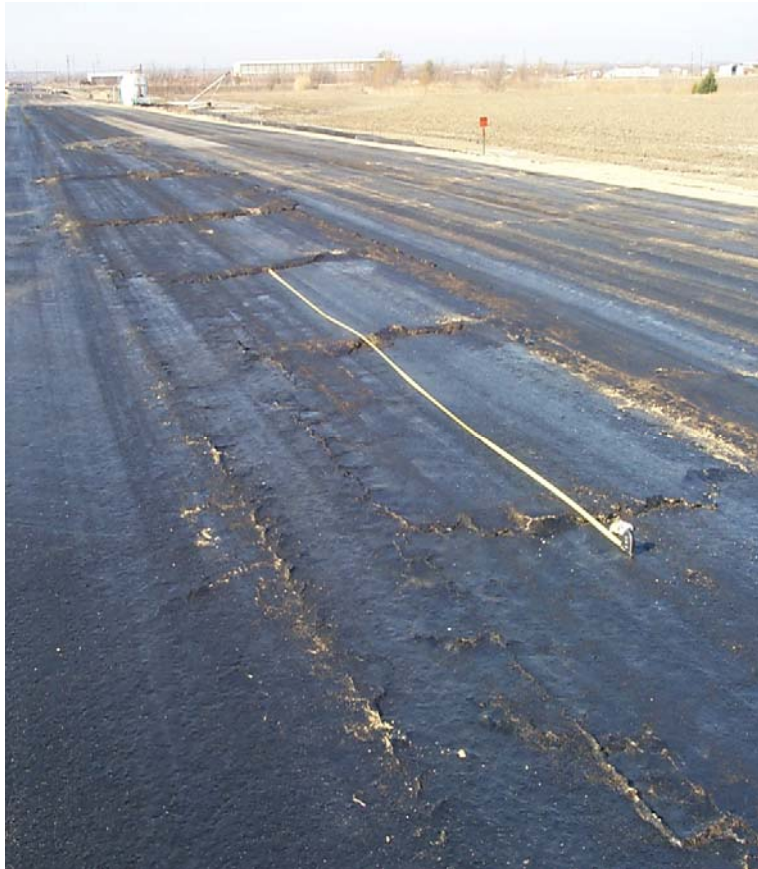
Figure 18. Vertical Heaves of Lime-Stabilized Subgrade on US 67 in Ellis County.

The safest thing is to remove all of the sulfate-bearing soil from the site and replace it with a material free of sulfates or sulfides. The existing lime-stabilized material still has about 1% unreacted gypsum, which could cause the swelling problem to recur.

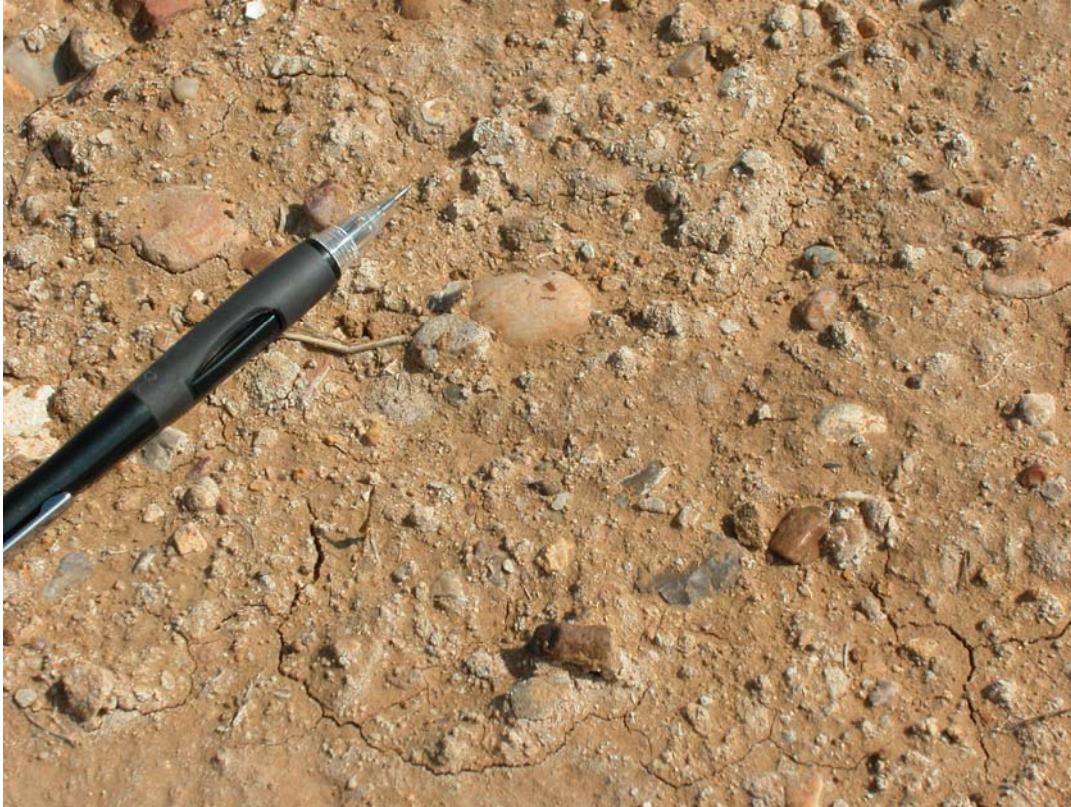
A quick study of the field site revealed small gypsum crystals and efflorescence of gypsum (Figure 23) on the embankment and in the drainage ditch adjacent to the widening project.

Figure 23. Mechanical Pencil Points to Small Gypsum Crystal.
(Note also the white patches.)

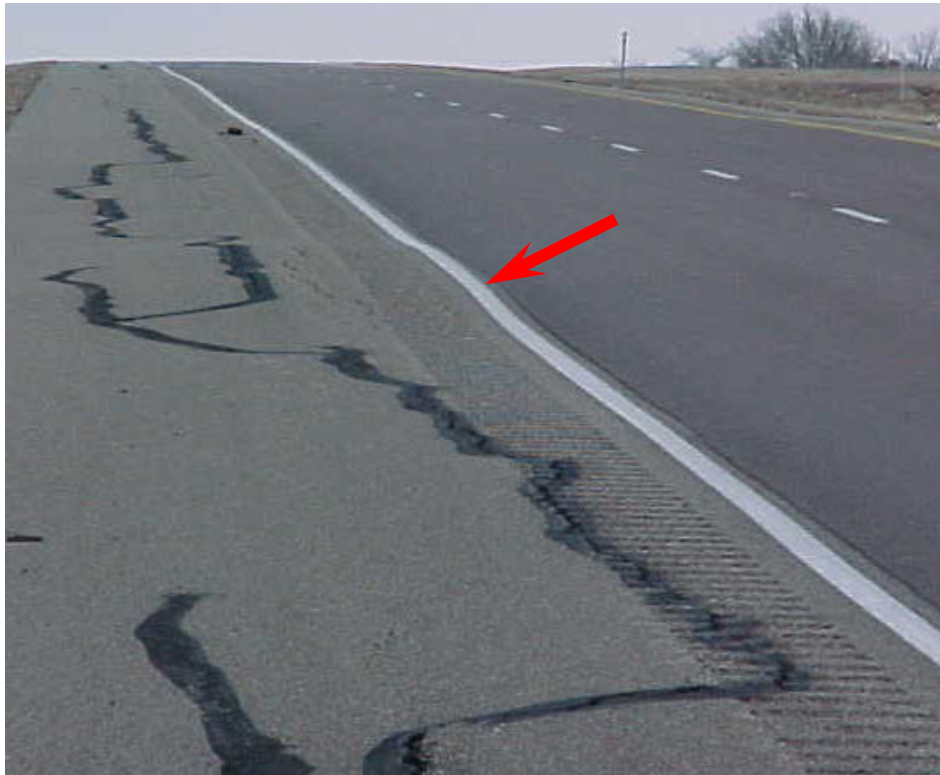
The Materials and Pavements Section of TxDOT evaluated the cause of extensive longitudinal cracking and severe roughness (swells) near Baylor Creek Bridge on US 287 in western Childress County ([Figure 25](#)). Both the northbound and southbound lanes were reconstructed approximately 5 years ago. There were 9 inches of lime-treated

subgrade (3 % wt.) in the reconstructed section. About 2 years after the reconstruction, the section near Baylor Creek developed extensive fatigue cracking in the right wheel paths and longitudinal edge cracking on the shoulders. The northbound lanes were milled and inlayed in this section approximately 2 years ago. [Figure 25](#) shows what the section looks like today.

Figure 25. Longitudinal Cracks on Shoulder and Swell (solid white line marking the shoulder) near Baylor Creek on US 287. (Image courtesy of Zhiming Si)

TxDOT made four recommendations addressing the problems on US 287. The first recommendation was that the existing soil be removed and replaced with a select fill. Secondly, they suggested reworking the existing subgrade with a lime and fly ash combination. The third recommendation was to use a mechanical stabilizer like Geogrid® in lieu of chemical stabilization. The last option was to mill the surface and apply a thin overlay and apply compost to the shoulders to stabilize moisture movement.

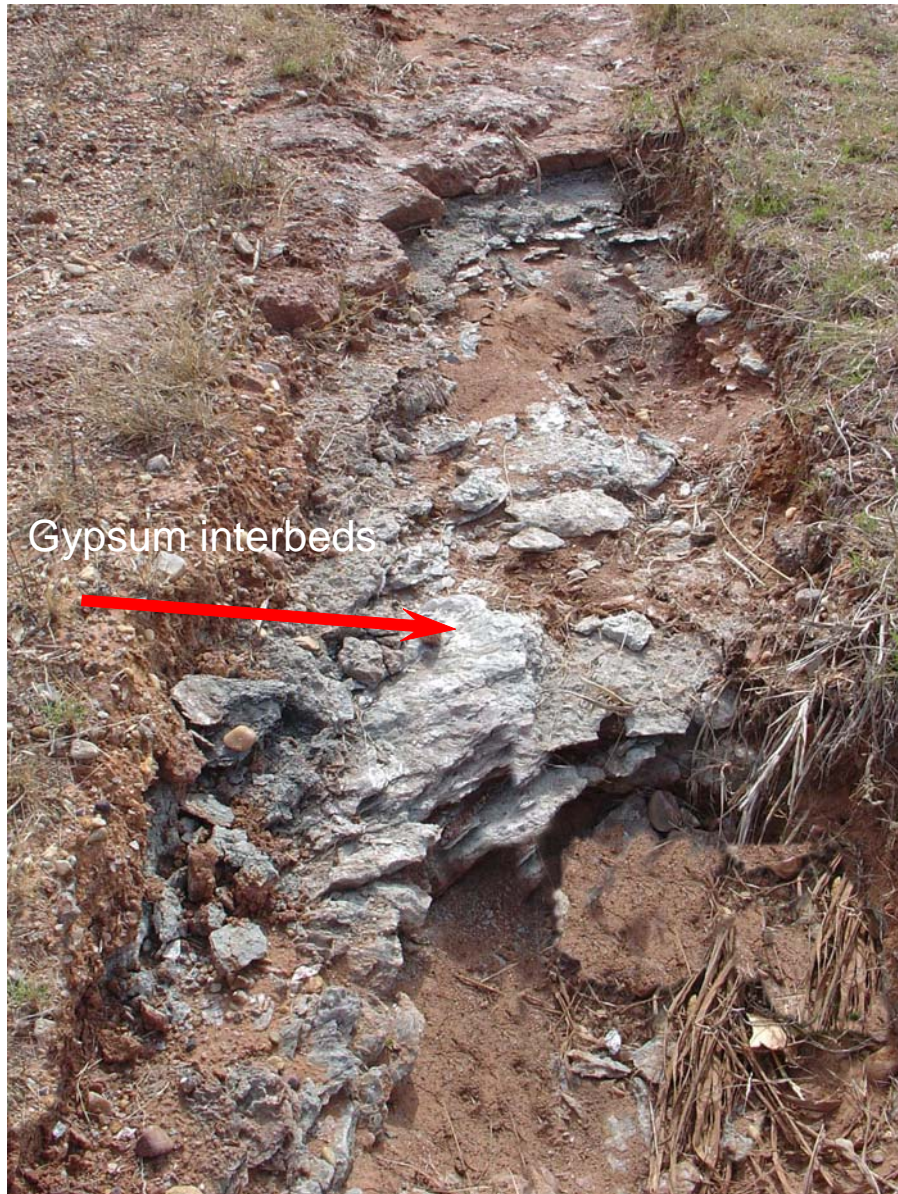
The cause of the repeated failure on US 287 is sulfate-induced heave generated from the lime reacting with the gypsum present in the underlying rocks (Figures 26 and 27). TxDOT tested different stabilizer options with this soil and determined that a combination of lime and fly ash was the best option for this high sulfate soil.

Figure 27. Gypsum Interbedded with Shale, Siltstone, and Dolomite near Baylor Creek along US 287. (Image courtesy of Zhiming Si)

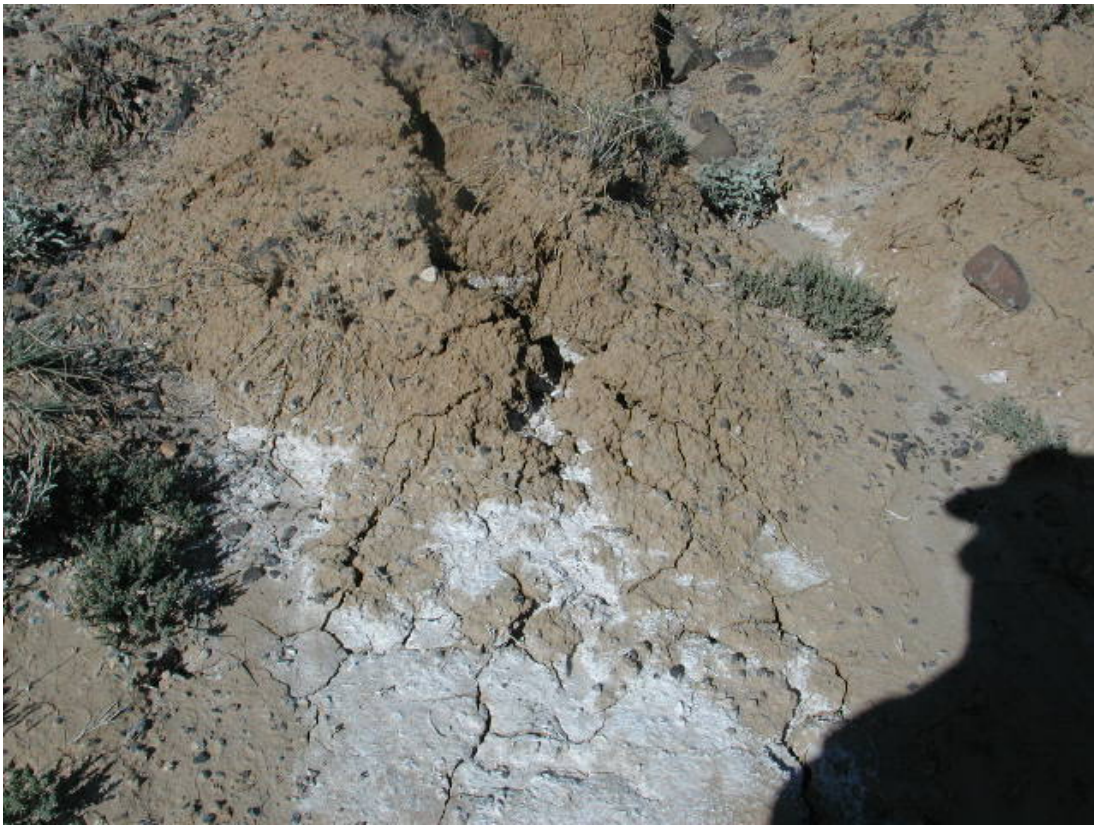
Just south of Alpine, a white powdery substance was observed in the drainage ditches on the side of the highway (Figure 28). This material is characteristic of gypsum that precipitates from groundwater that evaporates at the surface (efflorescence).

Figure 28. Efflorescence Observed on SH 118 South of Alpine.

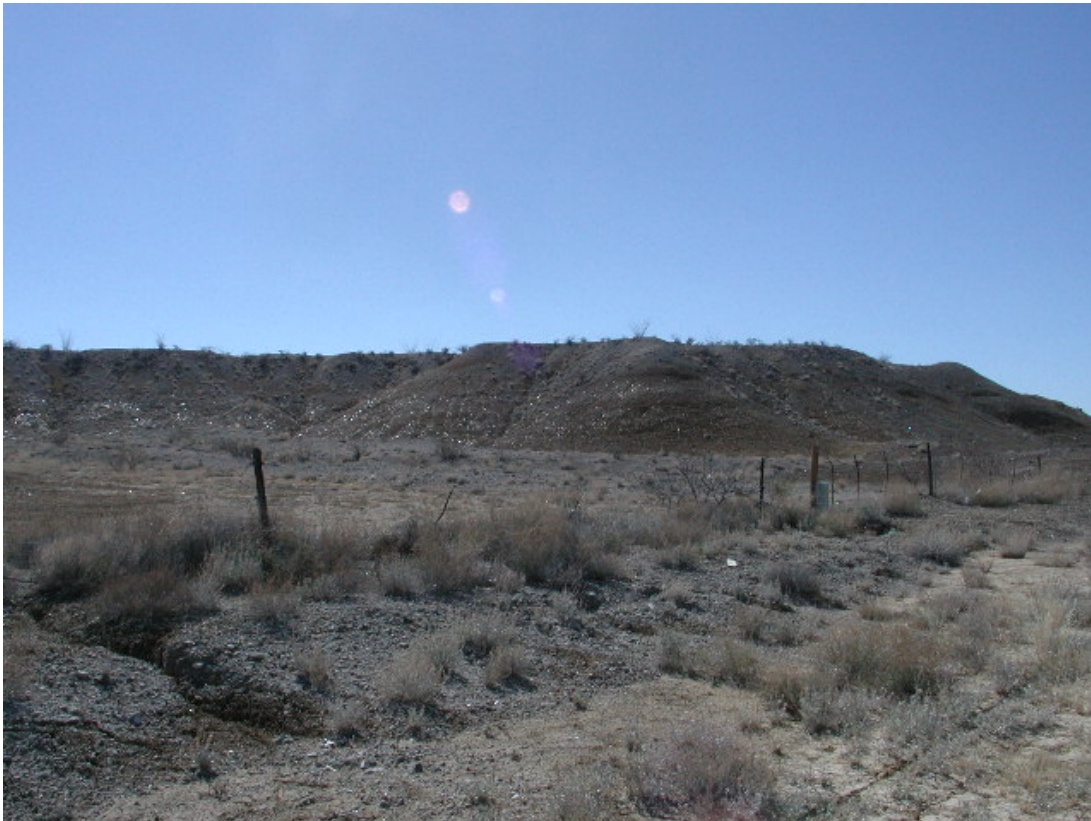
Farther south on SH 118, 3 miles north of the intersection with SH 170, more evidence of potential problems with sulfates surfaced. In the hills adjacent to the highway, sunlight was observed reflecting off crystals (Figure 29). Upon closer inspection, researchers suspicions were confirmed and gypsum crystals ranging in size

Figure 29. Aguja Formation Showing a Zone in the Center of the Image with White Spots. (Note: This is the Gypsum Shining in the Sunlight.)

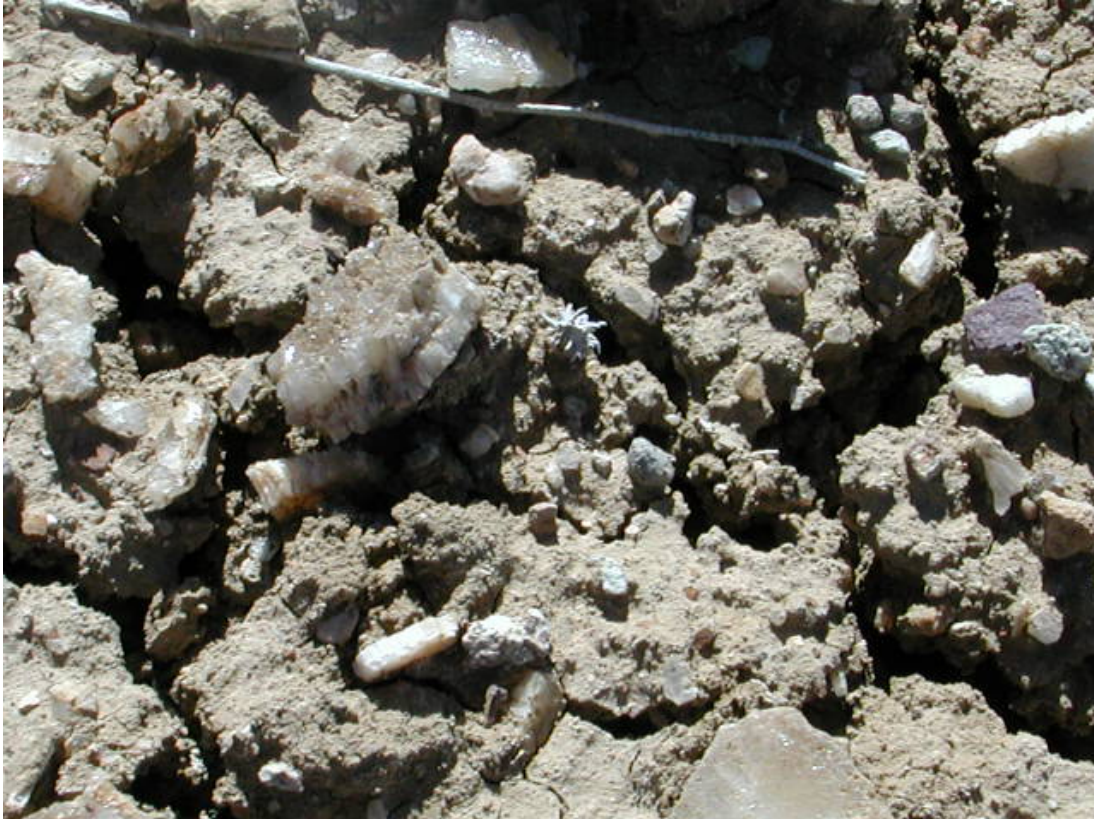
from less than 1 mm to several centimeters were observed (Figure 30). The description given in the Geologic Atlas of Texas did not mention gypsum or any other sulfur-bearing minerals; this is a case where observation of the surrounding countryside led to the discovery of the gypsum and consultation with published geologic maps may give one a false sense of security.

Figure 30. Image of Multiple Gypsum Crystals Observed on the Right-of-Way Adjacent to the Sparkling Hills in [Figure 29](#).

Tests were performed in the field, and sulfates were identified on SH 118. The researchers recommended to TxDOT personnel that they perform more extensive sulfate testing on the highway before the rehabilitation project begins. If they stabilize the subgrade, then they will need to develop a stabilization design prior to construction. Some possible stabilizers include combinations of fly ash plus lime and ground granulated blast furnace slag plus lime.

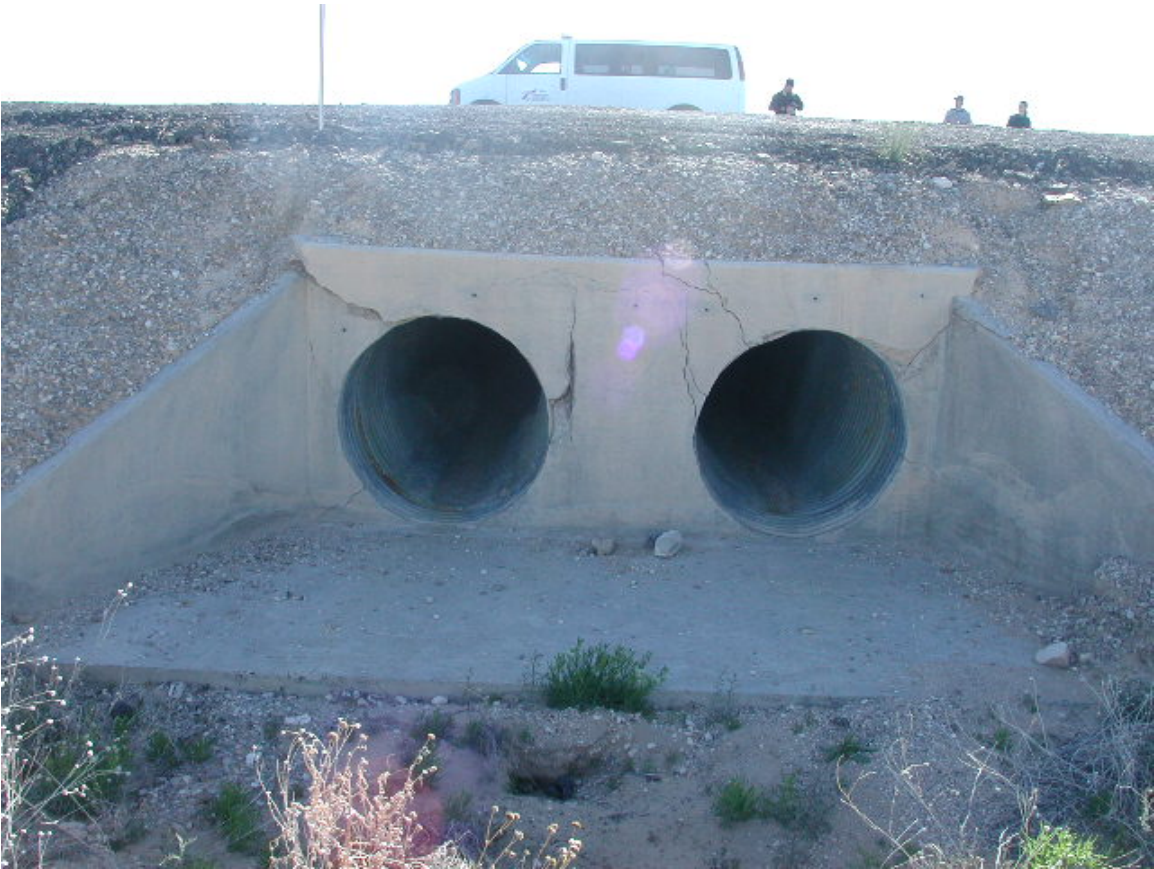
The road rises over the culverts and falls on the other side. The headwalls were cracked, and the culverts were often deformed ([Figure 31](#)). TxDOT wanted to know what was causing the problems.

Figure 31. Expansion of Cement-Treated Backfill on SH 54 North of Van Horn.

The geologic map again indicates gypsum in the rocks. The sand used in the backfill was full of gypsum, which reacted with the cement to form ettringite. The ettringite caused expansion, which deformed the culverts and broke the headwalls. TxDOT replaced the deformed culverts and used an untreated backfill around the culverts.
