**INVESTIGATION OF MAINTENANCE BASE REPAIRS OVER
EXPANSIVE SOILS: YEAR 1 REPORT**

Report 0-4395-1

Research Project Title: Optimum Spot Base/Subgrade Repair Techniques for Moderate to High
Traffic Highways over Highly Expansive Subgrade Soils

October 2002

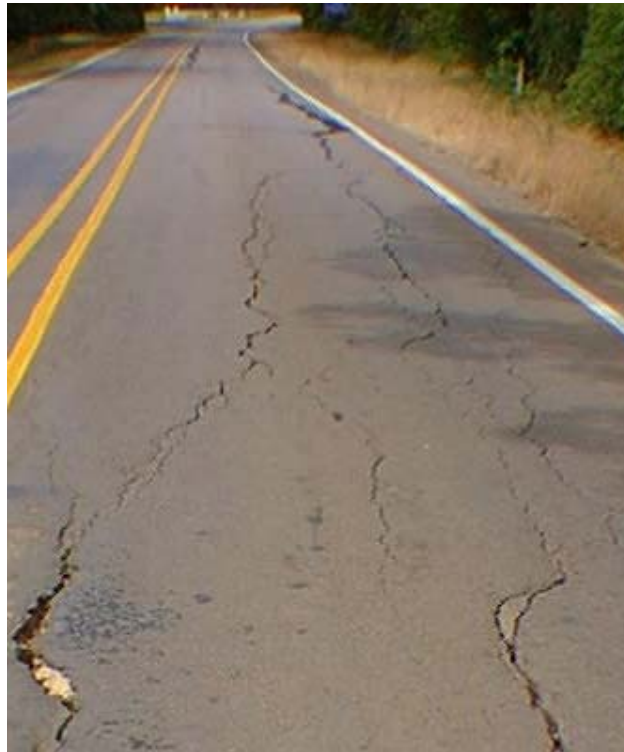
Figure 1. Example of Longitudinal Cracking.

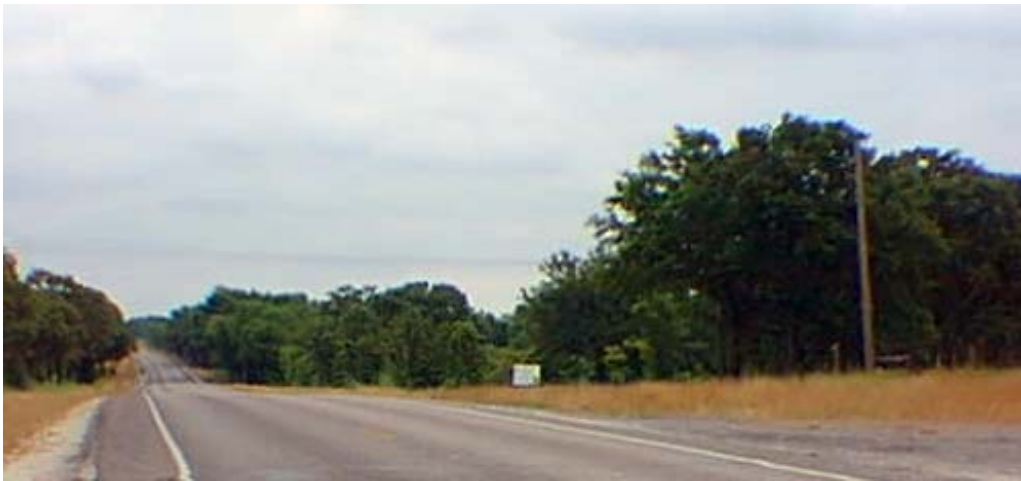
Figure 3. OSR with Geogrid after 2 Years of Service.

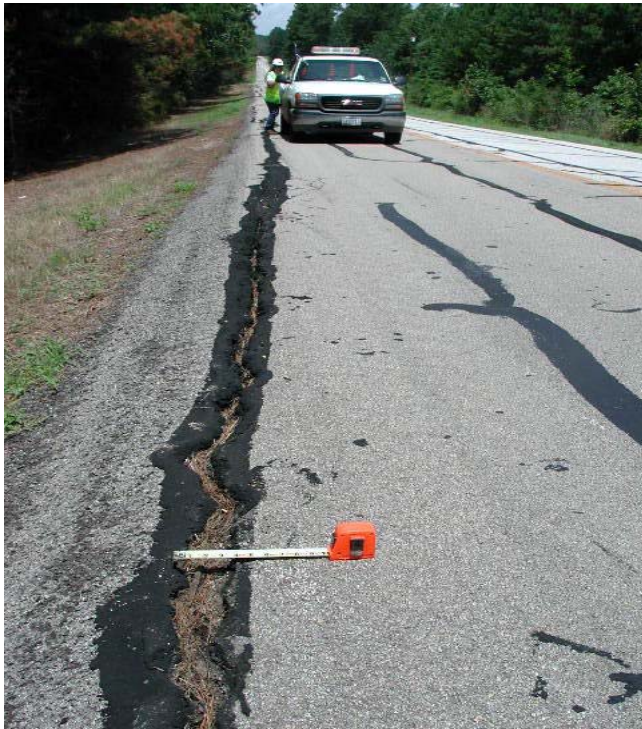
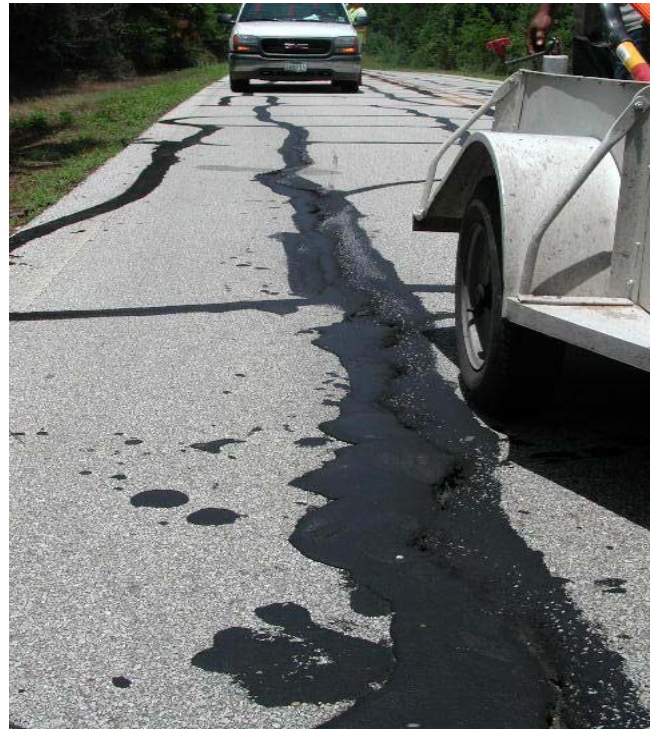
Figure 6. Views of FM 226 in July 2002.

Overall Road Summary: The combination of stiff bases, steep side slopes, and highly plastic soils appears to have resulted in less than desirable performance from the rehabilitation. Extensive block cracking, longitudinal cracking, and substantial maintenance requirements on the section all seem to indicate a better repair process must exist.

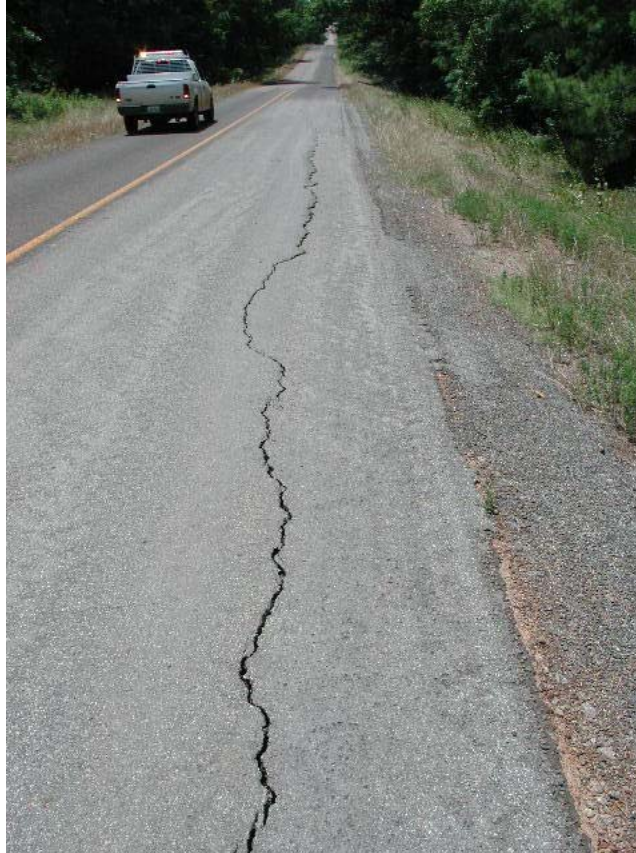
Three severe longitudinal cracks exist in the rehabilitated section under examination. Figure 9 shows a wide, faulted crack in the westbound direction in June 2002. Area Maintenance personnel indicate cracking reoccurred shortly after completion of the rehabilitation. Although the road does not yet exhibit the breakup shown in Figure 8, the wide cracking that exists will certainly allow water into the pavement and result in accelerated pavement deterioration.

Figure 9. Severe Longitudinal Crack in FM 2076 WB Rehab Section.

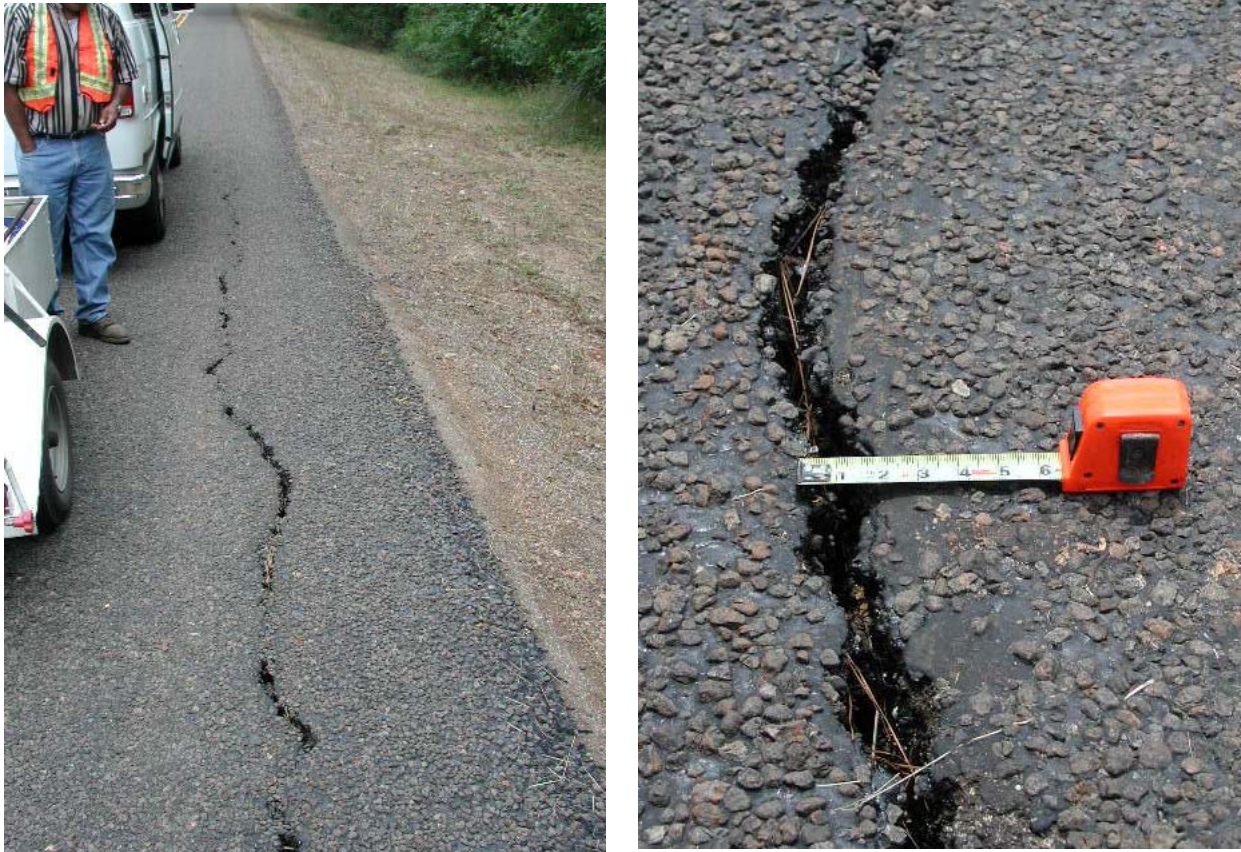
FWD data collected on FM 2076 reveal very stiff base layers exist both in the rehab section investigated, and in the existing section. This is consistent with the cores, which revealed a cement-treated base layer existed even several hundred feet outside the limits of the maintenance rehabilitation. Base moduli ranged from 828 to 1175 ksi.

Figure 10. Core Location by Severe Crack on FM 2076 EB in Rehab Section.

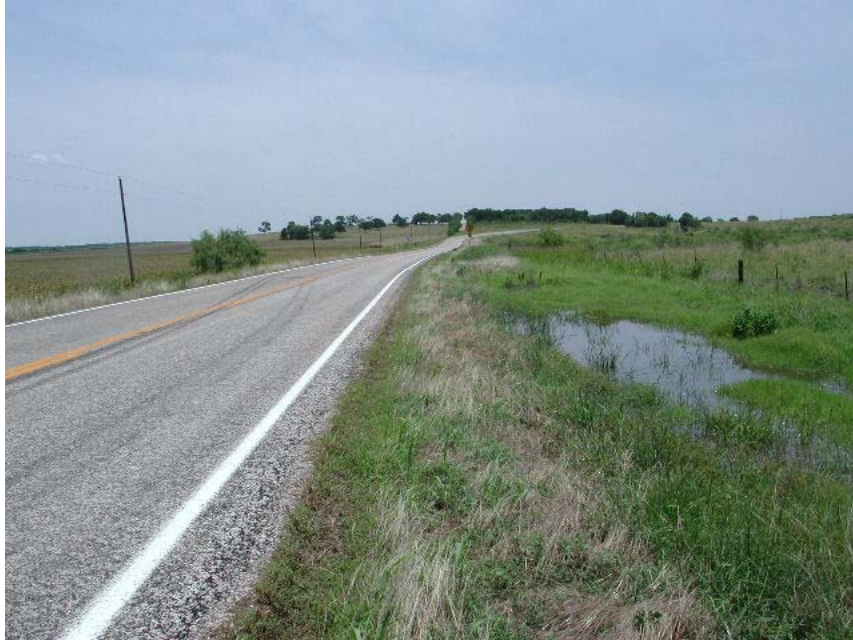
Figure 11. First Geogrid Section on FM 1915.

Field Observations: A control section exists between two sections utilizing the geogrid reinforcement on FM 1915. The first geogrid section, shown in Figure 11, starts at the Little River relief bridge and is 0.8 miles long. The section had one blade-on patch, a longitudinal crack approximately 4 feet long, and a short section with severe rutting (Figures 12 and 13). Numerous longitudinal cracks exist in the control section, which is also 0.8 miles long. Figure 14 shows these distresses. The second section with the grid reinforcement, which is 0.6 miles long, had no visible defects. Figure 15 shows this geogrid section on FM 1915.

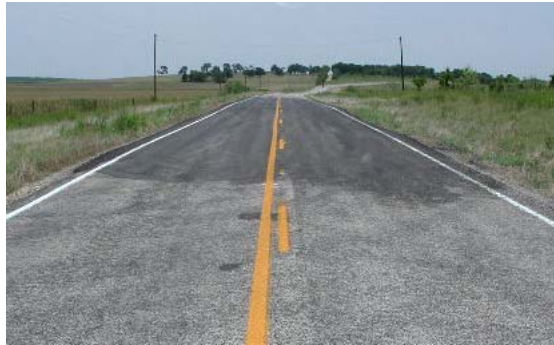
Figure 12. Blade-on Patch on First Geogrid Section on FM 1915.

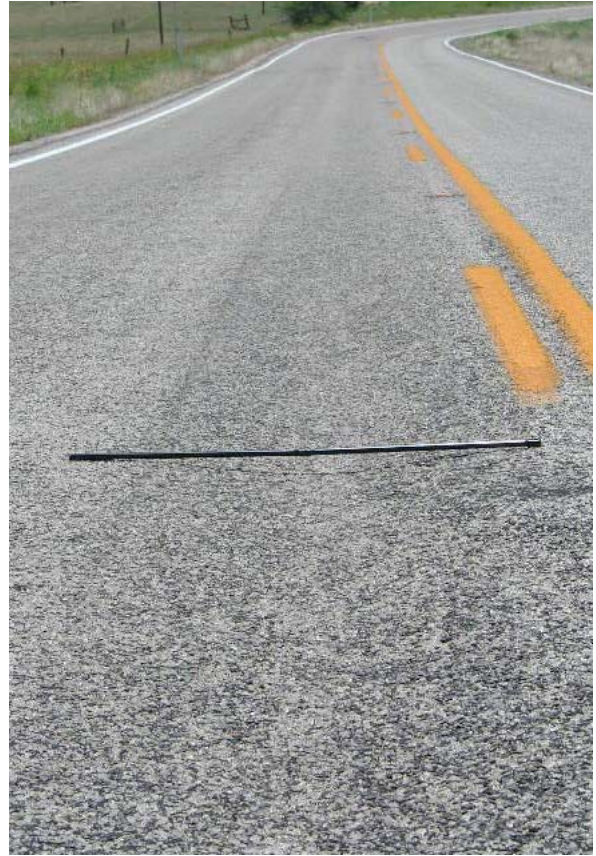
Figure 13. Longitudinal Crack and Rutting on First Geogrid Section on FM 1915.

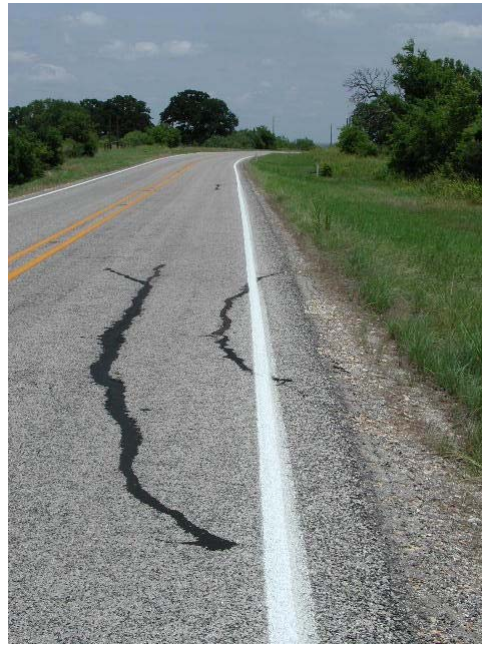
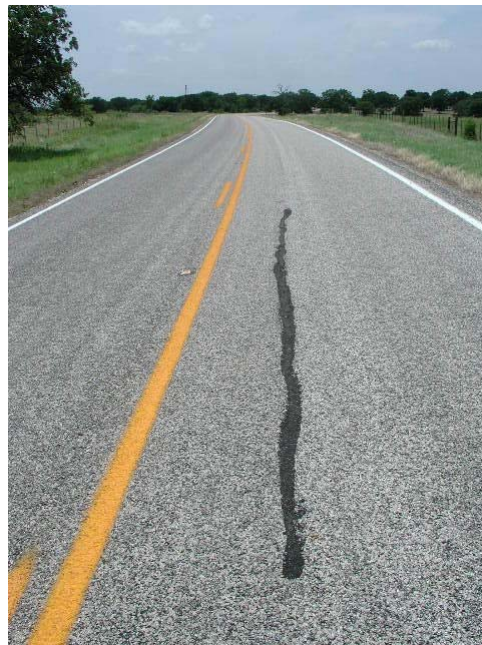
Figure 14. Longitudinal Cracking on Control Section on FM 1915.

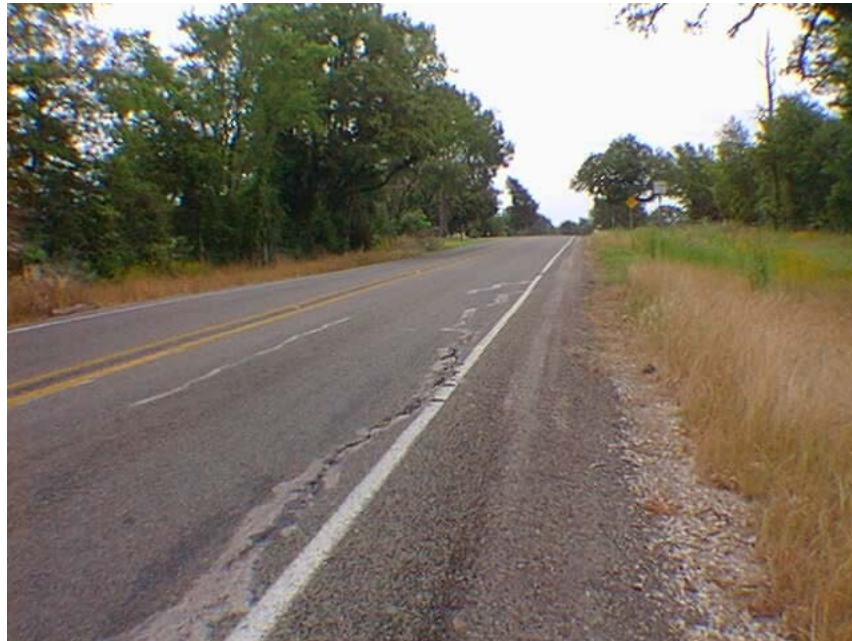
Primary Distress(es) before Treatment: Longitudinal cracking ([Figure 16](#)).

Figure 16. Representative Distresses on OSR.

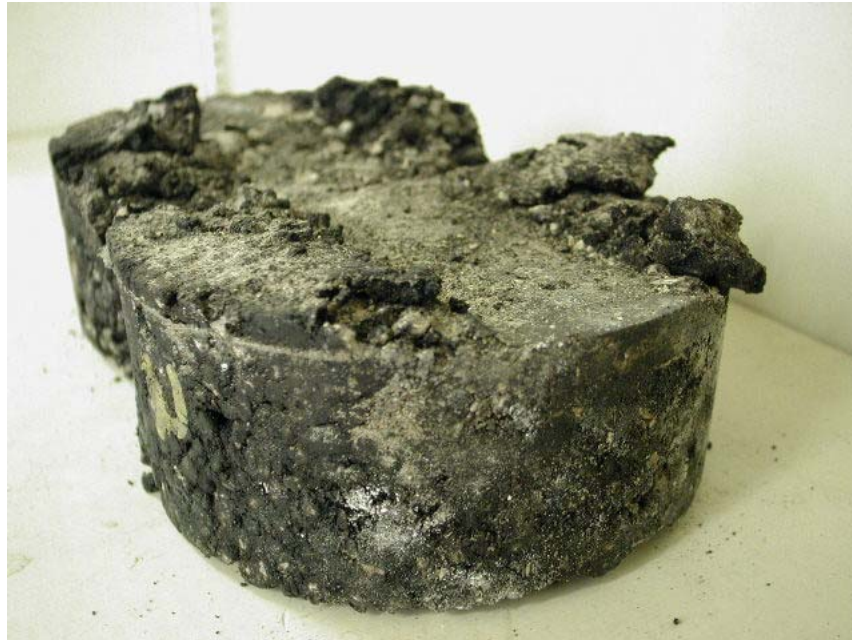
Figure 39. Black Base after Hamburg Test.
