1. Report No. FHWA/TX-05/0-4395-2		2. Government Accession No.		3. Recipient's Catalog No.	
4. Title and Subtitle FINALIZATION OF GUIDELINES FOR MAINTENANCE TREATMENTS OF PAVEMENT DISTRESS				5. Report Date August 2004

FINALIZATION OF GUIDELINES FOR MAINTENANCE TREATMENTS OF PAVEMENT DISTRESS

Report 0-4395-2
Project Number 0-4395
Project Title: Optimum Spot Base/Subgrade Repair Techniques for Moderate to High Traffic
Highways over Highly Expansive Subgrade Soils

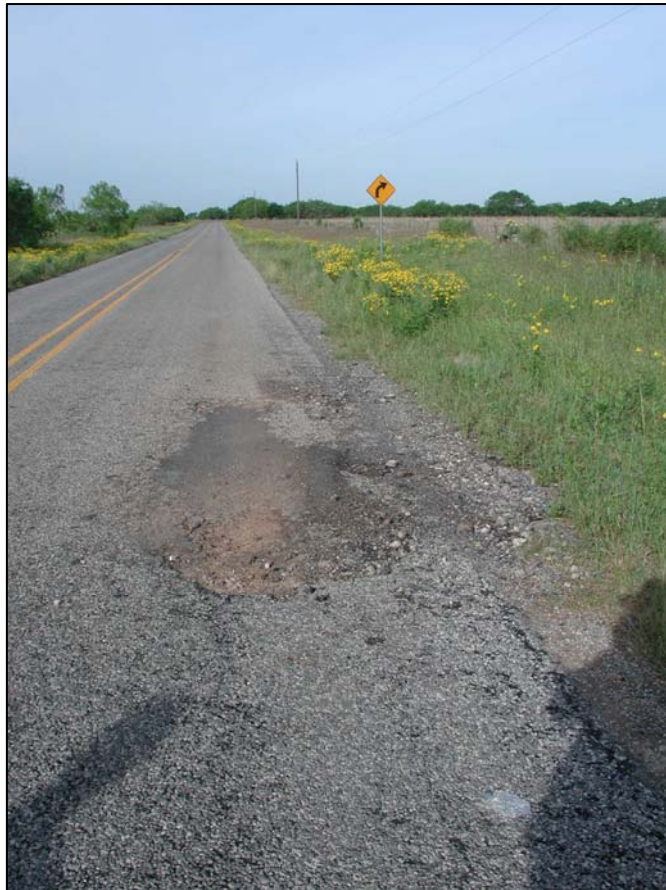
Figure 1.1. FM 1332 WB West of SH 16.

Site has fatigue cracking with popouts and has already had patch material applied (Figure 1.1).

A full-depth patch to good material is needed.

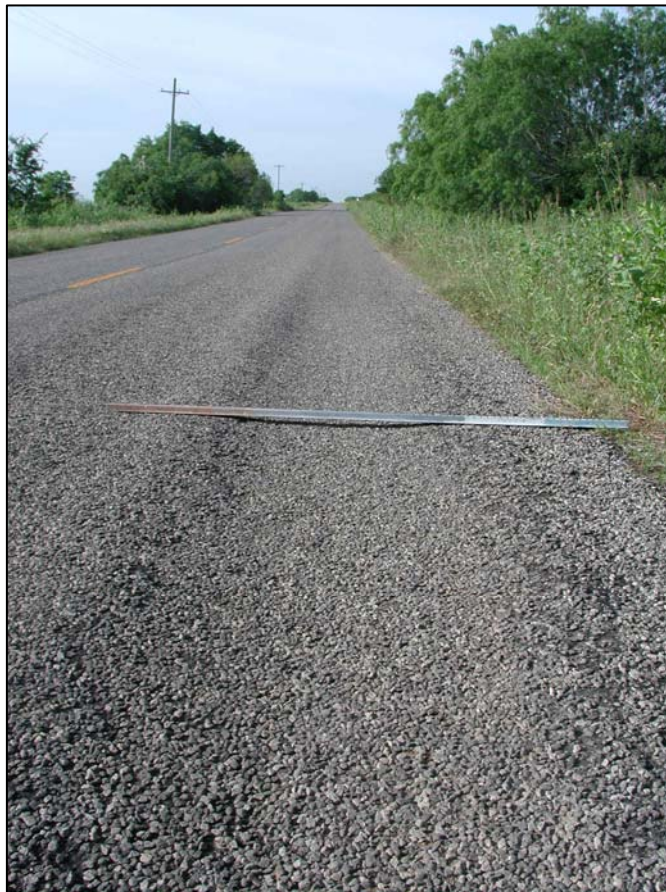
Figure 1.2. FM 1332 WB Toward End of TxDOT Maintenance.

Approximately 1.25-inch rut depth through the section exists ([Figure 1.2](#)).

The rut is both wide and deep. Consider a full-depth repair with additional base thickness and/or a subgrade treatment.

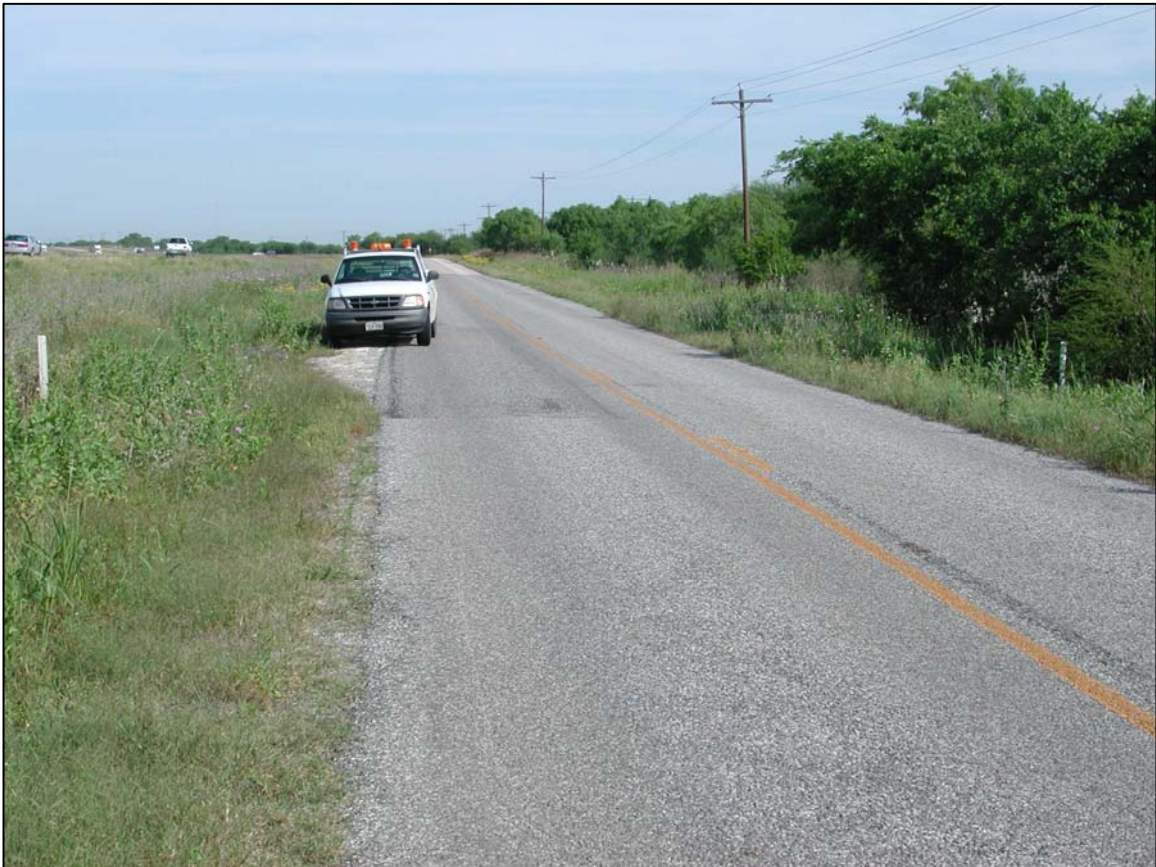
Figure 1.3. I 37 East Side Frontage Road Site 1.

The site already has a strip seal; approximately a 50-ft section in the sealed section appears to have been patched with cement treated base (CTB). There is no distress in the CTB section. The remainder of the site has moderate rutting at the outside wheel path. [Figure 1.3](#) shows the site.

Consider a CTB repair such as what appears to have been applied (and is performing well) in part of the section.

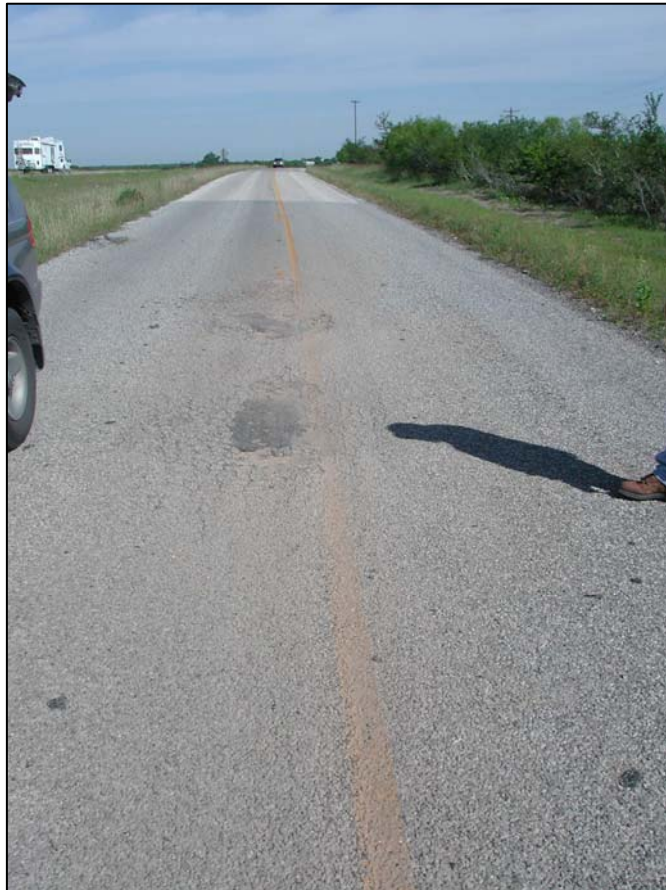
Figure 1.4. I 37 East Side Frontage Road Site 2.

Site has a seal coat and extensive fatigue cracking with popouts occurring ([Figure 1.4](#)).

A full-depth patch is recommended. Patch material has already been applied to buy some time, but like the strip seal is only covering up the problem. The distressed areas should be repaired with a good flex base or treated material (new or existing).

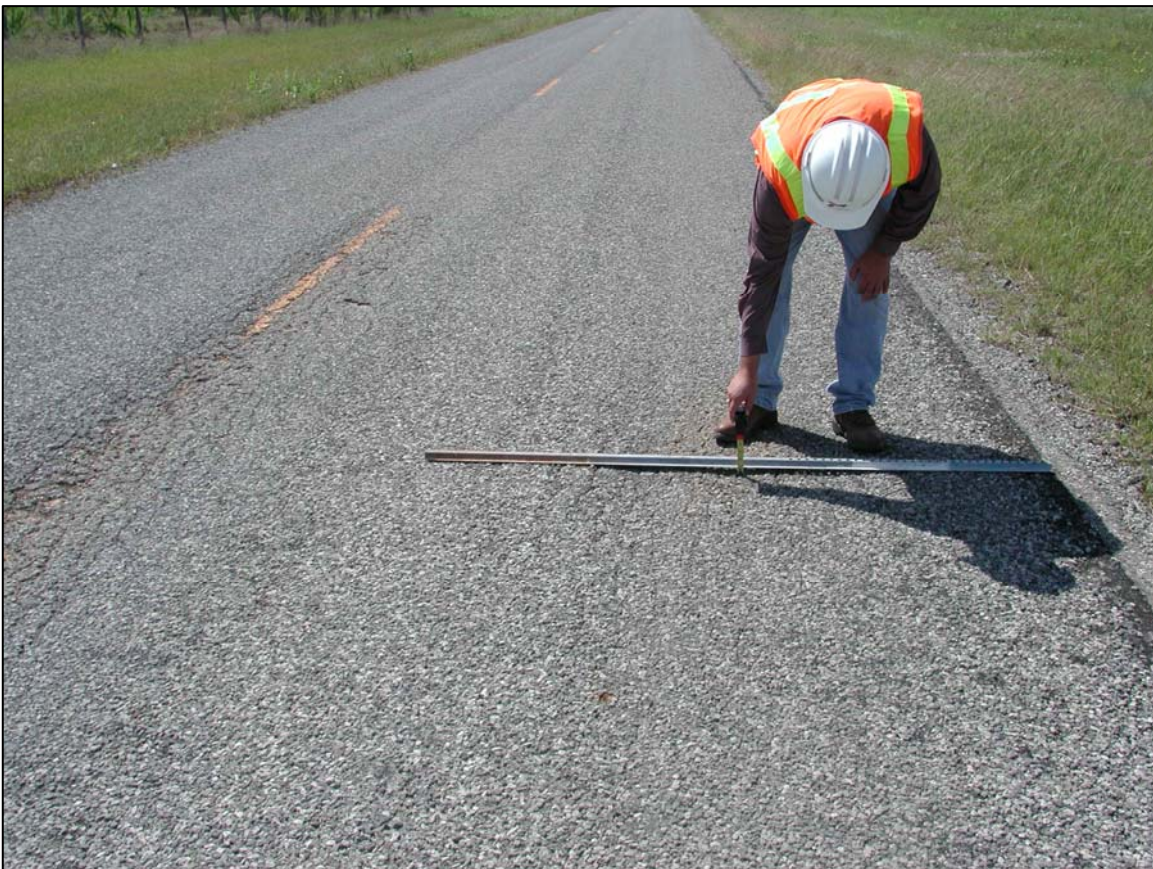
Figure 1.5. I 37 East Side Frontage Road Site 3.

Site has fatigue cracking and wide ruts approximately 1.125-inch deep. There is some exposed base in the cracked areas. The site has already had a newer seal coat applied.

Because of the high severity rutting and the presence of fatigue cracking, a full-depth repair is warranted.

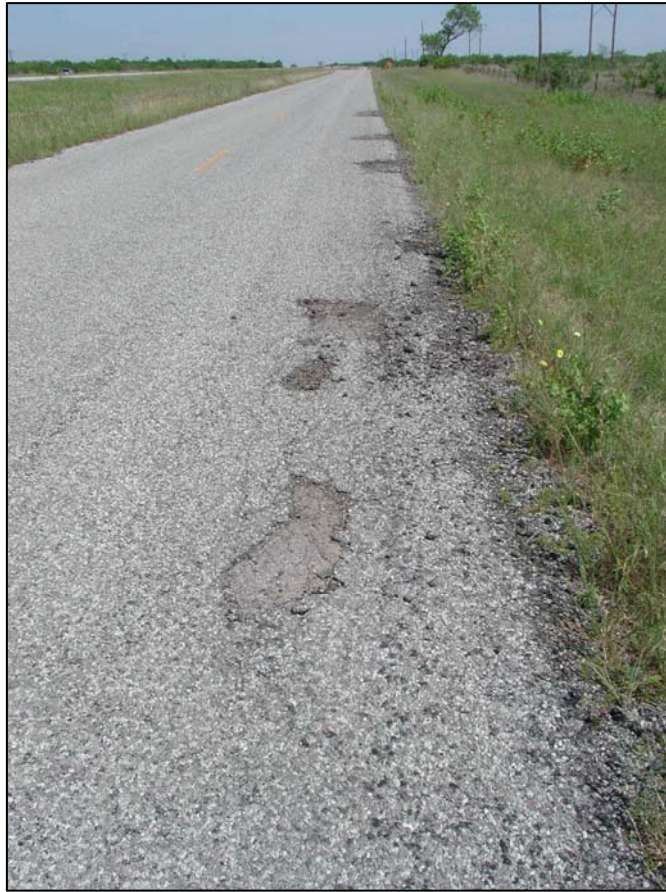
Figure 1.6. I 37 East Side Frontage Road Site 4.

The site has fatigue cracking at the edges with popouts occurring, as shown in [Figure 1.6](#).

Consider a base patch with a lightly stabilized material or, alternatively, recycling the existing edge with a reclaimer and adding a low level of cement. Consider adding a couple of feet to the road width to increase edge support.

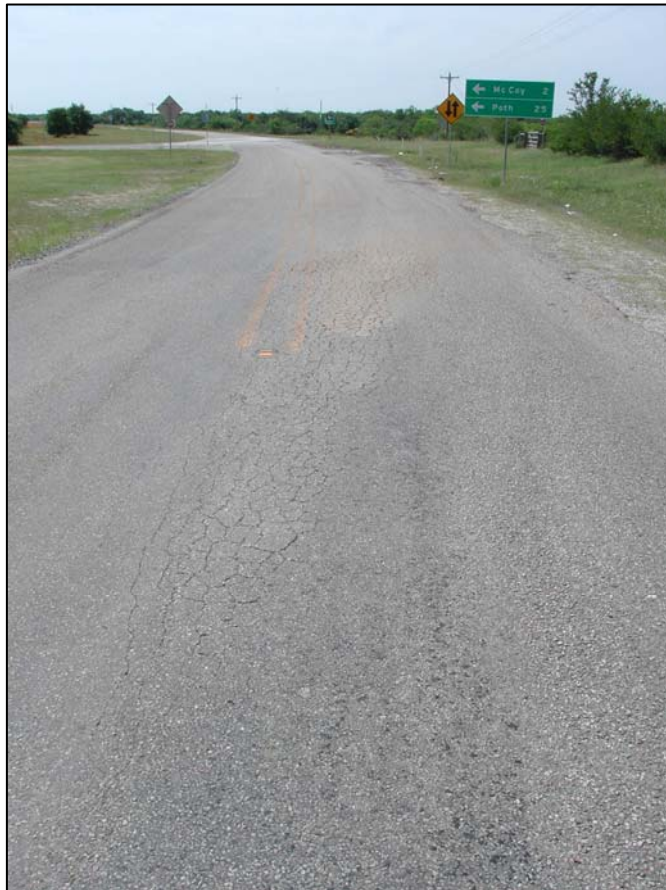
Figure 1.7. I 37 West Side Frontage Road Site 1.

Extensive fatigue cracking exists with rutting at the exit ramp from I 37 (Figure 1.7).

Upcoming contract work is scheduled for parts of the I 37 west side frontage road. Treatment at this site depends on if it is part of the upcoming contract work. If included in the contract work, a strip seal to keep water out (or perhaps no treatment at all, depending on the time frame until the contract begins) would probably be adequate. If not part of the contract work, the distressed section should be patched with a higher quality base material and/or an increased base thickness.

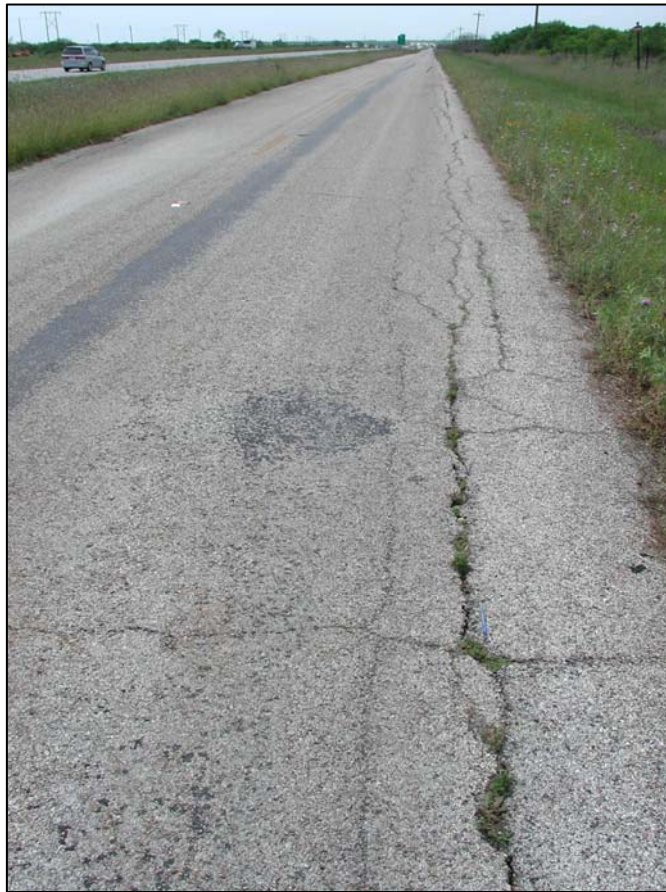
Figure 1.8. I 27 West Side Frontage Road Site 2.

Figure 1.8 shows longitudinal cracks near the edge, and some transverse cracking, at this site. From the crack pattern, the site looks like it may have a treated base.

The larger cracks could be filled and sealed, and the smaller cracks could be sealed. Since there is upcoming contract work on the section, other sites should receive higher priority.

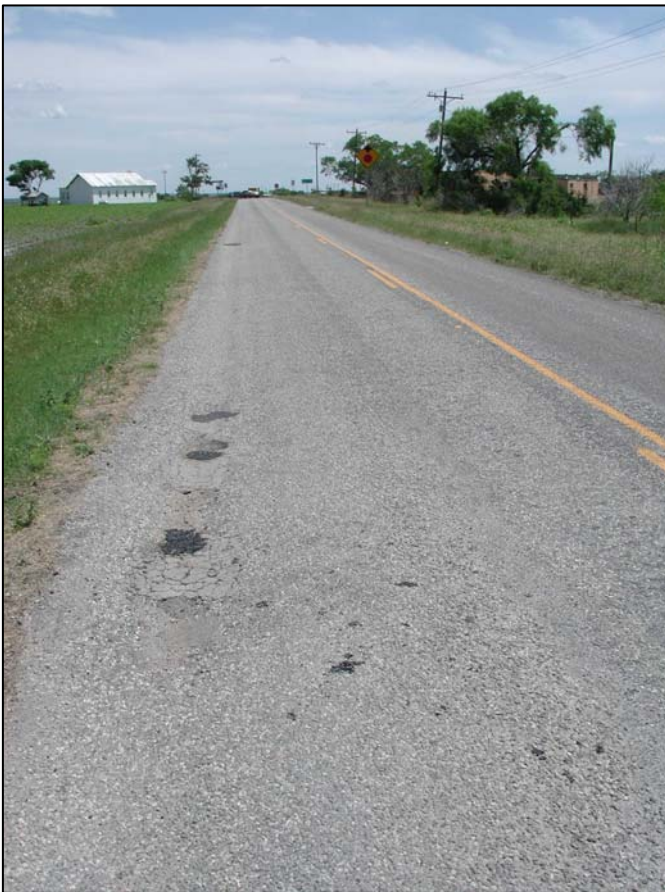
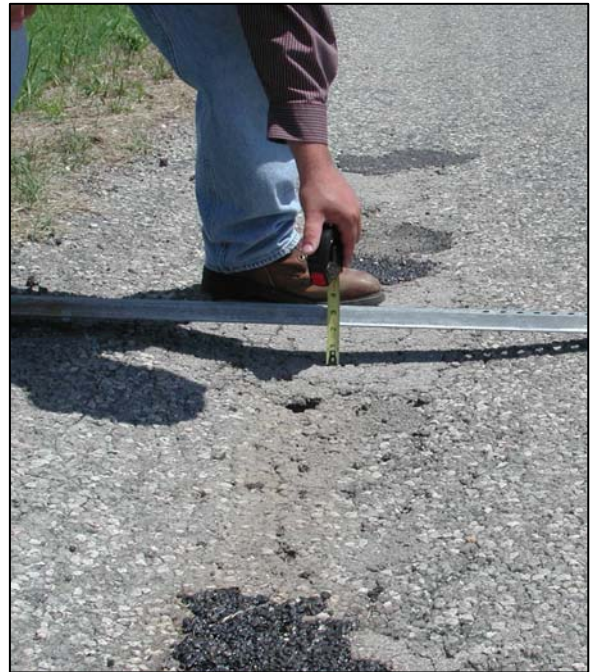
Figure 1.9. FM 2924 by RM 516.

Site has fatigue cracking and approximately 2-inch rut depth at the outside wheel path as shown in [Figure 1.9](#).

Suggestions include reconstructing the edge, if possible widening the edge to increase edge support, and consider increasing the base thickness.

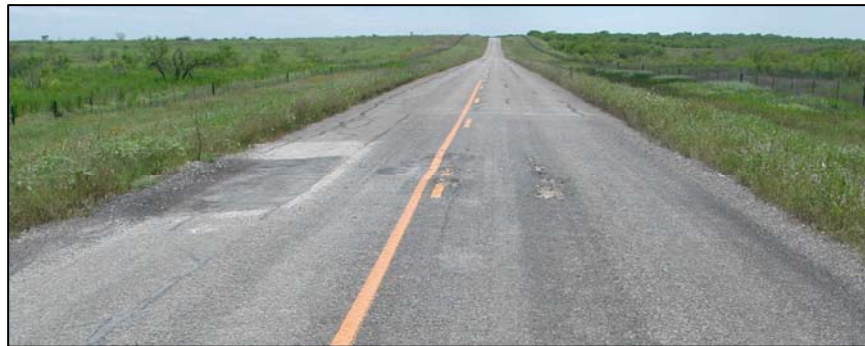
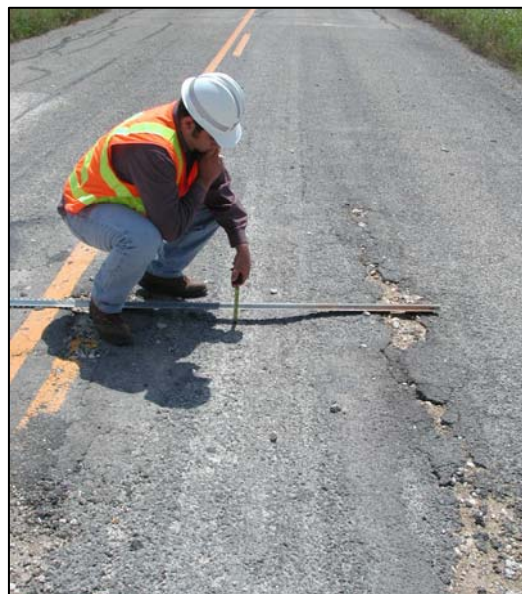
Figure 1.10. FM 791 West of 74 Ranch.

Greater than 2-inch rut depth exists in the wheel paths, popouts are occurring, and bare base is exposed. The existing pavement structure appears to be cement treated based upon the block cracking present. The distressed section already has seen maintenance activity.

Reconstruct the section. Both wheel paths are rutted, so there is a layer (base/subgrade or both) that is deficient. Prior to the work, try to verify the condition of the subgrade soil. From the wide rut widths it seems the subgrade may be weak and either a subgrade treatment or a thicker base is needed. Edge support also may be lacking at this site; if possible extend the road width to keep the wheel paths from being right at the edge. Proof roll the subgrade after the existing base is removed to identify weak spots. Try to find a good quality, non-moisture susceptible base, and make sure it gets compacted adequately.

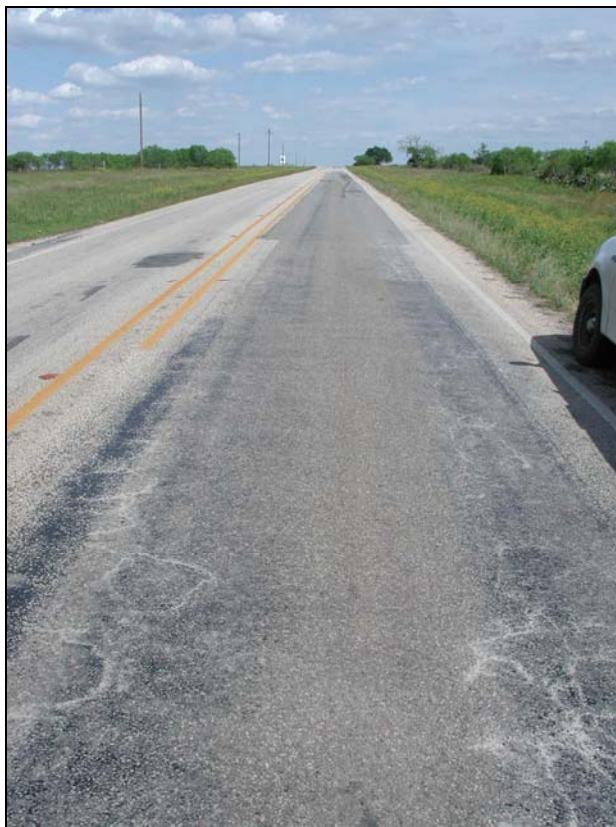
Figure 1.11. SH 173 West of SH 16.

Medium-severity fatigue cracking exists in both wheel paths; rutting also exists and there are numerous maintenance patches throughout the section. Contract rehab work is being initiated on the road. [Figure 1.11](#) shows the section.

Do nothing, since under the contracted rehab the contractor must keep the road passable.

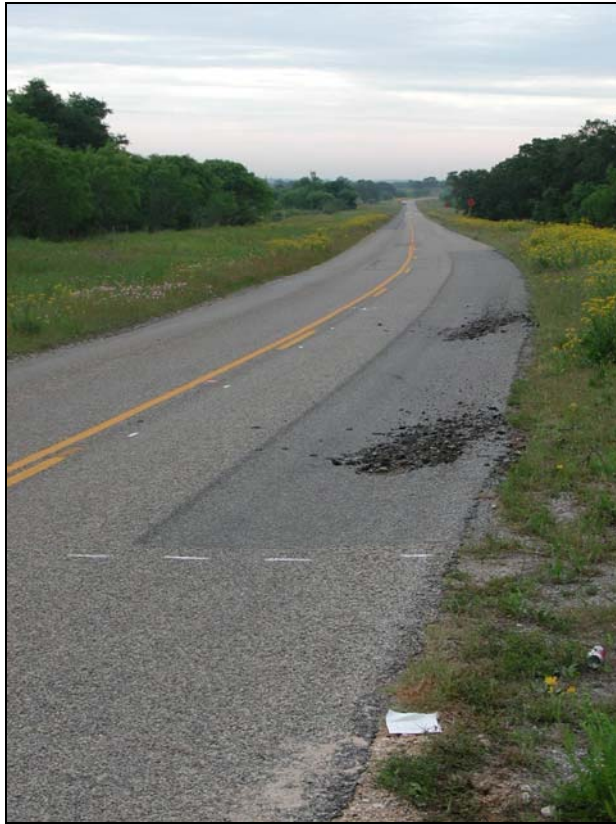
Figure 1.12. FM 3335 Just East of RM 526.

Cracking, shoving, and popouts occurred at the outside edge, as shown in [Figure 1.12](#). The pavement structure is a sandy clay subgrade with a poor quality sandstone base.

A base repair is necessary; consider widening the section for more edge support.

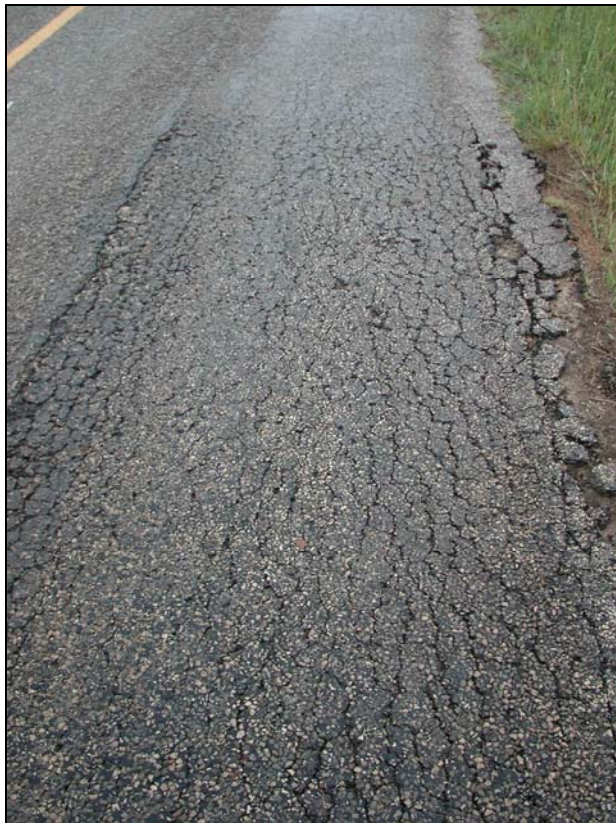
Figure 1.13. FM 3335 Fatigue Cracking.

This site, shown in [Figure 1.13](#), has severe alligator cracking covering more than half the width of the lane.

A full-depth repair is needed. On this road, TxDOT has had good success with using cement mixed in with the existing material.

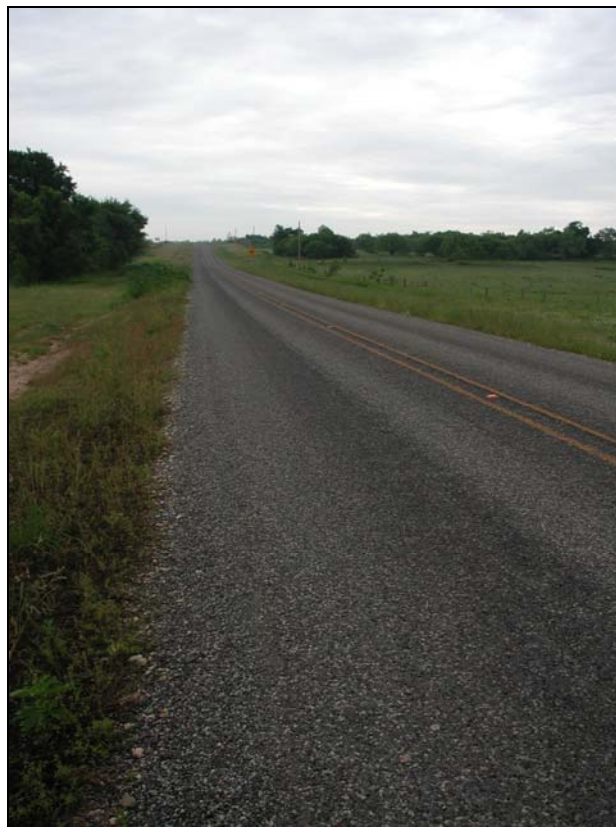
Figure 1.14. FM 3335 from FM 1107.

Figure 1.14 shows a section on FM 3335 from the intersection with FM 1107 to approximately 3000 ft east of FM 1107 that TxDOT maintenance forces rehabilitated in the summer of 2003. Prior to the work, the section had numerous locations with edge failures and popouts (like Figure 1.12) and fatigue cracking (like Figure 1.13). TxDOT treated the existing sandstone base with cement, then added 9 inches of new limestone flex base. As of this report date there is no distress in the section.

Not Applicable. Site is shown to illustrate good performance of TxDOT repair. One method suggested in the field guide is treating the existing base, and if the pavement is structurally inadequate the guide suggests consideration of an additional base thickness. At this site, TxDOT performed both, and the results were good.

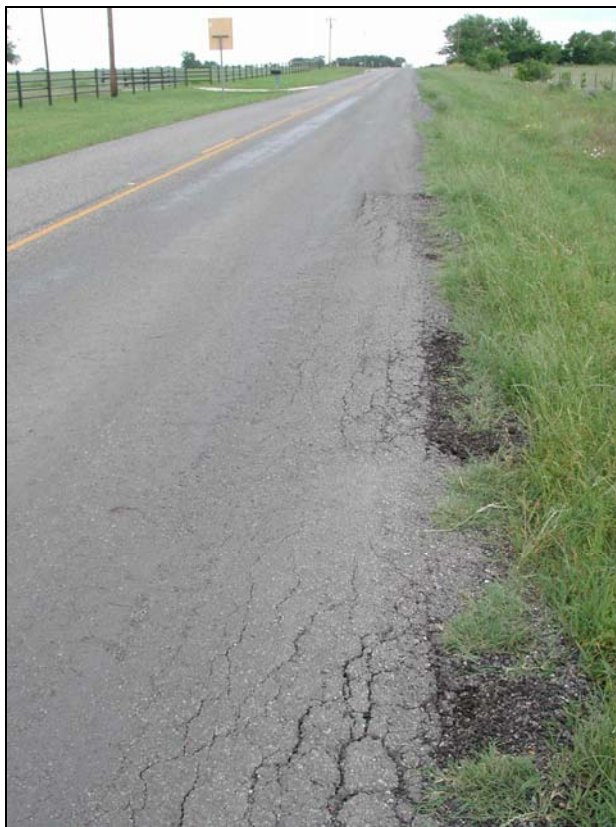
Figure 1.15. FM 775 Site 1.

Medium-severity fatigue cracking exists at the outside edge, along with some rutting, as shown in [Figure 1.15](#).

A base repair is needed; consider widening the edge for increased edge support.

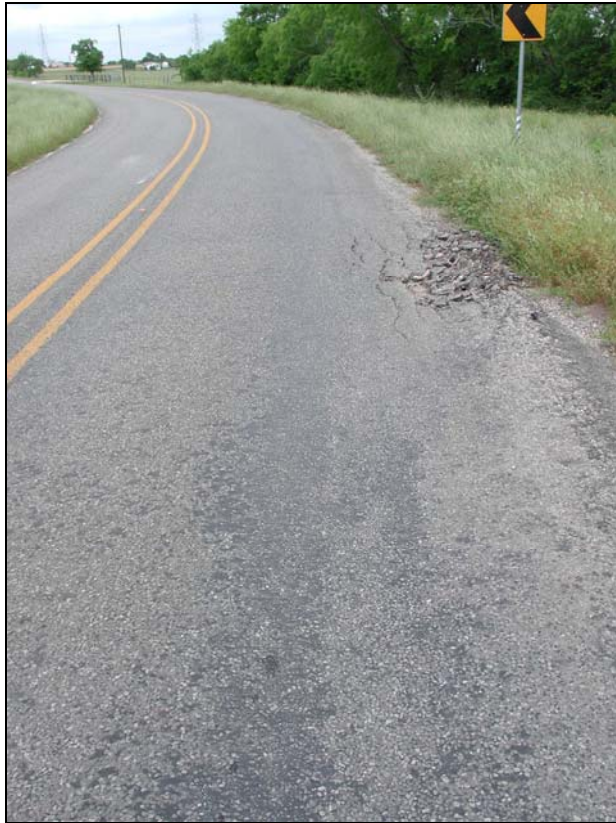
Figure 1.16. FM 775 Site 2.

Figure 1.16 shows the extensive cracking, popouts, and shoving occurring at the site.

A full-depth patch is needed. A stabilized base and a widened edge would decrease the likelihood of the problem reoccurring.

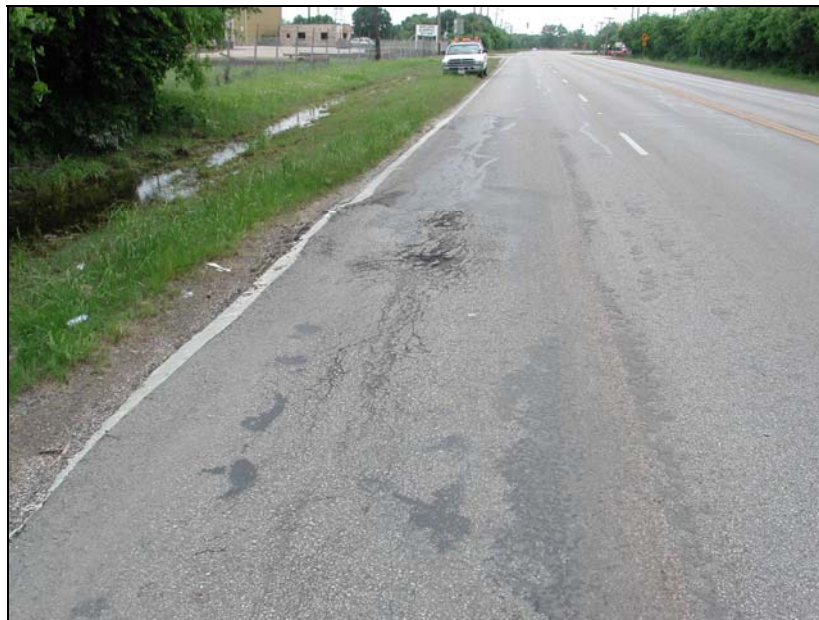
Figure 1.17. Loop 13.

The hot-mix surfacing on this pavement structure is approximately 15 years old. This site has extensive cracking and shoving occurring, as shown in [Figure 1.17](#).

Problems at this site may be partially caused by excessive moisture and lack of edge support. A base repair is suggested that addresses both issues. Utilizing a base repair with non-moisture susceptible materials and increasing edge support should provide a good repair.

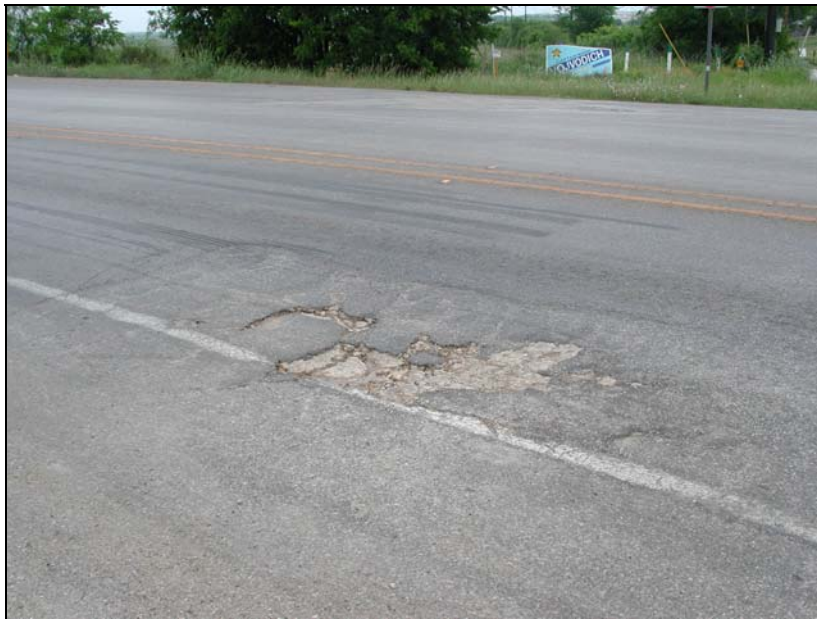
Figure 1.18. FM 1346 at S. Foster.

Figure 1.18 shows the failure at this site. Wide, deep ruts exist along with fatigue cracking.

A full-depth repair is warranted at this site and based upon the wide rutting, an increased base thickness and/or a subgrade treatment should be used.

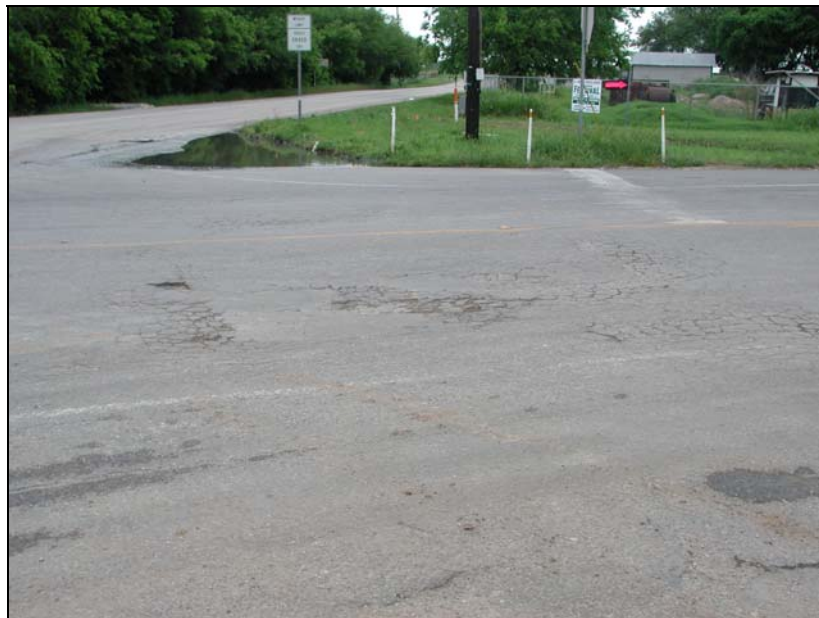
Figure 1.19. FM 1346 at FM 1516.

This site is at a four-way intersection. High- to medium-severity fatigue cracking exists as shown in [Figure 1.19](#), with some popouts starting to occur.

The extensive cracking across all the lanes at this site indicates more than a surface treatment is necessary. A full-depth repair, or perhaps removing the cracked surface and placing hot-mix asphalt (HMA), would be suggested treatment options.

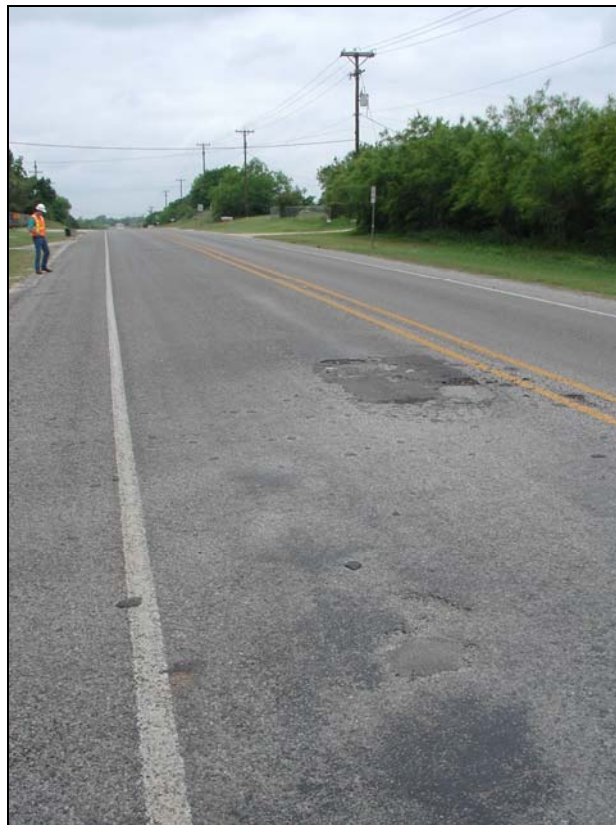
Figure 1.20. Loop 106.

Figure 1.20 shows the failure location at this site. Fatigue cracking with rutting and popouts has occurred; maintenance has already applied patch material to the surface, but the problem area has rapidly expanded beyond the area of the surface patch. Fines are pumping from the cracks. The maintenance supervisor reported a nearby project resulted in extensive heavy truck traffic, which caused rapid deterioration in the pavement structure.

A full-depth patch is warranted. Assuming the problem was accurately diagnosed as resulting from a sudden and temporary increase in truck traffic, a patch to solid material with a base of similar quality as the existing material should suffice.
