**PERFORMANCE REPORT ON JOINTED CONCRETE PAVEMENT
REPAIR STRATEGIES IN TEXAS**

Report 0-4517-1

Project 0-4517

Project Title: Develop Statewide Recommendations for Application of PCC Joint Reflective
Cracking Rehabilitation Strategies Considering Lufkin District Experience

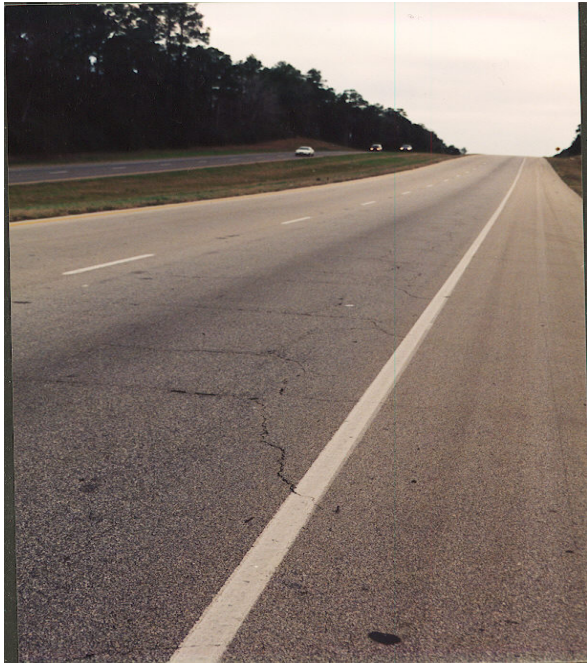
a) Section R4 Arkansas Mix (2000)

Section R4 has also reasonably good performance. This section consists of the large stone Arkansas mix, which is largely still the 1992 materials. There are some reflection cracks in the surface, but the overall ride is still good.

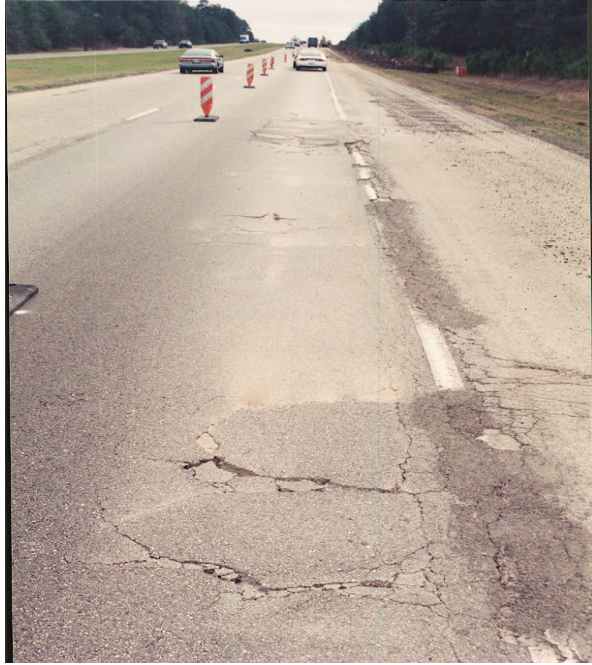
b) Section R2 Crack and Seat (2000)

- The best performing section was section R3 with no distress and a good ride.
- Section 4 was performing well. There was minor block cracking in some areas, but the overall ride was very good.
- The other sections were not performing well. The worst performing section was the crack and seat (R2), which was continuing to give structural problems.

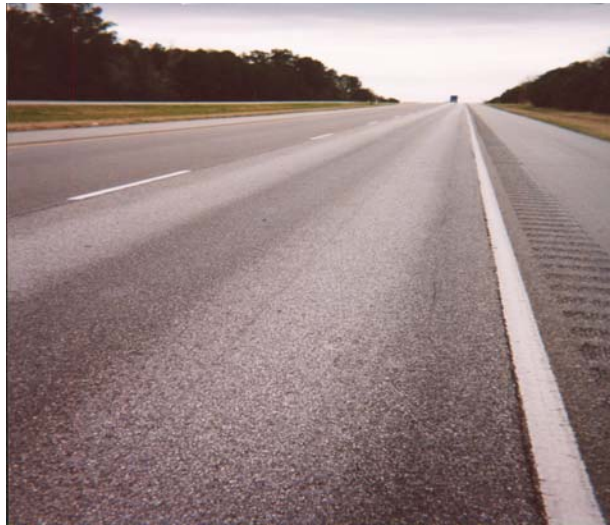
c) Flexible Base Overlay (section R3) (2000)

These conclusions were very interesting. Section 3 was the granular overlay, which initially rutted and cracked badly. Cho et al. reported that in 1995 (three years after original construction) the section had 450 sq. feet of alligator cracking (2). In 1997, the 3 inch surfacing in the outside lane was removed and replaced with 3 inches of new HMA. As reported in 2000, after three additional years in service the repaired lane in Section 3 was performing excellently with no apparent surface distress and excellent ride. The outside lane has the original HMA surface and it is severely cracked. It was, therefore, concluded that the initial poor performance of this section was attributed to a poor surfacing layer.

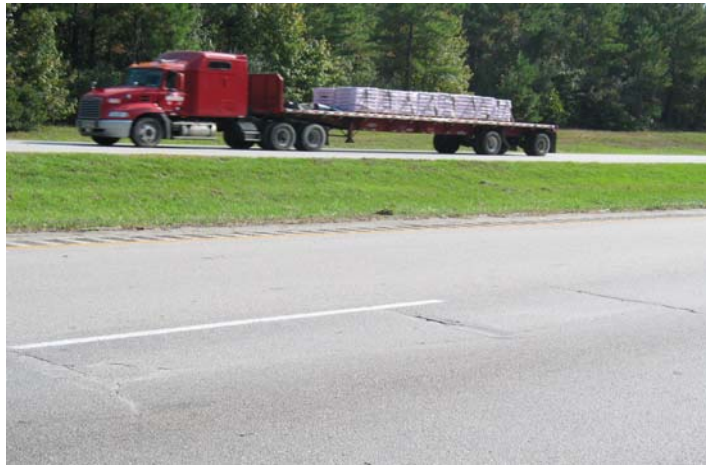
Section R1 continued to exhibit reflection cracking. Maintenance forces have placed additional patches on the section. [Figure 3](#) shows the condition.

Figure 3. Section R1 in 2003, Additional Patching with Reflection Cracking.

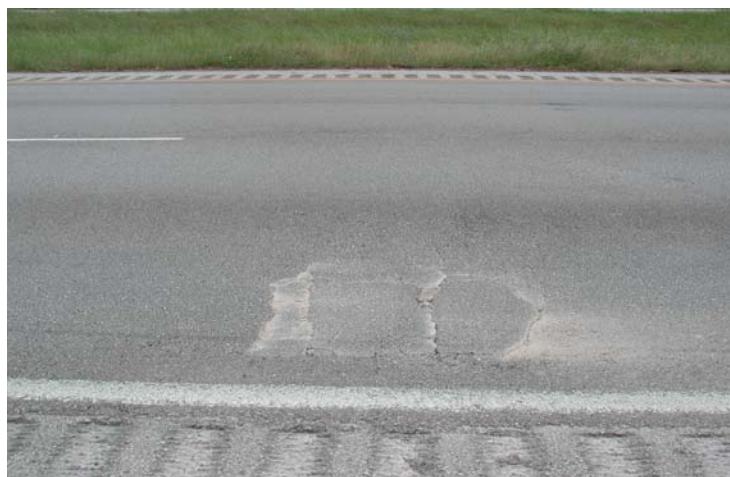
Sections R2 A and B continued to perform poorly. The cracked slabs appear to be unstable, and there are substantial failures with pumping, as shown below in [Figure 4](#). Maintenance forces have placed additional patches on the section.

Figure 4. Continued Failures in Section 2B the Crack and Seat Section after Multiple Repairs.

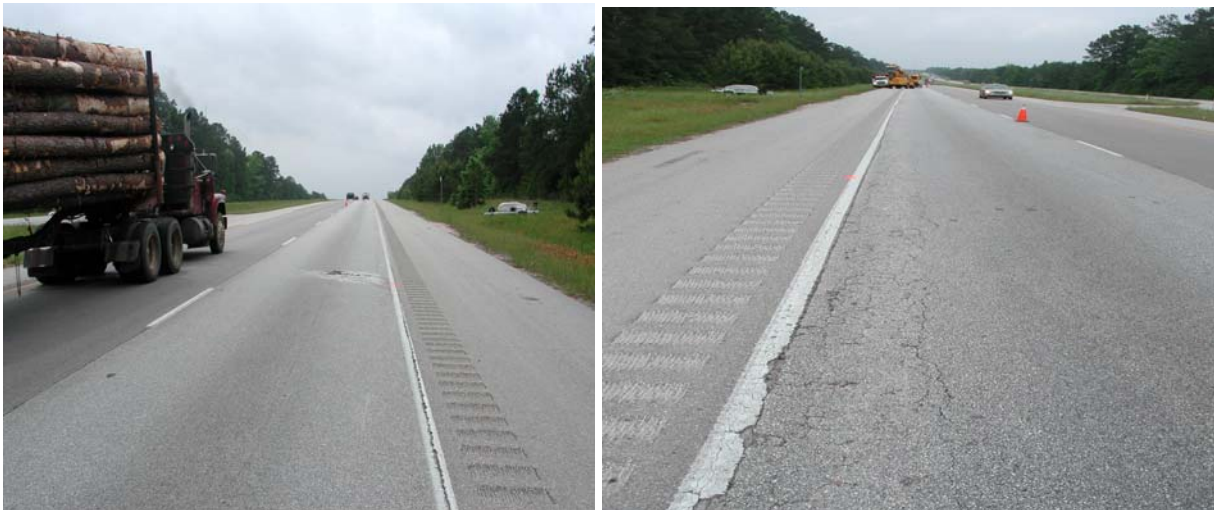
Section R3 was performing very well. As shown below in [Figure 5](#) there was no reflection cracking and only a small area of alligator cracking. However, the alligator cracking was confined to an area where the pavement shoulder had been replaced in 2000 to accommodate the MLS testing. The new shoulder was cement treated base (CTB), and a wide longitudinal crack was evident at the interface between the CTB shoulder and the flexible base main lanes. The alligator cracking was attributed to water entering this construction joint and weakening the flexible base. The normal and cracked areas of R3 are shown in [Figure 5](#).

Figure 5. Section R3 in 2003 Six Years after Resurfacing.

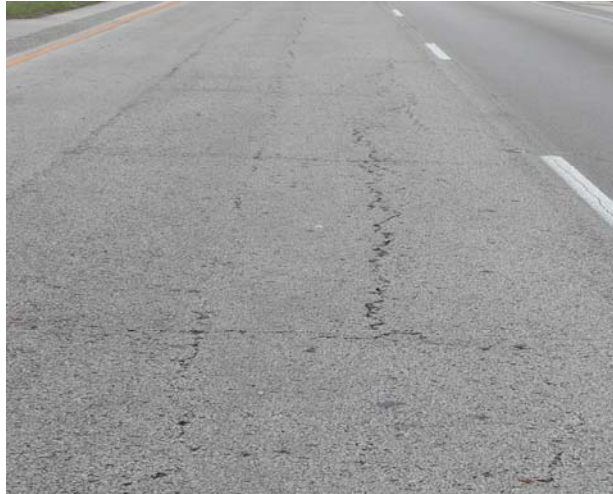
Section R4 was performing well but did exhibit extensive block cracking in the original surface layer as shown in [Figure 6](#). Some reflection cracking was also evident in the outside lane. The ride on the section was good.

Figure 6. Condition of Section R4 in 2003.

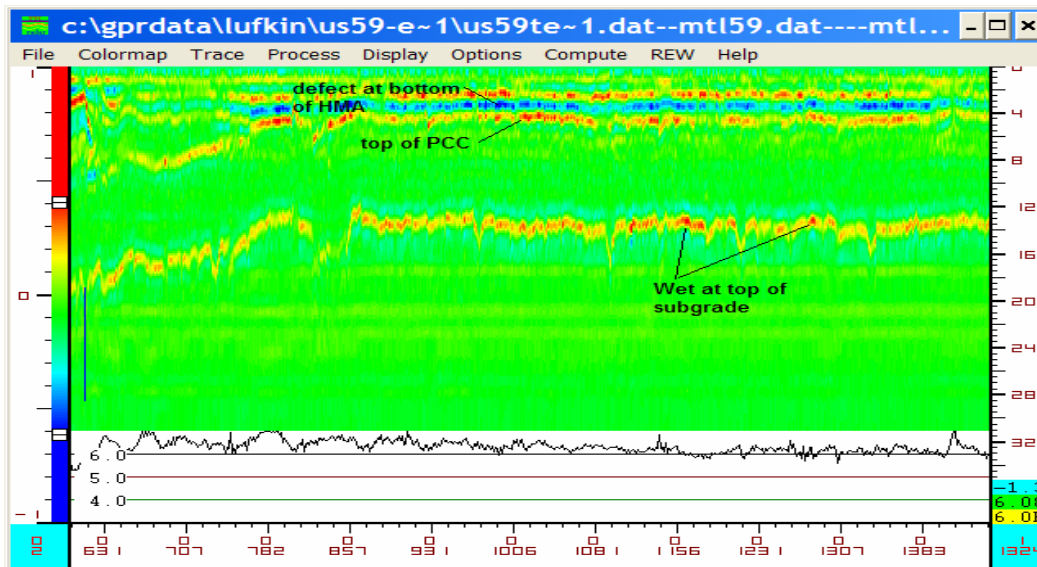
Figure 7. COLORMAP Display from Section R1.

distance scale in miles and feet is at the bottom. All of the pavement layers are visible. A surface removal technique has been used, and the pavement surface is at the top of the figure. The yellow line at approximately 2.5 to 3 inches below the surface is the bottom of the new HMA layer placed in 1997. The next yellow line at approximately 5 inches in depth is the top of the JCP. The line at approximately 13 to 14 inches deep is the bottom of the JCP. This reflection is strong indicating the presence of moisture beneath the slab.

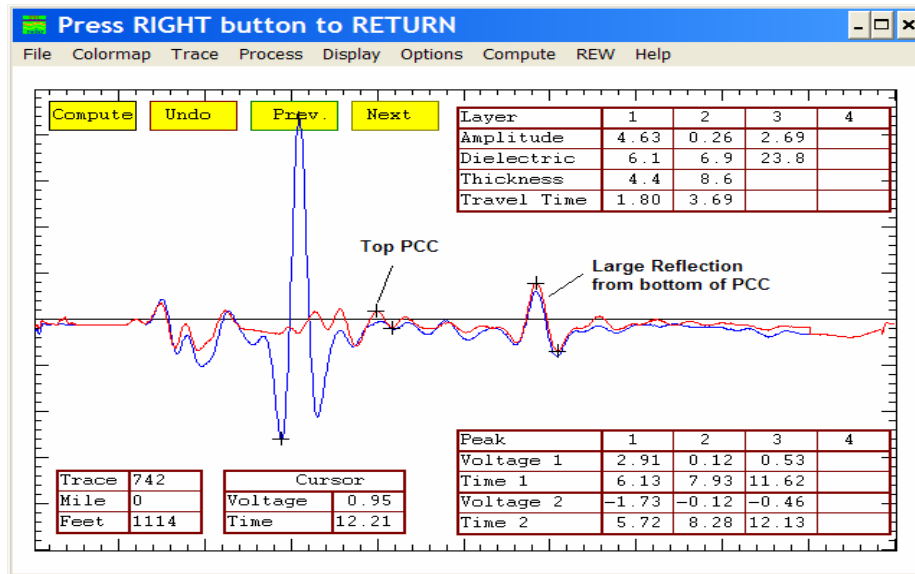
Figure 8. Individual Trace from Section R1.

Figure 8 shows an individual GPR reflection from section R1. The most significant feature of this trace is the large reflection from beneath the concrete. This reflection is an indication that the layer beneath the PCC is wet. The amplitude is higher than normally found from beneath concrete slabs.

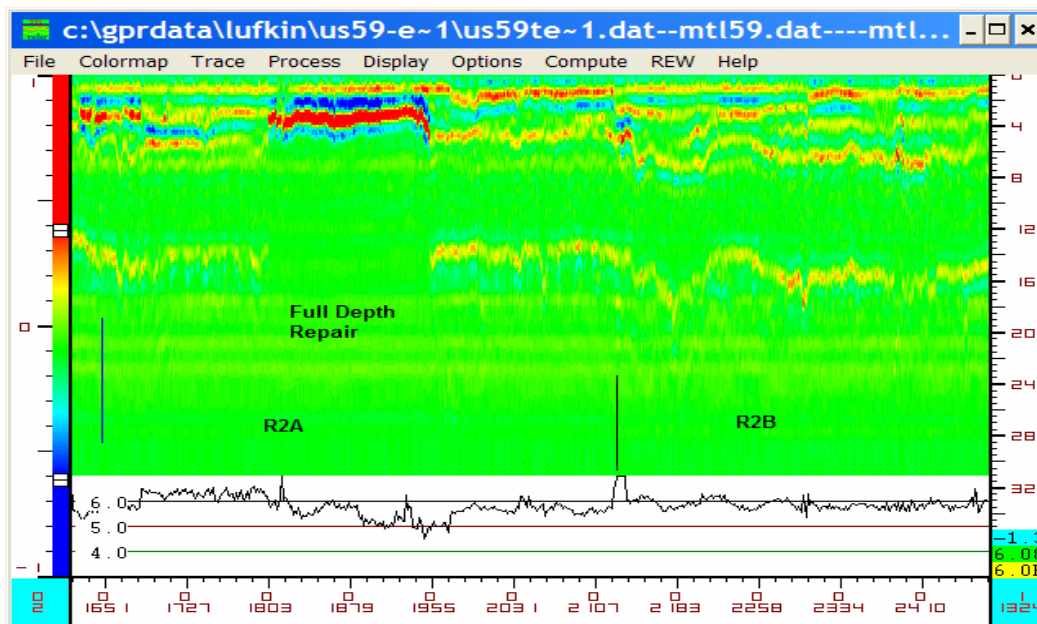
Figure 9. COLORMAP Display from Section R2.

Figure 9 below shows the COLORMAP plot for section R2. In the middle of section R2A (crack and seat plus 4 inches of HMA) the original pavement section has been replaced with full depth repair. This section consists of a thick cement treated base and 3 inches of HMA.

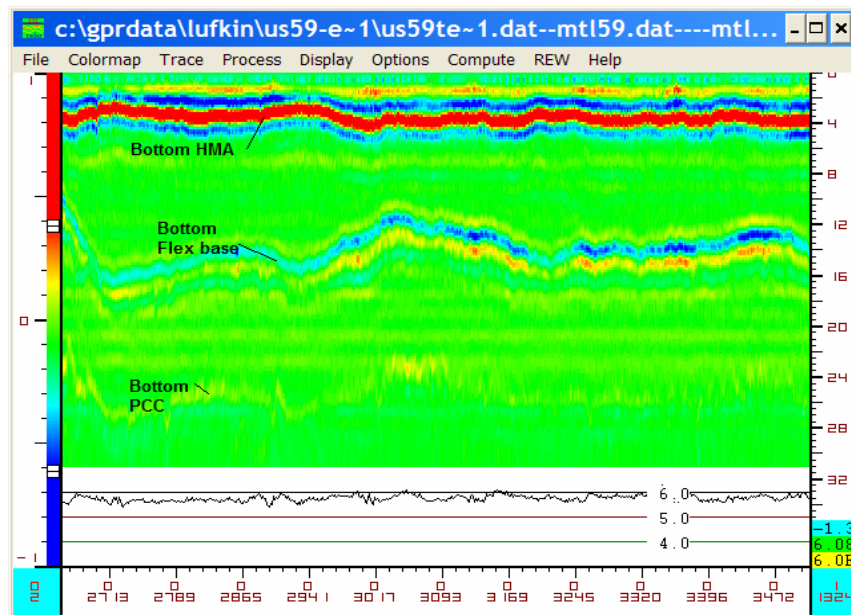
Figure 10. COLORMAP Display from Section R3.

In the original structure strong reflections are still found from beneath the concrete slab. The GPR data from section R3 (flexible base overlay) is shown in Figure 10. All layers in the pavement structure are clear in this figure. The surface is at the top of the figure. The strong red line approximately 4 inches down is from the top of the flexible base overlay. The blue-red-blue interface 12 to 16 inches down is from the bottom of the flexible base. This interface is complex as there was about 1 inch of original HMA left on top of the JCP before the flexible base was placed. The bottom of the JCP is the faint line towards the bottom of the figure. One observation here is that the average flexible base thickness was 8 inches, but that varied from around 10 inches at the beginning of the section to around 6 inches in the middle.

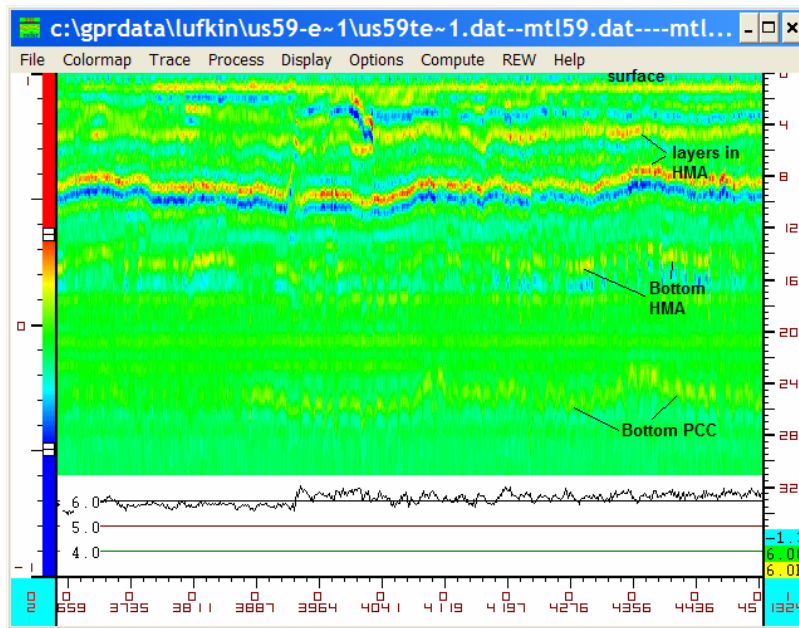
Figure 11. COLORMAP Display from Section R4.

Figure 11 shows the GPR data from section 4. This display is complex because there are many different layers within the HMA layer. The total HMA thickness is between 14 and 16 inches. The reflections from the bottom of the PCC are still visible but fainter than in the earlier figures. The complex nature of the reflections from section R4 is shown in Figure 12, which shows a single reflection. There are multiple reflections from within the structure, and it would have been difficult to estimate layer thickness without prior knowledge of the existing structure.

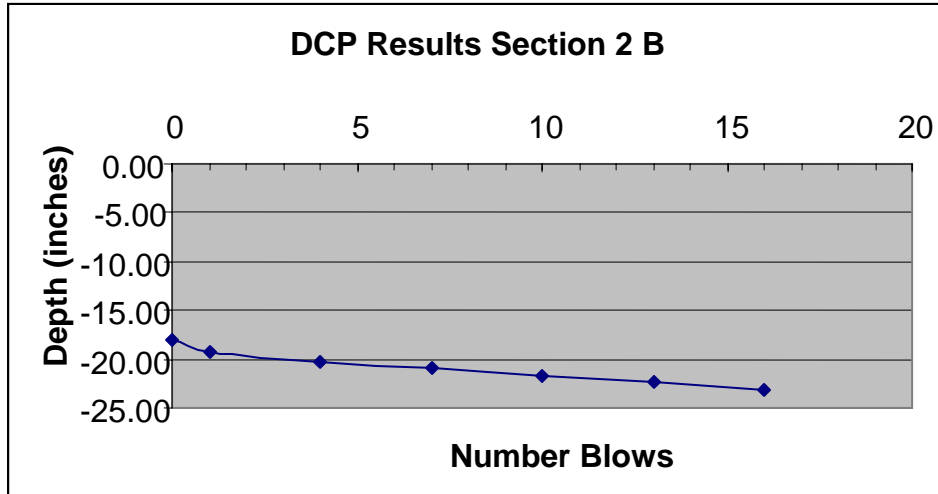
Figure 13. Dynamic Cone Penetrometer Data from Section R2.

Several DCP tests were conducted in sections R1, R2 and R3 to evaluate the subgrade in these sections. The most important information is shown in [Figure 13](#) and [Table 3](#). From the data collected there is a 2 to 3 inch thick layer of weak material just beneath the slab in sections R1 and R2. The base material beneath the slab is unstabilized select material. The estimated DCP modulus for this material is in the mid 20 ksi range, however directly below the slab this drops to around 8 ksi. However, no significant weak layer was found beneath the slab on section R3.

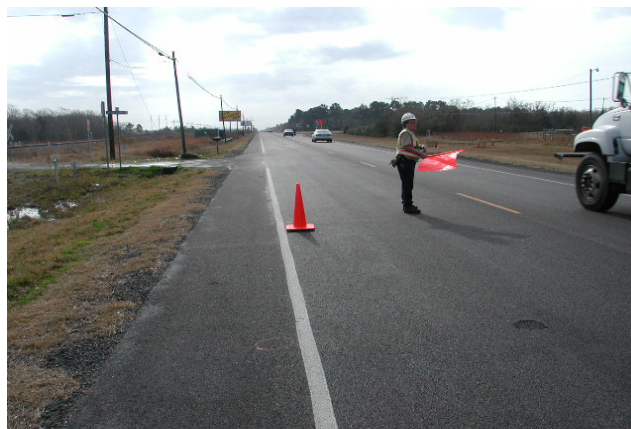
Figure 20. SH 3 Houston District.

Pavement inspection and sampling were conducted after one year in service. Figures 20 and 21 show the condition of the experimental and control sites. Neither the Strata® or Petromat section had any reflection cracks after one year, but most of the reflective cracks were present in the control section. The left lane has the Strata® whereas the right lane has the Petromat. After 1 year in service no cracks were observed in either lane.

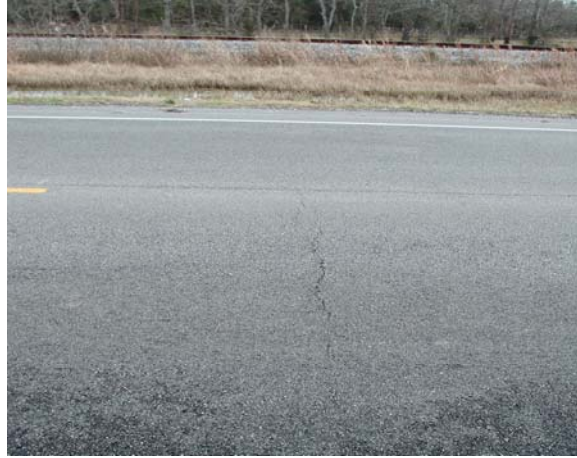
Figure 21. Reflection Cracks in the Control Section after One Year.

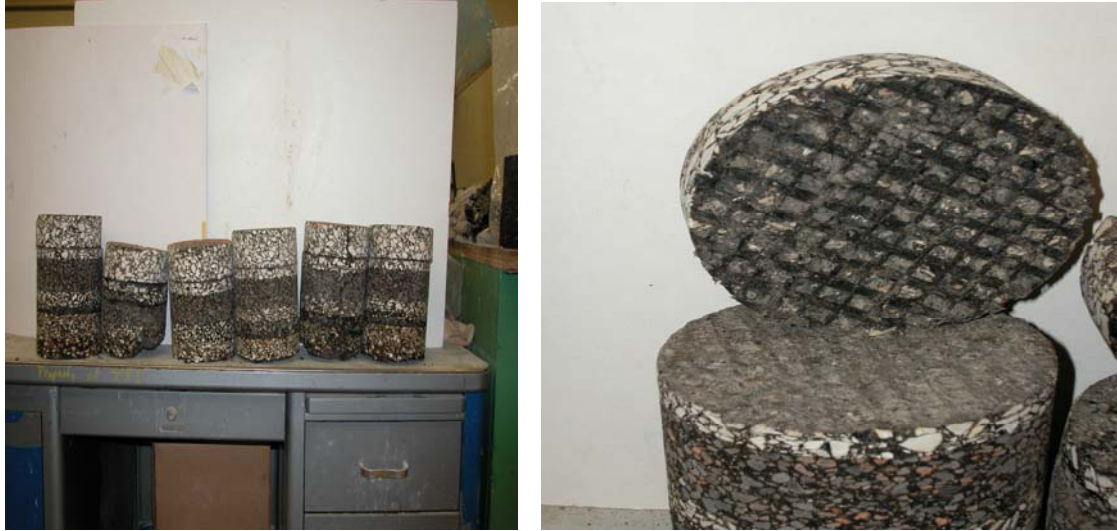
Figure 27. Cores Removed from the Lufkin Section on US 59.

Cores were taken from the GlasGrid® site in July 2003. At that time approximately 60 percent of the cracks had reflected through the grid. The cores are shown in [Figure 27](#). In all cores taken it was clear that the grid did not bond to the lower HMA (level-up) layer. This entire project was resurfaced in late 2003.

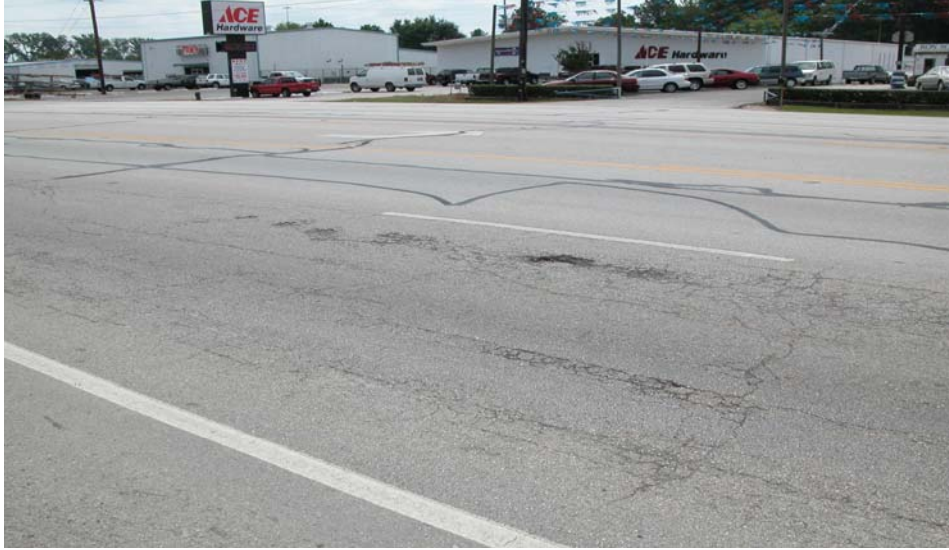
A condition survey was completed in May 2003. At that time both sections had substantial reflection cracking, but the condition of the Petromat section was much better than the GlasGrid® section. The GlasGrid® section is shown in Figures 28 and 29; longitudinal and transverse cracks were present but there was also severe alligator cracking in both wheel paths. In some areas pop-outs were occurring, and the top layer of asphalt was breaking loose. The section was also rough to drive. The typical condition of the Petromat section is shown in Figure 30. The Petromat did not significantly delay the reflection cracks, but the overall condition of the section was reasonable and the ride was still good.

Figure 28. GlasGrid® Section on FM 2920 after Four Years of Service.

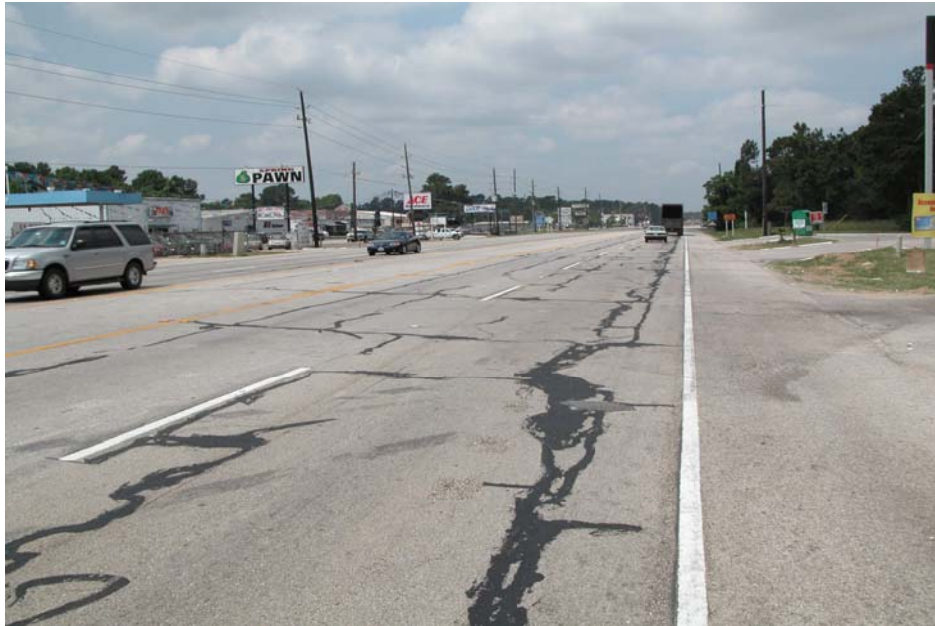
Figure 29. GlasGrid® Section on FM 2920 – Note Deterioration in Wheel Paths.

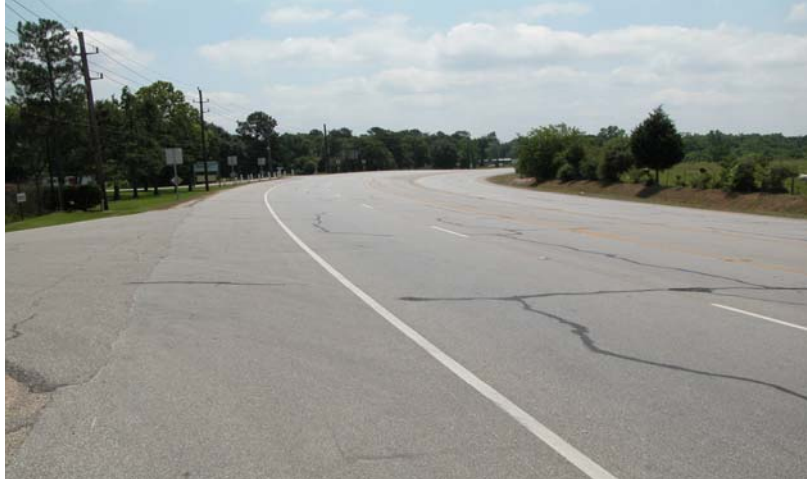
Figure 30. Petromat Section on FM 2920 after Four Years of Service.

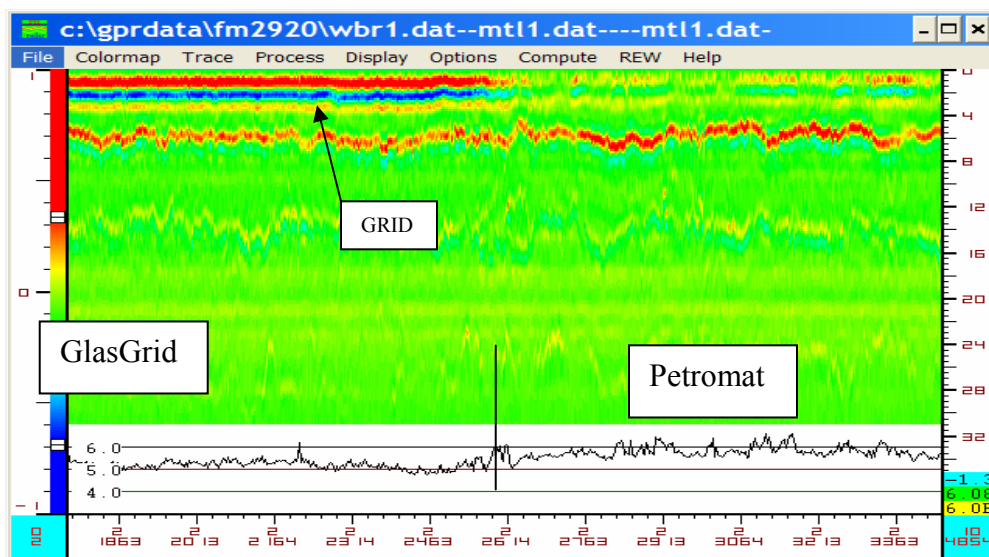
Figure 31. GPR Data from FM 2920 Houston from the Transition between GlasGrid and Petromat Sections.

To further evaluate the performance, ground penetrating radar data were collected on FM 2920. The GPR display from the transition from the GlasGrid® to the Petromat section is shown in Figure 31. The key feature of this figure is the strong reflection from the location of the grid. This red/blue reflection indicates that there is a high moisture interface within the HMA in the GlasGrid® section where none was found in the Petromat section. The moisture buildup could be at the bottom of the surface layer or in a small void left by the grid. More work is needed to identify the cause of this reflection. The interface in the Petromat section is judged as ideal, indicating no discontinuities and good bonding between layers.

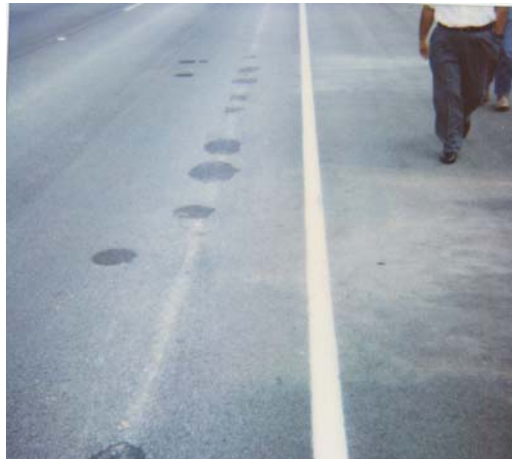
The IH 45 section performed very poorly. The first indication of problems was the occurrence of white powder in the wheel paths. This was followed by localized pop-outs of the surface layer. A photograph of the surface condition is shown in [Figure 32](#). No detailed evaluation was possible as the section had to be replaced within six months of being constructed. The Conroe area office laboratory cored the failed section and noted in all areas that the grid caused debonding with the surface layer.

Figure 32. Failure of the GlasGrid® Section on IH 45, Houston District (1999).

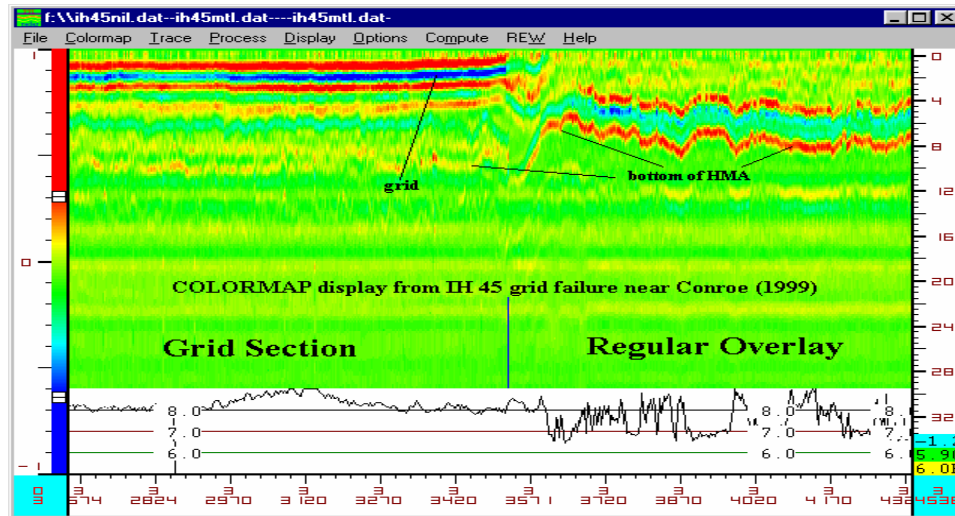
Figure 33. GPR Results from the GlasGrid® Failure on IH 45 (1999).

Just prior to replacement a ground penetrating radar survey was conducted on the failed section. [Figure 33](#) shows the GPR results.

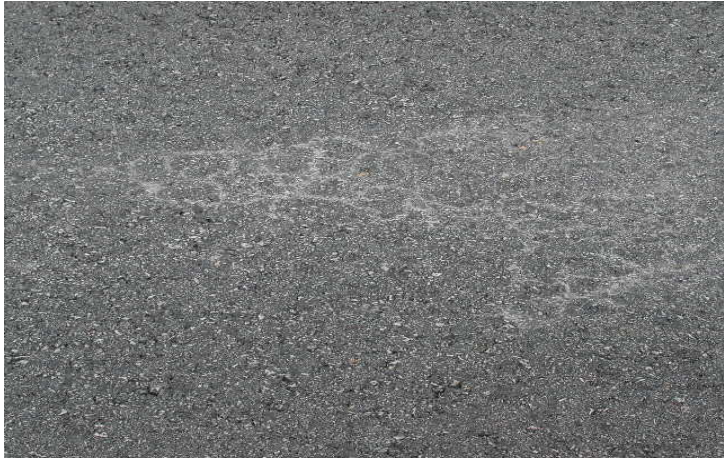
Figure 34. Initial Indications of Problems on GlasGrid® Installation on IH 45 in the Bryan District.

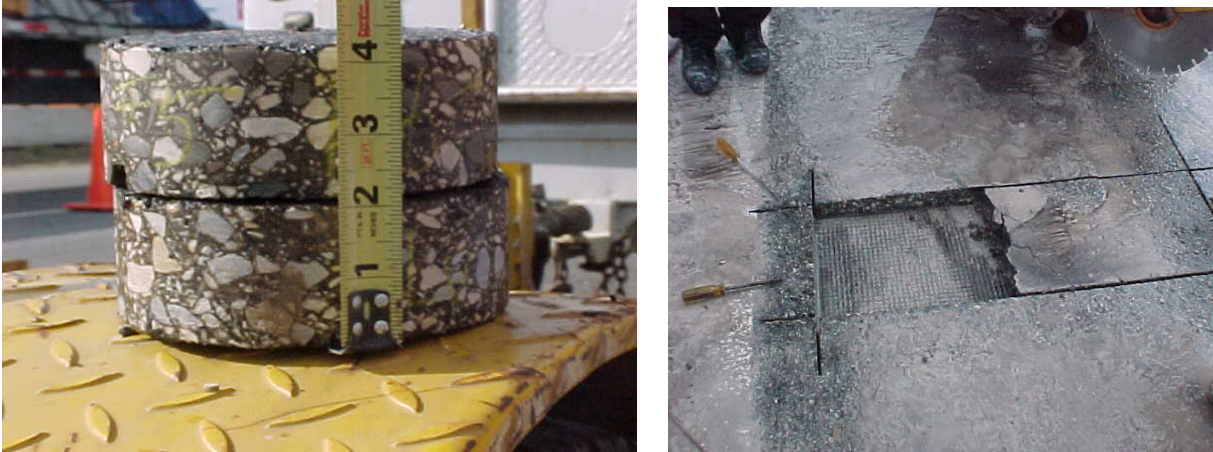
Figure 35. IH 45 Field Cores and Trench from the Failed GlasGrid® Section.

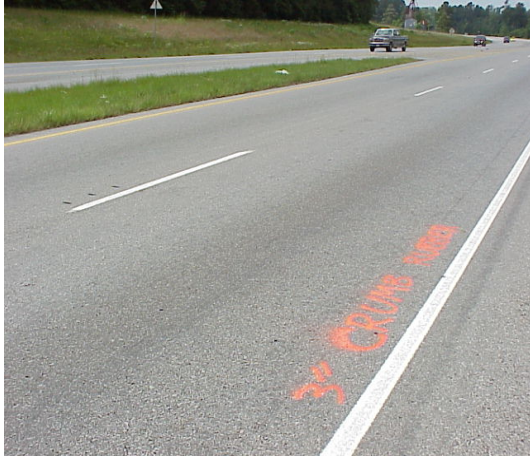
a) Crumb Rubber after 8 Years, Excellent condition

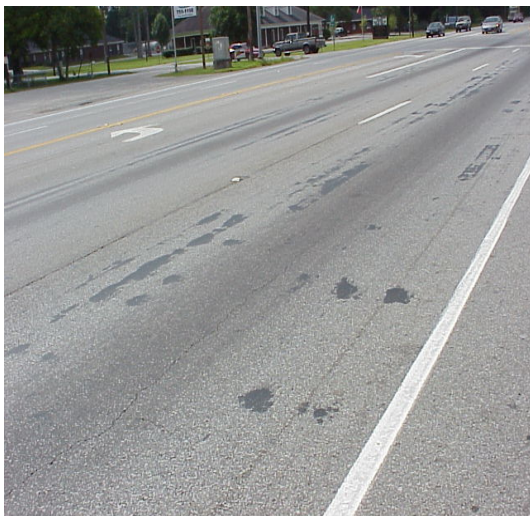
c) GlasGrid® Significant Longitudinal Cracking and Some Transverse

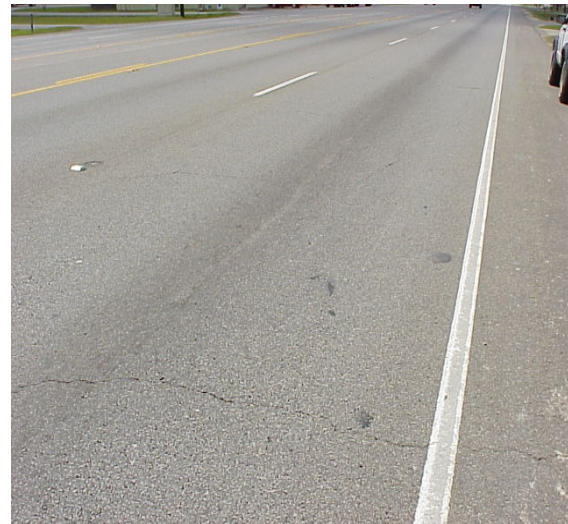
d) Control Section Regular Transverse Cracking

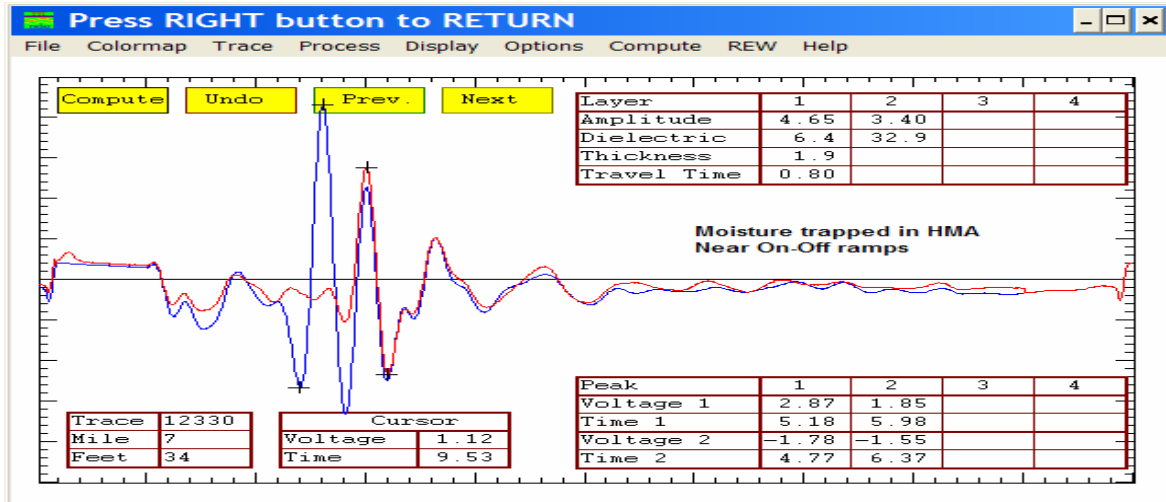
a) Low Severity - Moisture in HMA Layer 2 Inches Below Surface

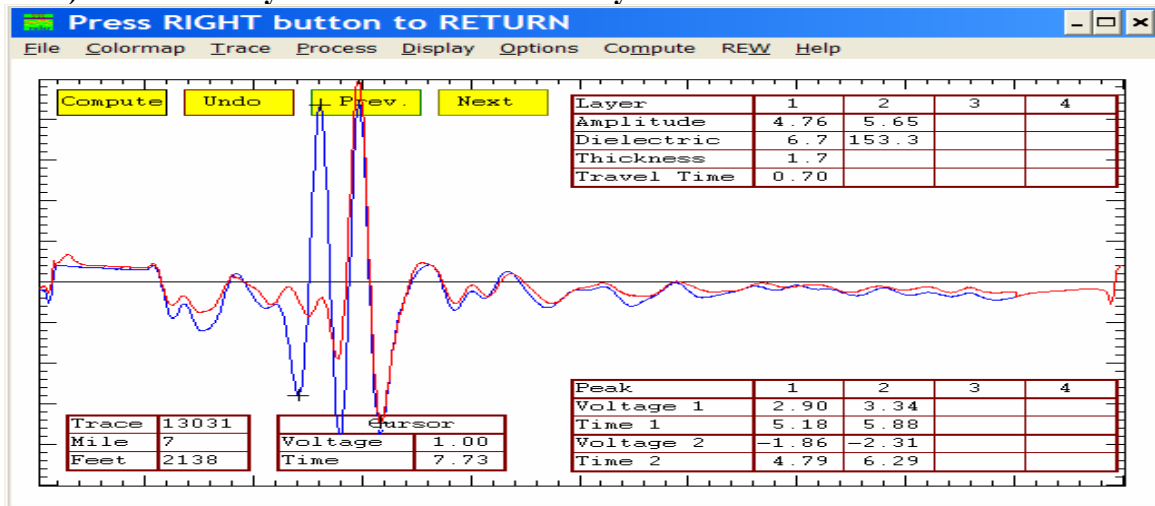
b) Medium Severity - Saturated Layer 2 Inches Down

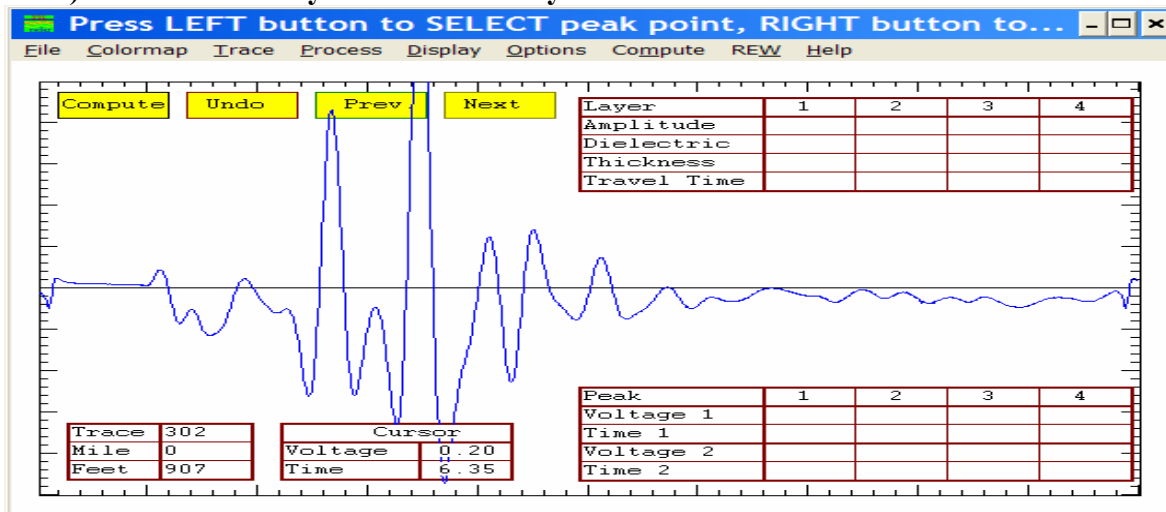
c) High Severity - Unknown Metallic Object, Foil or Metal Paint 4 Inches Below Surface

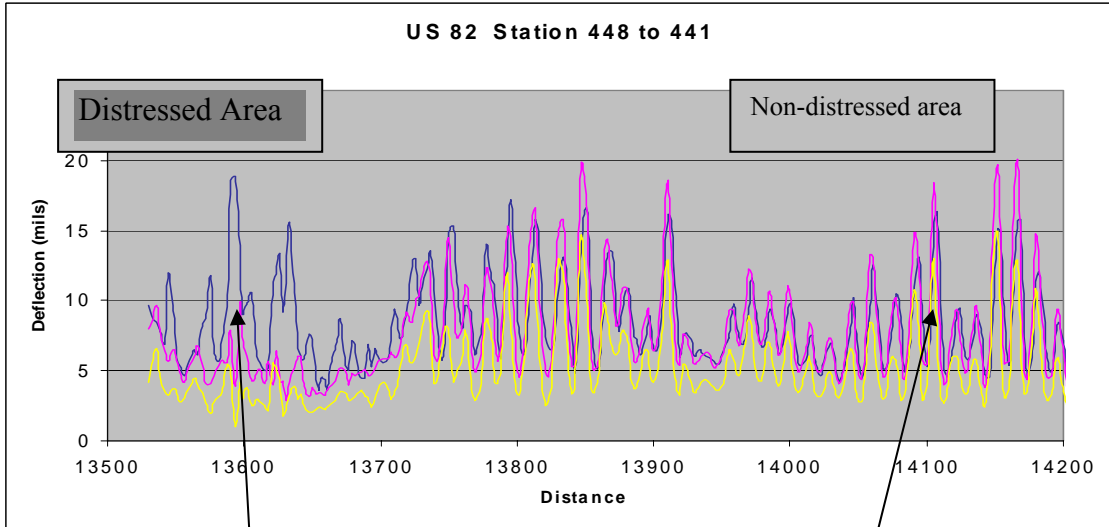
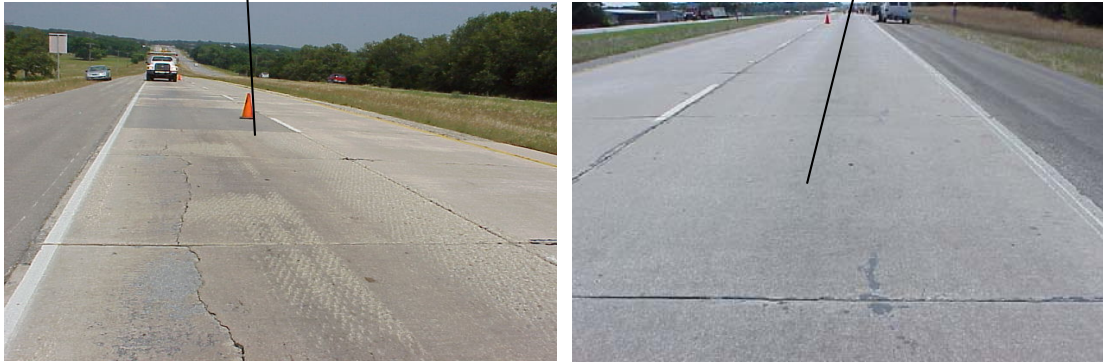
b) Pavement Condition in the Distressed and Non-distressed Area
