METHODS OF REDUCING JOINT REFLECTION CRACKING: FIELD PERFORMANCE STUDIES

Report 0-4517-3
Project 0-4517

Project Title: Develop Statewide Recommendations for Application of PCC Joint Reflective Cracking Rehabilitation Strategies Considering Lufkin District Experience

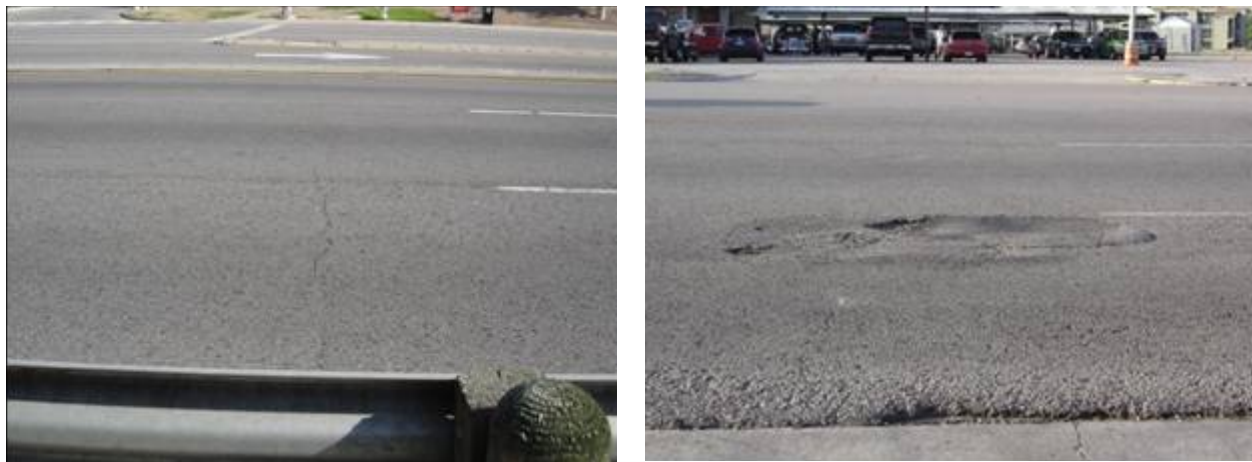
Figure 2. Photograph of Distresses on Loop 12.

The performance of this section was evaluated in June 2005, at an age of 3 years. A windshield visual survey revealed numerous transverse cracks and failures. A detailed visual inspection of 2500-ft of the eastbound section revealed 23 transverse cracks and 3 failures. Photographs of the transverse crack and failure distresses found on the section are shown in [Figure 2](#) below.

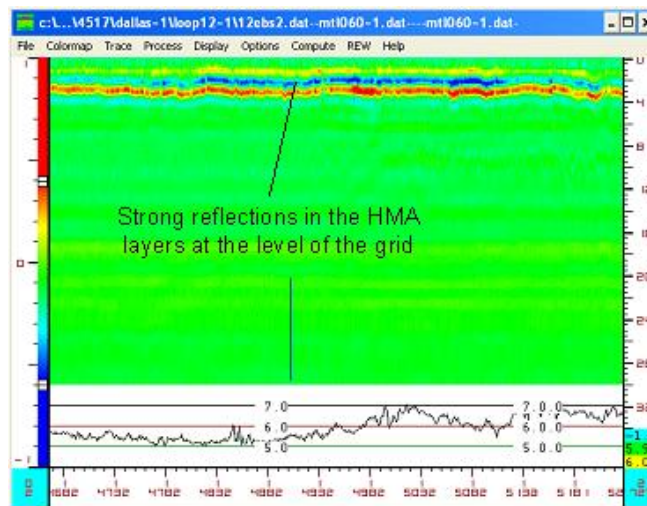
Figure 3. GPR Data Collected on Loop 12.

A GPR survey of the outside wheel path of the slow and middle lanes was conducted. The data show high reflections within the HMA layers at the level of the grid. For sections with grid products, this radar pattern has in the past indicated areas of debonding. The pattern was found over most of the section length of all surveyed lanes in both directions. Typical GPR data are shown in [Figure 3](#) below.

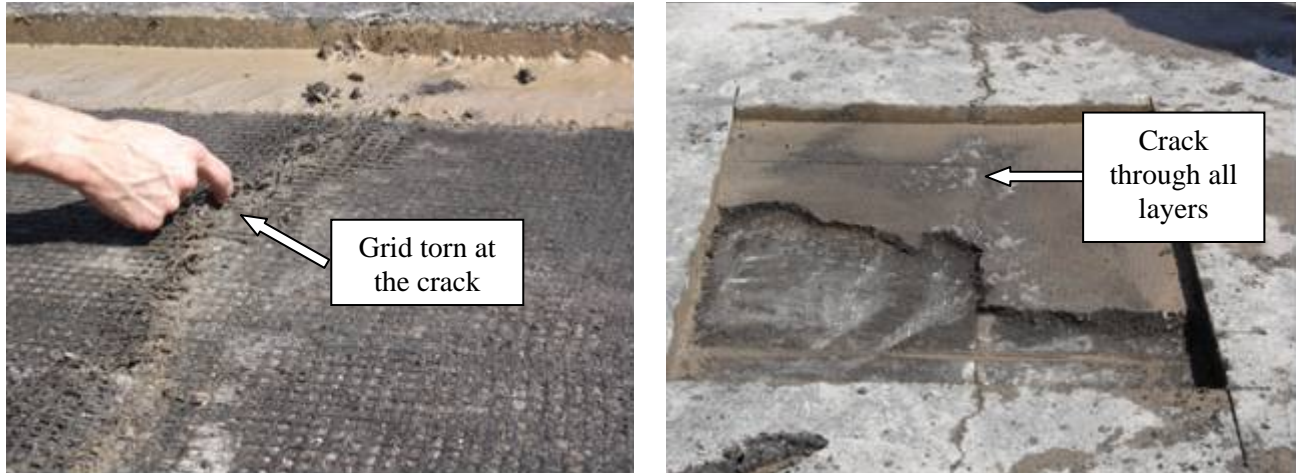
Figure 4. Photographs of a Trench at a Transverse Crack on Loop 12.

The trench with the reflection crack revealed that the surface course was poorly bonded to the grid and the underlying level-up course. The grid easily separated from the surface course when researchers lifted it out. The grid was torn at the crack, poorly bonded to the level-up course, and very weak. It could easily be torn apart by hand. Photographs of the trenching are shown in [Figure 4](#).

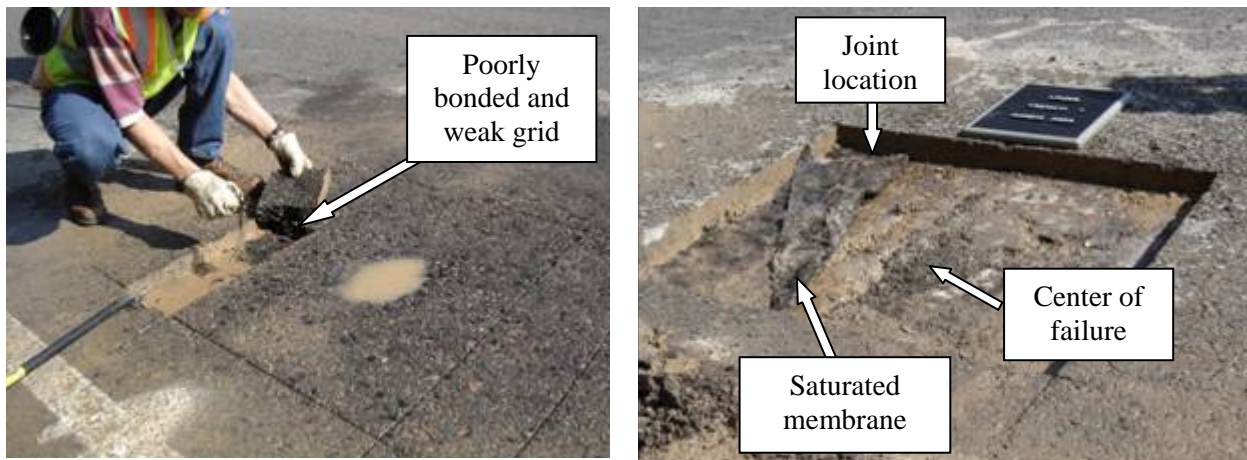
Figure 5. Photographs of a Trench at a Failure on Loop 12.

The trench with the failure revealed poor bonding between the grid and the HMA layers. The grid was severely deteriorated and could easily be torn apart by hand. The level-up layer was severely deteriorated and not well bonded to the underlying membrane over the joint. The membrane was intact and saturated with moisture. The failure did not occur at the joint, but at the edge of the membrane about 1½ ft from the joint where some cold patching seems to have been placed prior to the overlay. The mechanism of how this failure developed is still unclear, but the merits of the membrane at the joint have been questioned by the area office involved on this project. Photographs of the trenching are shown in [Figure 5](#) below.

Based on the radar data collected on this section and the findings from the trenching, it is apparent that the debonding of the asphalt layers at the grid is widespread on Loop 12 and the strength of the grid has deteriorated over the past 3 years. The grid was not highly effective in retarding the reflection of cracks through the HMA layers from the joints in the concrete pavement below.

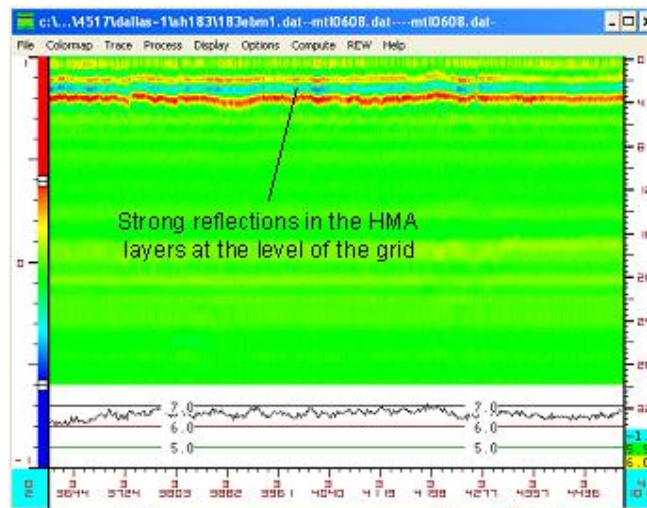
Figure 7. GPR Data Collected on SH 183.

A GPR survey of the outside wheel path showed patterns of high reflections in the HMA layers, which may be associated with debonding. The GPR data from this section is shown in [Figure 7](#).

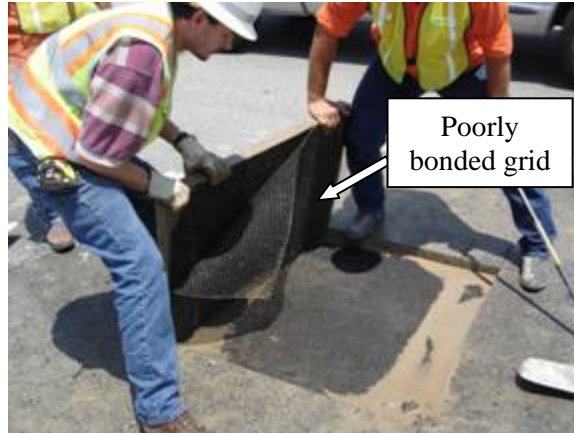
Figure 8. Photograph of a Trench on a Good Section on SH 183.

A trench was cut on the section with the ½-inch GlasGrid product (8501) with no distresses to evaluate the bonding between the layers. The trench was cut in the middle of the lane and not in the wheel path. The trench revealed poor bonding between the grid and both the surface and level-up layers. This condition can be seen in [Figure 8](#). The grid could be torn apart by hand, but not very easily.

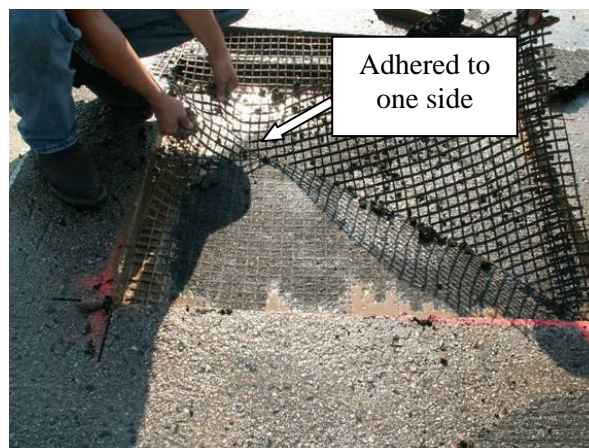
Figure 9. Photograph of a Well-Bonded Grid on SH 183.

Two trenches were cut in the section with the 1-inch GlasGrid product (8511); one at a location without a transverse crack and another at a location with a transverse crack. The trench at the location without the transverse crack revealed good bonding between the asphalt layers. The upper asphalt layer could not be easily lifted out from the trench due to the bond with the lower layers. The grid was firmly stuck to the level-up layer below. With a steady pull, the grid could be removed with tearing, and it dislodged some aggregate from the level-up layer. The bonding of the grid to the HMA layers was good and the condition of the grid was fairly good. A photograph of the grid is shown in [Figure 9](#).

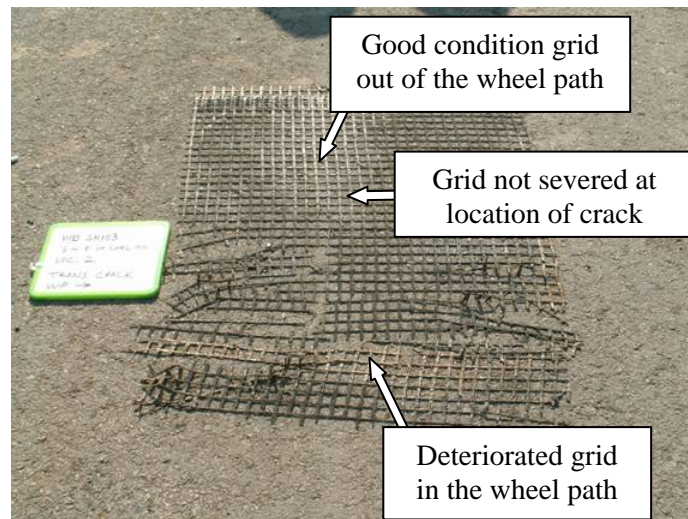
Figure 10. Photograph of an Extracted Grid on SH 183.

The second trench, at the transverse crack, revealed a grid that was poorly bonded to the upper HMA, but adhered to the level-up layer. The condition of the grid appeared to be fairly good out of the wheel path, but poor within the wheel path area. This may indicate that the grid is deteriorating as a result of traffic loading. In this trench, the grid was not severed at the location of the crack. This may indicate that the crack can propagate through the grid without the grid actually severing. A photograph of the grid is shown in [Figure 10](#).

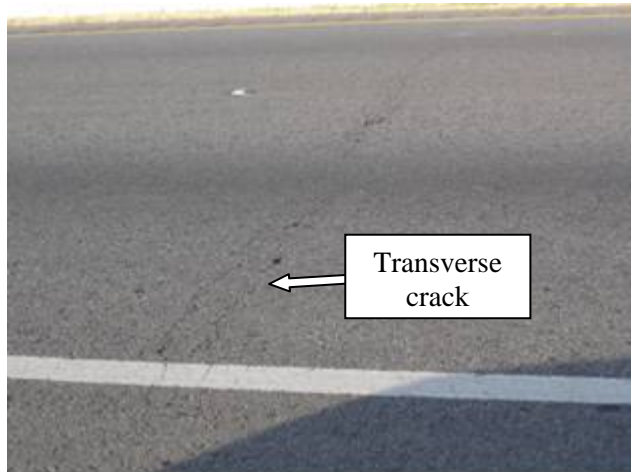
Figure 12. Photograph of a Transverse Crack on US 175.

The performance of this section was evaluated in June 2005, at an age of 2 years. A windshield visual survey revealed several transverse cracks across the full width of the pavement on one stretch of the road. A photograph of a typical distress is shown in [Figure 12](#).

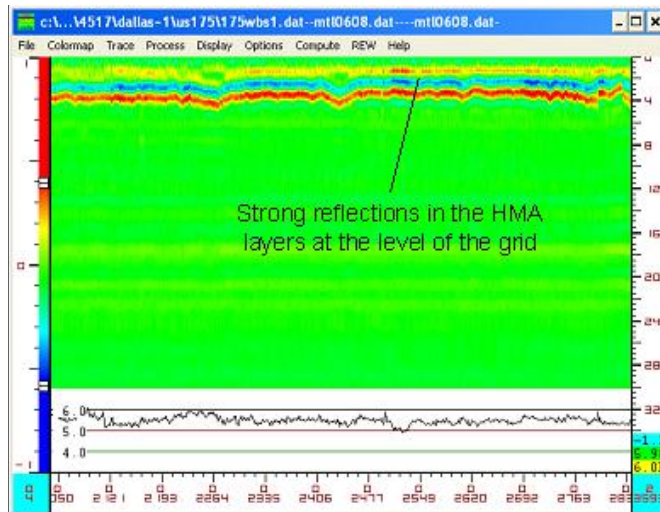
Figure 13. GPR Data Collected on Westbound US 175.

A GPR survey of the outside wheel path of both lanes was conducted. The data show high reflections within the HMA layers at the level of the grid, which may indicate debonding. The pattern was found over almost the entire section length of both the outside and inside lanes. Typical GPR data are shown in [Figure 13](#).

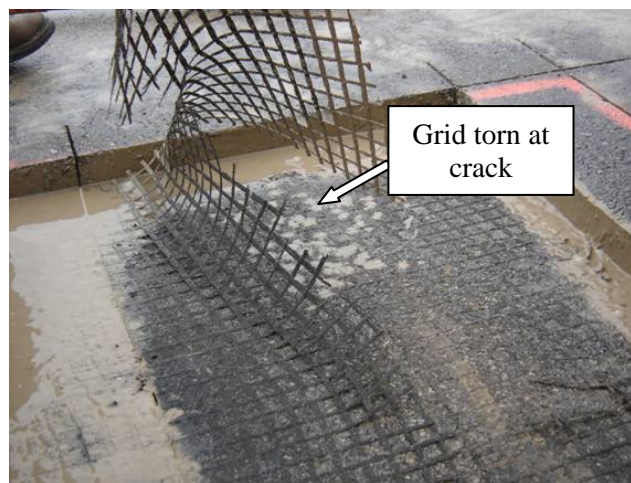
Figure 14. Photograph of a Trench at a Transverse Crack on US 175.

Two trenches were cut on the section. One trench was cut at a joint with a transverse crack and another at a joint with no transverse crack. The trench with the crack revealed that the grid was poorly bonded to the upper asphalt, but well bonded to the level-up layer, which was probably a result of the tack that was used. The grid was torn at the location of the crack. The grid was fairly strong, but could be torn apart by hand with some effort. A photograph of the trench is shown in [Figure 14](#).

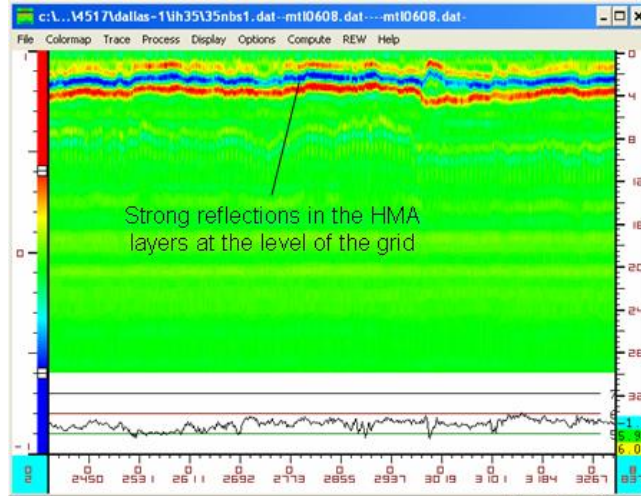
Figure 16. GPR Data Collected on IH 35E.

A GPR survey of the outside wheel path of both lanes was conducted. The data show high reflections within the HMA layers at the level of the grid, which may indicate debonding. The pattern was found over almost the entire section length of both the outside and inside lanes. Typical GPR data are shown in [Figure 16](#).

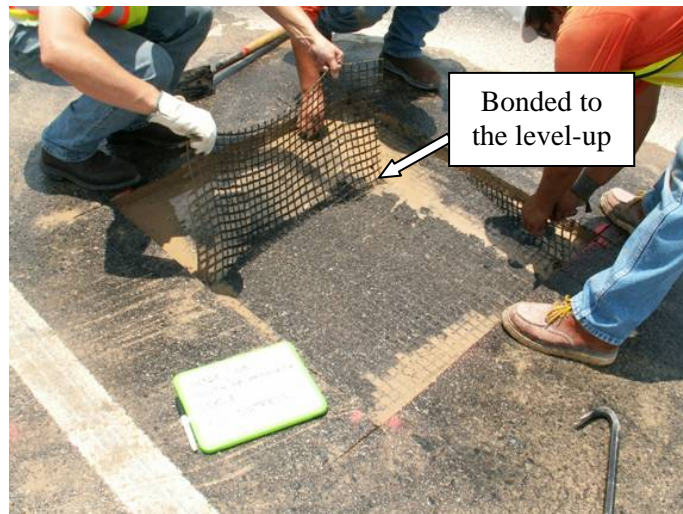
Figure 17. Photograph of a Trench on IH 35E.

Two trenches were cut on this section. Both were at locations with no distresses. Both trenches revealed poor bonding to the upper HMA layer, but good bonding to the level-up layer. The good bonding may be a result of the tack coat that was used. The grid was in good condition and strong. A photograph of the well-bonded grid is shown in [Figure 17](#).

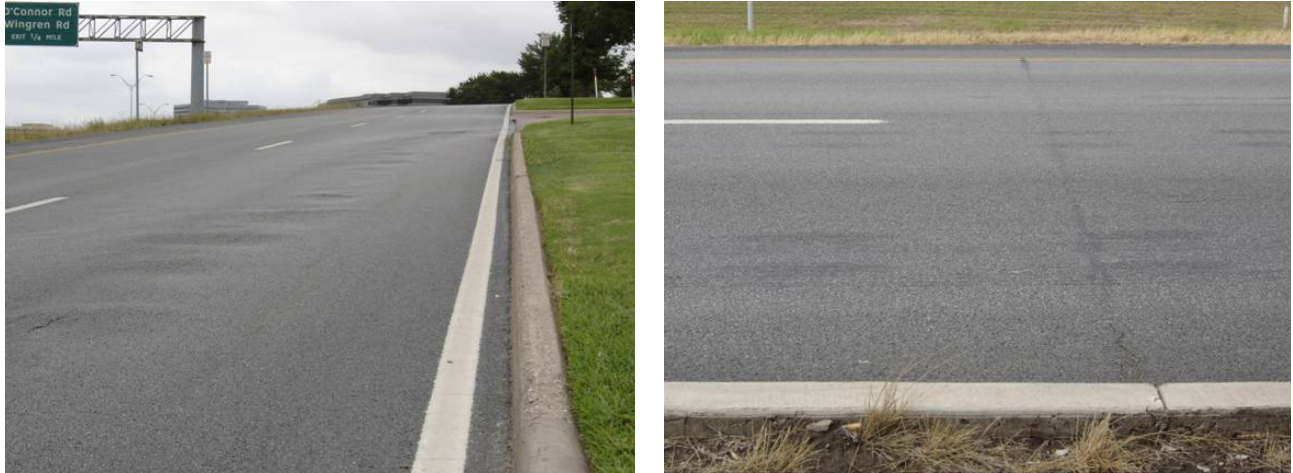
Figure 26. Photographs of Shoving and Transverse Cracks on SH 114.

The performance of this section was evaluated in June 2005, at an age of 2 years. A windshield visual survey revealed isolated cases of shoving in braking areas and fairly widespread transverse cracks on the sections with concrete underneath. Photographs of the distresses found on the section are shown in [Figure 26](#).

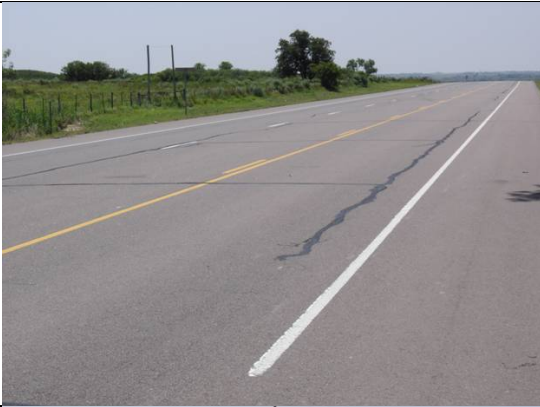
<p>3" HMA (Type C) 3.5" Asphalt stabilized base 6" 9-6-9 JPCP (existing)</p>	5 years	Very widespread longitudinal and transverse reflection cracks

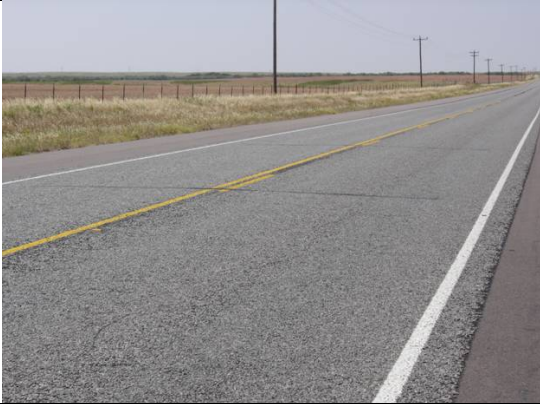
<p>4" HMA (Type D) 6" 9-6-9 JPCP (existing)</p>	2 years	Widespread transverse reflection cracks

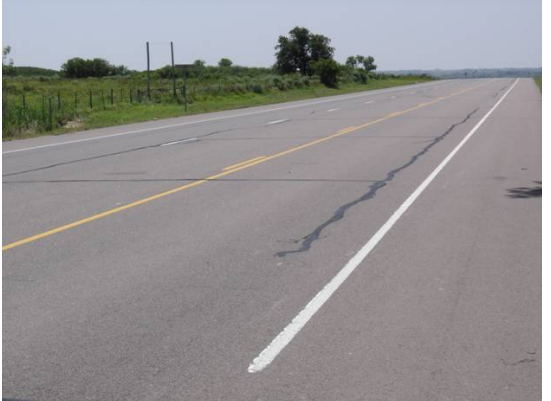
5 years	Very widespread longitudinal and transverse reflection cracks

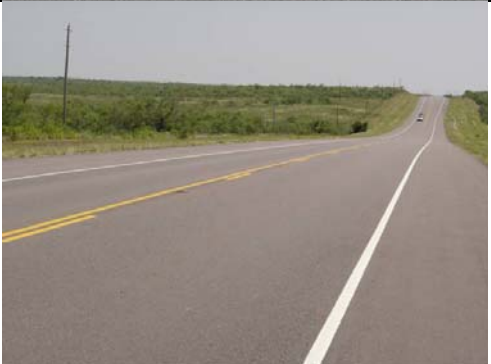
<p>4" HMA 8" Sand and gravel flexible base 6" 9-6-9 JPCP crack & seat</p>	5 years	Excellent condition. This section had recently been overlaid as an extension to a project on an adjacent section. No structural distress was evident at the time of the overlay.
