1. Report No. FHWA/TX-08/0-4687-2		2. Government Accession No.		3. Recipient's Catalog No.	
4. Title and Subtitle FIELD EVALUATIONS AND GUIDELINES FOR RUBBLIZATION IN TEXAS				5. Report Date September 2007 Published: December 2007

FIELD EVALUATIONS AND GUIDELINES FOR RUBBLIZATION IN TEXAS

Report 0-4687-2
Project 0-4687
Project Title: Rubblization and Crack and Seat
as Major Rehabilitation for Concrete Pavements

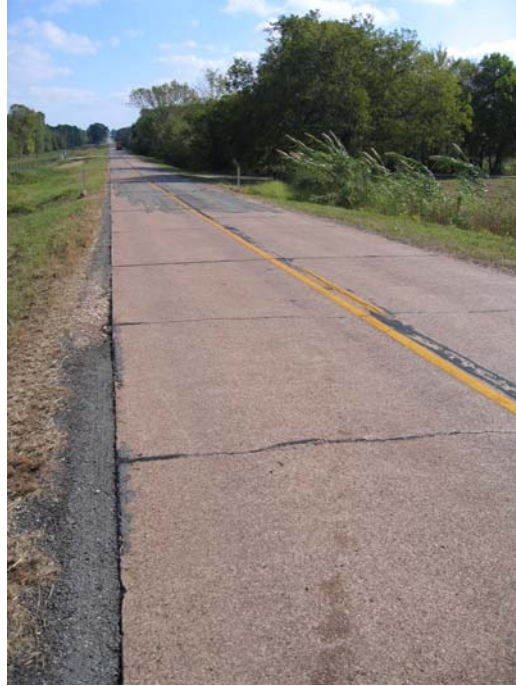
Based on the field investigation the structure on FM 912 consists of approximately 7 inches of JCP over the subgrade. Within the section, substantial cracking exists such as illustrated in [Figure 1.1](#). The average joint spacing is 40 feet, and the average transverse crack spacing is 6 to 7 feet. To evaluate if the FM 912 project is suitable for rubblization, the Texas Transportation Institute (TTI) performed a field analysis using GPR, FWD, and DCP testing. [Figure 1.2](#) illustrates representative GPR data from the project.

Figure 1.1. Cracked Slabs on FM 912.

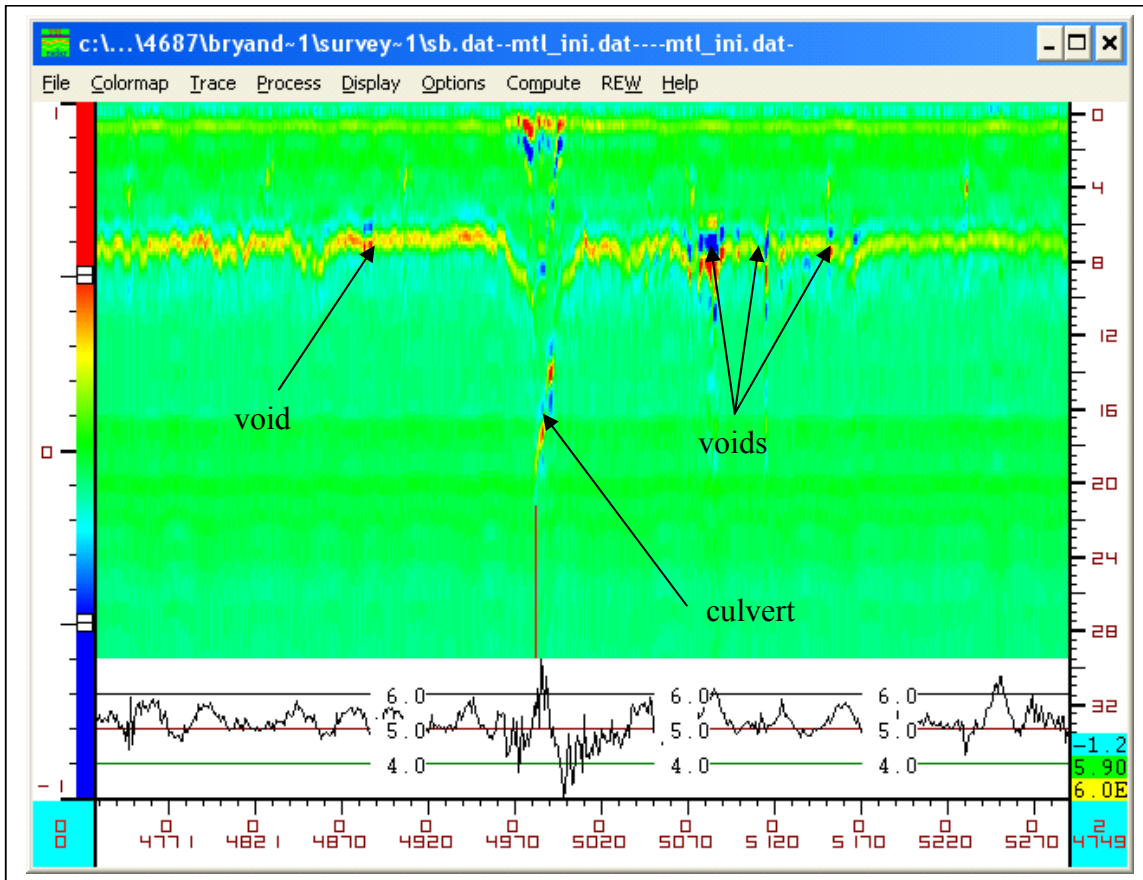
The GPR survey serves two primary purposes. First, the survey can identify locations of excessively wet subgrade or trapped water, both of which hinder the rubblization process. Second, the GPR survey can identify section breaks or changes in structure. In the GPR data, no locations of excessively wet subgrade were identified. The highest subgrade dielectric value was 7.3 (values above 10 can indicate excessively wet material). However, at the time of testing the weather had been dry for several months. From discussions with TxDOT personnel, portions of the FM 912 project have a history of developing voids underneath the slabs, particularly in the low-lying areas. While TxDOT reported that maintenance work had recently been performed on locations with voids, the GPR data still detected areas of voids beneath the slabs. [Figure 1.3](#) illustrates GPR data where voids exist. Follow-up testing with the DCP at selected locations verified the existence of voids beneath the slab. In the southbound (SB) travel direction, evidence of intermittent voids in the GPR data exist from RM 629 + 0.108 to 629 + 0.513. In the northbound (NB) travel direction, evidence of intermittent voids beneath the slabs exist from RM 629 + 0.898 to 628 + 0.936.

Figure 1.3. Voids beneath Slabs on FM 912.

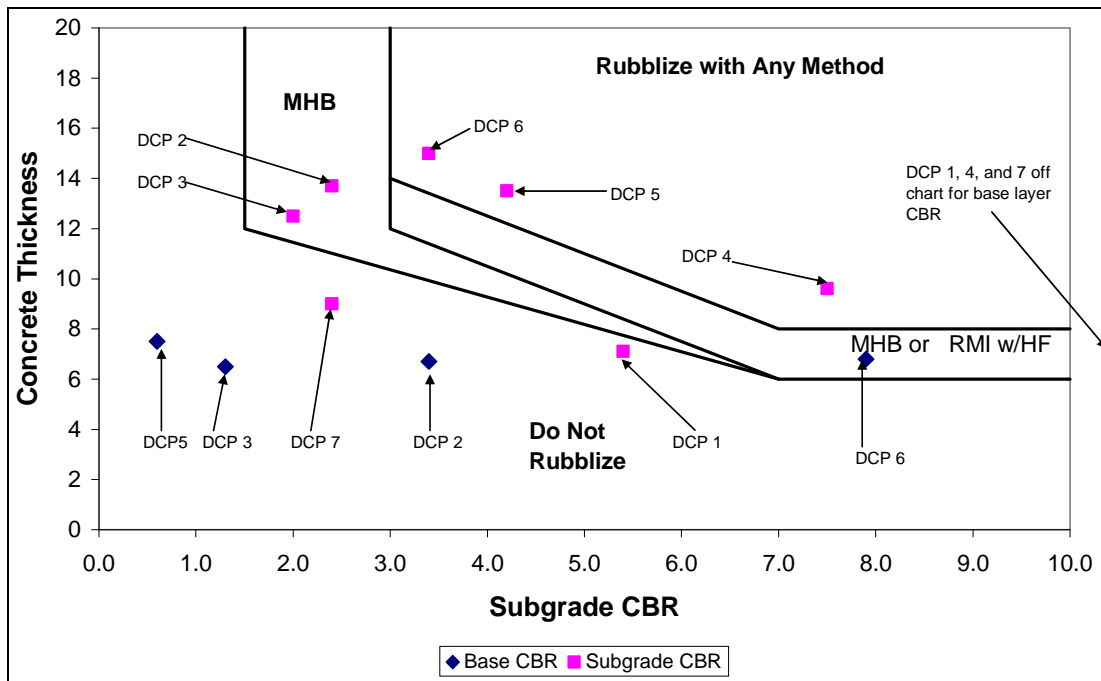
Figure 1.4 shows this chart with the FM 912 data. Of particular attention in this graph are the data from DCP tests 1, 4, 6, and 7, because these are the only locations where the support immediately beneath the slab is sufficient to where rubblization may be feasible. The location represented by DCP 4 should not be rubblized because the section falls within the limits of the project where voids are occurring beneath the slab. Of the remaining locations 1, 6, and 7, the data show the portions of the project represented by tests 1 and 7 may not be suitable for rubblization because of the poor soil conditions a few inches below the bottom of the concrete. Only at location 6 do the data indicate the project is suitable for rubblization with minimal risk.

Figure 1.4. DCP Results from FM 912 on IDOT Rubblization Selection Chart.
 Note: MHB = Multi-head breaker; RMI = Resonant Machines Inc; HF = High Flotation.

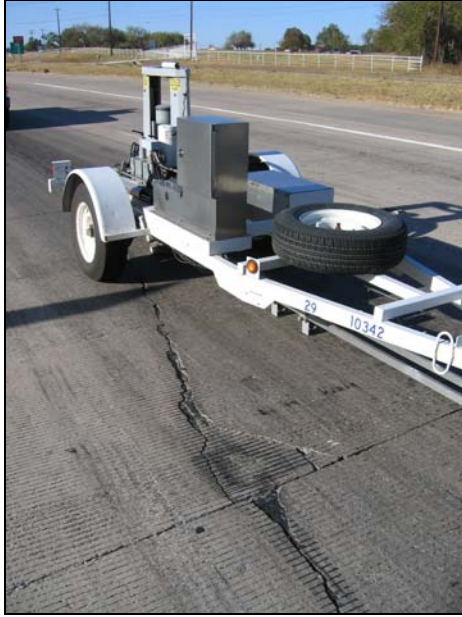
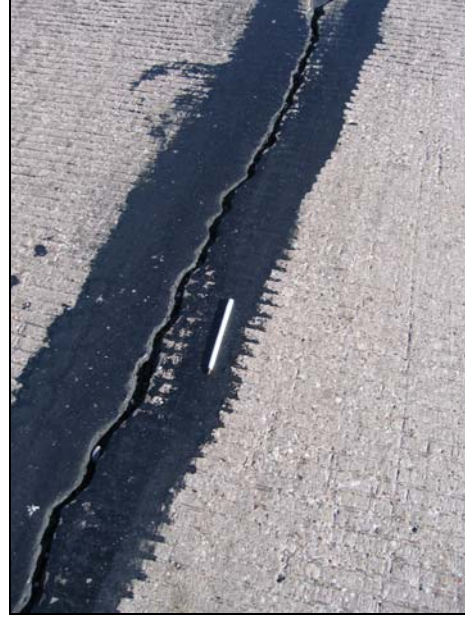
Within the section, substantial longitudinal cracking exists, such as illustrated in [Figure 3.1](#). To evaluate if the Loop 288 project is suitable for rubblization, TTI performed a field analysis using GPR, FWD, and DCP testing. [Figure 3.2](#) illustrates representative GPR data from the project. The GPR data could not distinguish the bottom of the lime-treated subgrade (LTS); however, the thicknesses observed in the GPR data for the concrete and asphalt-stabilized base (ASB) layers correspond well with the plan thicknesses.

Figure 3.1. Pavement Distress on Loop 288.

Based upon the results presented and discussed above, the Loop 288 project between FM 428 and US 380 is suitable for rubblization. Due to the pavement structure, the resonant machine may be a better method to rubblize this pavement. A forensic investigation revealed the primary cause of distress in the pavement is due to construction problems: the pavement did not crack at the saw-cut joints as designed, resulting in uncontrolled cracking in the concrete layer.

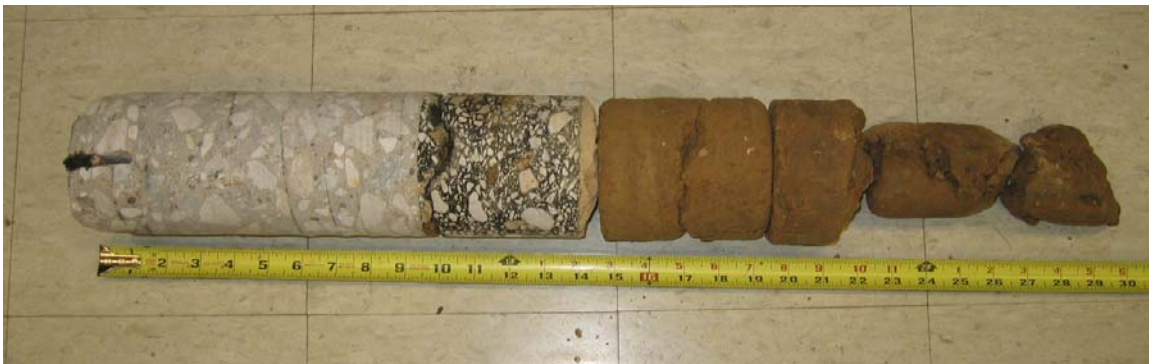
In an effort to determine the cause of the distress on Loop 288, a forensic investigation was conducted in January 2006. Two cores were taken as illustrated in Figure 3.5. The first core, shown in Figure 3.6, was collected 4230 feet east of FM 428 and was taken directly over the sawcut at the outside shoulder. This core revealed the concrete did not crack as intended at the sawcut. The second core, collected 4320 feet east of FM 428 and taken from directly over a longitudinal crack, revealed that the cracking is confined to the concrete layer. Figures 3.7 and 3.8 show that the ASB is not cracked where there is a longitudinal crack in the concrete. Therefore, based upon this investigation, researchers concluded the primary cause of distress on Loop 288 is due to a construction problem: the concrete did not crack at the sawcuts as designed.

Figure 3.6. Core over Saw Cut on Loop 288.
Note that the concrete did not crack at the sawcut.

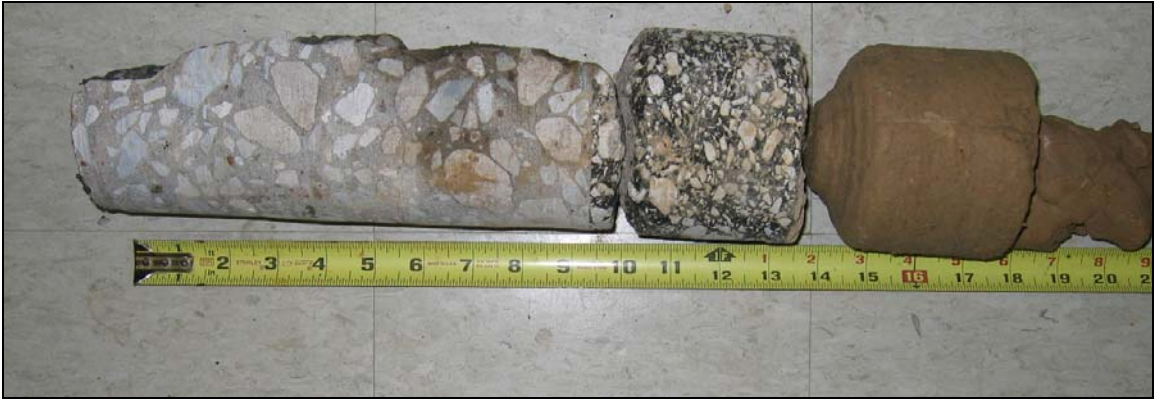
Figure 3.8. Core Collected over Longitudinal Crack.
Note the cracking is confined to the concrete layer.

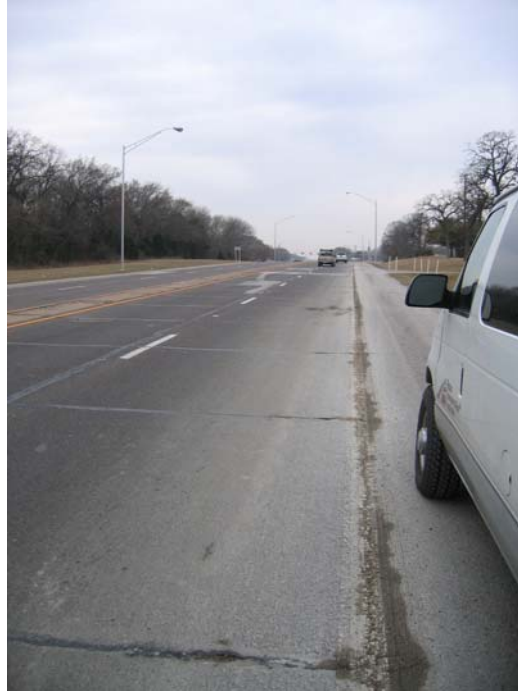
Based on the field investigation the structure consists of approximately 1 to 2.5 inches of HMA over approximately 10 inches of JCP pavement. [Figure 4.1](#) illustrates the general pavement condition. To evaluate if the project is suitable for rubblization, TTI performed a field analysis using GPR, FWD, and DCP data. [Figure 4.2](#) shows the GPR data from the EB travel direction. [Figure 4.3](#) shows a typical single GPR trace used to estimate pavement layer thicknesses and dielectric values.

Figure 4.1. Representative Pavement Condition on Loop 12.

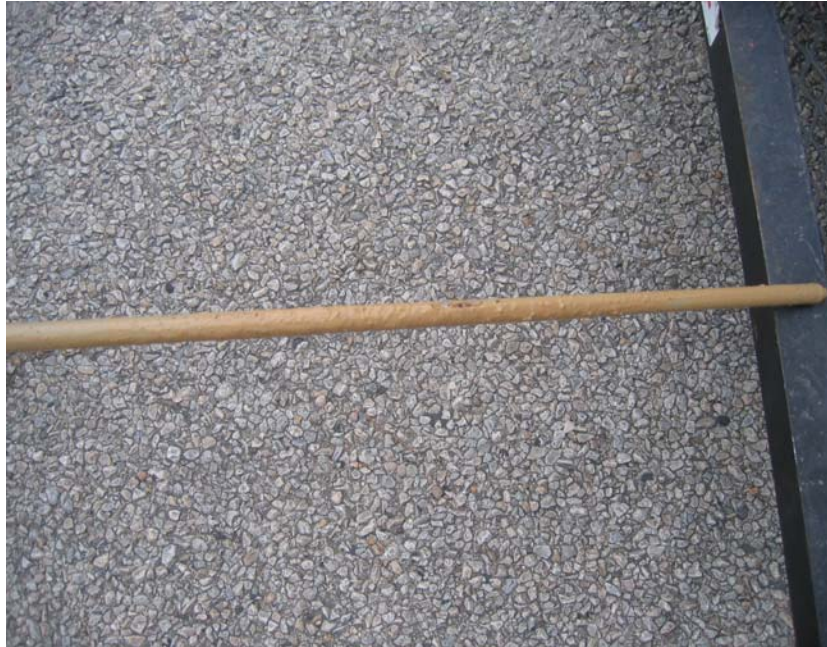
Note: Soil at DCP 4 and DCP 6 visibly wet on DCP rod when tested with DCP.

Figure 4.5. Wet Subgrade Soil on DCP Rod after Test at Location DCP 6.

Based upon the results presented and discussed above, the Loop 12 project between Jim Miller Road and US 175 is suitable for rubblization with either the resonant machines or multi-head breaker equipment. The only potential concern observed was a few locations of wet subgrade. Testing at these locations still revealed suitable subgrade support exists. However, it is possible that the vibrating action of the RMI machine could pump water; therefore, if rubblization is pursued using the RMI equipment, consideration should be given to installing edge drains prior to rubblization.

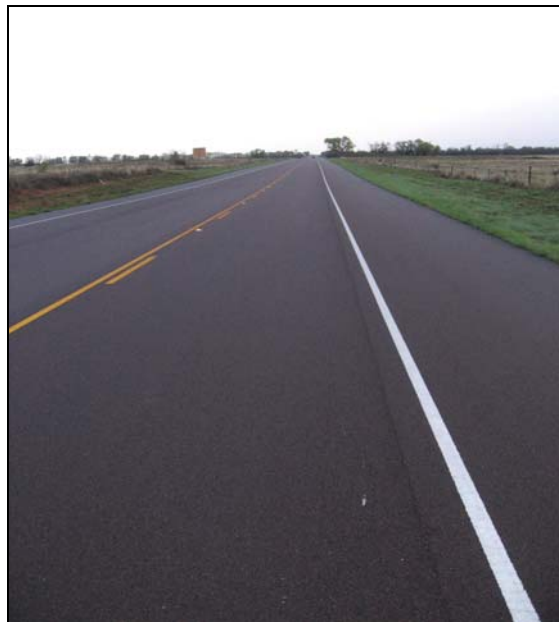
The latest survey at this site took place in April 2007 with GPR and FWD. [Figure 5.1](#) shows the site in April 2007. Visually the section still appears in excellent condition.

Figure 5.1. US 83 from FM 3256.

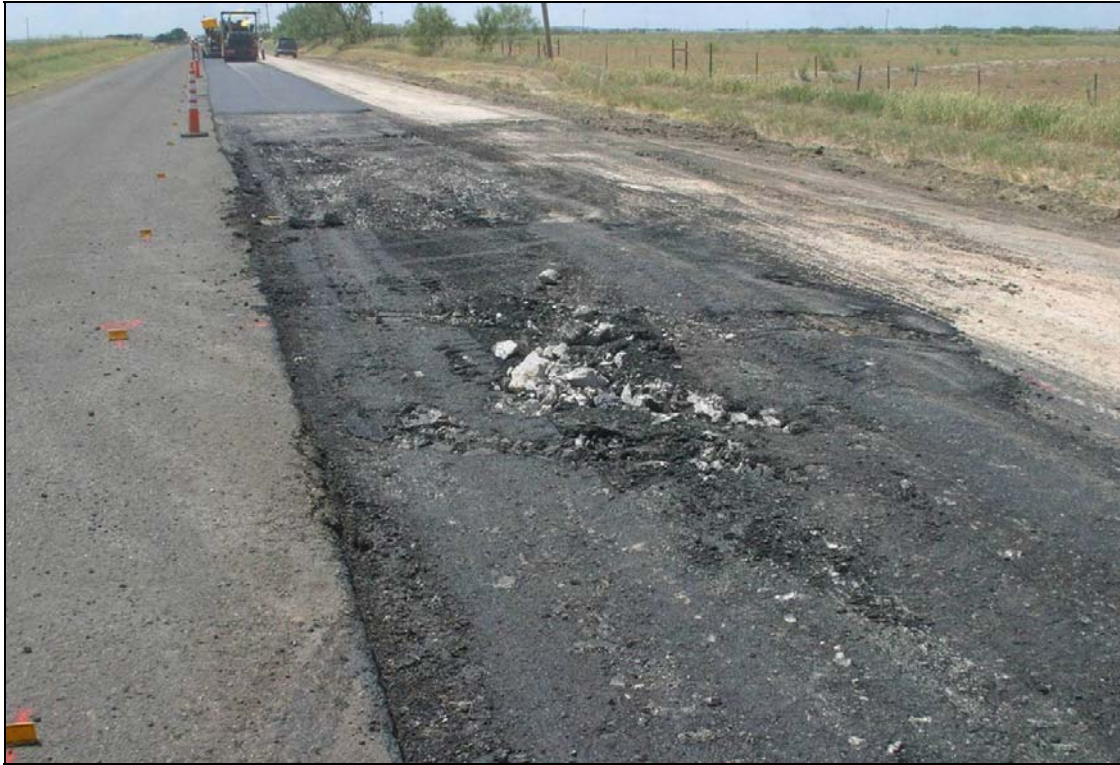
Duininck Brothers constructed the HMA overlays on top of the rubblized pavement. Unfortunately, although project personnel report that proof rolling was performed, the paving train found unstable locations during the course of HMA compaction. [Figure 6.7](#) shows one of these locations. The contractor reported these failures occurred while the vibratory rollers were operating on the HMA.

Figure 6.7. Failure on US 70 Encountered during Paving.

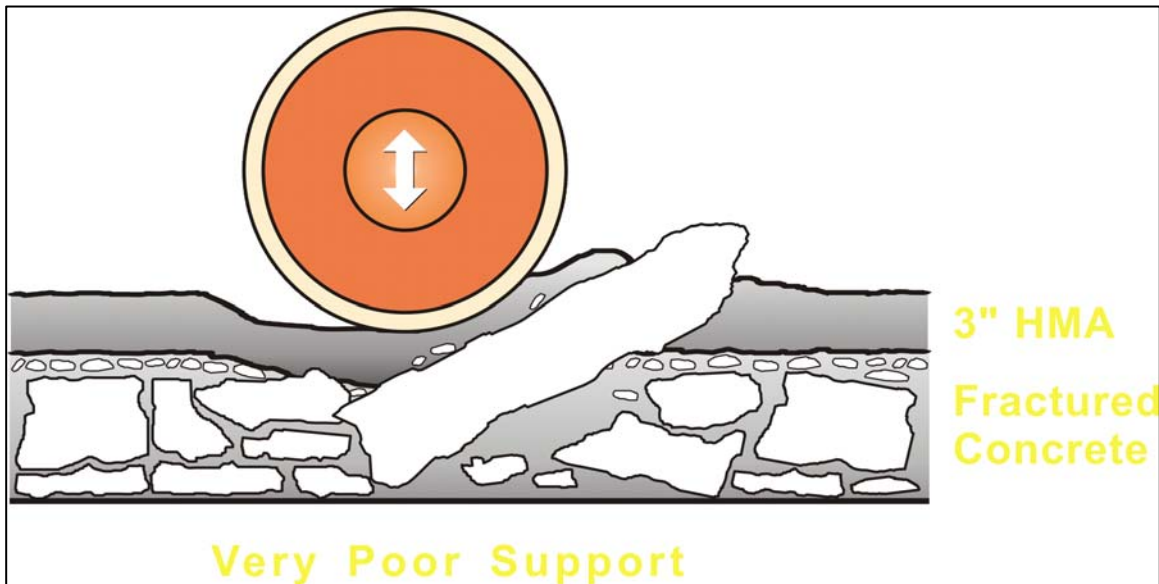
[Figure 6.8](#) shows the proposed mechanism of these failures. Essentially, during operation of the vibratory compactors, the large rubblized particles dislodged and rotated to where they protruded through the HMA.

Figure 6.8. Mechanism of Failure on US 70.

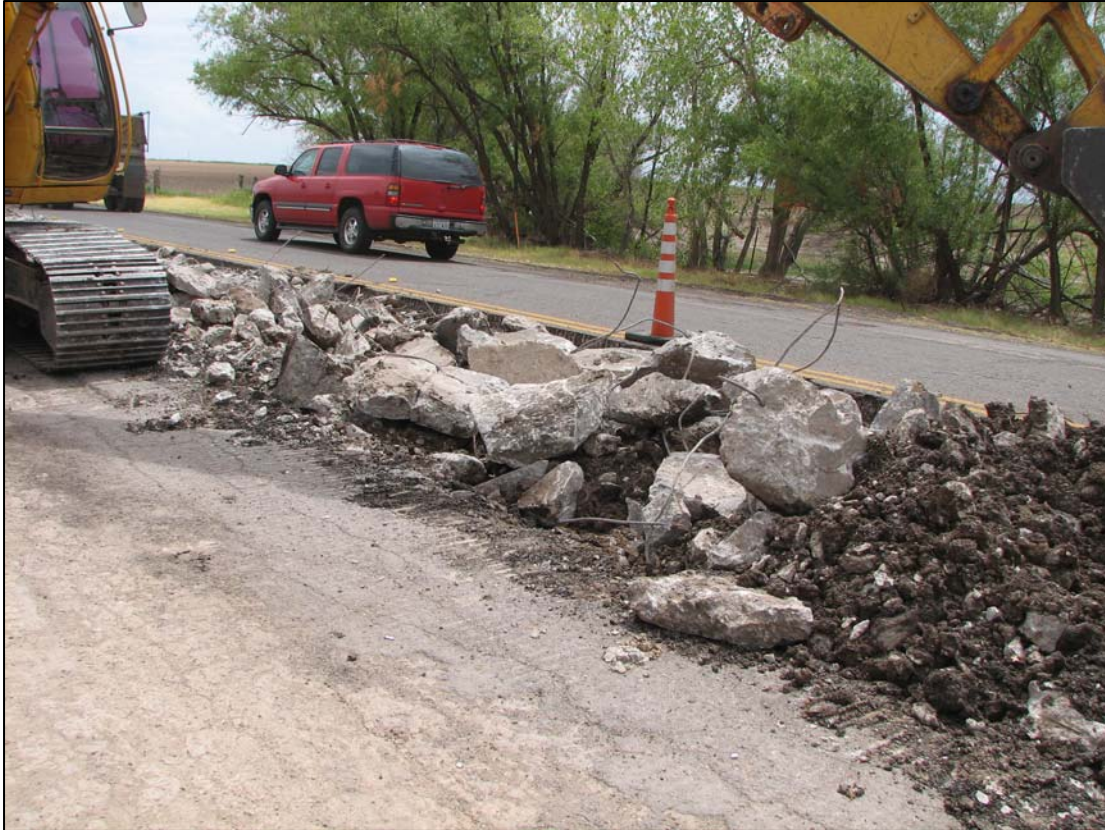
- Proof rolling did not detect weak spots. Although TxDOT reports proof rolling was conducted, the wheel loads apparently were not high enough or the process was not monitored sufficiently.

Figure 6.9. Out of Spec Particle Sizes at Failure Location.

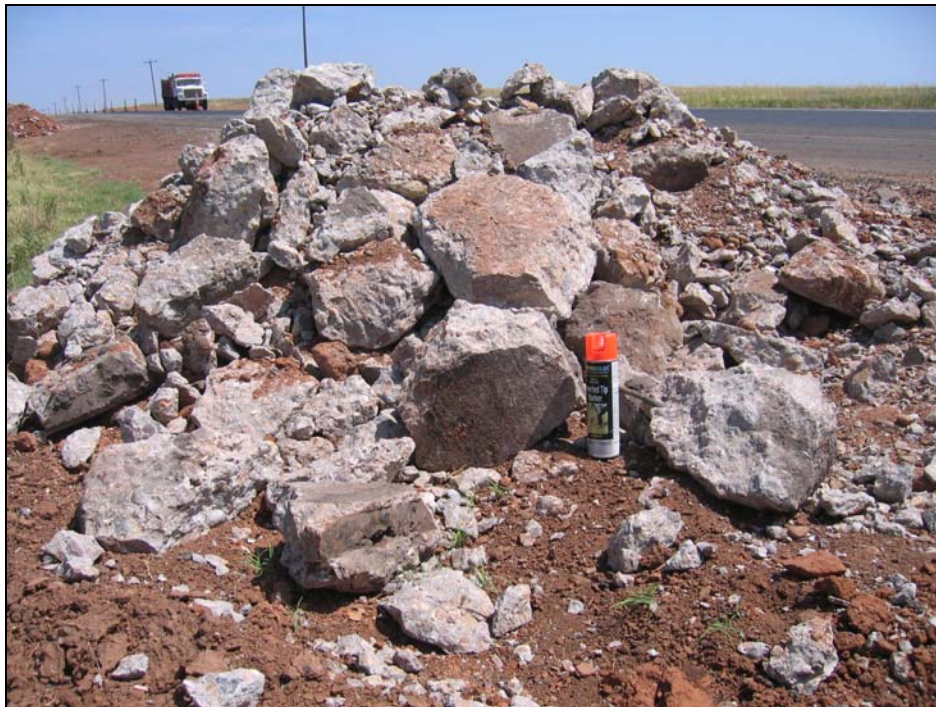
Figure 7.10. Large Particle Sizes Excavated from Removal Location.

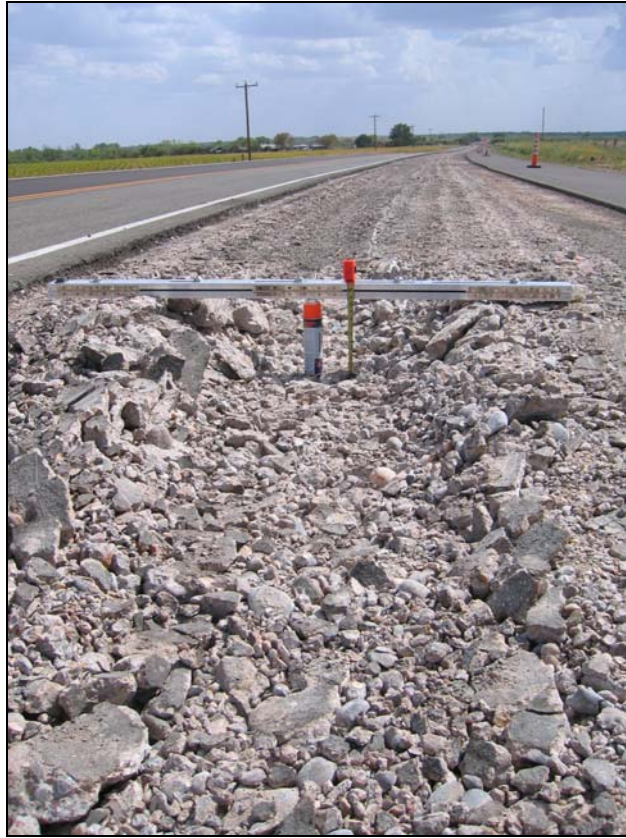
The resonant machine device rubblized the existing JCP, as [Figure 7.7](#) shows. [Figure 7.8](#) illustrates the typical surface view and cross section of the rubblized layer. Proof rolling, as [Figure 7.9](#) shows, aided the inspector in determining limits of instability for removal. Although the rubblizer successfully fractured the concrete on the entire project, locations requiring removal typically exhibited abnormally large particle sizes, as [Figure 7.10](#) illustrates. In some cases, the rubblizer created large ruts in the pavement, serving as its own proof roller and indicating the need for removal and replacement. [Figure 7.11](#) shows one such location of significant rutting in the rubblized layer from the RMI machine.

Figure 7.11. Rutting in Rubblized Layer from Resonant Breaker.

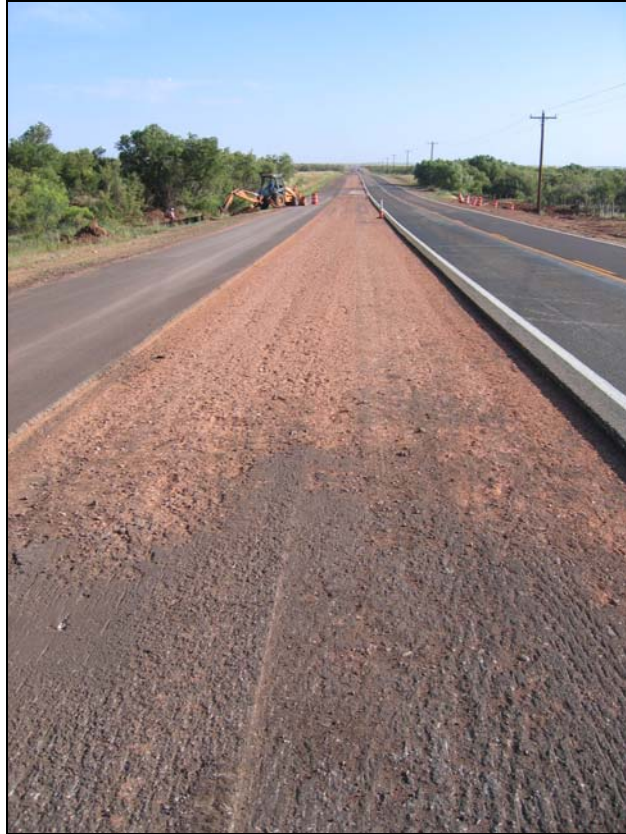
The survey of the site by TTI prior to construction highlighted two locations where the concrete pavement appeared to have already been replaced. Additionally, at several locations non-destructive test (NDT) data suggested rubblization likely would encounter problems due to the subgrade. Milling off the old HMA overlay revealed that the concrete indeed had been previously removed in two sections. [Figure 7.12](#) shows one of these locations. Additionally, [Figure 7.13](#) shows how the predictions of marginal locations in the pre-construction evaluation matched quite well with the locations that were removed and replaced due to instability.

Figure 7.12. Location of Prior Concrete Removal on US 83 from King / Cottle County Line.
