1. Report No. FHWA/TX-04/0-4852-1		2. Government Accession No.		3. Recipient's Catalog No.	
4. Title and Subtitle CRASH TESTING AND EVALUATION OF THE MODIFIED T77 BRIDGE RAIL				5. Report Date September 2003

CRASH TESTING AND EVALUATION OF THE MODIFIED T77 BRIDGE RAIL

Report 4852-1
Project Number 0-4852
Research Project Title: Development of the T77 Bridge Rail

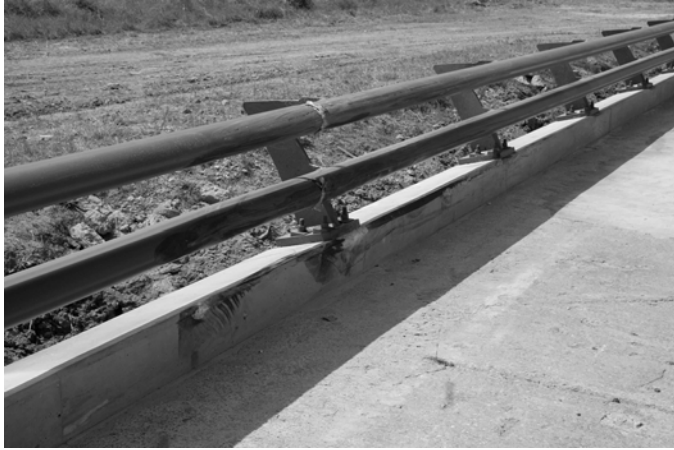
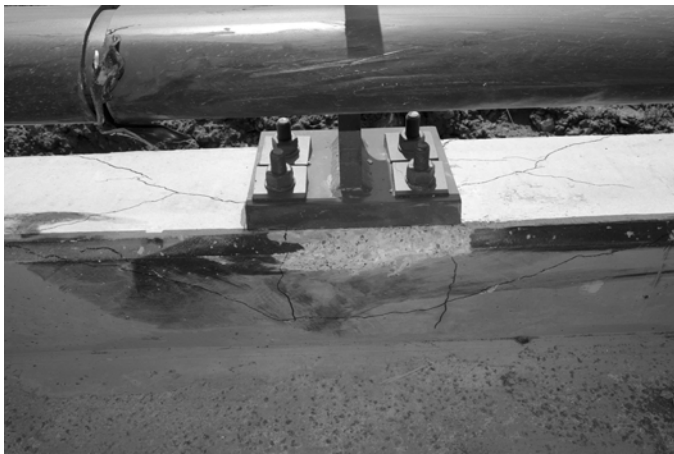
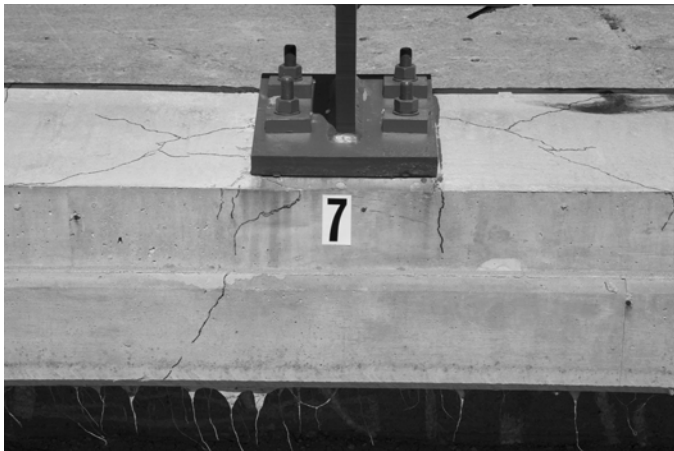
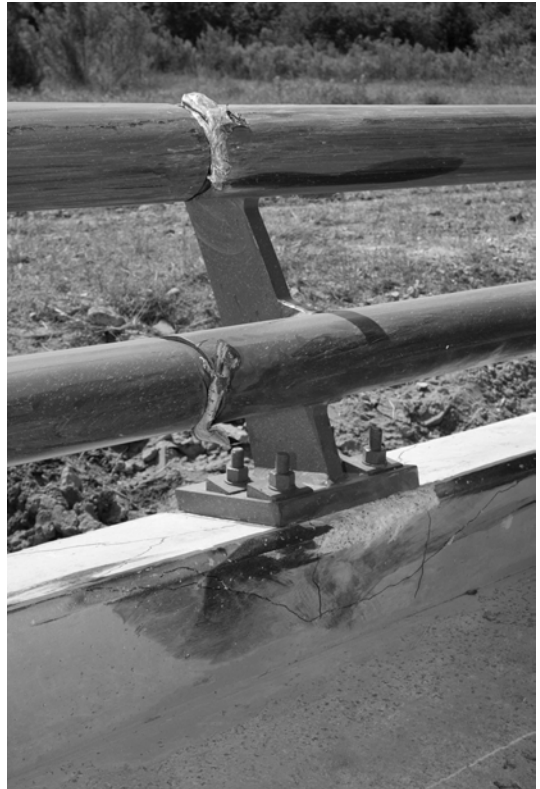
Figure 11. Installation After Test 448523-1.

Figures 10 and 11 show damage to the T77 bridge rail. The lower rail element had a 0.8 inch (21 mm) deep indentation in the traffic face. Cracks radiated out of the front and rear anchor bolts of post 7 and extended toward and down the rear side of the curb and into the deck. The traffic face of the curb was also fractured below the baseplate of post 7. Total length of contact of the vehicle with the bridge rail was 16.7 ft (5.1 m). Maximum dynamic deflection of the rail element was 1.1 inches (28 mm), and maximum permanent deformation was 0.8 inch (21 mm).

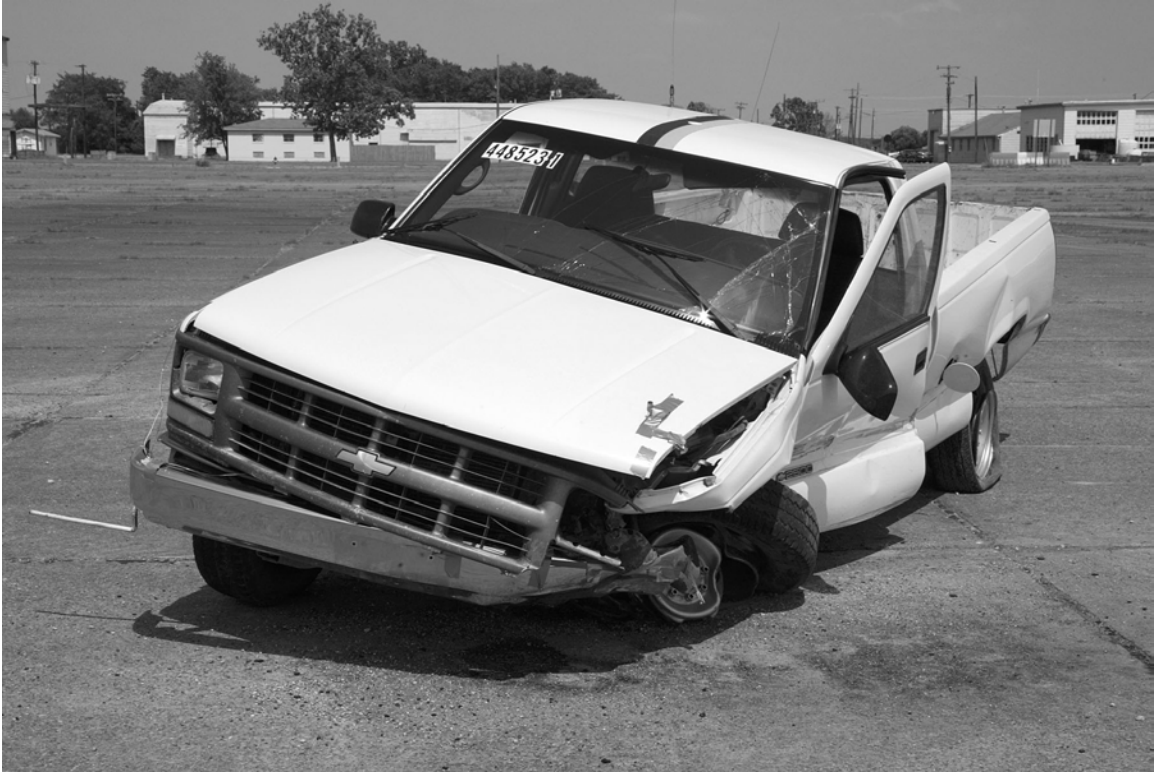
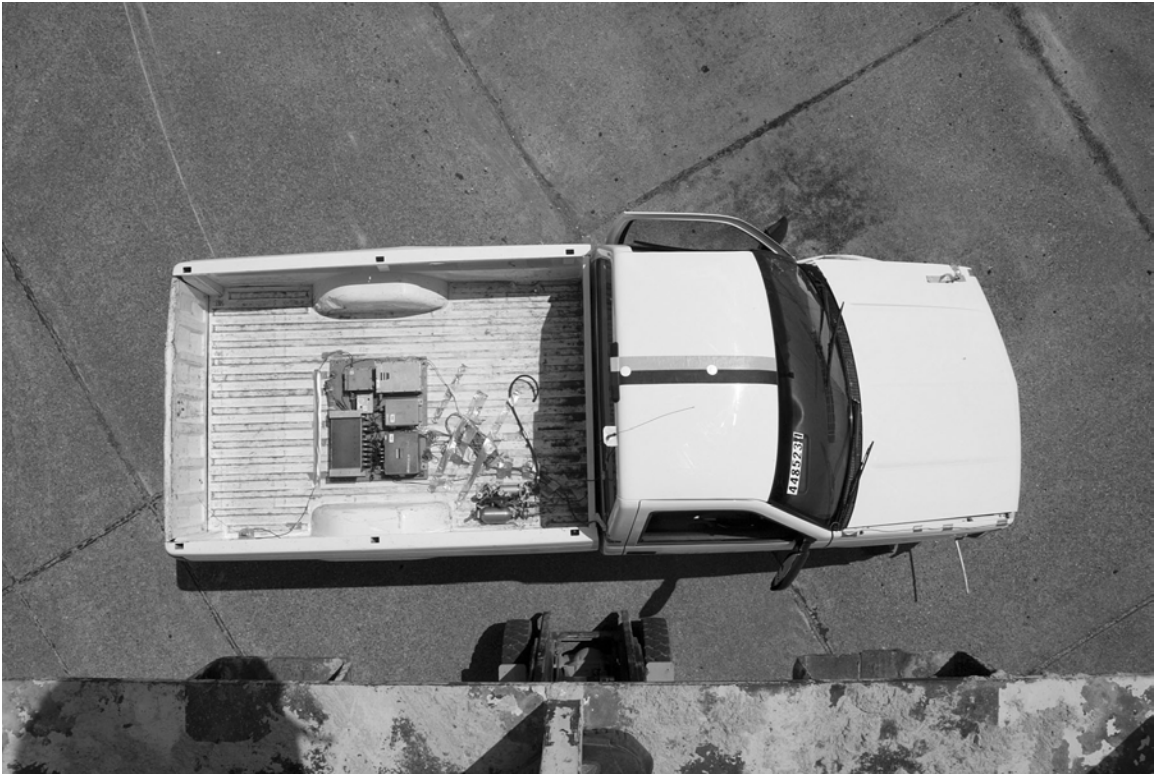
Figure 12. Vehicle After Test 448523-1.

Figure 12 shows damage to the vehicle. Structural damage was imparted to the left upper and lower A-arms, left outer tie rod end, left upper ball joint, floor pan, and left frame rail. Also damaged were the front bumper, hood, grill, radiator, fan, left front quarter panel, left door, left rear exterior bed, left rear tire and wheel rim, and rear bumper. The tire and outer rim separated from the inner rim of the left front wheel. Part of the leading edge of the wheel rim was torn off and left embedded in the rail splice joint. The windshield sustained stress fractures, and the instrument panel was deformed. Maximum exterior crush to the vehicle was 21.3 inches (540 mm) on the side plane at the left front corner at bumper height. Maximum occupant compartment deformation was 6.9 inches (174 mm) in the lateral area of the kick panel on the left side. Photographs of the interior of the vehicle are shown in Figure 13. Exterior crush and occupant compartment deformations are given in Appendix B, Tables 3 and 4.

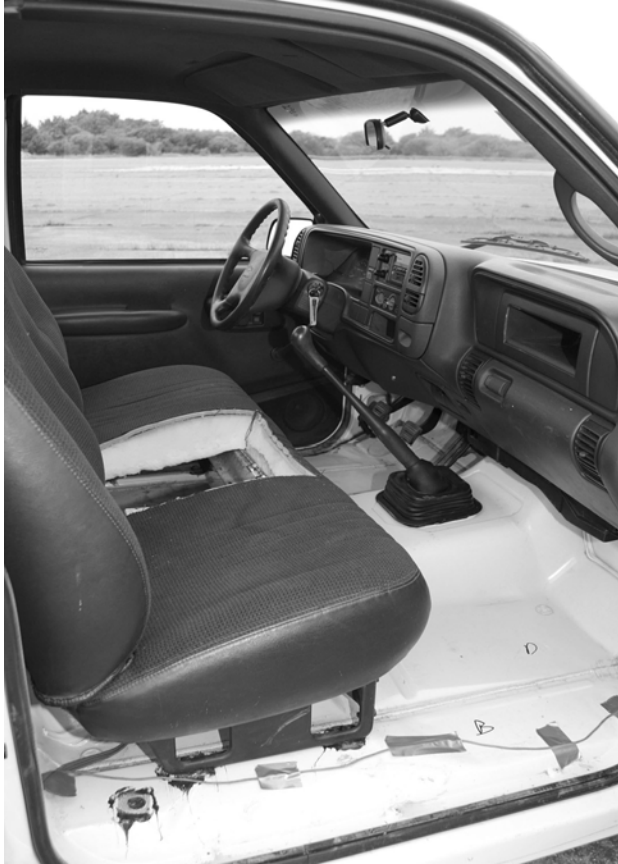
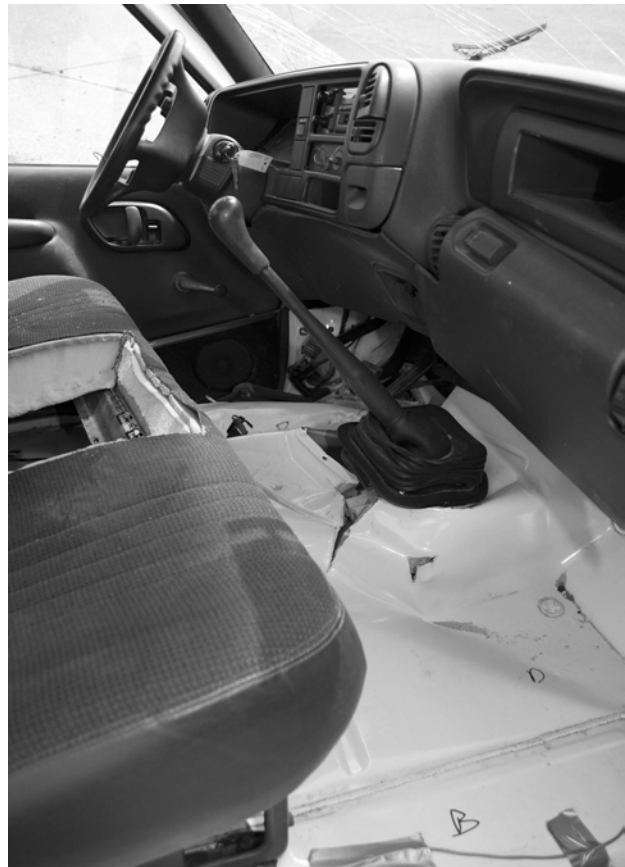
Figure 13. Interior of Vehicle for Test 448523-1.

Results: No detached elements, fragments, or other debris were present to penetrate or to show potential for penetrating the occupant compartment, or to present undue hazard to others in the area. Maximum occupant compartment deformation was 6.9 inches (174 mm) in the left kick panel laterally across the cab. (FAIL)

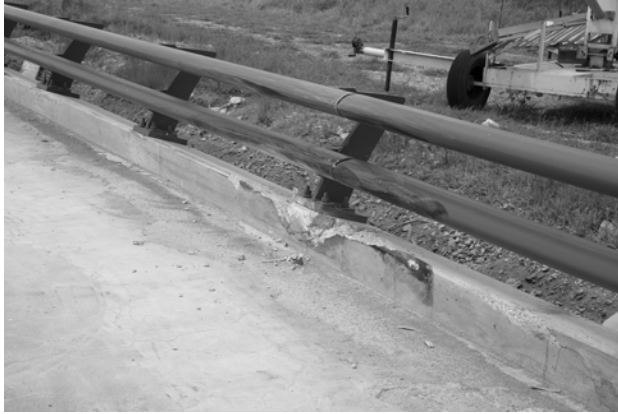
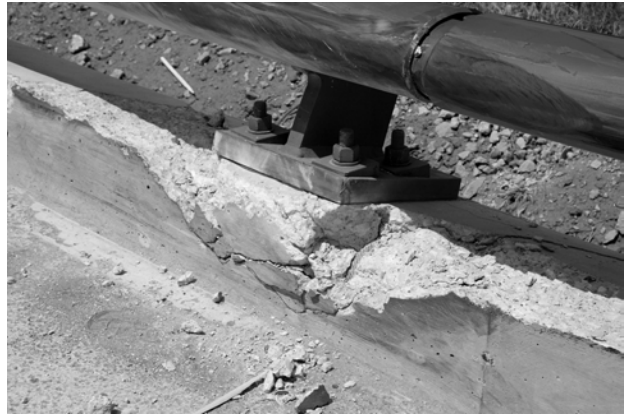
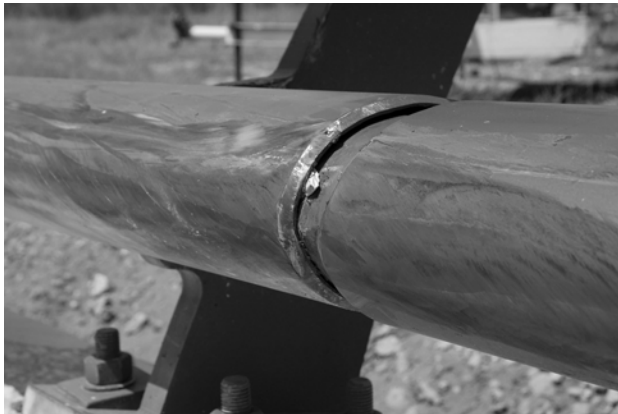
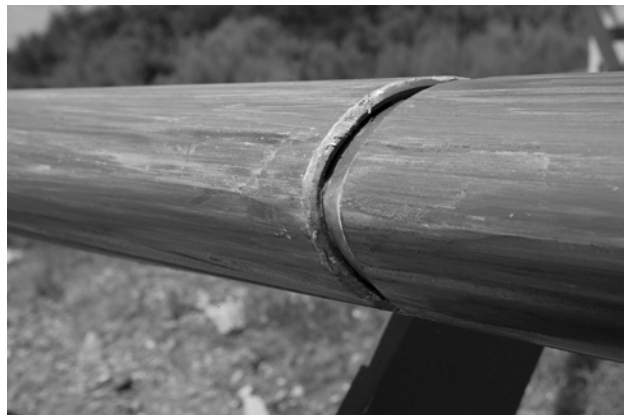
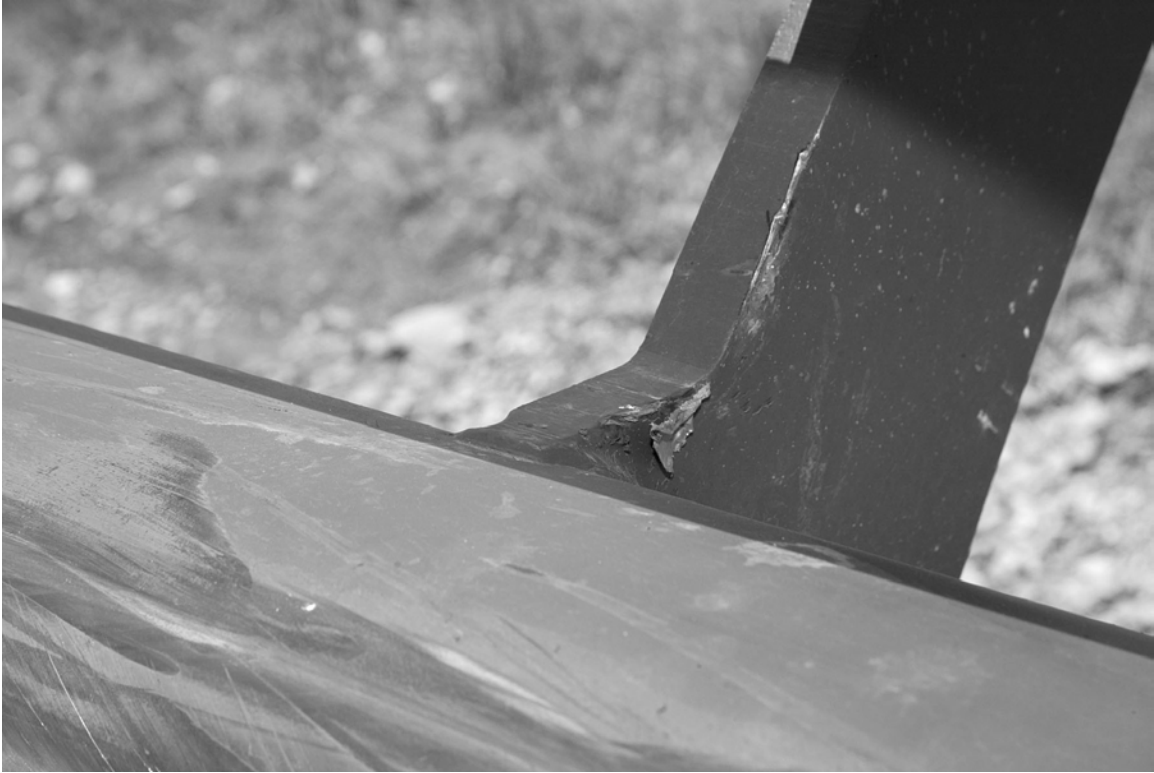
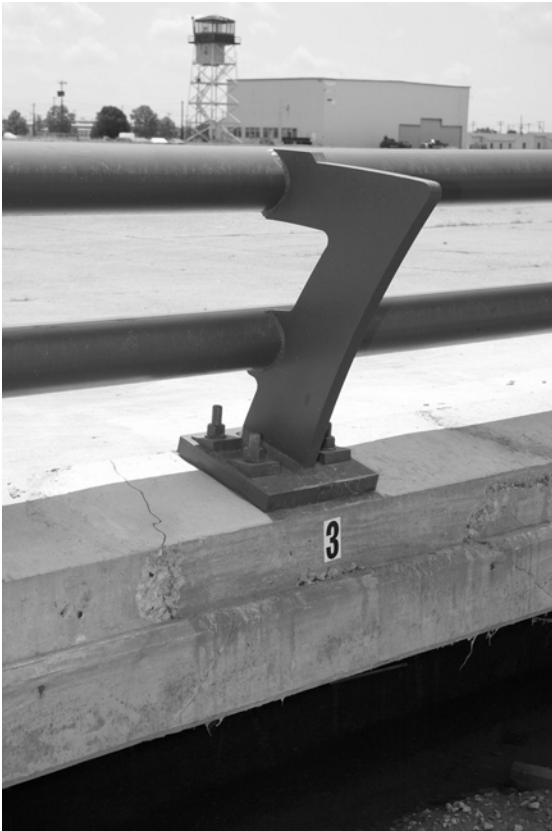
Figure 18. Installation After Test 409260-1.

Damage to the T77 bridge rail is shown in Figures 17 and 18. Cracks radiated out of the front and rear anchor bolts of post 3 and 4 and extended toward and down the rear side of the curb and into the deck. The traffic face of the curb was also fractured below the baseplate of post 4. Total length of contact of the vehicle with the bridge rail was 12.4 ft (3.8 m). Maximum dynamic deflection of the rail element was not attainable and maximum permanent deformation was 0.7 inch (18 mm).

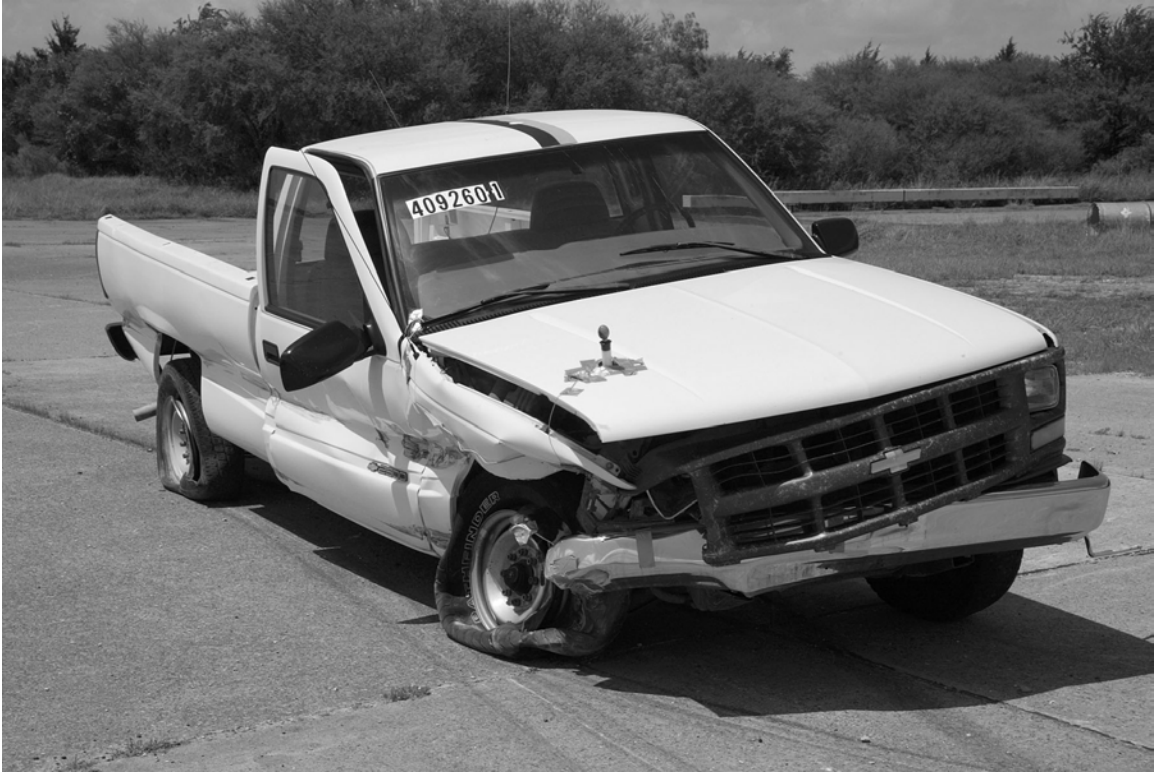
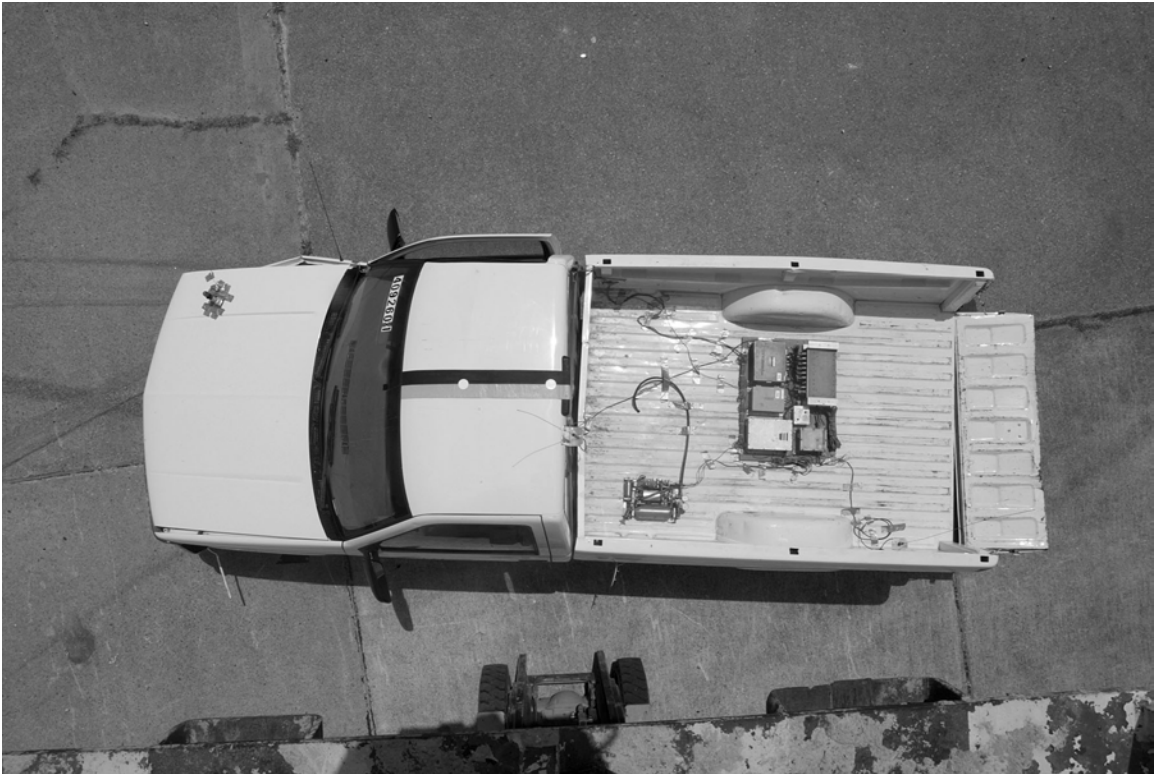
Figure 19. Vehicle After Test 409260-1.

Damage to the vehicle is shown in Figure 19. Structural damage was imparted to the right upper and lower A-arms, floor pan, and right frame rail. Also damaged were the front bumper, hood, grill, radiator, fan, right front quarter panel, right front tire and wheel rim, right door, right rear exterior bed, right rear tire and wheel rim, and rear bumper. Maximum exterior crush to the vehicle was 17.7 inches (450 mm) on the frontal plane at the right front corner at bumper height. Maximum occupant compartment deformation was 3.0 inches (76 mm) in the center front floor pan area over the transmission tunnel and in the lateral area of the kick panel on the right side. Photographs of the interior of the vehicle are shown in Figure 20. Exterior crush and occupant compartment deformations are given in Appendix B, Tables 5 and 6.

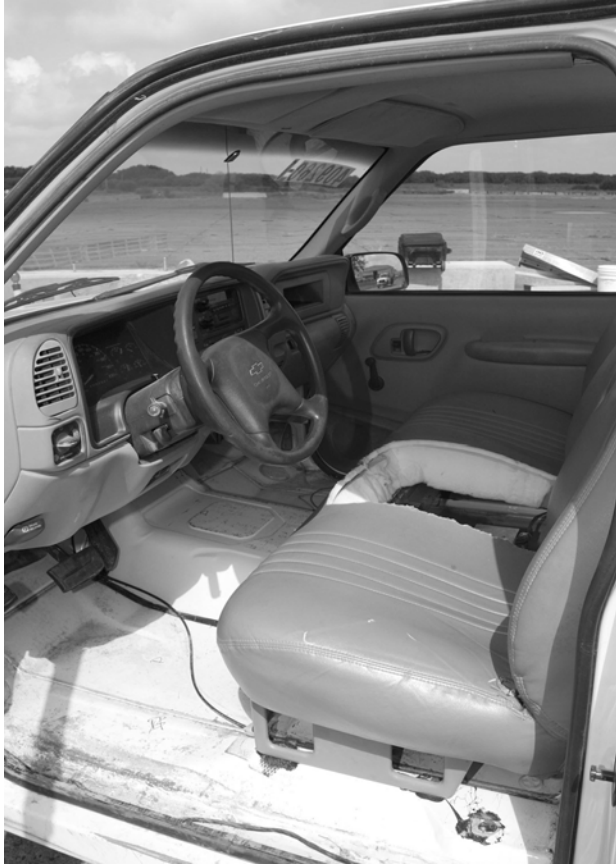
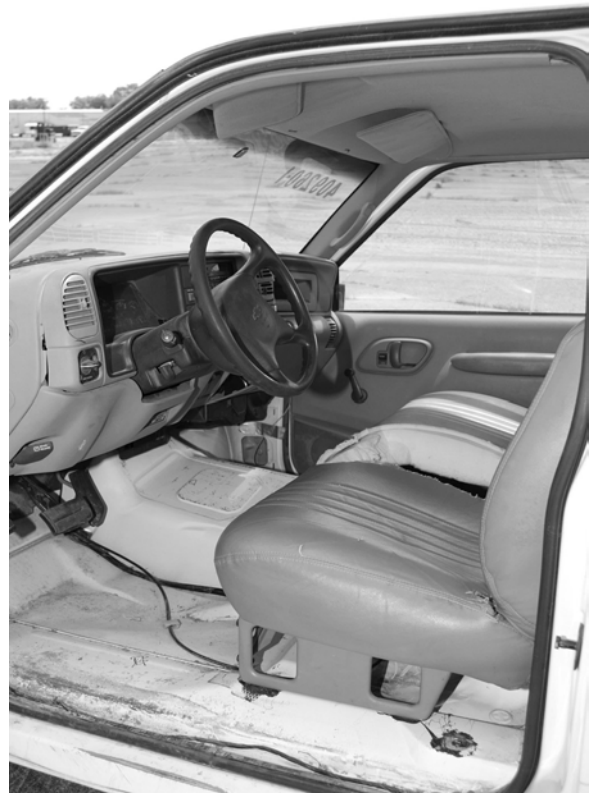
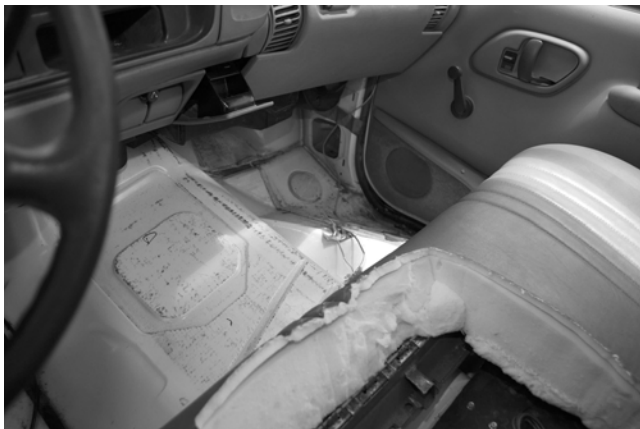
Figure 20. Interior of Vehicle for Test 409260-1.

Results: No detached elements, fragments, or other debris were present to penetrate or to show potential for penetrating the occupant compartment, or to present undue hazard to others in the area. Maximum occupant compartment deformation was 3.0 inches (76 mm) in the center front floor pan area over the transmission tunnel and in the left kick panel laterally across the cab. (PASS)
