1. Report No. FHWA/TX-06/0-5110-1		2. Government Accession No.		3. Recipient's Catalog No.	
4. Title and Subtitle INVESTIGATION OF SPALL REPAIR MATERIALS FOR CONCRETE PAVEMENT				5. Report Date Oct 2005; Resub Apr 2006, May 2006

INVESTIGATION OF SPALL REPAIR MATERIALS FOR CONCRETE PAVEMENT

Project Title: Best Practices for Concrete Pavement Spall Repairs

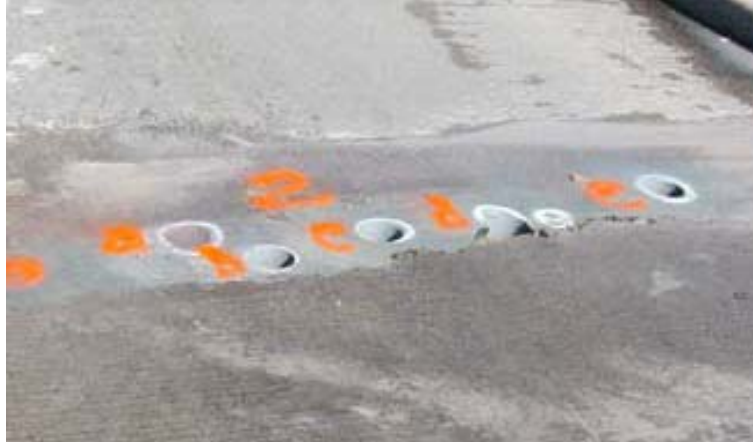
Figure 5.1 Location 1: Near the Intersection of SH 6 and Loch Katherine Lane

Researchers conducted field investigation in the Houston District at 11 locations using six materials. The first site investigated consisted of two locations approximately 200 feet south of the intersection of Loch Katherine Lane and SH 6. These two areas were inspected for specific defects and mechanisms affecting the performance of spall repair materials. The locations shown in [Figure 5.1](#) were repaired with the Delpatch material. It is evident the patch materials suffer from concrete breaking out from the perimeter of the repair area as shown in [Figure 5.2](#). This breakage tends to be very common among the different materials that are used to make spall repairs. The concrete that is broken out leaves jagged edges and areas to trap water adjacent to the repair patch. The most likely cause is micro cracks or delaminated concrete immediately below the original concrete surface adjacent to the repair that remain after the repairs are made.

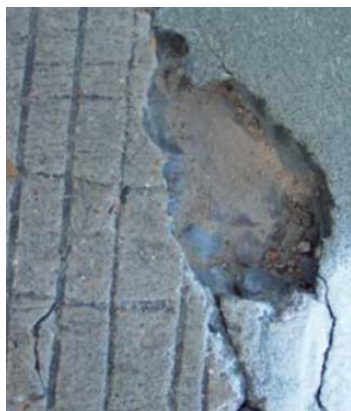
Figure 5.2 Spall Damage at Location 2

The repair procedure typically is to use a 25 lb or less jackhammer to remove the delaminated concrete and then to sandblast the exposed concrete surface, and finally to place the repair material. However, it appears that improvements in the repair procedure should focus on removing all cracked and delaminated concrete in the vicinity of the repair. Several cores were taken from these sites where close inspection indicated a high quality bond to the concrete as shown [Figure 5.3](#).

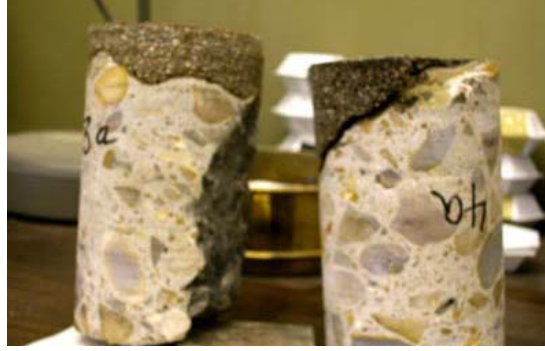
Figure 5.6 Cores Showing Broken Bond

Figure 5.6 illustrates that FlexPatch had a tendency to break away from the underlying concrete pavement during the coring operation. It seems to suggest a weak bond between FlexPatch and the existing concrete surface. Even with these characteristics, FlexPatch appeared to be providing adequate performance. Apparently, in order to be a successful spall repair material, a material manifesting high crack resistance must also have good bond strength. If the material manifests low crack resistance, then the requirements for bond strength are not as stringent.

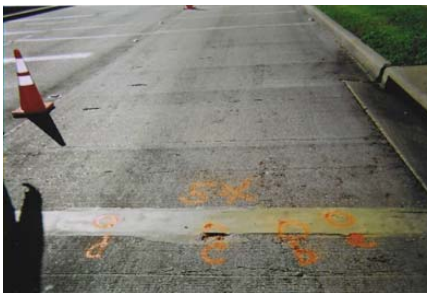
Figure 5.7 Spall Damage at Location 5

Based on previous experience, this particular area was most likely delaminated at multiple depths below the surface but apparently these several delaminations have not had a significant effect on the performance of the pavement. The rule of thumb that may be established based on this and other evidence obtained over several years of experience dealing with repairing spalled CRC pavement is that delaminations below 3-inch will typically create a spall in the pavement surface, and thus the majority of spall repairs will not be deeper than 2-inch.

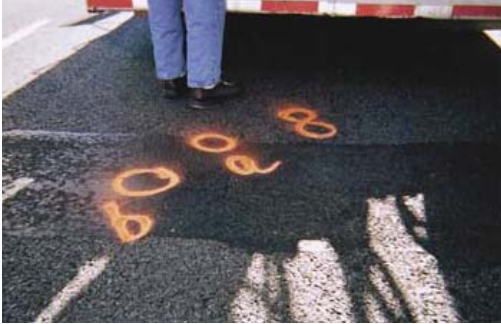
Figure 5.9 Location 8

Location 8 was on SH 6 and consisted of Fibrescreed, the fourth repair material investigated. The stiffness of this material is apparently lower than any of the three previously cored materials. Inspection of one of the cores taken from this site indicated a high quality bond shown in [Figure 5.10](#).

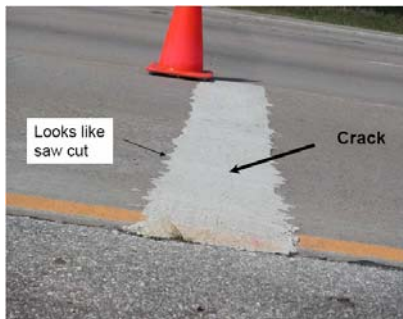
Figure 5.11 Location 10

The spall repair material at Location 10 was EucoSpeed, which includes the coarser aggregate near the intersection of SH 288 and Beltway 8. The investigation of Location 10 showed evidence of the saw cut that was applied before patching as shown in [Figure 5.11](#). The transverse cracking of existing concrete pavement was reflected through the repair material as [Figure 5.12](#); that is, the material indicated a low resistance propagation of these cracks.

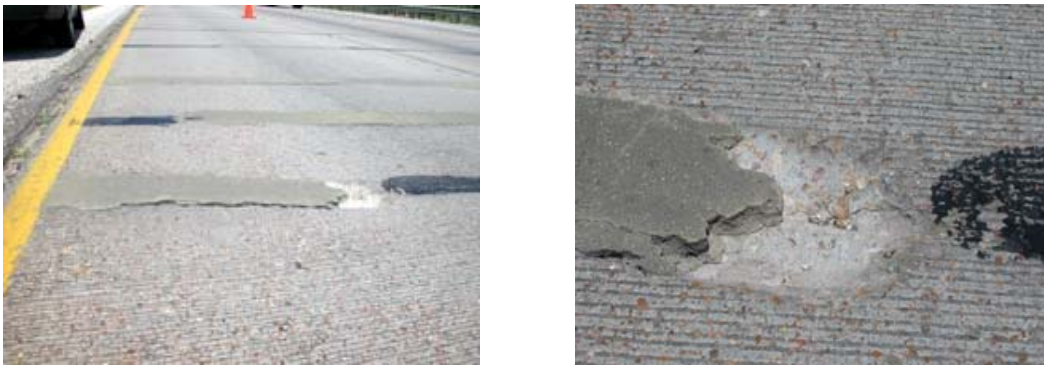
Location 11 was on the northbound lane of the intersection of SH 288 and Beltway 8. The spall of the location was repaired using FlexPatch and Wabo Crete side by side. The repair materials were applied to the patch areas which were tapered by grinding and milling which was different from the repair methodology employed at Location 10 using a sawcut to eliminate a need for tapering. Nonetheless, the investigation showed adequate performance of materials. However, as shown in [Figure 5.13](#), the de-bonding of Wabo Crete between the material and existing concrete appeared at a few patching areas while FlexPatch showed a good bonding quality. The de-bonding of repair material seems to result from delamination below the original concrete surface. The patching has been in service for approximately two years.

Figure 5.13 De-bonding of Repair Material at Location 11

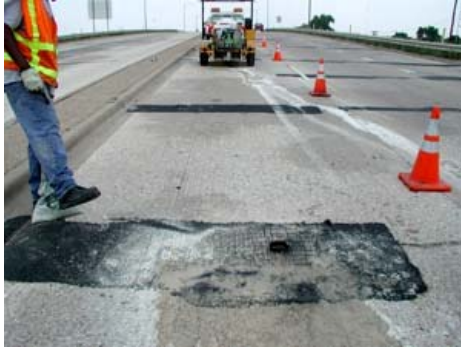
Figure 5.14 Highway 77 at Waco District

A field investigation and coring was carried out in the Waco District on the approach slab of a bridge spanning over railway on Highway 77 as shown in [Figure 5.14](#). The spall repair material used in this area was Fibrecrete, which is black colored and consists of mineral fillers, various fibers, sand, granite aggregate, and synthetic polymers that have a soft viscous nature, distributed by Marketing Associate, Inc. The stiffness of this material is obviously lower than any of the materials investigated. Therefore, the Fibrecrete patched has viscous properties even after being in place for a year.

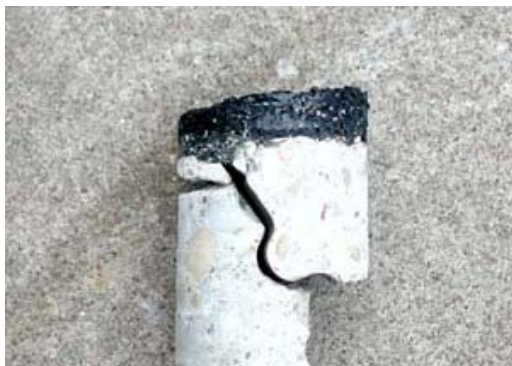
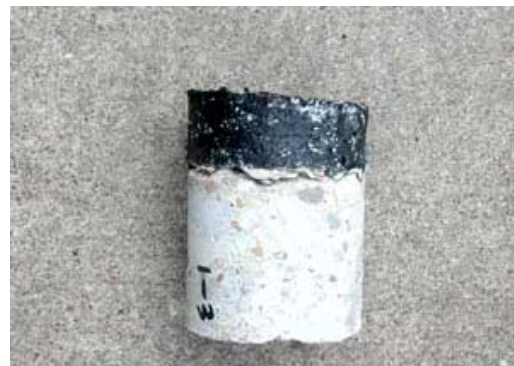
Figure 5.16 Cores Taken from Waco District

As illustrated in [Figure 5.16](#), cores taken from the repair area show the delamination at a depth of approximately 0.5 to 1-inch below existing concrete pavement surface. Although the delaminations have not significantly affected the performance of the pavement repaired with Fibrecrete, further deterioration as a result of the dislodgement of delaminated concrete may be problematic.

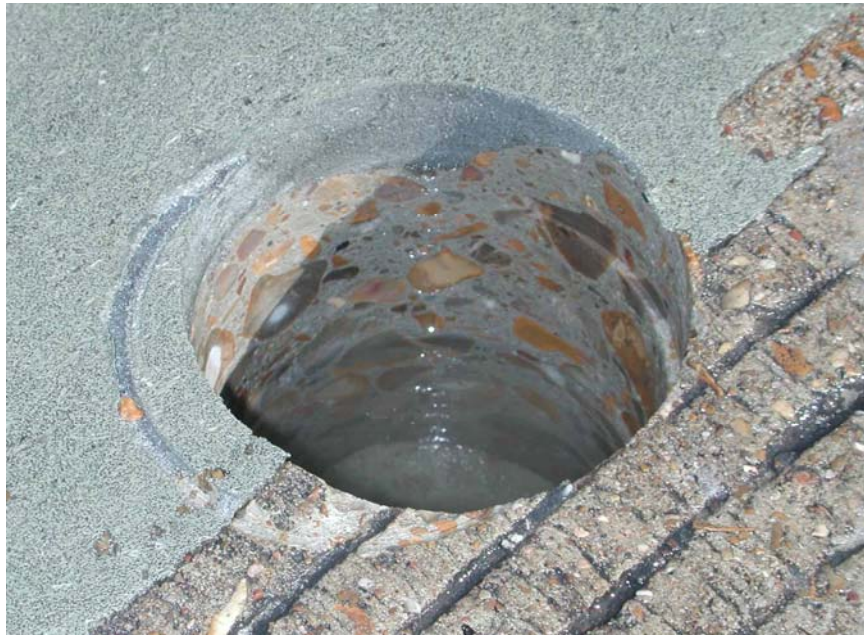
Figure 5.17 Delpatch Field Core from Houston

In Houston, researchers cored four different materials: Fibrescreed, Delpatch, FlexPatch, and WaboCrete (Wabo ElastoPatch). The photo of [Figure 5.17](#) illustrates the pavement where a core was taken of Delpatch.
