# **PERFORMANCE MONITORING PAVEMENTS WITH THERMAL SEGREGATION IN TEXAS**

Report 0-6080-1

Project Title: Performance Histories of Thermally Segregated HMA

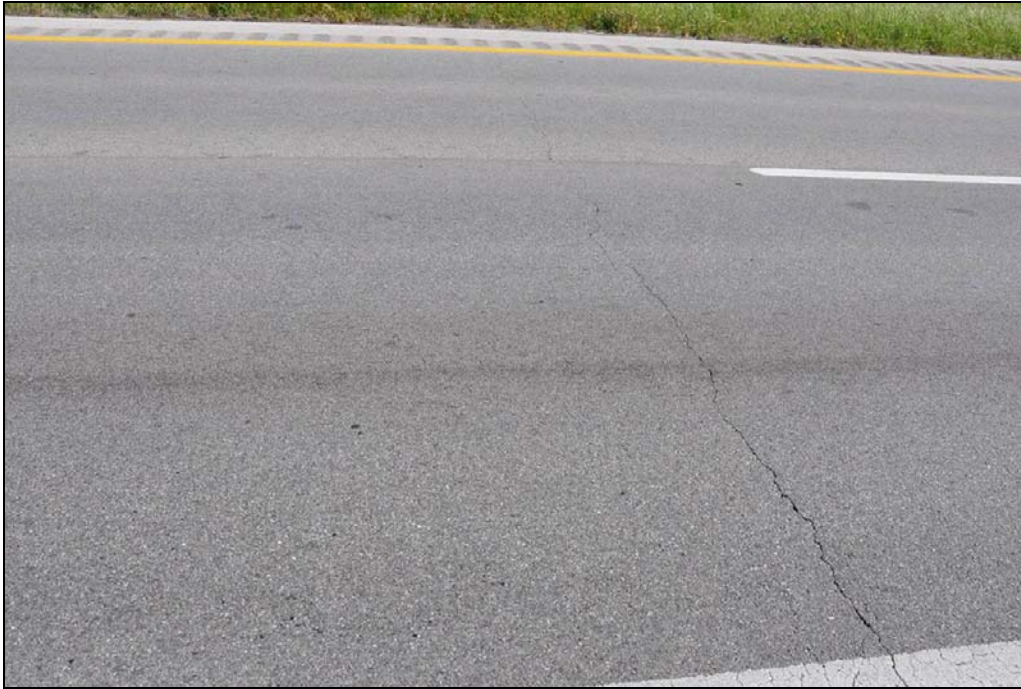
In July 2011, TTI conducted a visual and GPR survey of this project. The only distresses noted were occasional transverse cracks, as [Figure 8](#) illustrates, and occasional longitudinal cracking on the shoulder. The longitudinal cracking was likely due to the subgrade and dry weather pattern that existed at the time of the survey. The GPR survey did not reveal any items of concern, with clean, uniform traces and uniform surface dielectric values. [Figure 9](#) presents an example excerpt from the GPR data collected over the westbound inside lane.

**Figure 8. Example Transverse Cracking on IH 10 after Four Years of Service.**

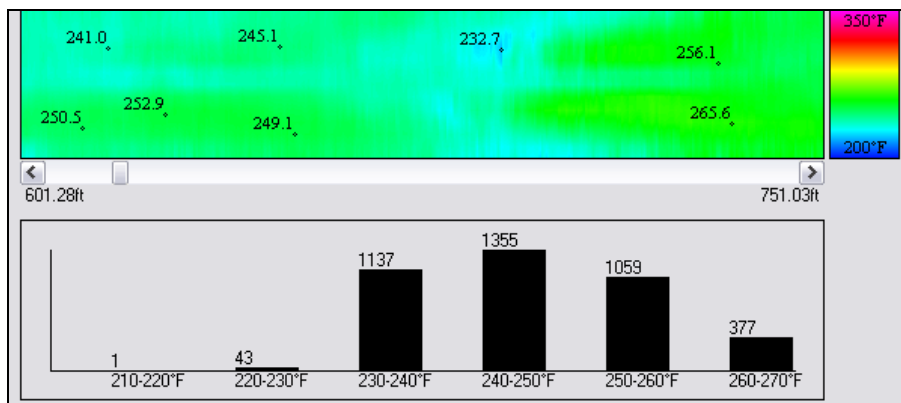
Figure 34 presents the most severe location of thermal differentials observed on the US 81 project. This location has a temperature differential of 36°F; only two other profiles were observed with temperature differentials exceeding 30°F.

**Figure 34. Location of Most Severe Temperature Segregation on US 81.**

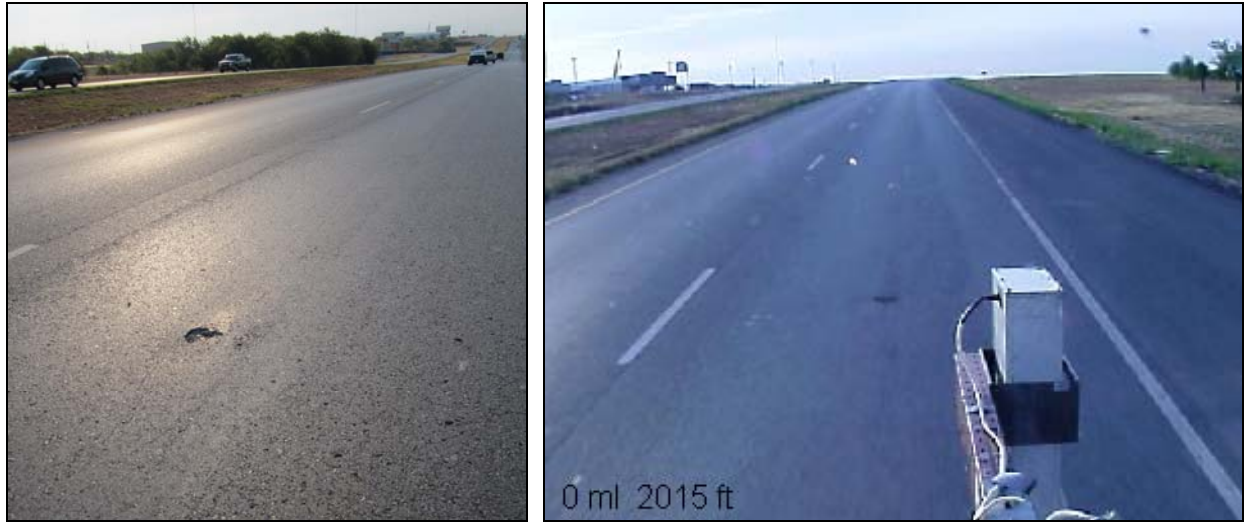
TTI performed a visual and GPR survey on the US 81 section in August 2011. The section exhibited some roughness, which was probably due to the subgrade, and had five locations of low-severity potholes, as Figure 35 shows.

**Figure 35. Localized Distress on US 81.**

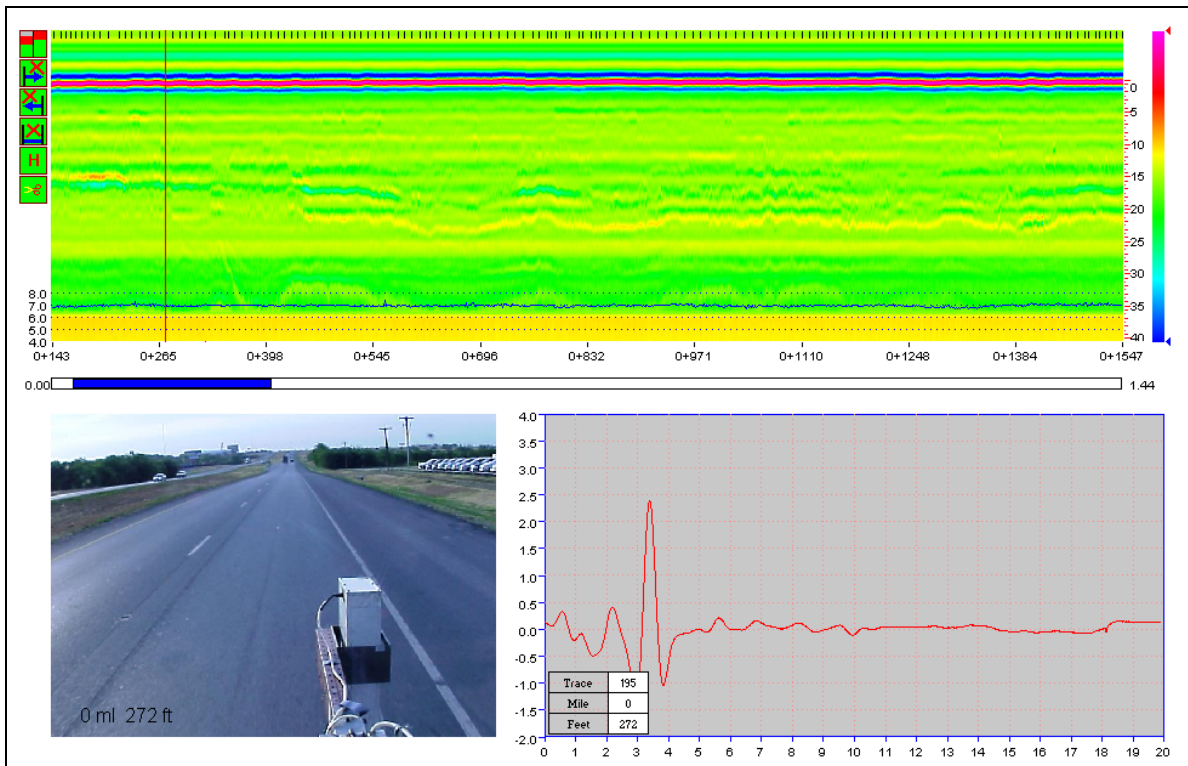
Figure 36 shows example radar data from the section. The radar data are clean with very uniform surface dielectric, and no odd radar traces exist at the locations with the distress. A review of the thermal profiles also did not reveal any anomalies at the locations. Additionally, the problem areas observed were almost in the centerline, as Figure 35 shows. Due to these observations, researchers ruled out segregation as a potential cause for the observed distress.

**Figure 36. Example GPR Data from US 81.**

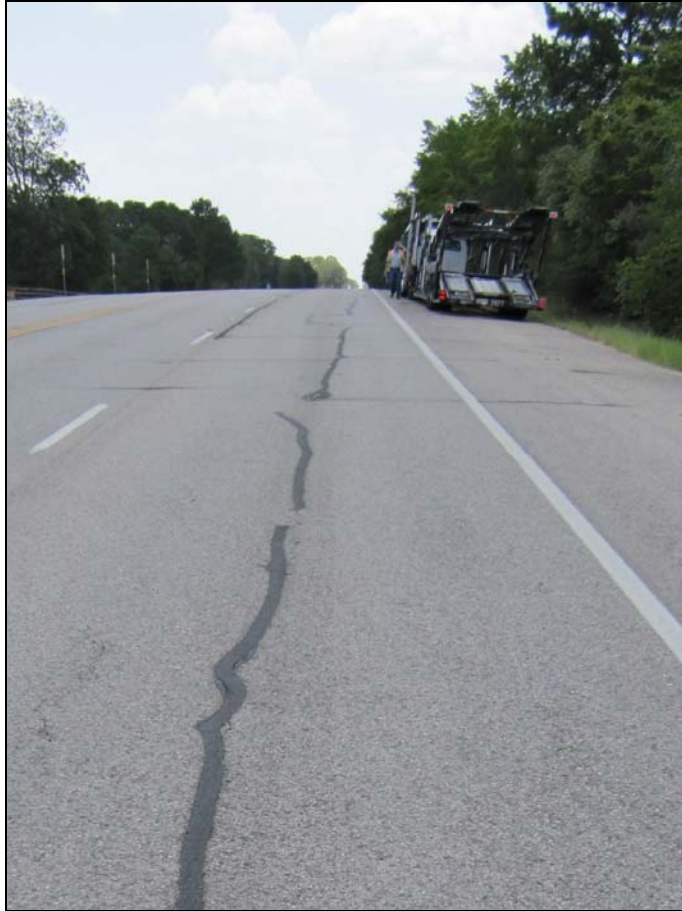
TTI performed a follow-up visual and GPR survey on the section in July 2011. The section exhibited transverse and reflection cracking and some longitudinal cracking, as [Figure 43](#) illustrates.

**Figure 43. Transverse and Longitudinal Cracking on BU 290.**

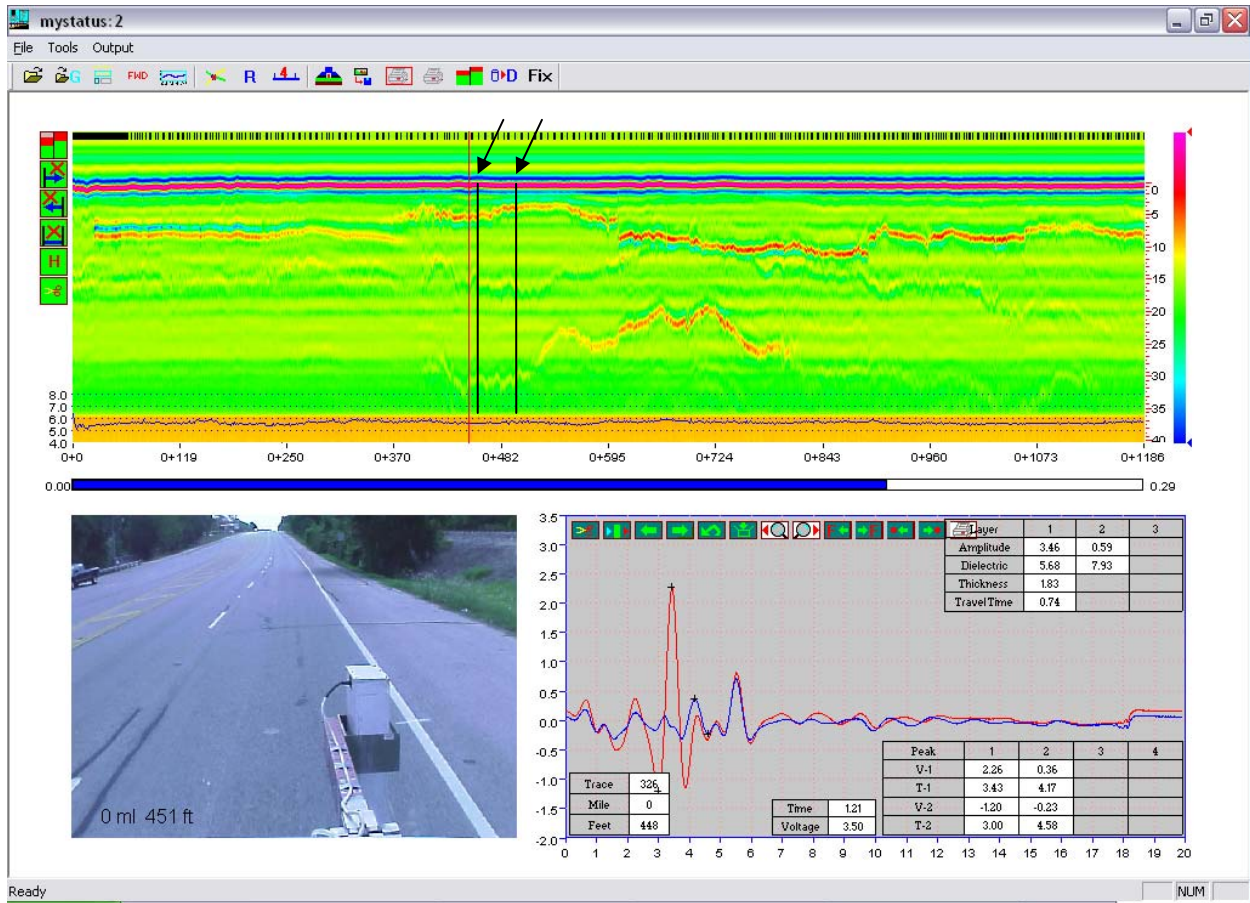
Figure 44 illustrates the GPR data collected on the section. The GPR data do not show any unusual traces at the segregated locations identified during construction. Additionally, Figure 45 shows photos as of July 2011 at the locations that exhibited greater than 10 percent air voids at the time of construction. Based upon the radar and condition data, at this time no distress in the field appears due to these segregated locations.

**Figure 44. GPR Data on BU 290 after Seven Years of Service.**  
*Note: segregated areas identified during construction annotated with arrows.*

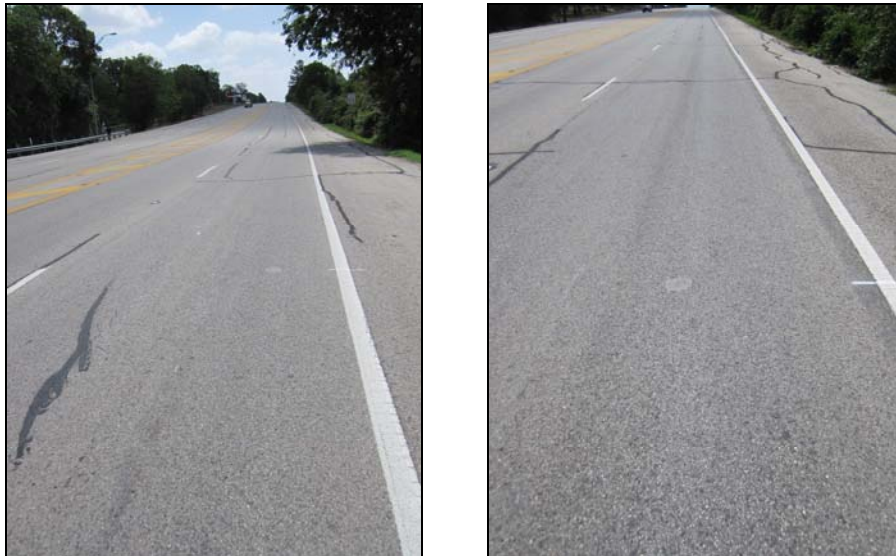
**Figure 45. Thermally Segregated Locations on BU 290 after Seven Years of Service.**

Although a few segregated locations of over 10 percent air voids were observed at the time of construction, after seven years of service no unusual distress was identified at those locations. Current cores from the segregated zones identified during construction were between 7 and 8 percent air voids, so densification under traffic occurred. Comparing performance test results (overlay and Hamburg test) from these current pavement cores to current cores from the non-segregated zones revealed no notable difference. It appears that during trafficking, on this project the segregated zones densified into what would be considered a “normal” air void content range and exhibited performance properties comparable to the mix identified as non-segregated at the time of construction. In both cases, the Hamburg results were acceptable and the overlay test results were poor, with specimens from both segregated and non-segregated zones failing in three cycles.

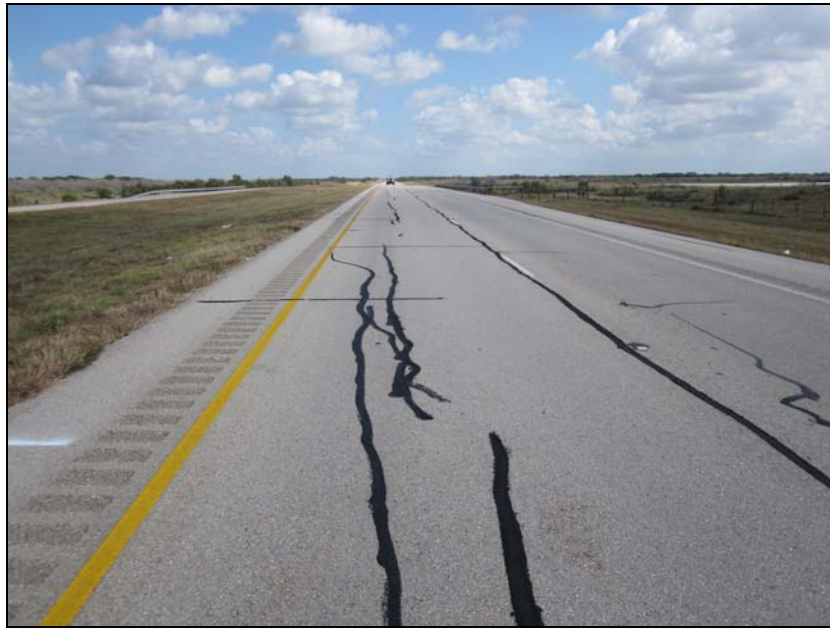
TTI conducted a visual and GPR survey on this section of US 77 in July 2011, approximately five years after construction. The pavement exhibited some longitudinal and transverse cracking, as [Figure 51](#) illustrates. Additionally, the visual and GPR survey shows clear signs of truck-end segregation. [Figure 52](#) presents the GPR data, which show cyclical dips in the surface dielectric value. Many of these cyclical dips correspond to locations of high air voids shown in [Figure 49](#) identified at the time of construction.

**Figure 51. US 77 Section after Five Years of Service.**

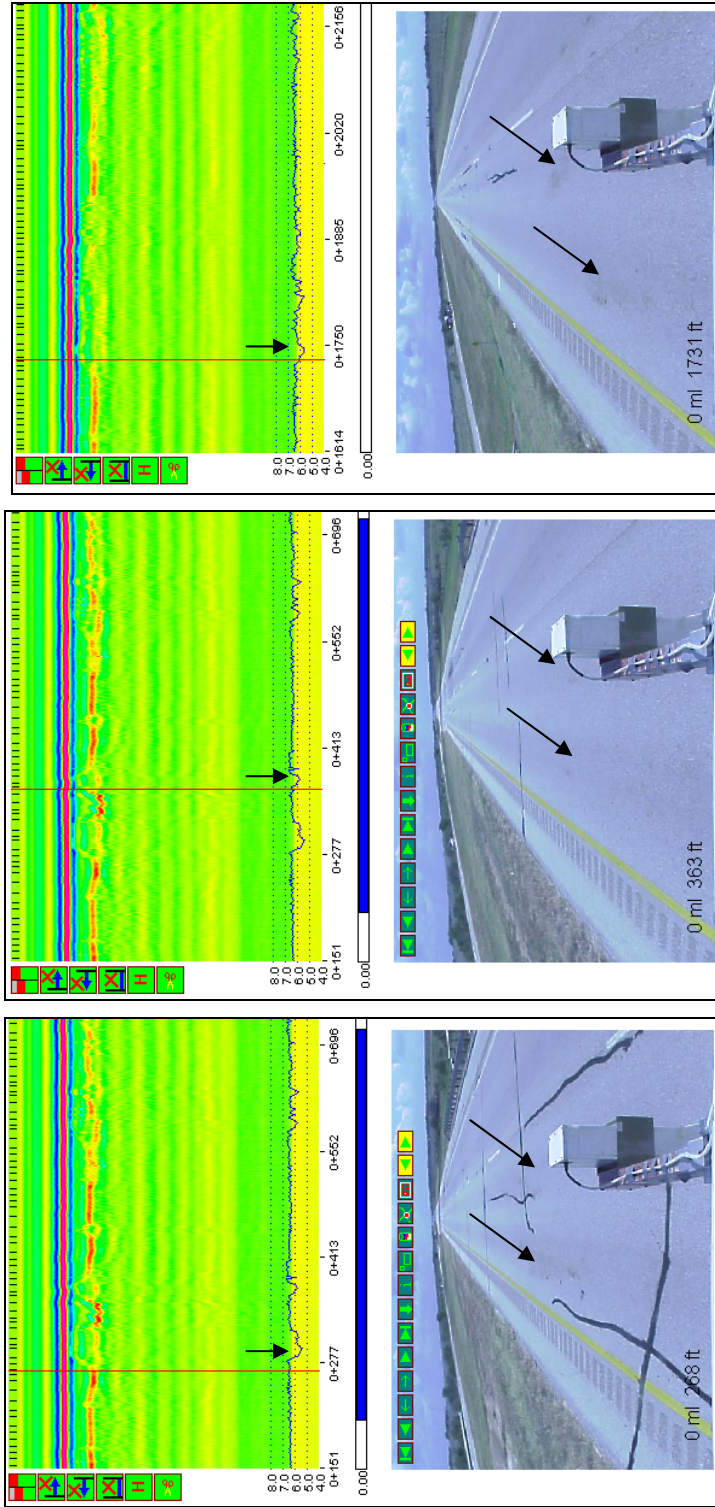
[Figure 53](#) illustrates the current condition of some of these segregated locations. Although difficult to distinguish in [Figure 53](#), all locations show signs of a coarser texture. At one location, a crack originates over the segregated location in the inside wheel path. However, since longitudinal cracking exists project-wide, this occurrence may not necessarily be due to the segregation.

**Figure 53. Cyclically Segregated Locations on US 77 after Five Years of Service.**

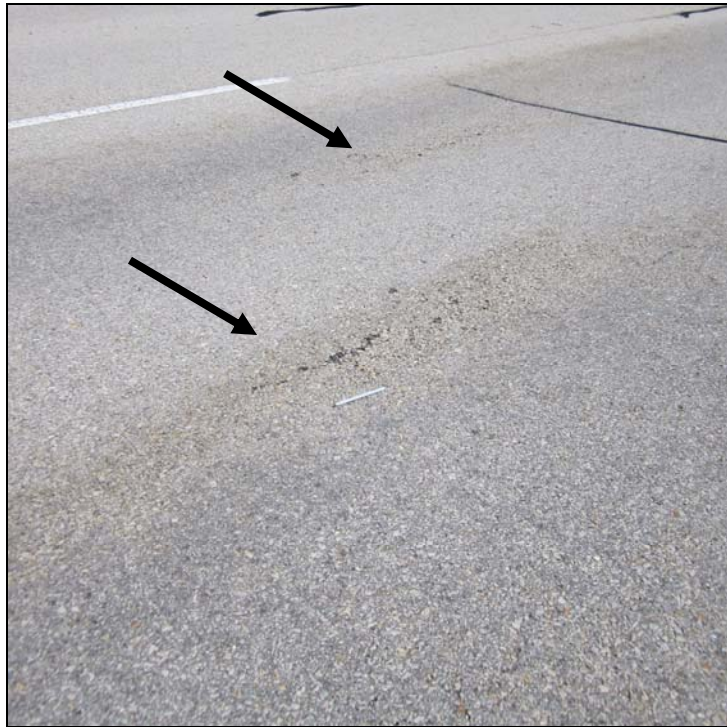
Elsewhere on the US 77 project, other locations of segregation were observed, as [Figure 54](#) illustrates. Although these locations were not surveyed at the time of construction, [Figure 54](#) illustrates classic cases of cyclical segregation, exhibiting a coarser surface texture, raveling, and cracking. Additionally, some locations of patching exist on the project, and at one location, these patches were centered about 150 ft apart, typically the distance between truckloads. [Figure 55](#) shows this location.

**Figure 54. Segregated Location on US 77.**

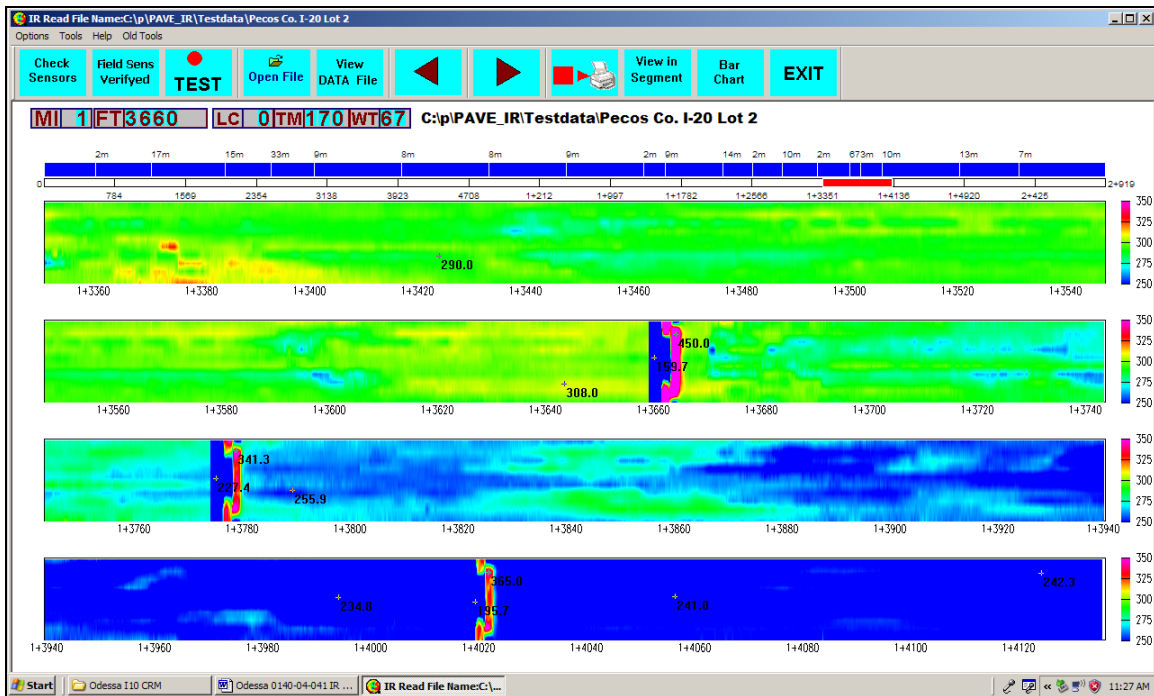
Figures 61 and 62 show examples of the temperature profile from the possible problem locations. In Figure 61, the paver stop at 1 mi. + 3660 ft, and the surface temperature of the mat when the paving train resumed was 159°F, while under the burners that surface temperature was 450°F.

Figure 61. Potential Problem Area in Lot 2 on IH 10 CRM.

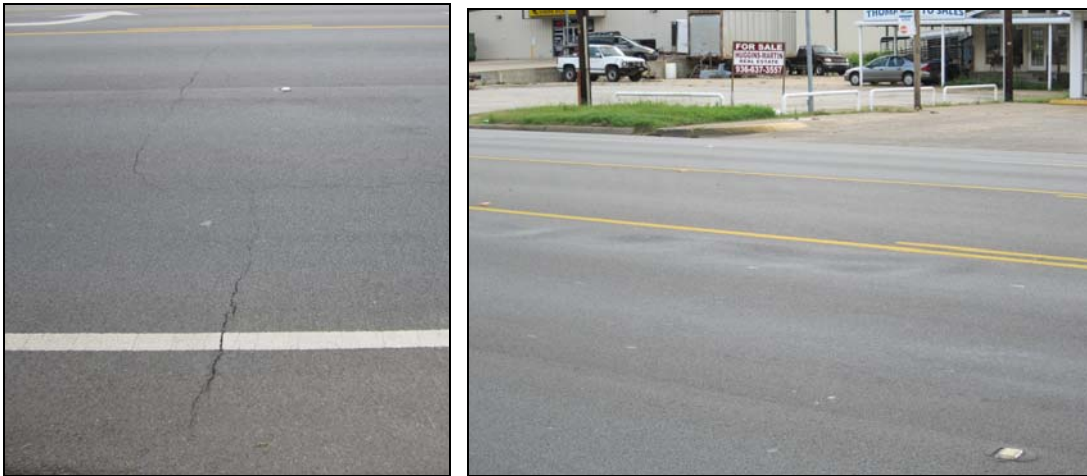
In July 2011, TTI conducted a follow-up visual and GPR survey on the section. The only distresses observed were reflection cracking and some locations of corrugations. [Figure 67](#) provides visual examples of these distresses.

**Figure 67. Distresses Observed on BU 59 after Five Years of Service.**

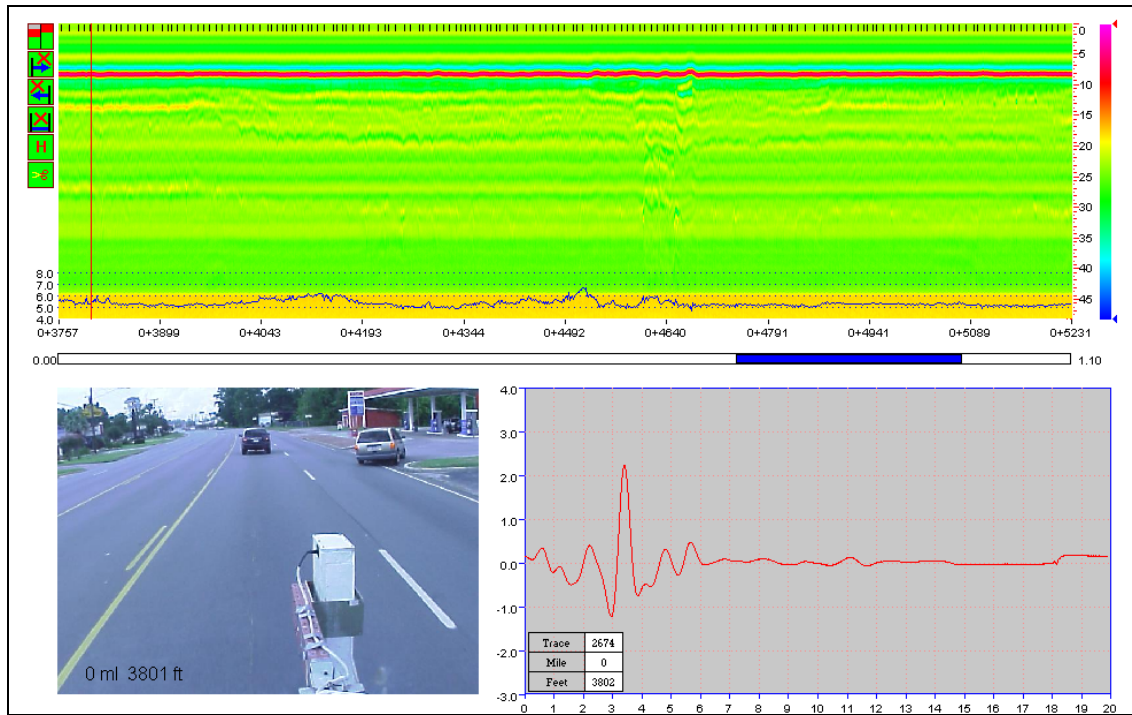
Figure 68 shows example GPR data from the section. The GPR data are clean and have some notable variations in the surface dielectric. However, no distress appears apparent at these locations, and the locations of corrugations in the pavement do not seem to consistently match any changes in the dielectric from the GPR.

**Figure 68. GPR Data on BU 59 after Five Years of Service.**

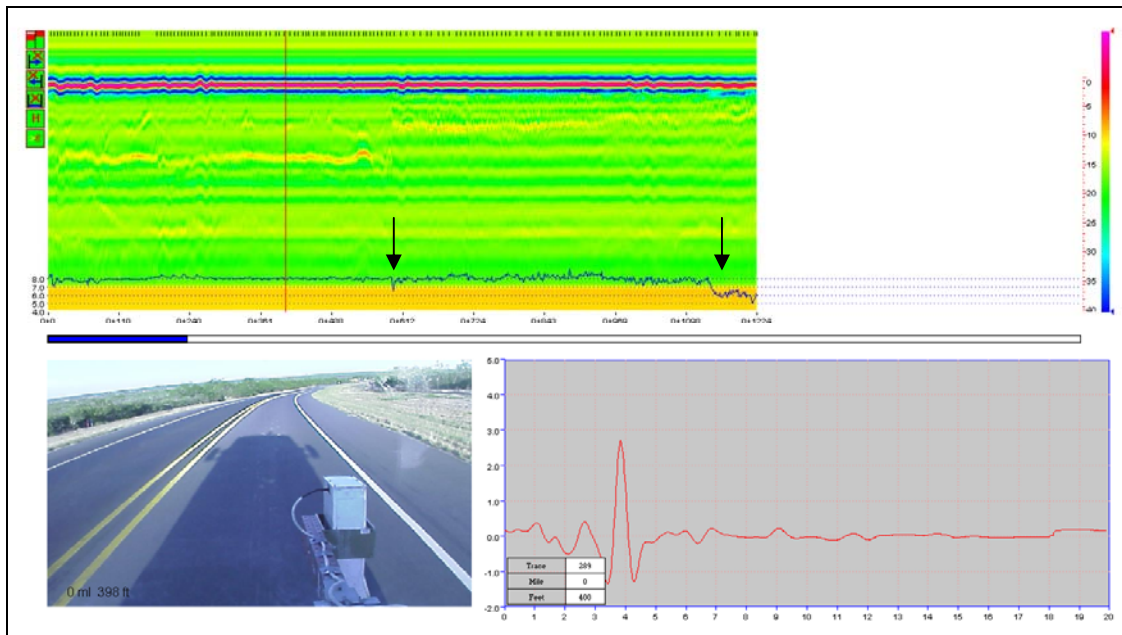
In July 2011, TTI conducted a follow-up visual and GPR survey. Figure 73 shows the GPR data, which show a significant drop in the dielectric in the middle and at the end of the evaluated section. Visually, some locations of coarser surface texture, and some corrugations, were observed. Figures 74 and 75 show the thermally segregated locations selected for coring.

**Figure 73. US 90 CAM after Three Years of Service.**

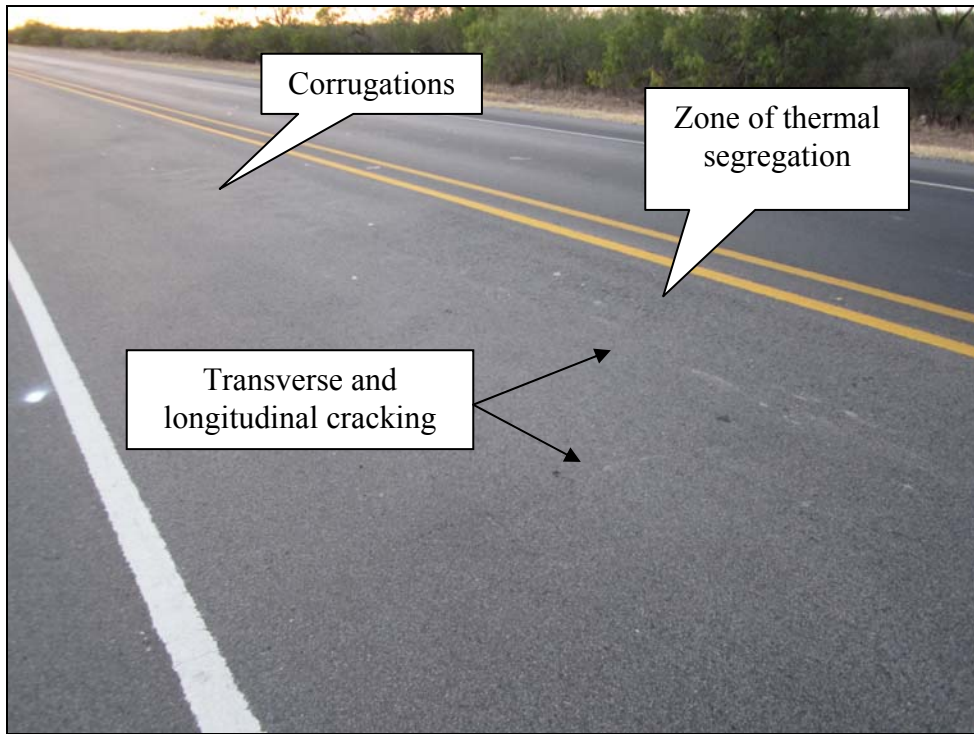
**Figure 75. Corrugations, Cracking, and Thermal Segregation on US 90 CAM after Three Years of Service.**  
*Note: follow-up coring performed at location of arrow, which corresponds with 525 ft in [Figure 71](#).*

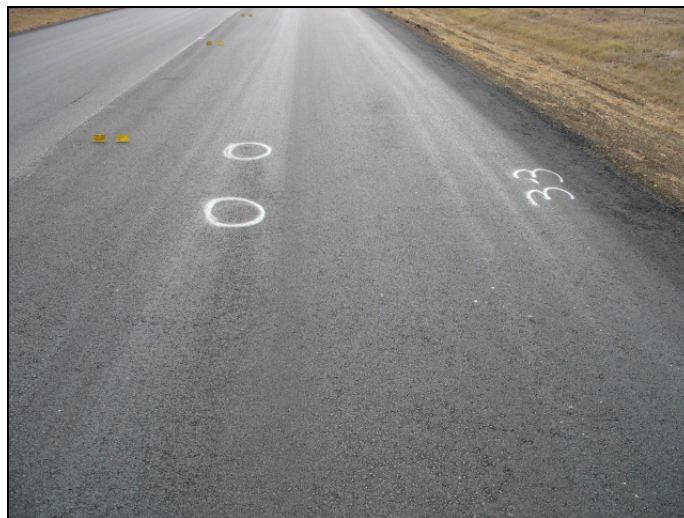
**Figure 80. Visually Observed Segregation on FM 2440 after Construction.**

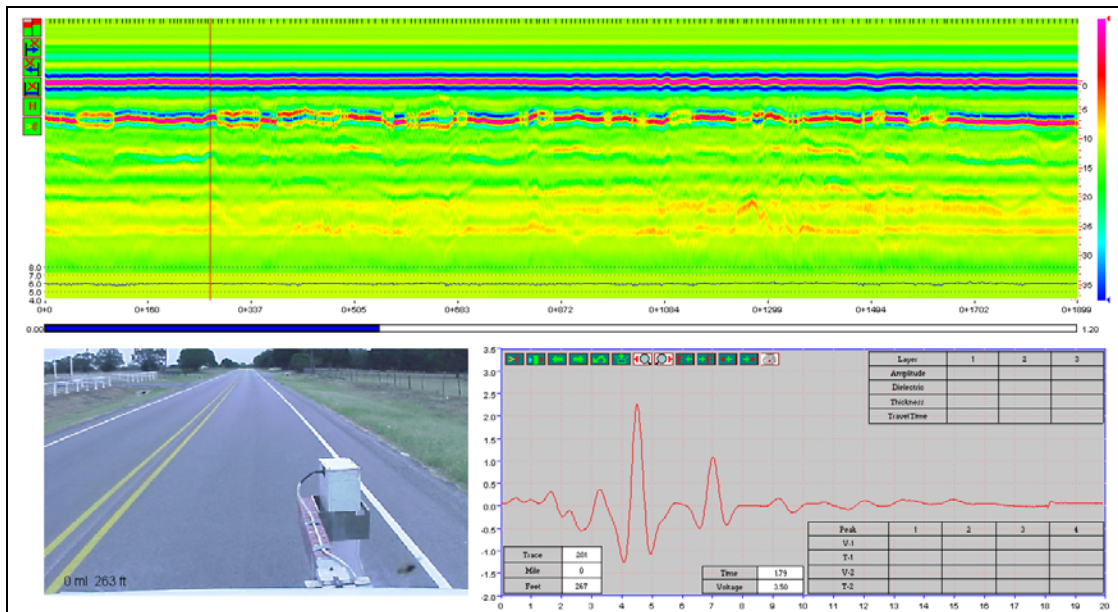
Figure 84. FM 2440 after 3 Years of Service.

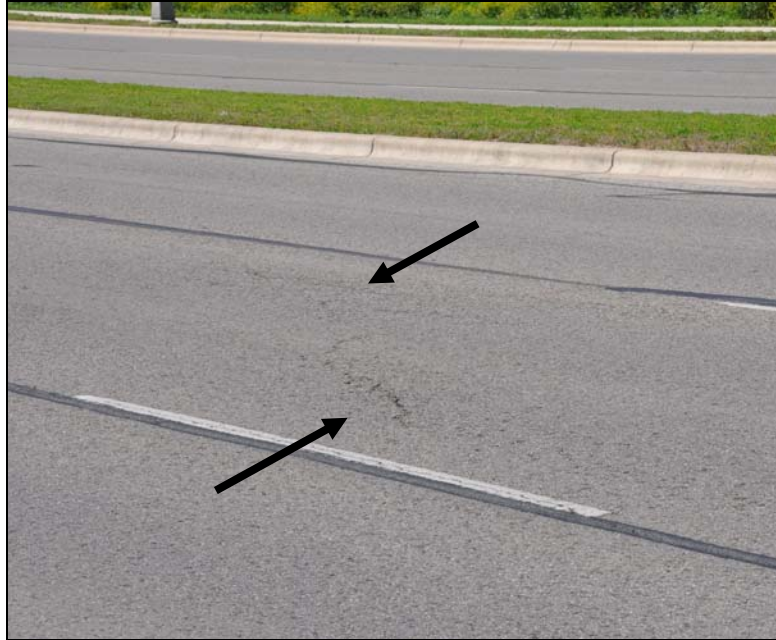
**Figure 105. Example Cyclical Cracking on A.W. Grimes.**

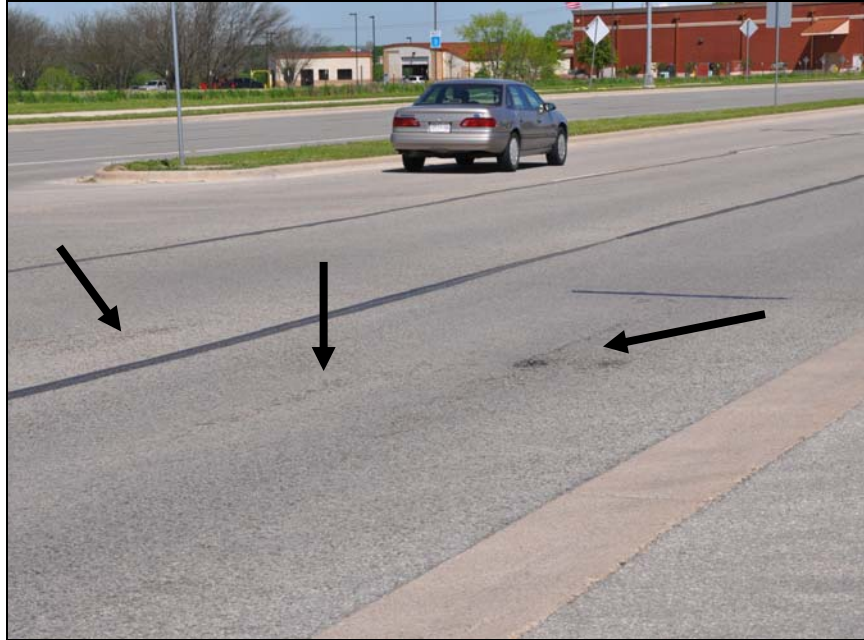
**Figure 106. Example Cyclical Distress with Raveling and Cracking on A.W. Grimes.**

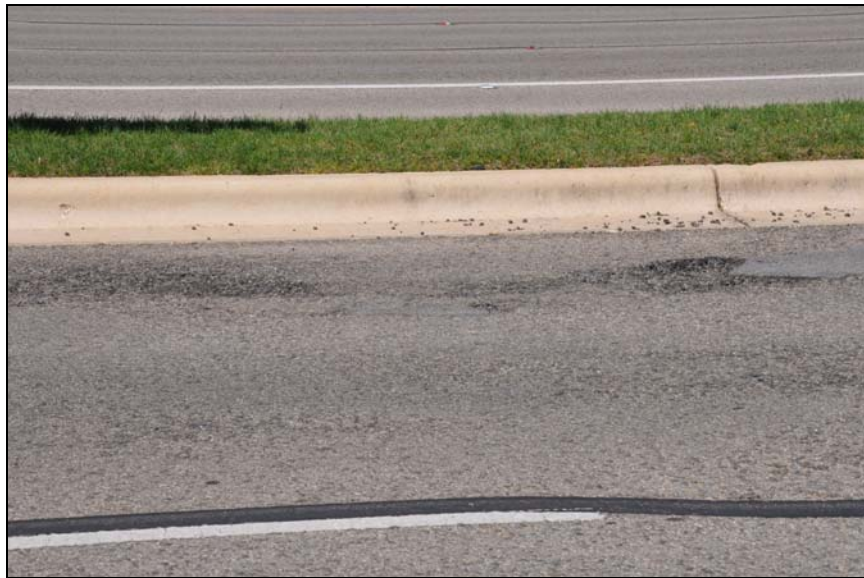
**Figure 107. Severe Raveling on A.W. Grimes.**

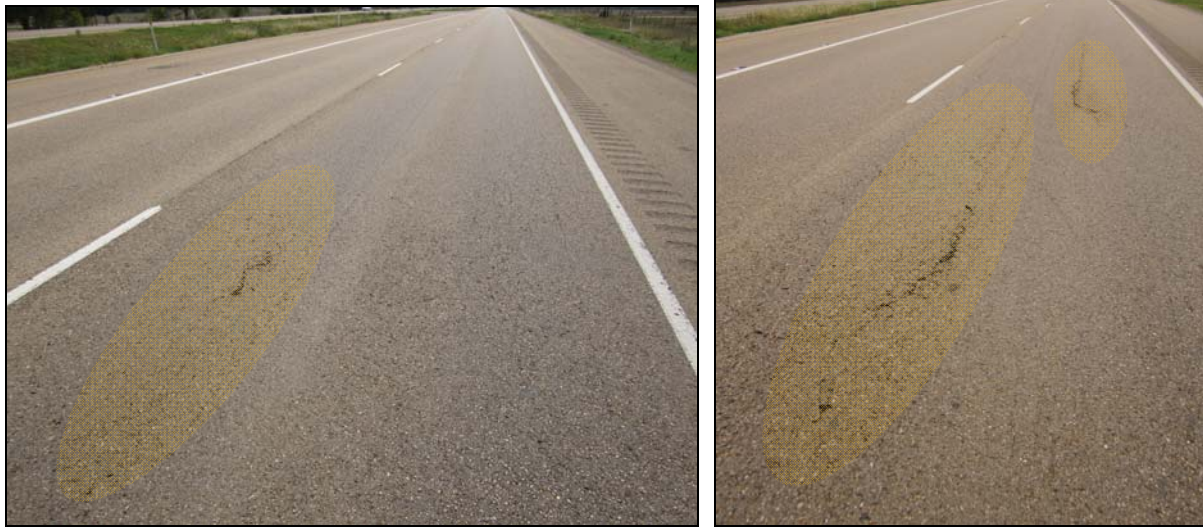
**Figure 108. Examples of Cyclical Distress on SH 21.**

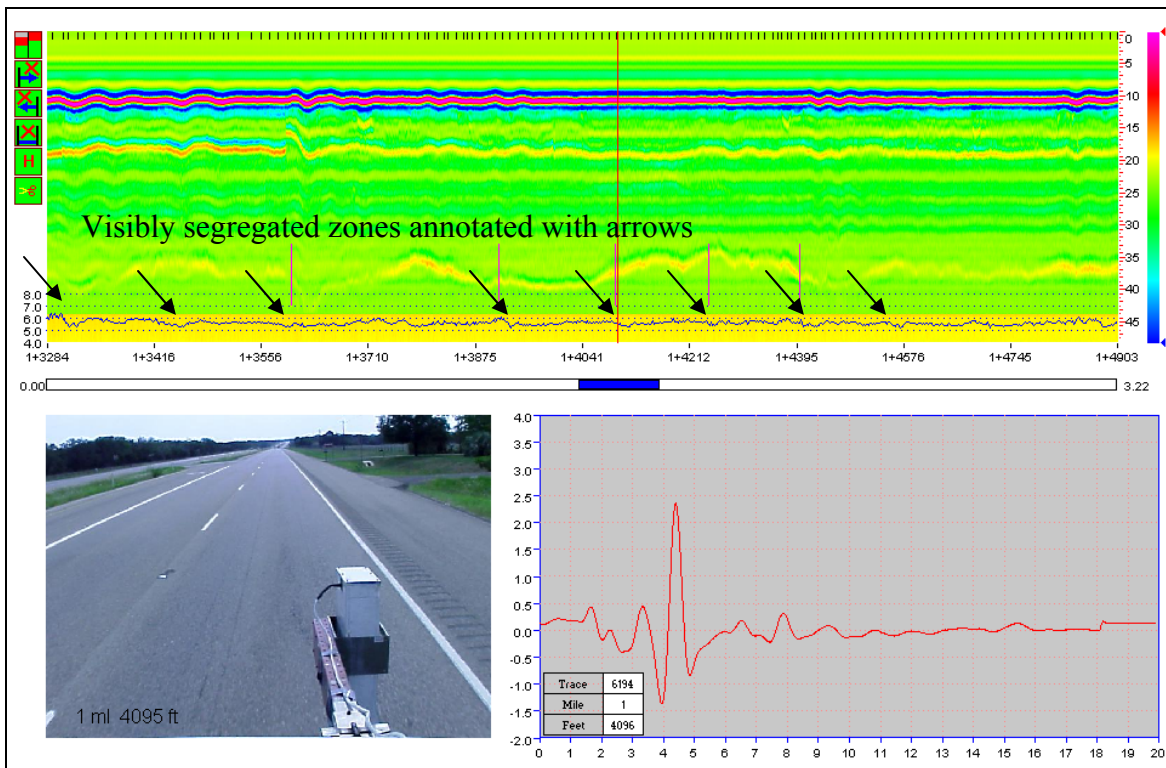
**Figure 109. Example GPR on SH 21 with Cyclical Distress.**

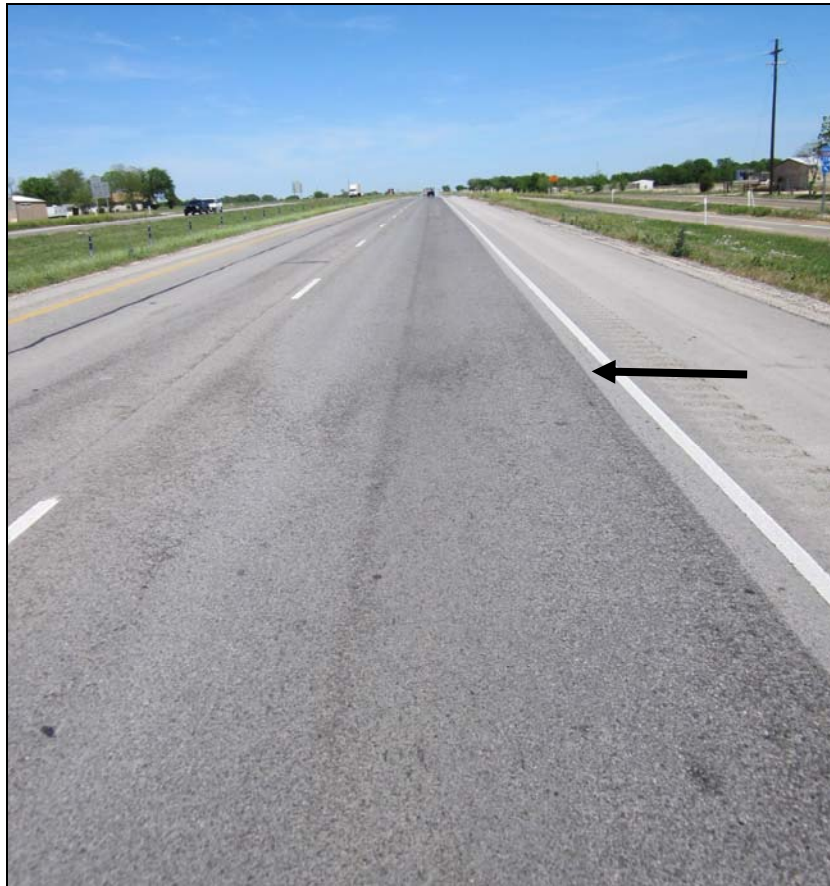
**Figure 110. Zone of Cyclic Segregation on IH 35W.**

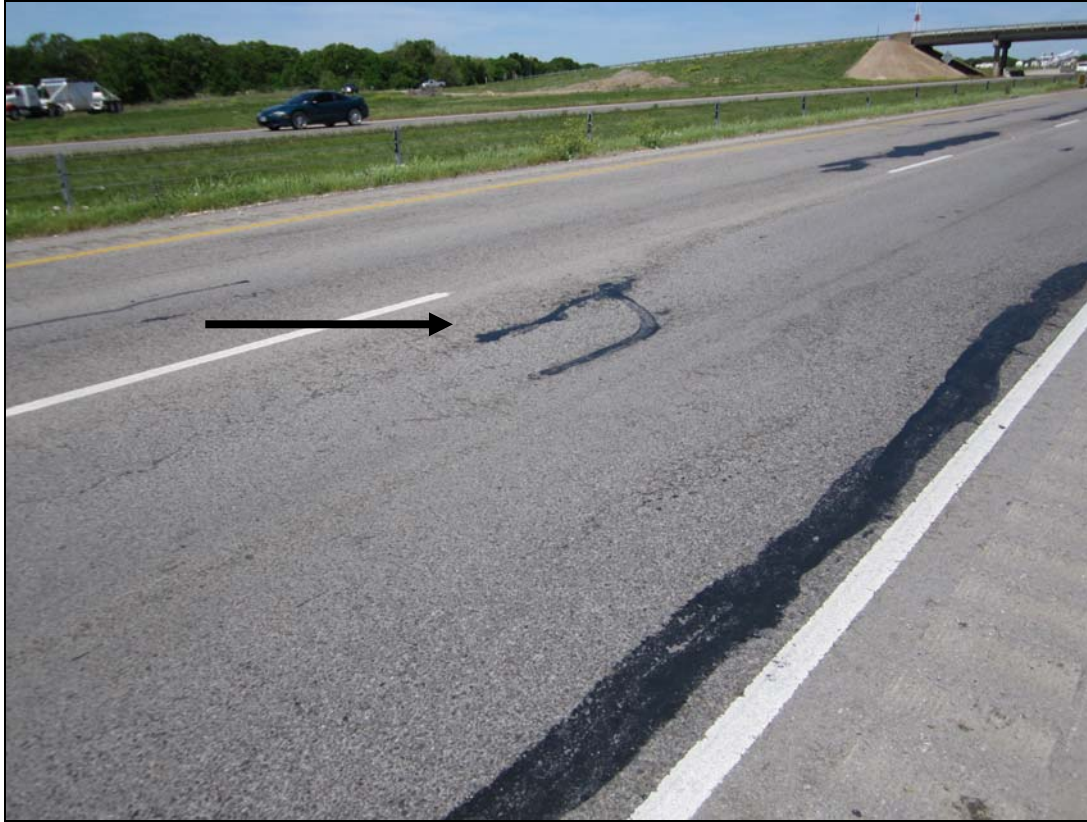
**Figure 111. Raveling and Cracking Failures in Segregated Zones on IH 35W.**

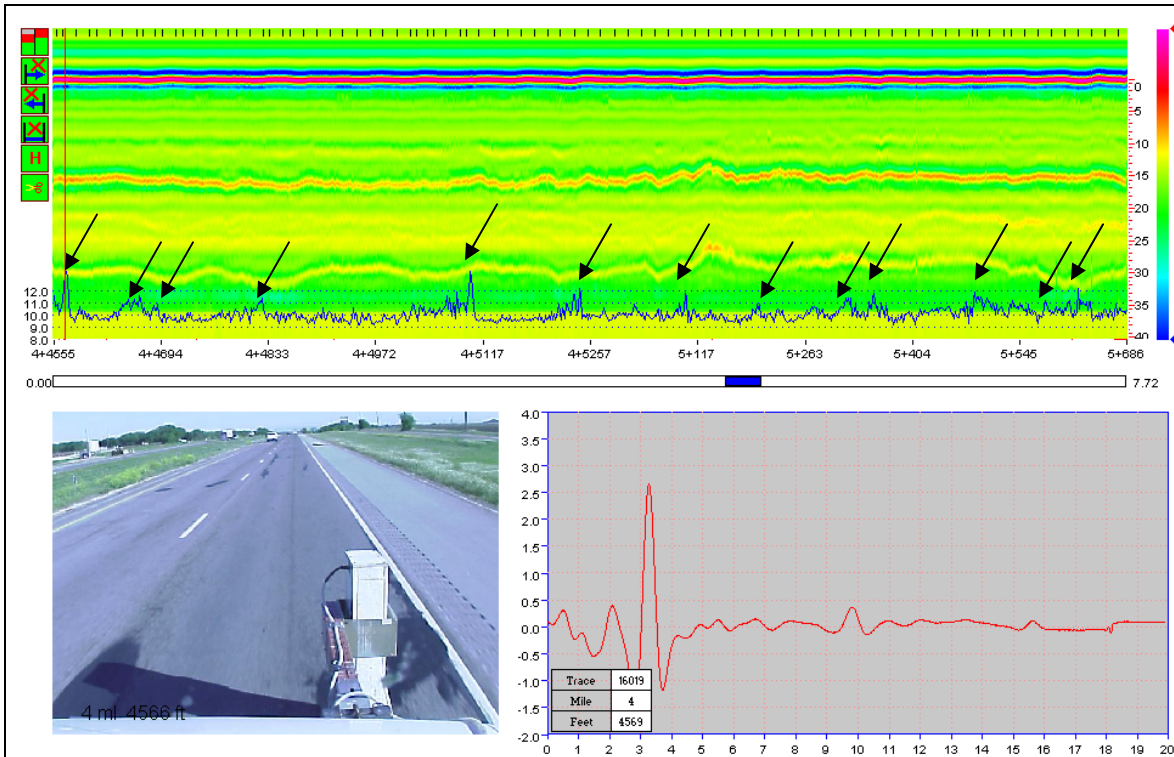
**Figure 112. Cyclic Failures with Raveling and Cracking on IH 35W in GPR.**

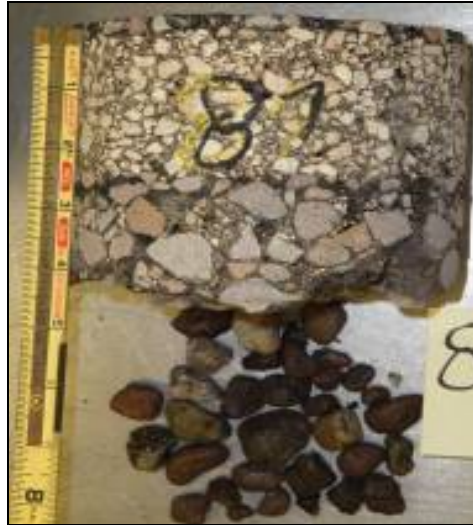
**Figure 115. Core Taken from TRM 87 on IH 20.**
