1. Report No. FHWA/TX-11/0-6120-1		2. Government Accession No.		3. Recipient's Catalog No.	
4. Title and Subtitle TREATMENTS TO REDUCE THE FREQUENCY OF FREEWAY EXIT SIGN HITS				5. Report Date January 2011 Published: June 2011

9. Performing Organization Name and Address Texas Transportation Institute The Texas A&M University System College Station, Texas 77843-3135				10. Work Unit No. (TRAIS)

# **TREATMENTS TO REDUCE THE FREQUENCY OF FREEWAY EXIT SIGN HITS**

Report 0-6120-1

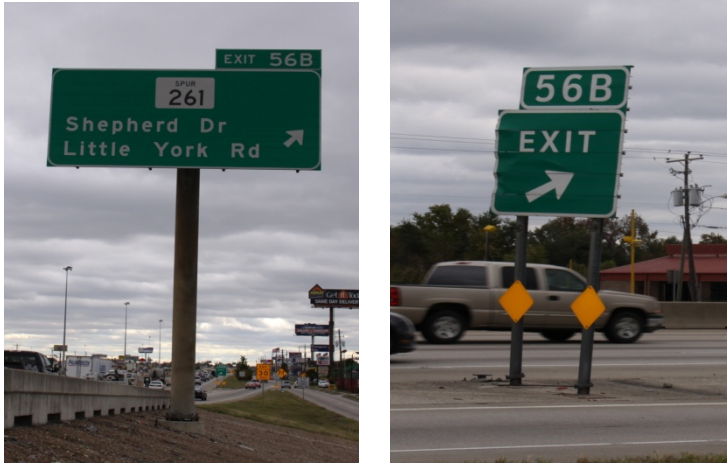
<p>Exit Direction sign shown on left. Exit Gore sign shown on right; note the use of diamond-shape reflectors on posts</p>
Key Distances from Painted Gore	
Advance Guide Sign (1/2 mi)	+2660 ft
Advance Guide Sign (METRO)	+2370 ft
Exit Direction Sign	+220 ft
Exit Gore Sign	-250 ft
Average Speeds (mph)	
Non-Exiting Traffic (lane 4)	56.5
Exiting Traffic	51.6
Speed Limits (mph)	
Main Lanes	65
Exit Ramp Advisory	30

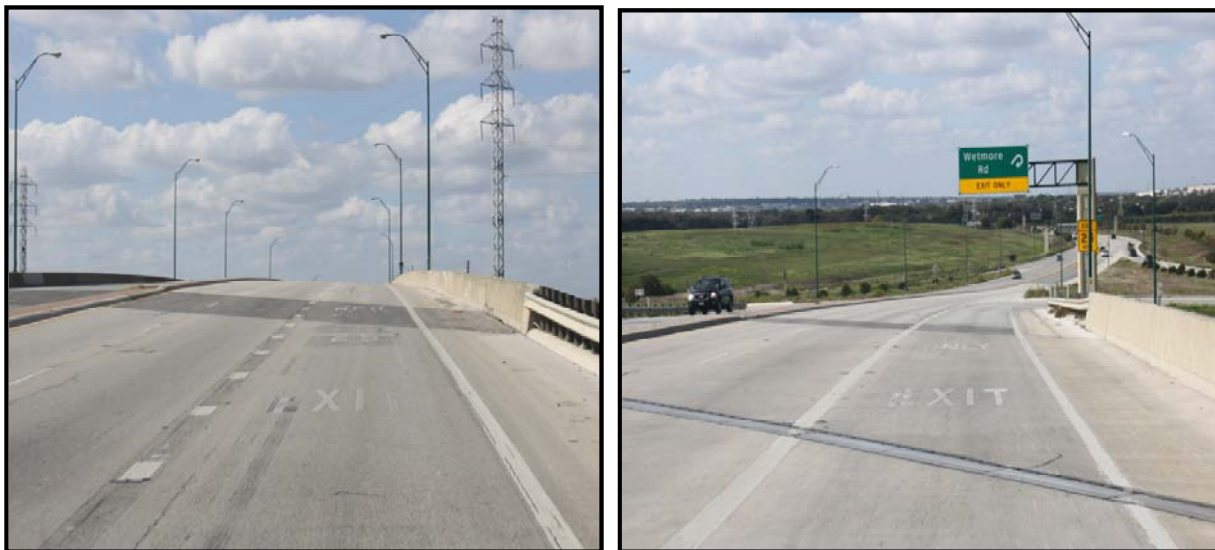
**Figure 18. Example of a Potential Hazard—Steep Grade before an Exit.**

Roadway conditions requiring significant deceleration were also taken into account. These include inadequate superelevation, sharp horizontal curve, steep grade, inadequate shoulder, lane drop, and lane width reductions. [Figure 18](#) illustrates an example of a steep grade approaching an exit. Posted and advisory speeds were recorded and operating speeds were measured for each location. This allowed researchers to determine the adequacy of existing sight distances. Field staff also assessed the visibility of potential hazards at each site.

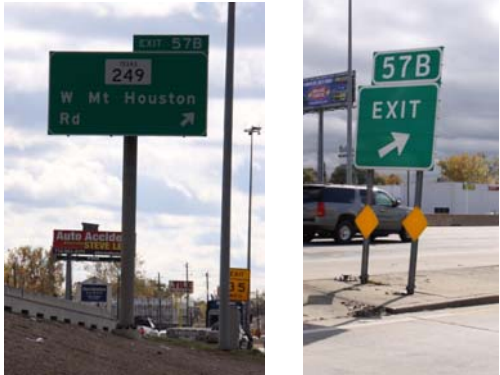
<p>Exit Direction Sign shown on left; Exit Gore Sign on right; note the use of type 1 object markers on posts</p>
<i>Key Distances from Painted Gore</i>	
Advance Guide Sign	+1700 ft
Exit Direction Sign	+280 ft
Exit Gore Sign	-280 ft
<i>Distance at which exit gore sign is first visible to driver</i>	+1225 ft
Average Speeds (mph)	
Non-Exiting Traffic (lane 4)	61.8
Exiting Traffic	52.2
Speed Limits (mph)	
Main Lanes	65
Exit Ramp Advisory	35

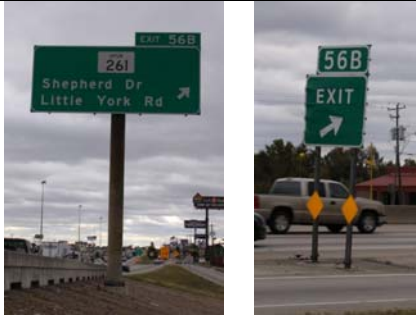
<p>Exit Direction Sign shown on left; Exit Gore Sign on right; note the use of type 1 object markers on posts</p>
<i>Key Distances from Painted Gore</i>	
Advance Guide Sign (1/2 mi)	+2660 ft
Advance Guide Sign (METRO)	+2370 ft
Exit Direction Sign	+220 ft
Exit Gore Sign	-250 ft
<i>Distance at which exit gore sign is first visible to driver</i>	+1000 ft
Average Speeds (mph)	
Non-Exiting Traffic (lane 4)	56.5
Exiting Traffic	51.6
Speed Limits (mph)	
Main Lanes	65
Exit Ramp Advisory	30

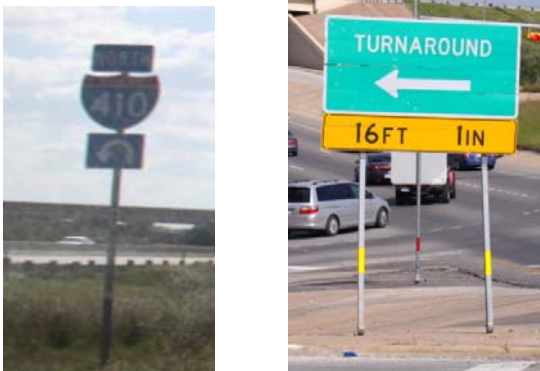
<p>Turnaround Guide Sign, Turnaround Gore Sign</p>
<i>Key Distances from Painted Gore</i>	
Turnaround Guide sign	+90 ft
Turnaround Gore sign	-181 ft
<i>Distance at which exit gore sign is first visible to driver</i>	~ 750 ft (at this distance, sign is barely visible with some visual clutter). At ~595 ft, turnaround sign is more clearly visualized with less clutter at this point
<i>Average Speeds (mph)</i>	
U-turn Exiting Traffic (at gore)	21
U-turn Traffic (upstream of gore)	28
<i>Speed Limits (mph)</i>	
Frontage Road	45
Turnaround Advisory	None
