## TEMPORARY LARGE GUIDE SIGNS

**Test Report 0-6782-1**

**TEXAS A&M TRANSPORTATION INSTITUTE  
COLLEGE STATION, TEXAS**

**TEXAS DEPARTMENT OF TRANSPORTATION**

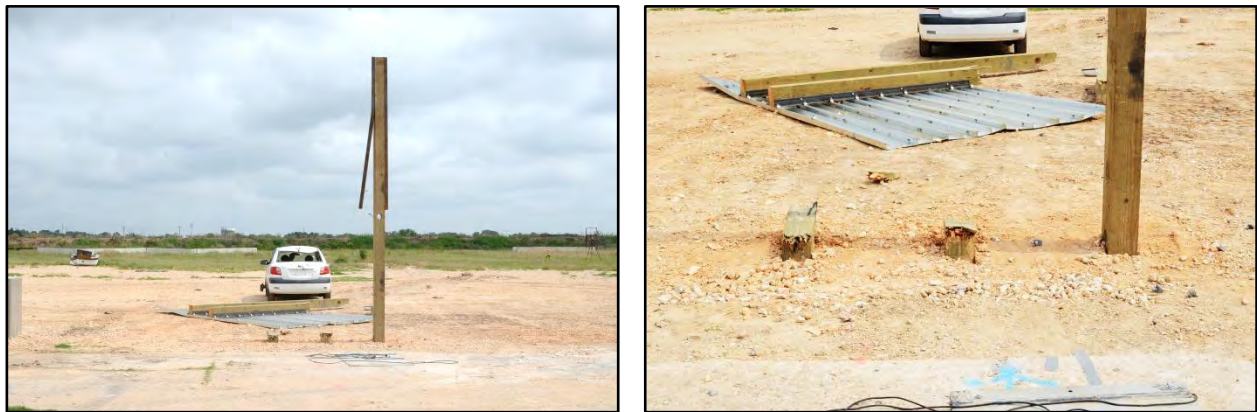
Figure 4.4 shows damage to the wood post sign support system after the test. The left support leg fractured at the hole near ground level and remained connected to the sign panel. The middle support leg fractured at the hole the hole near ground level and below the sign panel. The upper portion of the middle support leg remained attached to the sign panel. The right support leg remained intact and the soil around the post was only disturbed. The sign panel separated from the right support leg and contacted the roof of the vehicle before coming to rest on the ground.

**Figure 4.4. Direct Embedded Wood Support Temporary Guide Sign System after Test No. 467823-1.**

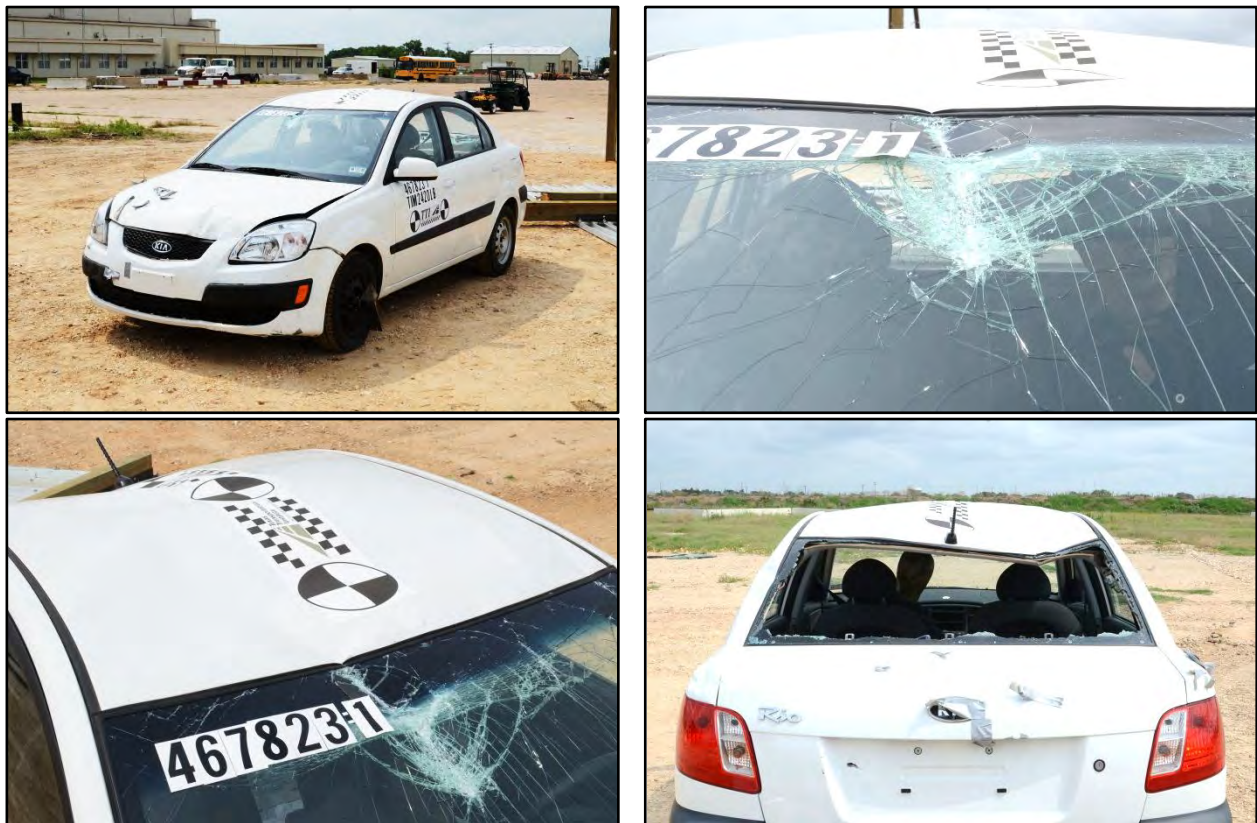
vehicle. The windshield shattered over an area of 12 inches  $\times$  16 inches near the top center, and just above this area the roof was pushed downward towards the occupant compartment 1.75 inches. Just right of centerline of the roof over the rear passenger compartment was an area measuring 23 inches  $\times$  24 inches that was deformed downward towards the occupant compartment. Maximum occupant compartment deformation was 3.5 inches in the roof over the right rear occupant compartment. Exterior crush and occupant compartment measurements can be found in [Tables B2](#) and [B3](#) of [Appendix B](#).

**Figure 4.5. Vehicle after Test No. 467823-1.**

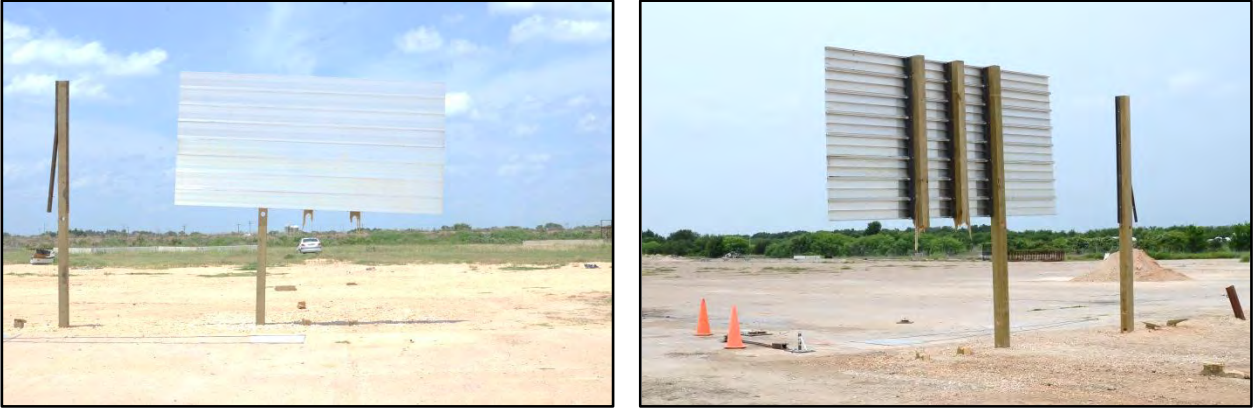
**Figure 4.8. Direct Embedded Wood Support Temporary Guide Sign System after Test No. 467823-2.**

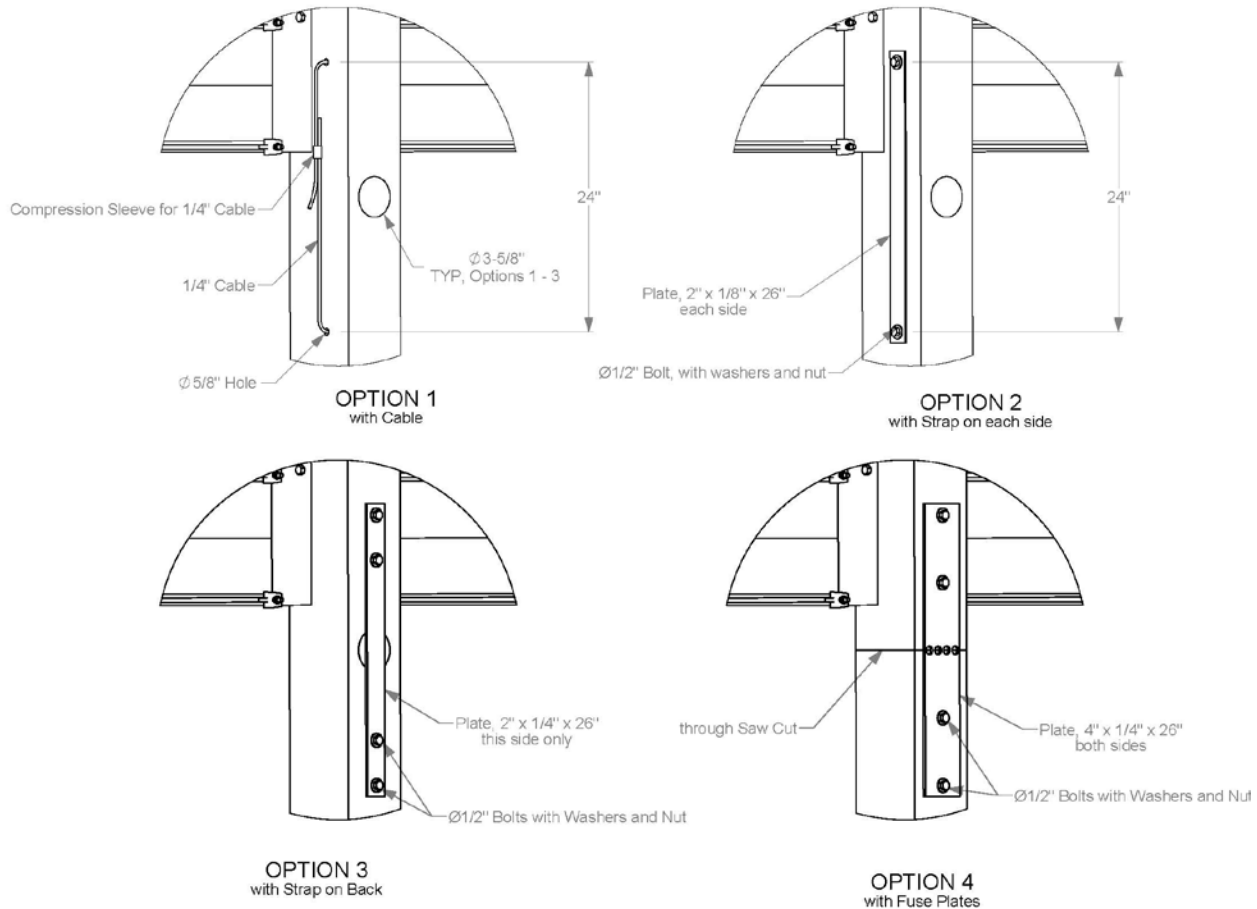
unidirectional. It is designed to operate for a frontal impact but would not operate in the same mode for a backside impact. Therefore, this would not be the preferred option if the temporary wood post guide sign is intended for use in a median of a divided highway, or within the clear zone for opposing traffic on an undivided highway.

**Figure 4.11. Design Options for Direct Embedded Wood Support Temporary Guide Sign System.**

In consultation with TxDOT, design option 1 was selected for further evaluation. [Figure 4.12](#) provides overall details the modified direct embedded wood support temporary guide

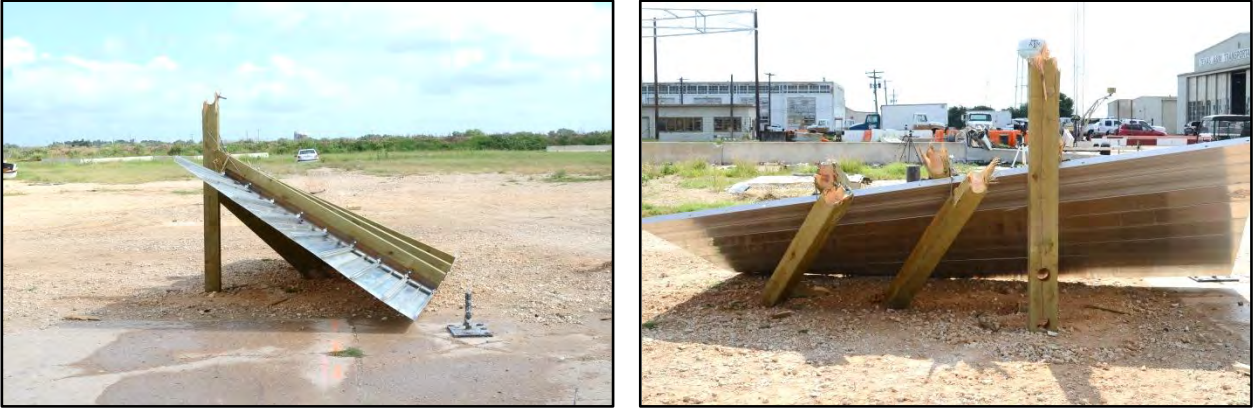
[Figure 4.15](#) shows damage to the wood post sign support system after the test. The right and middle support legs fractured at the holes at bumper height, near ground level, and below the sign panel as designed. The upper sections of right and middle support legs remained attached to the sign panel and to the fractured lower sections via the restraining cable. The left support leg fractured at the hole below the sign panel with minimal displacement in the soil. The sign panel remained attached to the lower section of the left support leg via the restraining cable.

**Figure 4.15. Modified Direct Embedded Wood Support Temporary Guide Sign System after Test No. 467823-2b.**

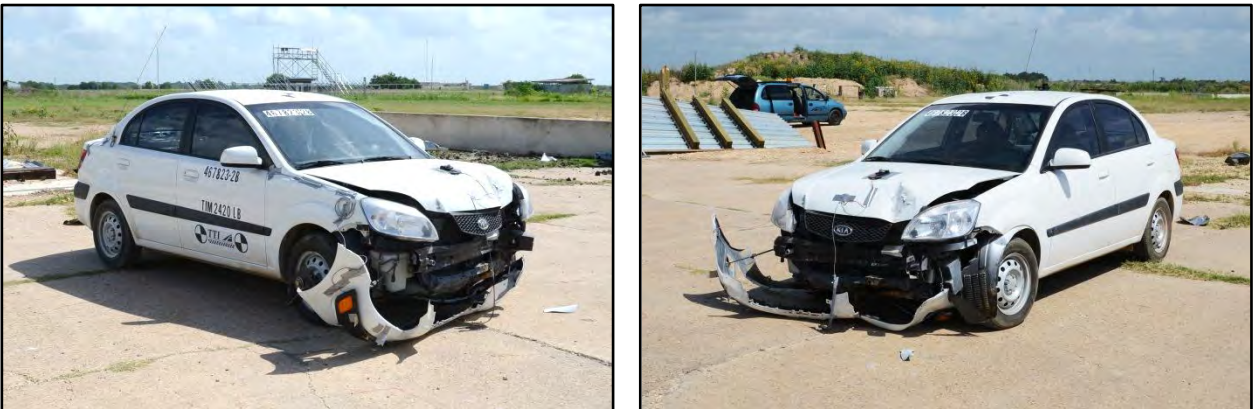
Figure 4.16 shows the damage sustained by the vehicle during the test, which included the front bumper, hood, radiator and radiator support. The front end was deformed 6.5 inches on the left of centerline and 3.0 inches on the right of centerline just below bumper height. No occupant compartment deformation or penetration occurred during the test. Exterior crush and occupant compartment measurements can be found in Tables E2 and E3 of Appendix E.

**Figure 4.16. Vehicle after Test No. 467823-2.**

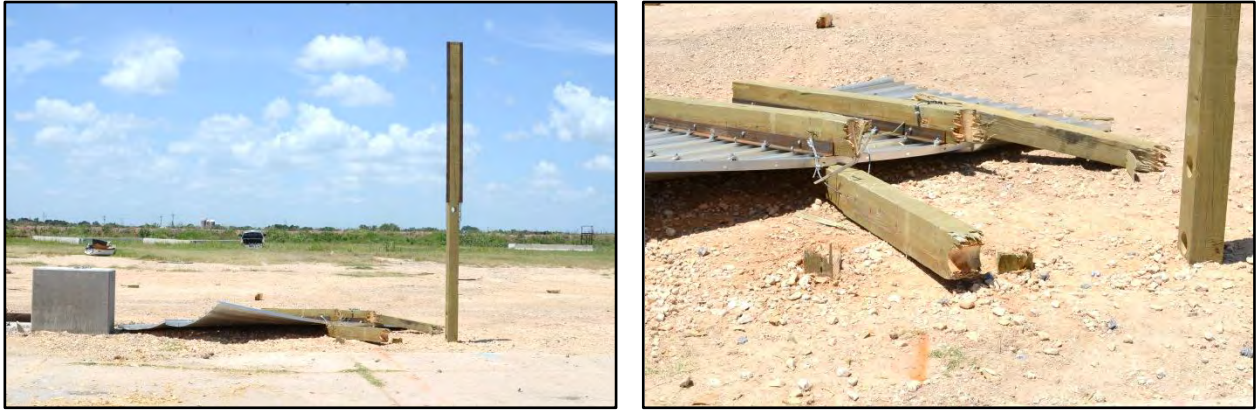
**Figure 4.19. Modified Direct Embedded Wood Support Temporary Guide Sign System after Test No. 467823-3.**

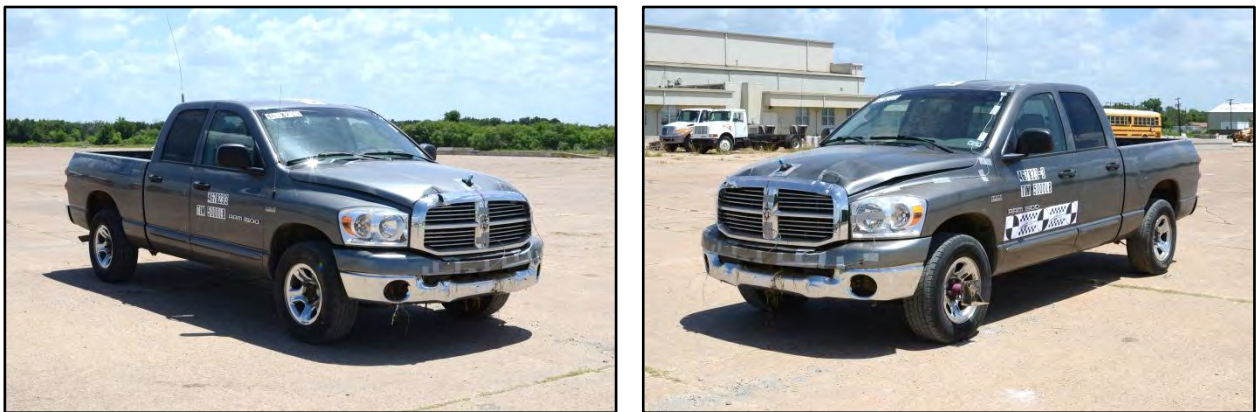
**Figure 4.20. Vehicle after Test No. 467823-3.**

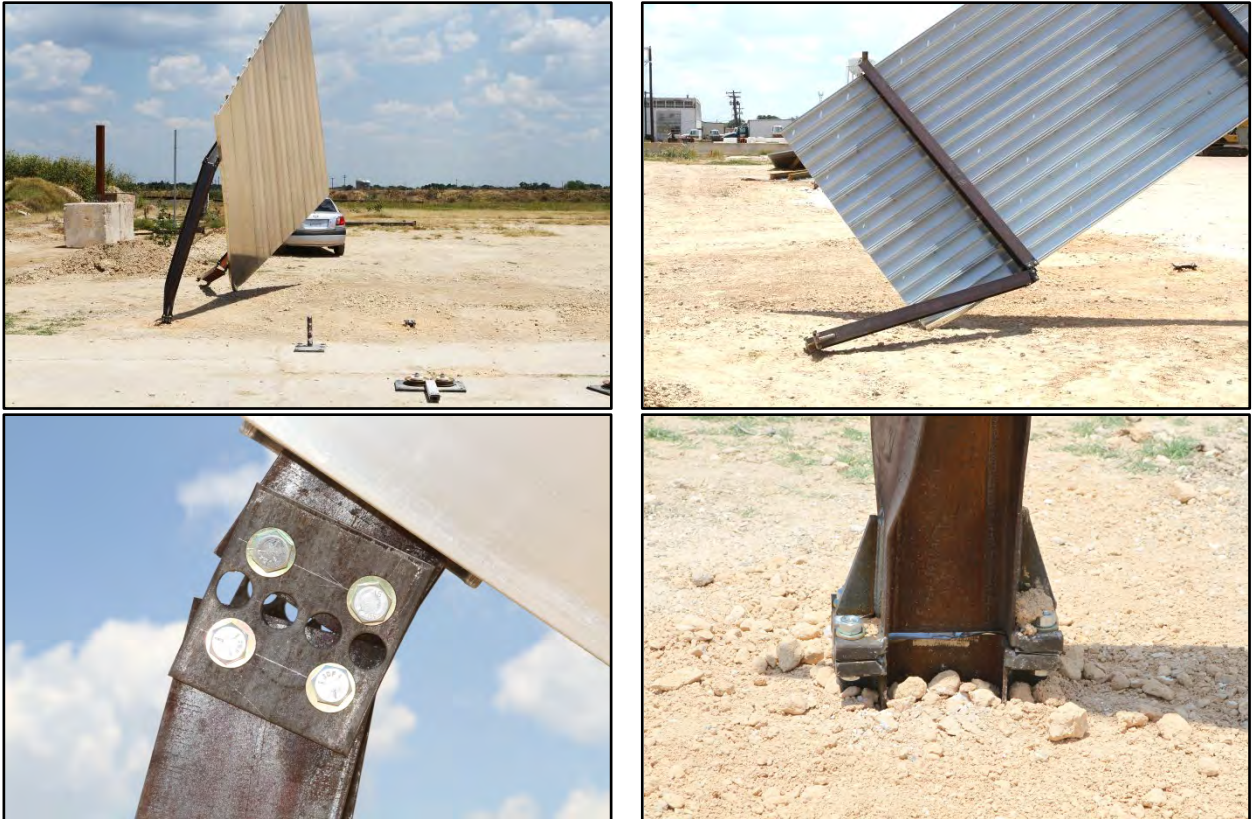
**Figure 5.5. Direct Embedded Steel Support Temporary Guide Sign System after Test No. 467823-4.**

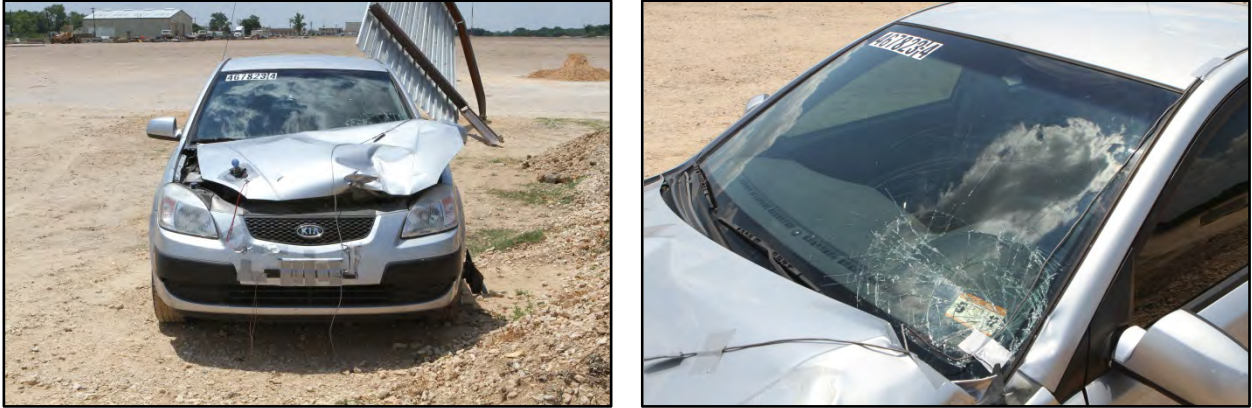
**Figure 5.6. Vehicle after Test No. 467823-1.**
