# CRASH TEST AND EVALUATION OF TL-2 SHORT RADIUS GUARDRAIL TREATMENT

**Test Report 0-6913-R1**

**TEXAS A&M TRANSPORTATION INSTITUTE  
COLLEGE STATION, TEXAS**

**TEXAS DEPARTMENT OF TRANSPORTATION**

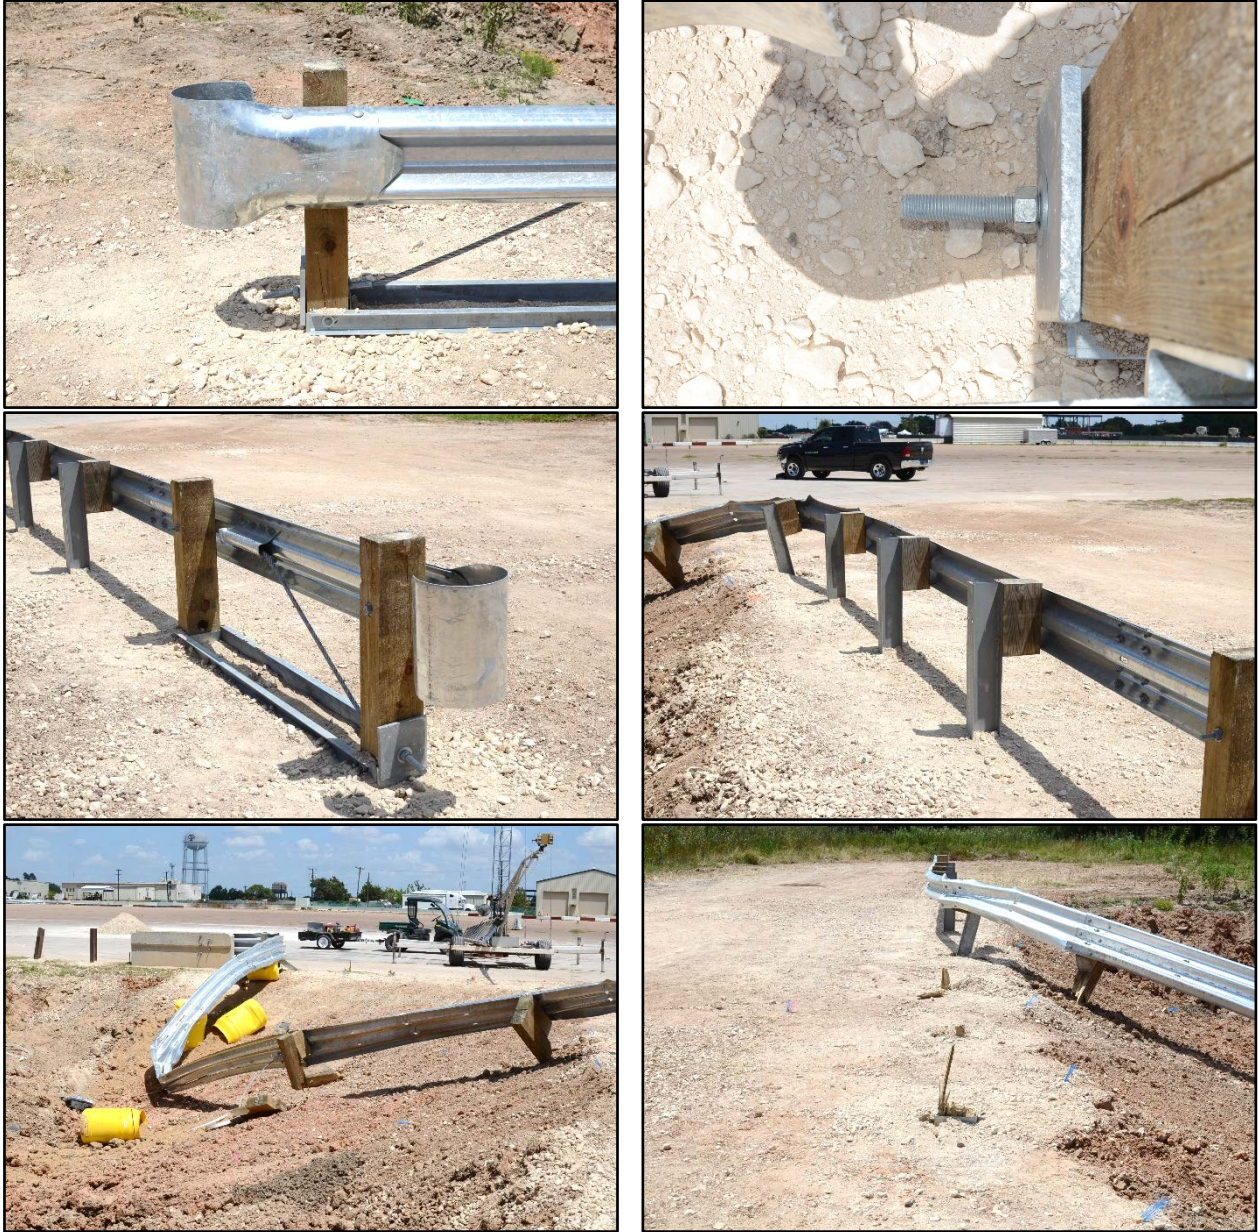
**Figure 7.4. Damage to Rail Section Perpendicular to Roadway after Test No. 469137-3-1.**

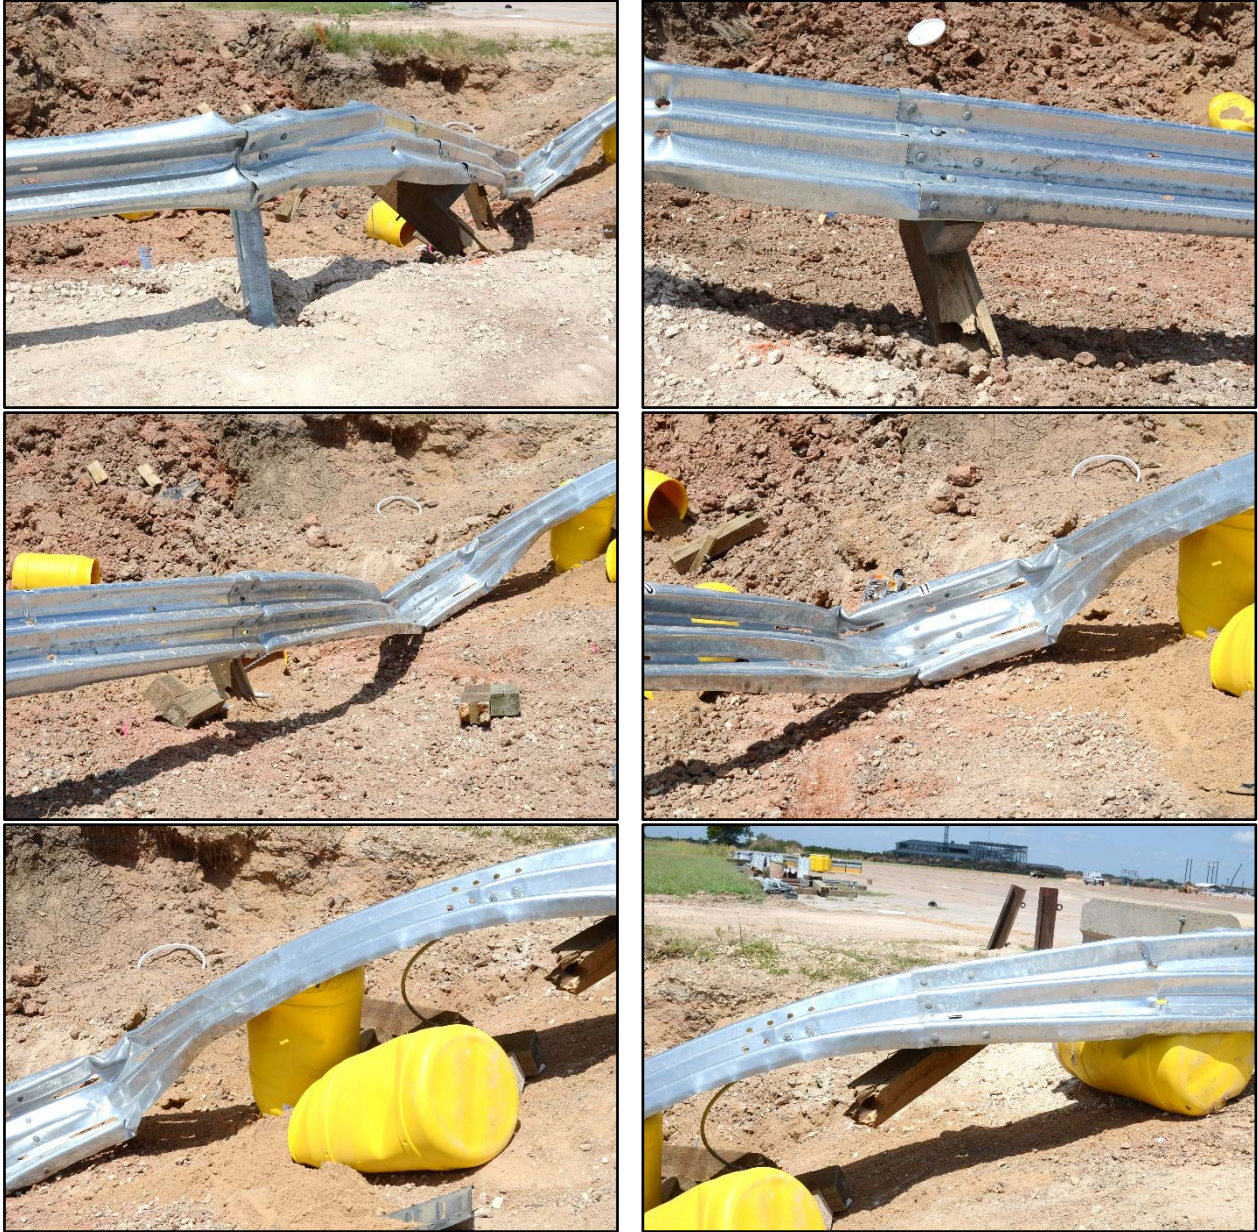
**Figure 7.5. Damage to Nose after Test No. 469137-3-1.**

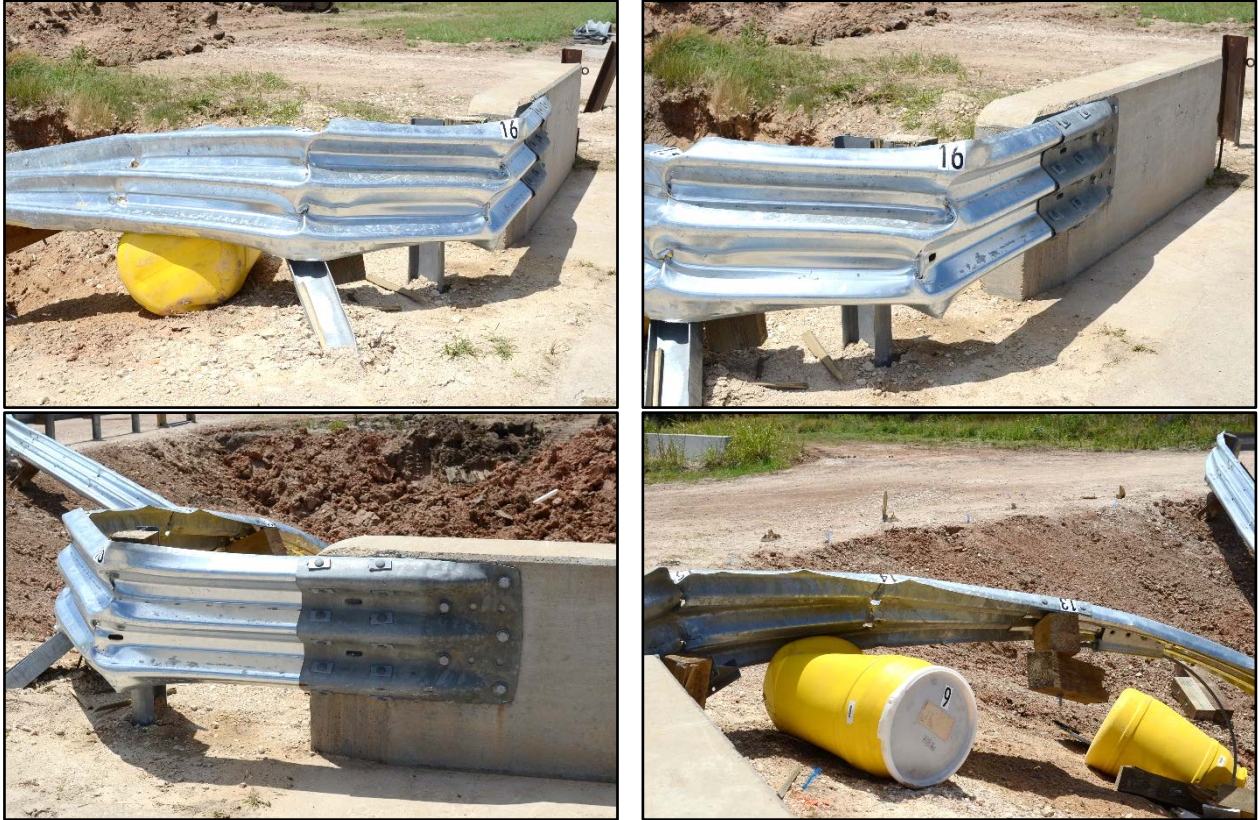
**Figure 7.6. Damage to Rail Section Parallel to Roadway after Test No. 469137-3-1.**

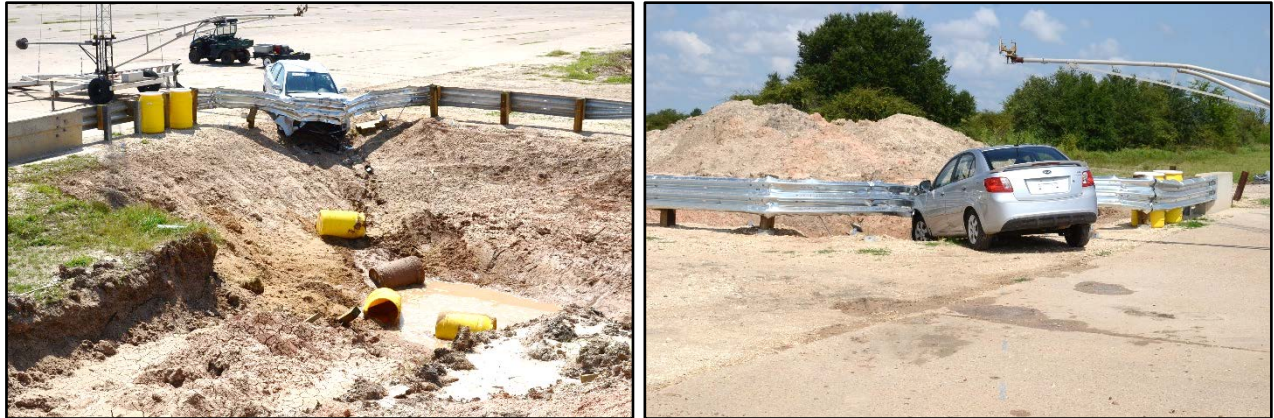
**Figure 8.3. TxDOT Low-Speed Short Radius Guardrail Treatment and Test Vehicle after Test No. 469137-3-2.**

Figures 8.3 through 8.6 show the damage to the TxDOT low-speed short radius guardrail treatment. No disturbance of the soil around posts 1 through 6 was noted. Post 7 was displaced through the soil 1.0 inch toward field side. Post 8 was displaced through the soil 2.38 inches toward the field side and was leaning 85° toward the field side. Post 9 was displaced through the soil 9.25 inches toward the field side and was leaning 80° toward the field side. The ground tube for post 10 was displaced through the soil 3.75 inches, and the post fractured at the top of the ground tube. The ground tube for post 11 was displaced through the soil 0.25 inches, and the post fractured at the top of the ground tube. The ground tube for post 12 was displaced through the soil 0.38 inches, and the post fractured at the top of the ground tube. The ground tube for post 13 was displaced through the soil 0.12 inches, and the post fractured at the top of the ground tube. The soil was disturbed around post 14, and the rail element separated from the blockout. No disturbance of the soil around posts 15 and 16 was noted. Drums 1–4 were resting in the ditch, and drum 5 was pushed toward the field side 3.0 inches. Working width was 2.5 ft, and height of working width was below grade (vehicle in ditch). Maximum dynamic deflection during the test was 10.5 ft, and maximum permanent deformation was 10.5 ft.

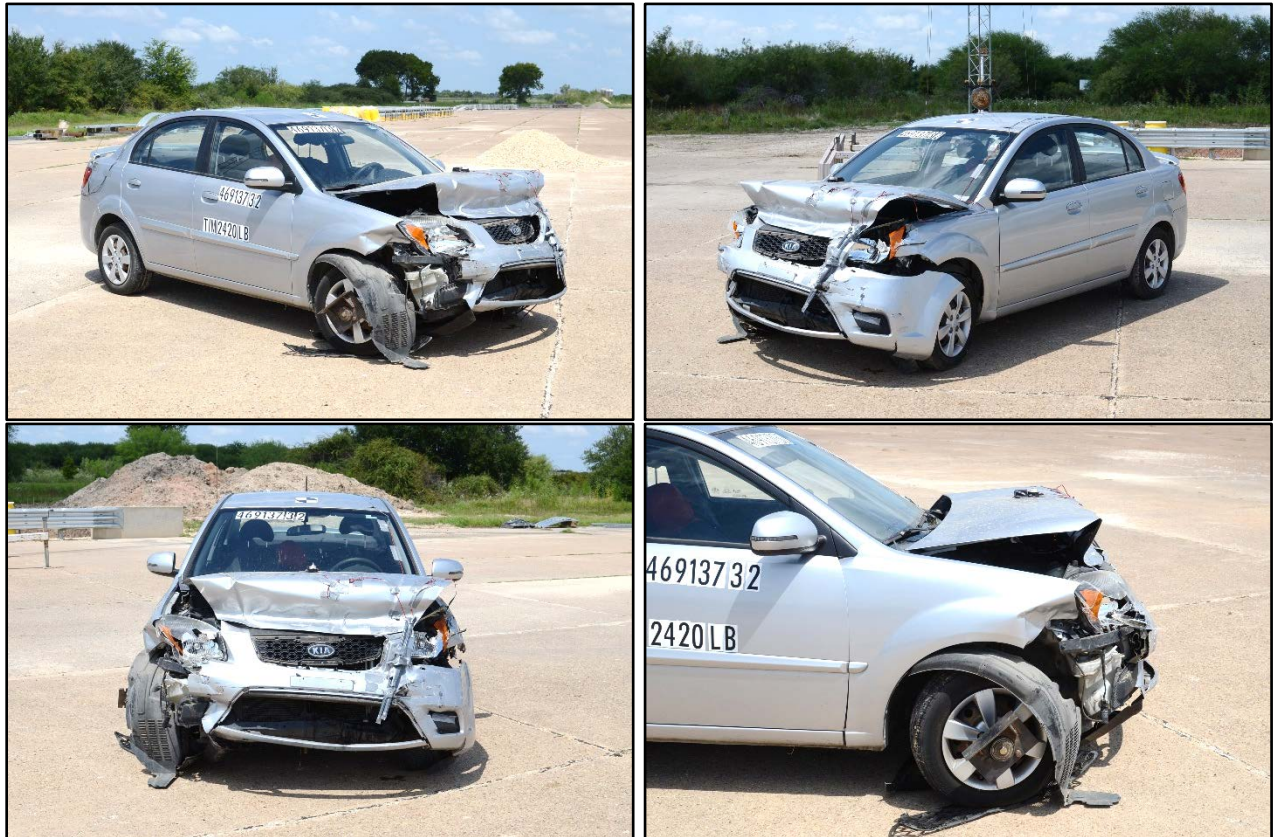
**Figure 8.7. Test Vehicle after Test No. 469137-3-2.**

Figure 8.7 shows the damage sustained by the vehicle. The front bumper, hood, grill, radiator, radiator support, headlights, and right and left front fenders were damaged. Maximum exterior crush to the vehicle was 5.0 inches in the front plane at the left corner at bumper height. No occupant compartment deformation or intrusion occurred. Figure 8.8 shows the interior of the vehicle. Tables E.2 and E.3 in Appendix E.1 provide exterior crush and occupant compartment measurements.

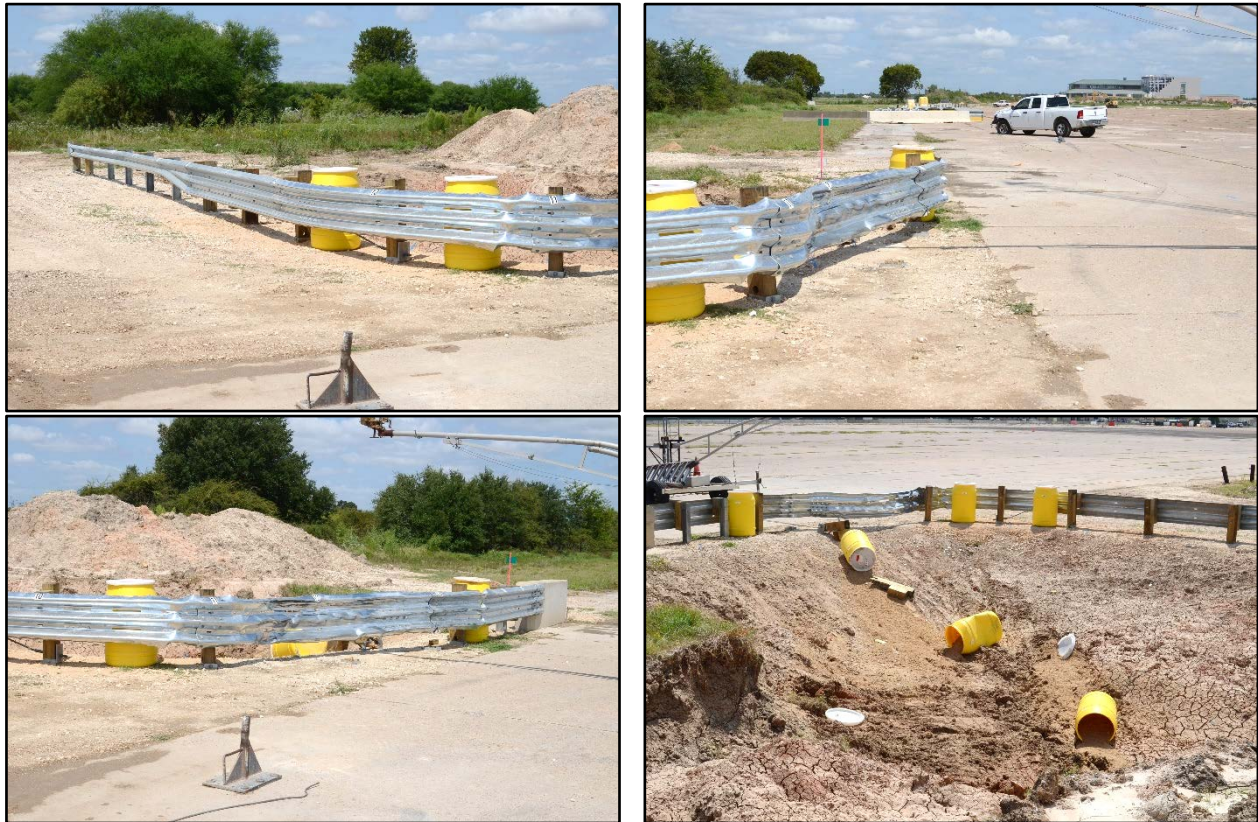
**Figure 9.3. TxDOT Low-Speed Short Radius Guardrail Treatment after Test No. 469138-3-3.**

Figures 9.3 through 9.6 show the damage to the TxDOT low-speed short radius guardrail treatment. The soil around posts 1 through 10 showed no signs of movement. Post 11 was displaced through the soil 0.62 inch toward the field side and leaning 86° toward the field side. Posts 12 and 13 fractured at the top of the foundation tube. Post 12 separated from the rail element and came to rest in the ditch. Post 13 separated from the rail but remained attached to the rail element. Post 14 was displaced through the soil 0.12 inch toward the field side. The soil around posts 15 and 16 showed no signs of movement. Working width was 1.5 ft, and the height of maximum working width was 2.5 ft. Maximum dynamic deflection during the test was 3.8 ft, and maximum permanent deformation was 2.9 ft.

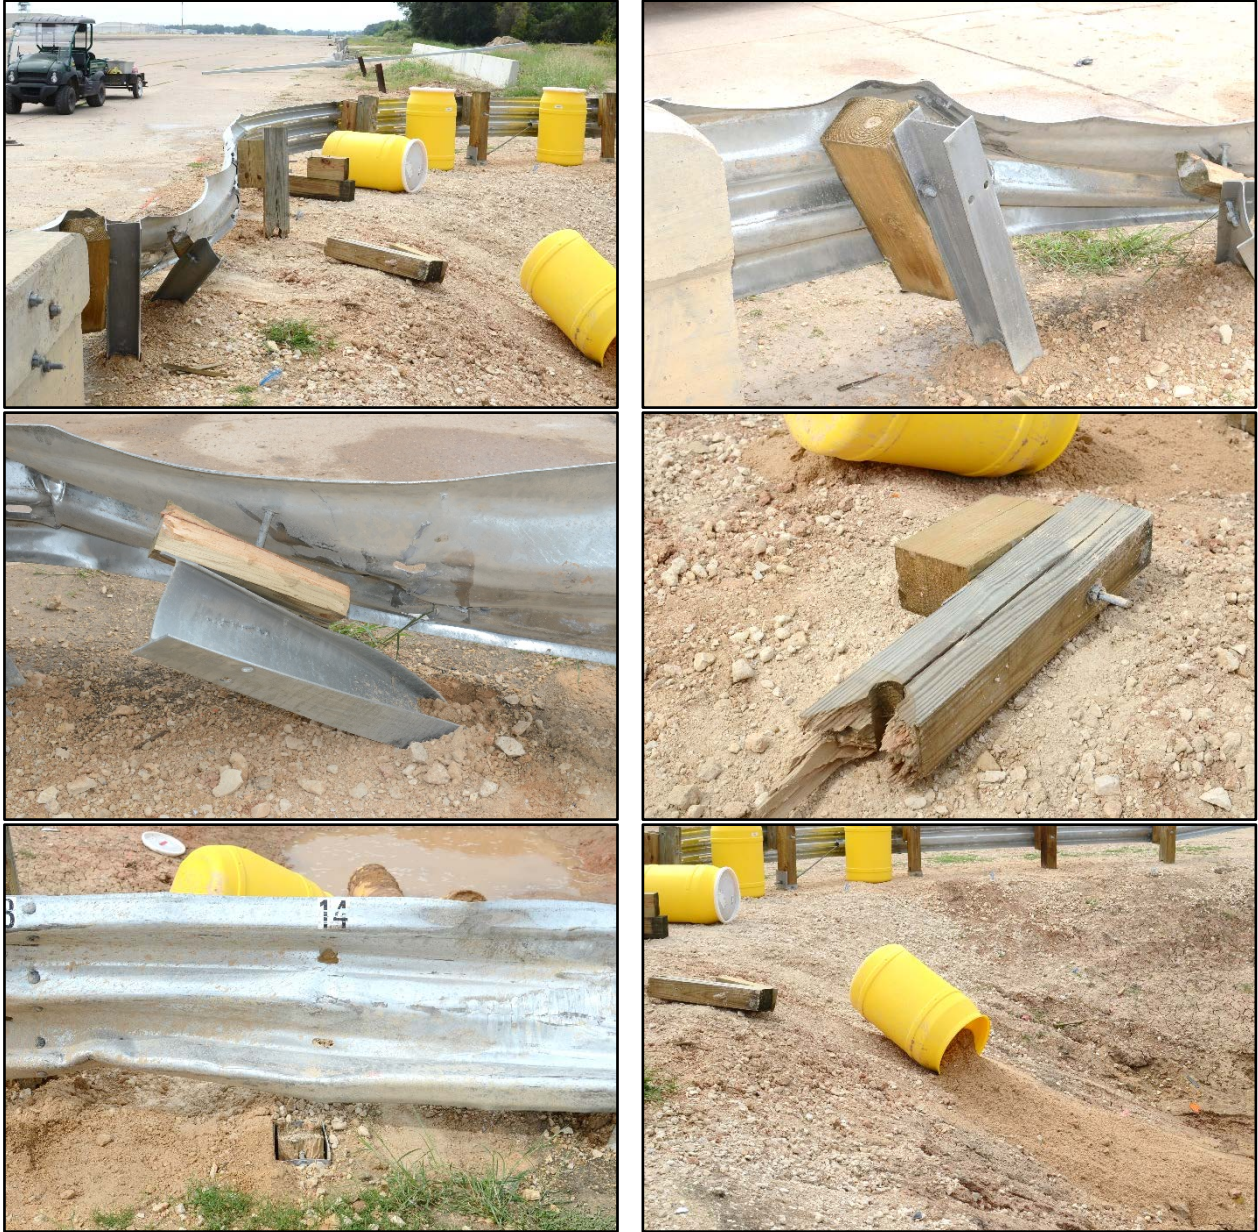
**Figure 10.4. Damage to Rail Section Parallel to Roadway after Test No. 469138-3-4.**

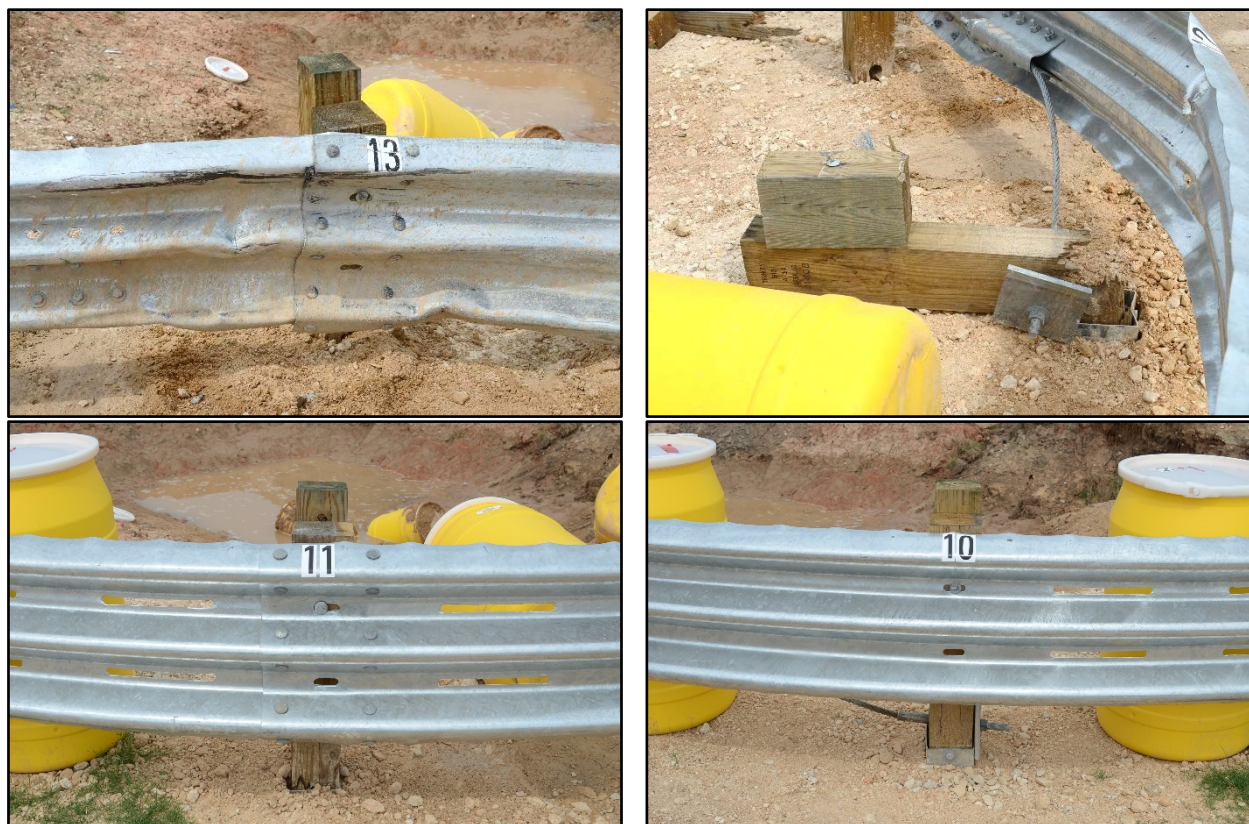
**Figure 10.5. Damage to Post 13 through 10 after Test No. 469138-3-4.**
