# **MASH EVALUATION OF TxDOT ROADSIDE SAFETY FEATURES— PHASE III**

## **Test Report 0-6946-R3**

1. Report No. FHWA/TX-20/0-6946-R3		2. Government Accession No.		3. Recipient's Catalog No.	
4. Title and Subtitle <b>MASH EVALUATION OF TXDOT ROADSIDE SAFETY FEATURES—PHASE III</b>				5. Report Date <b>Published: May 2020</b>

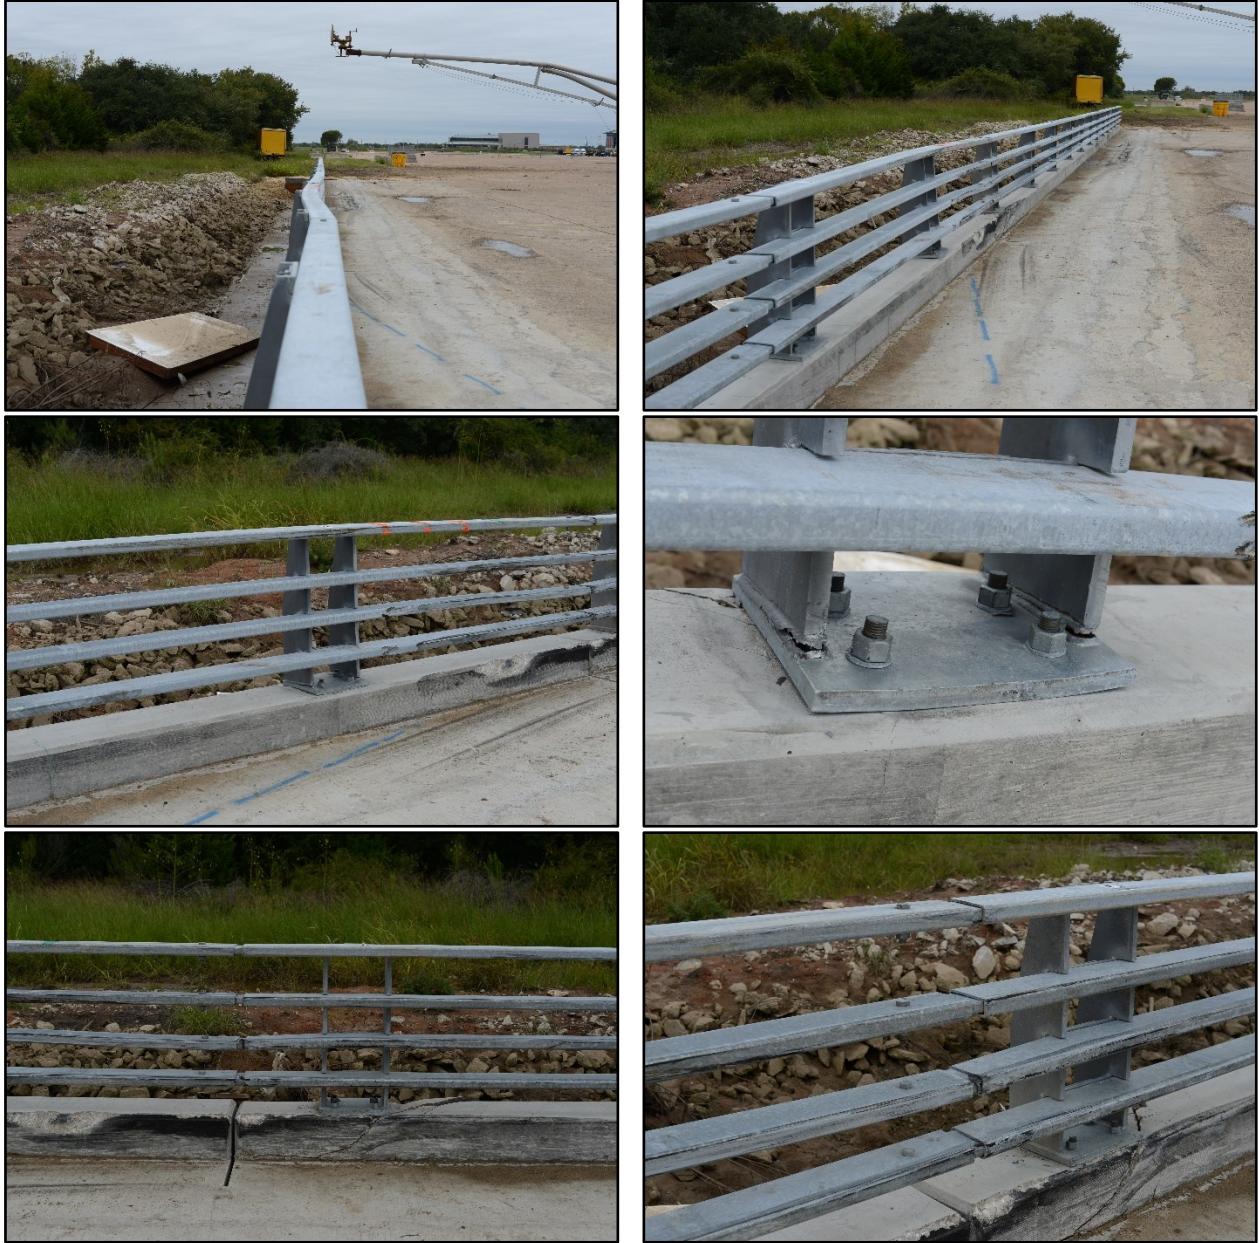
**Figure 2.5. C1W Bridge Rail after Test No. 469469-1.**

Figure 2.5 shows the damage to the C1W bridge rail. The bridge rails were deformed at the location of impact. The concrete was fractured around posts 4, 5, and 6. Post 5 was leaning back  $3.1^\circ$  from vertical. Post 4 was leaning back toward the protected side  $5.9^\circ$  from vertical and was fractured at the weld where the vertical plates are connected to the base plate. There was a secondary contact at post 14 to the end of the bridge rail. No damage was noticed, other than black marks from the tire. Working width was 4 ft, and the height of the working width was 13.1 ft. Maximum dynamic deflection during the test was 0.9 ft, and maximum permanent deformation was 0.3 ft.

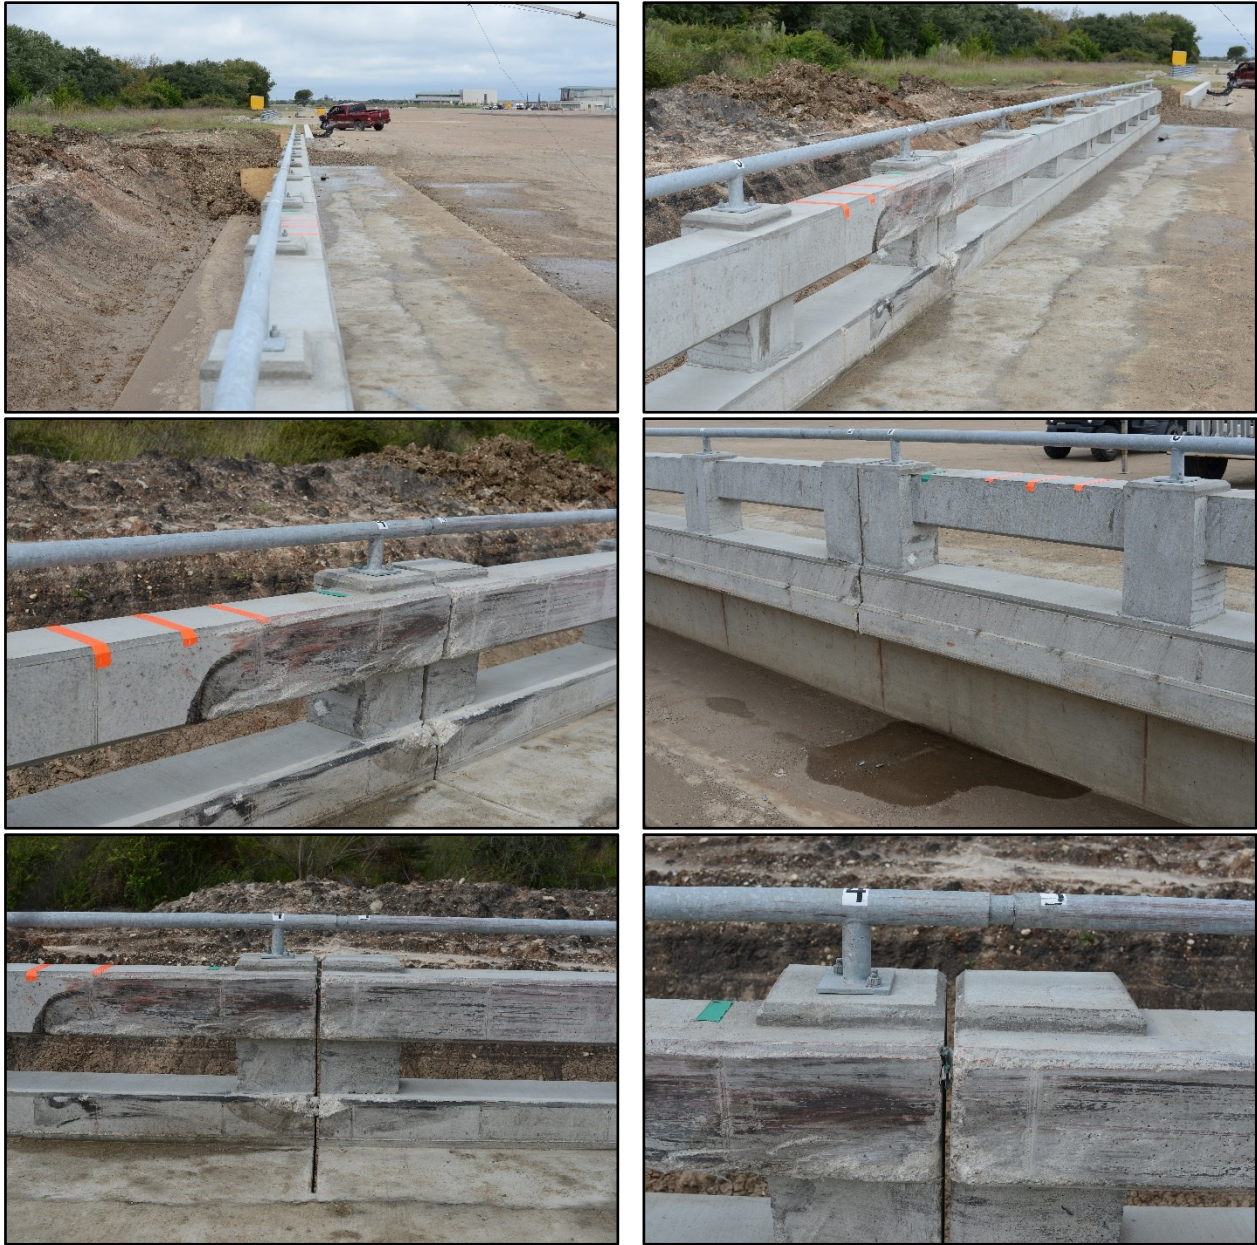
**Figure 3.5. Modified C66 Bridge Rail after Test No. 469469-2-1.**

Figure 3.5 shows the damage to the Modified C66 bridge rail. Some of the edges of the concrete at the joint between posts 4 and 5 were damaged and missing a small amount of material. No further damage to the bridge rail was noted. Working width was 20.5 inches, and the height of the working width was 58 inches. Maximum dynamic deflection during the test was 1.1 inches for the steel rail element on top of the concrete parapet. There was no measurable dynamic deflection of the concrete parapet. There was no measurable permanent deflection in either the concrete parapet or the steel rail element.

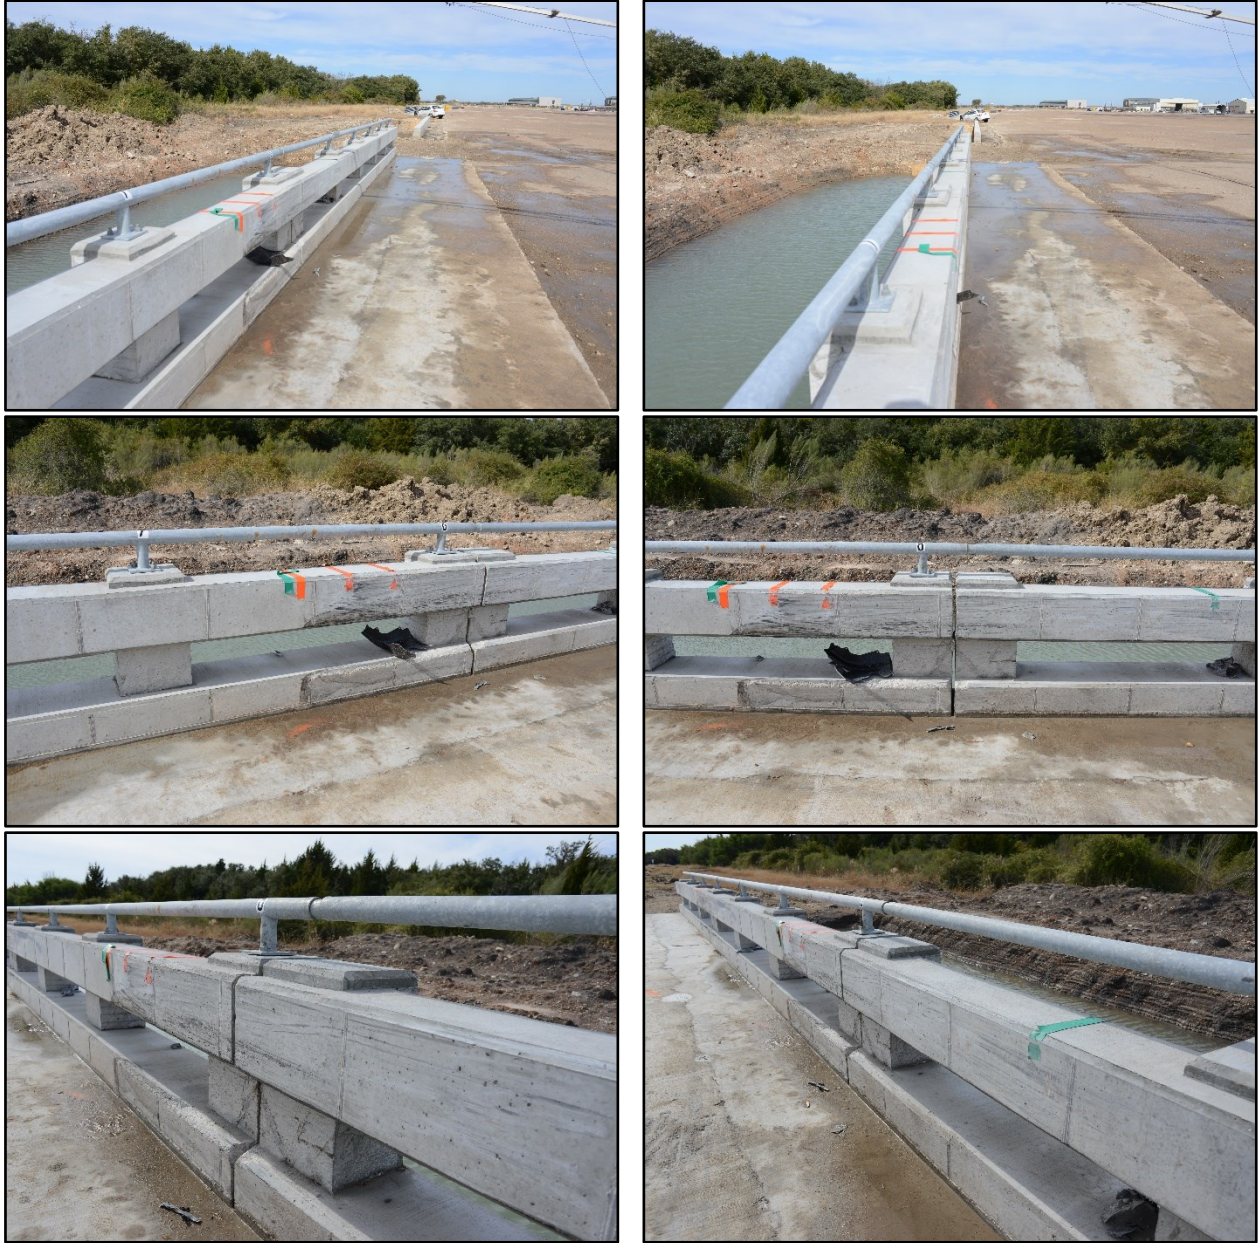
**Figure 3.11. Modified C66 Bridge Rail after Test No. 469469-2-2.**

Figure 3.11 shows the damage to the Modified C66 bridge rail. Some of the edges of the concrete at the joint between posts 8 and 9 were damaged and missing a small amount of material. No further damage to the bridge rail was noted. Working width was 16 inches, and the height of the working width was 32 inches. There was no measurable dynamic or permanent deflection in either the concrete parapet or the steel rail element.
