# DEVELOPMENT OF MODIFIED TxDOT SINGLE-POST SKID-MOUNTED SIGN SUPPORT

## Test Report 0-6968-R3

TEXAS A&M TRANSPORTATION INSTITUTE  
COLLEGE STATION, TEXAS

1. Report No. FHWA/TX-21/0-6968-R3		2. Government Accession No.		3. Recipient's Catalog No.	
4. Title and Subtitle DEVELOPMENT OF MODIFIED TxDOT SINGLE-POST SKID-MOUNTED SIGN SUPPORT				5. Report Date Published: June 2021

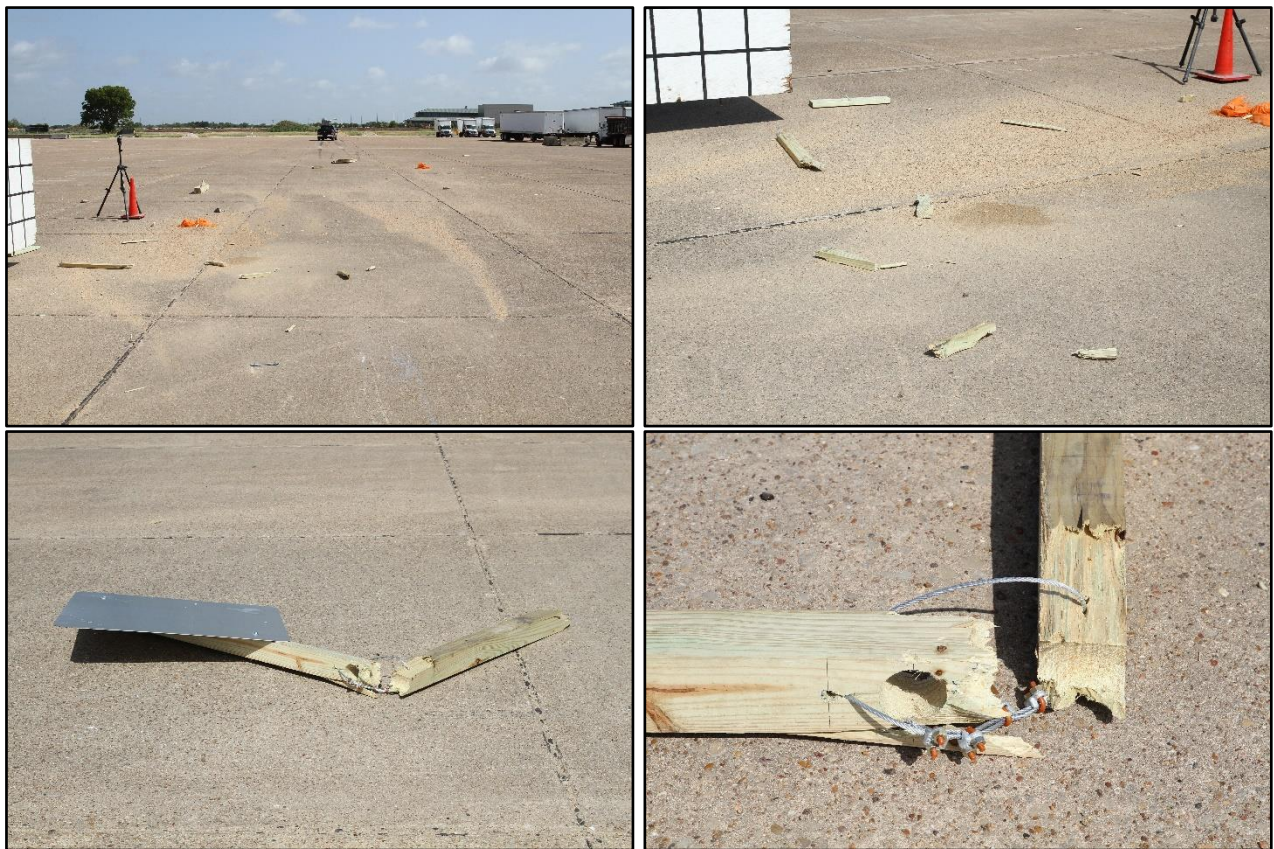
**Figure 4.5. Modified TxDOT Single Skid-Mounted Sign Support after Test No. 469680-03-2.**

Figure 4.5 shows the damage to the modified TxDOT single skid-mounted sign support. The debris field started 2 ft from impact and extended 30 ft downstream, 12 ft to the left, and 20 ft to the right, with smaller pieces of the base, post, and sandbags scattered throughout. There was a 4-ft-long piece of a skid 10 ft to the left and 45 ft downstream of impact. There was a 1-ft-long piece of the post 80 ft downstream and in line with the impact path. The sign panel and attached post section landed 105 ft downstream and 5 ft to the right of impact. There was also a 1-ft-long section of post located 15 ft to the right and 120 ft downstream of impact.

During Crash Test No. 469680-03-2, the sign panel contacted the roof of the 2270P vehicle, sliced a 22-inch-long hole in the roof, and penetrated the occupant compartment over the driver’s seat. Film analysis indicated that while the tether cable prevented the fractured segments of the support post from separating, the amount of slack in the cable delayed its effectiveness in influencing the trajectory of the connected segments. A decision was made to reduce the length of the tether cable and remove the excess slack to more quickly engage the hinge mechanism provided between the two fracture segments of the support post. *MASH* Test 3-72 at 90 degrees was repeated on the redesigned single skid-mounted sign support, as described in the next chapter.

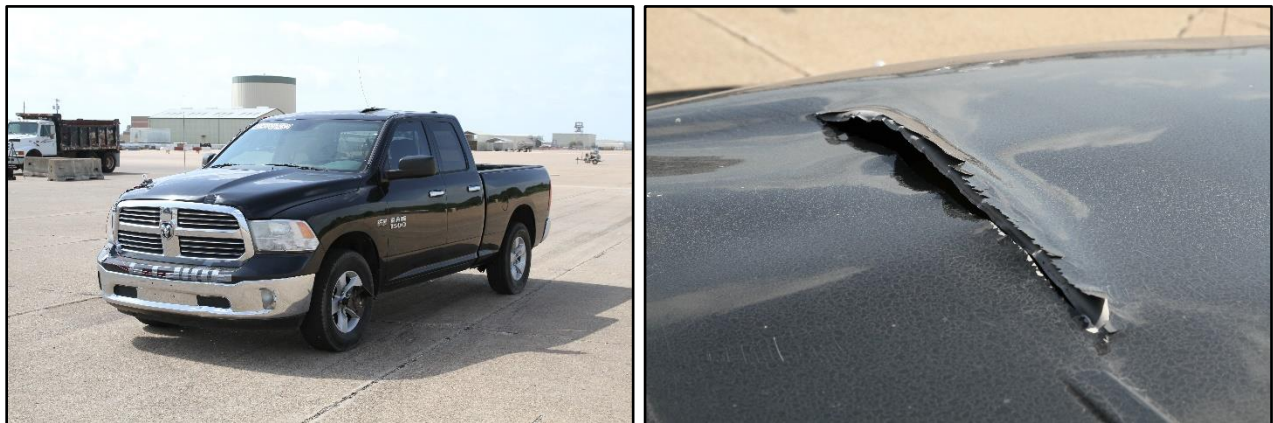
Figure 4.6. Test Vehicle after Test No. 469680-03-2.

Figure 4.6 shows the damage sustained by the vehicle. The front bumper sustained a 4-inch  $\times$  4-inch  $\times$  0.5-inch deformation 13 inches to the left of the centerline of the vehicle. There was also a 4-inch  $\times$  3-inch  $\times$  0.5-inch deformation at the front edge of the hood 13 inches to the left of the centerline of the vehicle. There was a 22-inch-long cut in the roof 13 inches to the left of the centerline and starting 1 inch rearward of the front windshield. No fuel tank damage was observed. Maximum exterior crush to the vehicle was 0.5 inches on the bumper and hood 13 inches left of the centerline of the vehicle. The sign panel penetrated the roof of the occupant compartment over the driver's seat. Figure 4.7 shows the interior of the vehicle after the test. Tables B.3 and B.4 in Appendix B.1 provide exterior crush and occupant compartment measurements.

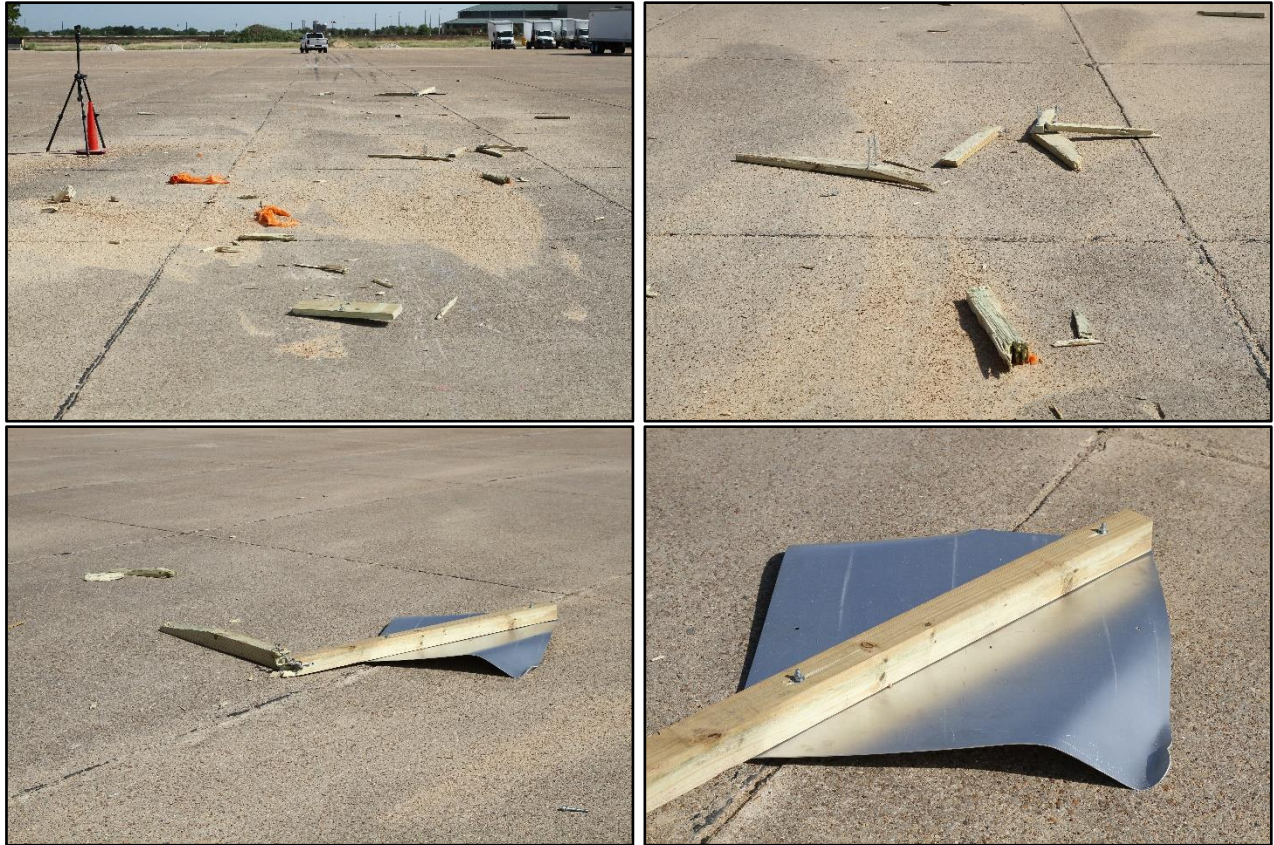
**Figure 5.5. Modified TxDOT Single Skid-Mounted Sign Support after Test No. 469680-03-2A.**

Figure 5.5 shows the damage to the modified TxDOT single skid-mounted sign support. The debris field started from the point of impact and extended 12 ft to the left, 12 ft to the right, and 82 ft downstream of the point of impact. The sign panel with the attached post came to rest 82 ft downstream and 6 ft to the left of impact.

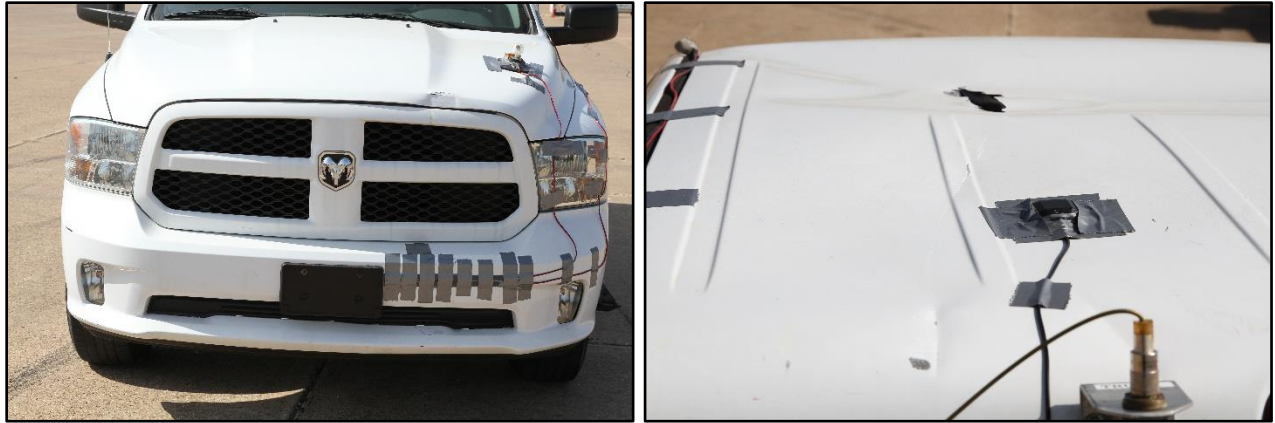
Figure 5.6. Test Vehicle after Test No. 469680-03-2A.

Figure 5.6 shows the damage sustained by the vehicle. The front bumper sustained a 4-inch  $\times$  6-inch  $\times$  0.75-inch deformation 13 inches to the left of the centerline of the vehicle. There was also a 4-inch  $\times$  2-inch  $\times$  0.5-inch deformation at the front edge of the hood 13 inches to the left of the centerline of the vehicle. There was a 12-inch-long cut in the roof 13 inches to the left of the centerline and starting 1 inch from the top edge of the front windshield. No fuel tank damage was observed. Maximum exterior crush to the vehicle was 0.75 inches. The sign panel penetrated the roof of the occupant compartment over the driver's seat. Figure 5.7 shows the interior of the vehicle. Tables C.3 and C.4 in Appendix C.1 provide exterior crush and occupant compartment measurements.

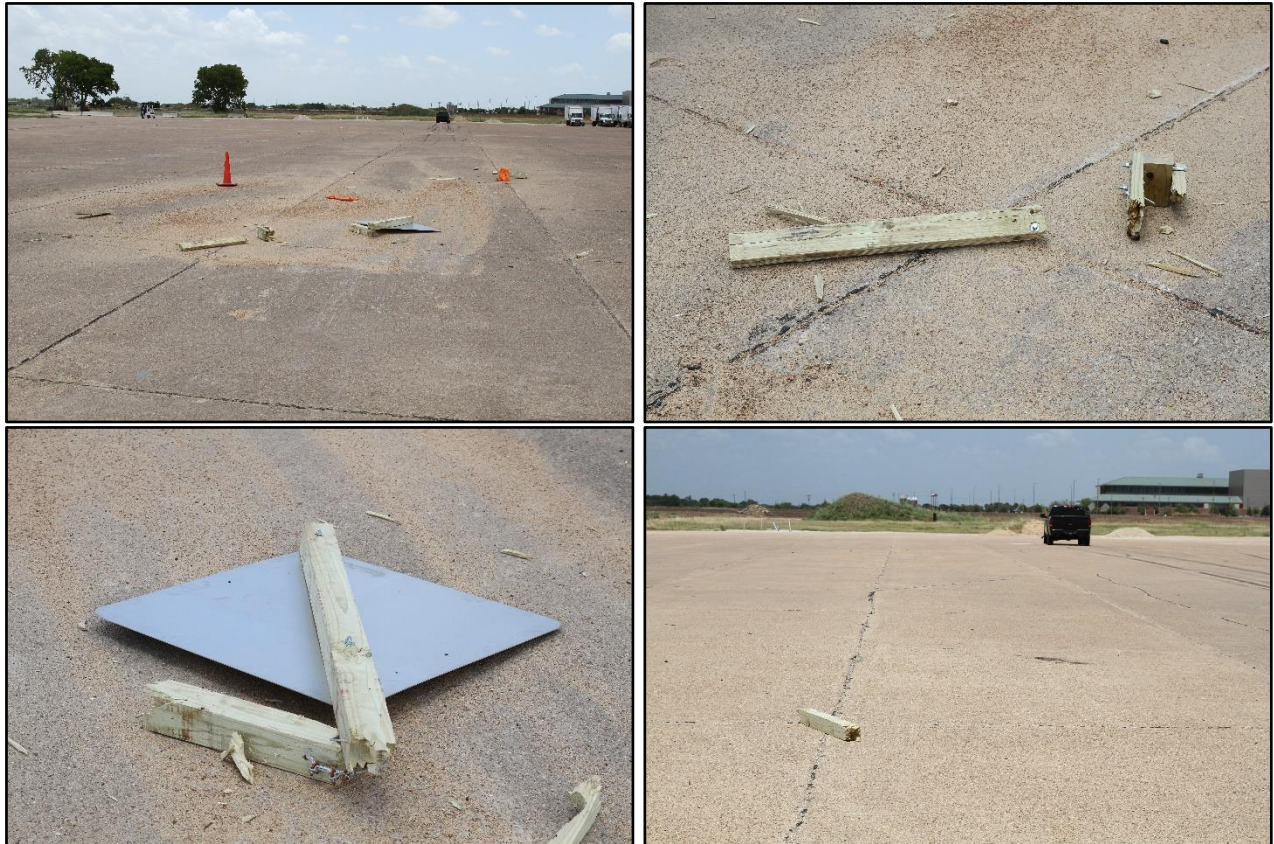
**Figure 6.5. Modified TxDOT Single Skid-Mounted Sign Support after Test No. 469680-03-2B.**

Figure 6.5 shows the damage to the modified TxDOT single skid-mounted sign support. The debris field extended from 6 ft left, 6 ft right, and 45 ft downstream of impact, with the exception of one 20-inch-long piece of the post that landed 210 ft downstream and 32 ft to the left of impact. The sign panel and the attached segments of the fractured post came to rest 15 ft downstream and in line with the impact path.

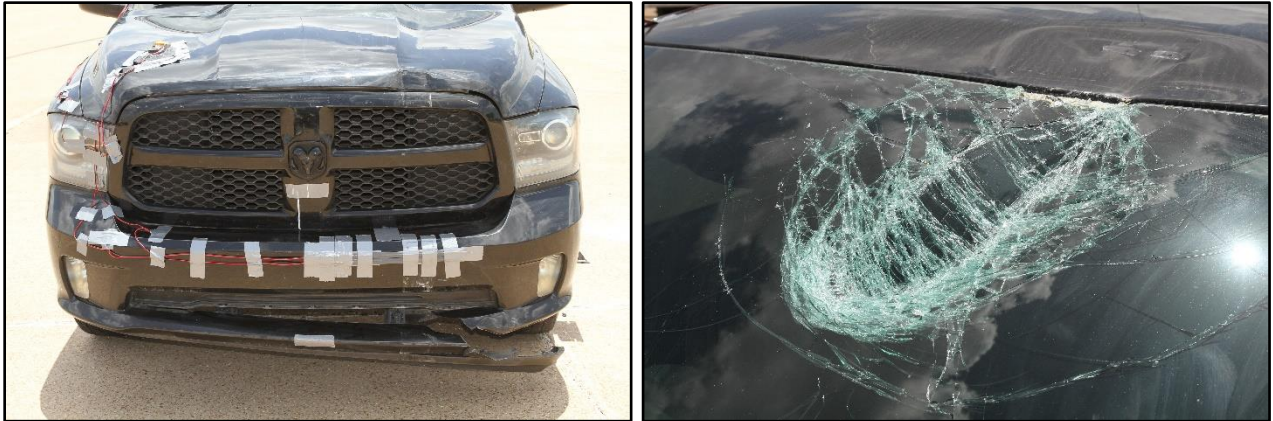
**Figure 6.6. Test Vehicle after Test No. 469680-03-2B.**

Figure 6.6 shows the damage sustained by the vehicle. The front bumper sustained a 4-inch  $\times$  5-inch  $\times$  0.25-inch deformation 13 inches to the left of the centerline of the vehicle. There was also a 4-inch  $\times$  3-inch  $\times$  0.5-inch deformation at the front edge of the hood 13 inches to the left of the centerline of the vehicle. The windshield was shattered over an area of 12 inches  $\times$  14 inches  $\times$  1 inch near the top center at the roofline; however, there was no tear or cut in the windshield laminate. There was an 8-inch  $\times$  6-inch  $\times$  0.75-inch deformation in the roof 13 inches to the left of the centerline with no tear or cut. No fuel tank damage was observed. Maximum exterior crush to the vehicle was 1.0 inch in the windshield. Maximum occupant compartment deformation was 1.0 inch in the windshield area. Figure 6.7 shows the interior of the vehicle. Tables D.3 and D.4 in Appendix D.1 provide exterior crush and occupant compartment measurements.

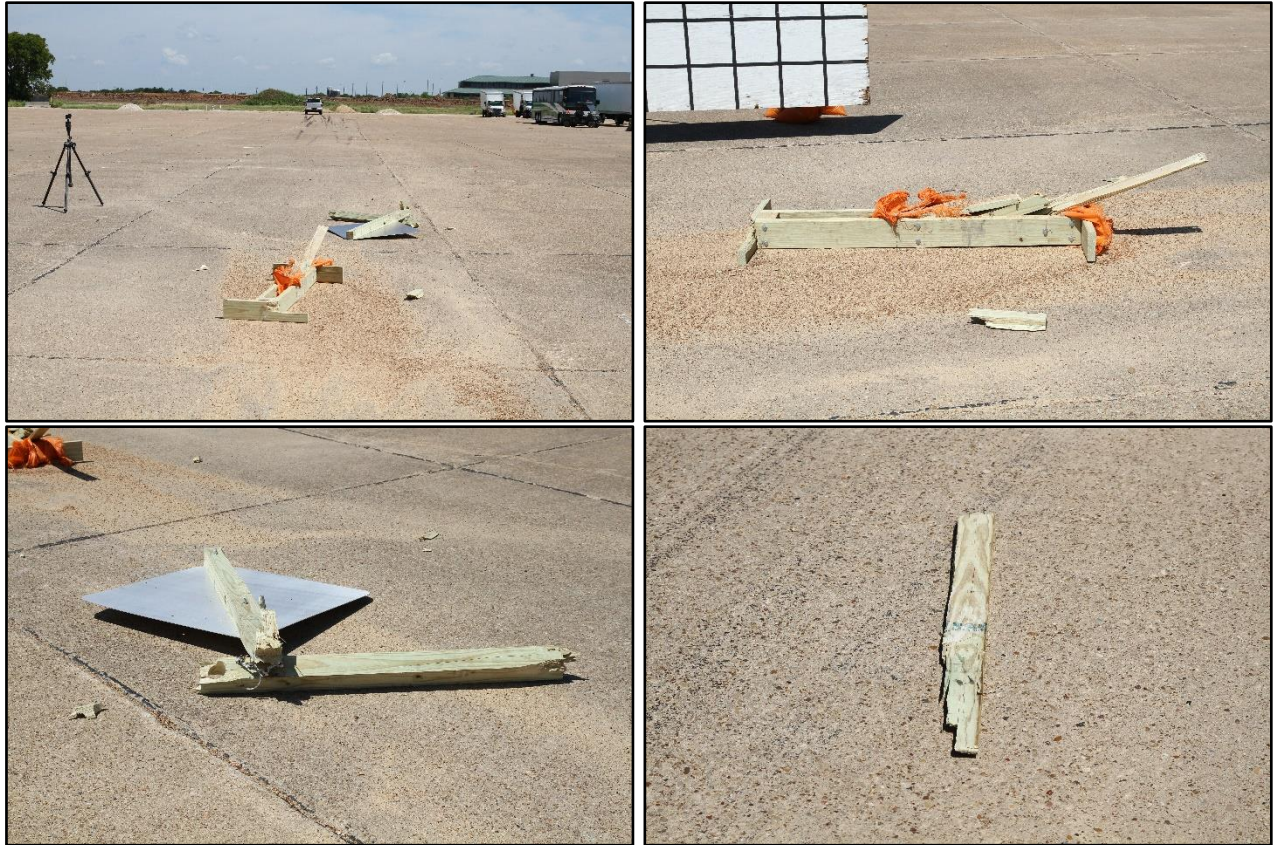
**Figure 7.3. Modified TxDOT Single Skid-Mounted Sign Support after Test No. 469680-03-4.**

Figure 7.3 shows the damage to the modified TxDOT single skid-mounted sign support. The base of the sign support came to rest 16 ft downstream and in line with impact. The sign and attached post segments landed 32 ft downstream and 2 ft to the right of impact. The support post fractured at several locations, including through the weakening holes, at the base, and at bumper height.
