MASH TEST 3-11 EVALUATION OF MODIFIED TxDOT ROUND WOOD POST GUARDRAIL SYSTEM

Test Report 0-6968-R4

TEXAS A&M TRANSPORTATION INSTITUTE

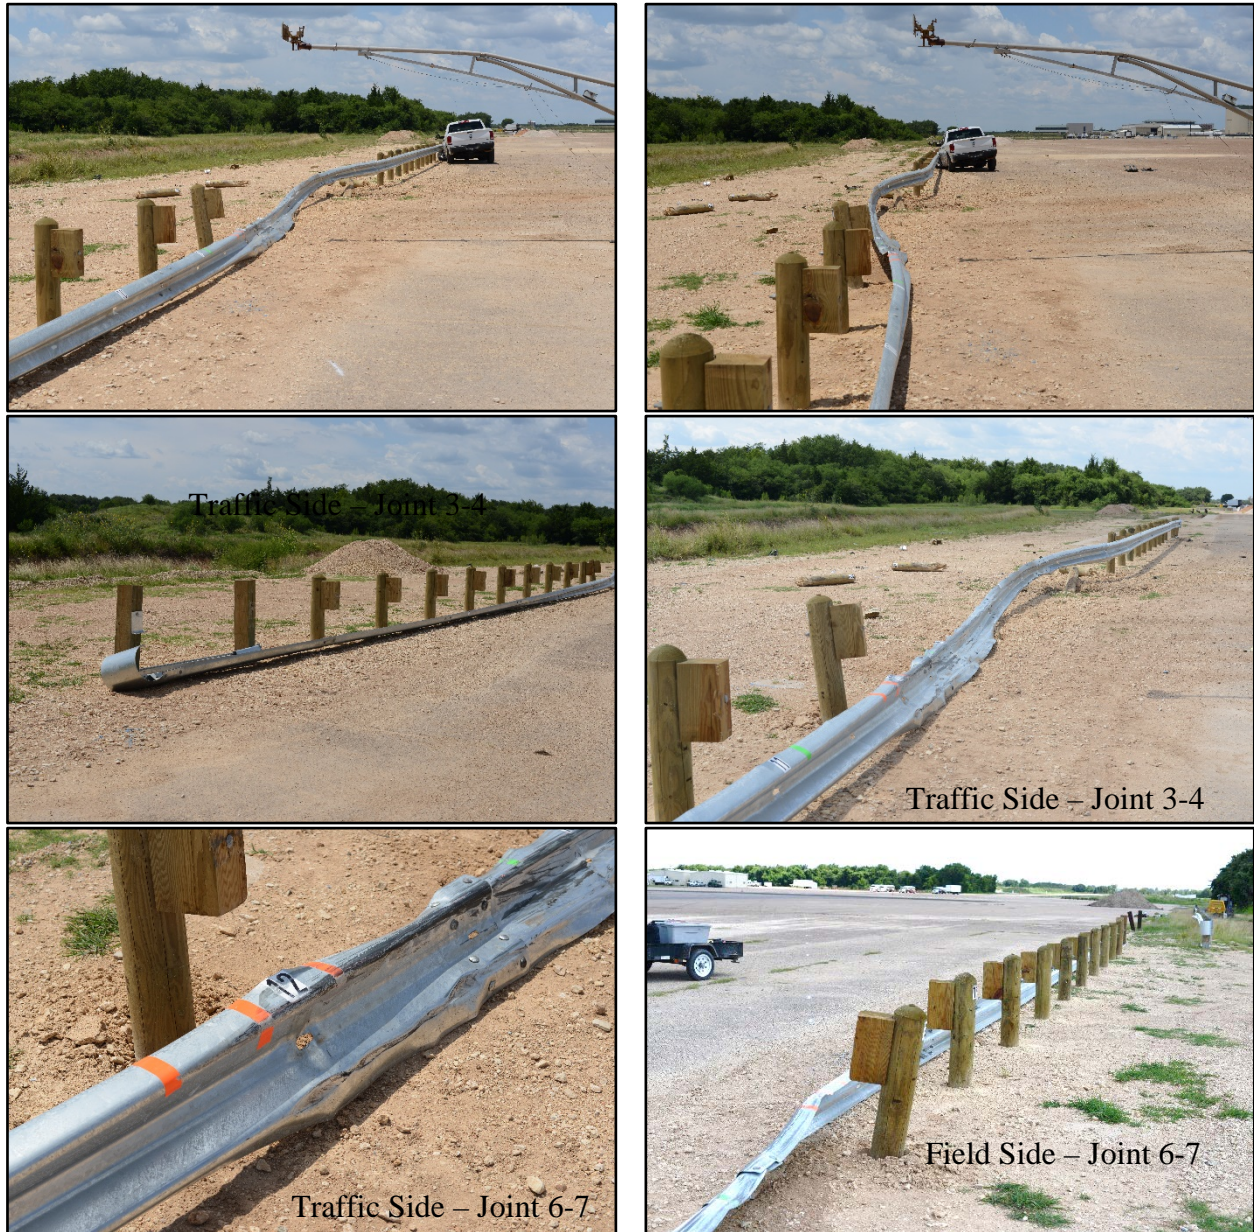
Figure 5.3. Barrier after Test No. 469688-5-1.

Figure 5.3 shows the damage to the barrier. The rail released from posts 1 through 19. Posts 11–16 and 18 were broken at ground level, and post 17 was pulled out of the ground. Working width for the test was 62.2 inches, and the height of the working width was 57.4 inches. Maximum dynamic deflection during the test was 44.1 inches, and maximum permanent deformation was 37 inches at post 16.

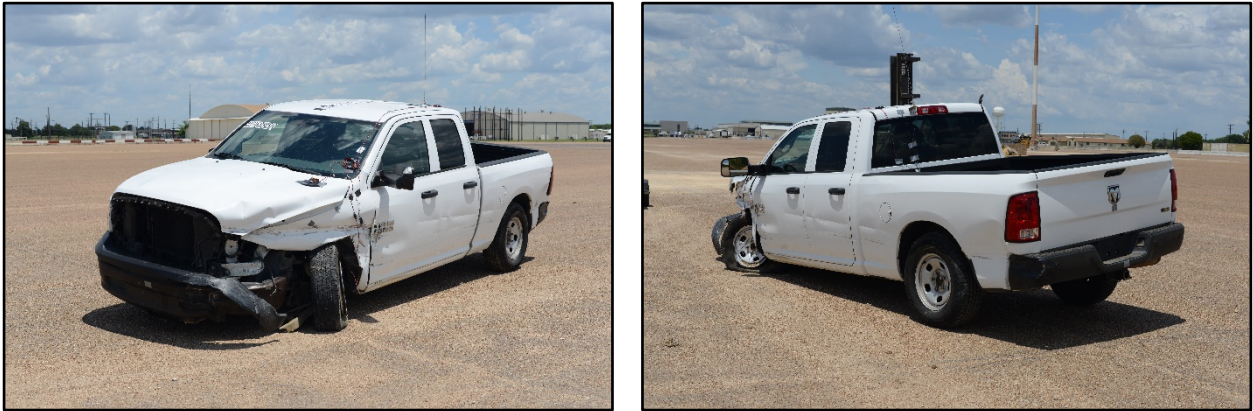
Figure 5.4. Test Vehicle after Test No. 469688-5-1.

Figure 5.4 shows the damage sustained by the vehicle. The front bumper, hood, grill, left headlight, left front fender, left front tire and rim, left front lower A-arm, and left front door were damaged. Maximum exterior crush to the vehicle was 11.0 inches in the horizontal at bumper height. No measurable occupant compartment deformation occurred. Figure 5.5 shows the interior of the vehicle.
