MASH TL-3 EVALUATION OF TXDOT EXTRA-LARGE MAILBOXES

Test Report 0-6968-R9

**TEXAS A&M TRANSPORTATION INSTITUTE
COLLEGE STATION, TEXAS**

TEXAS DEPARTMENT OF TRANSPORTATION

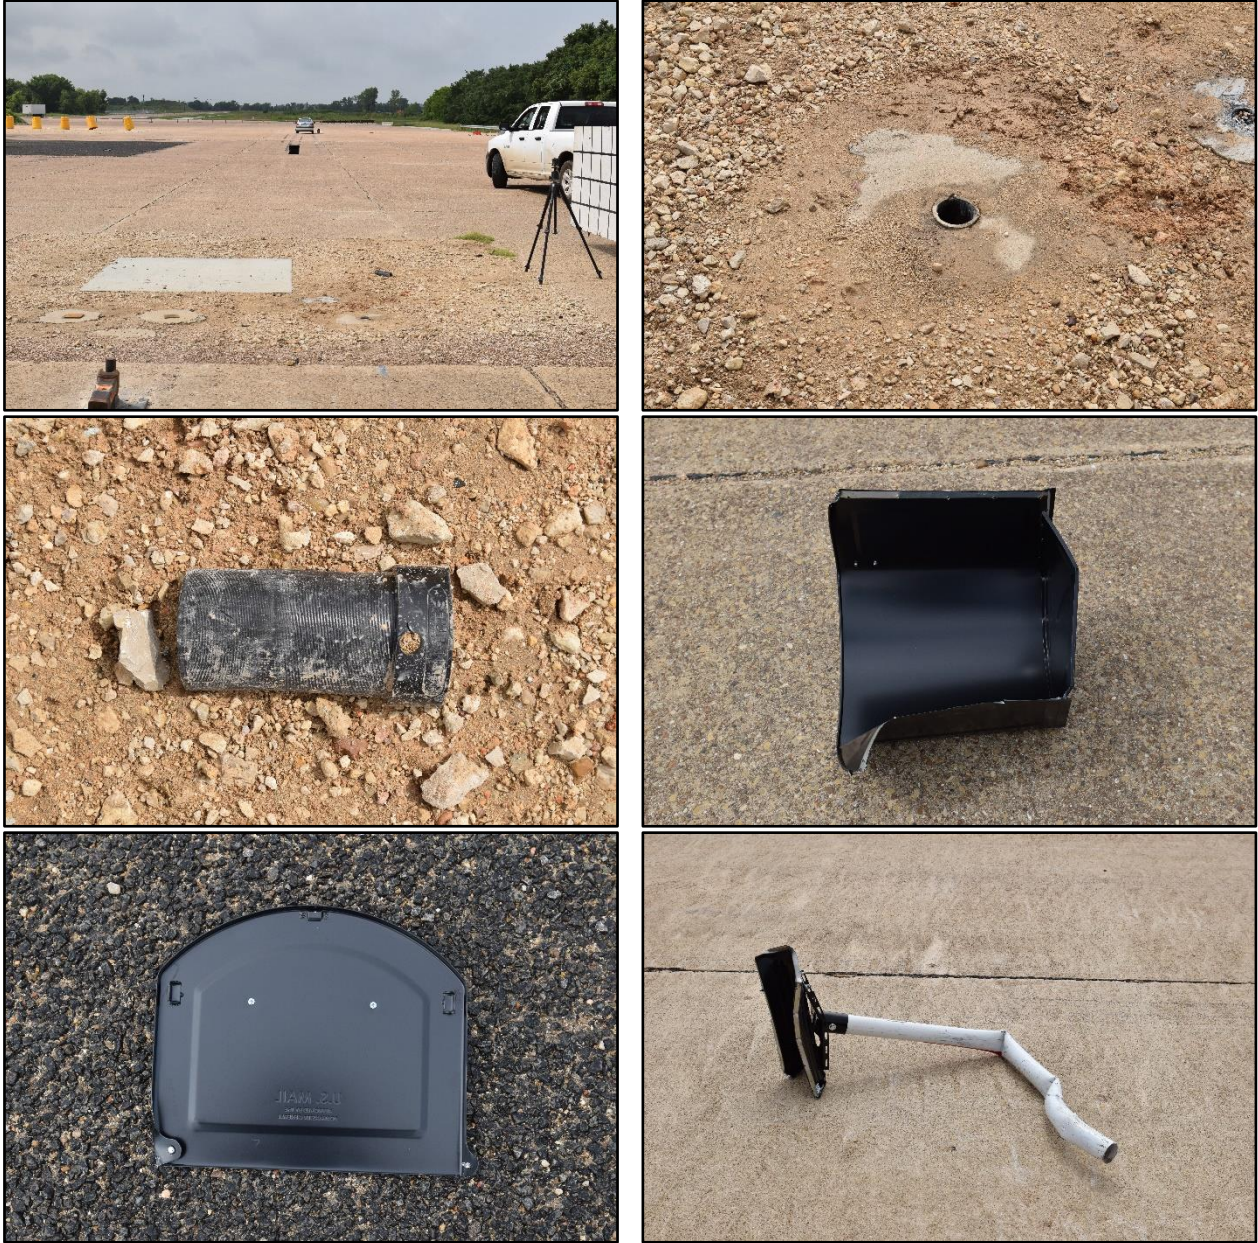
Figure 4.6. Mailbox after Test No. 469689-1-1.

Figure 4.6 shows the damage to the mailbox. The post pulled out of the socket. The mailbox separated into three pieces. The top, sides, and back stayed together and landed 99 ft downstream, and the mailbox door landed 102 ft downstream and 25 ft left. The bottom of the mailbox remaining attached to the post, which stayed engaged with the front of the test vehicle until it stopped, then slid to a stop 7 ft past the vehicle.

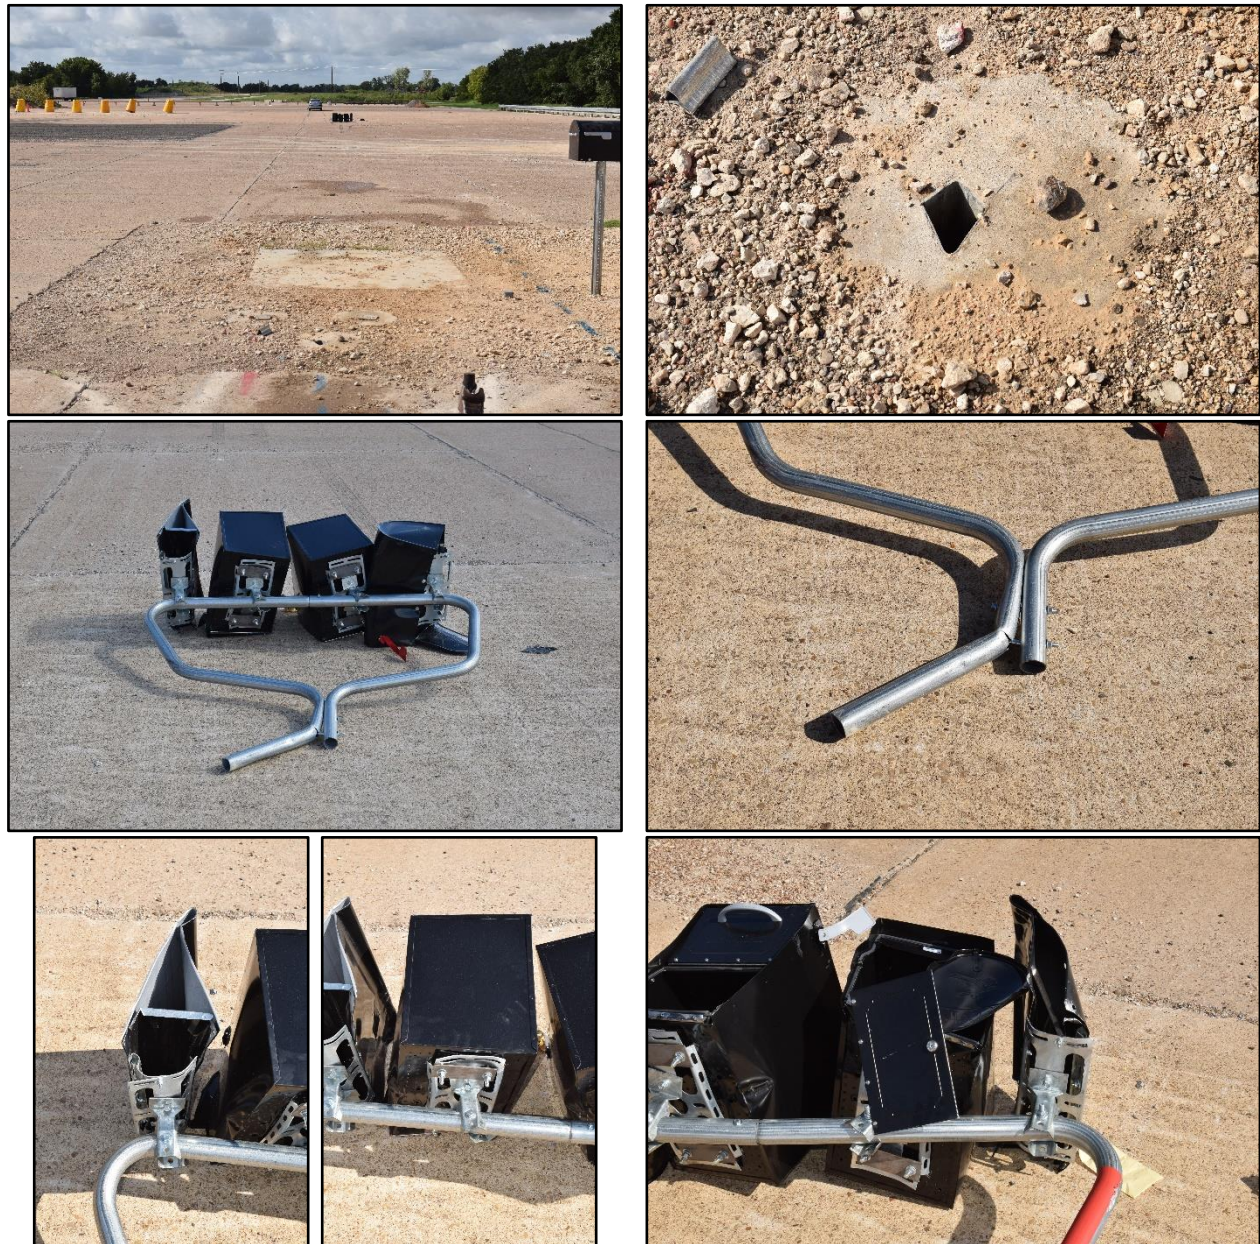
Figure 5.6. Mailboxes after Test No. 469689-1-2.

Figure 5.6 shows the damage to the mailbox installation. The bent post pulled out of the V-Wing Socket. The post and mailbox assembly remained intact and landed 115 ft downstream from the impact point.

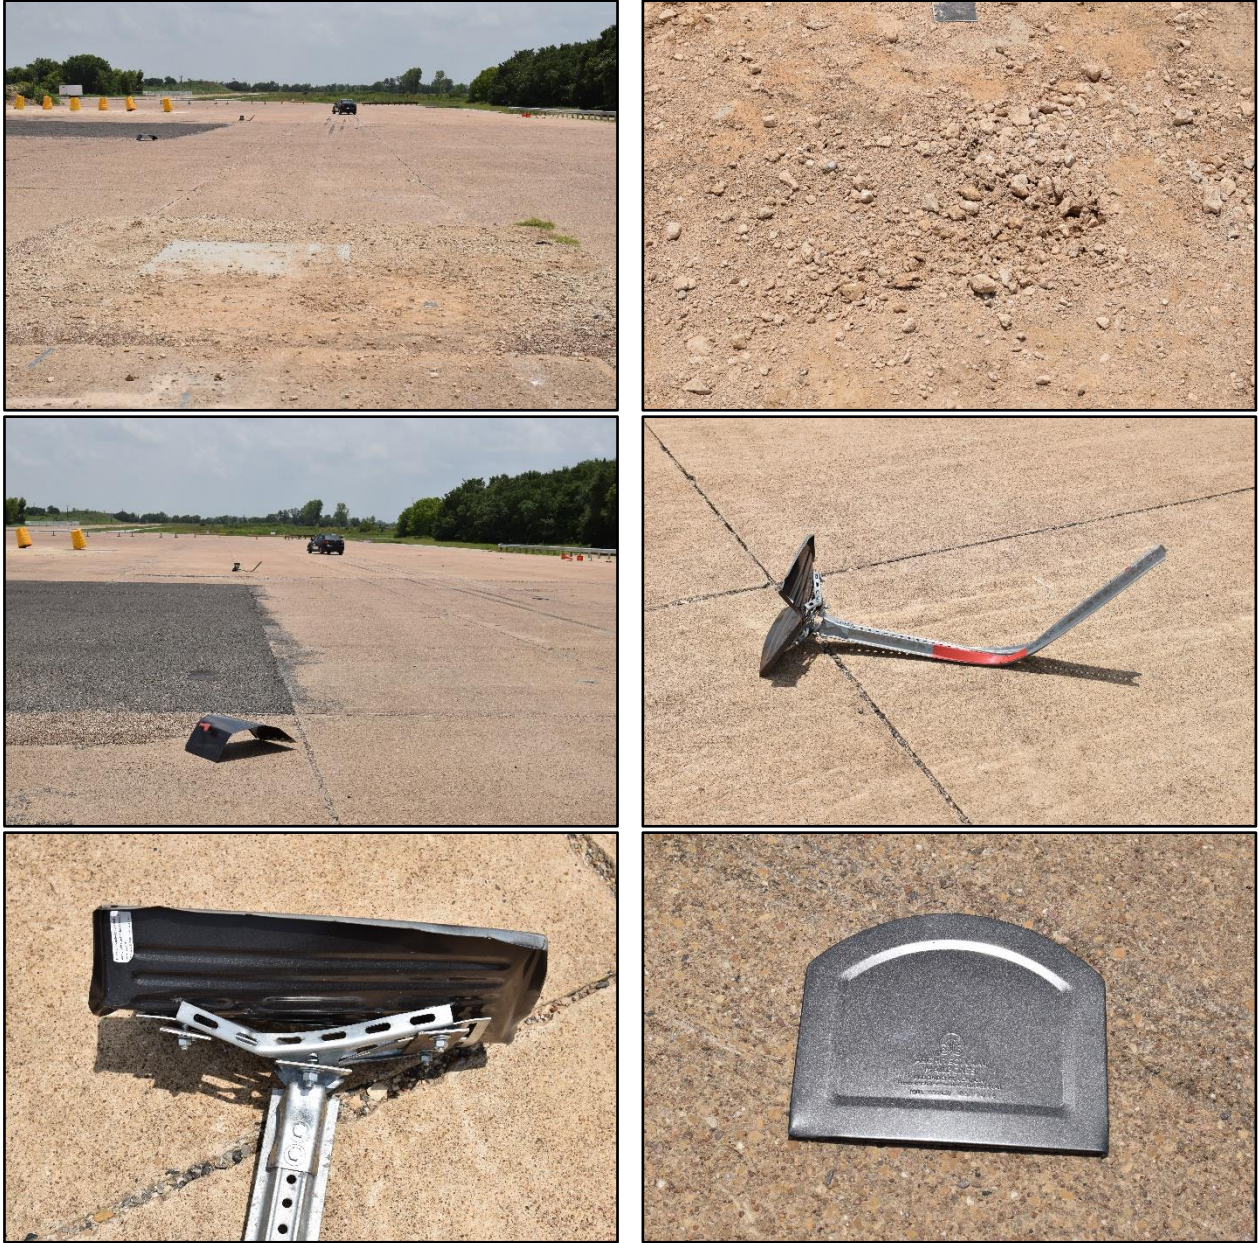
Figure 6.6. Mailbox after Test No. 469689-1-3.

Figure 6.6 shows the damage to the mailbox. The support pulled out of the soil. The mailbox separated into four pieces. The bottom of the mailbox remaining mounted to the support and landed 177 ft downstream and 22 ft left. The other pieces landed from 12 ft right to 25 ft left and from 84 ft to 210 ft downstream.

It became clear that a bracket that would connect the support, the mailbox floor, and the mailbox side was a possible solution to avoid separation of the mailbox floor from the rest of the mailbox body. Thus, four L brackets were integrated into the mailbox support assembly as described above. Figures 7.1 through 7.4 show the details of these brackets.
