Development of Guidelines for Inspection, Repair, and Use of Portable Concrete Barriers—Volume 1: Technical Report

Technical Report 0-7059-R1-Vol1

TEXAS A&M TRANSPORTATION INSTITUTE
COLLEGE STATION, TEXAS

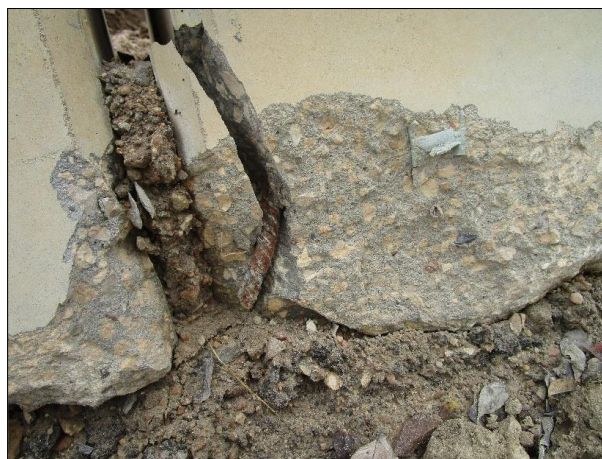
When the rebar is exposed to moisture and water, possibly because of inadequate cover or surface irregularity, a chemical reaction takes place, resulting in the formation of iron oxide (rust) on the rebar surface. Due to the production of iron oxide, the rebar volumetrically expands by up to six times its original volume. This increase in volume imposes significant expansive forces on the surrounding concrete, which can cause a chunk of the concrete to spall and break off. Spalling increases access of air and water to the rebar embedded within the barrier and creates a cycle of corrosion, exacerbating the process with each subsequent cycle (2). Figure 2.2 shows an example of a barrier with a corroded rebar and spalled concrete.

Figure 2.2. Corrosion of Reinforcing Bar Embedded in the Toe of the Concrete Barrier.

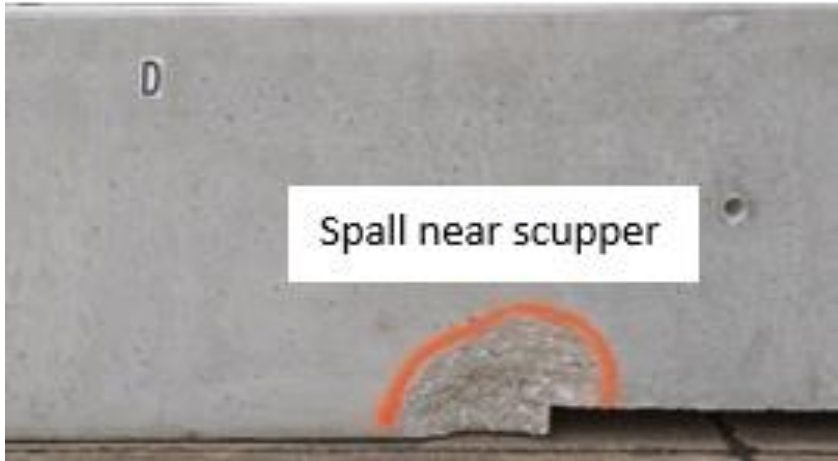
<p data-bbox="639 831 1325 898">Spall at drainage scupper. No exposed reinforcement. Barrier is acceptable.</p>
A-2

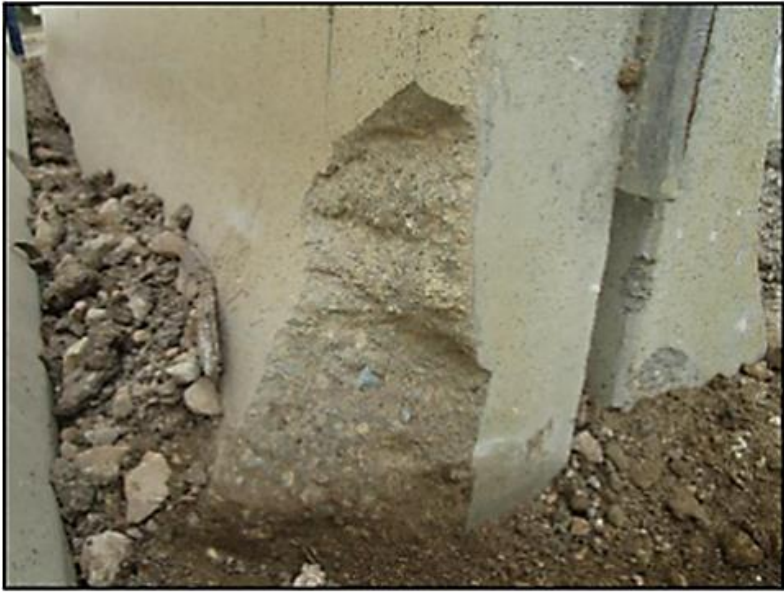
<p data-bbox="571 1541 1390 1608">Spall at bottom corner at barrier end. No exposed reinforcement. Barrier is acceptable.</p>

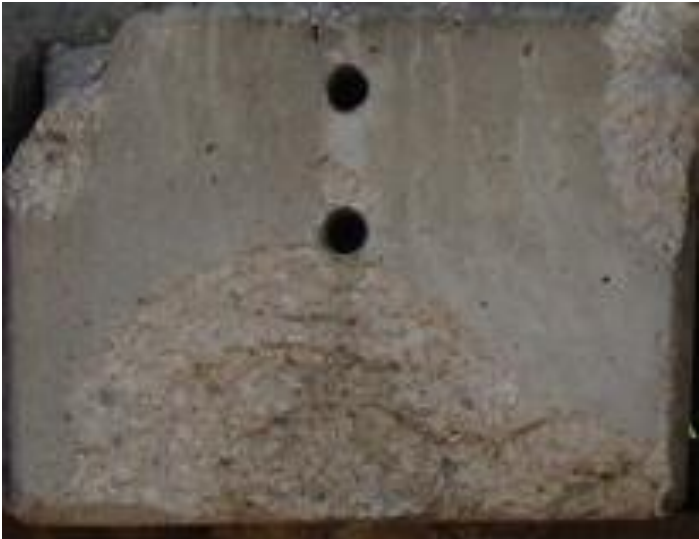
<p data-bbox="607 1572 1360 1640">Multiple spalls in same barrier. No exposed reinforcement. Barrier is acceptable.</p>

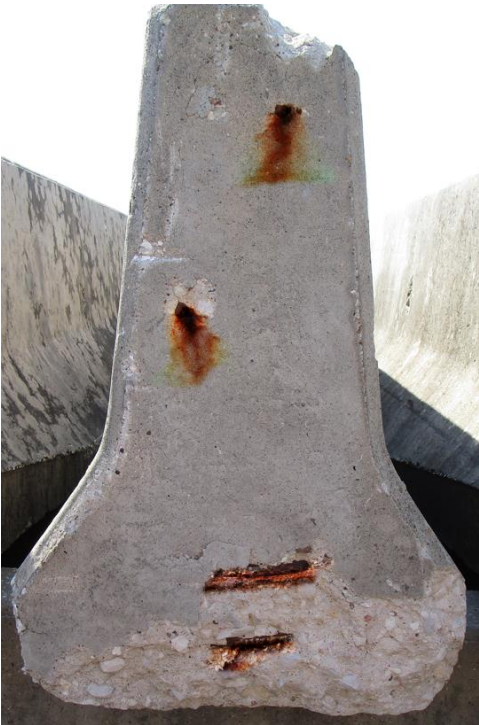
<p data-bbox="542 1087 1408 1157">Spalling exposing reinforcement. Evidence of significant corrosion. Barrier is unacceptable and should be removed from service.</p>

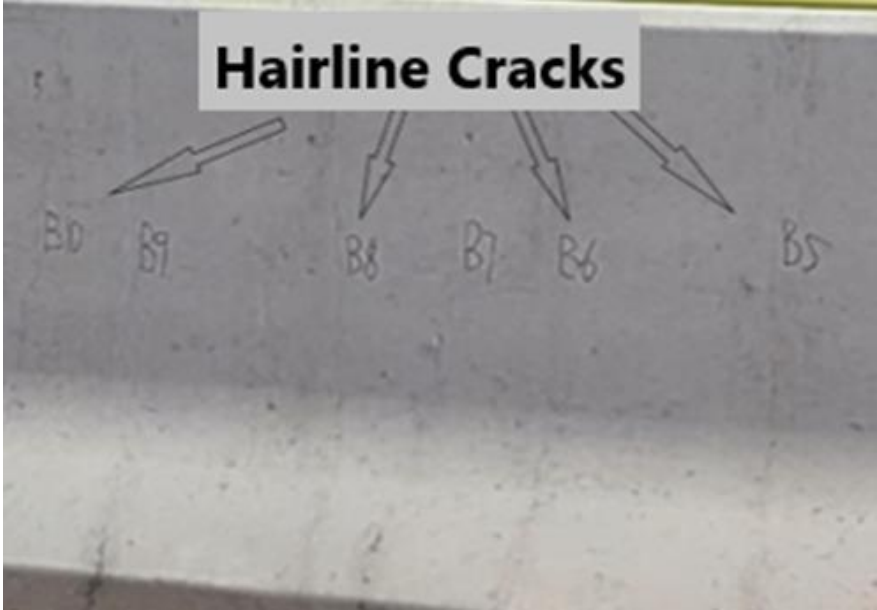
<p data-bbox="669 953 1263 989">Multiple hairline cracks. Barrier is acceptable.</p>
D-2

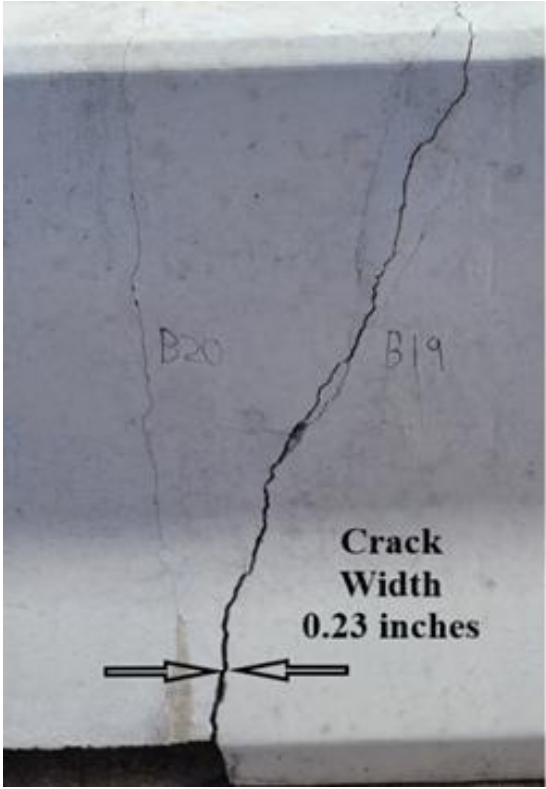
<p data-bbox="477 1619 1416 1686">Crack width measuring less than 0.25 inches. No reinforcement exposure through crack. Barrier acceptable with repair.</p>

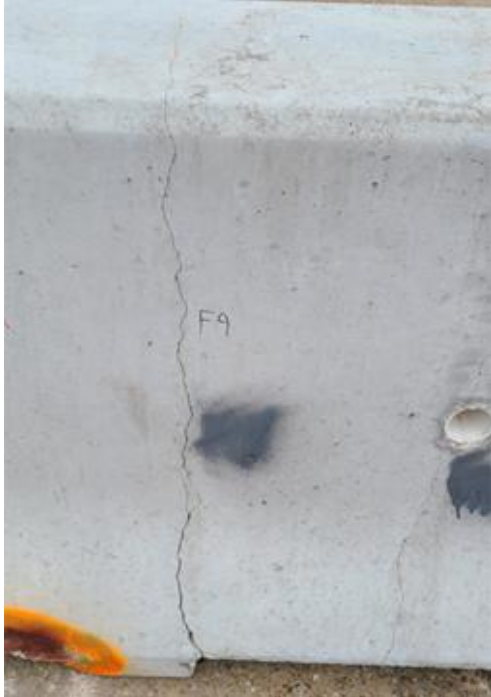
<p data-bbox="479 976 1416 1045">Crack width measuring less than 0.25 inches. No reinforcement exposure through crack. Barrier acceptable with repair.</p>
E-6

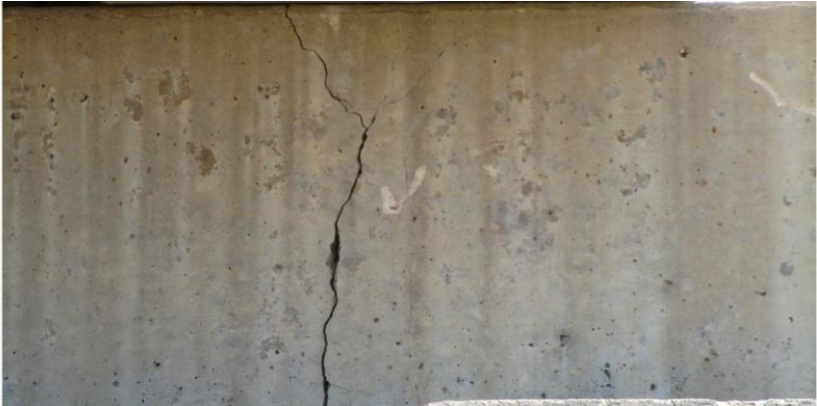
<p data-bbox="479 1501 1416 1572">Crack width measuring less than 0.25 inches. No reinforcement exposure through crack. Barrier acceptable with repair.</p>

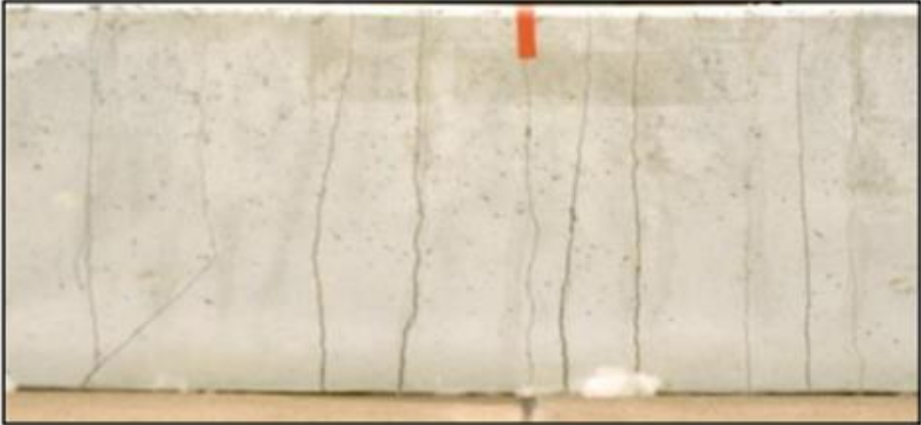
<p data-bbox="488 1461 1403 1566">Multiple cracks with measured summed widths greater than 0.25 inches within 1 ft of longitudinal barrier length. Barrier is unacceptable and needs to be discarded.</p>

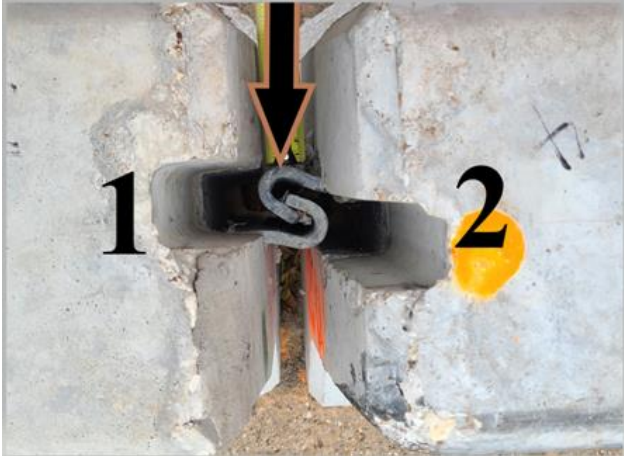
<p data-bbox="501 783 1390 888">JJ hooks are not corroded or cracked. Each JJ hook's angular rotation measures less than 20 degrees, and each opening measures less than 1 inch. Both barrier segments with these JJ hooks are acceptable.</p>
G-2

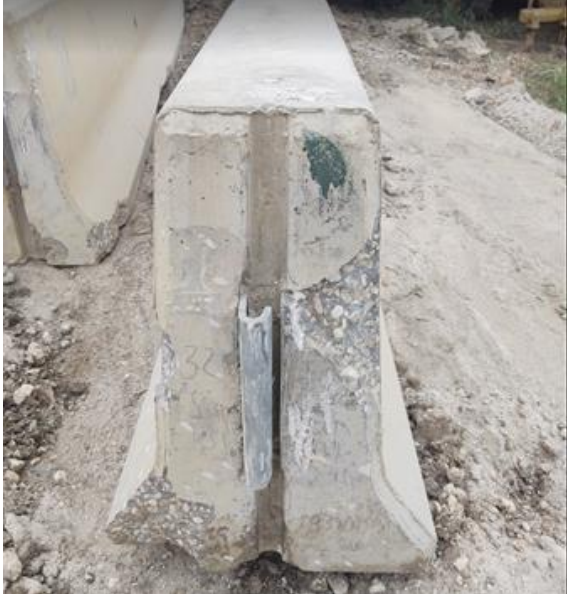
<p data-bbox="485 1520 1406 1623">JJ hook is not corroded or cracked. JJ hook's angular rotation measures less than 20 degrees, and the opening measures less than 1 inch. JJ hook is acceptable.</p>

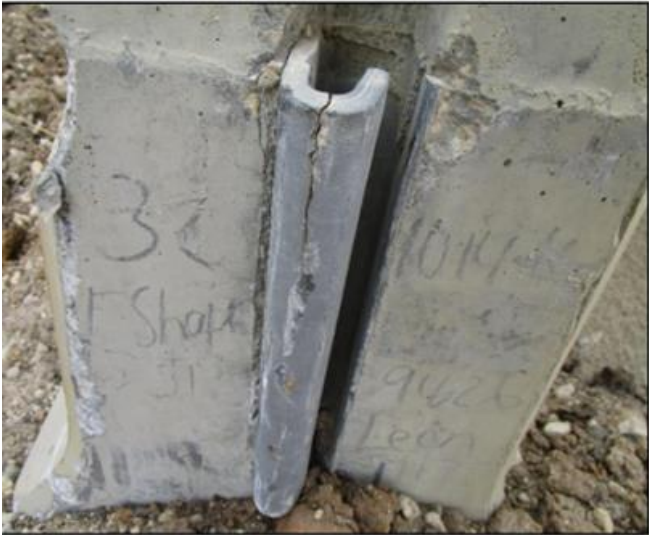
<p data-bbox="521 1463 1370 1528">JJ hook presents cracking. Barrier is unacceptable and needs to be discarded.</p>
