Test Report No. 440822-01

**EVALUATION OF ATTACHMENTS TO CONCRETE BARRIER
SYSTEMS TO DETER PEDESTRIANS**

Texas Department of Transportation
<https://tti.tamu.edu/documents/0-7082-R1-Vol2.pdf>

1. Report No. FHWA/TX-23/0-7082-R1-Vol2		2. Government Accession No.		3. Recipient's Catalog No.	
4. Title and Subtitle EVALUATION OF ATTACHMENTS TO CONCRETE BARRIER SYSTEMS TO DETER PEDESTRIANS—VOLUME 2: CRASH REPORT				5. Report Date Published: August 2023

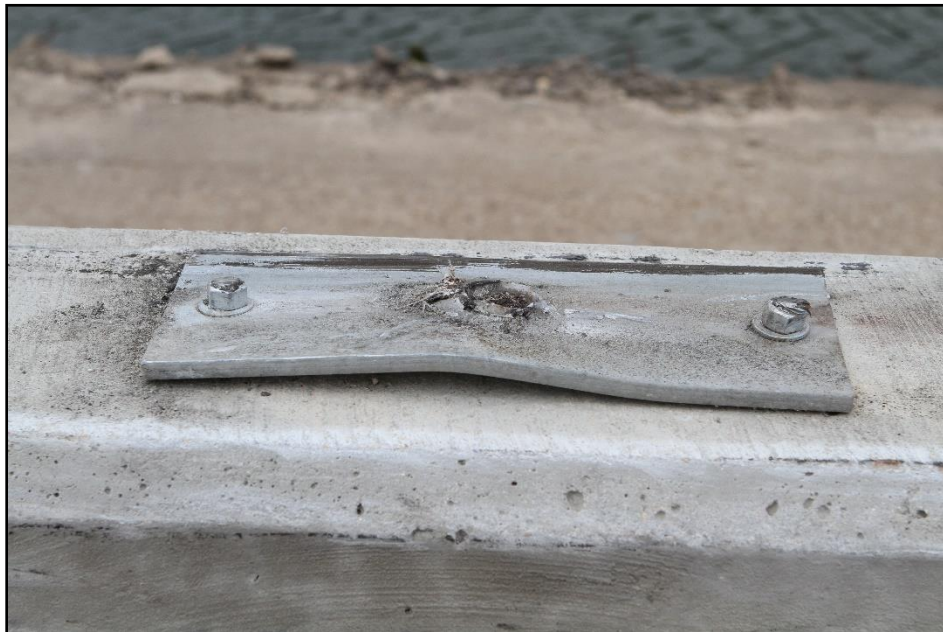
There was some scuffing and gouging at impact on the concrete barrier. Panels 6–20 were removed from the parapet. Panels 6 and 7 landed behind the parapet, and the others landed from 195 to 240 ft downstream. The pipe-to-plate connection failed at panels 7, 11, 15, and 16. The anchor bolts failed on the others.

Figure 5.8. Armorcast® Gawk Screen on Single-Slope Barrier after Test at Base Plate with Missing Post, Test 440822-01-1.

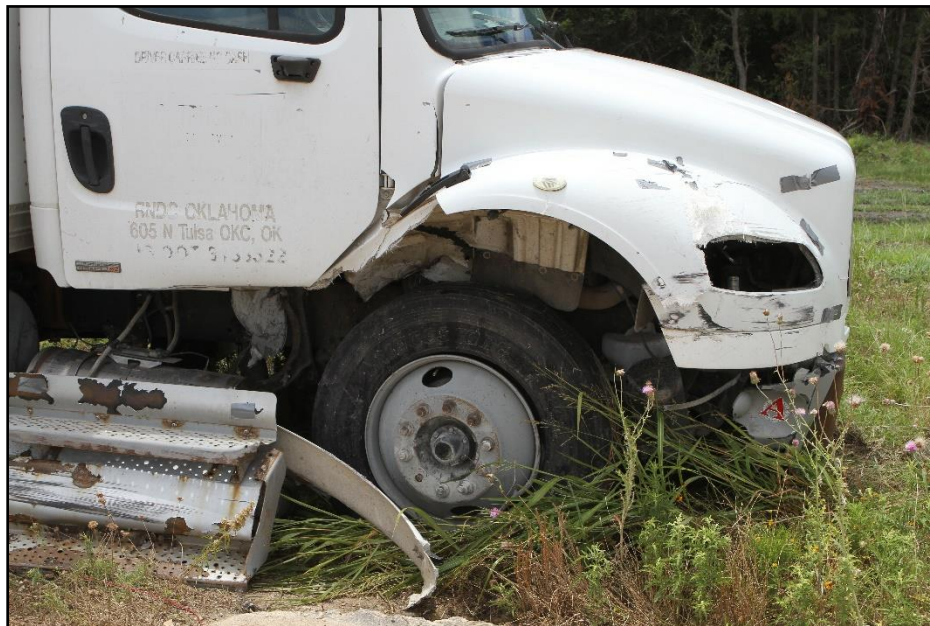
Figure 6.8. Impact Side of Test Vehicle after Test 440822-01-2.

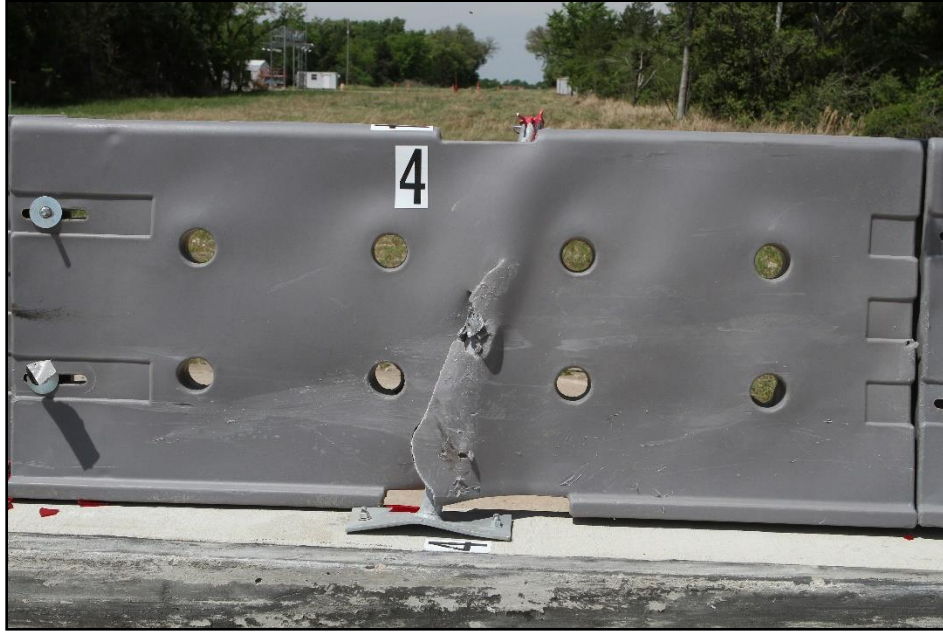
Figure 7.7. Armorcast® Gawk Screen on F-Shape Barrier after Test at Post 4, Test 440822-01-3.

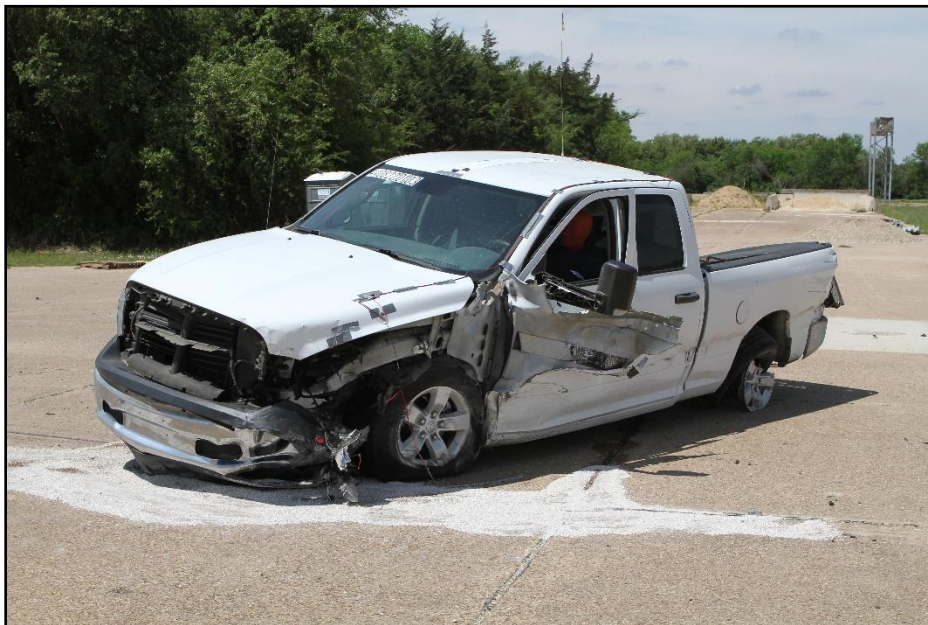
Figure 7.8. Impact Side of Test Vehicle after Test 440822-01-3.

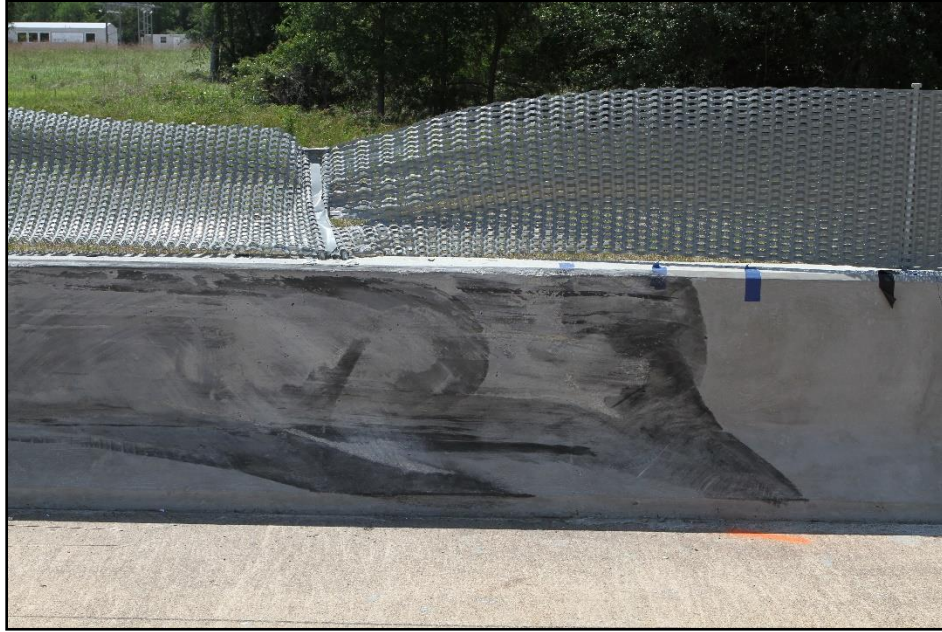
Figure 8.7. Screen-Safe® Glare Screen on F-Shape Barrier after Test at the Joint of Posts 6 and 7, Test 440822-01-4.

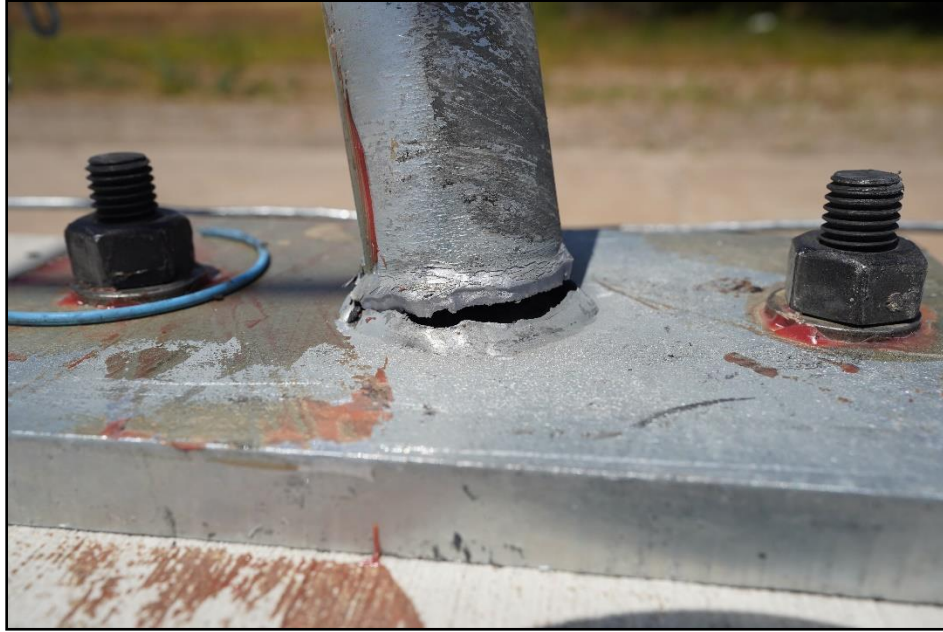
Figure 9.7. Chain-Link Fence on F-Shape Barrier after Test at the Base of Post 6, Test 440822-01-5.
