MASH TEST 4-12 ON T2P RETROFIT BRIDGE RAIL

Test Report 0-7086-R5

TEXAS DEPARTMENT OF TRANSPORTATION

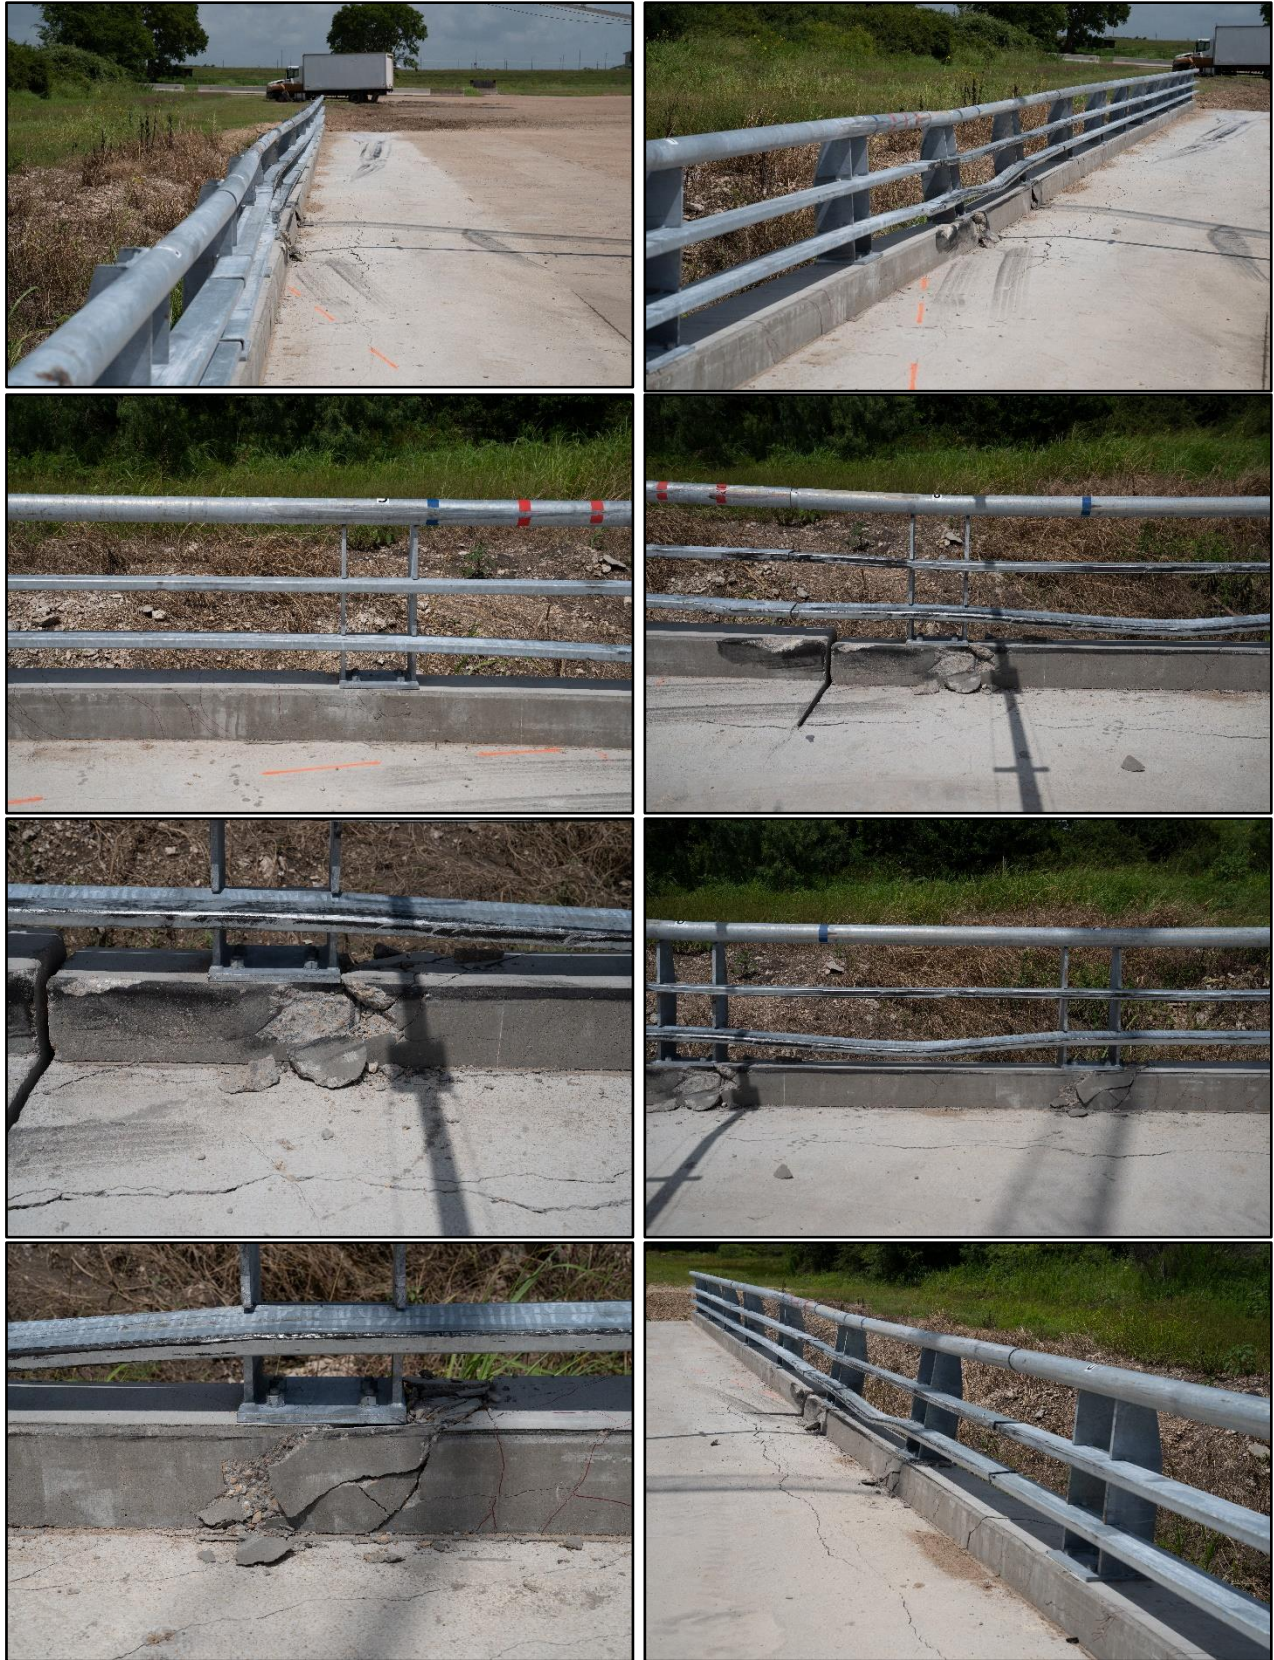
Figure 5.3. TxDOT T2P Retrofit Bridge Rail after Test No. 440861-2.

Figure 5.3 and Figure 5.4 show the damage to the TxDOT T2P retrofit bridge rail, and Table 5.2 shows post lean after the test. There was major cracking of the deck on the traffic side of the curb up to the edge of the field joint, which extended from post 3 to 2 ft downstream from post 10. There was also cracking under the deck from the field joint to 1 ft downstream from post 7, which ran along the anchor bolts, and from the field joint to post 7, there was a crack where the deck and wall intersected. The curb had some spalling and exposed rebar on the traffic and field side at post 6, and the curb downstream of the field joint was 3 inches lower on the field side and 1¼ inches lower on the traffic side than the curb upstream of the joint. The lower

rail was deformed just downstream of impact and was 6 inches lower than its pre-impact height. The existing cracks in the curb were outlined in black, and the cracks that occurred post-impact were outlined in red. Working width* was 64.4 inches, and height of working width was 144.3 inches. Maximum dynamic deflection during the test was 14.9 inches, and maximum permanent deformation was 9.0 inches.

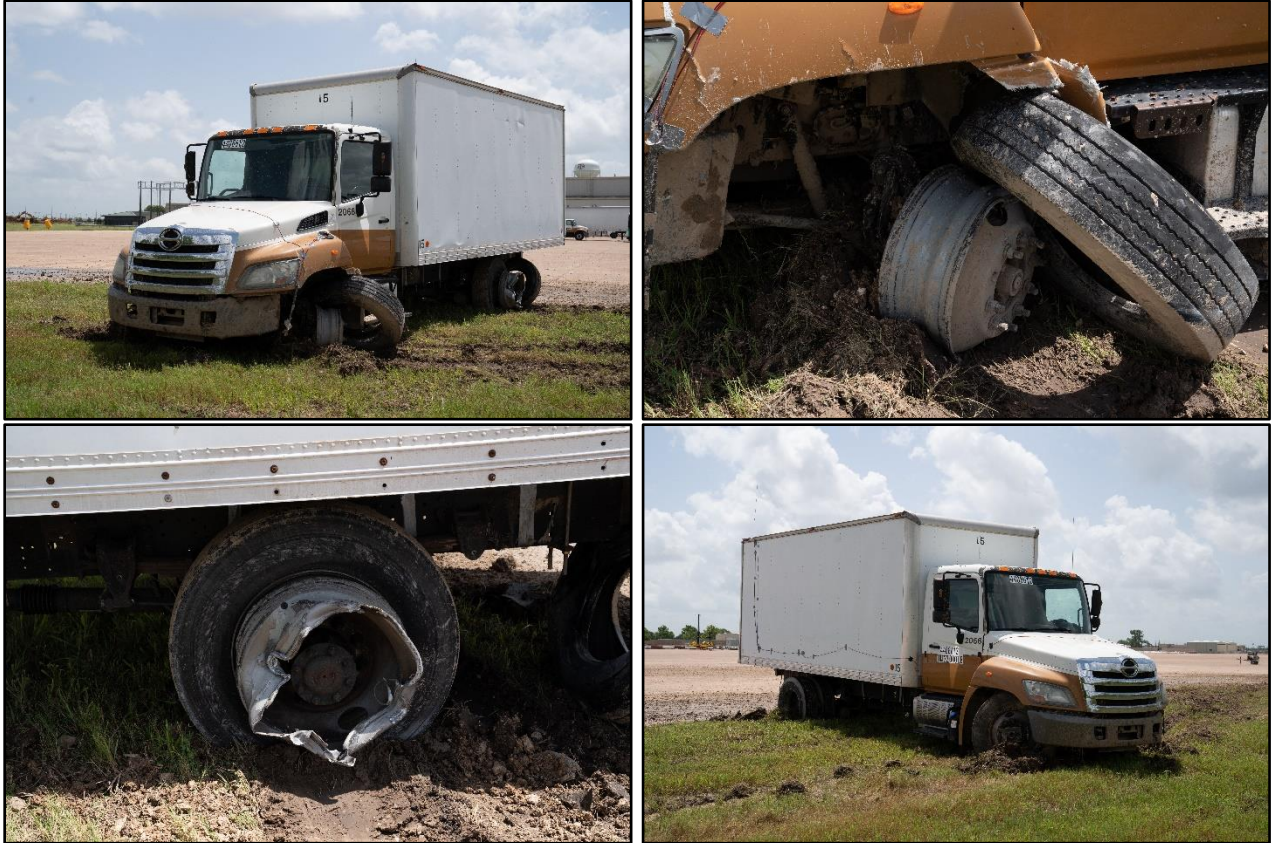
Figure 5.5. Test Vehicle after Test No. 440861-2.

Figure 5.5 shows the damage sustained by the vehicle. The front bumper, hood, left front tire and rim, left front U-bolts, left rear outer tire and rim, and left rear corner of the cargo box were damaged. No damage to the fuel tank was observed. Maximum exterior crush to the vehicle was 10.0 inches in the front plane at the left front corner at bumper height. No occupant compartment deformation or intrusion was noted. Figure 5.6 shows the interior of the vehicle.
