A SURVEY OF DISTRESS AND DEBRIS
IN THE JOINTS OF PAN-FORMED CONCRETE BRIDGES

Research Report No. 12-1

Improved Methods for Cleaning Joints
In Concrete Bridge Decks

January, 1974

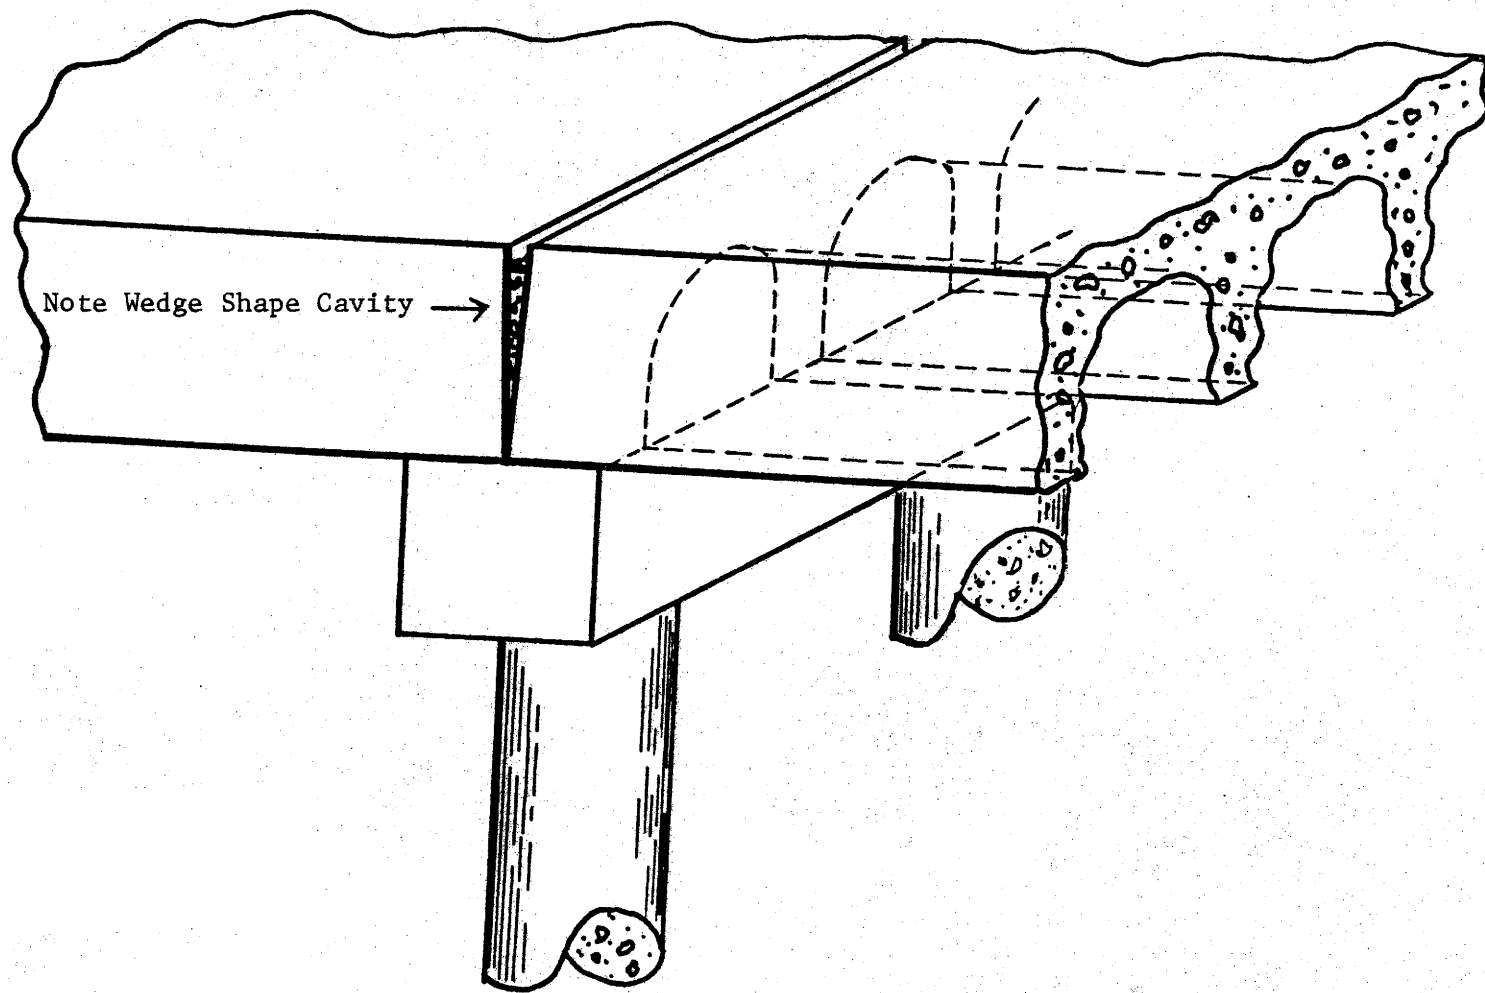
1/4 inch wide at the top and closed at the bottom. The wedge shaped cavity thus formed provides a space for the debris to accumulate. See Figure 1.

Figure 1: Fixed joints in pan-formed bridges are generally open about 1/4 inch at the top and completely closed at the bottom. Typically, adjacent spans are both doweled to the pier cap at these joints.

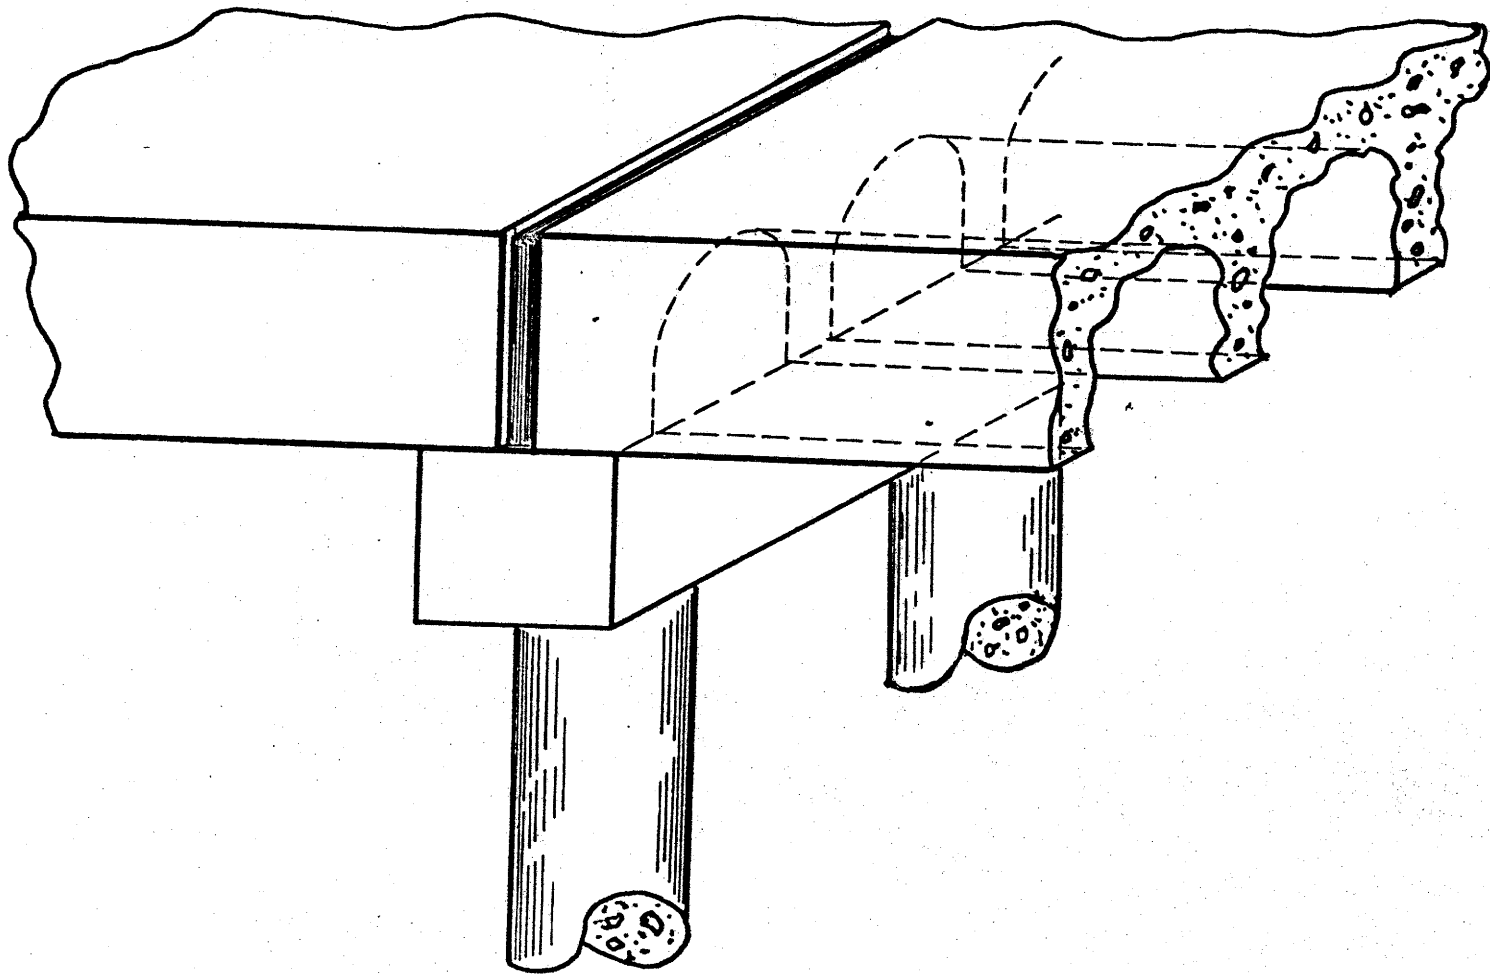
The expansion joints were found, typically, to be about 3/4 inch wide and to contain a fiberboard filler beneath an asphaltic seal, as shown in Figure 2. In most cases, as seen in Figure 3, these seals had failed to prevent entry of debris. The high-pressure water-jet technique, which is under investigation in this study, appears well adapted to removal of debris, filler and deteriorated seal material from these expansion joints. For the narrower, tapered fixed joints, however, it appears that only the near-surface debris can be removed by this technique.

Figure 2: Expansion joints in pan-formed bridges are generally 3/4 inch wide and contain a fiberboard filler. Typically, only one of the adjacent spans is doweled to the pier cap.

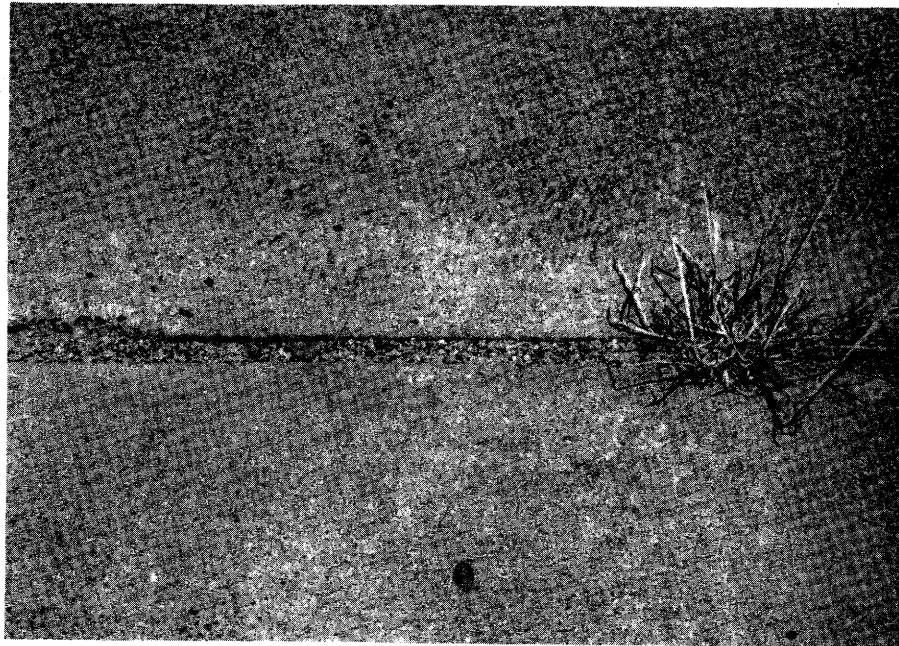
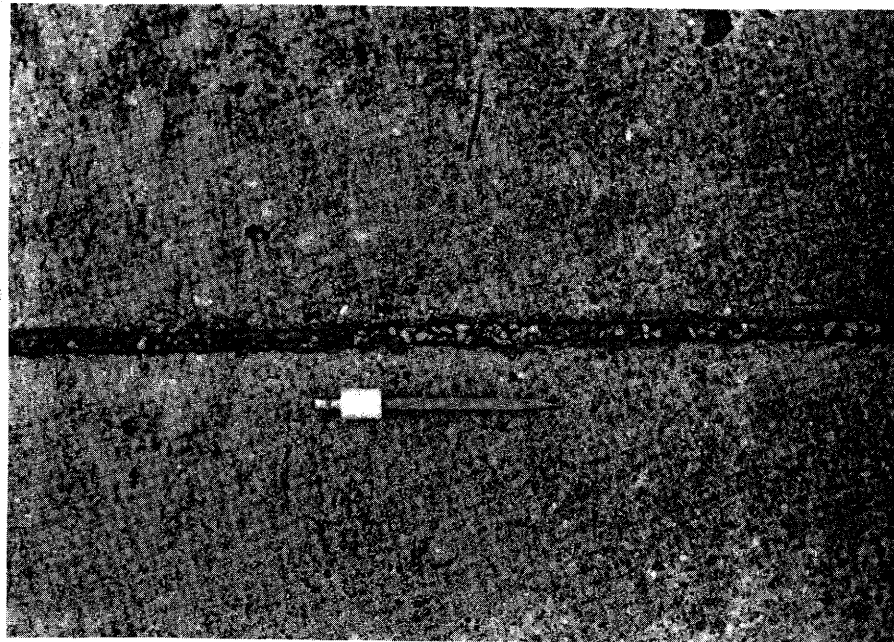
Figure 3: Ineffective joint seals in pan-formed bridges often allow the accumulation of incompressible debris.

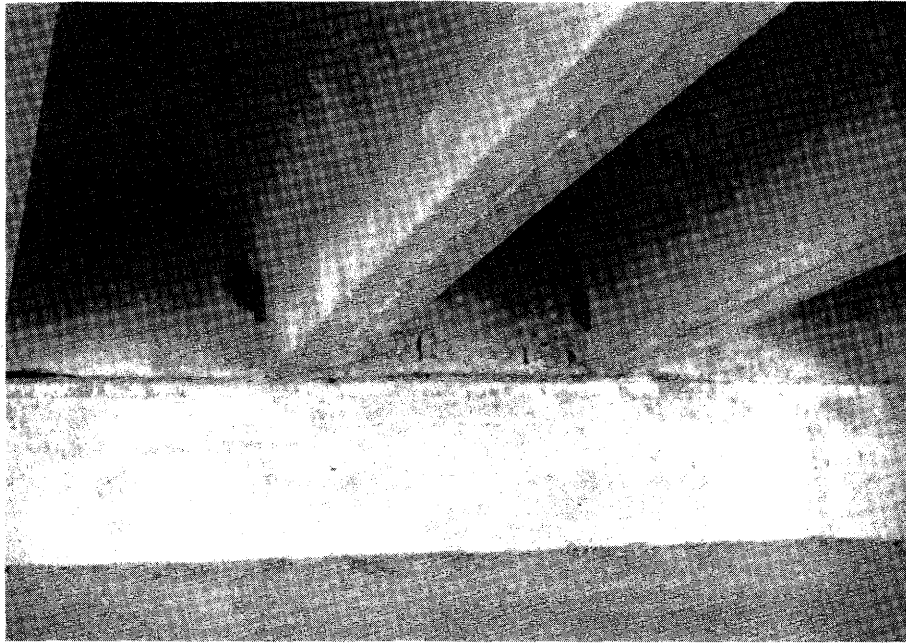
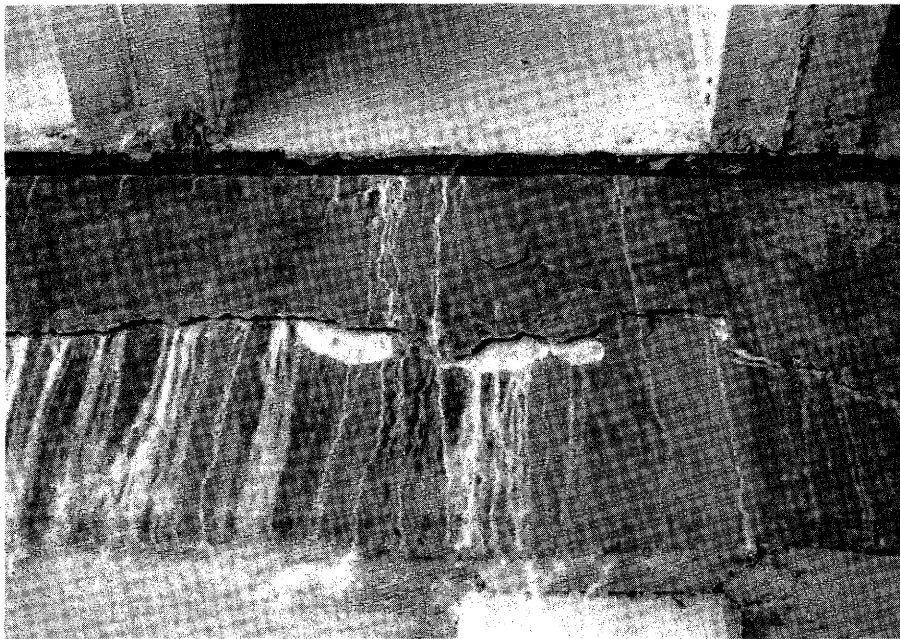
Indications of serious distress, such as cracked diaphragms or cracked pier caps, as shown in Figure 4, were seen in 26 of the 73 structures. Table II shows the distribution of the damage with respect to the type of joint at which it was observed to occur.

Figure 4: Distress at joints in pan-formed bridges results from damaging expansion pressures. The top photograph shows a ruptured diaphragm and the lower a ruptured pier cap.

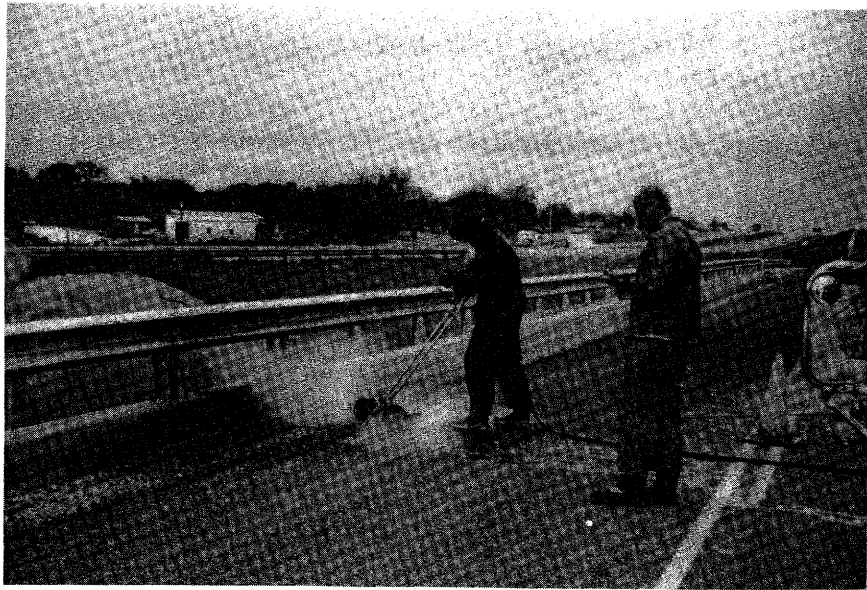
Figure 5: High-pressure water-jet being used to clean debris from joint. The jet "gun" has been mounted on a cart to facilitate operations.

The high-pressure water-jet technique, a joint cleaning method being examined in this study, is currently being used experimentally by maintenance personnel of several Texas Highway Department districts. See Figures 5 and 6. From the results to date, this technique appears highly effective for removing debris, filler and deteriorated seal materials from expansion joints. However, some pebbles are so firmly wedged in the joints that they can be removed only by breaking them into pieces. The water-jet is not able to do that. The narrow width and wedge shape of fixed joints severely limit the effectiveness of the water-jet. It is not possible in practice to remove all debris from such joints by the high-pressure water-jet technique. Even though it will not completely clean the narrow wedge joints, it may remove enough debris to relieve the joint and possibly prevent serious distress. Accordingly, its effectiveness for this purpose will be explored further.

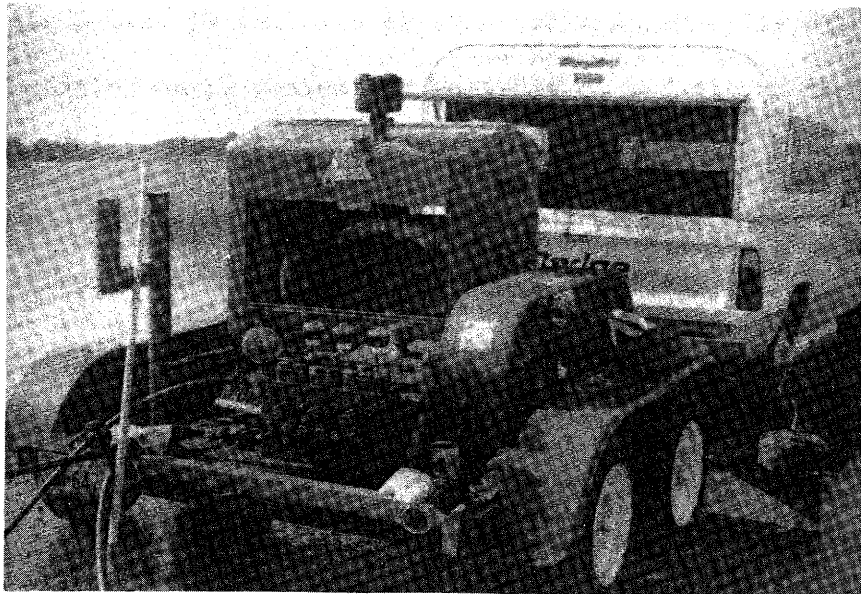
Figure 6: Trailer-mounted high-pressure pump used with the water-jet gun.

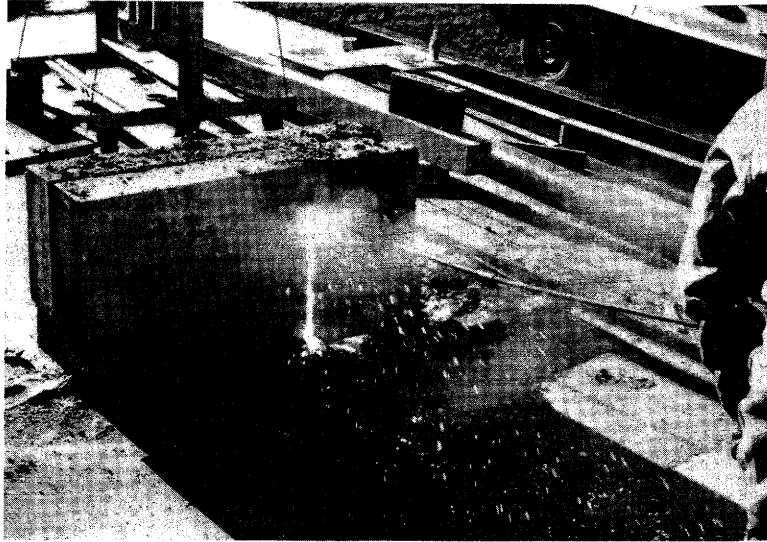
Figure 7: Oxygen-iron torch melting a hole through concrete.

Binding at fixed joints can be relieved to some extent by cutting the dowels which join the beams to the pier cap. Several methods appear feasible for cutting these dowels under appropriate conditions. When the deck can be jacked up to expose part of the pins, a conventional cutting torch could be used to sever them. Without jacking up the deck, a horizontal circular diamond saw or the oxygen-iron, concrete-melting torch could be used. See Figure 7. With either of these latter methods, it is recognized that a certain amount of concrete will be cut away or damaged in the process of getting to the pins. However, it is believed that the loss of concrete would be acceptably small and that a satisfactory procedure might be developed along these lines.

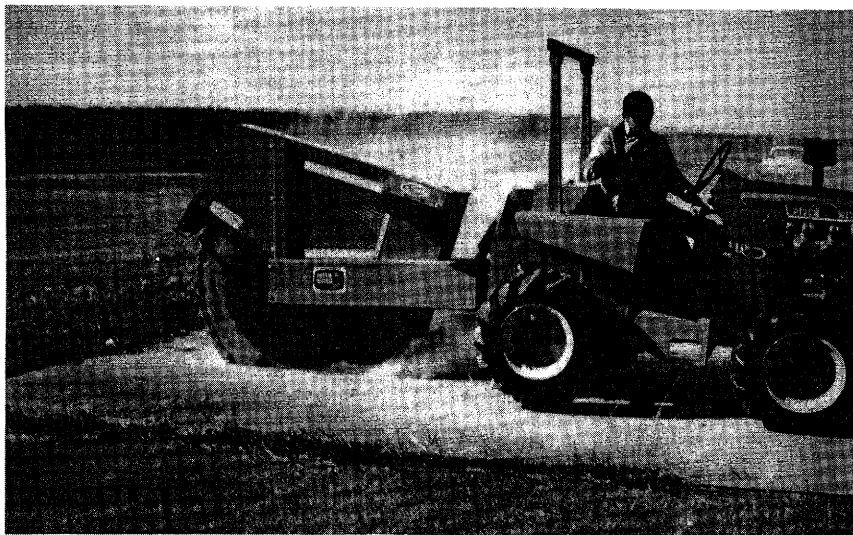
Figure 8: "Ditch-Witch" tractor mounted concrete cutting saw.

Three techniques for cutting concrete by sawing have been found which appear applicable to widening the narrow fixed joints. These techniques use the Ditch Witch (or the similar Vermeer) tractor-mounted device shown in Figure 8, the wire saw, and the circular diamond saw. The toothed wheels of the tractor-mounted devices cut an undesirably wide (4-inch) slot and their teeth are subject to rapid wear.

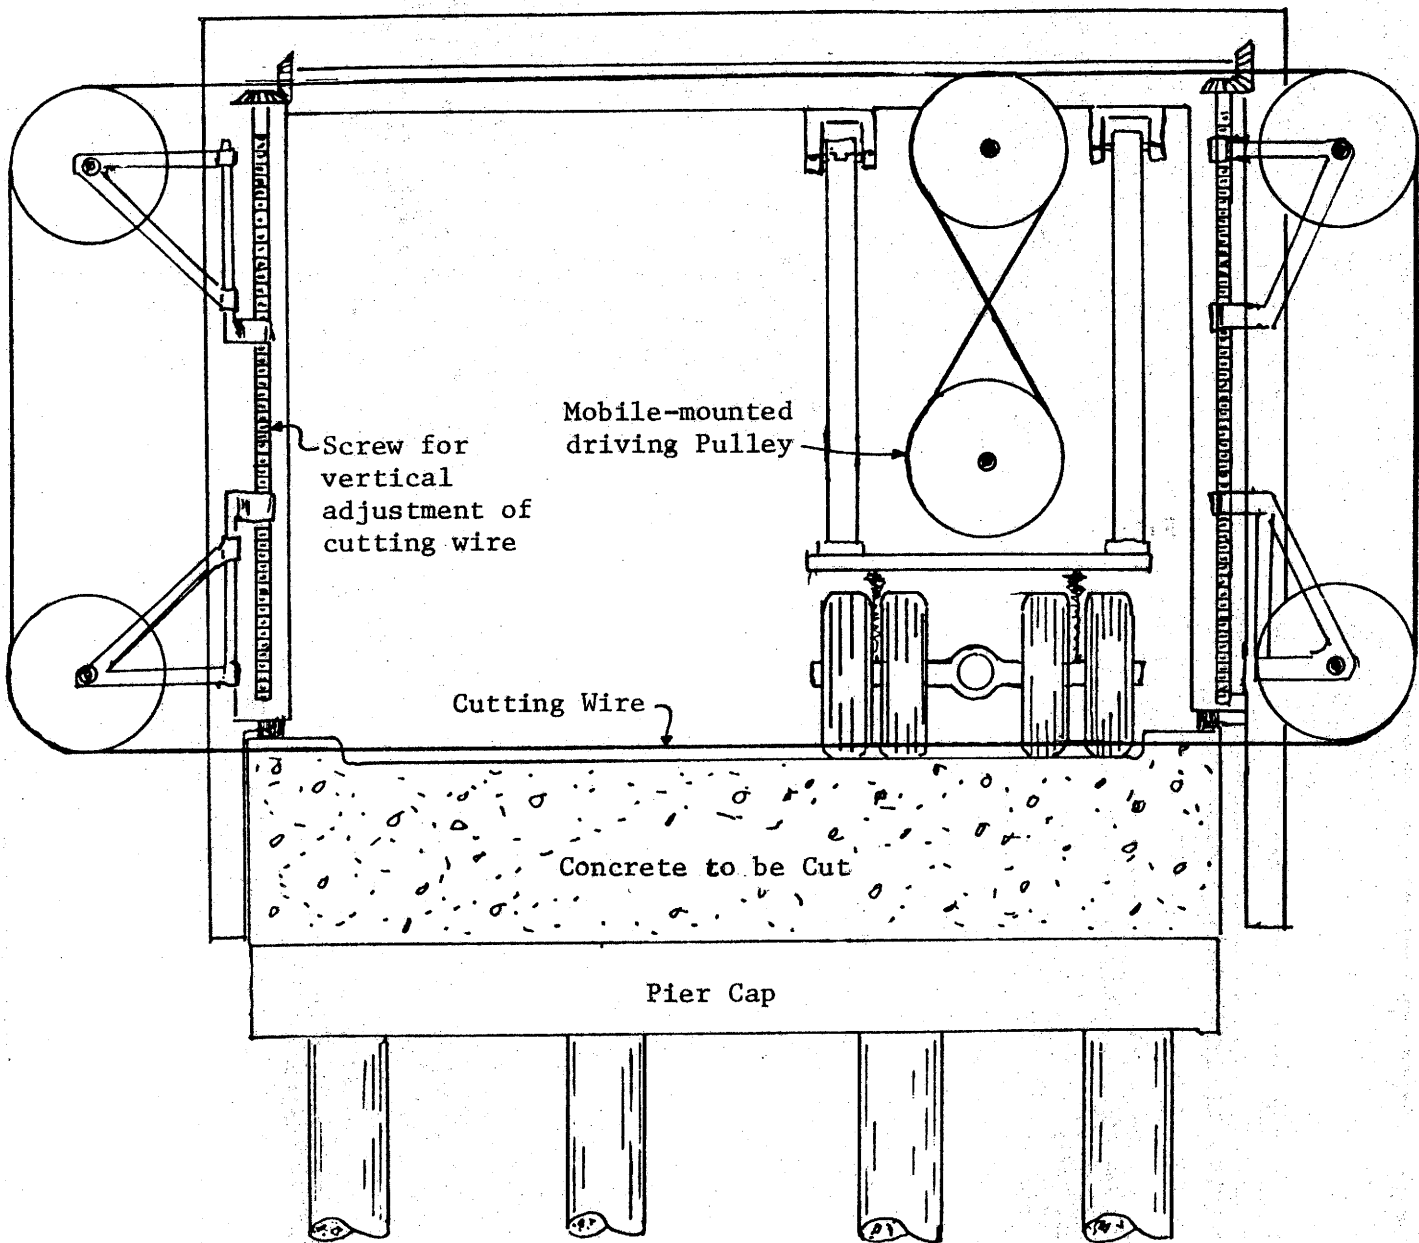
Figure 9: Conceptual sketch of wire-saw device for use on bridge decks.

A wire-sawing technique, as used commercially in granite quarrying and in finish cutting of stone, has been considered. Based upon preliminary estimates, it appears that a major effort would be necessary to adapt the wire-sawing method to widening bridge deck joints and would result in a cumbersome mechanism. See Figure 9. While such a device appears to have

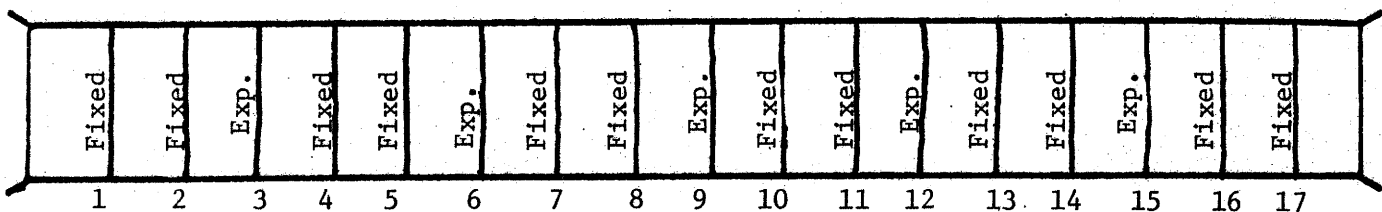
- Joint 1 width 1/4 inch at surface, 0 at bottom - Full of debris, no seal
- 2 width 1/4 inch at surface, 0 at bottom - Full of debris, no seal
- 3 width 1 inch at surface, 1/2 at bottom - Full of debris, no seal

- 4 width 1/4 inch at surface, 0 at bottom - Full of debris, no seal
- 5 width 1/4 inch at surface, 0 at bottom - Full of debris, no seal
- 6 width 3/4 inch at surface, 1/2 at bottom - Full of debris, no seal

- 7 width 1/4 inch at surface, 0 at bottom - Full of debris, no seal
- 8 width 1/4 inch at surface, 0 at bottom - Full of debris, no seal
- 9 width 1 inch at surface, 1/2 at bottom - Full of debris, no seal

- 10 width 1/4 inch at surface, 0 at bottom - Full of debris, no seal
- 11 width 1/4 inch at surface, 0 at bottom - Full of debris, no seal
- 12 width 1 inch at surface, 1/2 at bottom - Full of debris, seal deteriorated

- 13 width 1/4 inch at surface, 0 at bottom - Full of debris, no seal
- 14 width 1/4 inch at surface, 0 at bottom - Full of debris, no seal
- 15 width 1 inch at surface, 1/2 at bottom - Full of debris, seal deteriorated

- 16 width 1/4 inch at surface, 0 at bottom - Full of debris, no seal
- 17 width 1/4 inch at surface, 0 at bottom - Full of debris, no seal

Notes: Spalling on pier-caps 1, 6 & 10.

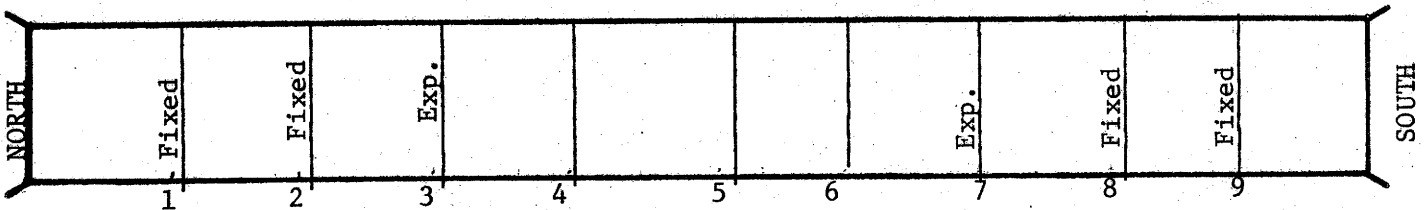
- Joint 1 width 1/2 inch at surface, 1/4 at bottom - Full of debris, traces of seal
- 2 width 1/2 inch at surface, 1/4 at bottom - Full of debris, traces of seal
- 3 width 1 3/4 inch at surface - Full of debris, seal poor
- 4 width 7/8 inch at surface, 1/2 at bottom - Full of debris, little of seal remaining
- 5 width 1/2 inch at surface, 3/8 at bottom - Full of debris, little of seal remaining
- 6 width 1/2 inch at surface, 3/8 at bottom - Seal 70% gone
- 7 - Seal 30% gone
- 8 width 1/2 inch at surface, 3/8 at bottom - Seal 70% gone
- 9 width 1/2 inch at surface, 3/8 at bottom - Seal 70% gone

Notes: No fiberboard in any joints.
 Pier caps 1, 2, 4, 5, 6, 8 & 9 repaired.
 Pier caps 3, 7 O.K.
 Several diaphragms patched, majority O.K.

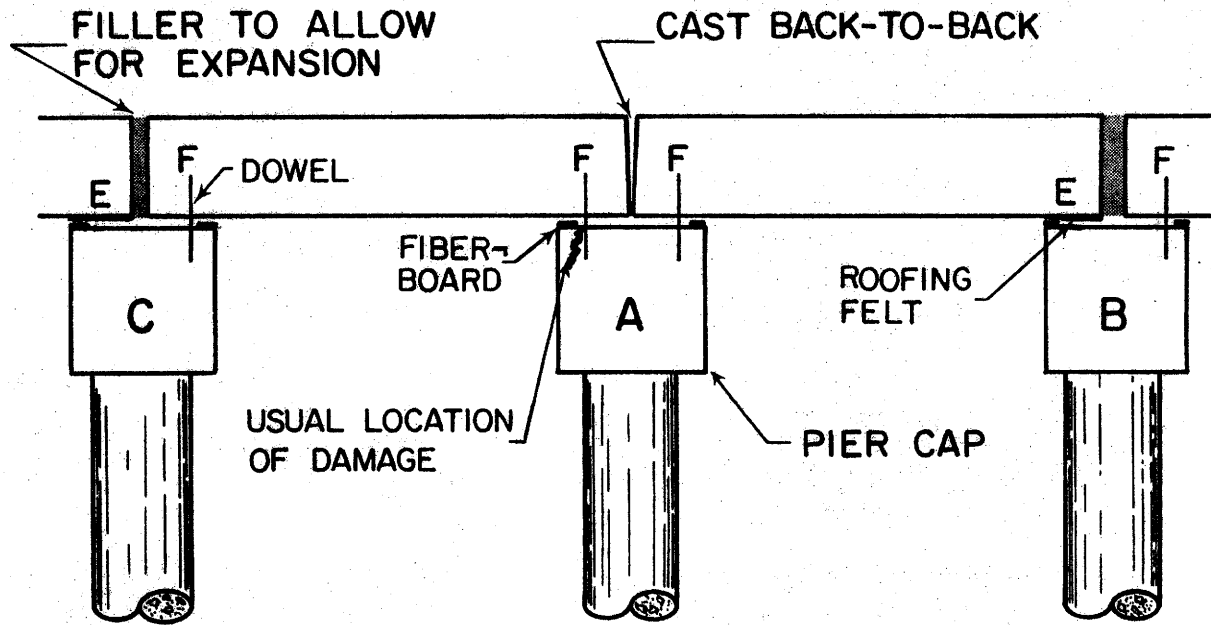
Figure B-1: Diagram of distress pattern.

Referring to Figure B-1, a rise in temperature will cause the concrete to expand. The closed joint at A prevents movement at A. Therefore, the far end of each span adjacent to A moves away from A. At the right end, movement to the right is possible if joint B is open, and no trouble occurs there. To the left, at joint C, a dowel restrains movement, but if movement takes place, it occurs either by bending the pier or by sliding on the pier cap with bending of the dowel. If the dowel bends, it is possible for it to cause spalling of the pier cap. However, spalling does not usually occur at C, it generally occurs at A.

Now consider a drop in temperature. The concrete shrinks, but the expansion joint B permits sliding at B which relieves a portion of the tension in the slab between A and B caused by the temperature drop. However, at C no sliding can occur. Therefore, the span between A and C pulls the dowels at both ends toward the center of the span. This applies pressure on the vertical section between each dowel and the vertical face

of the pier cap. In an ideal case, equal pressures would occur at A and C which would give an equal chance for damage to occur at either location. It is observed, however, that damage occurs predominantly at A, very seldom at C.

Consider, in addition to the drop in temperature, the presence of debris in the joint at A, as shown in Figure 1. When traffic loads deflect the slab, the joint opens more at the top than at the bottom and loose debris drops farther into the joint. When the load leaves the span, the upward deflection tends to close the joint, but the debris which has worked its way down prevents closure. This develops pressure between the ends of the two slabs at A.

The combination of the pressure caused by the debris filled joint and that caused by shrinkage of the concrete due to a drop in temperature results in greater force on the left side dowel at A than on the right side. Thus, more outward force exists on the left dowel at A than on any other dowel, and that force is greatest when the temperature is lowest. Under these circumstances, the left side of the pier cap at A is the one most likely to be damaged.
