CONCRETE RESURFACING OVERLAYS

TWO BRIDGE DECKS

Research Report No. 130-8  
A Study of Reinforced Concrete Bridge Deck Deterioration:  
Diagnosis, Treatment and Repair  
Research Study 2-18-68-130

August, 1972

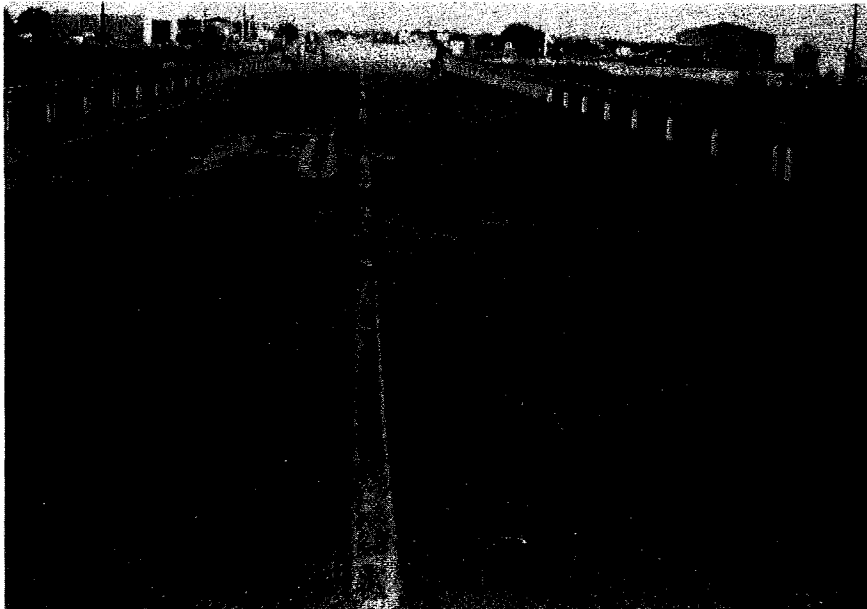
Figure 2. General View of the Deck before Repair  
Colorado River Bridge.

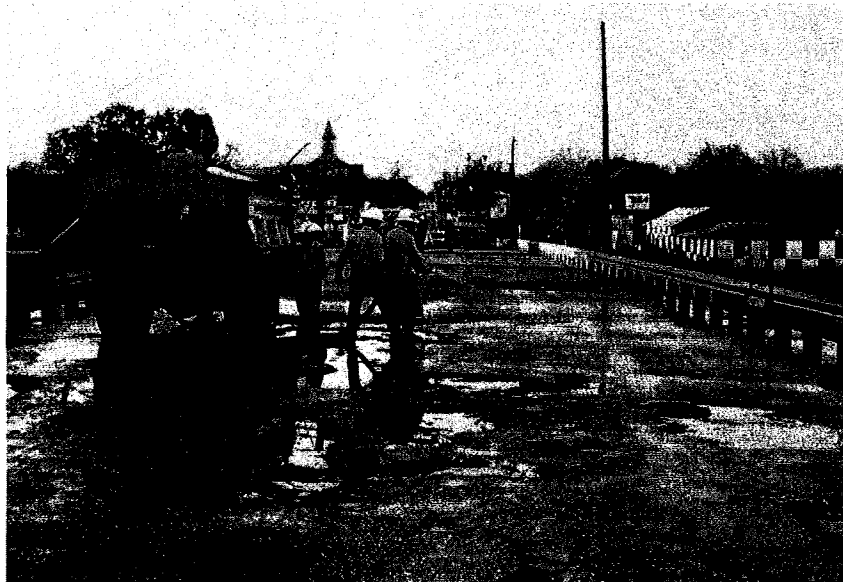
Isolated spalls, Fig. 14, have been patched from time to time, and two full depth deck replacement patches of Fast-Fix<sup>1</sup> concrete were made just prior to the overlay repair. Transverse cracks extending through the deck were present in a number of places. Two areas of checkerboard cracks were visible on the bottom of the deck between the steel I-beams, but this cracking was not considered to be serious enough to replace that part of the deck.

Figure 14. Delamination of Bosque River Bridge.

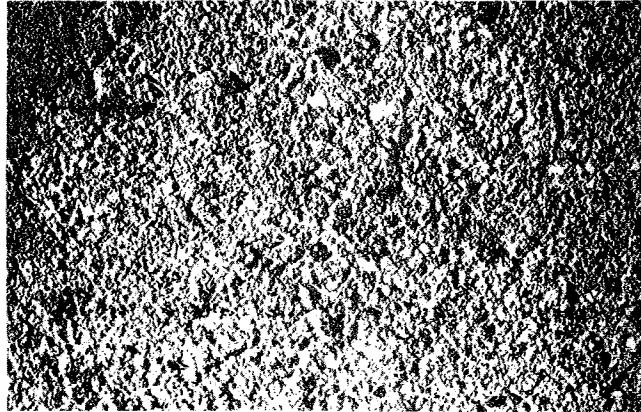
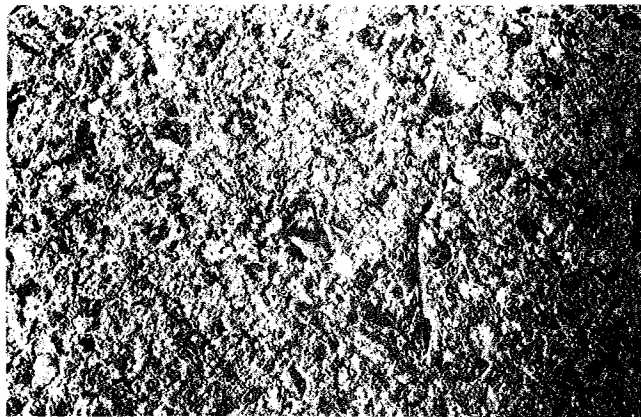
A scarifier, McDonald Scabbler (12), followed the jack hammers to remove the top surface of the entire deck, including sound portions as well as those areas that had been routed out. The rusty exposed steel was then sandblasted to remove rust. Debris left by the Scabbler and sandblaster was blown from the deck which was then flushed with water to remove dust and fine particles left by the air jet. Fig. 15 shows the impacting faces of the Scabbler, and the surfaces of the original concrete and the Fast-Fix concrete that had been subjected to the Scabbler.

b) Scarified Original Deck Concrete

c) Scarified Fast-Fix Concrete

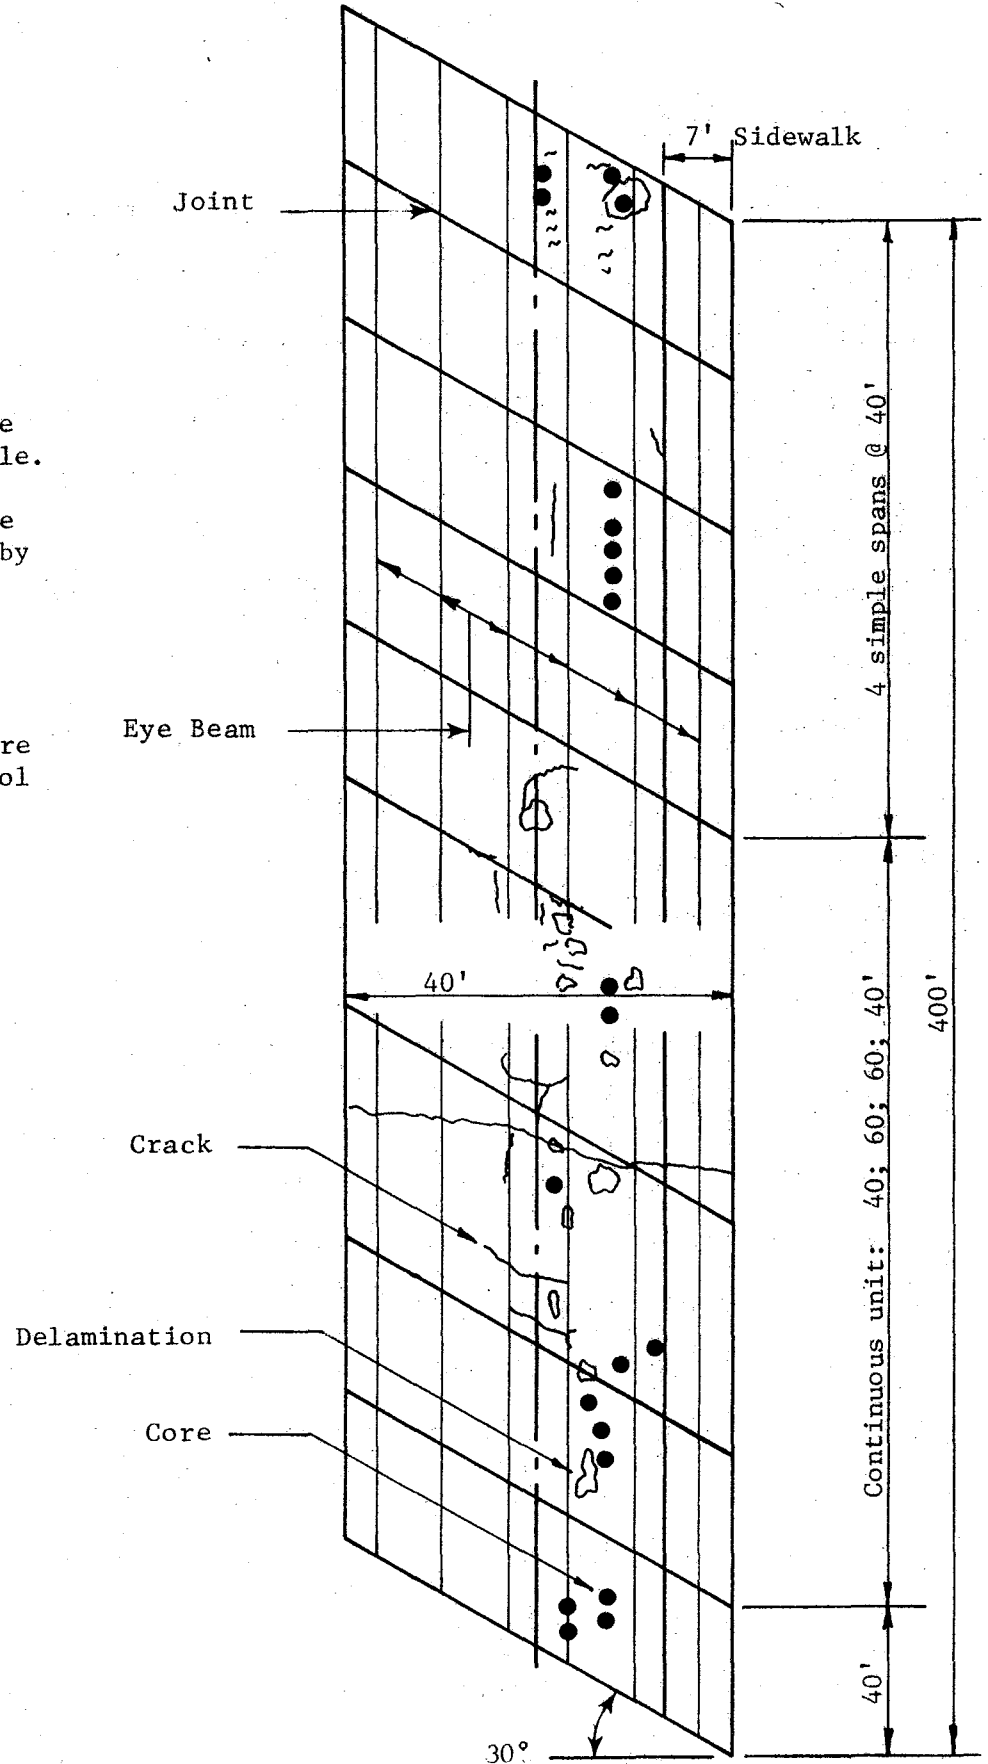
Numerous short diagonal cracks were found in the overlay at the north end of the bridge over the full depth slab replacement material, Fast-Fix concrete. These cracks looked very much like plastic shrinkage cracks, but they were not seen when the curing mats were removed, five days after placement. Four cores were taken through the overlay material over those cracks. Two of them were cracked completely through the overlay, another about  $3/4$  through, and the other to  $1/2$  of its depth. No other cracking of this particular kind was found, but there were a number of transverse and longitudinal cracks. Most of these were found at or in the vicinity of two cold joints in the continuous unit, Fig. 16. One of those joints was on a skew angle and it was accompanied by extensive

Figure 16. Deck plan of Bosque River Bridge showing  
locations of cracks, delaminations, and cores.

Several delaminated (unbonded) areas were detected by sounding with a chain drag. All except two small areas were located in either the continuous unit or in the area of the full depth Fast-Fix concrete at the north end of the bridge, Fig. 16. There were no cracks surrounding the unbonded areas.

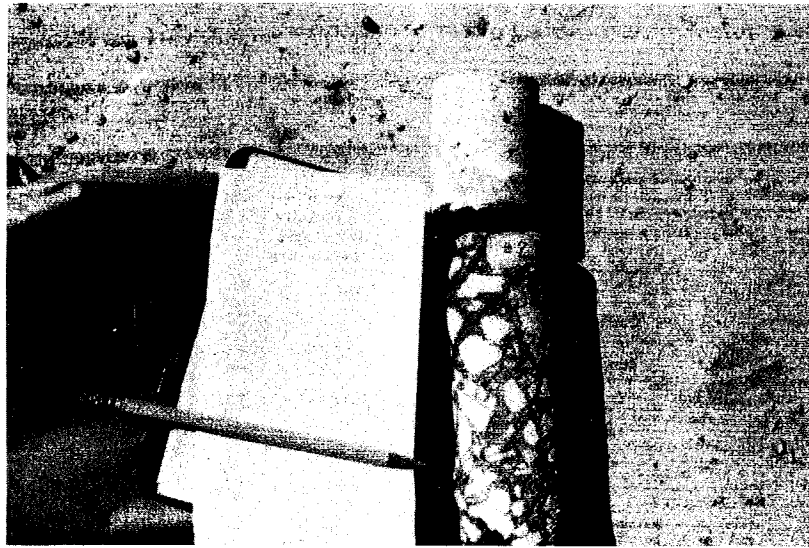
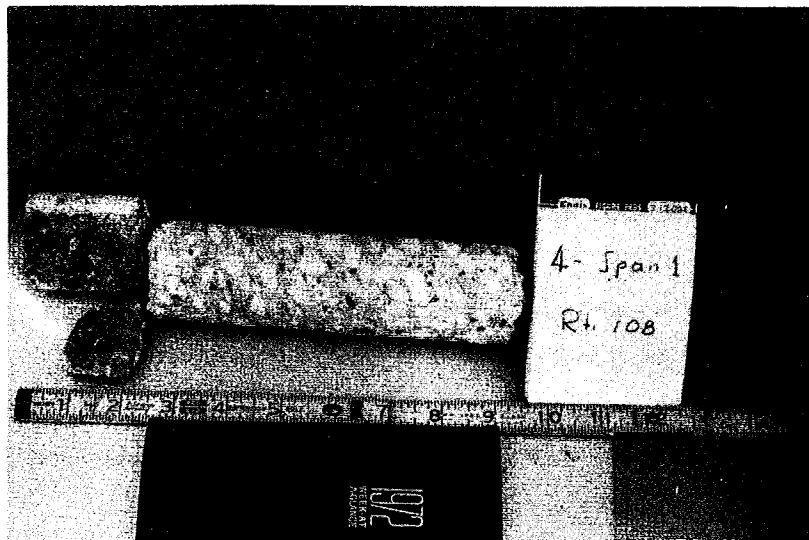
Figure 17. Two-in. Cores from Bosque River Bridge Showing Breaks at Bond Line. Also, note Cracked Overlay in 4-Span 1 Specimen.

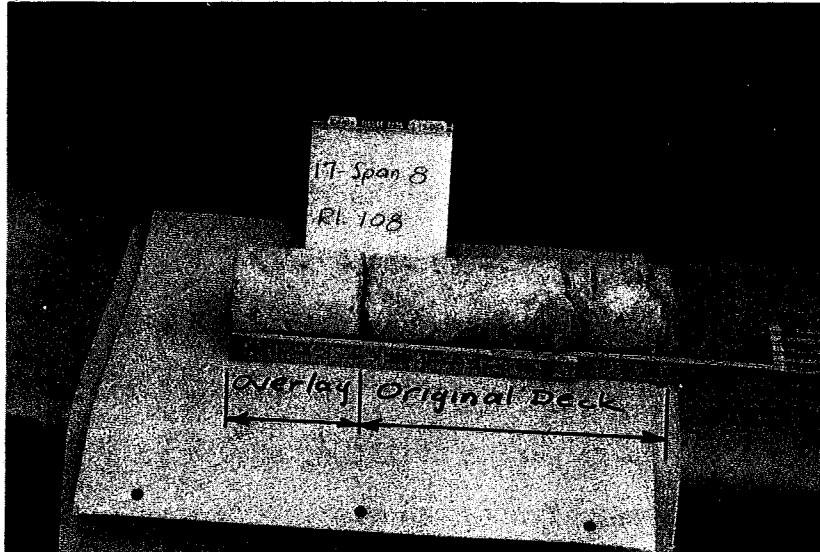
Figure 18. Two-in. Dia. Core from Bosque River Bridge Showing Abrasion at Interface at Overlay and Slab Due to Grinding When Overlay Broke Loose During Drilling.

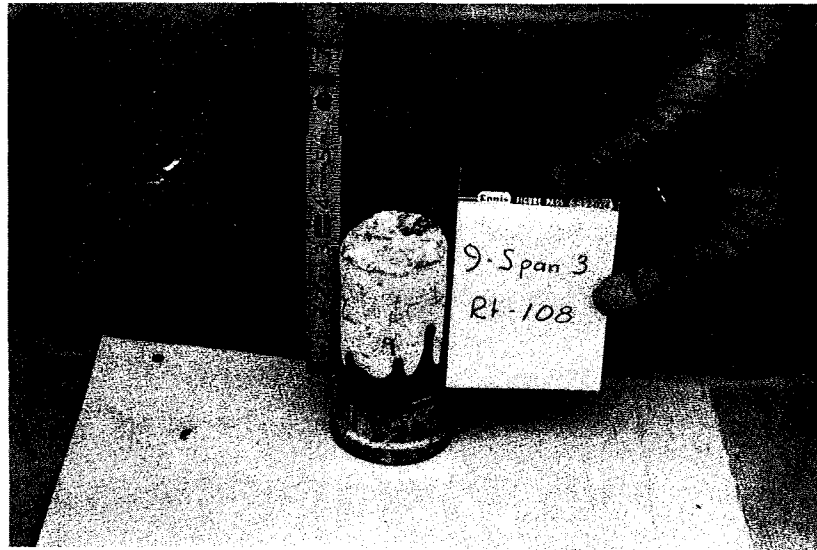
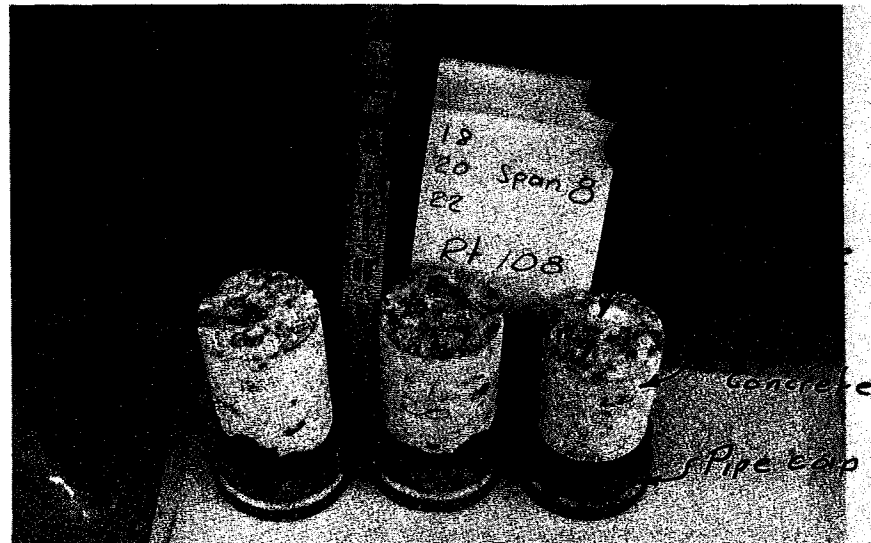
Tensile bond strengths from six 2 in. specimens from the Bosque River bridge are shown in Table V. In each specimen, a residue of mortar from the base slab broke away with the overlay, Fig. 19. Some of the residue was small pieces of broken aggregate, which is discussed later. All specimens that were collected intact, i.e., not having the interface ground away during drilling, showed grout layers varying in thickness from about 1/16 in. to 1/8 in., but there were no powdery interfaces such as were found in the Colorado River bridge cores.

Figure 19. Pipe Cap Test Specimens, Bosque River Bridge. Lighter Color material on the Bonded Faces Broke Away From the Original Deck; Darker Material is Bonding Grout.

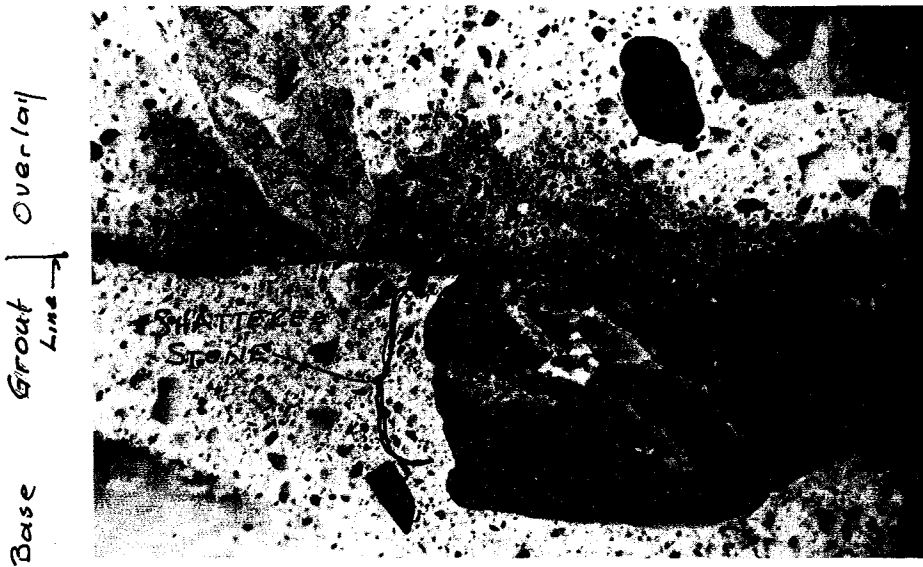
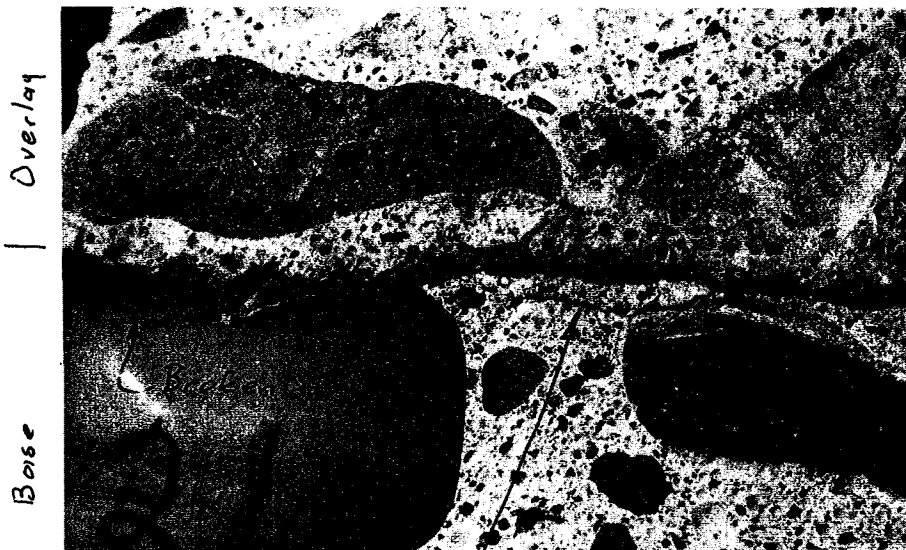
A number of aggregates at the top surface of the old concrete were shattered, and the cracks in those stones, discernable to the naked eye, were easily seen through a reading glass. Fig. 21, micro photographs, show broken aggregate and crushed mortar at the top of the original deck. Those stones were exposed to the blows of the scarifier when the deck was being prepared, and they were crushed under the impacting hammers of that machine. In some areas the mortar matrix of the old material showed cracks parallel to the surface. Those isolated cracks were presumably caused by the scarifier when its hammers impacted the mortar.

Figure 21. Microscopic Views, 10X, of Shattered Stone and Crushed Mortar at the Top Surface of the Old Deck of the Basque River Bridge.
