1. Report No. TX-92/1313-1F		2. Government Accession No.		3. Recipient's Catalog No.	
4. Title and Subtitle Evaluation and Repair of Fatigue Damage to Midland County Bridges				5. Report Date October, 1992

Evaluation and Repair  
of  
Fatigue Damage  
to  
Midland County Bridges

Final Report

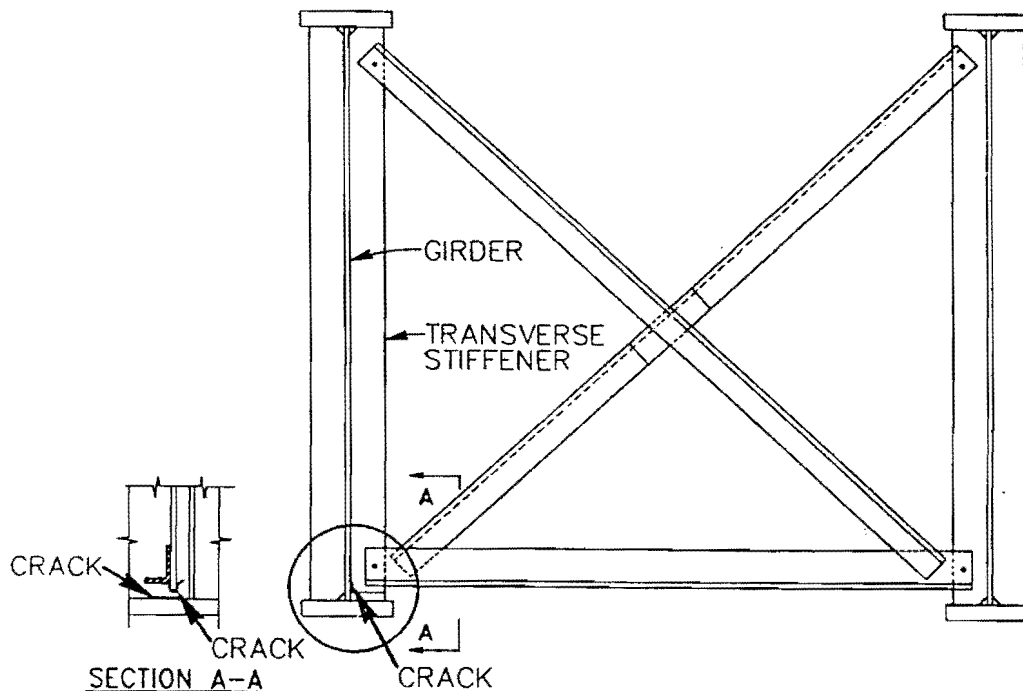
Type A1 - This type of cracking is found at or near the web gap in positive moment regions. Therefore, the cracking occurs near the bottom flange as shown in Fig. 2-1. The cracking was found at both the tight-fit stiffener end (diaphragm Type B and C) as well as the one-inch web gap detail (diaphragm Type C'). The more severe cracking

occurred in the westbound span where the new diaphragms in Bay D were staggered relative to the existing diaphragm line (Diaphragm Nos. 4-11). The location of all detected Type A1 cracks are given in Figs. A-1 and A-2 (see Appendix A).

Figure 2-1: Location of Type A1 fatigue cracking.

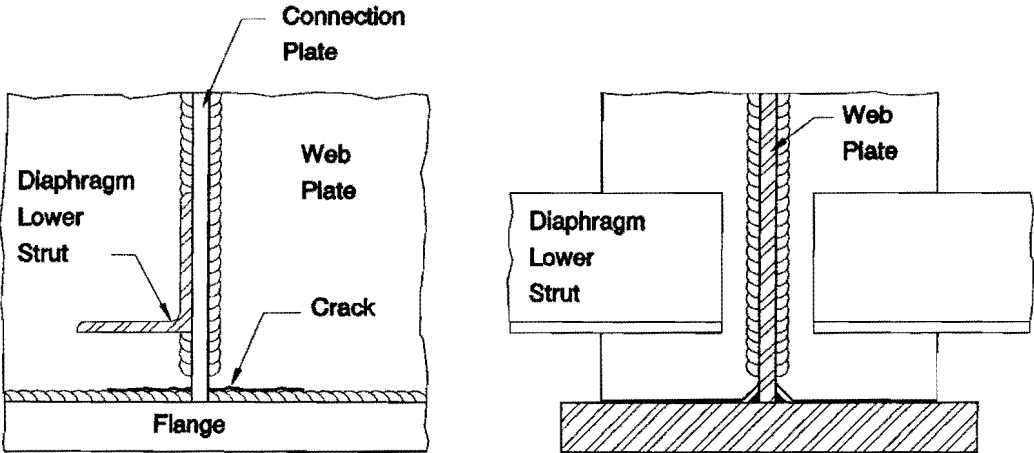
Illustrative examples of Type A1 cracking are given in Figs. 2-2 and 2-3 for the tight-fit and one-inch web gap detail respectively. Note that the cracking can occur at one or both boundaries of the web gap. A fatigue crack can develop along the web-to-flange fillet weld, running parallel with the primary bending stress. Fatigue cracks also developed vertically along the toe of the fillet weld between the connection plate and the web plate. As this crack increases in length, there is a tendency for it to turn perpendicular to the weld axis.

Figure 2-2: Type A1 fatigue cracking in tight-fit detail.

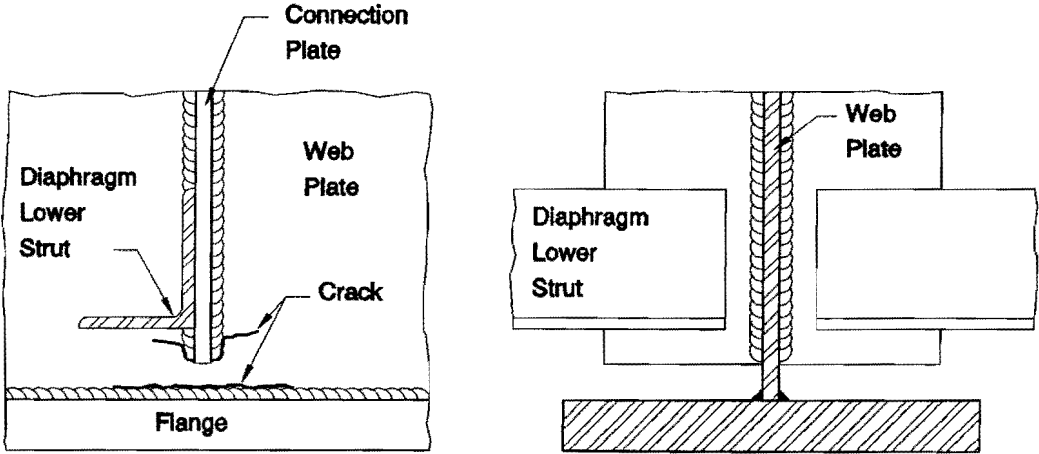
Figure 2-3: Type A1 fatigue cracking, web gap detail.

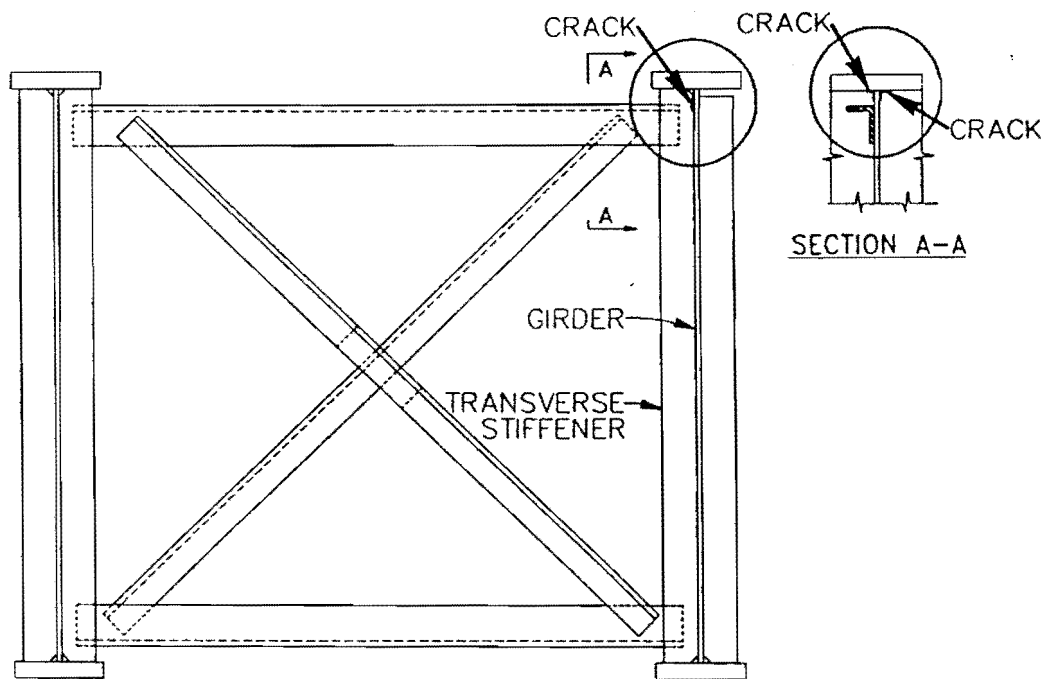
Type A2 - This type of fatigue cracking is similar to Type A1 but is found in the negative moment region where the tension flange is on the top. The cracking occurred at both the tight-fit and cut short detail and exhibited crack patterns to those shown in Figs. 2-2 and 2-3 for the positive moment region. A schematic view of the fatigue cracking is shown in Fig. 2-4. Only three Type A2 cracks were detected during the 1990 inspection (see Figs. A-3 and A-4).

**Figure 2-4:** Typical location Type A2 fatigue cracking.

Based on information obtained from the contract drawings for the 1983 widening, a retrofit procedure was developed to repair Type A2 cracking. A total of 28 web gap locations were repaired (21 Westbound and 7 Eastbound). All of this type of cracking occurred in the negative moment region, at or near a support bent (see Fig. A-15 and A-16).

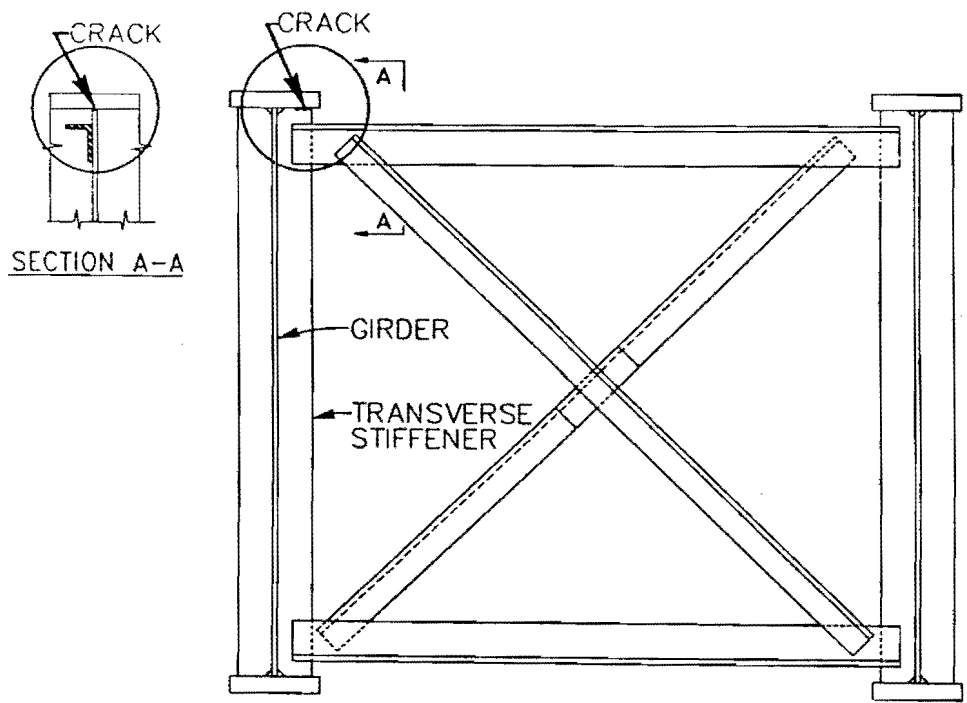
Type A3 - This type of fatigue cracking is one of the more perplexing cases of distortion-induced fatigue cracking. Even though a rigid attachment was provided between the end of the connection plate and flange, fatigue cracking still developed, as illustrated in Fig. 2-5. High stress ranges can occur at the connection plate end due to the eccentricity of the diaphragm member forces and, possibly, poor weld quality. This initiates a fatigue crack at the root of the fillet weld that will eventually propagate through the weld throat and into the connection plate or flange plate.

Figure 2-5: Typical location of Type A3 fatigue cracking.

The Type A3 cracking has occurred at all three diaphragm details (B, C, and C') but appears to be confined to the top flange in the positive moment regions of bending where the concrete deck provides a higher degree of restraint against the rotation of the flange.

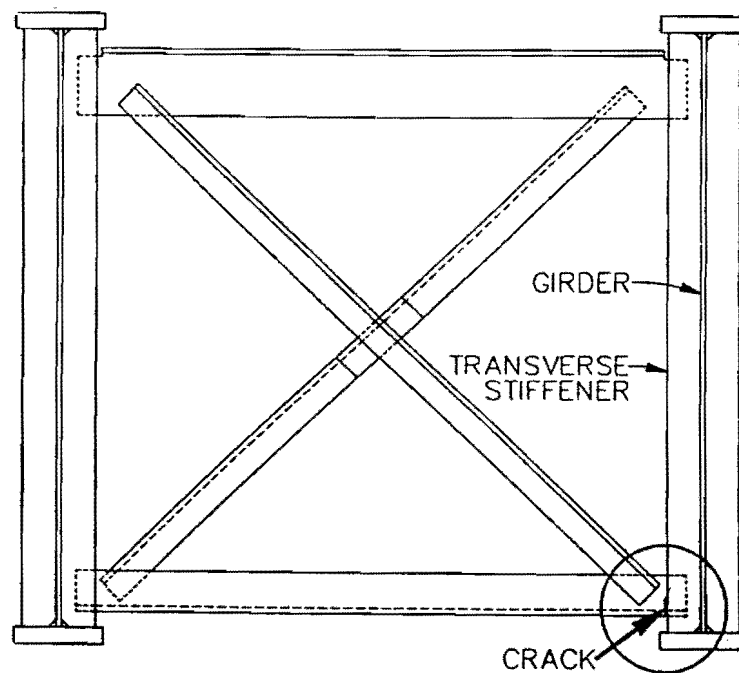
Type B1 - This type of fatigue cracking occurs in the weldment between the lower diaphragm strut and the connection plate as shown in Fig. 2-6. This type of fatigue cracking developed due to the eccentric load on the lower strut from the diagonal member. All three diaphragm types exhibited this type of fatigue cracking.

Type B2 - This type of fatigue cracking is similar to Type B1 but is used to identify fatigue cracks that have advanced to the stage where the lower strut has completely separated from the connection plate. This has occurred at approximately 20 locations in both structures.

Figure 2-6: Typical location of Type B1 fatigue cracking.

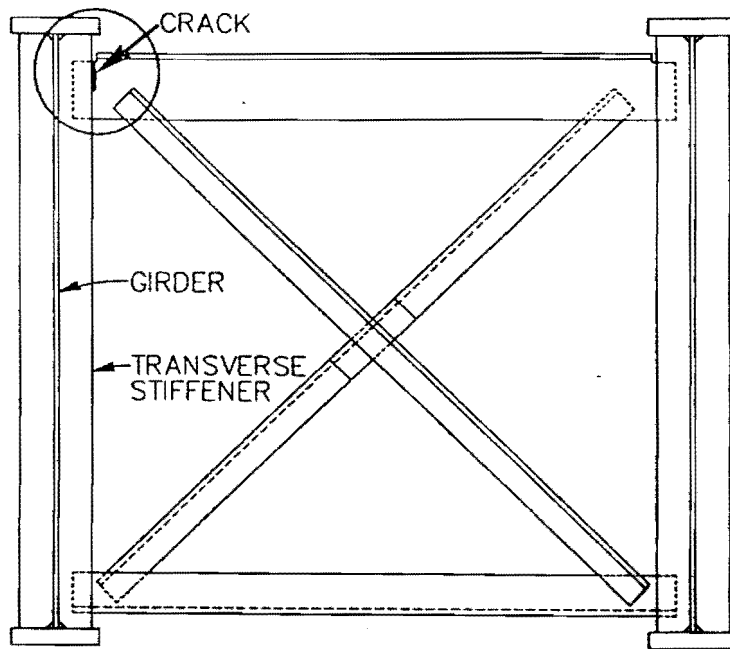
Type B3 - This type of fatigue cracking is confined to the Type C diaphragm detail where the crack developed at the cope where the flange of the WT section was blocked. This type of fatigue crack developed at approximately 13 different locations (Fig. 2-7).

Figure 2-7: Typical location of Type B3 fatigue cracking.

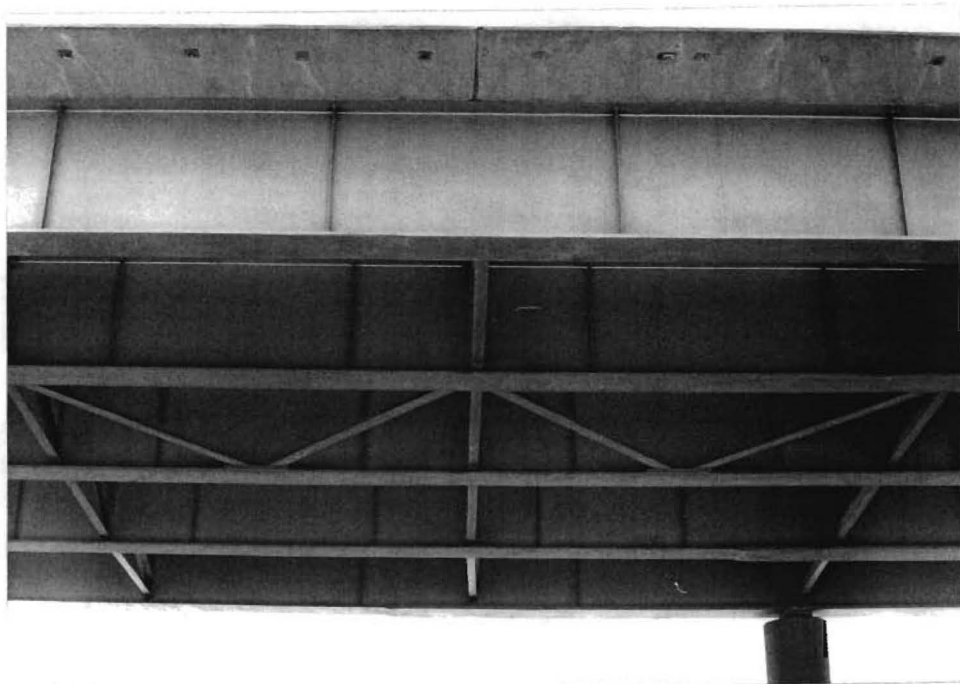
- 1) The girder No. 5 line on the westbound structures was improperly aligned during construction. It appears that the entire girder line (773 ft.) is shifted to the west approximately 2 in. This has resulted in an offset or skew of the diaphragms between Girder No. 4 and No. 5, as shown in Fig. 2-8. This may add to the bending stresses in the diaphragm members.
- 2) The diaphragm connection plates on the first girder shop segment of girder line No. 5 of the westbound structure (from Bent 1 to Dia. No. 12) were improperly laid out during fabrication, as shown in Fig 2-9. The connection plates were offset

Figure 2-8: View of Girder No. 5 offset, Westbound Structures.

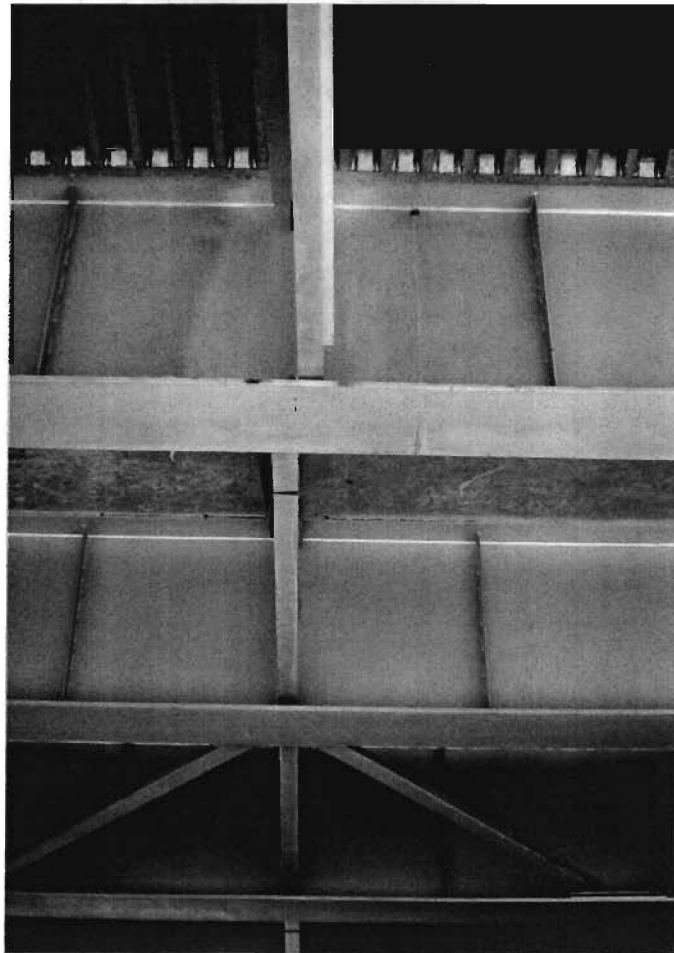
approximately 4 in. to the west of the correct position. This would have resulted in a large skew if the diaphragm relative to the web plate of the connection plate was connected as fabricated. This condition was apparently corrected in the field by welding additional connection plates on the outside face of Girder No. 4. As a consequence, the diaphragm connection plates on Girder No. 4 are offset to the existing diaphragm connection plates. The offset between these connection plates has exasperated the distortion at the web gap as indicated by the severity of the cracking reported in the inspection report. This condition resulted in a more flexible web gap since the diaphragm forces are not directly distributed out to adjacent girder bays and diaphragms.

**Figure 2-9:** View of Girder No. 5 connection plate offset, Westbound Structures.

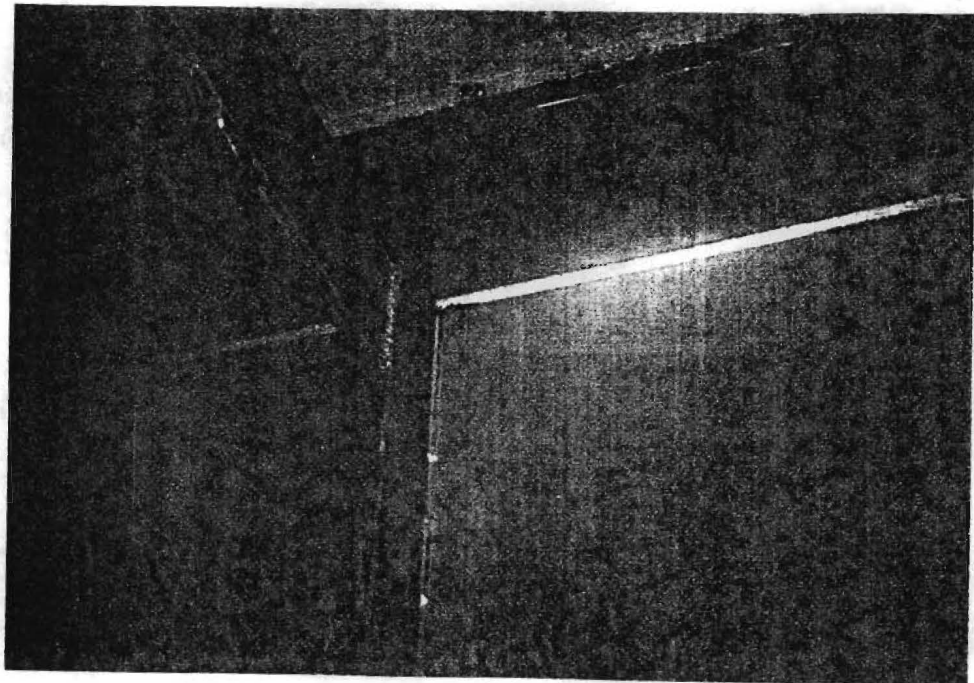
CRACK OVER STIFFENER

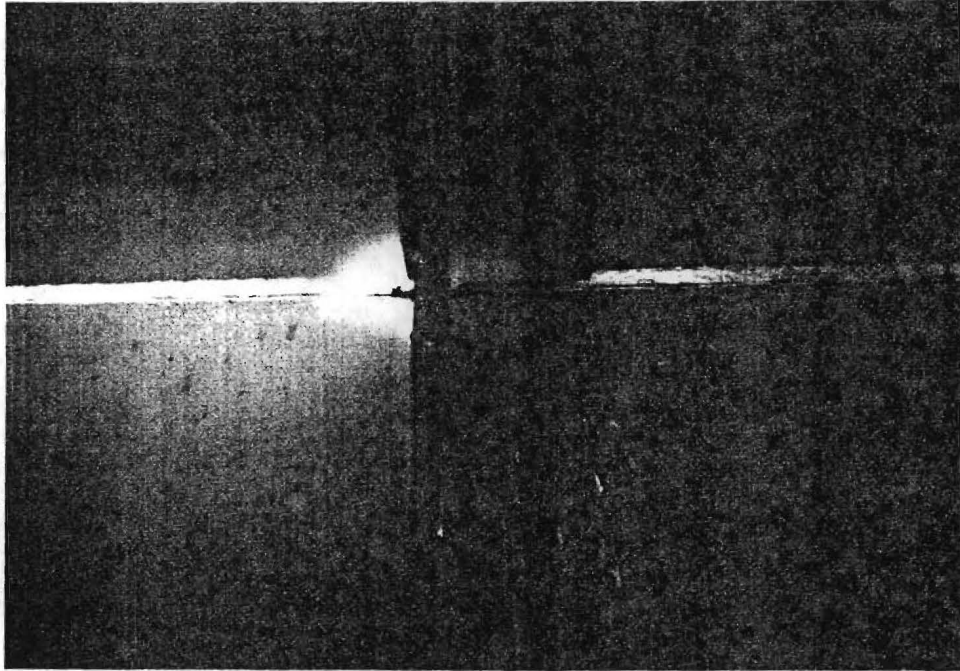
CRACK FURTHER DEFINED WITH DYE PENETRANT

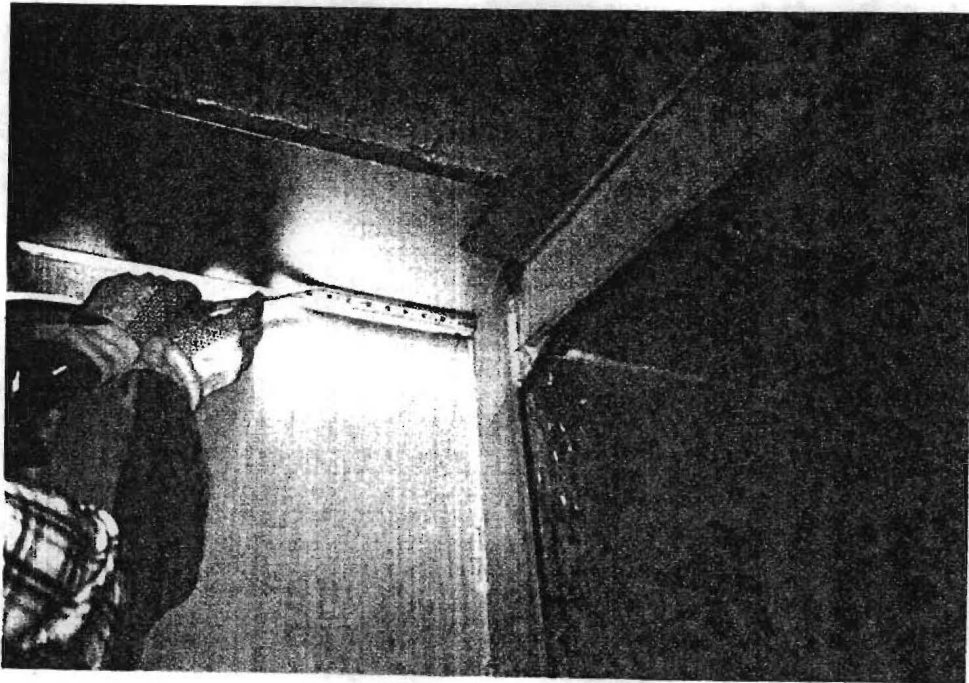
TYPICAL CRACK LENGTH 2-4" ON EITHER  
SIDE OF STIFFENER

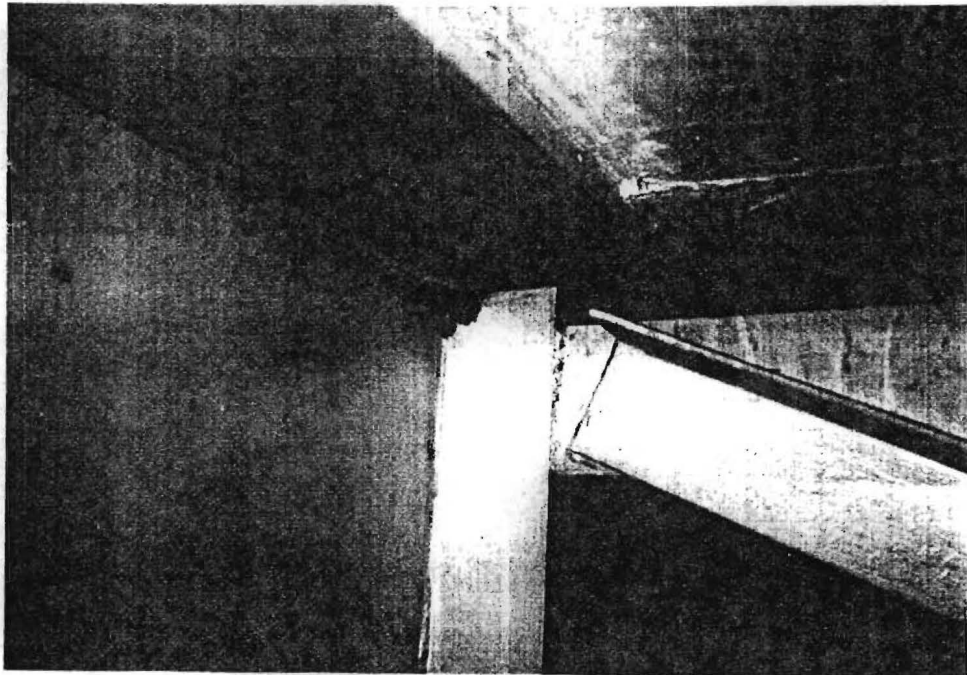
BACK GOUGED CRACK READY FOR REPAIR

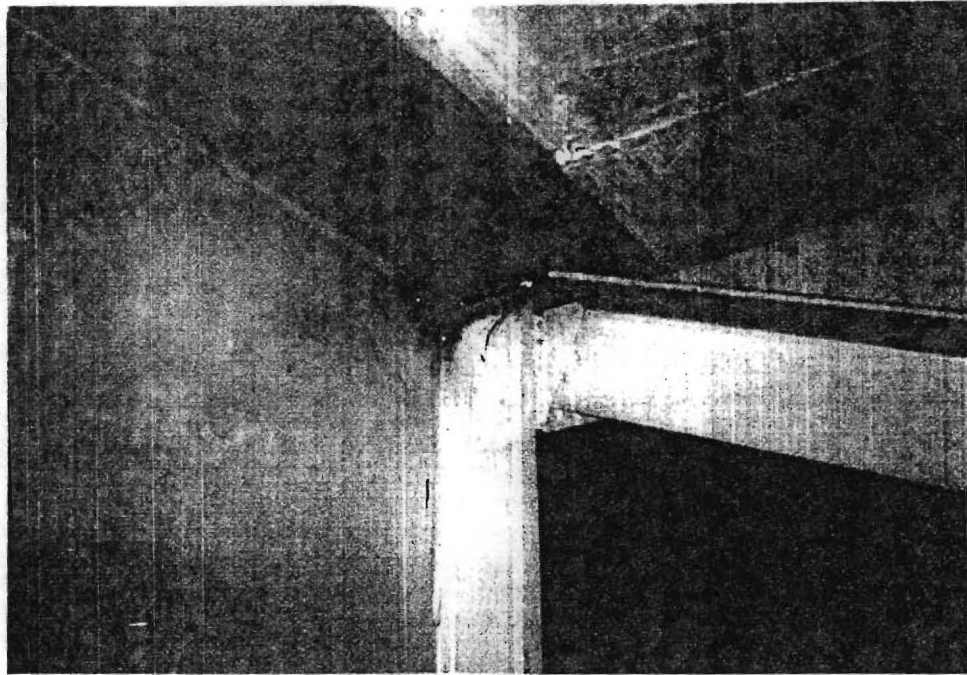
COMPLETED REPAIR AND RETROFIT AT DIAFRAM

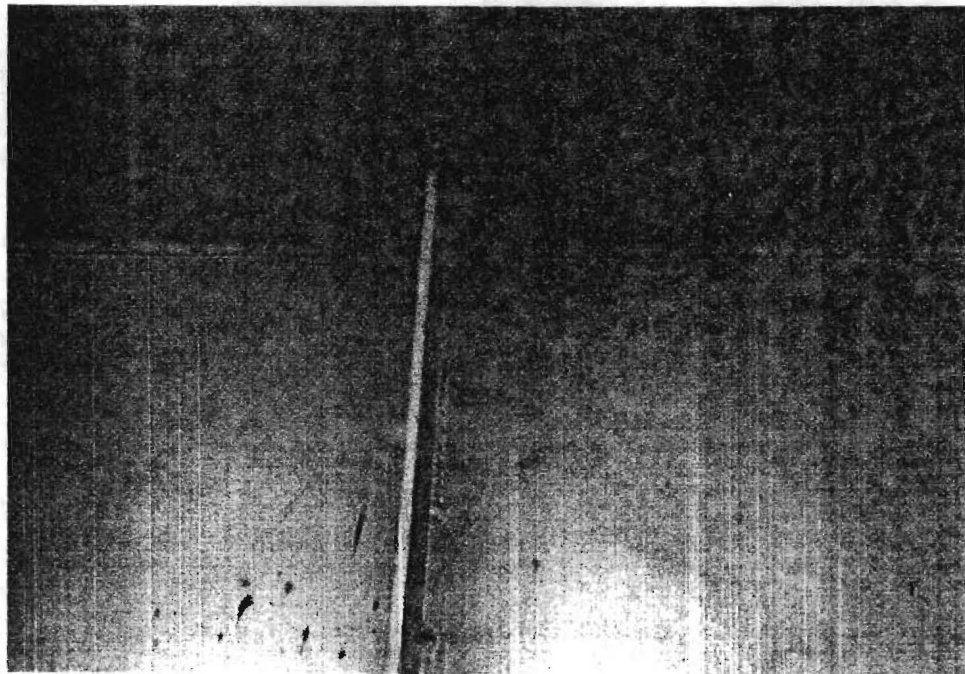
COMPLETED REPAIR AND RETROFIT ON  
BACKSIDE OF DIAFRAM CONNECTION
