1. Report No. FHWA/TX-97/1360-1		2. Government Accession No.		3. Recipient's Catalog No.	
4. Title and Subtitle EVALUATION OF REPAIR PROCEDURES FOR WEB GAP FATIGUE DAMAGE				5. Report Date September 1996

EVALUATION OF REPAIR PROCEDURES FOR WEB GAP FATIGUE DAMAGE

Research Report 1360-1
Research Study Number 0-1360
Research Study Title: Repair Procedures for Fatigue Damage in
Steel Highway Bridges

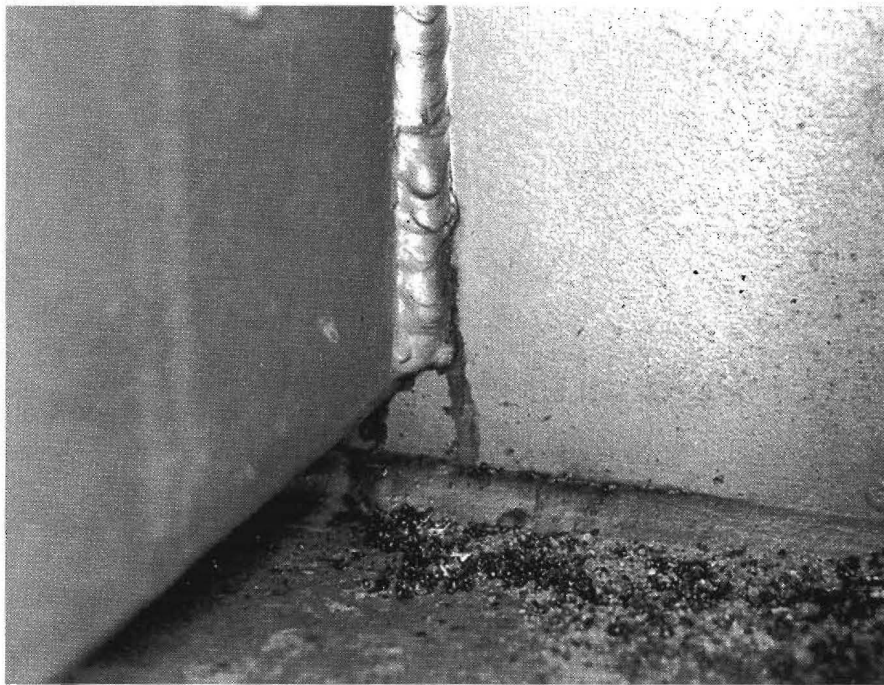
Due to the lack of rigid connection plate attachments, fatigue cracks developed in the unstiffened web gaps at the ends of diaphragm connection plates, shown in Fig. 1-2. Fatigue cracks developed along the upper toe of the web-to-flange fillet weld, as well as from the end termination of the connection plate fillet weld. The vertical weld toe crack is particularly critical since it is driven not only by the out-of-plane distortion stresses but also by the in-plane bending stress.

Figure 1-2: Fatigue crack at end of unstiffened web gap of diaphragm connection plate.

A partial solution to the fatigue cracking was to remove the source of the distortion by either permanently removing diaphragms or using a connection plate welded to the flanges.

While these methods prevented further fatigue crack growth, it was still necessary to remove or arrest the existing fatigue cracks since they could propagate when subjected to the primary stresses. The present study focuses on the evaluation of the methods used to remove or arrest the existing fatigue crack. In addition, the retrofit of field welding the connection plate to the tension flange was also investigated.

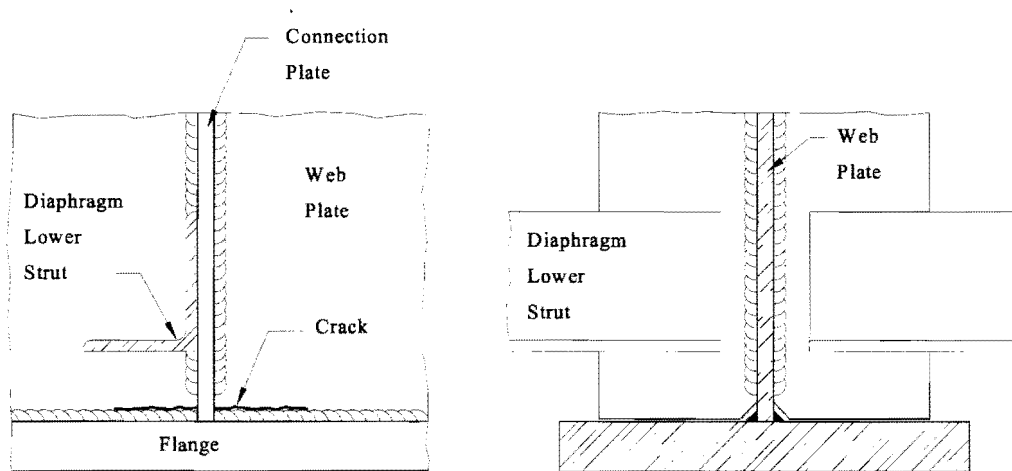
Illustrative examples of the cracking are given in Figs. 1-4 and 1-5 for the tight-fit and 25 mm (one-inch) web-gap detail respectively. Note that the cracking can occur at one or both boundaries of the web gap. A fatigue crack can develop along the web-to-flange fillet weld, running parallel with the primary bending stress. Fatigue cracks also develop vertically along the toe of the fillet weld, between the connection plate and the web plate. As this crack increases in length, there is a tendency for it to turn perpendicular to the weld axis.

Figure 1-4: Fatigue cracking in tight-fit detail.

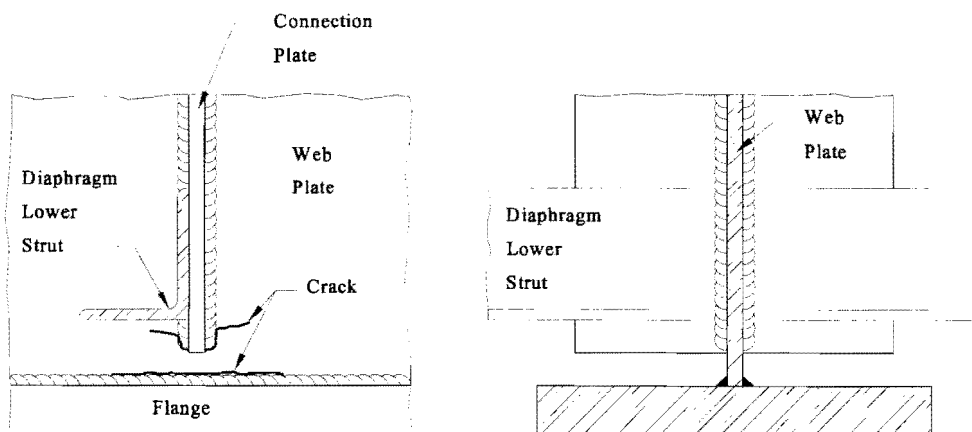
Figure 1-5: Fatigue cracking in web-gap detail.

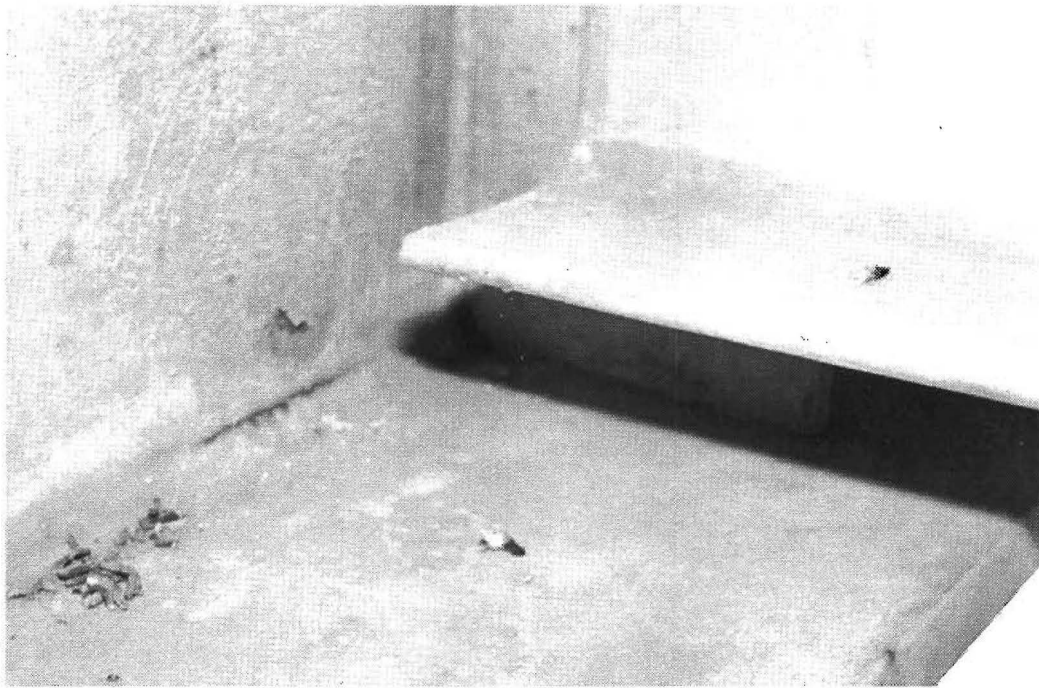
At every location where fatigue cracks developed at and around the end of the diaphragm connection plate, a crack also developed along the toe of the web-to-flange fillet weld (see Fig. 2-1). Regardless of which of the three repair procedures were used to arrest the web plate crack, this crack was repaired in the same manner (i.e., no gouging and re-welding).

Figure 2-1: Crack in web-to-flange fillet weld.

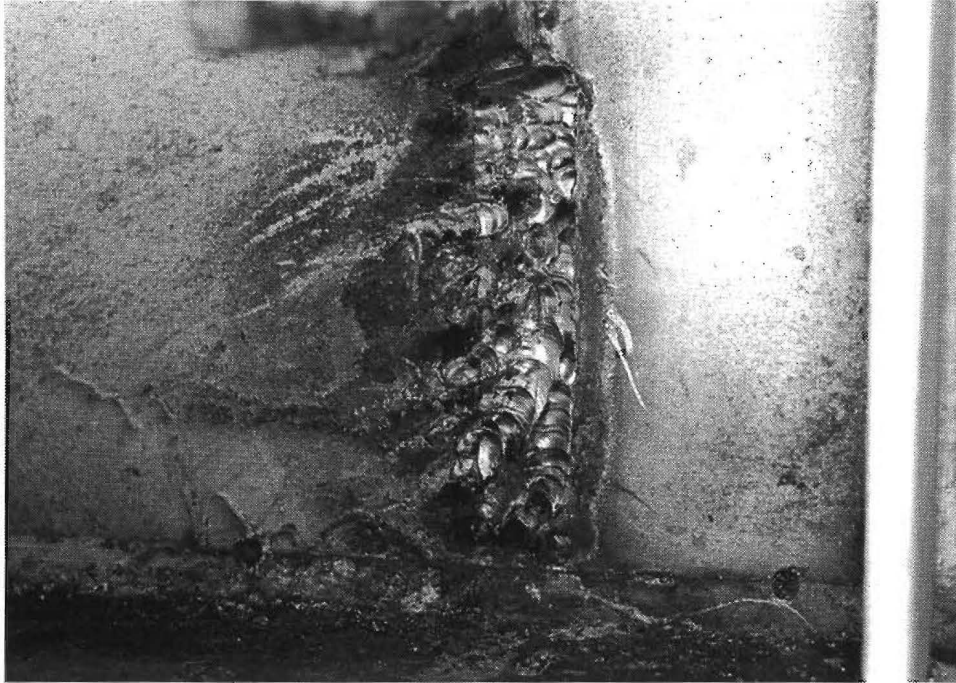
Figure 2-2: Web plate after removal of connection plate end by air-arc gouging.

Prior to hole drilling, the end of the connection plate was removed to provide better access to the region. Approximately 150 mm (6 in.) of the connection plate was removed by air-arc gouging. Care was taken to avoid gouging the web plate as the melted metal was washed from the cut. These gouges, if not repaired, could become initiation sites for additional fatigue cracking. The welders performing this portion of the repair were instructed to cut no closer than 3 mm (1/8 in.) from the web-plate to prevent web plate gouging. Figure 2-2 shows a connection plate with the end removed by air-arc gouging. Note that a portion of the connection plate fillet weld (and connection plate edge) still remains on the web plate.

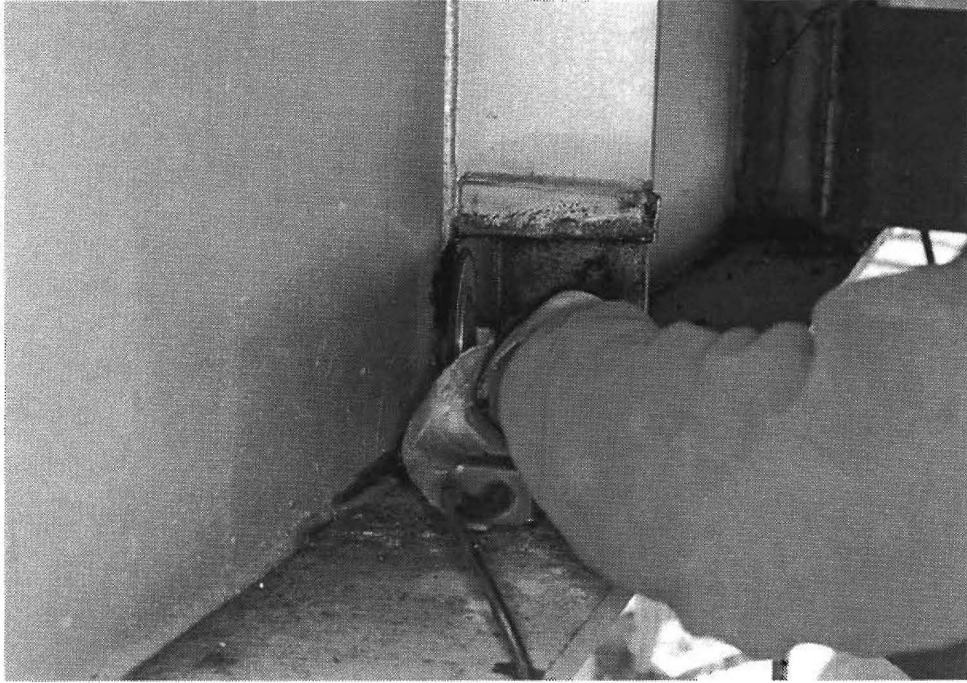
Figure 2-3: Grinding to remove remaining web material and connection plate.

The remaining 3 mm (1/8 in.) of connection plate and weld was then removed by grinding. Typically, a rotary grinder was used for this operation, as shown in Fig. 2-3. This operation also prepared the web plate for the next step in the repair procedure by providing a smooth surface.

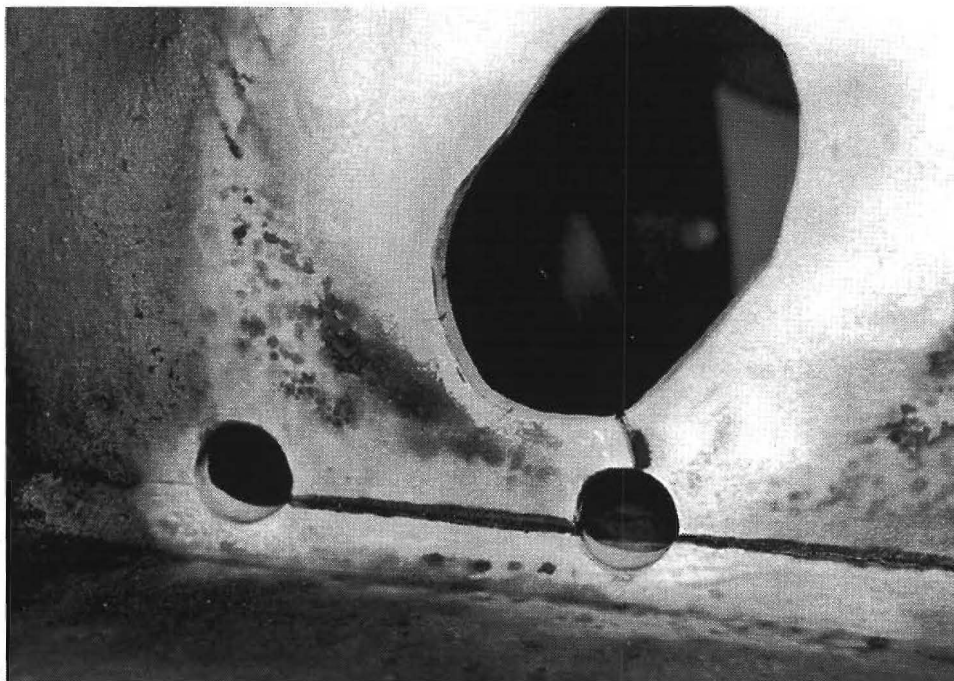
Figure 2-13: Dye penetrant test showing remaining cracks.

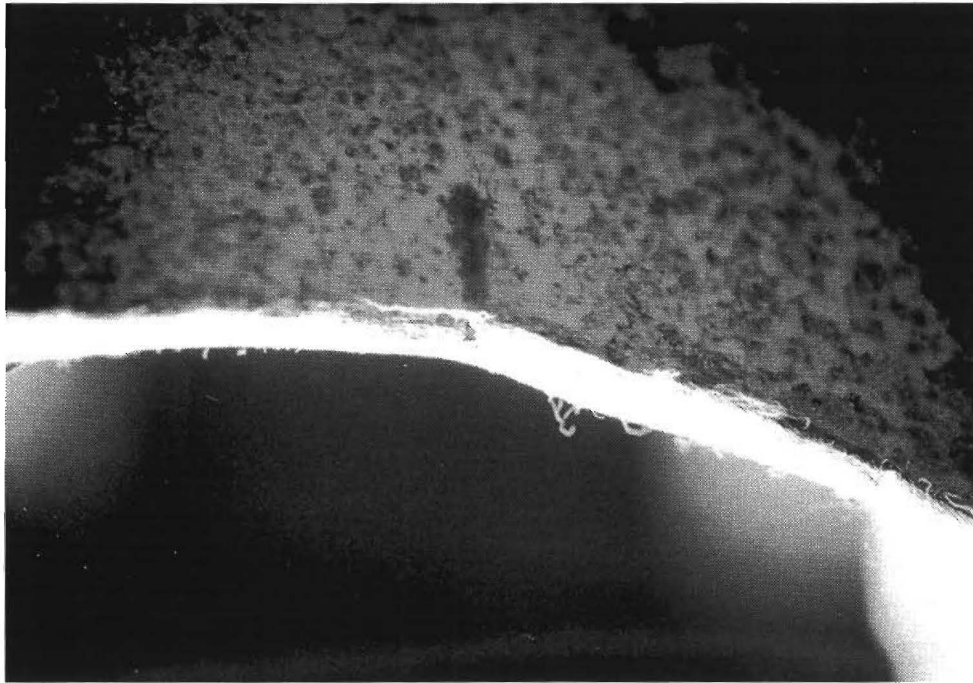
Fatigue testing of Girder 1 was resumed after this repair was made and ended at approximately 2.8 million cycles when a 305 mm (12-in.) crack developed in the web plate near the bottom longitudinal fillet weld at one end of the girder. The crack was due to bending stresses caused by buckling ("oil-canning") of the web plate and was not due to any problems associated with the weld repairs.

Figure 3-40: Crack propagating from surface flaw near Stiffener 1-1.

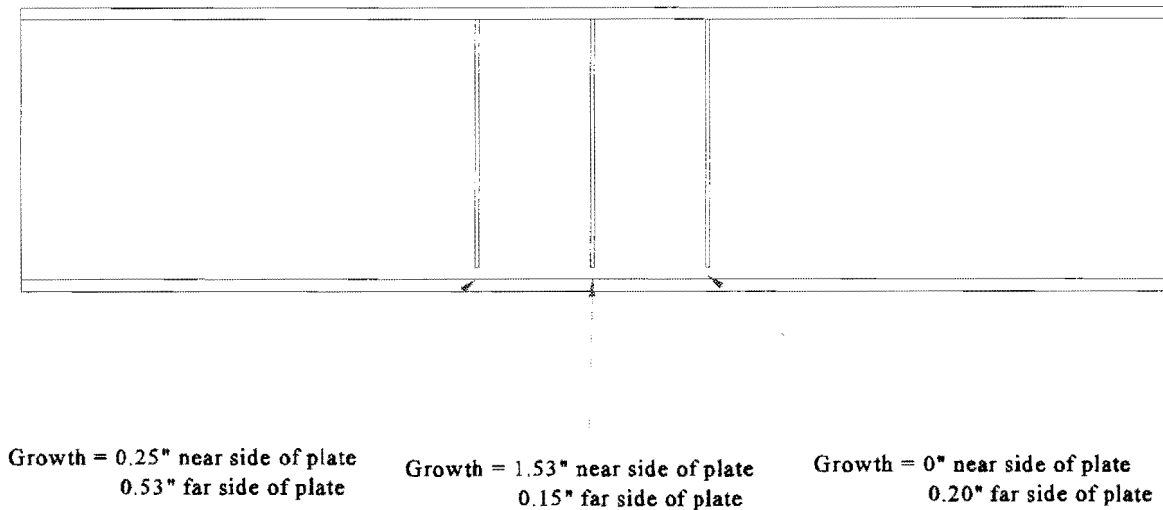
Upon completion of the fatigue testing of Girder 2 (3.3 million cycles) the crack lengths of the unretrofitted web-to-flange cracks were re-measured. As shown in Fig. 3-42, crack growth was observed at all three locations. These longitudinal cracks were located in the constant moment region of bending, so no crack extension was expected. An explanation for the crack growth is out-of-plane bending of the web plate caused by an oil can effect. A slight eccentricity in the application of the actuator loading can cause the oil canning. In addition, extensive gouging and re-welding occurred above the unrepaired cracks. The resulting heat input and shrinking would result in significant residual stresses perpendicular to the plane of the crack.

Figure 3-42: Growth of web-to-flange cracking Test Girder 2.
