1. Report No. FHWA/TX-95/1442-1F		2. Government Accession No.		3. Recipient's Catalog No.	
4. Title and Subtitle  SHORT-RADIUS THRIE BEAM TREATMENT FOR INTERSECTING STREETS AND DRIVES				5. Report Date November 1994

6. Performing Organization Code	
7. Author(s) Roger P. Bligh, Hayes E. Ross, Jr., and Dean C. Alberson				8. Performing Organization Report No. Research Report 1442-1F

**SHORT-RADIUS THRIE BEAM TREATMENT FOR  
INTERSECTING STREETS AND DRIVES**

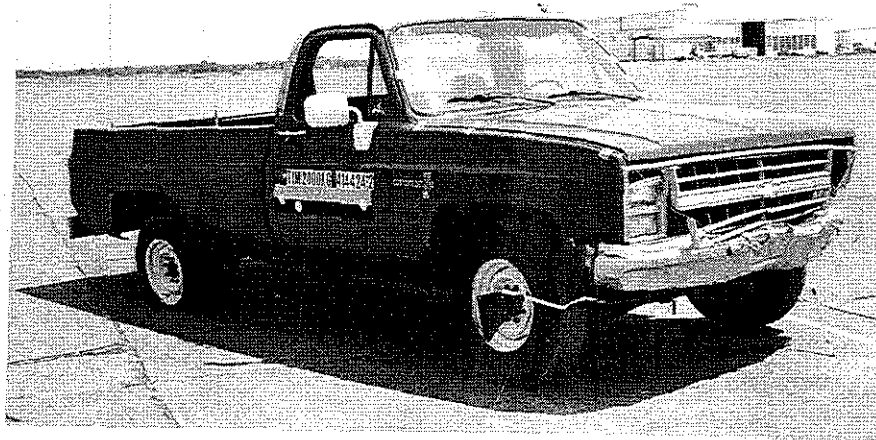
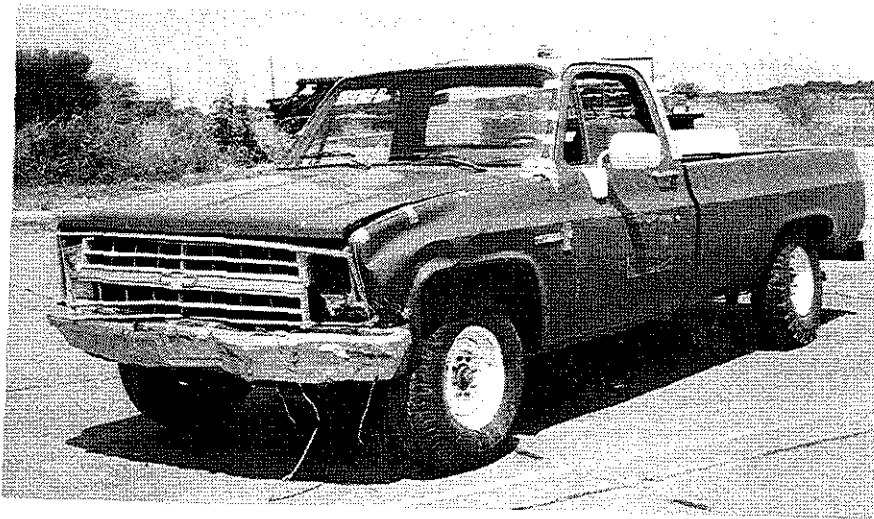
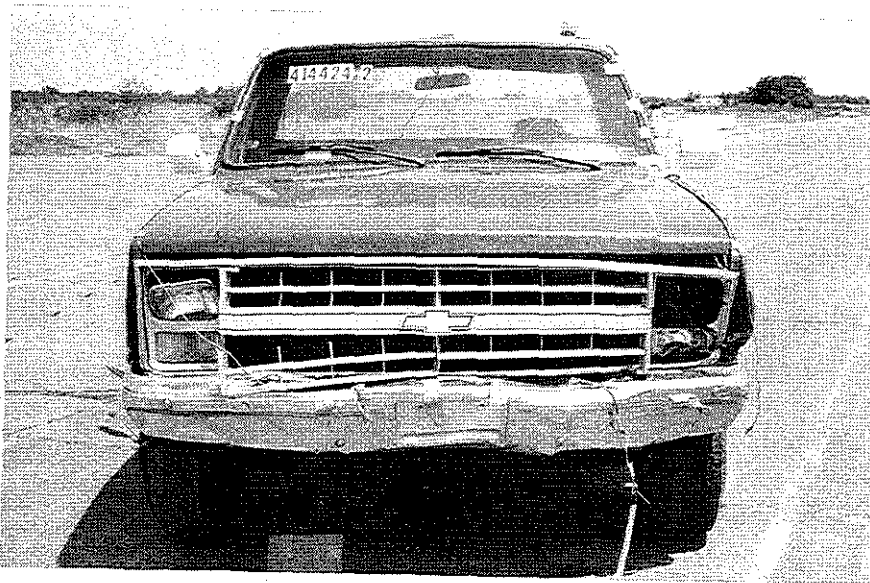
Figure 21. Vehicle after test 414424-2.

Damage to the test installation is shown in Figure 20. Posts 7, 8, 9, 10 in the curved section of rail all broke at ground level. Maximum dynamic deflection was 3.05 m (10.0 ft), and the maximum residual deformation was 2.84 m (9.3 ft) at post 8. As shown in Figure 21, damage sustained by the vehicle was relatively minor. The maximum crush was recorded to be 280 mm (11.0 in.) at the left front corner at bumper height.

This test was judged to be a failure since it failed to contain the test vehicle. Analysis of the high-speed film appeared to indicate that the posts in the impact region were at least partially responsible for the observed twisting and dropping behavior of the rail. It was theorized that the posts were rotating in the soil and initiating the rotation of the three beam before they had sufficient time to release from the rail and/or fracture at the ground line. The short-radius treatment was subsequently modified in an attempt to minimize this behavior. The modification consisted of removing the post bolts from posts 7, 8, and 9 in the curved section of rail. A 3/8-in diameter lag screw was used to provide vertical support to the rail at these locations. The modified system was then retested as described below.

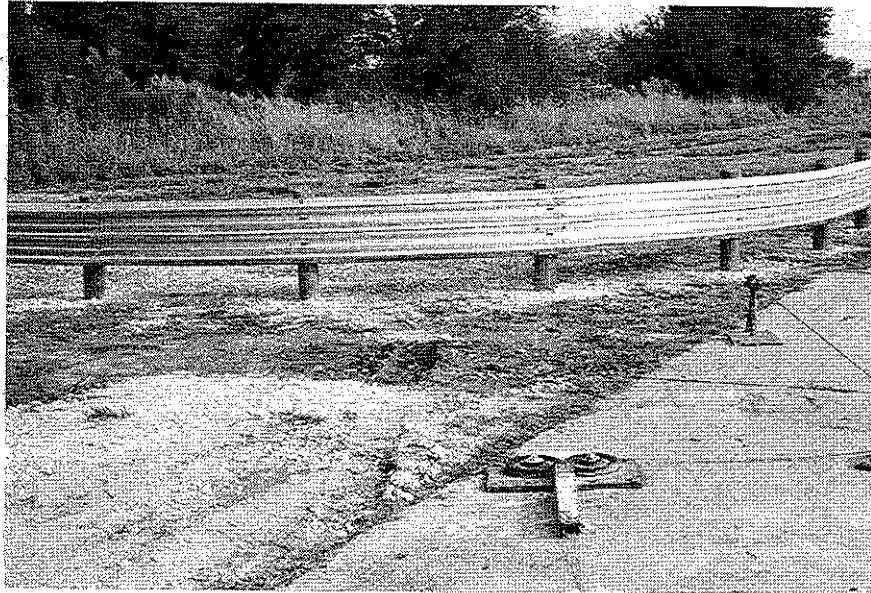
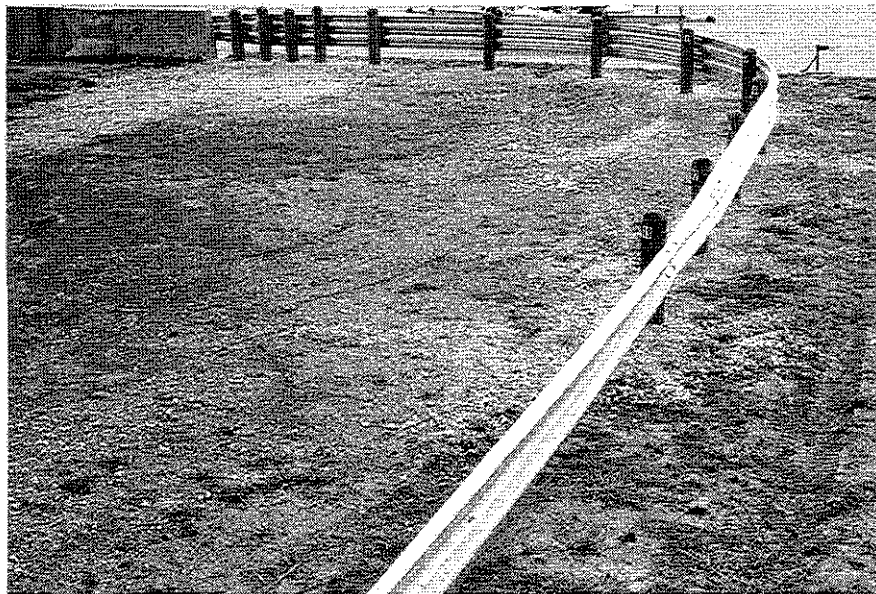
Figure 22. Installation before test 414424-3.

test was then repeated using the same impact conditions as Test 1442-2. Photographs of the modified system are shown in Figure 22.

In an effort to decrease the rotation of the three-beam rail observed in the previous test, the post bolts were removed from several posts in the curved section of rail. The pickup-truck

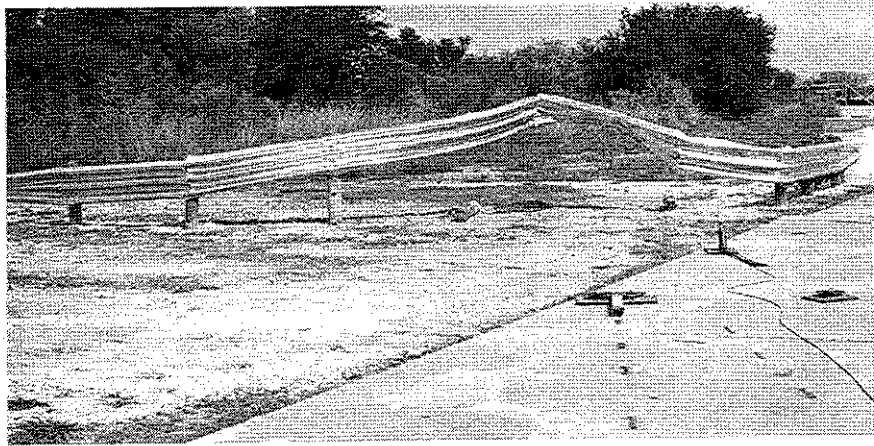
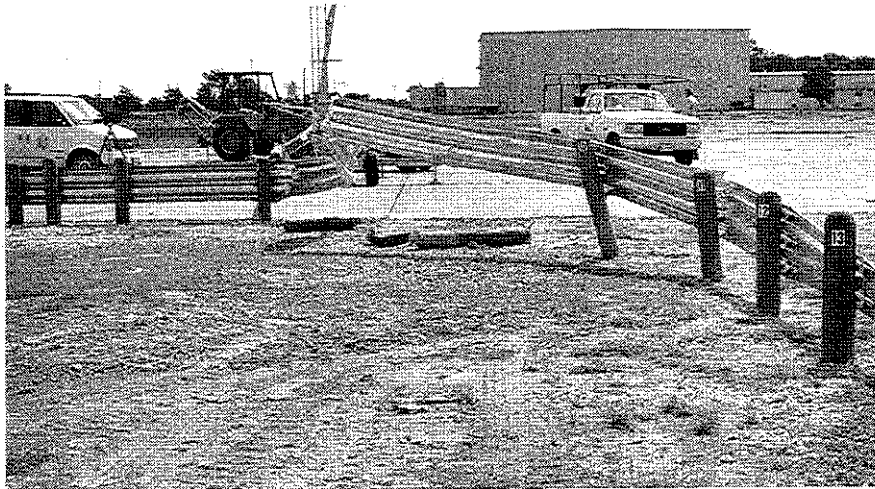
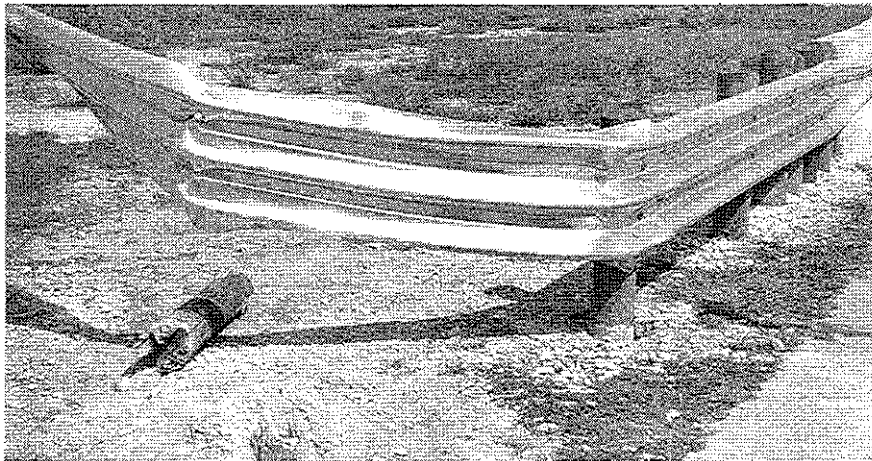
Figure 34. Installation after test 414424-4.

Damage received by the guardrail is shown in Figure 34. Posts 7, 8, and 9 fractured at or below the ground line as designed. Posts 6, 10, 11, 12, and 13 were disturbed. Maximum dynamic rail deflection was 3.22 m (10.6 ft), and the maximum residual deformation was 2.90 m (9.5 ft) at post 8.

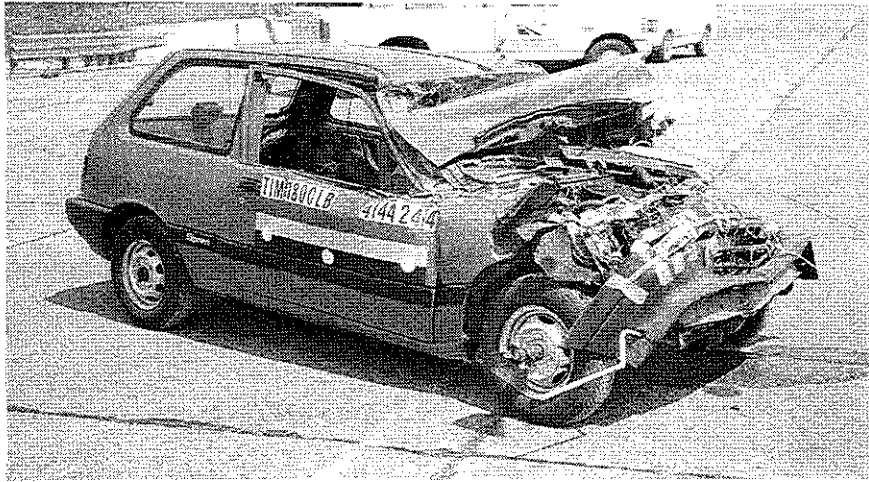
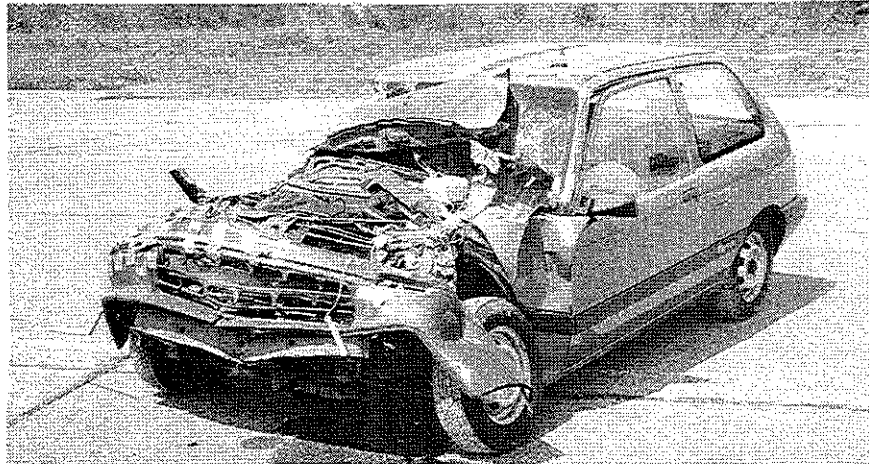
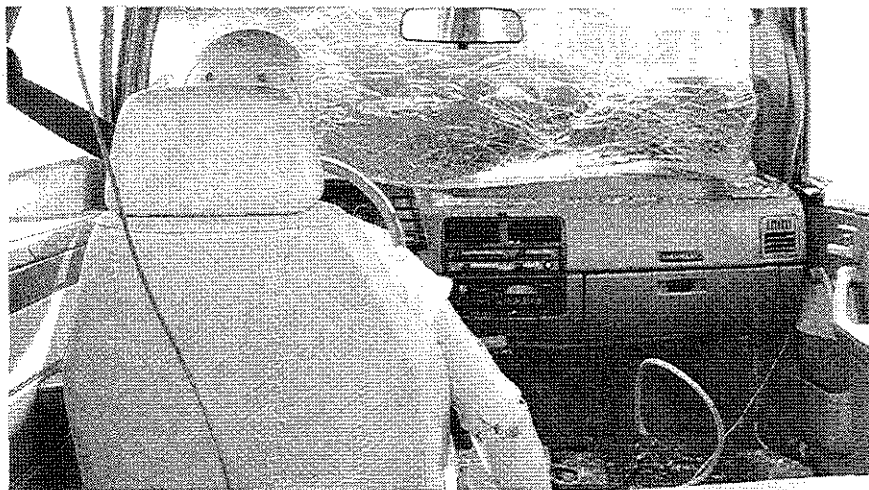
Figure 35. Vehicle after test 414424-4.

Damage sustained by the vehicle is shown in Figure 35. Although the windshield and passenger side window were shattered, there was no intrusion of vehicular or barrier components into the passenger compartment. The maximum crush was measured to be 570 mm (22.4 in.) at the left front corner of the vehicle at bumper height.
