STUDY OF IN-SERVICE BRIDGES CONSTRUCTED  
WITH PRESTRESSED PANEL SUB-DECKS

Research Report 145-1

A Study of Prestressed Panels and Composite Action in  
Concrete Bridges Made of Prestressed Beams, Prestressed  
Sub-deck Panels, and Cast-in-place Deck

Research Project No. 2-5-70-145

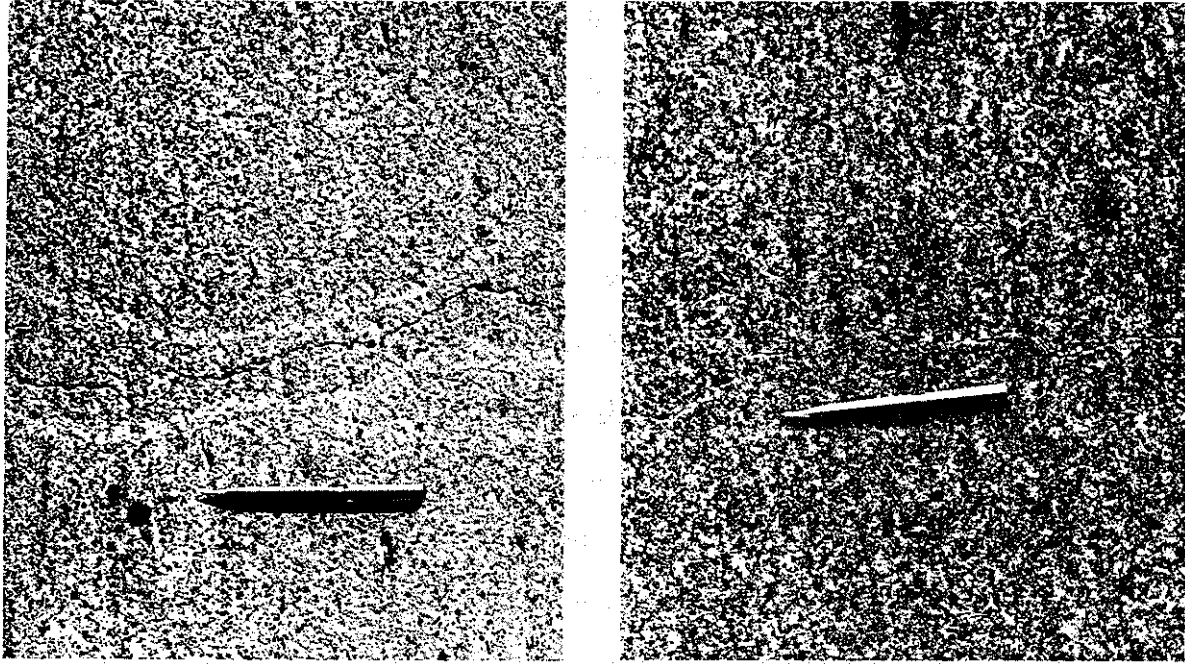
1. Mapping of Crack Patterns: Some transverse cracking was visible on the cast-in-place decks of both the north-bound and south-bound overpasses. The position of those cracks which could be detected were determined by measuring their distance from one end of a span and by measuring their length. Each span of the two bridges has been assigned the identifying number shown in Fig. 2, and the crack patterns that were obtained are presented by span in Appendix A. Figure 8 shows cracks typical of those found in the decks of both structures.

Figure 8. Typical Transverse Cracks in Cast-in-place Deck.

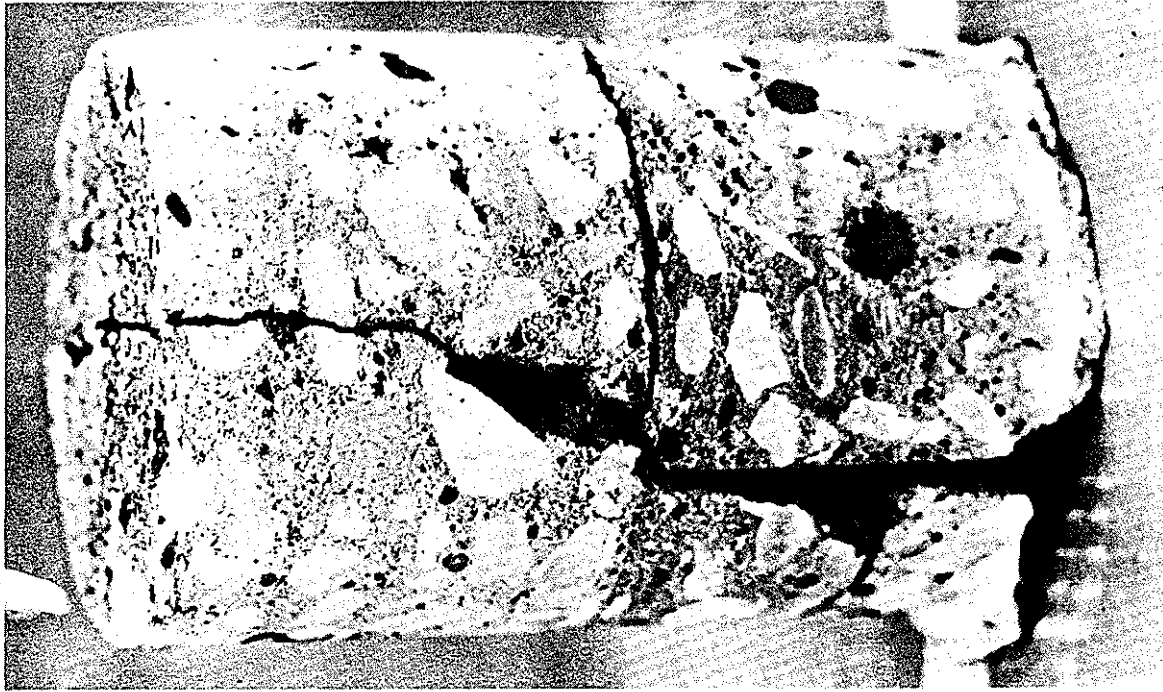
Figure 10. Core Sample No. 2.

The second and third cores were taken over a joint between two prestressed panels, at a point where a crack occurred in the cast-in-place slab. The second core, like the first, fell through the deck. It broke into several pieces, which were reassembled for the photograph shown in Fig. 10. The sample split vertically through the crack in the cast-in-place slab and horizontally along part of the interface of the slab and prestressed panel. The bond between these two elements to the left of the vertical split remained secure.

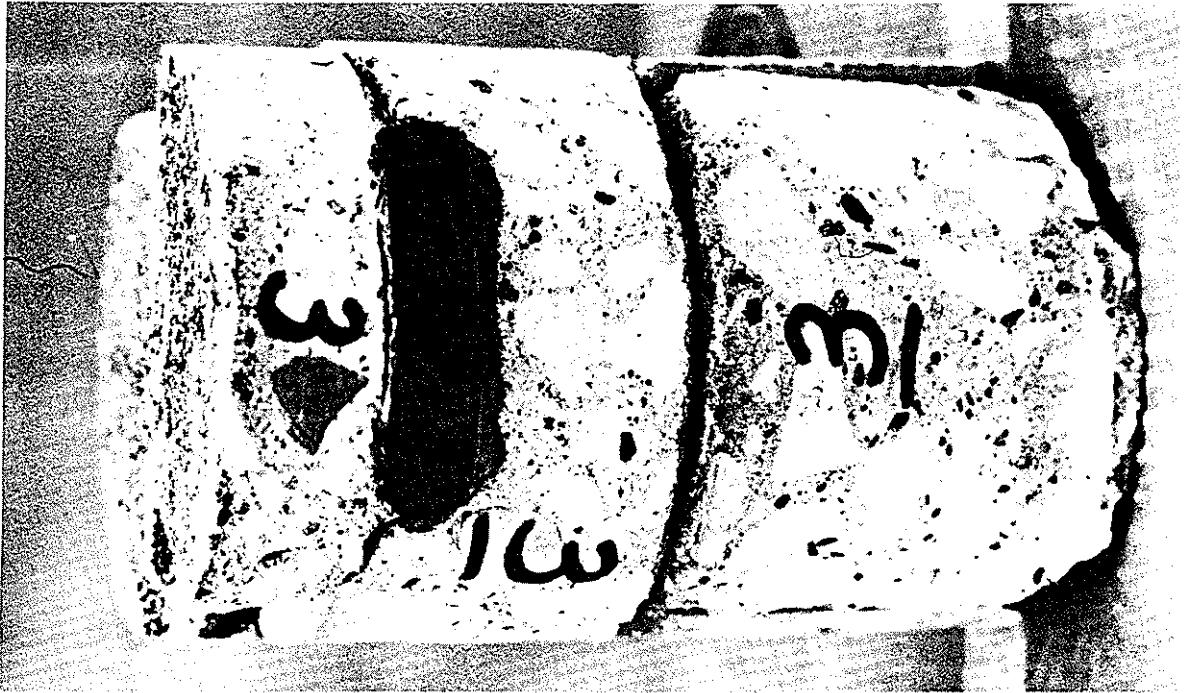
Figure 11. Core Sample No. 3.

The third sample, shown in Fig. 11, lodged in the coring bit and was broken at the interface of the precast and cast-in-place concrete when attempts were made to pry it from the coring tool. The concrete over the face of separation was clean, which indicated a new break, not an old one.

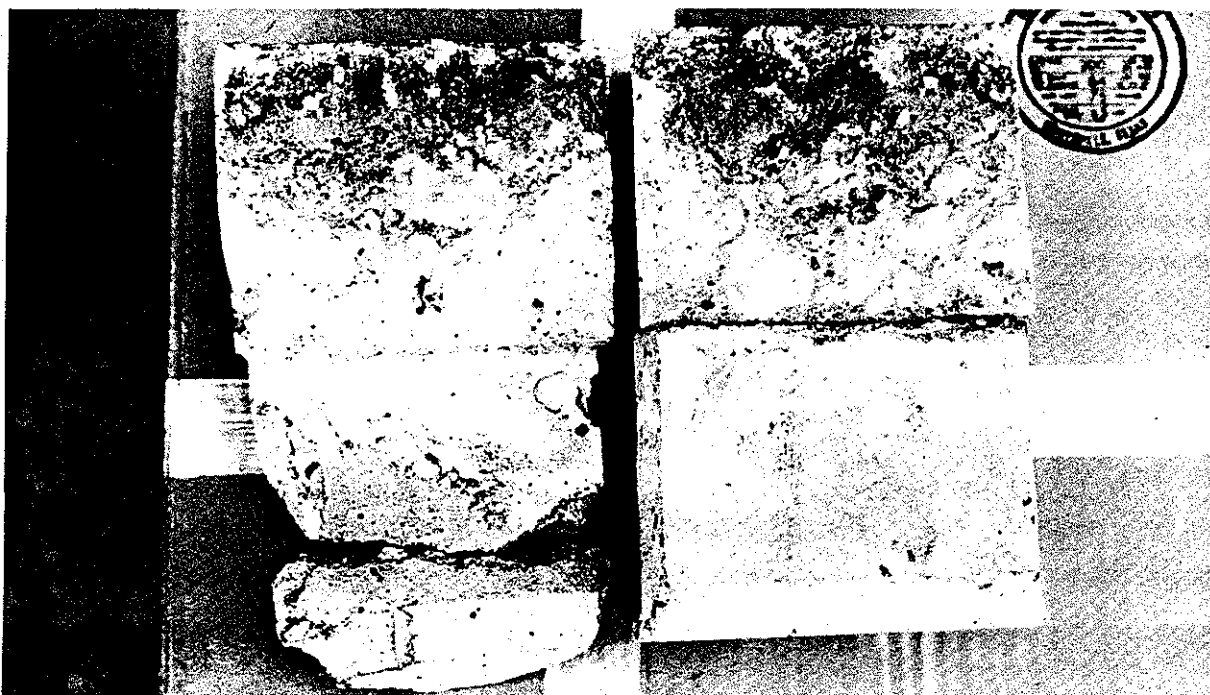
The position of the second and third cores over a crack in the cast-in-place slab permitted an estimate of the depth of such cracks by observing the extent of the discoloration of the concrete. Figure 13 shows core sample No. 2, layed open along the vertical crack shown in Fig. 10. The top surface of the deck, visible in Fig. 10, is at the top of Fig. 13. It appears that the crack in the cast-in-place slab extended approximately half way through the slab, based on the depth of darkened concrete visible.

Figure 13. Discoloration of Concrete at Crack in Cast-in-place Deck.

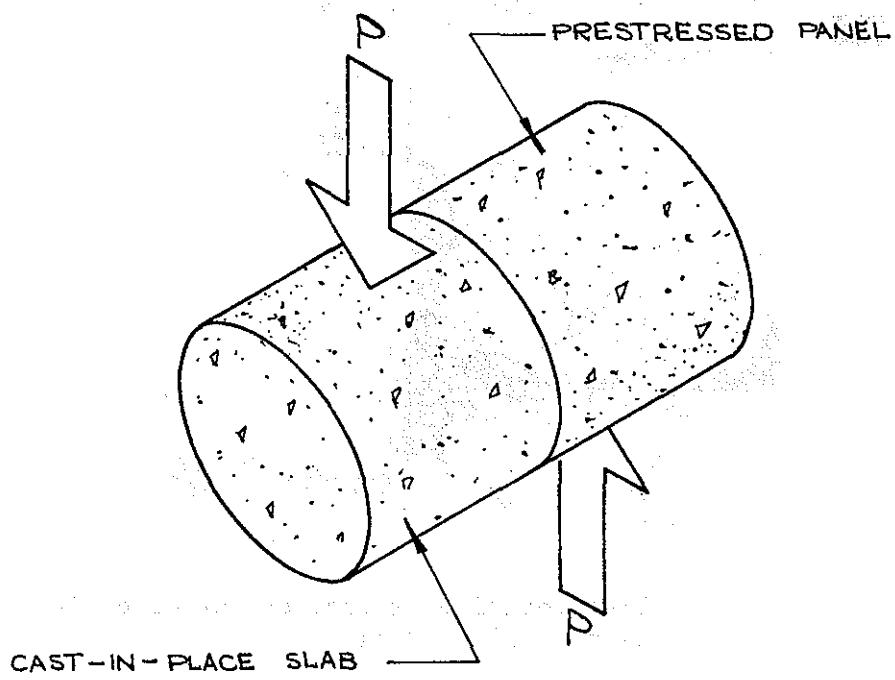
Figure 14. Shear Test of Core Sample.

In each core, the finishing marks in the concrete at the interface between slab and panel were well defined. If slippage along this interface had occurred, these projections would probably have been ground smooth. Some discoloration was noted on the interface of core No. 3, possibly from oil or curing compound present on the top face of prestressed panel prior to pouring of the cast-in-place slab. This may have contributed to the partial separation of the core along this interface. The one core sample which was removed intact and subjected to a direct shear test exhibited substantial bond strength.

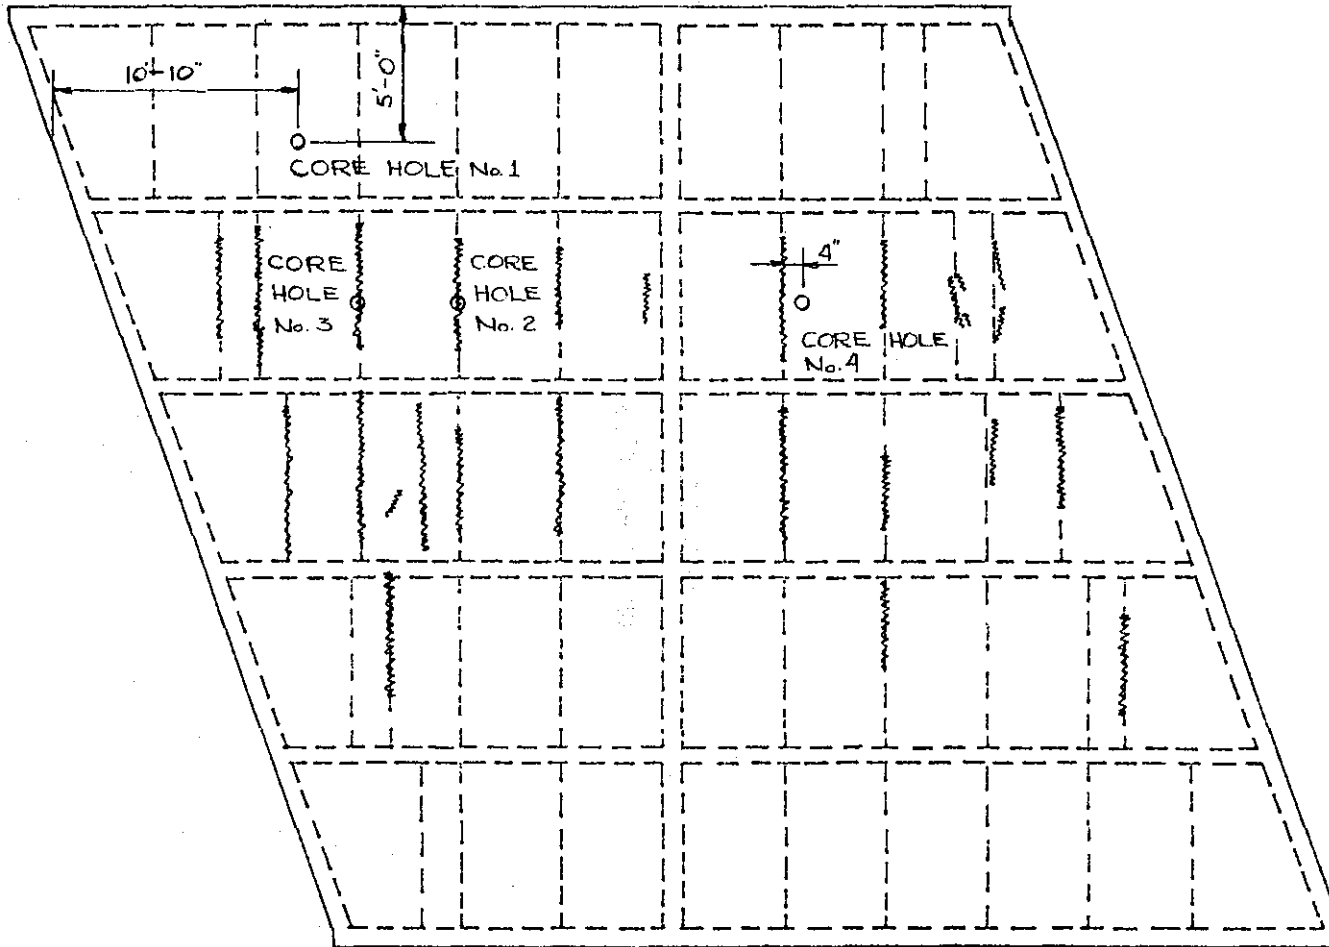
3. Core Samples: The north end span of the north-bound overpass was chosen for coring, and four, 4 in. diameter cores were taken at the locations indicated in Fig. A.1.

Figure A.1. Cracks in Cast-in-place Deck, Span 1NB.

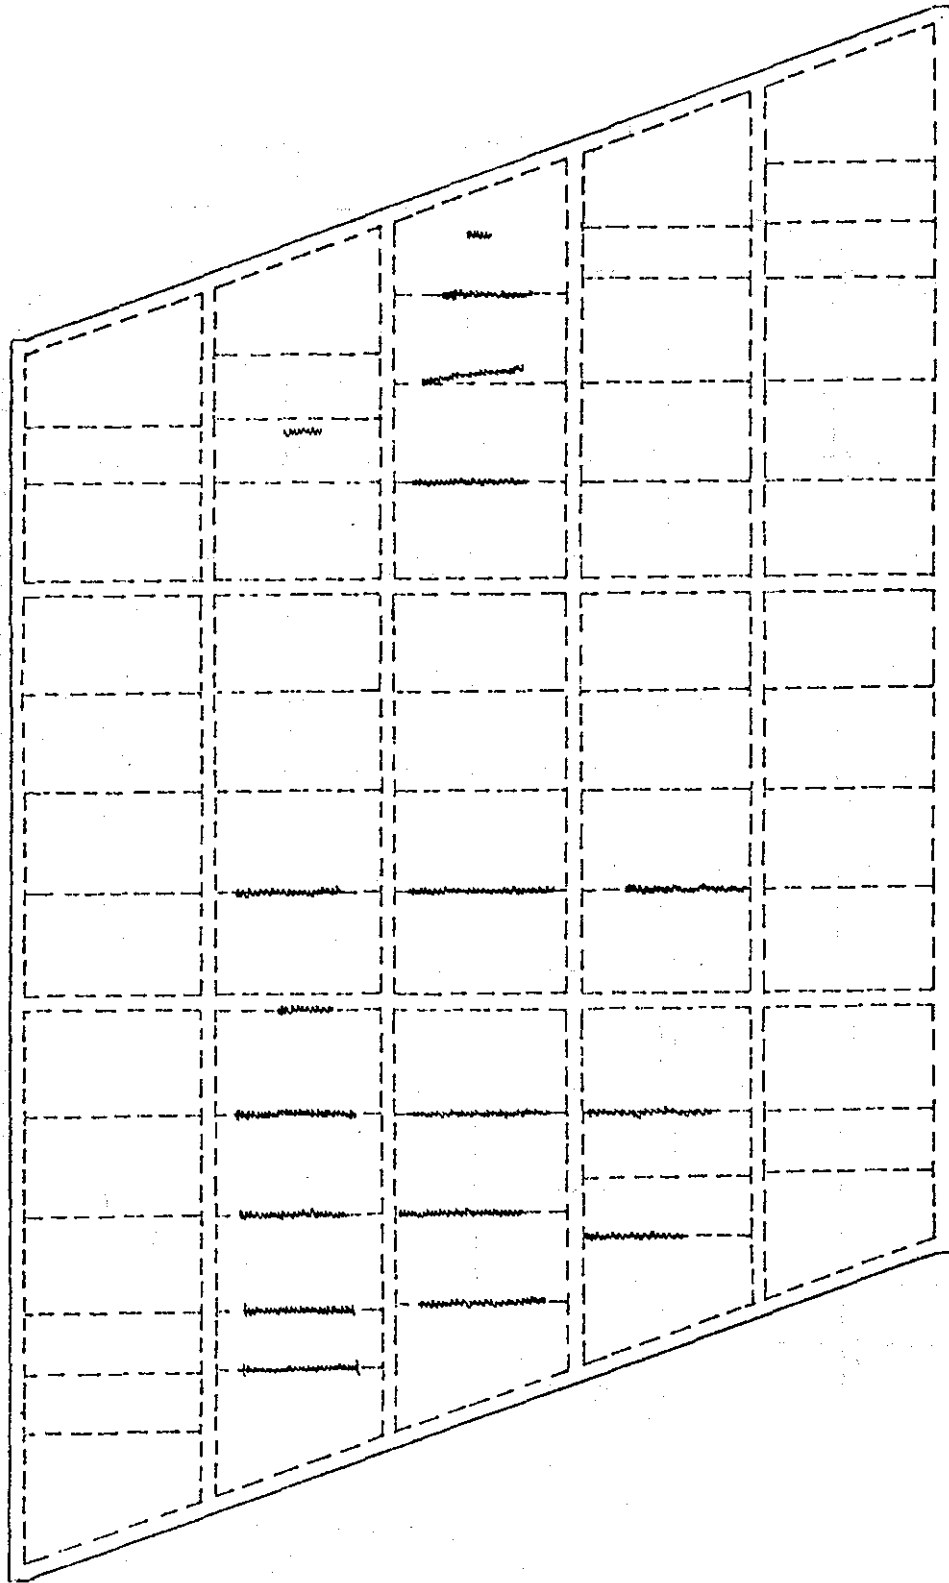
Figure A.2. Cracks in Cast-in-place Deck, Span 2NB.

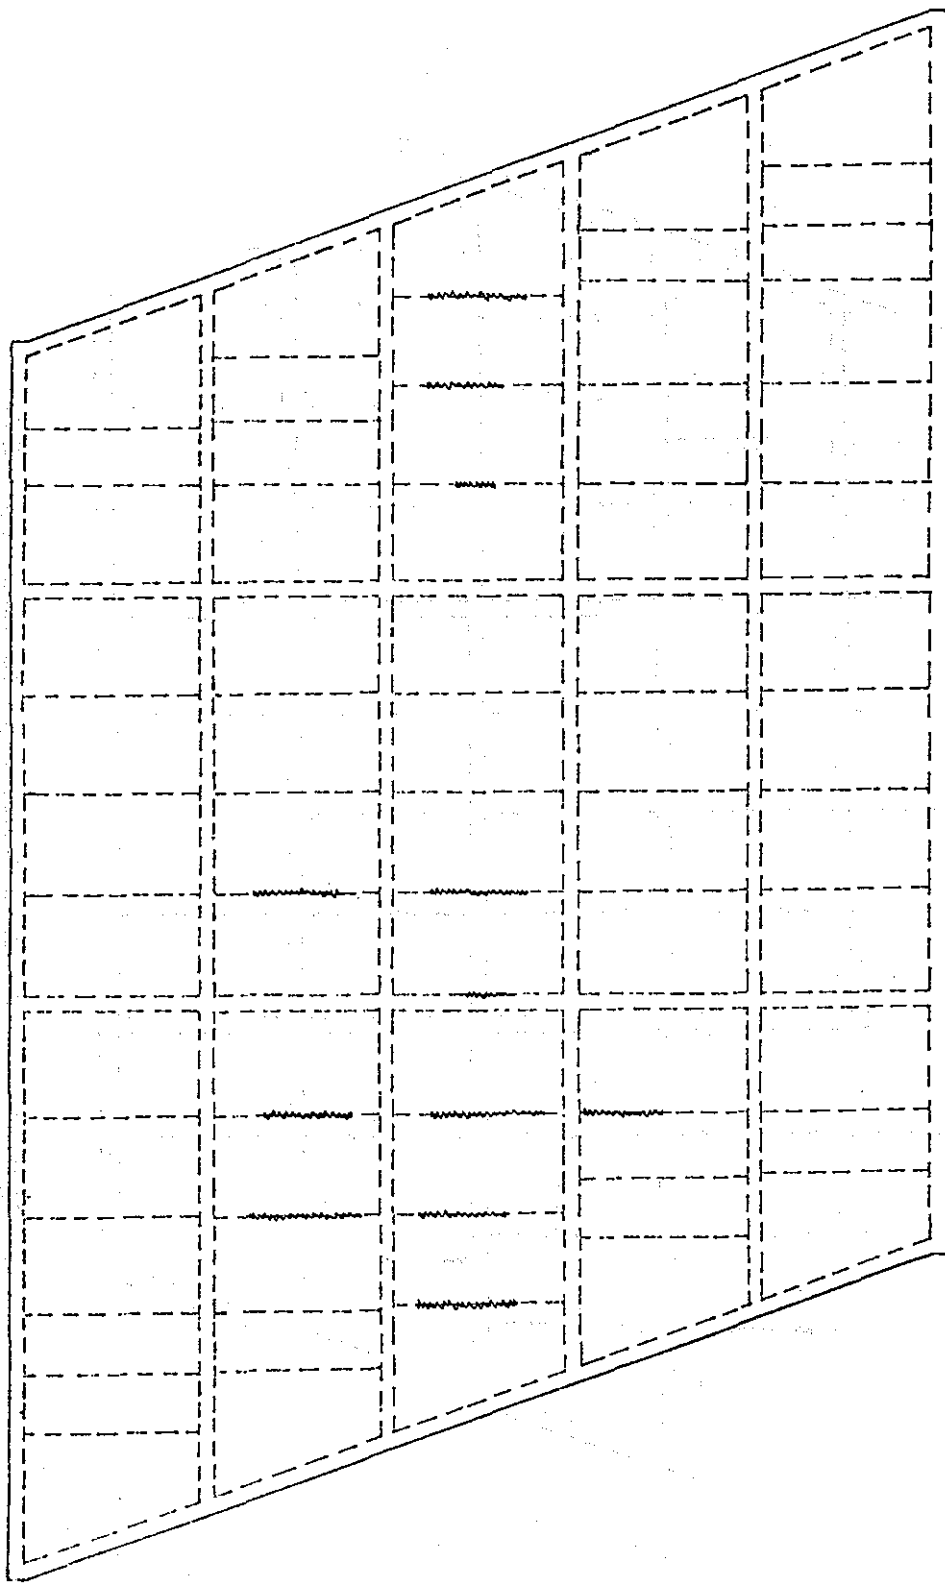
Figure A.3. Cracks in Cast-in-place Deck, Span 3NB.

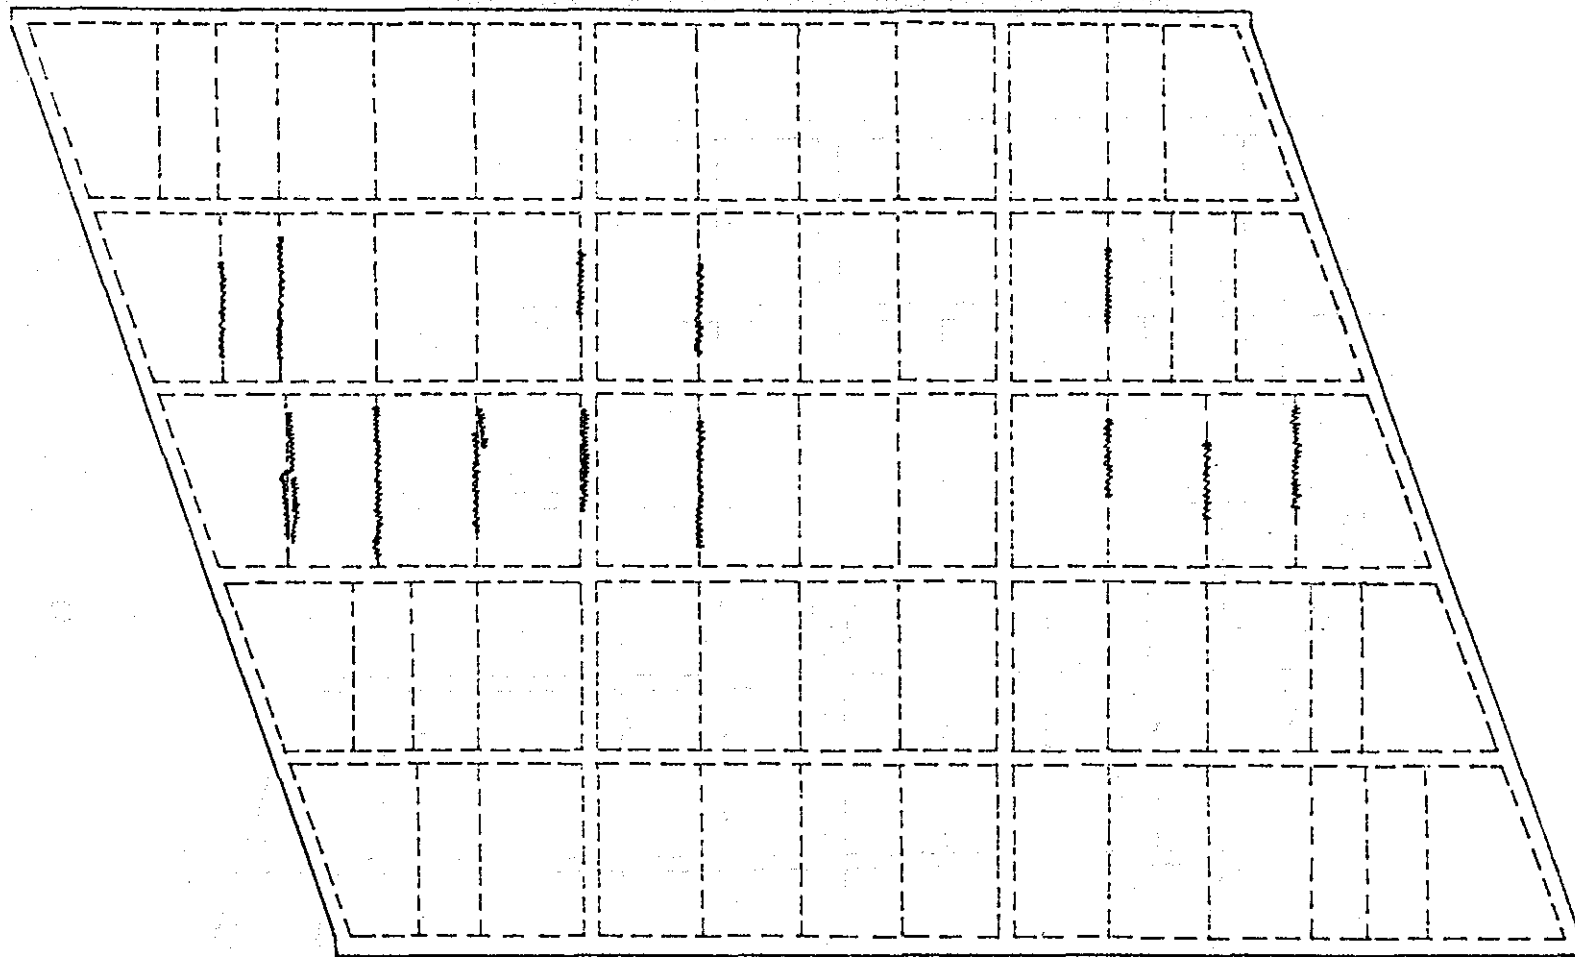
Figure A.4. Cracks in Cast-in-place Deck, Span 4NB.

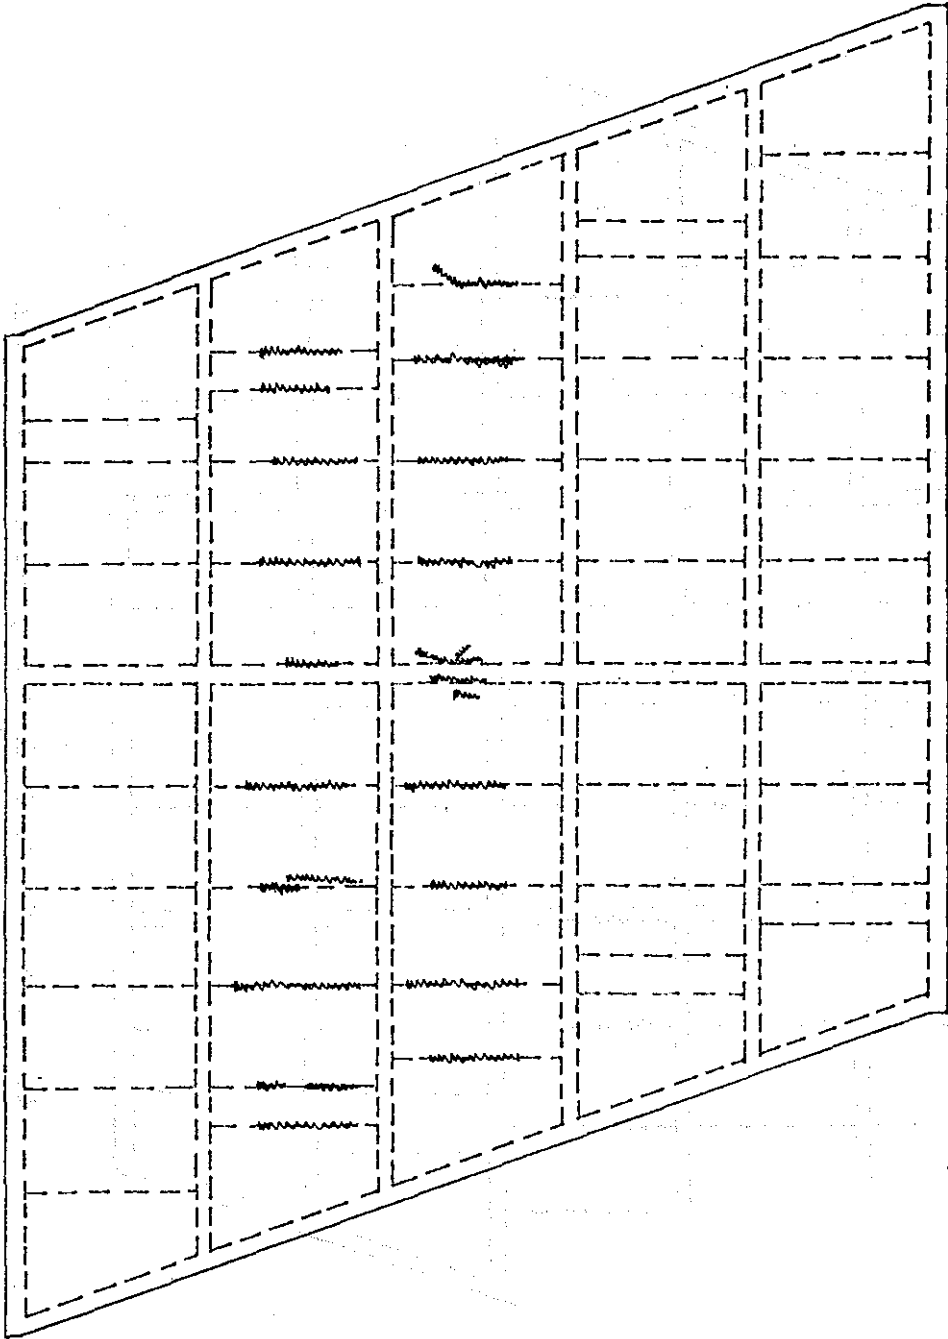
Figure A.5. Cracks in Cast-in-place Deck, Span 5NB.

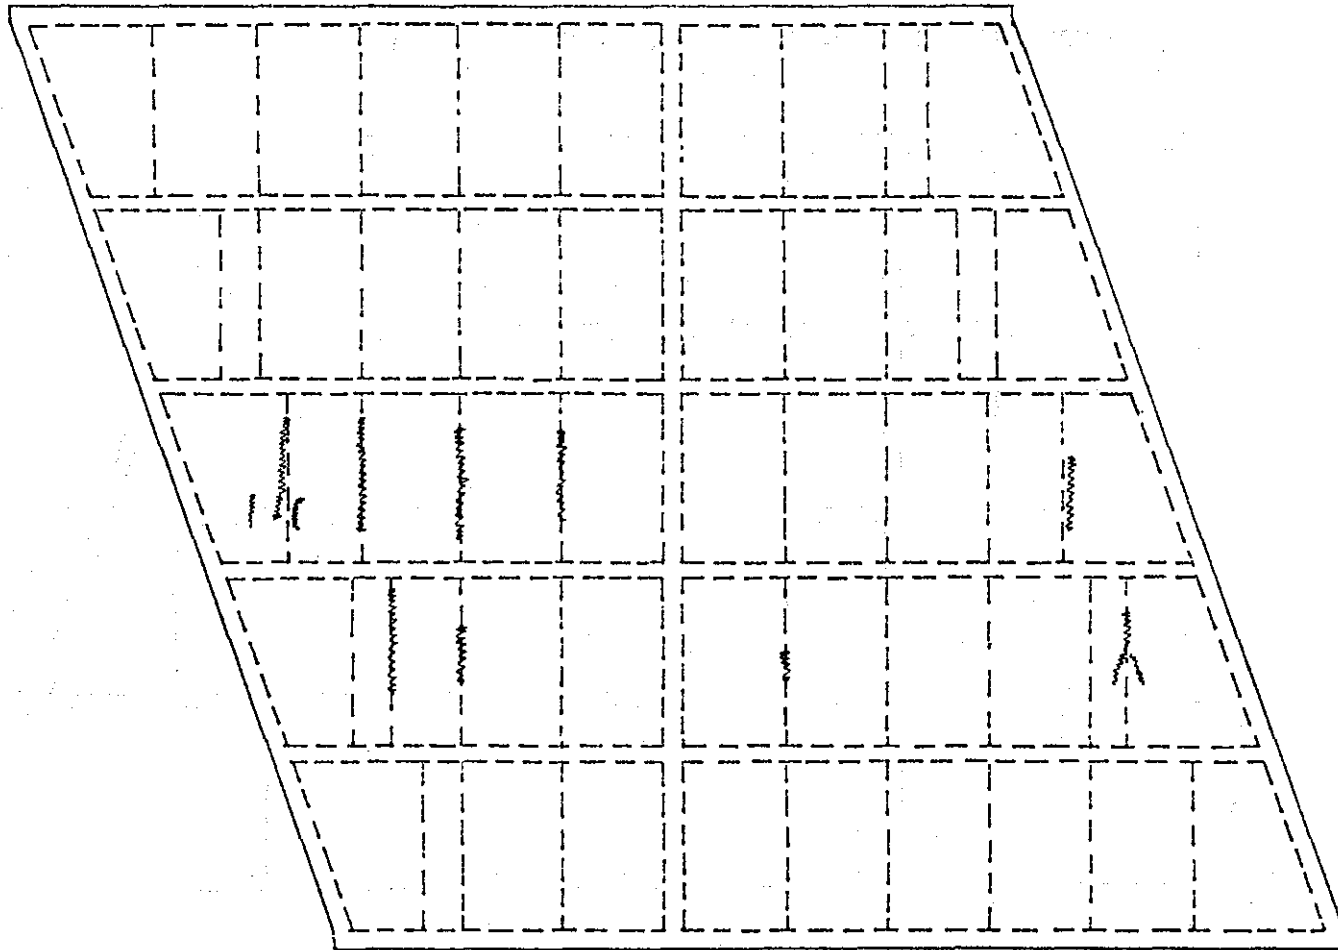
Figure A.6. Cracks in Cast-in-place Deck, Span 1SB.

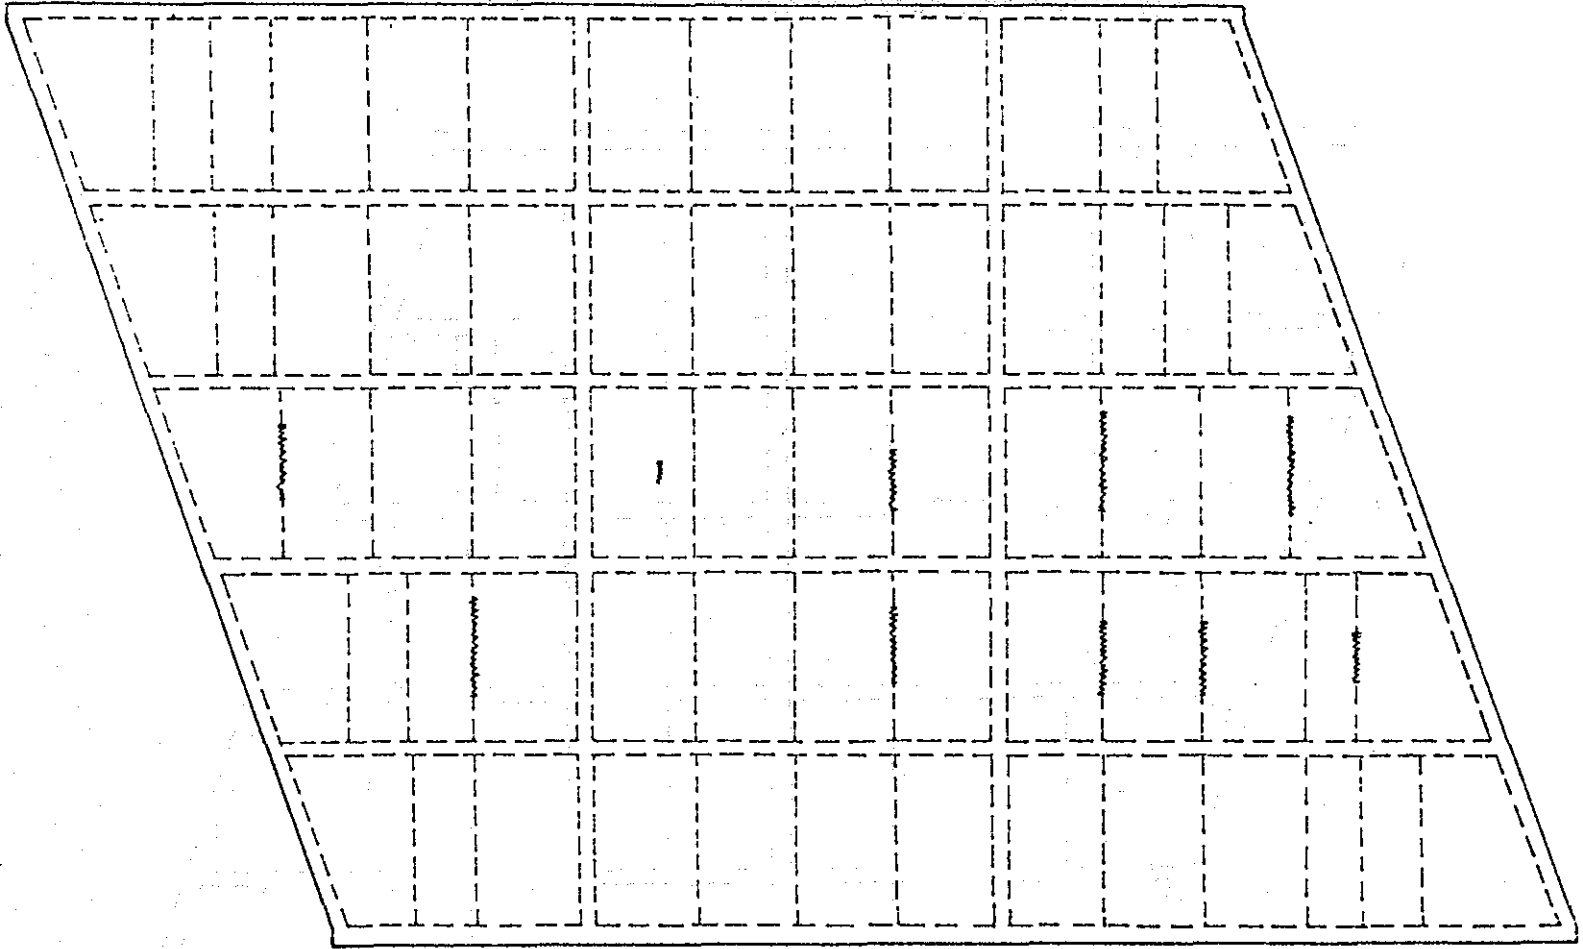
Figure A.7. Cracks in Cast-in-place Deck, Span 2SB .

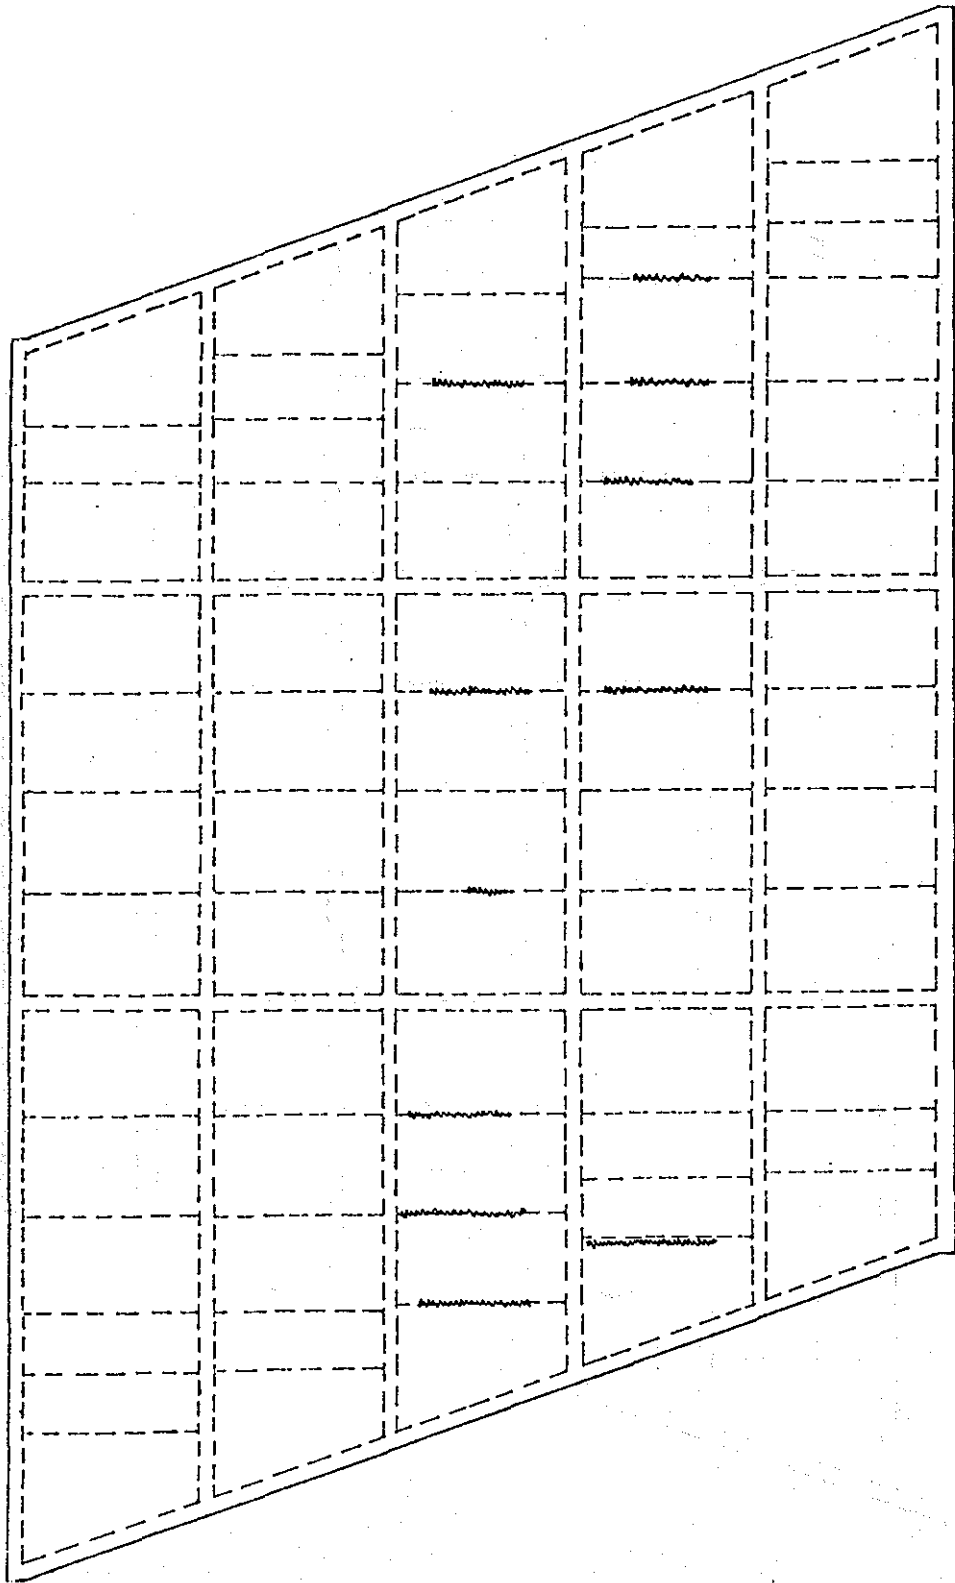
Figure A.8. Cracks in Cast-in-place Deck, Span 3SB.

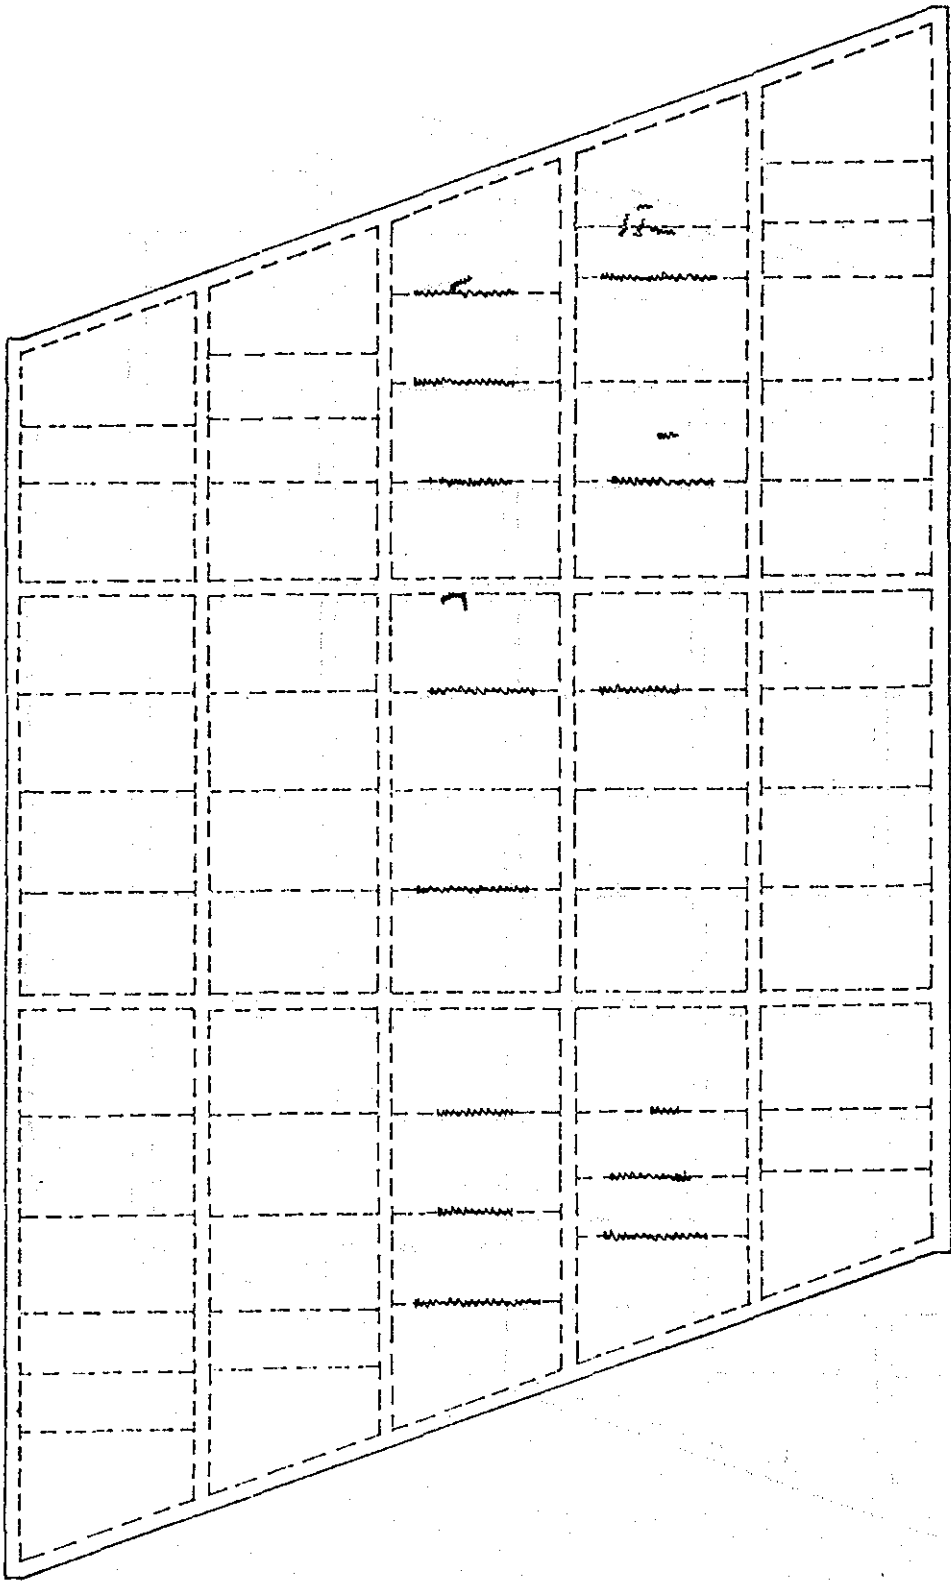
Figure A.9. Cracks in Cast-in-place Deck, Span 4SB.

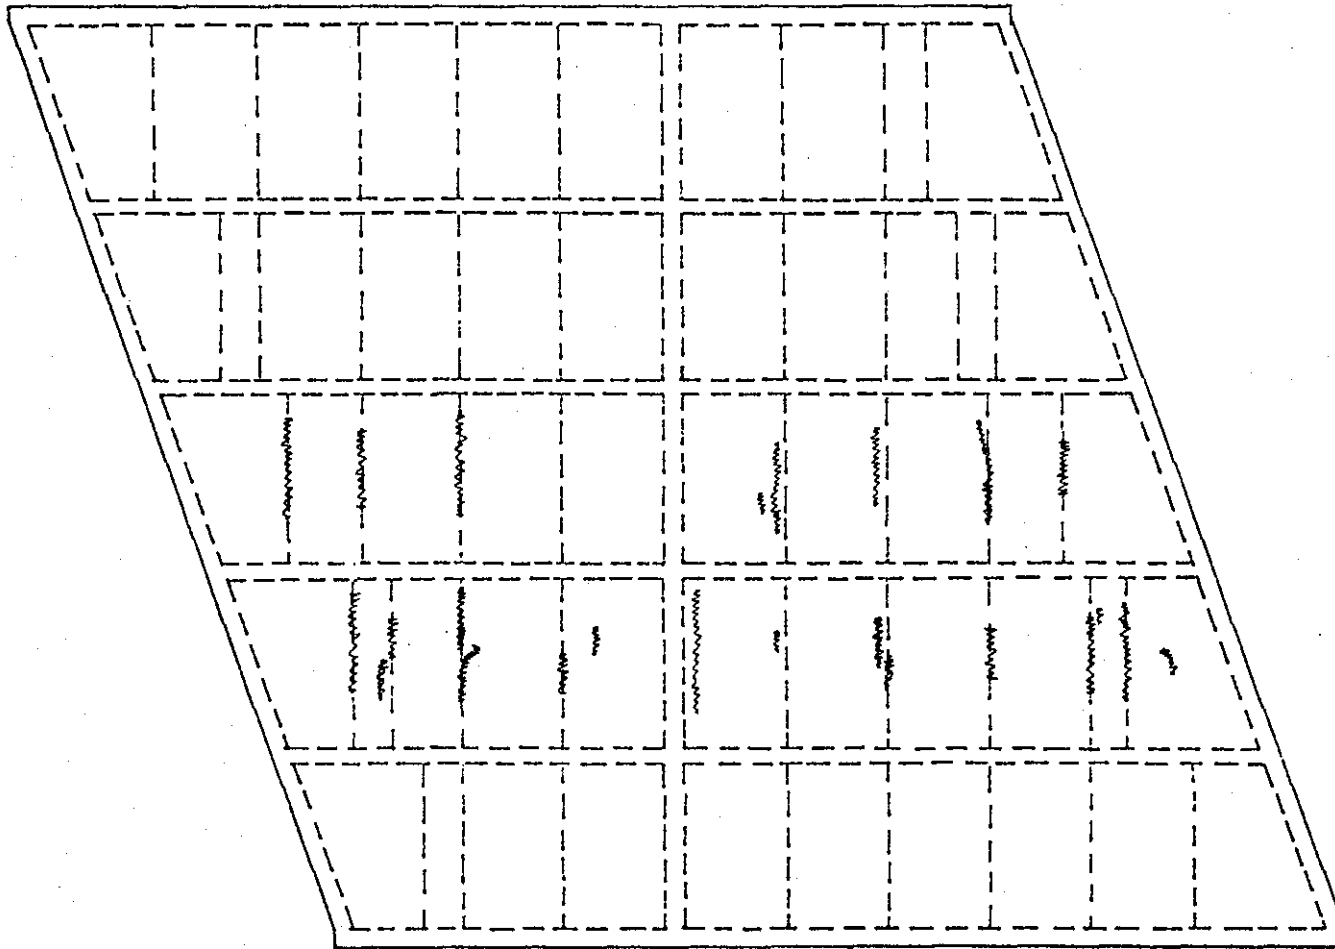
Figure A.10. Cracks in Cast-in-place Deck, Span 5SB.
