1. Report No. FHWA/TX-01/1458-3		2. Government Accession No.		3. Recipient's Catalog No.	
4. Title and Subtitle TESTING AND EVALUATION OF RECYCLED MATERIALS IN ROADSIDE SAFETY DEVICES				5. Report Date October 2000 Resubmitted: April 2001

9. Performing Organization Name and Address Texas Transportation Institute The Texas A&M University System College Station, Texas 77843-3135				10. Work Unit No. (TRAIS)

# **TESTING AND EVALUATION OF RECYCLED MATERIALS IN ROADSIDE SAFETY DEVICES**

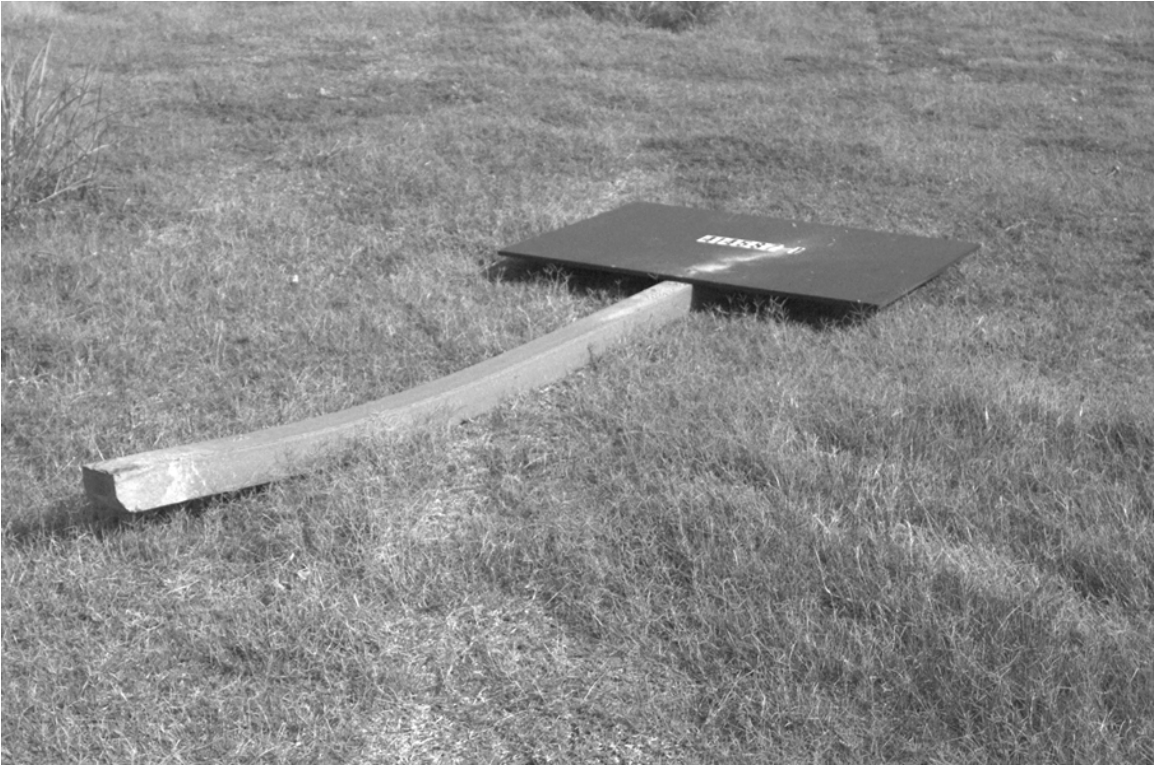
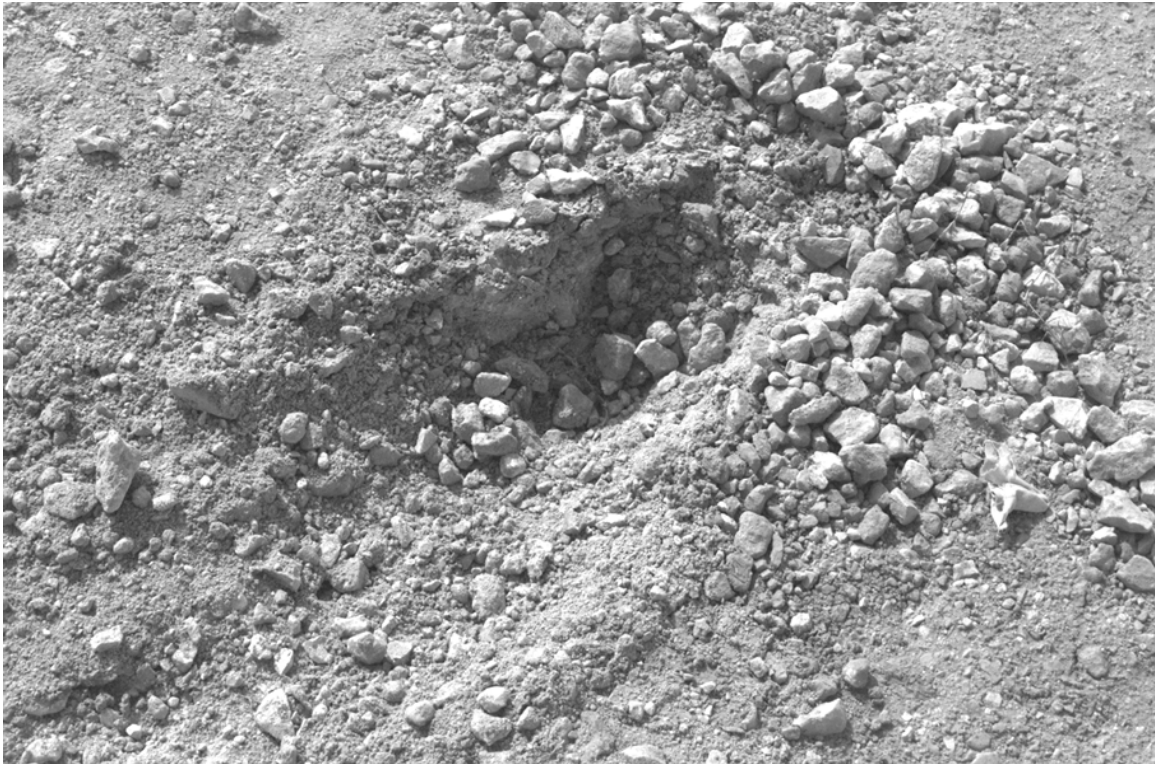
**Figure 8. Support After Test 414587-1.**

The sign support fractured 203 mm below ground level. The support and sign were dragged under the vehicle until the vehicle came to a stop. The sign support was not reusable. Damage to the sign installation is shown in [figures 7 and 8](#).

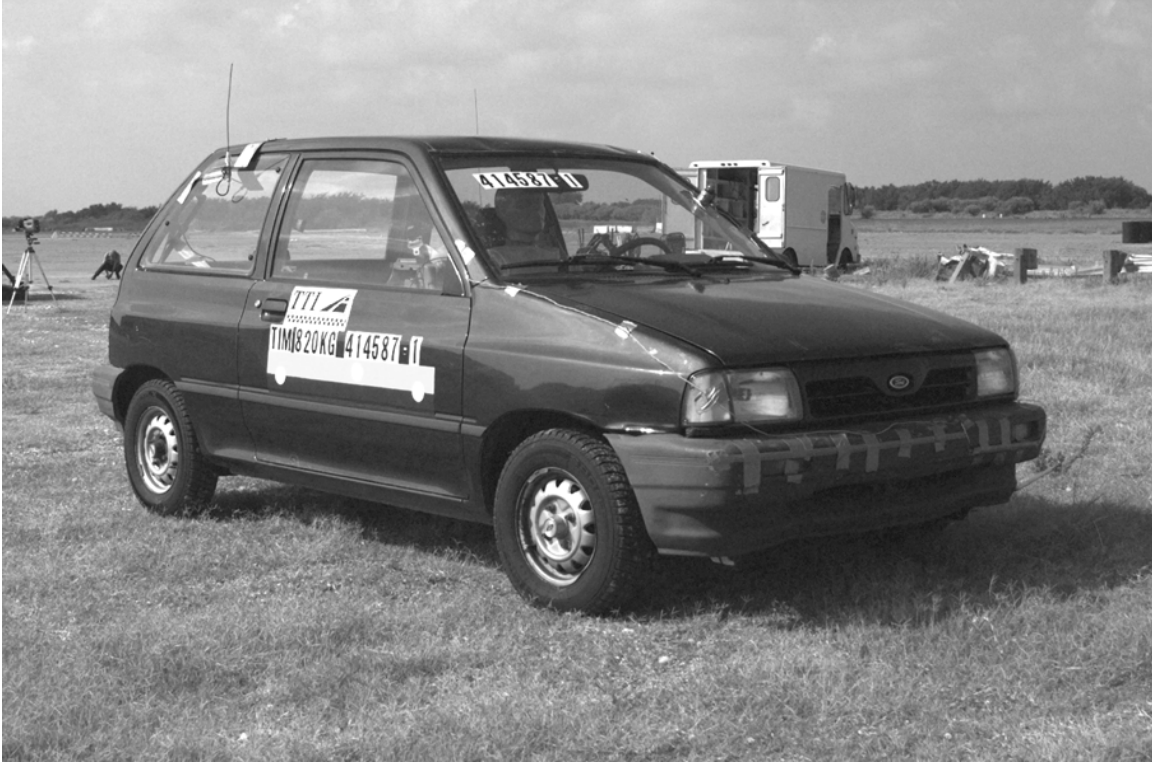
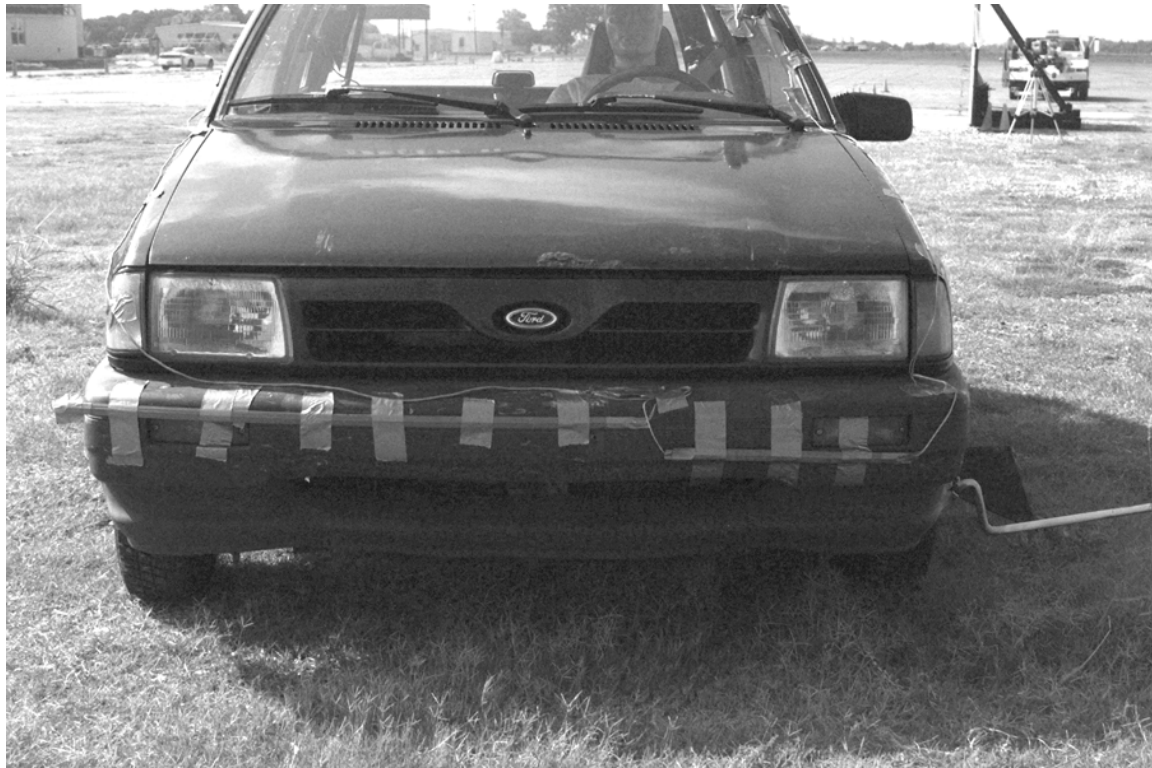
**Figure 9. Vehicle After Test 414587-1.**

As seen in [figure 9](#), no damage was sustained by the vehicle from its contact with the support. There was no measurable exterior crush, and no deformation or intrusion into the occupant compartment. Subsequent tests re-used the vehicle.

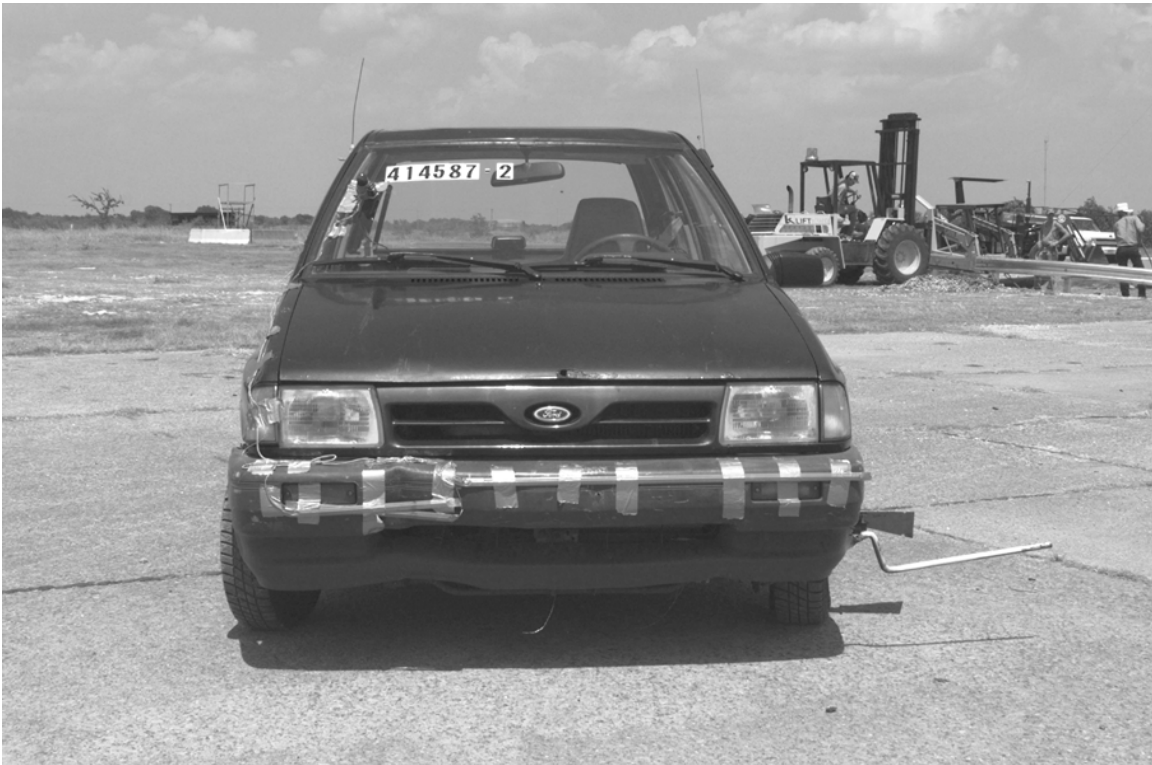
**Figure 14. After Impact Trajectory for Test 414587-2.**

The sign support fractured near ground level, as shown in figures 14 and 15, and then into three sections. The base of the support fractured at 10 mm (impact side) and 45 mm (rear side) above ground level. The sign panel and a piece of the support separated during initial impact and came to rest near the impact point. One section of the support was 0.3 to 0.6 m long, and the other was 1.8 m long. The soil around the support was only disturbed. The support was not reusable.

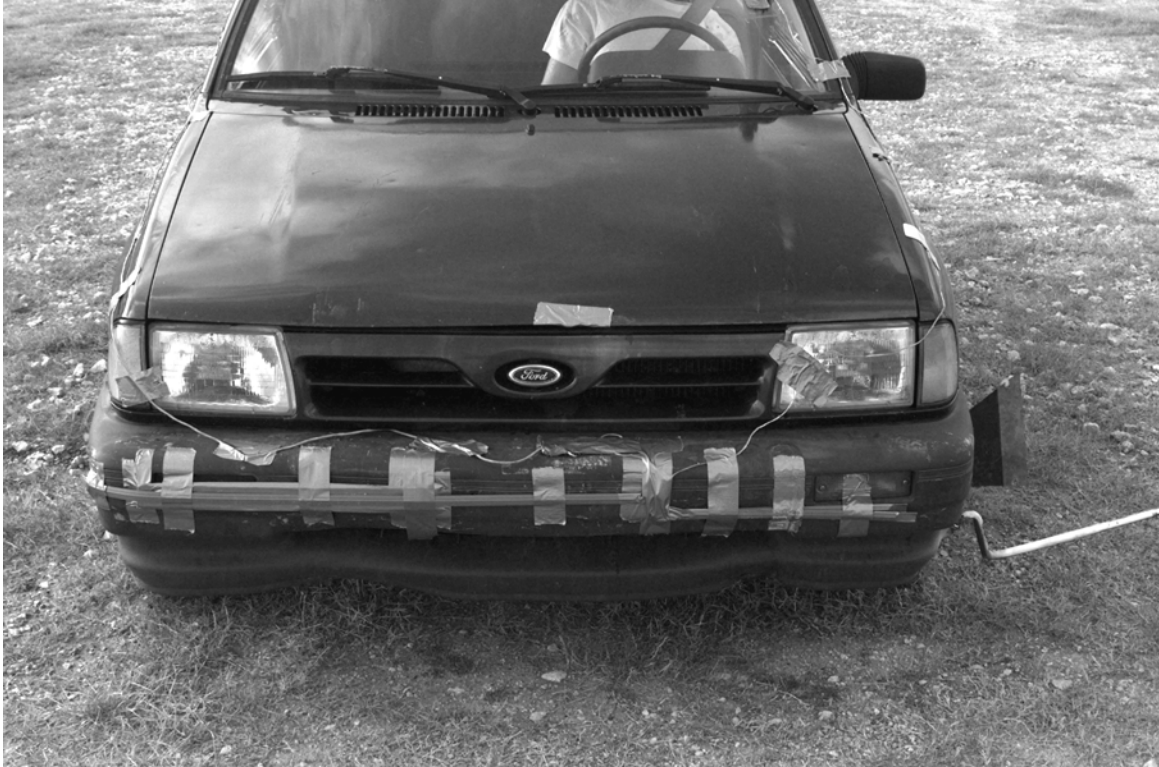
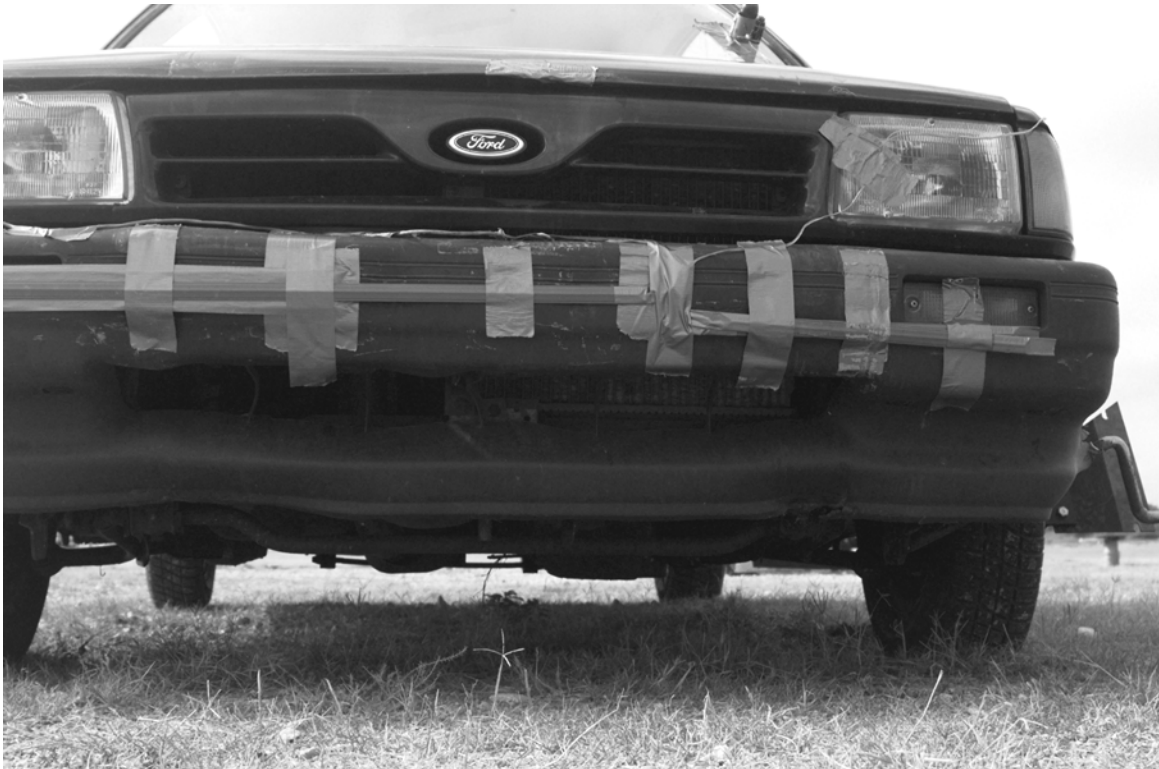
**Figure 23. Vehicle After Test 414587-3.**

Damage received by the vehicle was minor, as shown in [figure 23](#). The left front bumper showed no damage from contact with the support. A dent was noted on the lower left air deflector. No deformation or intrusion into the occupant compartment occurred. The vehicle was re-used in the next test.

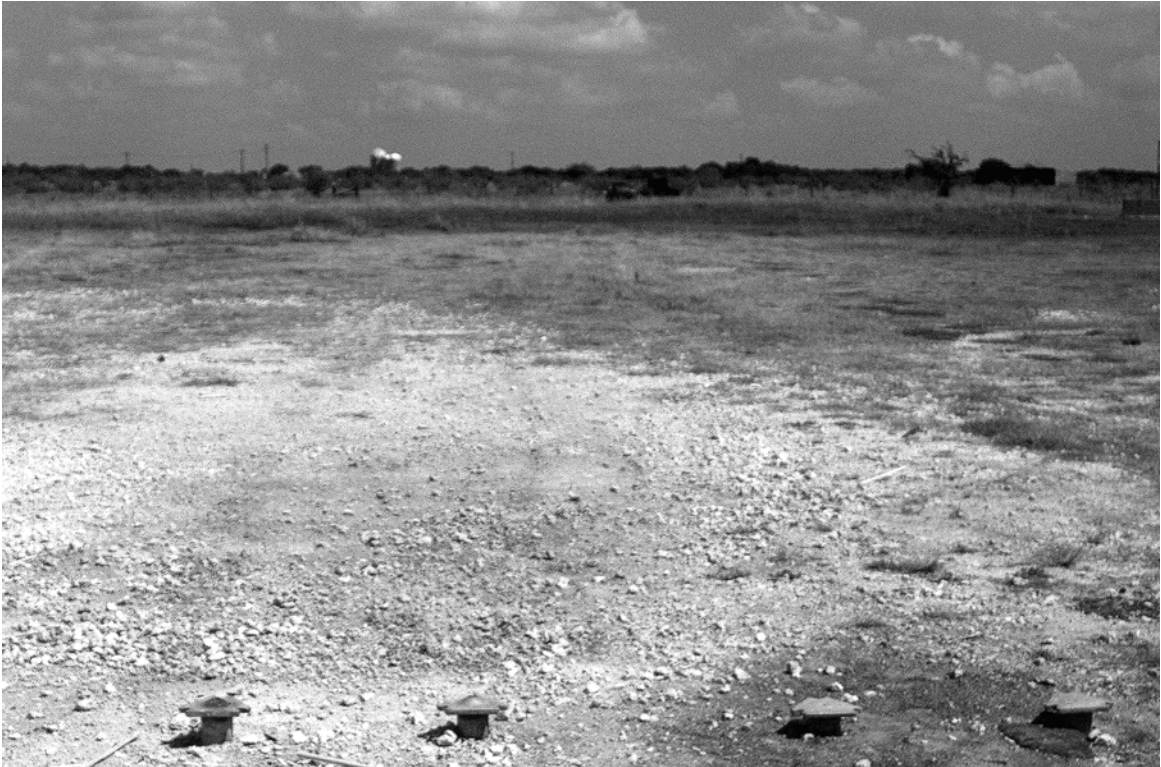
**Figure 28. After Impact Trajectory for Test 414587-4**

As can be seen in figures 28 and 29, the support pulled out of the ground without fracturing. The support was deformed from ground level to just above bumper height. The sign panel was split and separated from the support.

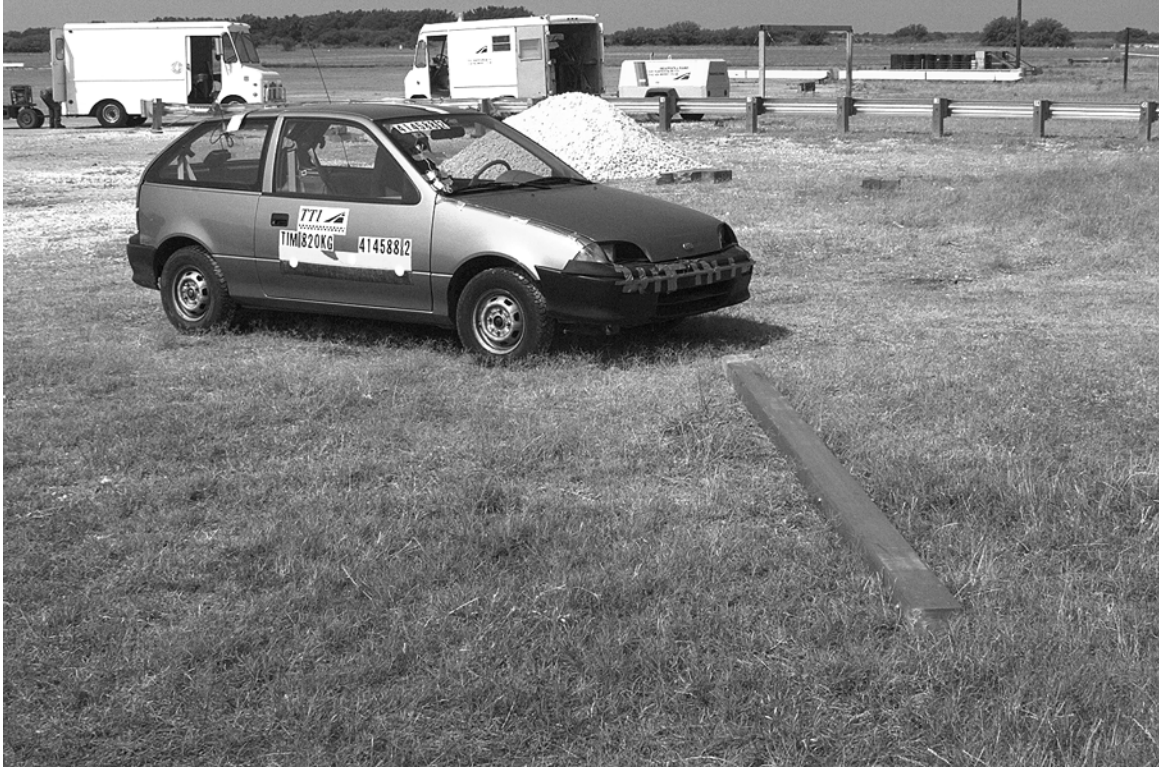
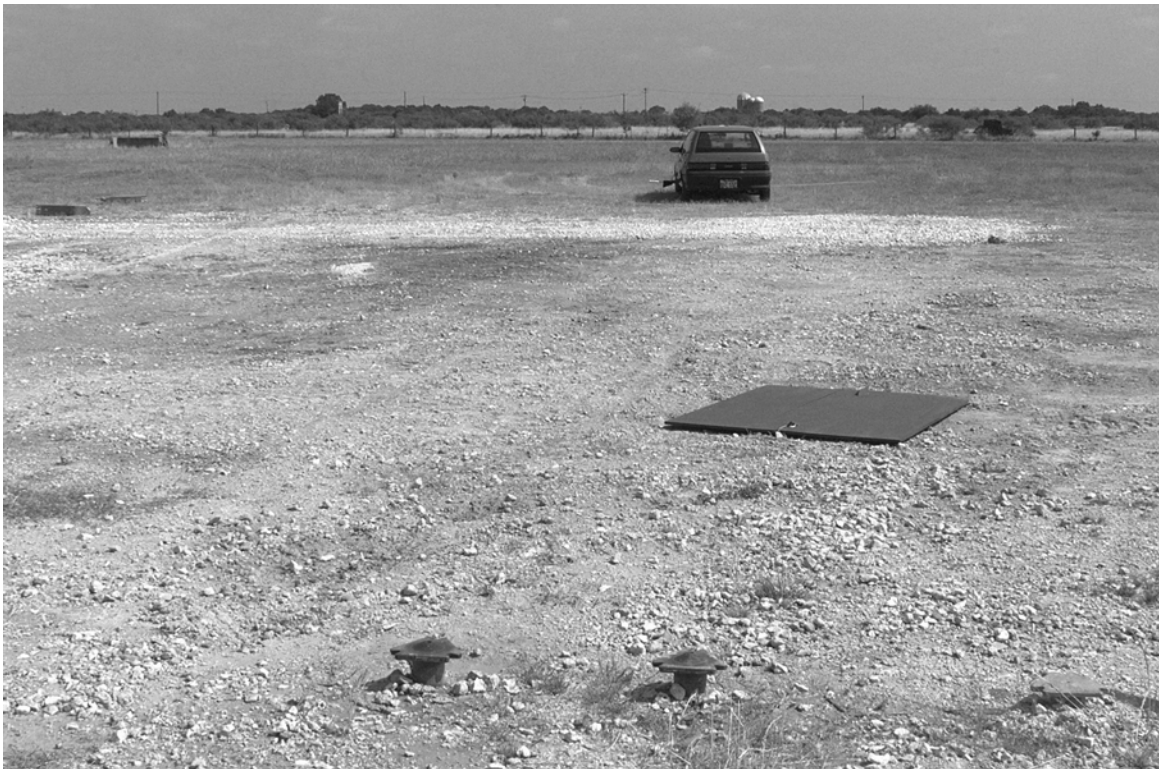
**Figure 35. After Impact Trajectory for Test 414588-2.**

As can be seen in figures 35 and 36, the support fractured just below ground level leaving 788 mm below the ground. The sign panel was separated from the support.
