CRASH TEST AND EVALUATION OF A STIFFENED  
METAL BEAM GUARD FENCE MEDIAN  
BARRIER FOR USE AROUND  
LUMINAIRE SUPPORTS

RESEARCH REPORT 146-13F  
STUDY 2-10-68-146  
ADAPTATION OF ATTENUATION SYSTEMS

CRASH TEST AND EVALUATION  
OF A  
STIFFENED METAL BEAM GUARD FENCE MEDIAN BARRIER  
FOR USE AROUND LUMINAIRE SUPPORTS

November 1975

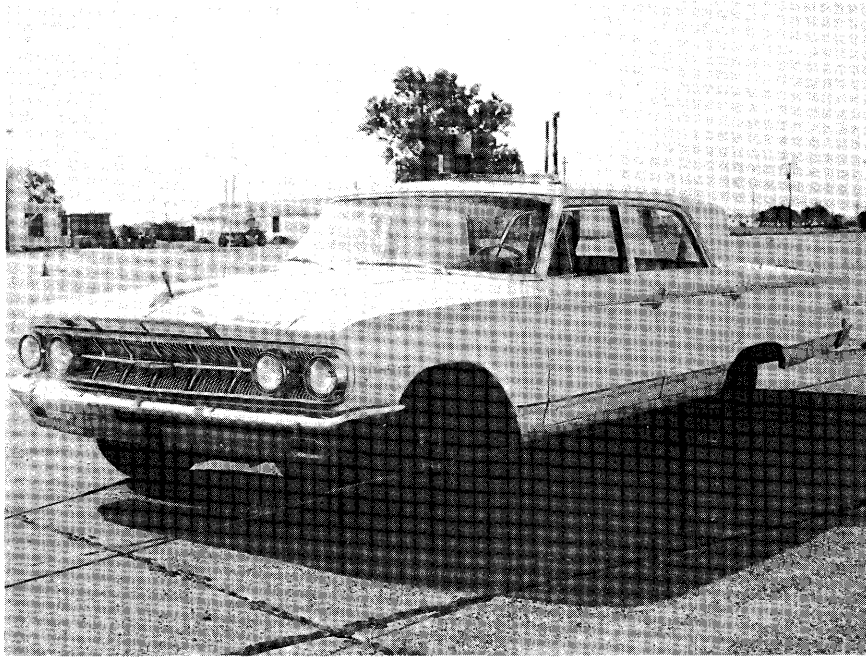
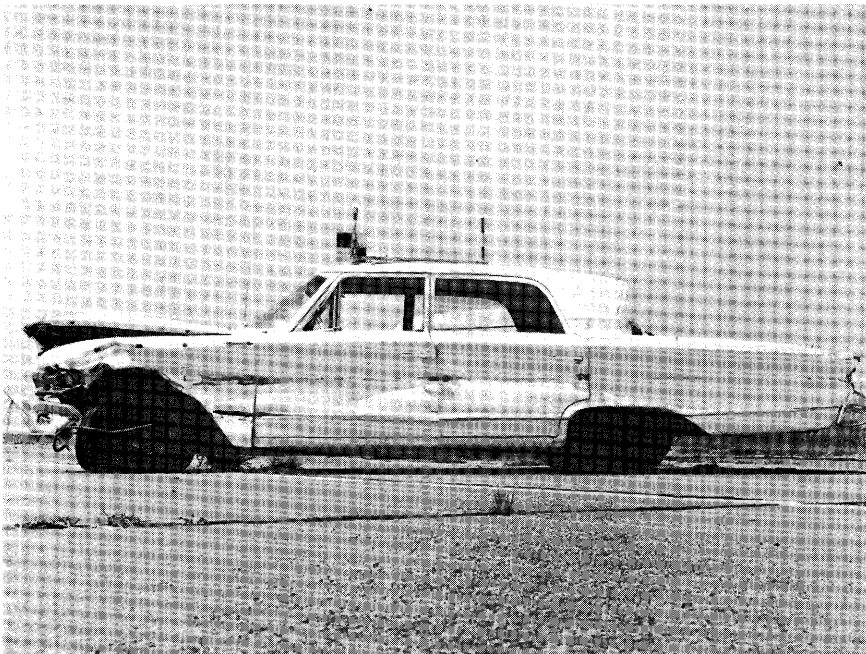
**FIGURE 3 TEST MBIOL VEHICLE BEFORE  
AND AFTER IMPACT**

The test, designated as MB-101, was conducted with a 1963 Mercury Monterrey 4-door Sedan weighing 4270 lb (1935 kg). The impact angle of the test vehicle and the metal beam guard fence was  $15^{\circ}$  as measured between the vehicle centerline and the guard fence centerline. The point of impact of the left front fender of the vehicle and guard fence was approximately 9 ft 8 in. (3.35 m) upstream from the luminaire support. This impact point was determined by guiding the center of gravity of the vehicle directly at the luminaire support (see Figure 1) in order to obtain maximum vehicle penetration at the pole location. The impact speed was 61.9 mph (99.6 km/hr). The vehicle exit angle was approximately 10 degrees and it was smoothly redirected without snagging the luminaire pole. The left front wheel and steering linkage were damaged, see the lower part of Figure 2 and the vehicle was inoperable after impact.

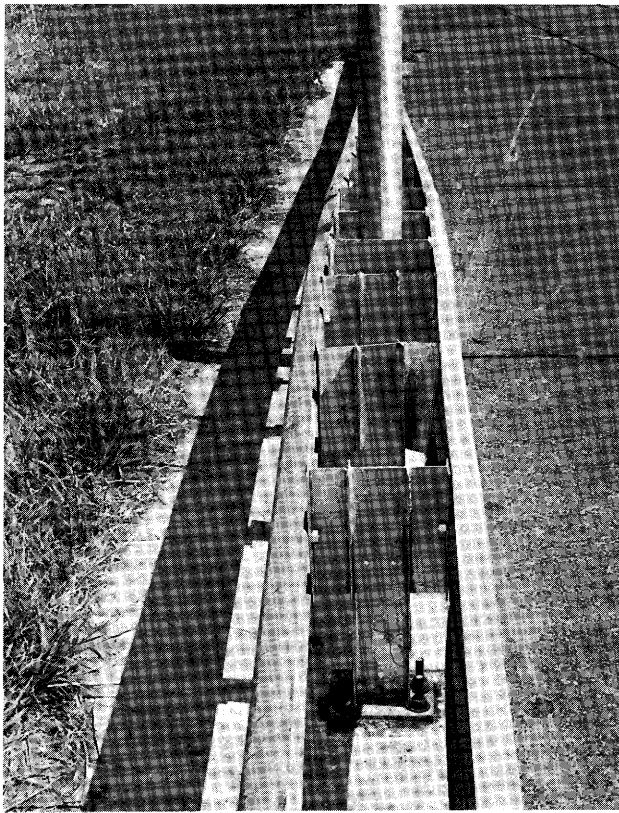
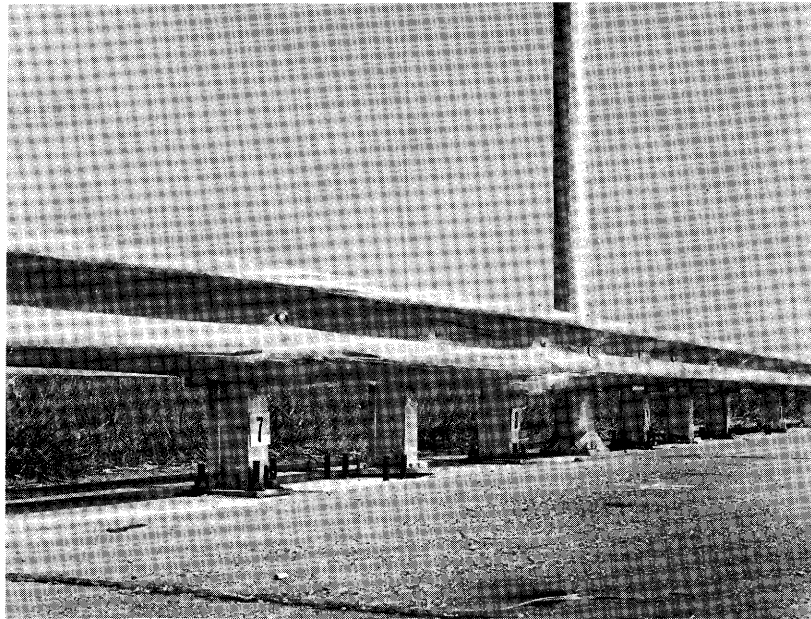
**FIGURE 4 TEST MBOI MEDIAN BARRIER  
AFTER IMPACT**

The median barrier is shown after the impact in Figure 4. The "W" section is deformed in the vicinity of the impact and the impacted post and the intermediate post are slightly bent about their bases. The spacer on the intermediate post is damaged. Repair to the metal beam guard fence, if required at all, would be limited to the replacement of one length of "W" section and two posts with spacers.

The left front wheel and steering linkage were damaged so the vehicle was inoperable after the impact. Repairs to the metal beam guard fence, if required at all, would have been limited to the replacement of one length of 10 gage "W" section and two posts with spacers.

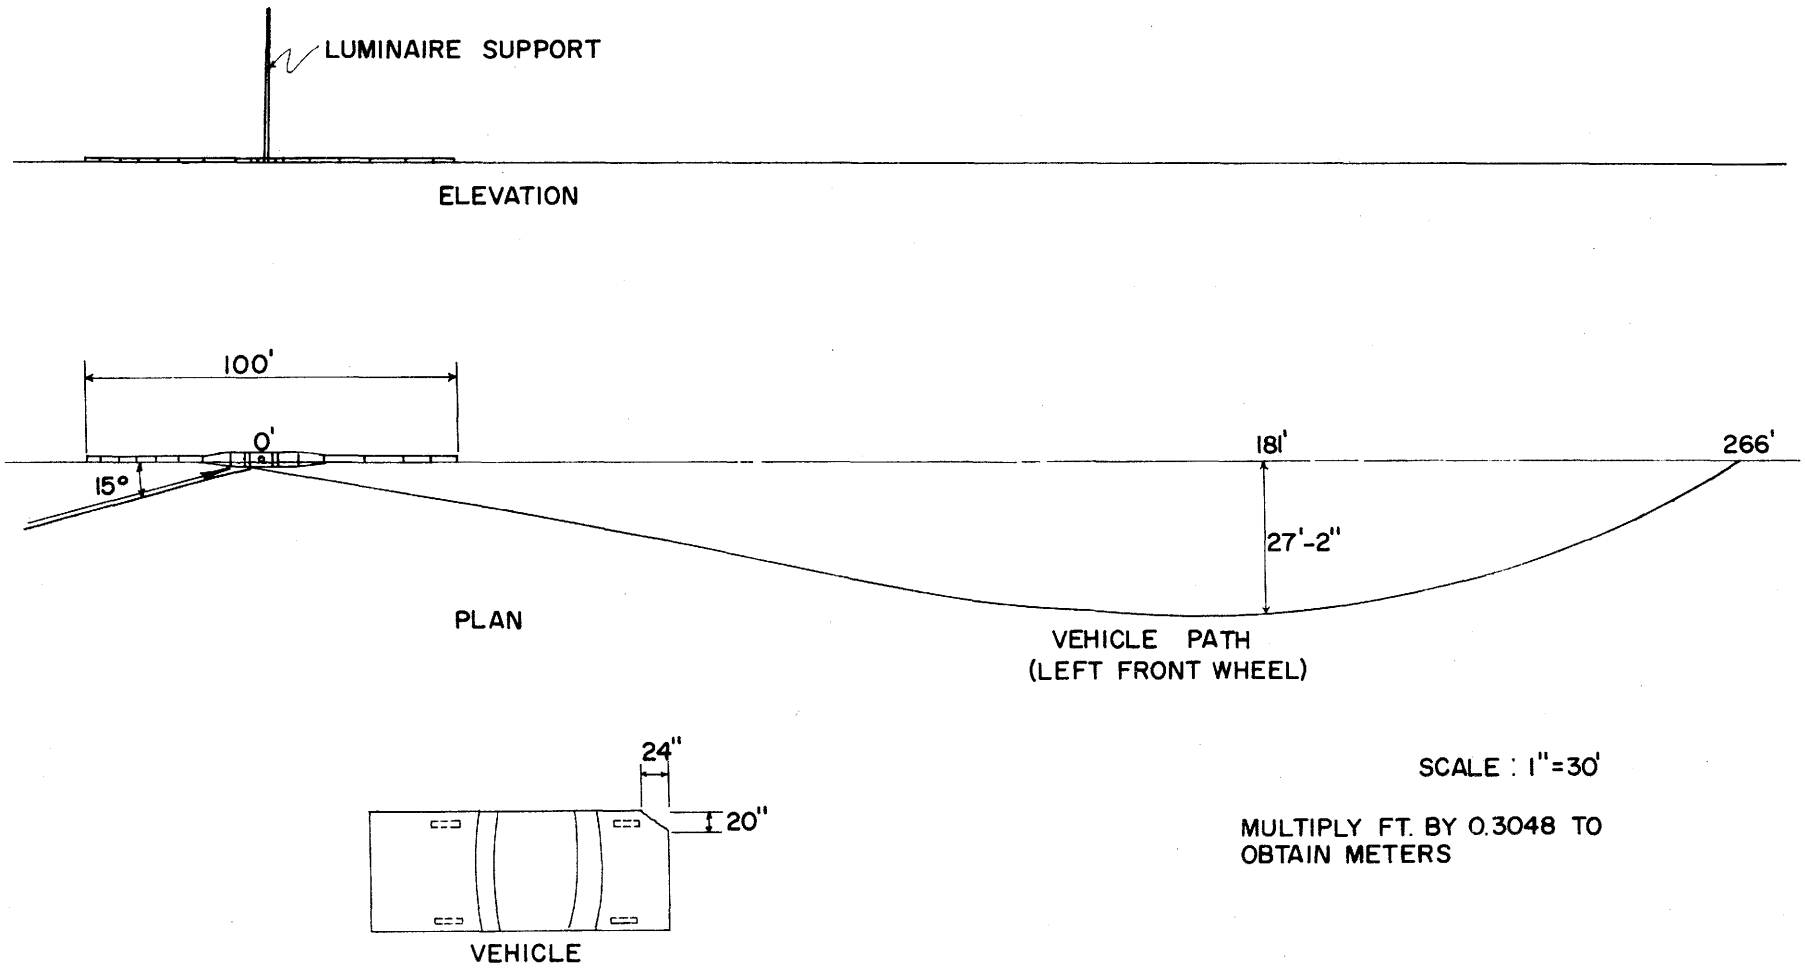
FIGURE 5 TEST MB101 VEHICLE PATH AFTER TEST

The vehicle path is shown plotted to scale in Figure 5. The path shown is for the left front wheel. Sequence photographs shown in Figures 6 and 7 show that the vehicle fenders deform and go over the impacted "W" section. It appears that at time 174 milliseconds the sheet metal contacted the luminaire support. A study of the accelerometer traces shows that this contact had little effect on the behavior of the vehicle, and is therefore considered to be insignificant or not a snag. The highest 50 millisecond average longitudinal deceleration occurred
