**IN-SERVICE EXPERIENCE ON
INSTALLATIONS OF TEXAS
MODULAR CRASH CUSHIONS**

Research Report Number 146-2

Research Study Number 2-8-68-146

December 1969

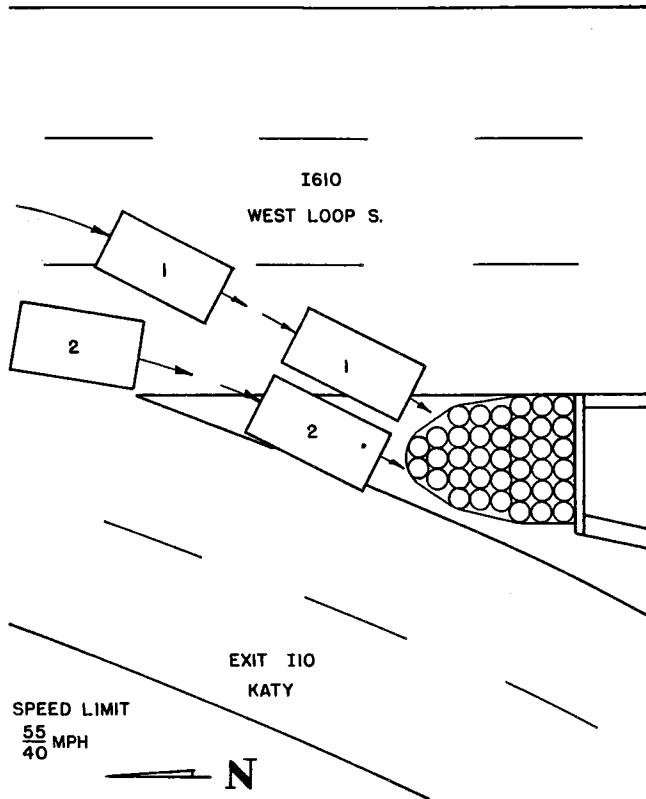
The first accident involving a Modular Crash Cushion occurred on December 12, 1968, 8:40 p.m., at Site No. 3. Figure 6 shows, in sketch form, how the accident occurred. Vehicle 1 was changing lanes to accommodate the IH 10 exit. During this maneuver, the right side of Vehicle 1 struck the left side of Vehicle 2. Both vehicles then simultaneously struck the Modular Crash Cushion head-on. Figure 7 shows the very minor damage to each of the vehicles involved in the collision. Figure 8 shows the extent of damage to the Modular Crash Cushion. Neither driver sustained injury, and both vehicles were driveable after the collision. The accident report indicates the weather was clear and pavement dry at the time of the accident.

Figure 6. Schematic View of Accident Sequence at Site No. 3 on December 12, 1968.

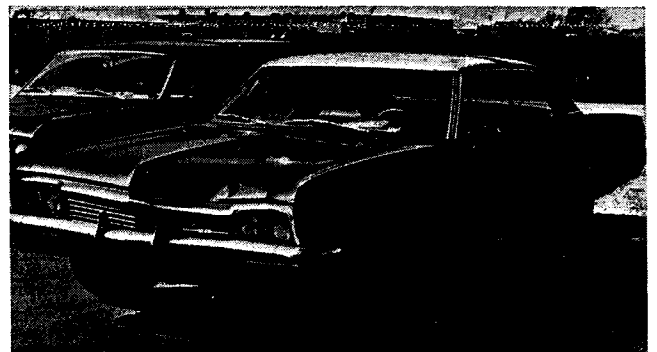
Figure 7. Damage to Vehicles in Accident at Site No. 3 on December 12, 1968.

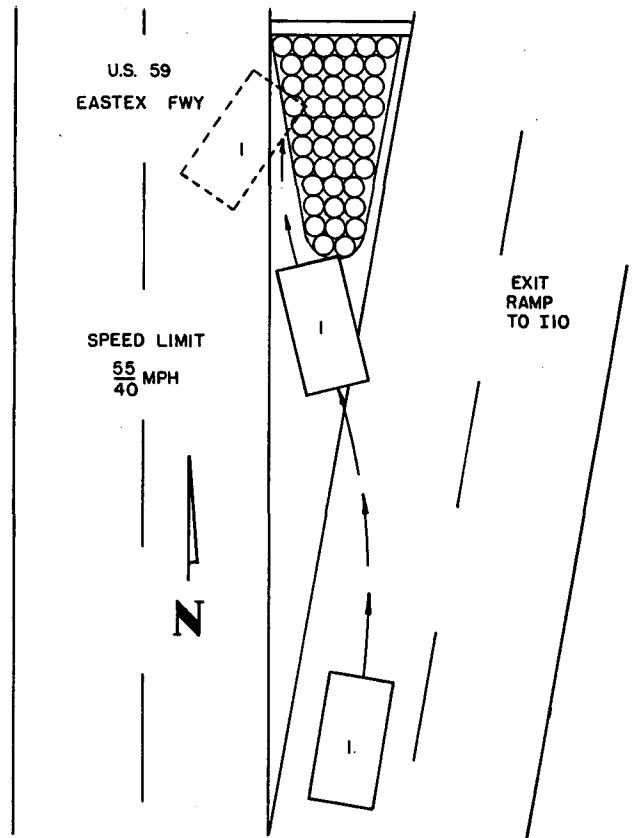
The third accident occurred on February 15, 1969, 11:00 p.m., at Site No. 4, and as shown in Figure 10. The vehicle was traveling North on Eastex Freeway and while attempting to change lanes, struck the Modular Crash Cushion on the left-hand side of the right front of the vehicle. After crushing the first ten barrels on the left-hand side of the Modular Crash Cushion, the vehicle came to a stop. Photographs of

Figure 10. Schematic Sketch of Accident at Site No. 4 on February 15, 1969.

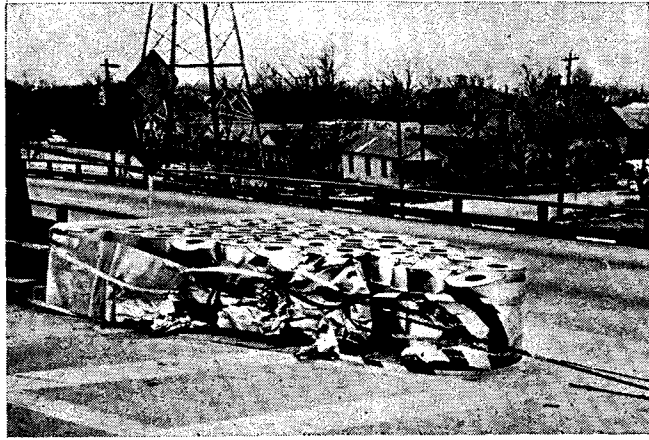
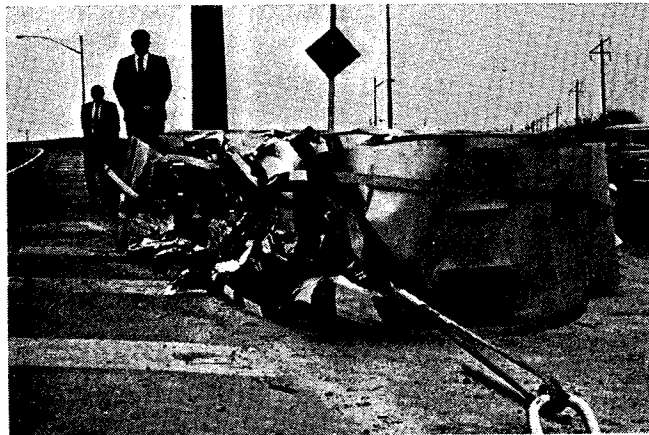
the vehicle are not available, but the investigating officer estimated \$700 damage to the right front of the vehicle. It was reported that the driver refused treatment for minor injuries and that he had been drinking. The officer's report stated that the weather was clear and the pavement dry at the time of the accident. Figure 11 shows the damage done to the Modular Crash Cushion.

Figure 11. Cushion Damage from Accident at Site No. 4 on February 15, 1969.

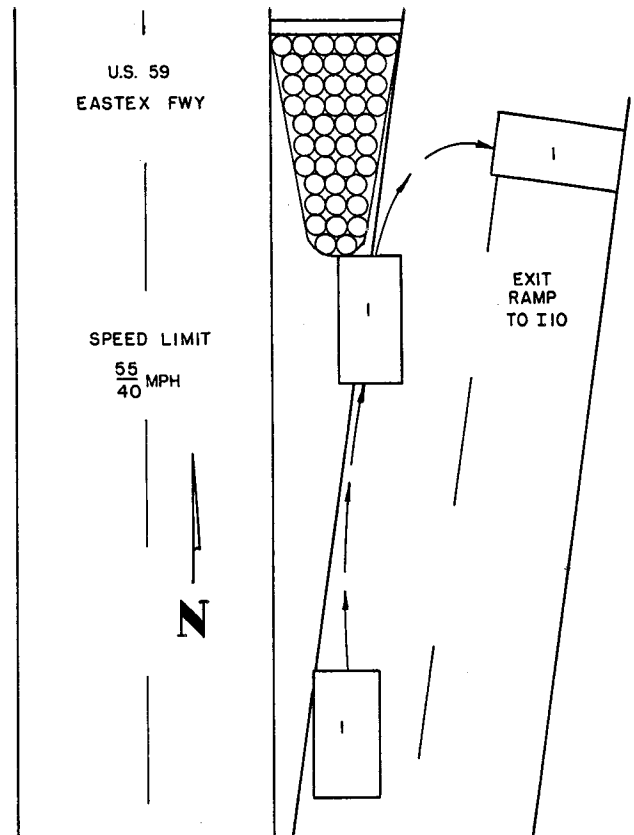
exit ramp from the Eastex Freeway to IH 10, struck the Modular Crash Cushion with the left side of the vehicle impacting the right side of the crash cushion. The sketch in Figure 12 shows the path of the vehicle, as it swerved from the crash cushion, moved across the exit ramp and struck the guardrail on the right side of the ramp. Photographs of the crash cushion damage are shown in Figure 14 while Figure 13 indicates damage sustained by the vehicle. The accident report states that the driver sustained minor injuries. The report also shows that the driver had been drinking, failed to keep a proper lookout, and was not wearing his seat belt when the accident occurred. The weather is reported to have been clear, and the road surface dry at the time of the accident.

Figure 12. Schematic Sketch of Accident at Site No. 4 on March 19, 1969.

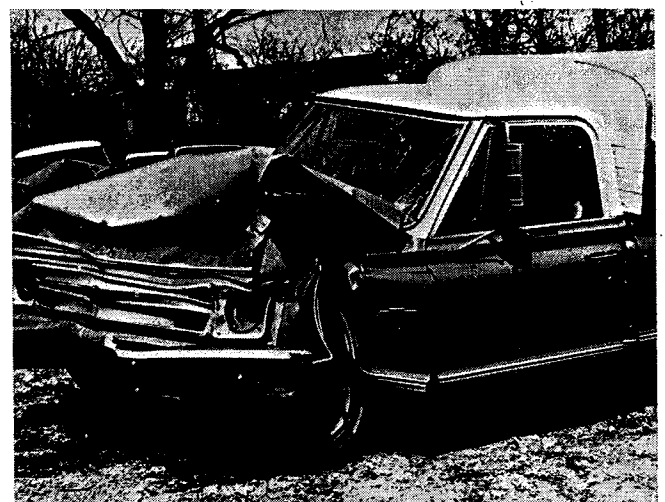
Figure 13. Vehicle Damage Sustained in Accident at Site No. 4 on March 19, 1969.

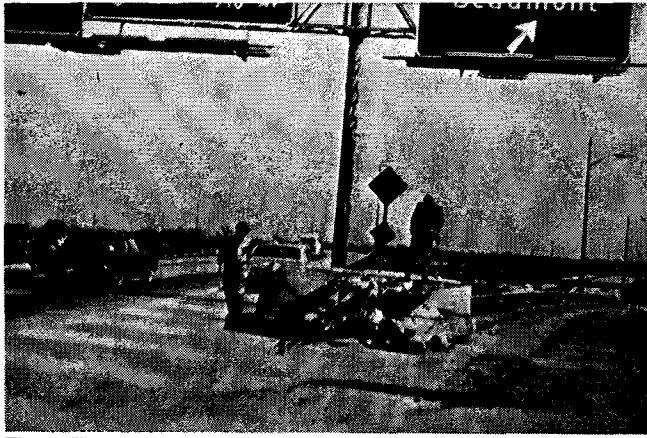
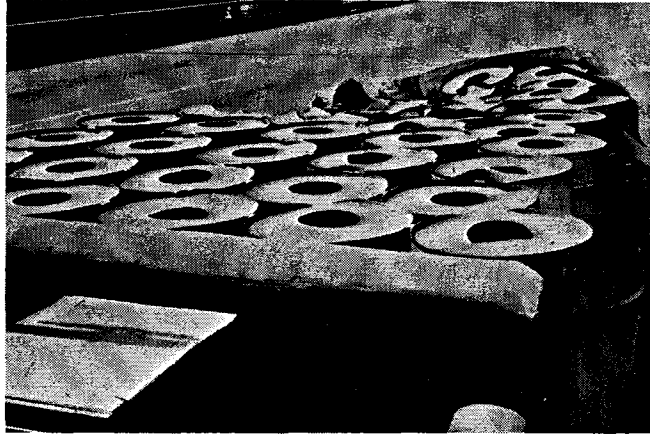
Figure 14. Damage to Cushion at Site No. 4 from Accident on March 19, 1969.

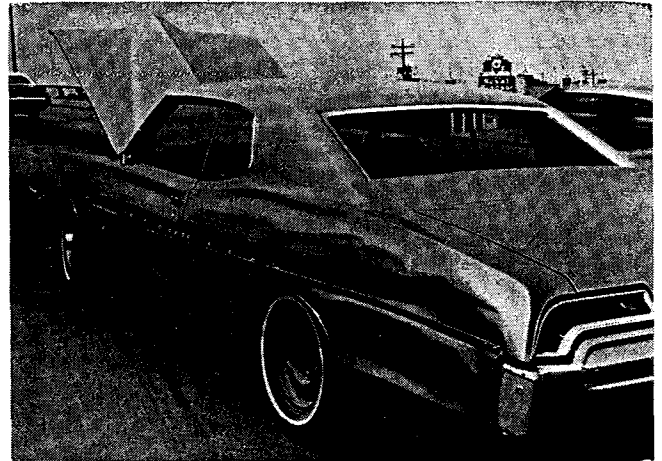
Figure 16. Vehicle Damage from Accident at Site No. 2 on June 17, 1969.

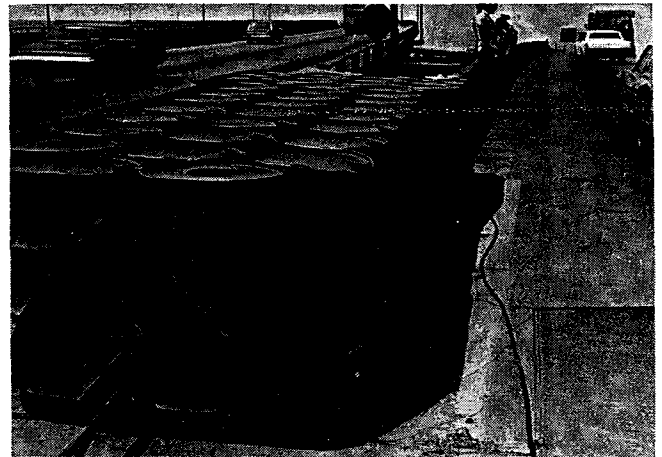
Figure 17. Cushion Damage from Accident at Site No. 2 on June 17, 1969.

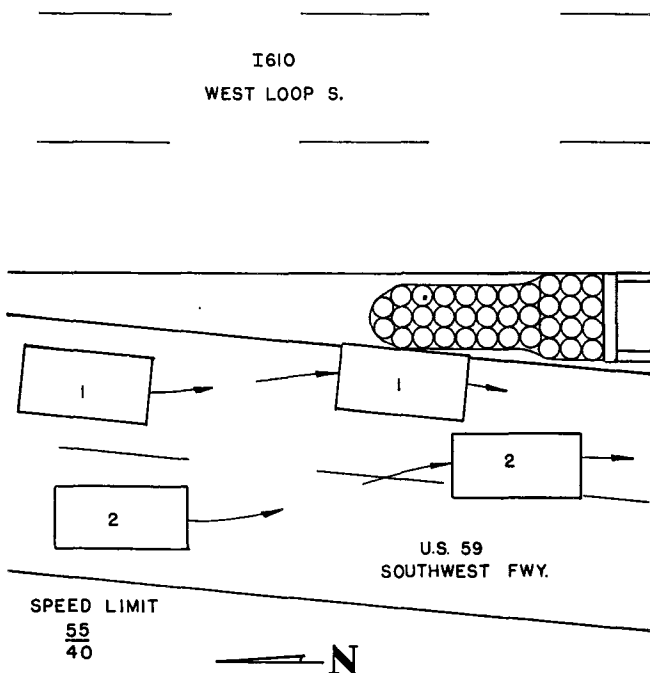
The sixth accident took place at Site No. 2 on June 17, 1969, at 11:45 a.m. As may be seen in the sketch in Figure 15, the driver of Vehicle No. 1 was forced to sideswipe the Modular Crash Cushion in order to avoid a collision with Vehicle No. 2 as Vehicle No. 2 changed lanes. Damage to Vehicle No. 1 is shown in Figure 16, and Figure 17 illustrates the damage to the crash cushion. The accident report indicates no injury to the

Figure 15. Schematic Sketch of Accident at Site No. 2 on June 17, 1969.

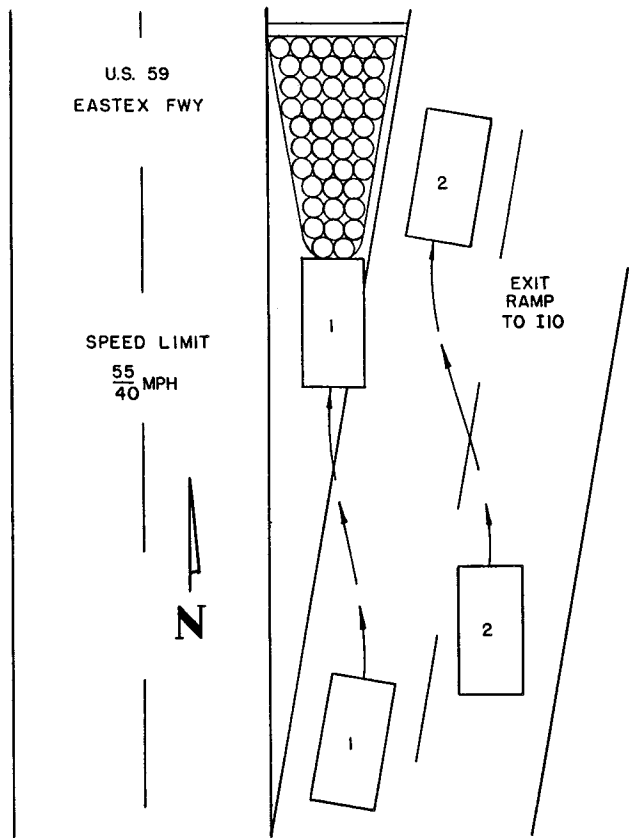
The next accident took place at Site No. 4 on June 22, 1969, at 4:45 a.m. The accident sequence, shown in Figure 18, illustrates the path of the colliding vehicle. Vehicle No. 2 cut in front of Vehicle No. 1 as Vehicle No. 2 changed lanes. The driver of Vehicle No. 1 reported hitting his brakes and skidding into the Modular Crash Cushion in a head-on attitude. Damages to Vehicle No. 1 are shown in the photograph in Figure 19, while damage to the crash cushion is shown in Figure 20. The accident report states that the weather was clear and road surface dry. There were no injuries in this accident.

Figure 18. Schematic Sketch of Accident at Site No. 4 on June 22, 1969.

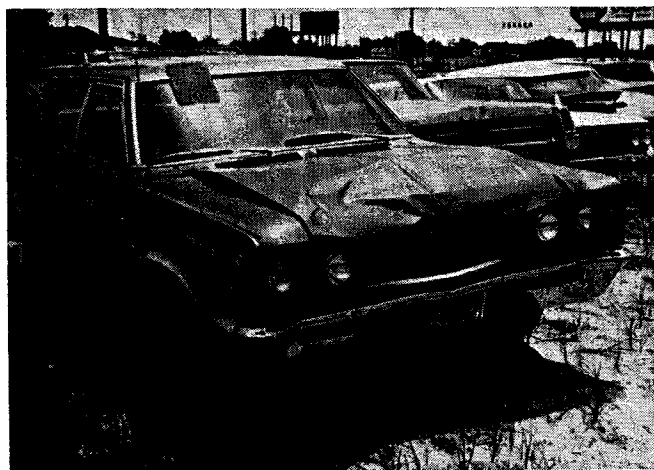
Figure 19. Vehicle Damage from Accident at Site No. 4 on June 22, 1969.

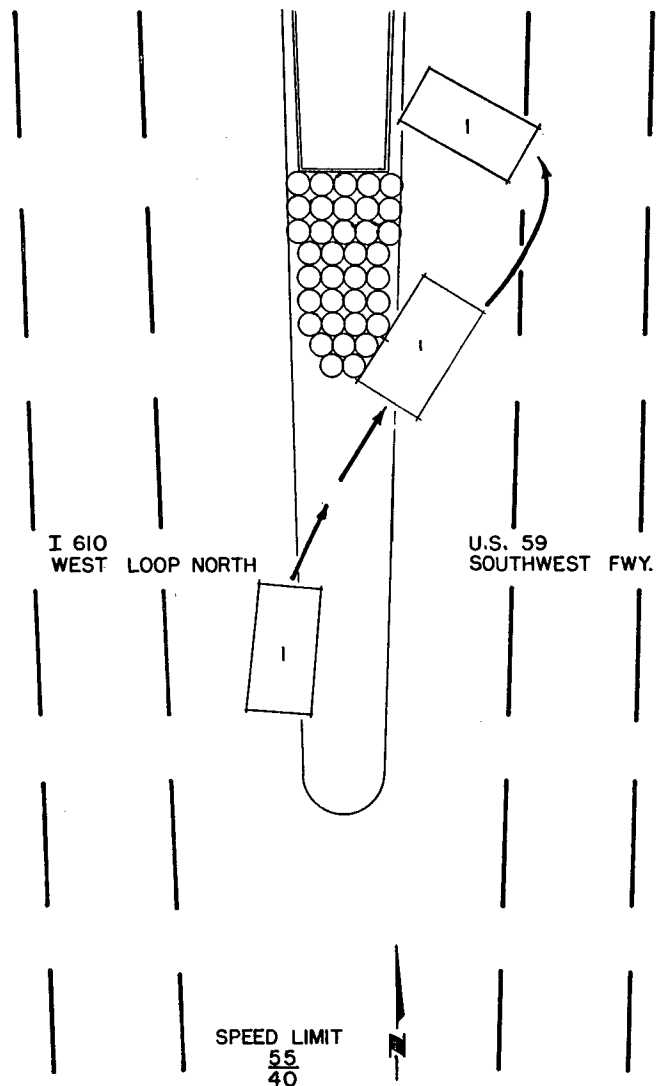
On September 4, 1969, at 2:15 a.m., a vehicle side-swiped the cushion at Site No. 1. The right rear of the vehicle impacted the left front of the cushion as shown in Figure 21. Damage to the cushion and vehicle are shown in Figure 22. The accident report indicates the driver was exceeding the speed limit by approximately 5 mph, made his exit maneuver too late, struck the crash cushion, but sustained no injuries. Also, the weather was clear and the pavement dry.

Figure 21. Schematic Sketch of Accident at Site No. 1 on September 4, 1969.

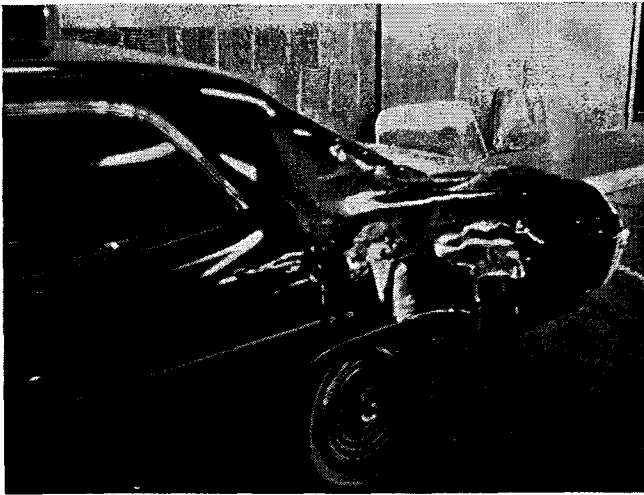
Vehicle Damage

Figure 22. Vehicle and Cushion Damage at Site No. 1 on September 4, 1969.

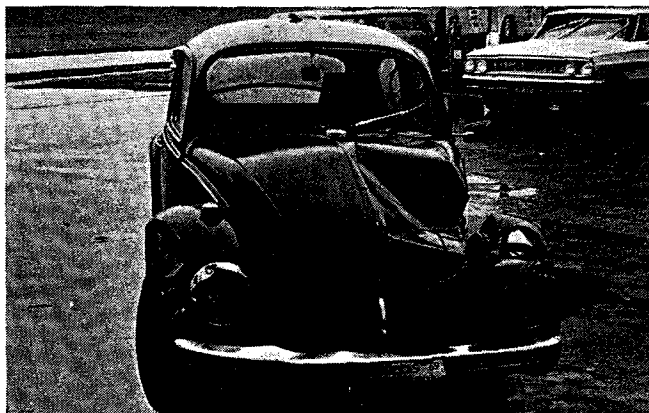
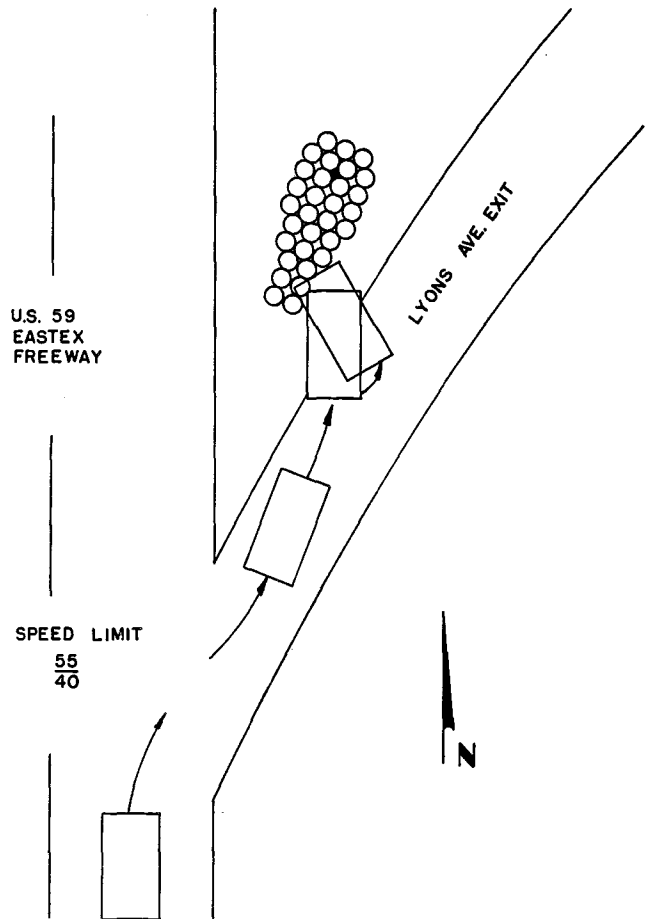
Figure 23. Sequential Sketch of Accident at Site No. 5 on October 4, 1969.

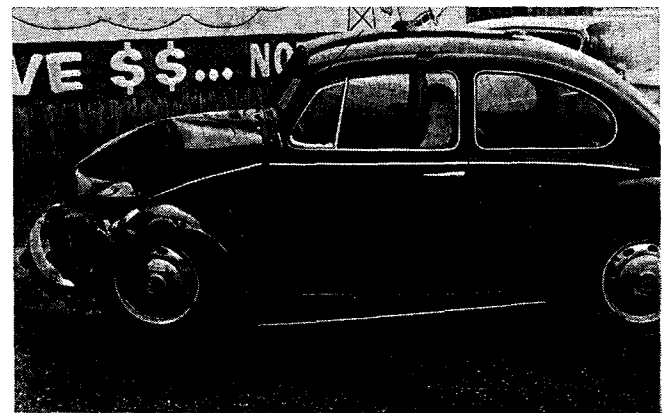
tained damages as shown in Figure 24. The accident sequence is sketched in Figure 23 as no photos of the cushion were available.

Figure 24. Vehicle Damage from Accident at Site No. 5 on October 4, 1969.

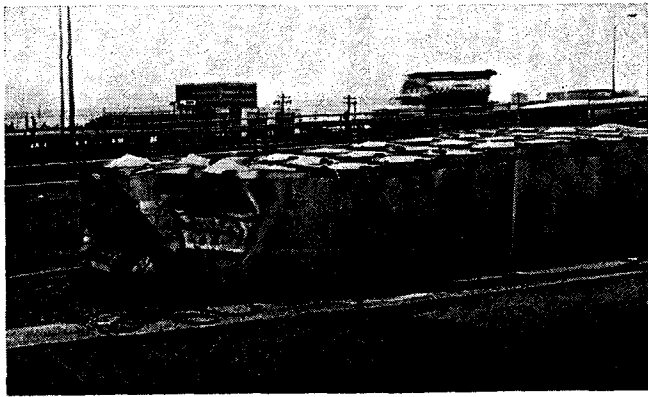
Cushion Damage at Site No. 2

On October 12, 1969, three Modular Crash Cushions were impacted. The accidents on this date at Sites 2 and 5 were minor head-on collisions by persons unknown. Figure 25 shows the cushion damages at these

Figure 25. Cushion Damage at Site Nos. 2 and 5 on October 12, 1969.

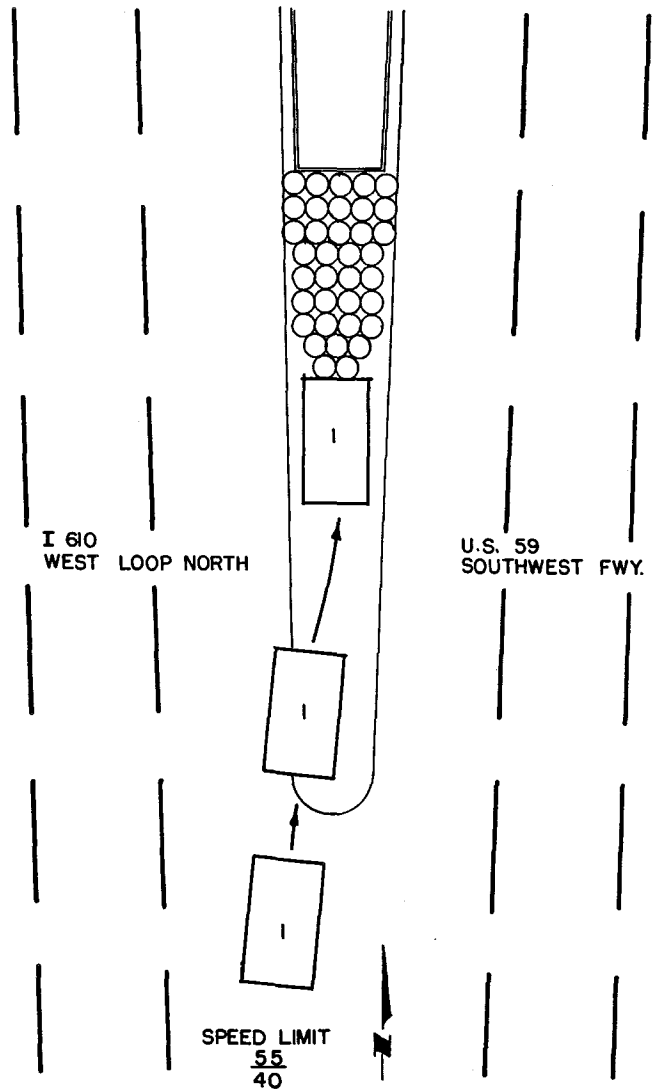
Figure 26 shows the sequential sketch of the colliding vehicle's path, while Figure 27 shows several photos of the damage to the vehicle. Figure 29 is a still photo from the surveillance camera and was taken during impact. Figure 30 indicates the complete crushing of the cushion. The crush energy of the barrel system was entirely used up to stop the vehicle and the vehicle itself crushed about 12 to 13 inches. This crash

Figure 26. Sequential Sketch of Accident at Site No. 1 on October 12, 1969.

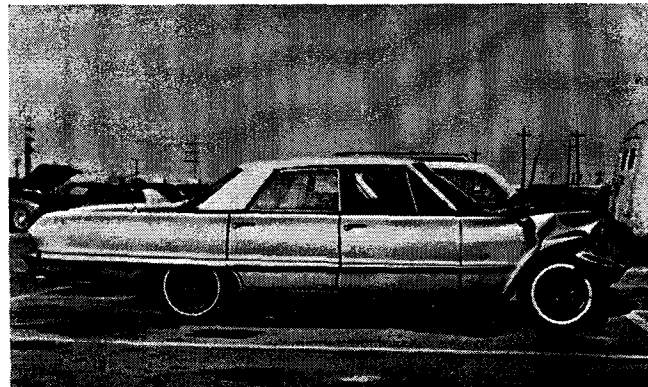
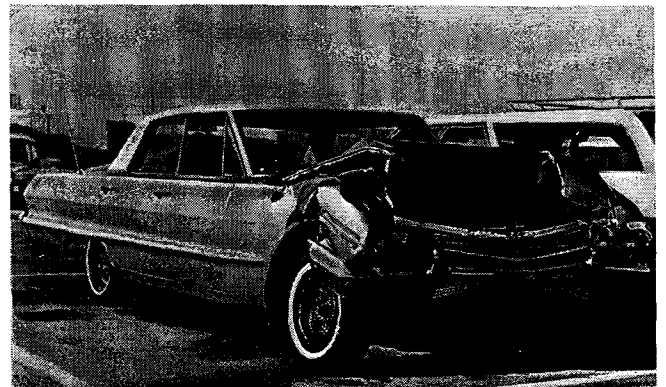
two sites. The accident at Site No. 1 on this date was a major head-on collision at an estimated impact speed of 70 mph. This estimated speed was based on the energy required to crush the 55-gallon drums. The vehicle came to a complete stop in approximately 17 ft.; consequently, the average deceleration of the vehicle was approximately 9.5 g's.

Figure 27. Vehicle Damage from Accident at Site No. 1 on October 12, 1969.

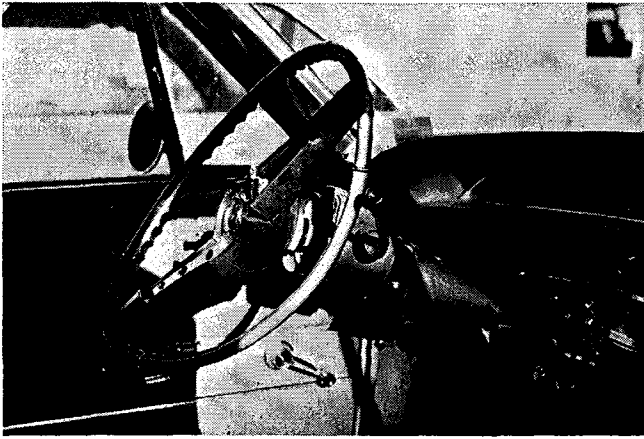
Even though neither the driver nor the passenger was wearing seat belts, their injuries were moderate. The driver received a broken nose and bruised ribs from impacting the steering wheel; Figure 28 shows the damaged steering wheel. The passenger received a broken collarbone.

Figure 28. Steering Wheel Damage from Accident at Site No. 1 on October 12, 1969.

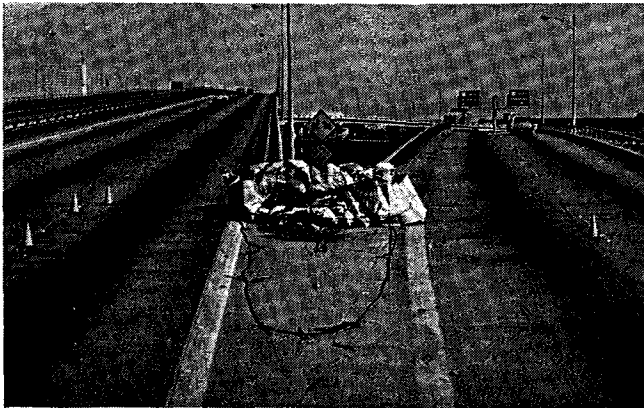
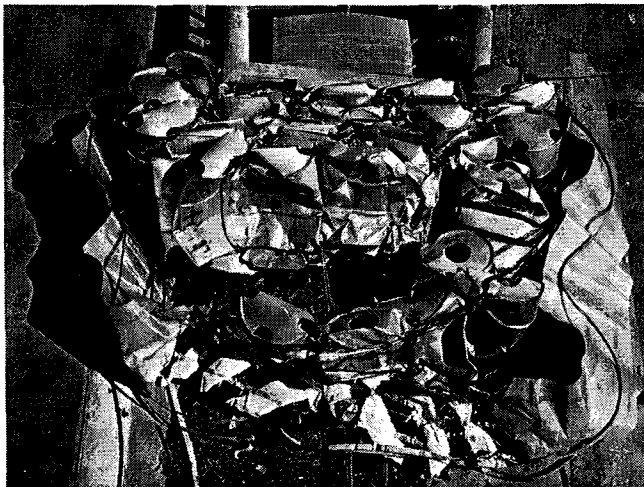
Figure 30. Cushion Damage from Accident at Site No. 1 on October 12, 1969.

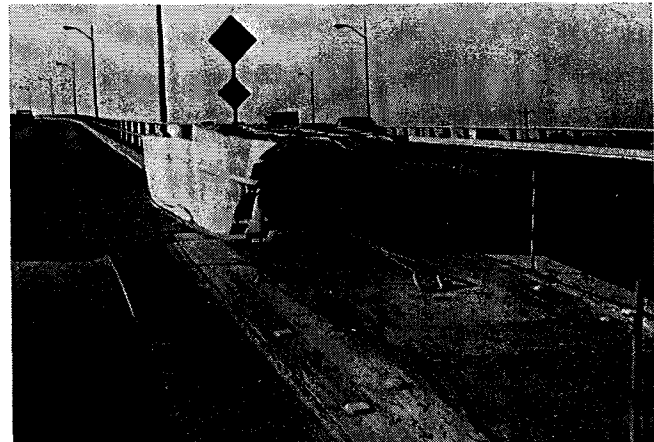
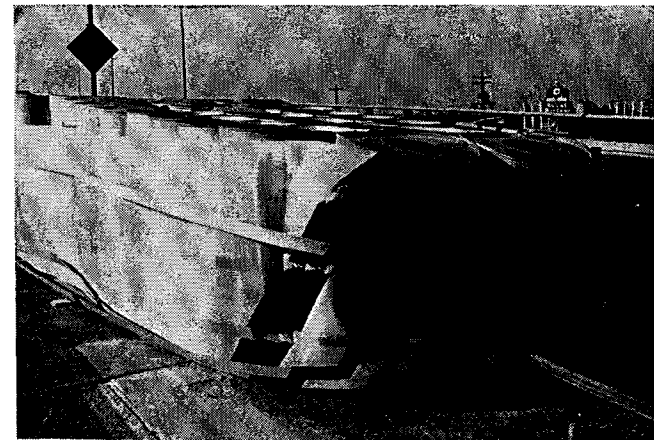
The thirteenth accident occurred at Site No. 2 on October 22, 1969. There was no information on the vehicle, but the cushion damage is shown in Figure 31 and indicates the collision was a minor head-on.

Figure 31. Cushion Damage from Accident at Site No. 2 on October 22, 1969.
