CRASH TEST OF MILE POST MARKER

Research Report Number 146-8

Studies of Field Adaption of Impact
Attenuation Systems

Texas Transportation Institute
Texas A&M University
College Station, Texas

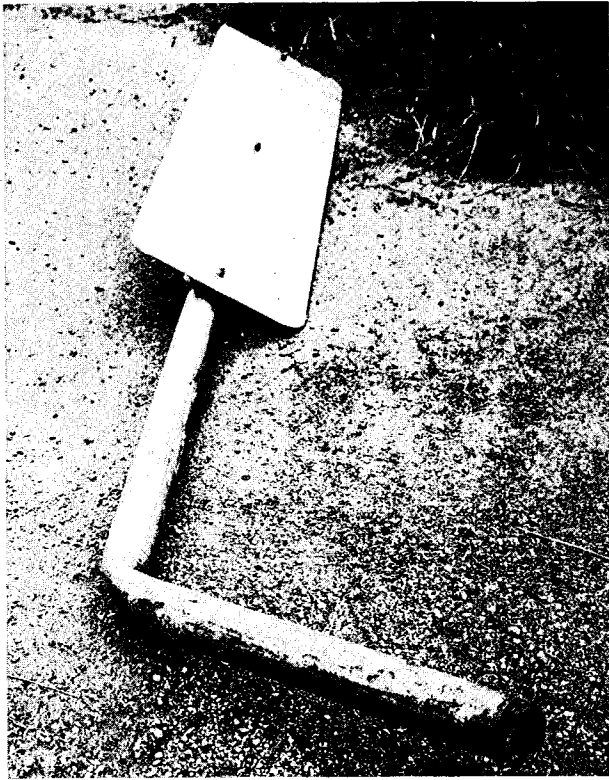
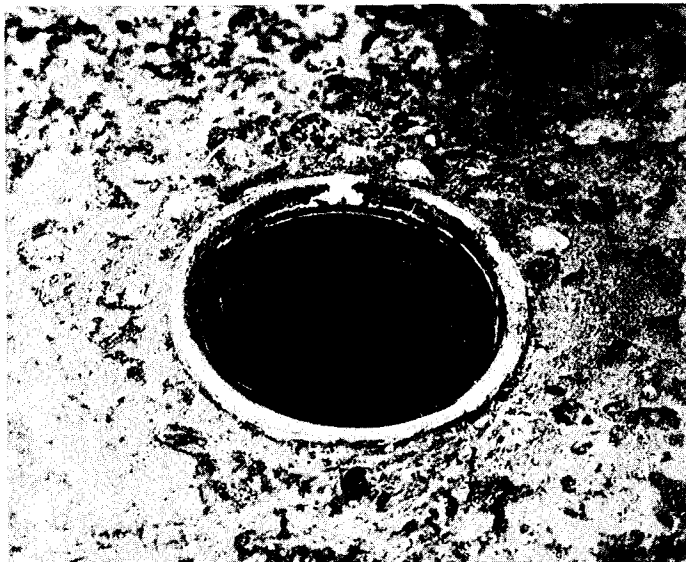
Figure 3. "After" photographs of mile post marker.

The standard threaded coupling breakaway feature resulted in only 1.6 mph change in vehicle velocity during impact. However, the behavior of the sign panel and post, which struck the windshield, is considered undesirable. The post buckled at the bumper height, the threaded end pulled out of the coupling, and the post and sign penetrated the windshield into the passenger compartment of the vehicle. Penetration through the windshield was estimated to have been about 3 in. and was reduced by the sign's contact with the vehicle's cowl, windshield, wiper assembly, and top of dash.

Modifications to the proposed mile post marker are certainly indicated in order to minimize the probability of a secondary impact into the windshield and passenger compartment.

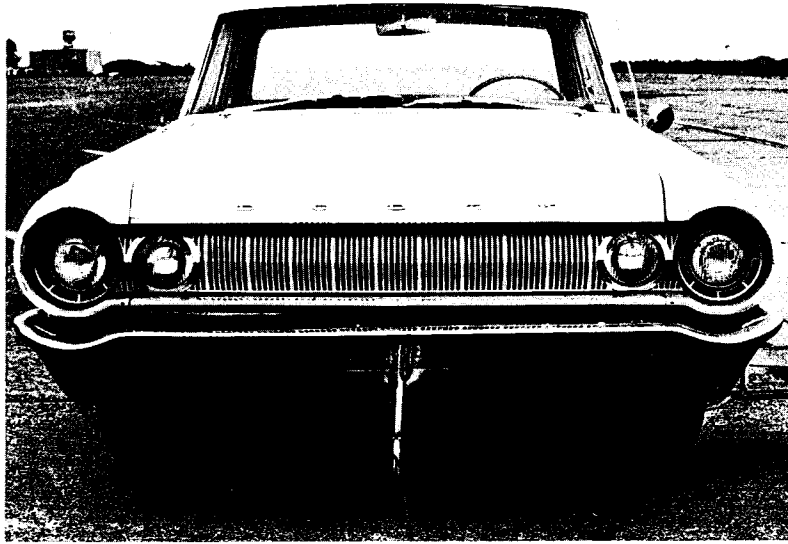
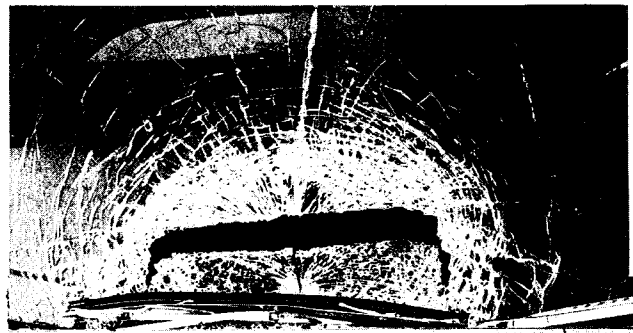
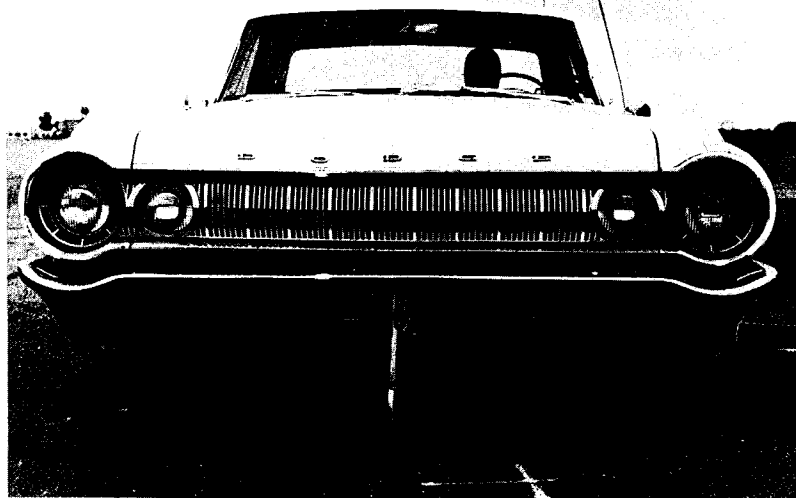
Figure 4. "Before" and "after" photographs of test vehicle.

The standard threaded coupling breakaway feature resulted in only 1.6 mph change in vehicle velocity during impact. However, the behavior of the sign panel and post, which struck the windshield, is considered undesirable. Penetration through the windshield was estimated to have been about 3 in. and was reduced by the sign's contact with the vehicle's cowl, windshield, wiper assembly and top of dash.

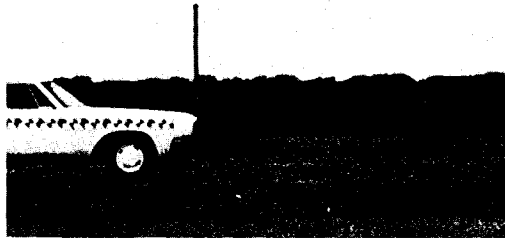
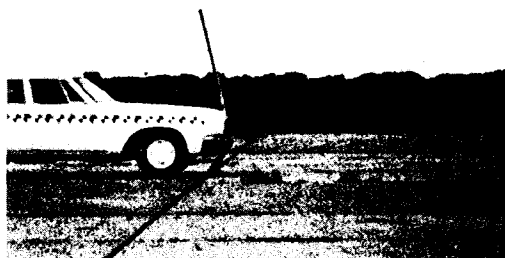
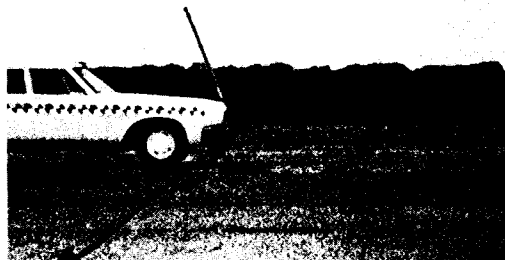
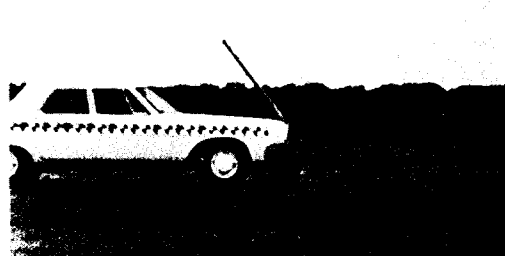
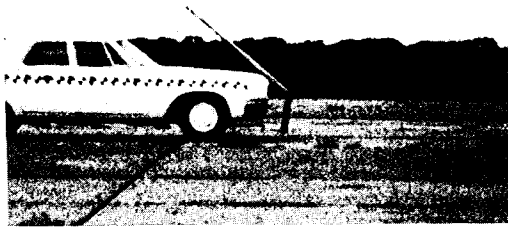
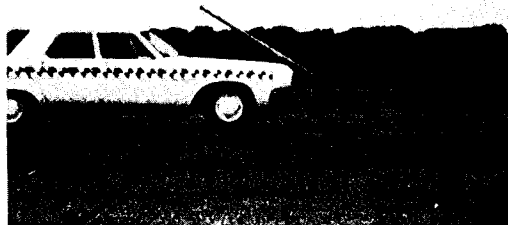
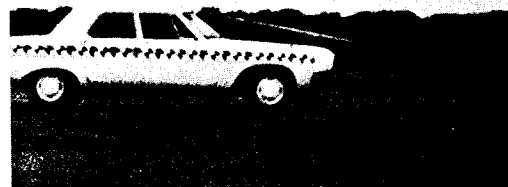
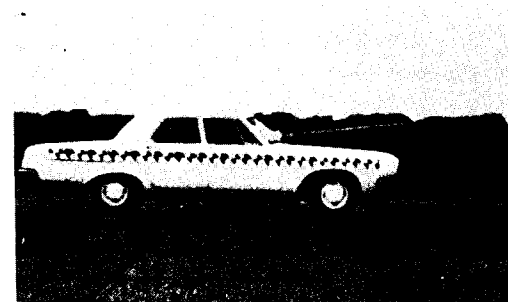
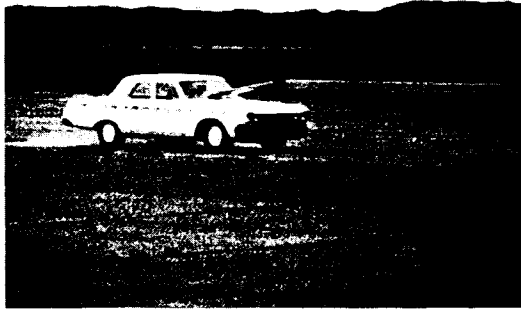
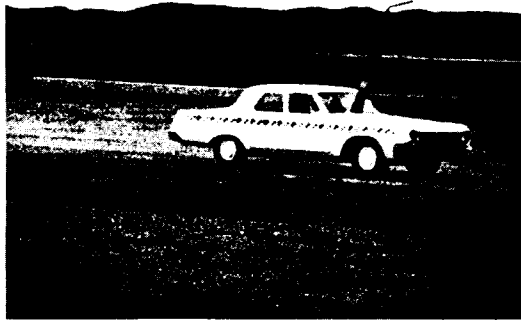
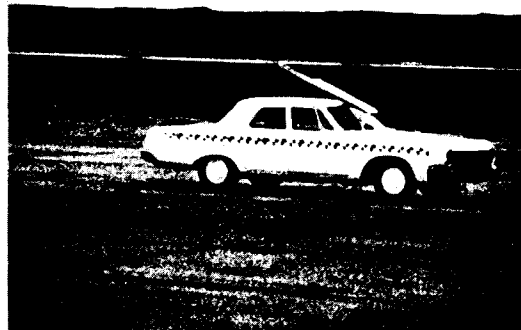
Figure 5. Sequence photographs from high-speed film.

The standard threaded coupling breakaway feature resulted in only 1.6 mph change in vehicle velocity during impact. However, the behavior of the sign panel and post, which struck the windshield, is considered undesirable. As can be observed from the sequence photographs in Figure 5, after the post buckled at the bumper height and the threaded end pulled out of the coupling, the post and sign penetrated the windshield into the passenger compartment of the vehicle. Penetration through the windshield was estimated to have been about 3 in. and was reduced by the sign's contact with the vehicle's cowling, windshield, wiper assembly and top of dash.
